**PHASE I
ENVIRONMENTAL SITE ASSESSMENT**

FORMER McLOUTH STEEL FACILITY

**1491 WEST JEFFERSON AVENUE
TRENTON, MICHIGAN 48183**

August 8, 2017

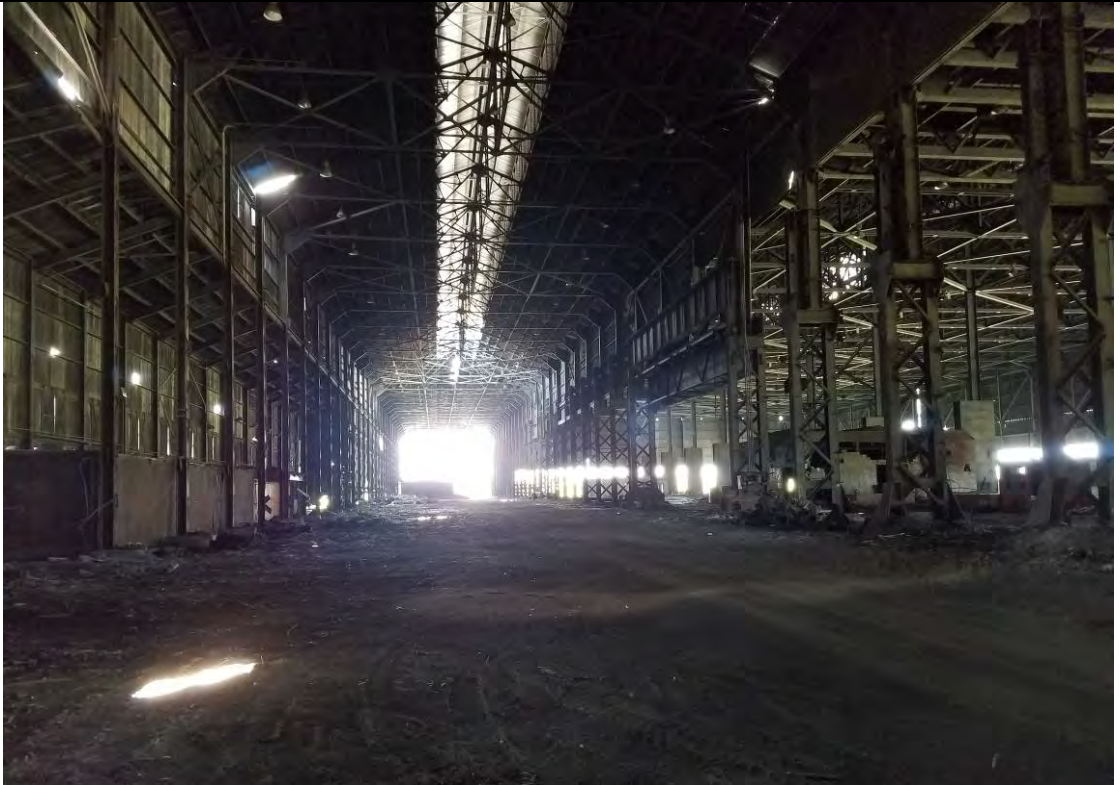
Client Name: City of Trenton		Site Location: 1491 W. Jefferson Avenue, Trenton, MI 48183	Project No. 170443-0100
Photo No. 25	Date: 7/17/17

Direction Photo Taken: North			
Description: Area 2 General interior view of north end of Soaking Pit Building.

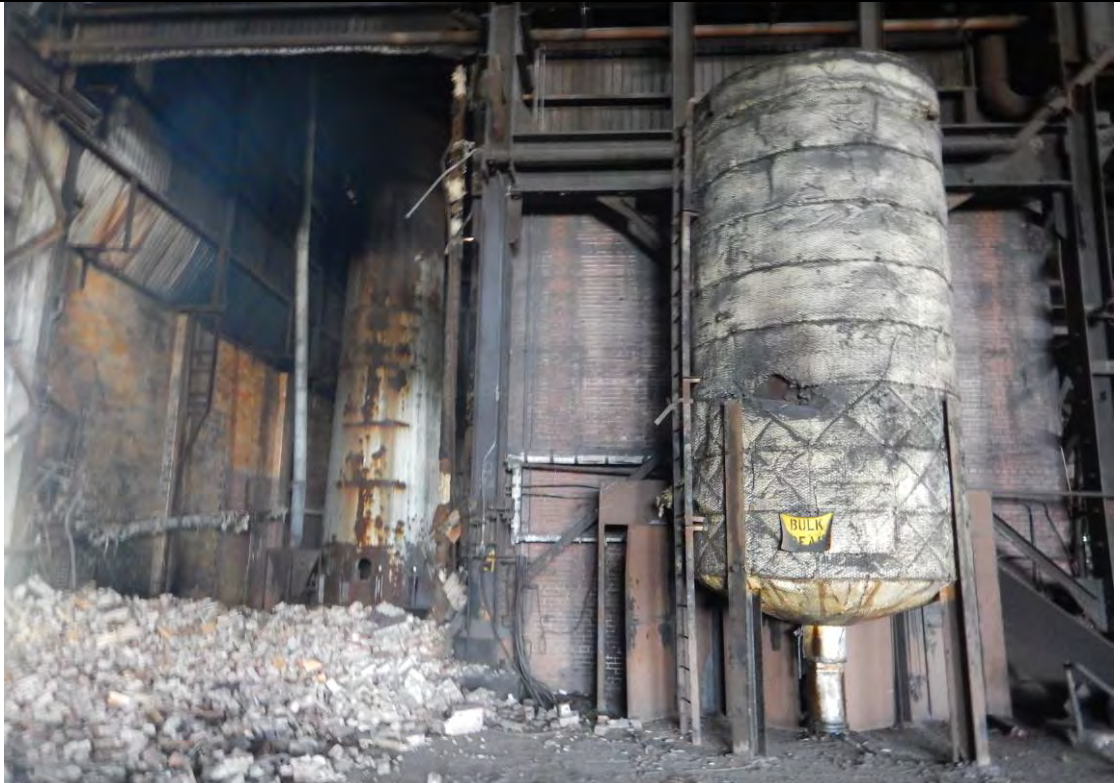
Client Name: City of Trenton		Site Location: 1491 W. Jefferson Avenue, Trenton, MI 48183	Project No. 170443-0100
Photo No. 27	Date: 7/21/17

Direction Photo Taken: West			
Description: Area 2 Bulk Grease AST near north end of Rolling Mill Building. South stack of former furnace visible in left background.

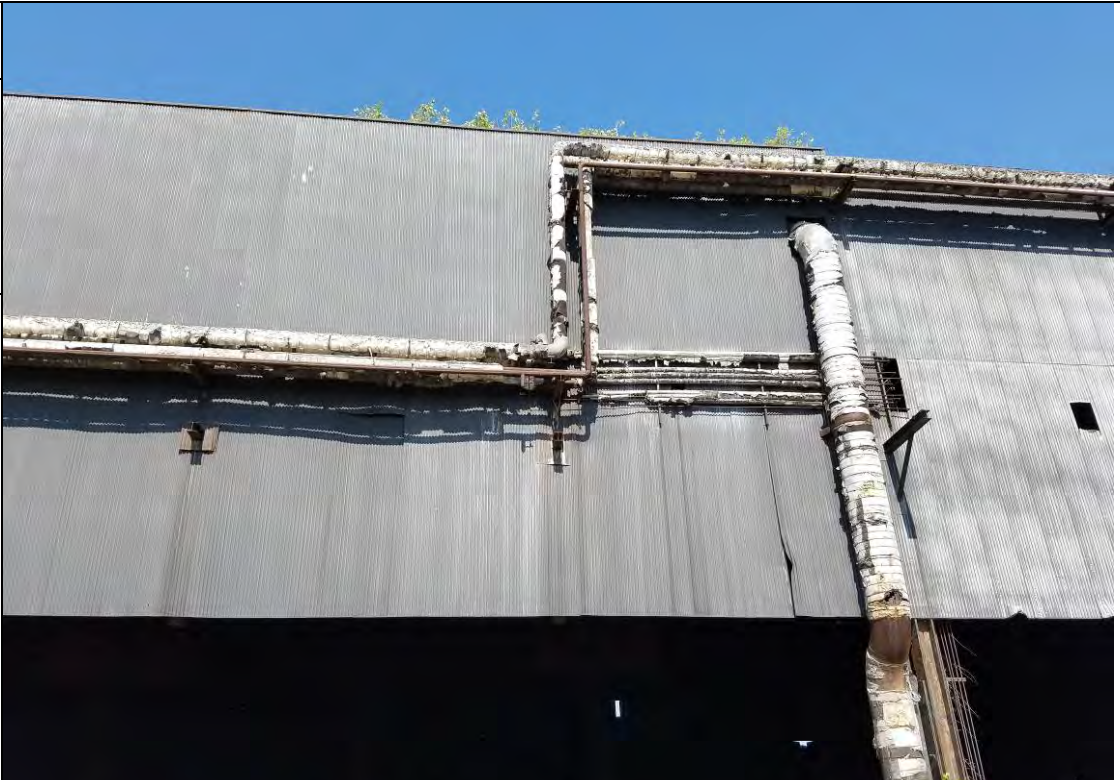
Photo No. 28	Date: 7/17/17

Direction Photo Taken: West		
Description: Area 2 General building exterior of Slab Handling and Storage Building showing potential ACM covered pipes and ducts.

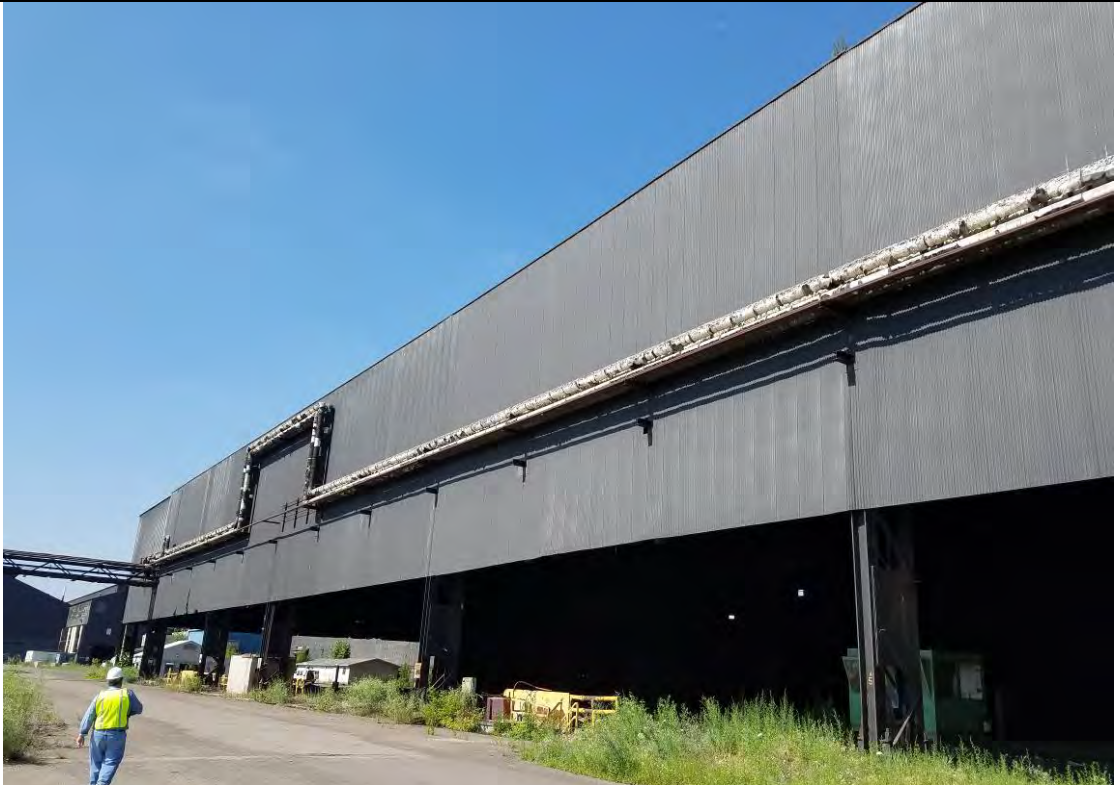
Client Name: City of Trenton		Site Location: 1491 W. Jefferson Avenue, Trenton, MI 48183	Project No. 170443-0100
Photo No. 29	Date: 7/17/17

Direction Photo Taken: Southwest			
Description: Area 2 Same as Photo No. 28 from different perspective.

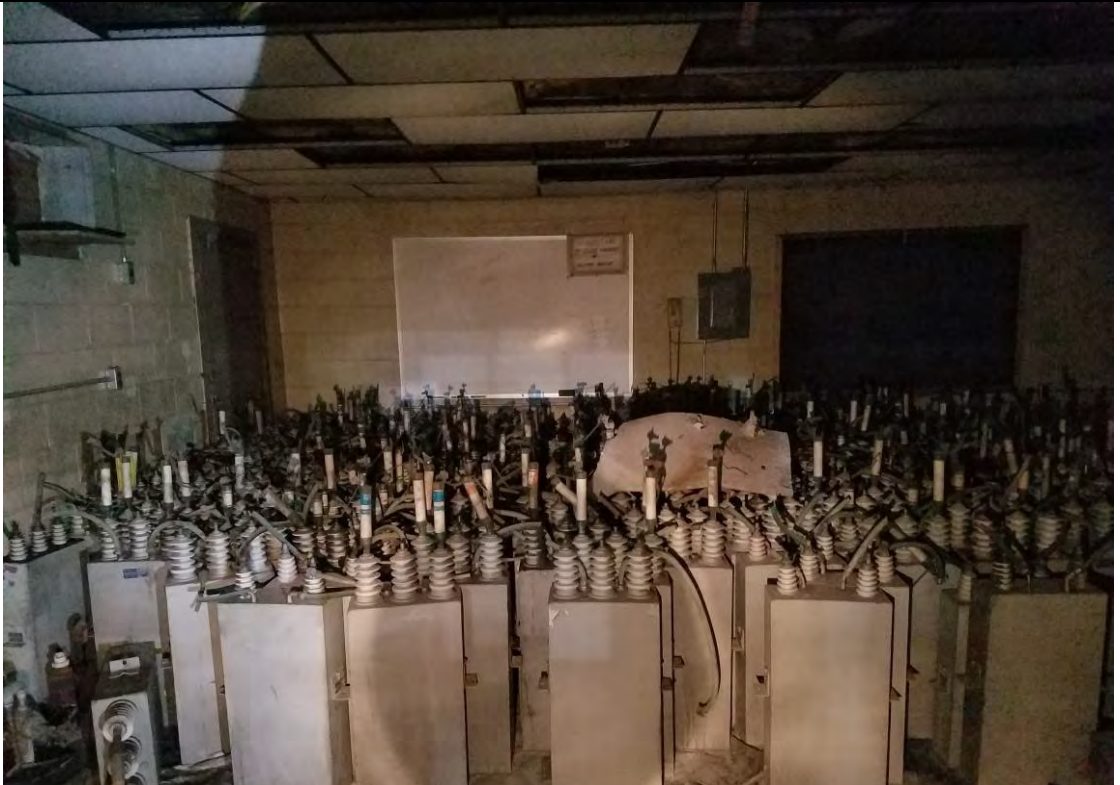
Client Name: City of Trenton		Site Location: 1491 W. Jefferson Avenue, Trenton, MI 48183	Project No. 170443-0100
Photo No. 35	Date: 7/17/17

Direction Photo Taken: East			
Description: Area 2 Non-PCB capacitors stored in "PCB" placarded building west of AST/drum staging area in Slab Handling and Storage Building.

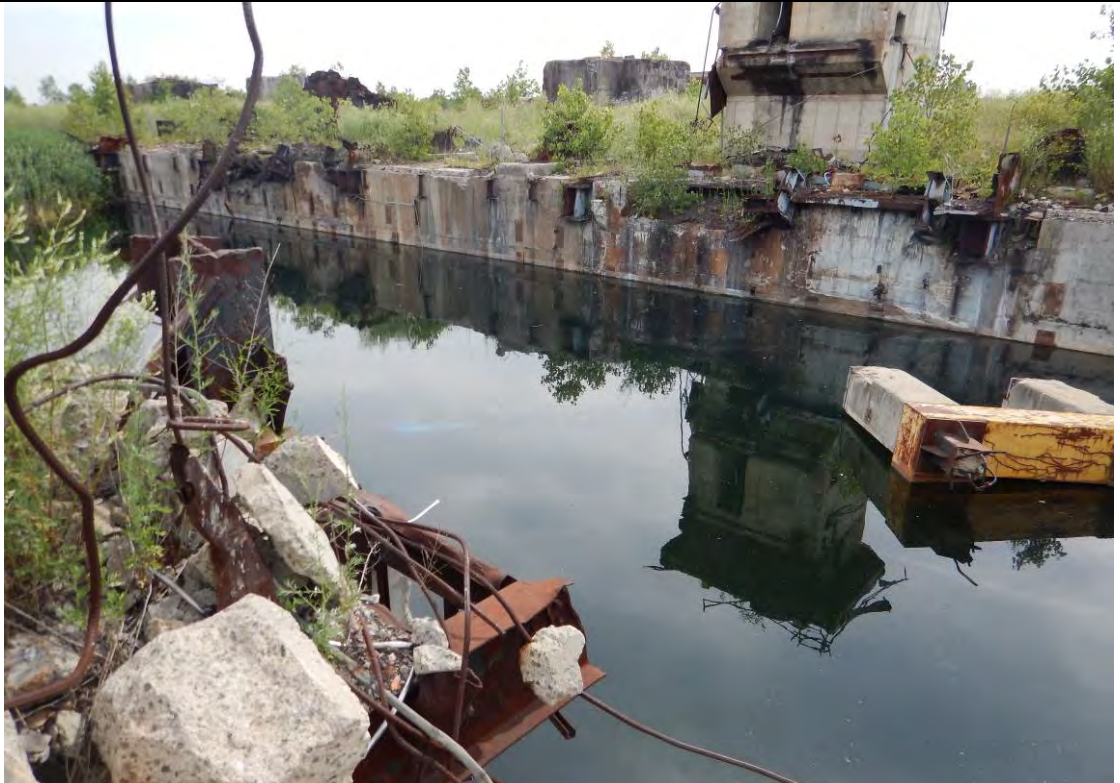
Client Name: City of Trenton		Site Location: 1491 W. Jefferson Avenue, Trenton, MI 48183	Project No. 170443-0100
Photo No. 47	Date: 7/21/17

Direction Photo Taken: Northeast			
Description: Area 2 Recirculation basin in lower level of former Continuous Casting Building.

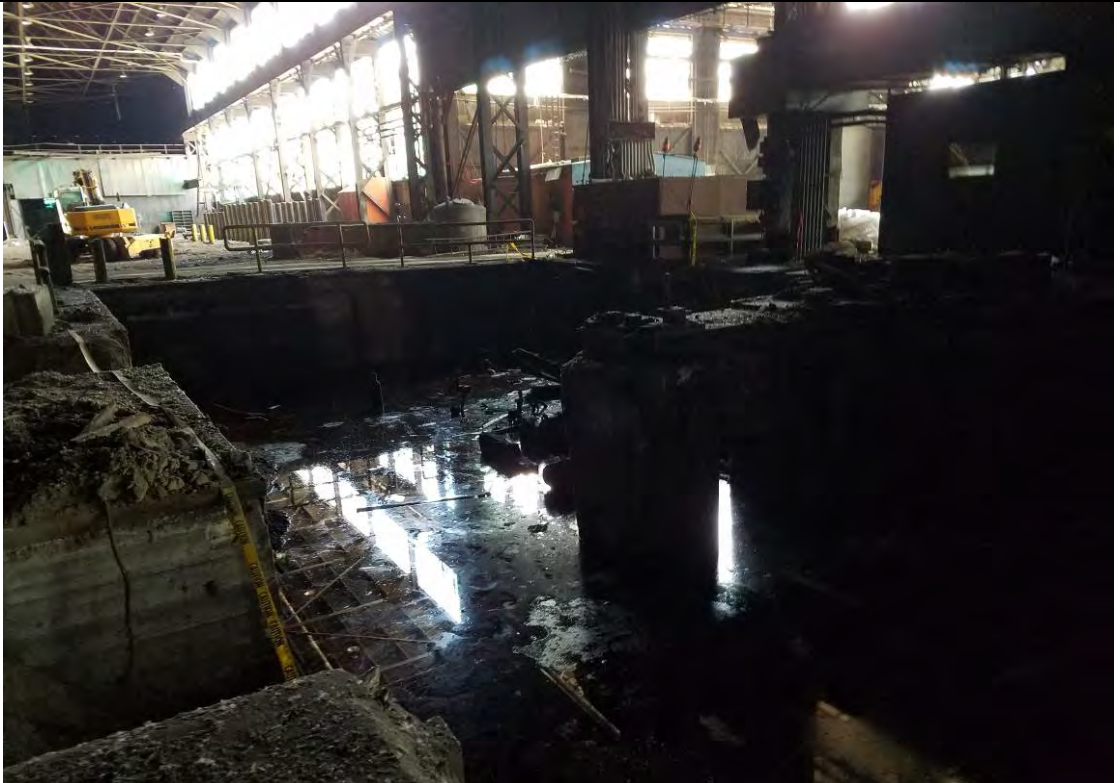
Client Name: City of Trenton		Site Location: 1491 W. Jefferson Avenue, Trenton, MI 48183	Project No. 170443-0100
Photo No. 49	Date: 7/17/17

Direction Photo Taken: Southwest			
Description: Area 2 Down Coiler Sump area. Oily water and drums and compressed gas cylinders sitting in the water.

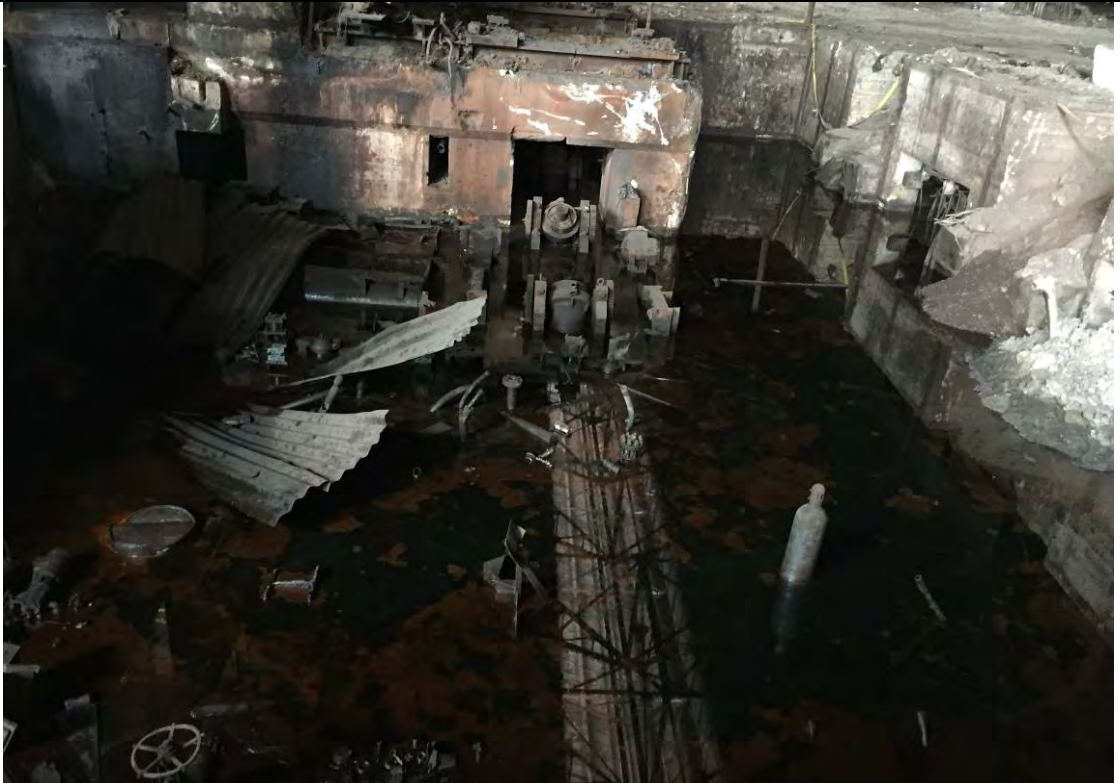
Client Name: City of Trenton		Site Location: 1491 W. Jefferson Avenue, Trenton, MI 48183	Project No. 170443-0100
Photo No. 51	Date: 7/17/17

Direction Photo Taken: North			
Description: Area 2 Same as Photo No. 49 – Note oil covered water, compressed gas cylinder, drum (at left) and flooded equipment.

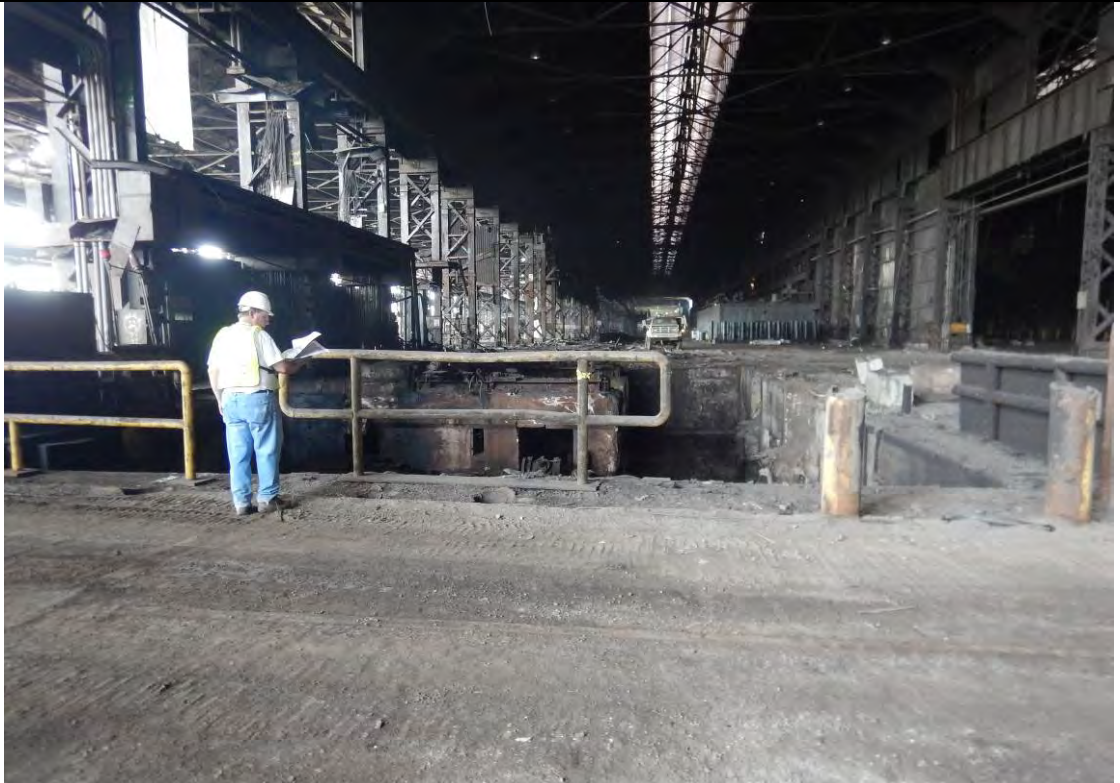
Client Name: City of Trenton		Site Location: 1491 W. Jefferson Avenue, Trenton, MI 48183	Project No. 170443-0100
Photo No. 53	Date: 7/21/17

Direction Photo Taken: North			
Description: Area 2 Down Coiler Sump from floor level - same as Photo No. 49

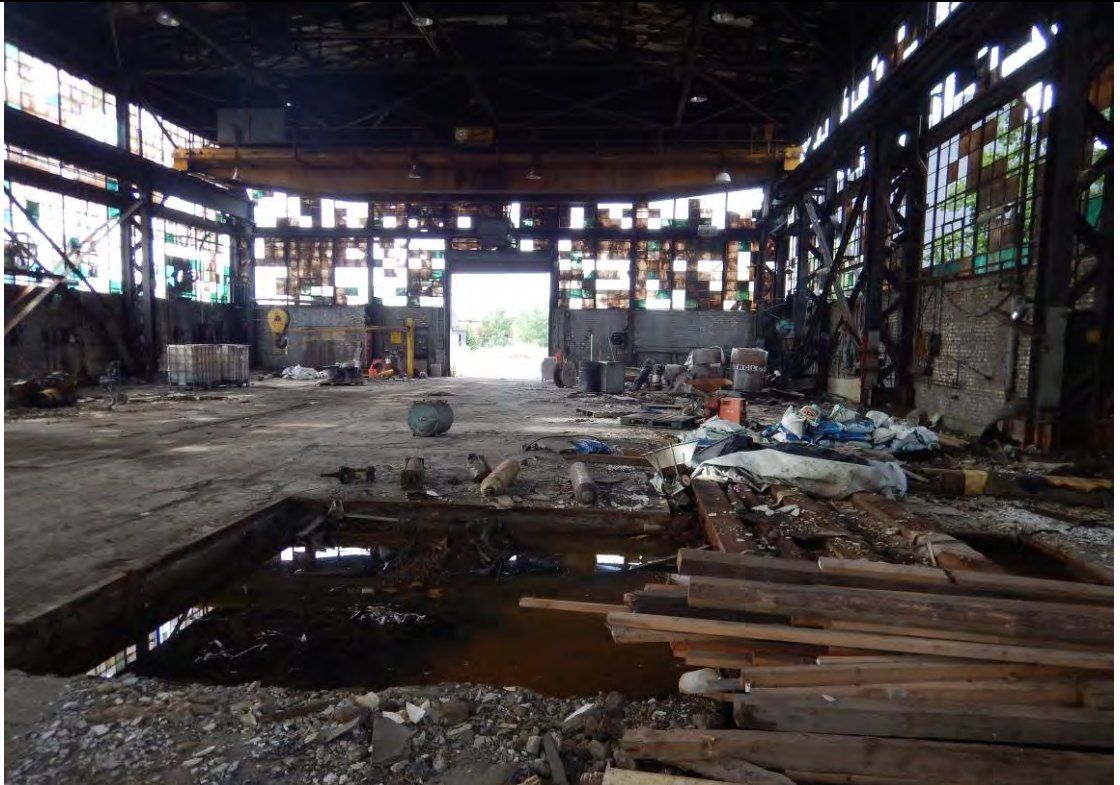
Client Name: City of Trenton		Site Location: 1491 W. Jefferson Avenue, Trenton, MI 48183	Project No. 170443-0100
Photo No. 61	Date: 7/21/17

Direction Photo Taken: North			
Description: Area 2 Same as Photo No. 59. Hoist or lift pit in foreground.

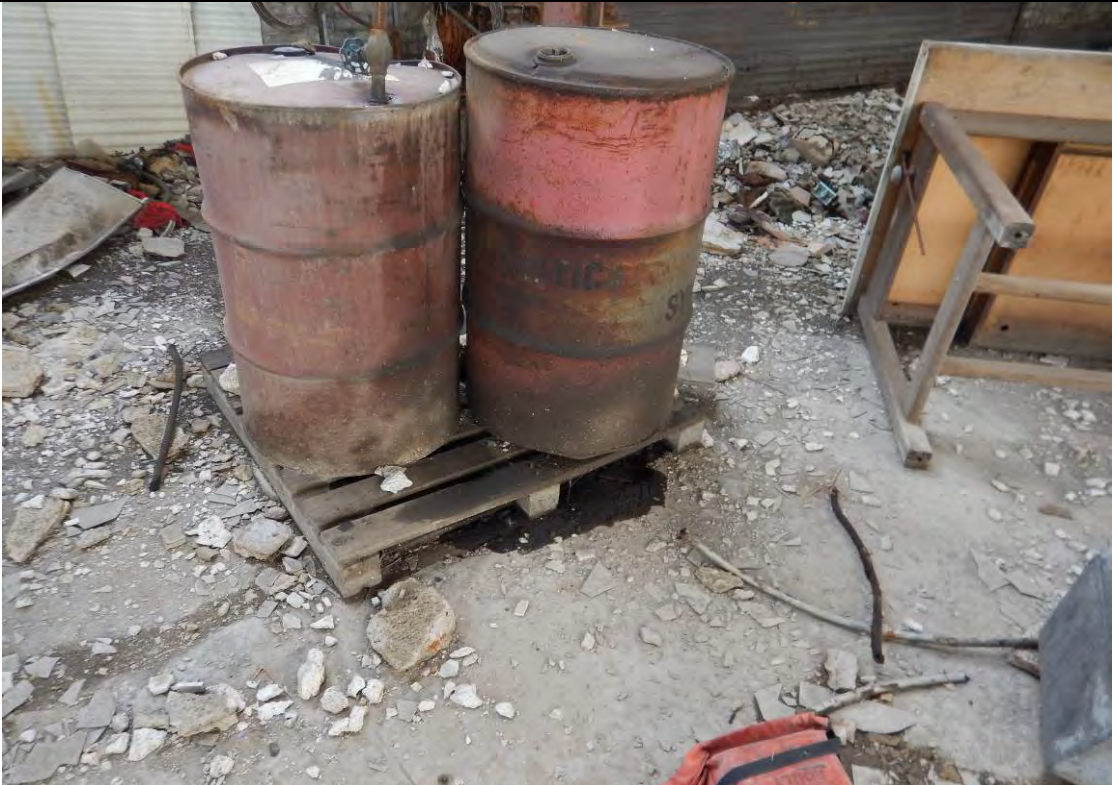
Client Name: City of Trenton		Site Location: 1491 W. Jefferson Avenue, Trenton, MI 48183	Project No. 170443-0100
Photo No. 65	Date: 7/21/17

Direction Photo Taken: Northwest			
Description: Area 2 Close up of leaking drums in Photo No. 64.

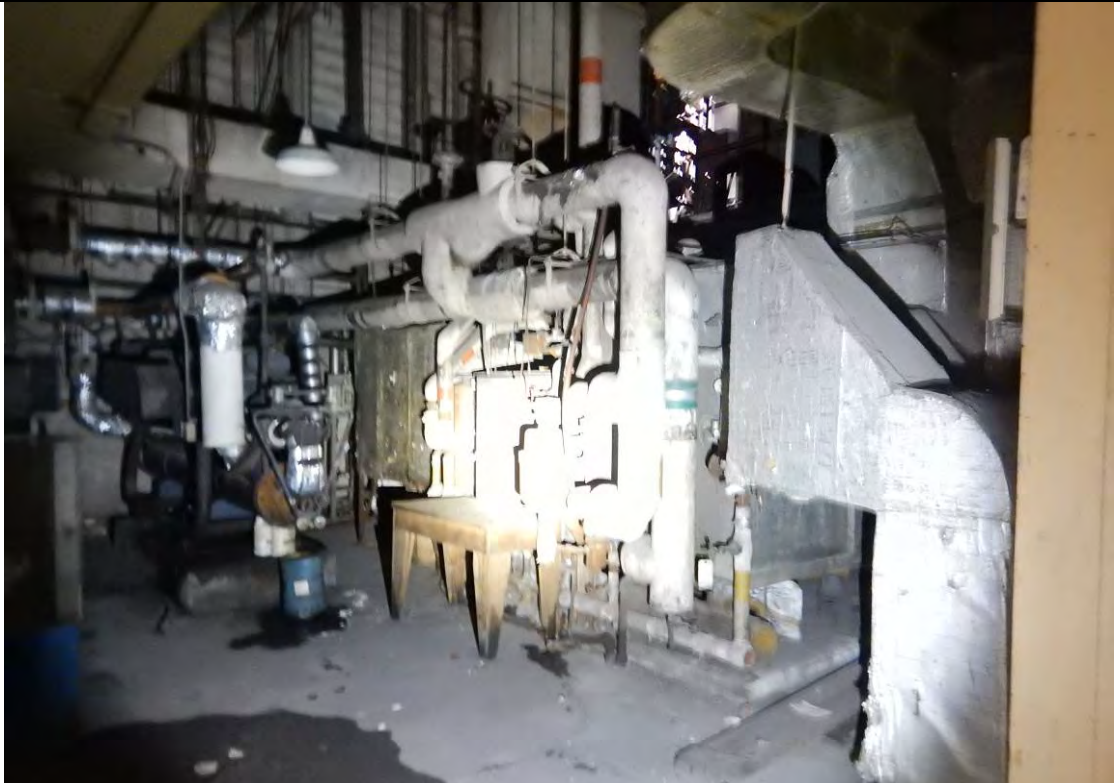
Client Name: City of Trenton		Site Location: 1491 W. Jefferson Avenue, Trenton, MI 48183	Project No. 170443-0100
Photo No. 67	Date: 7/21/17

Direction Photo Taken: Southeast			
Description: Area 2 Boiler in separate room at north end of Machine Shop Building with possible ACM insulation on pipes and ducts.

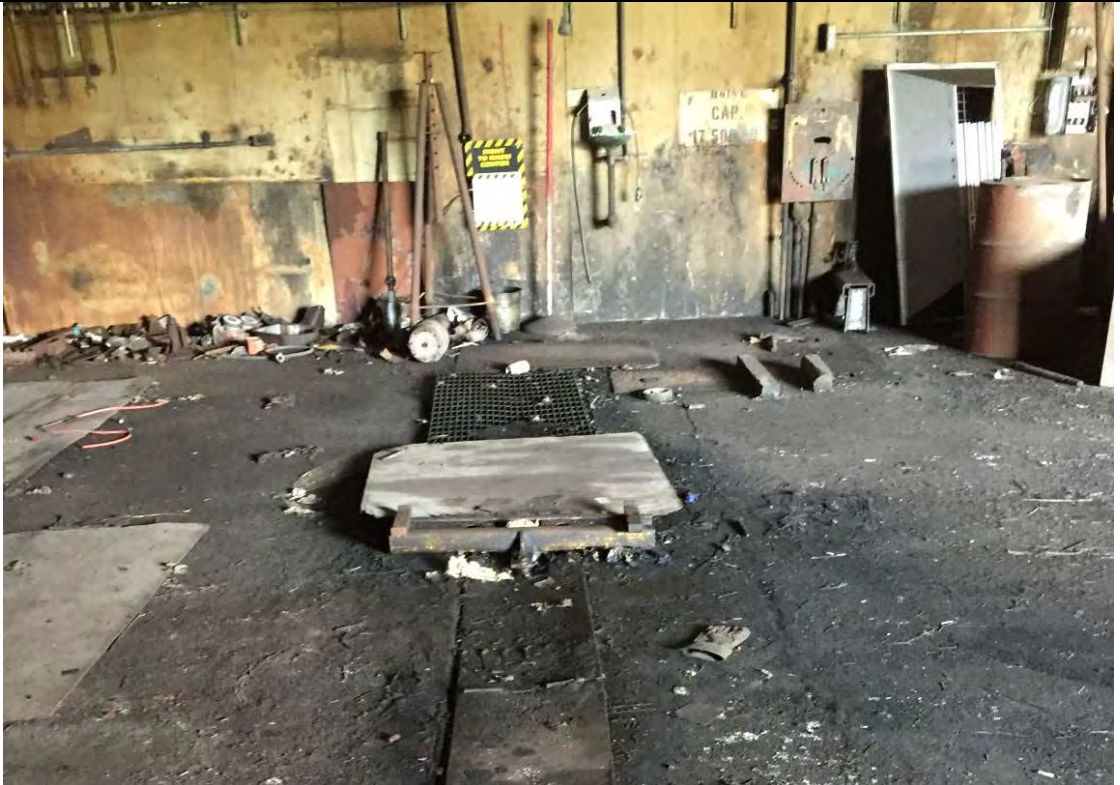
Client Name: City of Trenton		Site Location: 1491 W. Jefferson Avenue, Trenton, MI 48183	Project No. 170443-0100
Photo No. 71	Date: 7/17/17

Direction Photo Taken: East			
Description: Area 2 Mobile Equipment Building – truck lift with dark oil visible under grate at east end of lift trench.

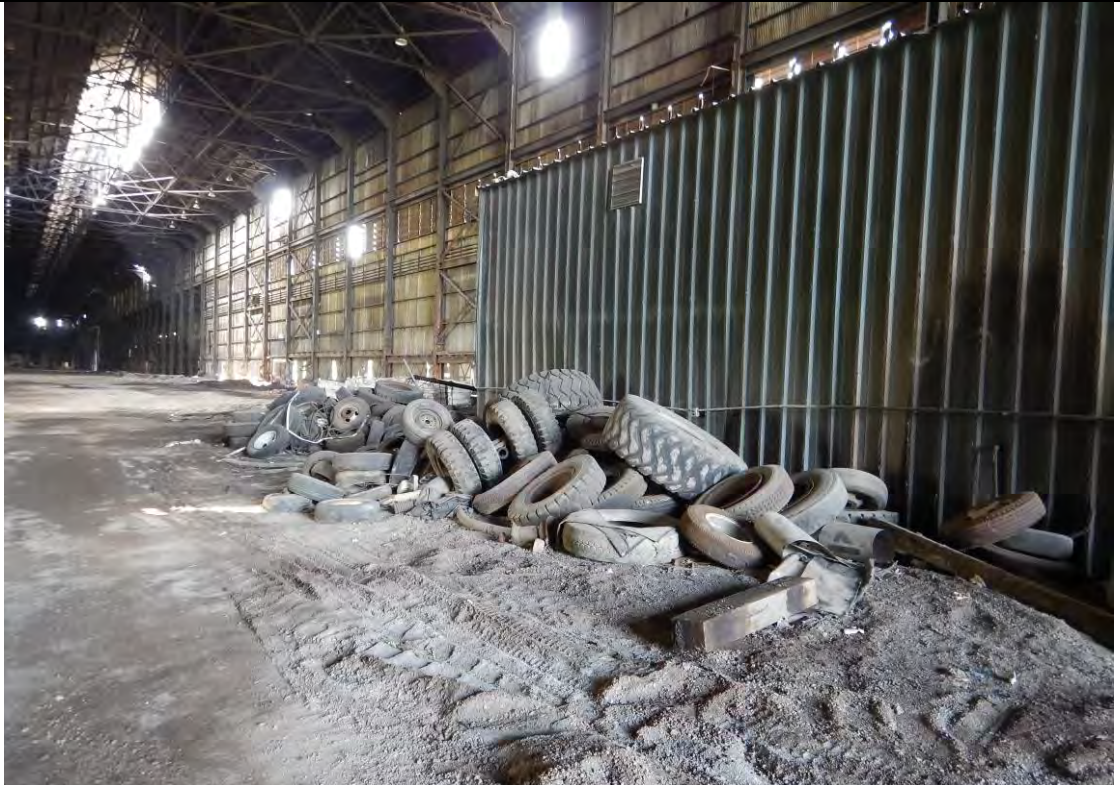
Client Name: City of Trenton		Site Location: 1491 W. Jefferson Avenue, Trenton, MI 48183	Project No. 170443-0100
Photo No. 73	Date: 7/21/17

Direction Photo Taken: South			
Description: Area 2 Outer wall of Mobil Equipment Building (not shown on map). Building protrudes into Soaking Pit Building. Numerous old tires outside wall.

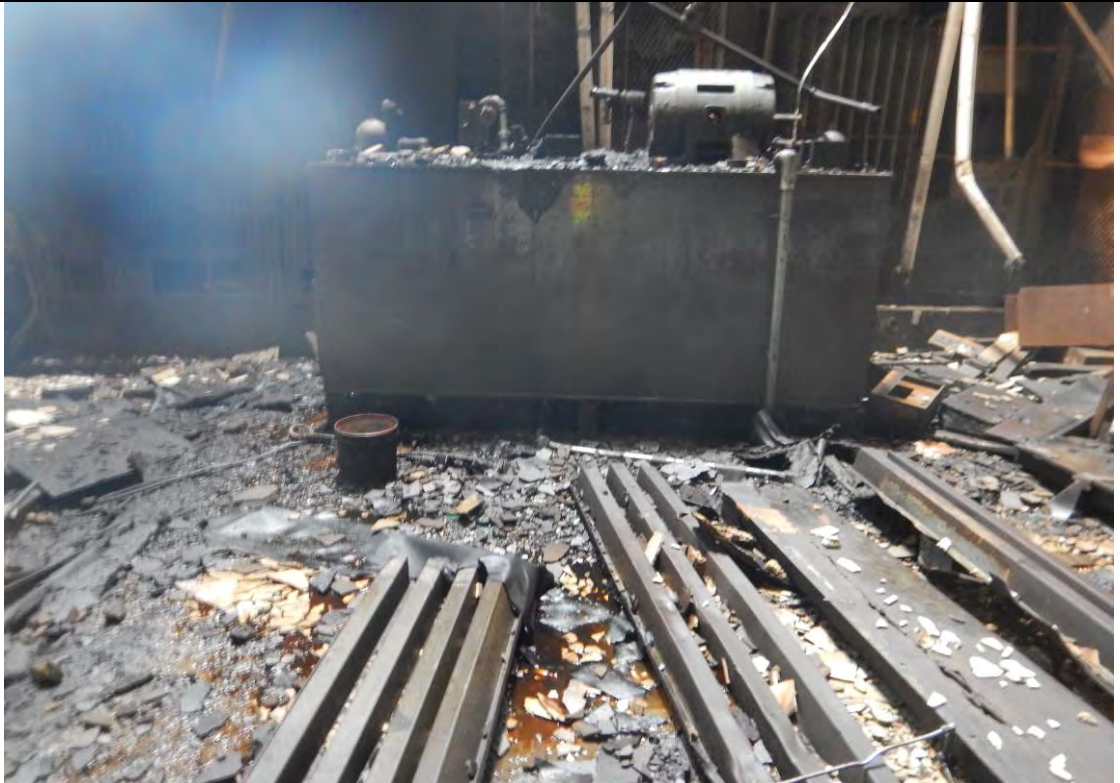
Client Name: City of Trenton		Site Location: 1491 W. Jefferson Avenue, Trenton, MI 48183	Project No. 170443-0100
Photo No. 75	Date: 7/21/17

Direction Photo Taken: West			
Description: Area 2 Oily AST with oil on floor in No. 2 Finishing and Shipping Building.

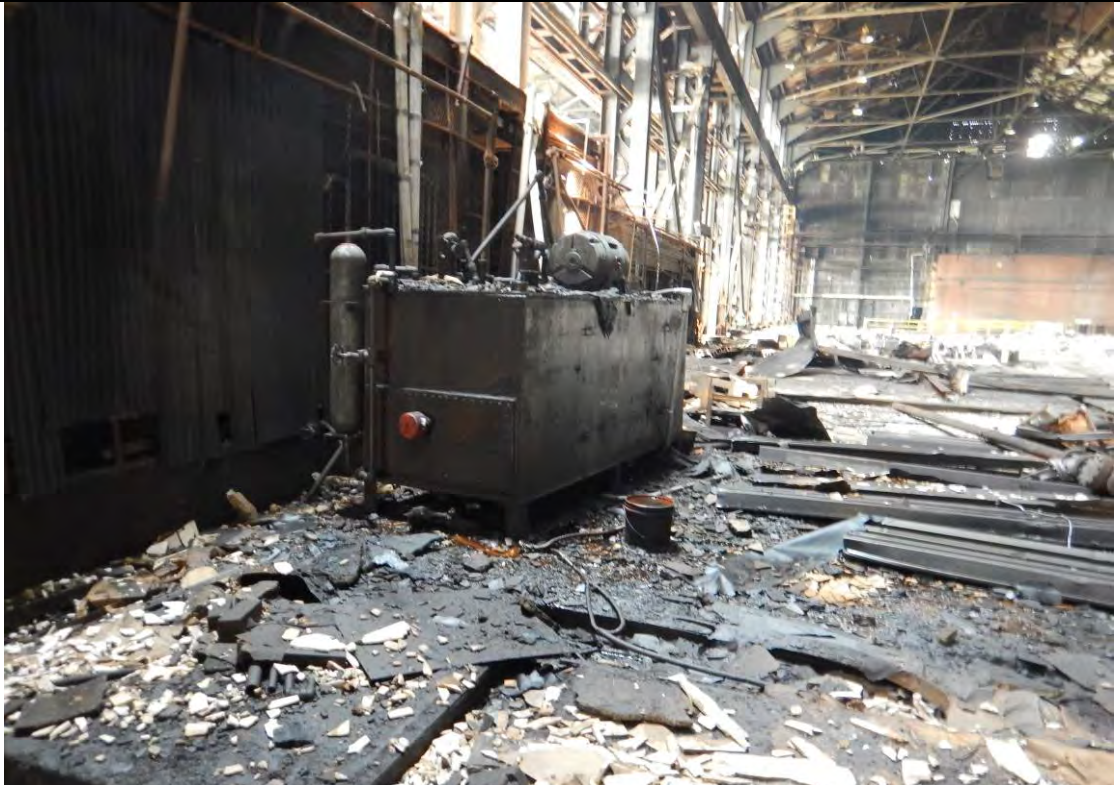
Client Name: City of Trenton		Site Location: 1491 W. Jefferson Avenue, Trenton, MI 48183	Project No. 170443-0100
Photo No. 77	Date: 7/21/17

Direction Photo Taken: North			
Description: Area 2 Same as Photo No. 75 from different perspective. Railing for Coil Transfer Tunnel visible in background against far wall.

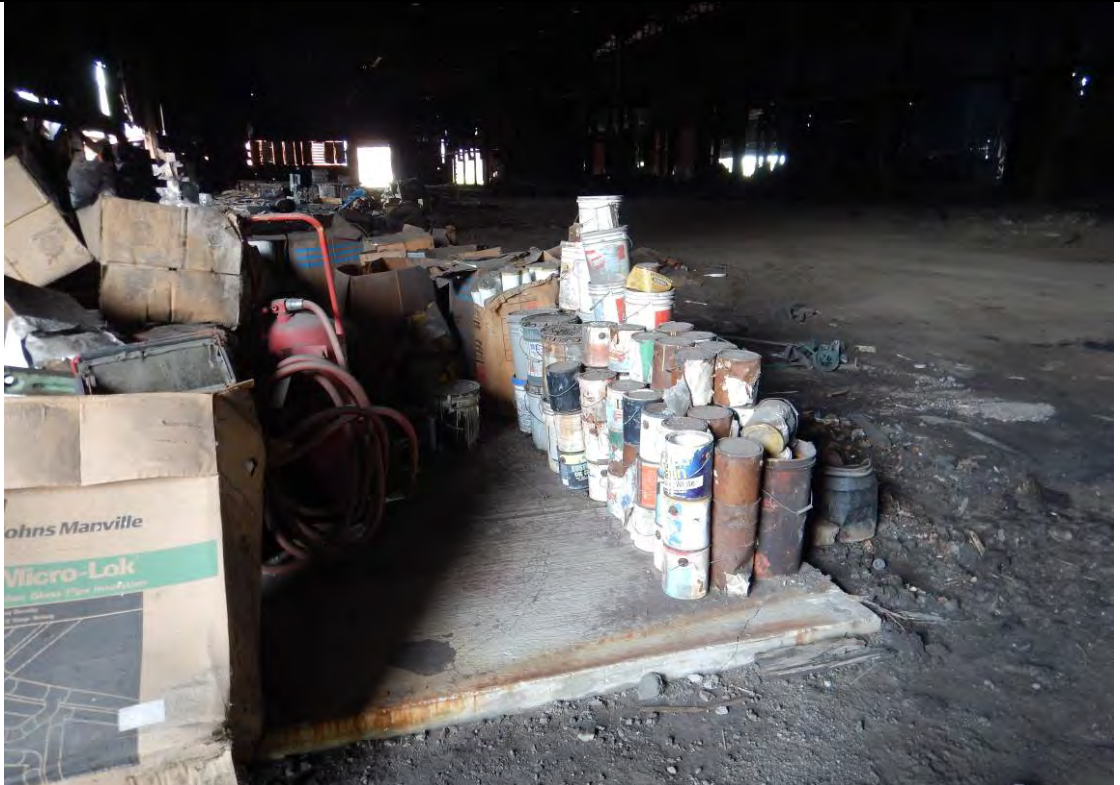
Client Name: City of Trenton		Site Location: 1491 W. Jefferson Avenue, Trenton, MI 48183	Project No. 170443-0100
Photo No. 79	Date: 7/21/17

Direction Photo Taken: North			
Description: Area 2 Cans of paint, adhesives, cans, hydraulic cement and other materials on pallets at southwest corner of Slab Conditioning Building.

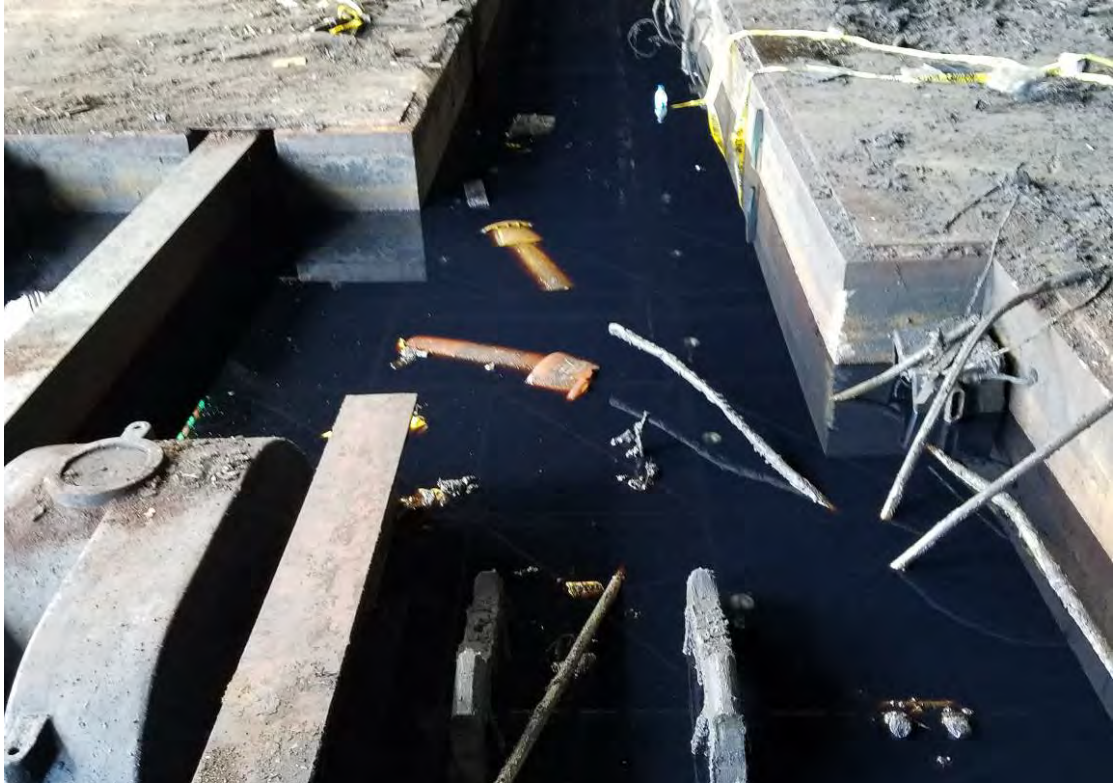
Client Name: City of Trenton		Site Location: 1491 W. Jefferson Avenue, Trenton, MI 48183	Project No. 170443-0100
Photo No. 85	Date: 7/17/17

Direction Photo Taken: South			
Description: Area 2 Same as Photo No. 83 - trenches at end of Pickling Line filled with oil and debris.

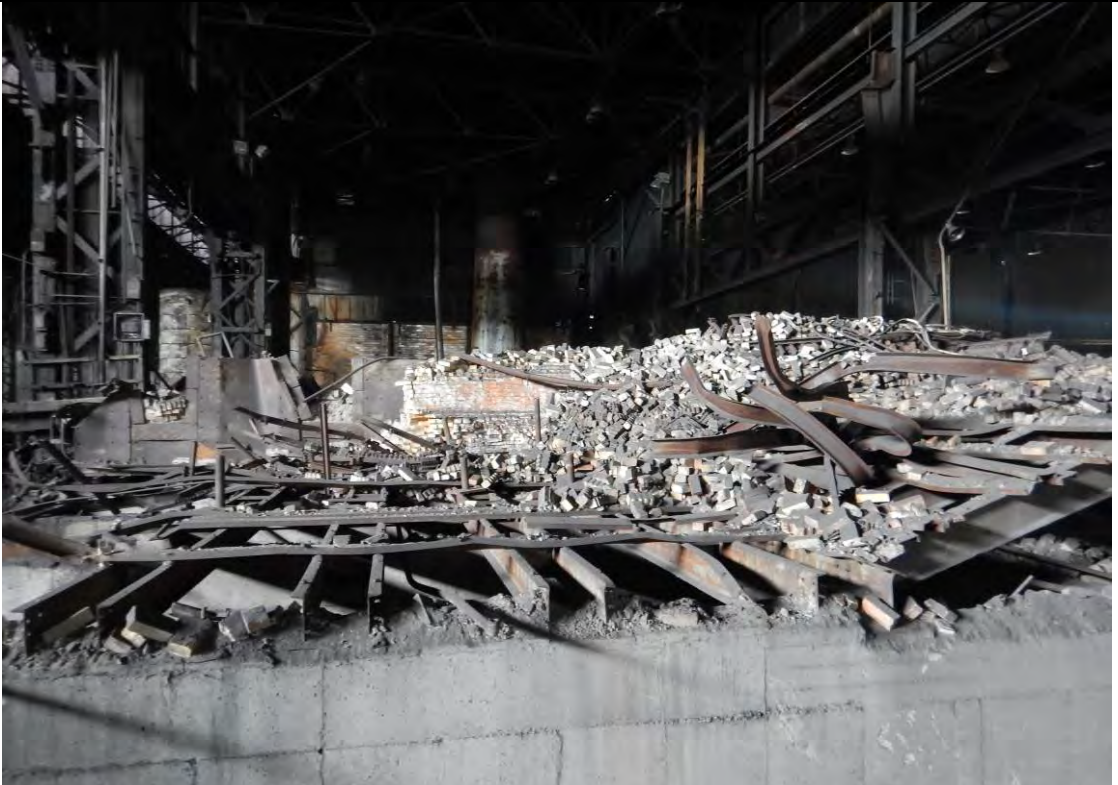
Client Name: City of Trenton		Site Location: 1491 W. Jefferson Avenue, Trenton, MI 48183	Project No. 170443-0100
Photo No. 89	Date: 7/21/17

Direction Photo Taken: South			
Description: Area 2 Top edge of pit/Sump at north end of former reheat furnace with debris behind— stack for exhaust visible in background.

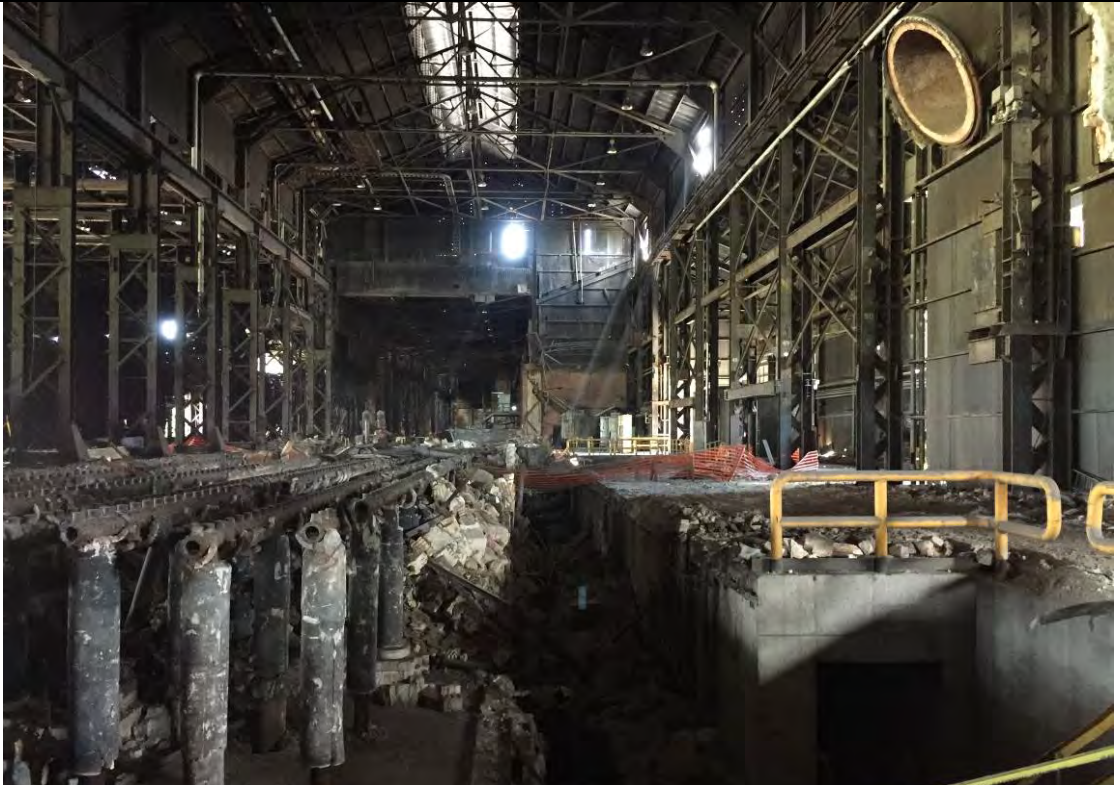
Client Name: City of Trenton		Site Location: 1491 W. Jefferson Avenue, Trenton, MI 48183	Project No. 170443-0100
Photo No. 91	Date: 7/21/17

Direction Photo Taken: South			
Description: Area 2 Reheat furnace at south end of Soaking Pit Building. Note burners with possible ACM to left and exhaust at upper right which lead to stack shown in Photos No. 31 and 34.

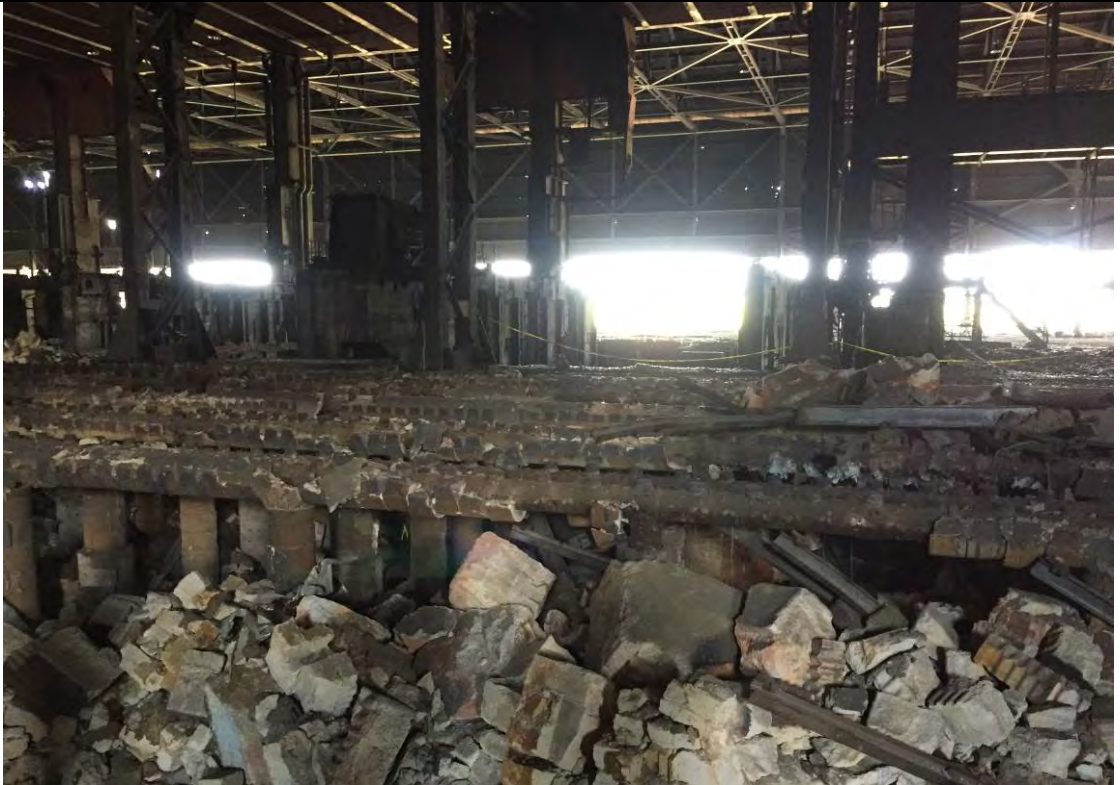
Client Name: City of Trenton		Site Location: 1491 W. Jefferson Avenue, Trenton, MI 48183	Project No. 170443-0100
Photo No. 93	Date: 7/17/17

Direction Photo Taken: East			
Description: Area 2 Same as Photo No. 91, showing burners with possible ACM coverings.

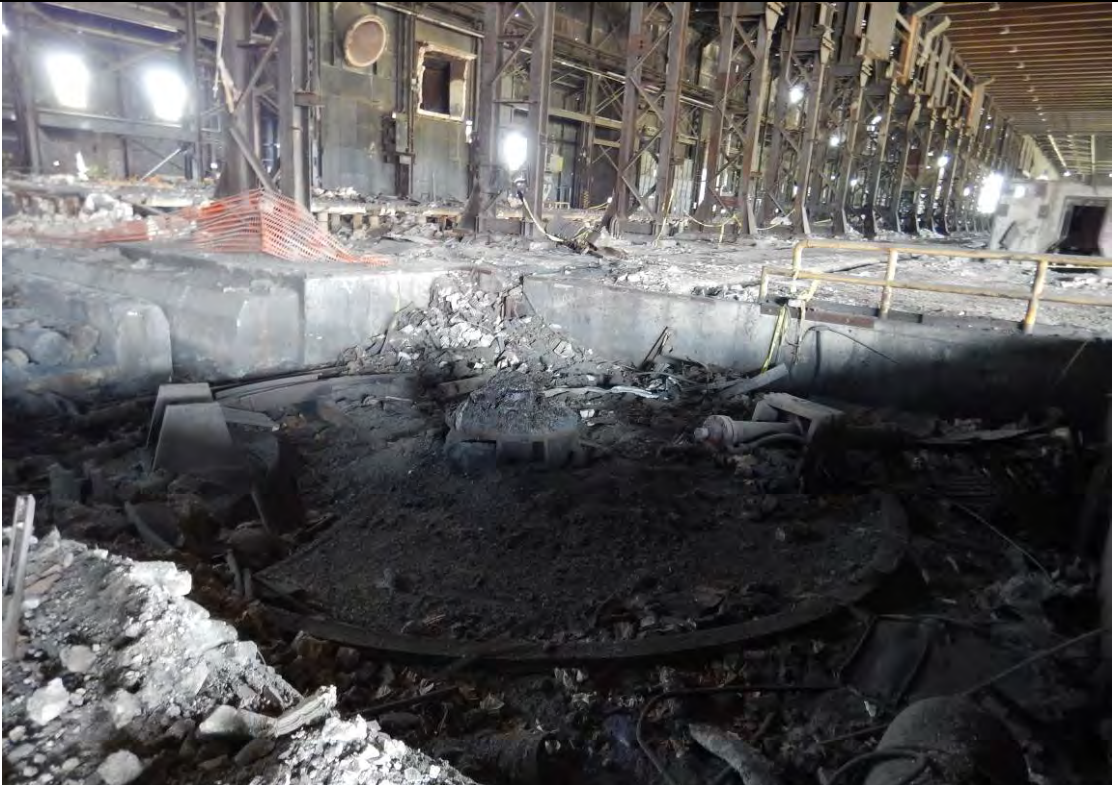
Client Name: City of Trenton		Site Location: 1491 W. Jefferson Avenue, Trenton, MI 48183	Project No. 170443-0100
Photo No. 95	Date: 7/21/17

Direction Photo Taken: Northwest			
Description: Area 2 Turnstile at Reheat Sump, south of electric re- heaters.

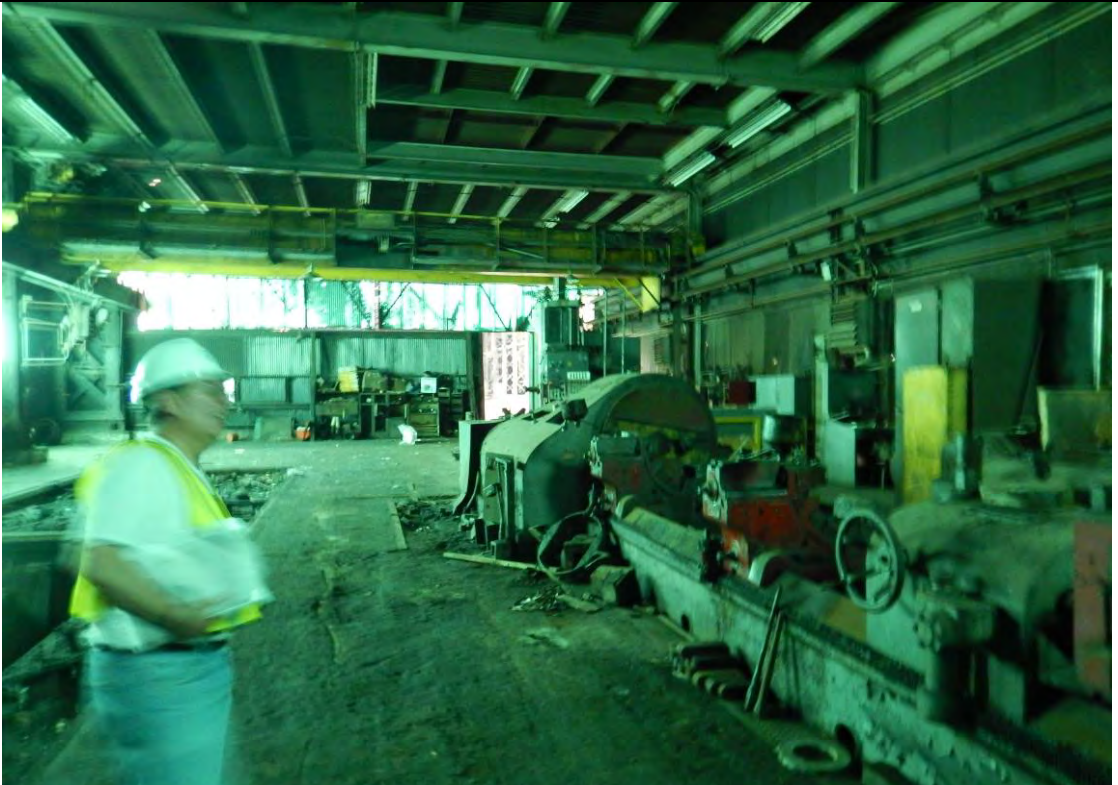
Client Name: City of Trenton		Site Location: 1491 W. Jefferson Avenue, Trenton, MI 48183	Project No. 170443-0100
Photo No. 97	Date: 7/21/17

Direction Photo Taken: North			
Description: Area 2 Roll Shop located at southwest corner of Coil and Storage Area/Rolling Mill Building.

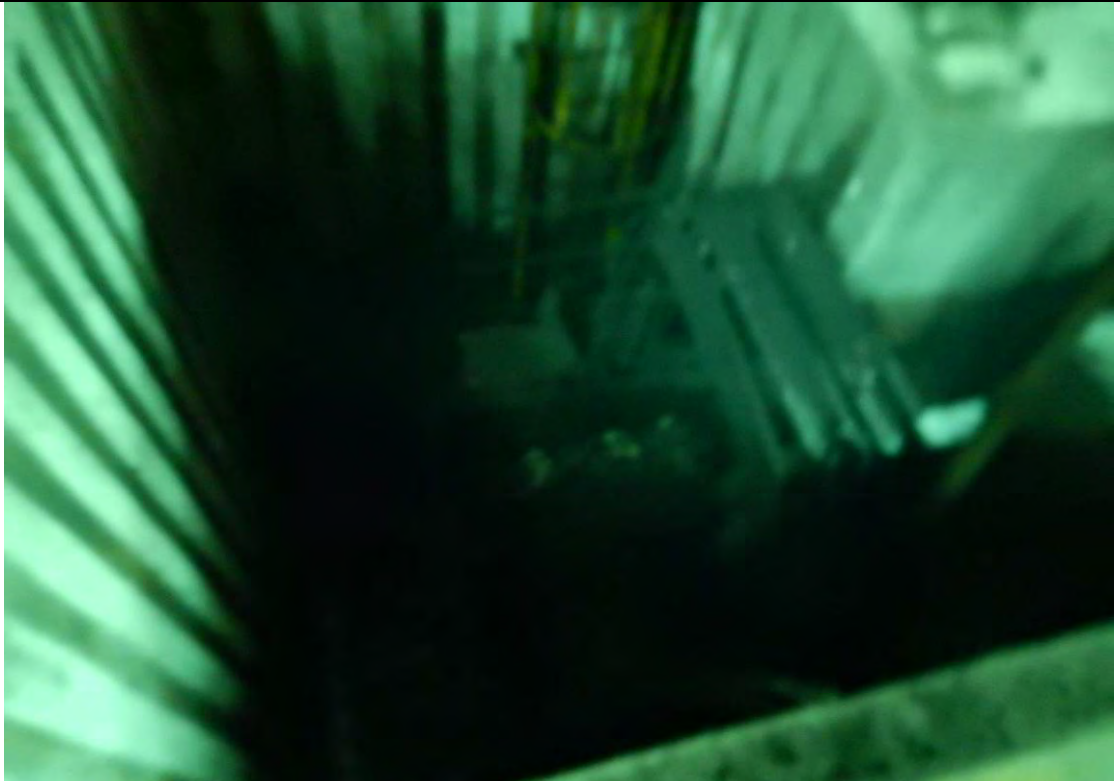
Client Name: City of Trenton		Site Location: 1491 W. Jefferson Avenue, Trenton, MI 48183	Project No. 170443-0100
Photo No. 99	Date: 7/21/17

Direction Photo Taken: Down			
Description: Area 2 Water in bottom of deep pit at southwest corner of Roll Shop.
