**PHASE I
ENVIRONMENTAL SITE ASSESSMENT**

FORMER McLOUTH STEEL FACILITY

**1491 WEST JEFFERSON AVENUE
TRENTON, MICHIGAN 48183**

August 8, 2017

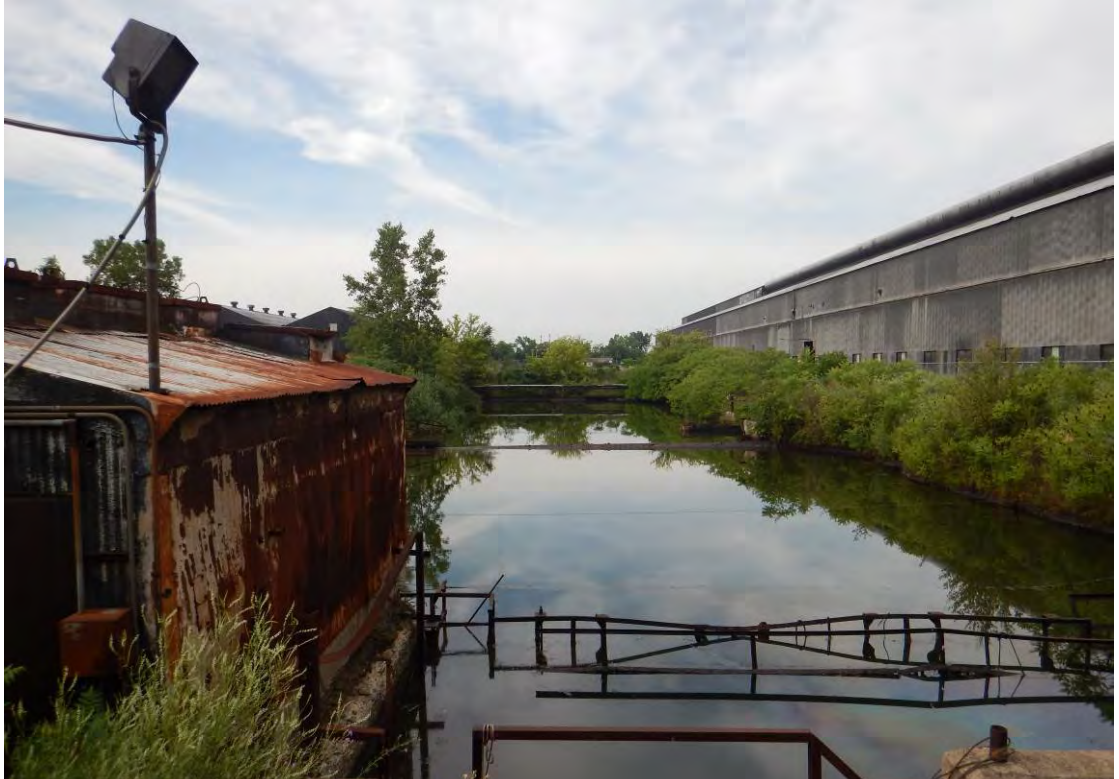
Client Name: City of Trenton		Site Location: 1491 W. Jefferson Avenue, Trenton, MI 48183	Project No. 170443-0100
Photo No. 101	Date: 7/21/17

Direction Photo Taken: South			
Description: Area 2 Sedimentation Basin with pump house to the left and No. 3 Finishing and Shipping Building to the right.

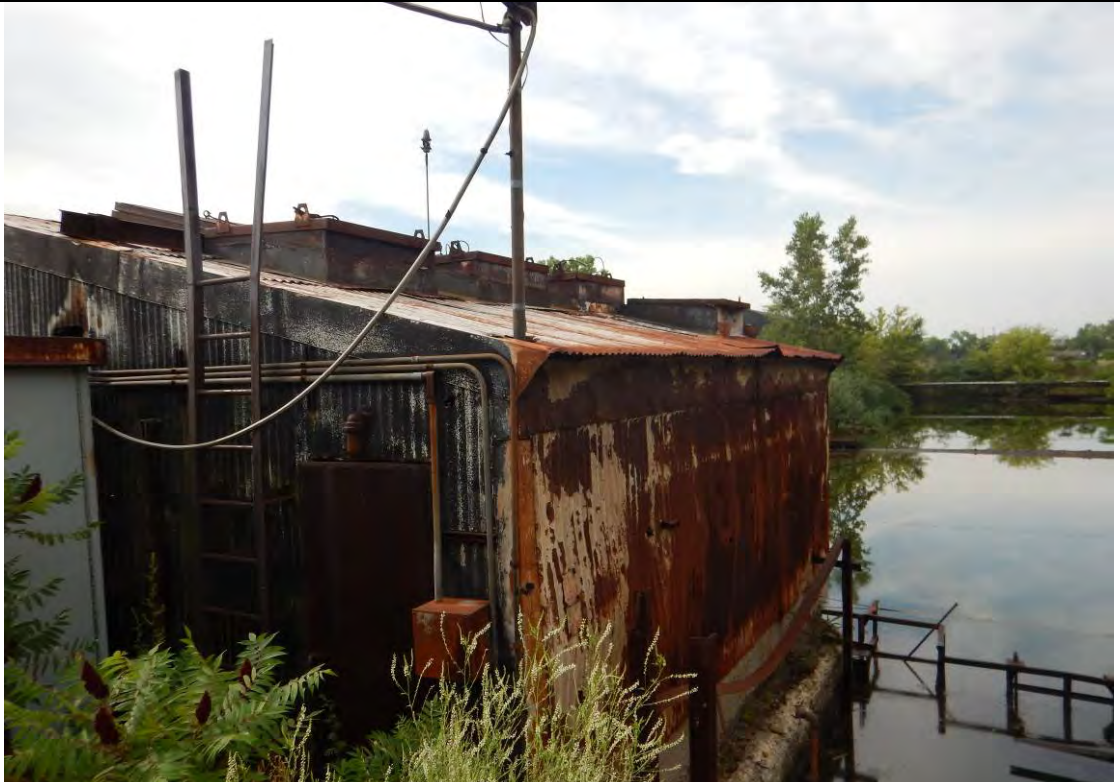
Client Name: City of Trenton		Site Location: 1491 W. Jefferson Avenue, Trenton, MI 48183	Project No. 170443-0100
Photo No. 103	Date: 7/21/17

Direction Photo Taken: South			
Description: Area 2 Sedimentation Basin pump house.

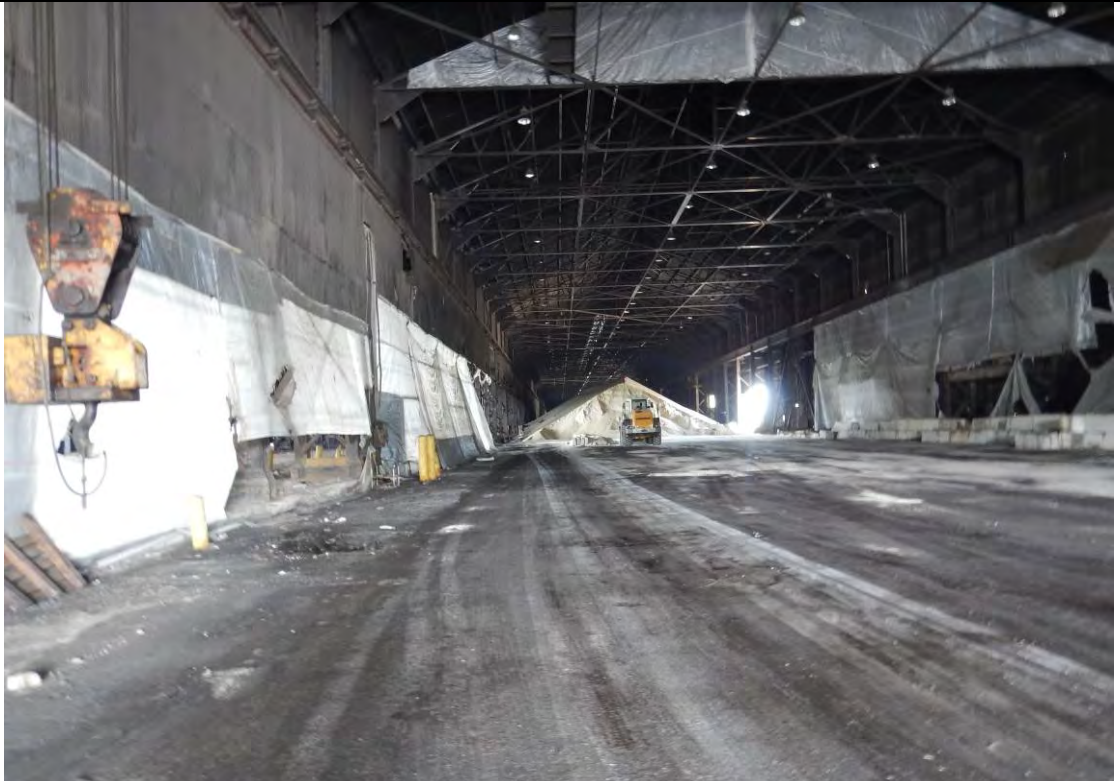
Client Name: City of Trenton		Site Location: 1491 W. Jefferson Avenue, Trenton, MI 48183	Project No. 170443-0100
Photo No. 105	Date: 7/21/17

Direction Photo Taken: North			
Description: Area 2 Sugar bulk storage in No. 3 Finishing and Shipping building.

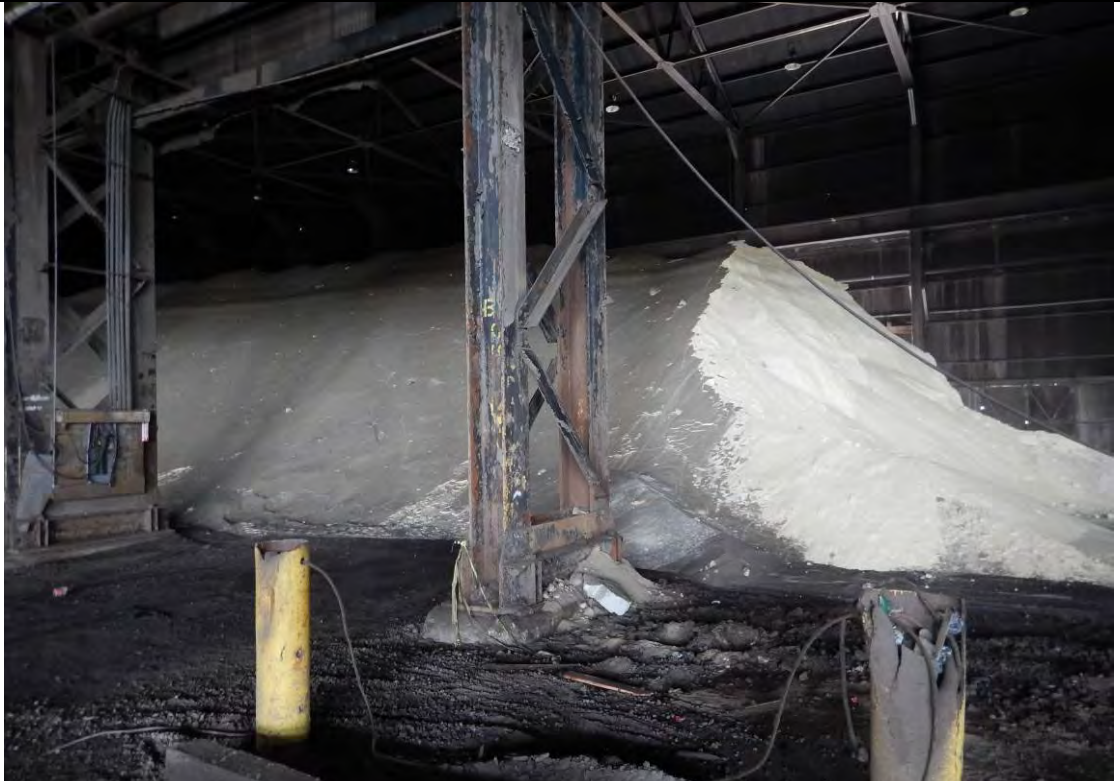
Client Name: City of Trenton		Site Location: 1491 W. Jefferson Avenue, Trenton, MI 48183	Project No. 170443-0100
Photo No. 107	Date: 7/21/17

Direction Photo Taken: Northeast			
Description: Area 2 Same as Photo No. 105 from the west.

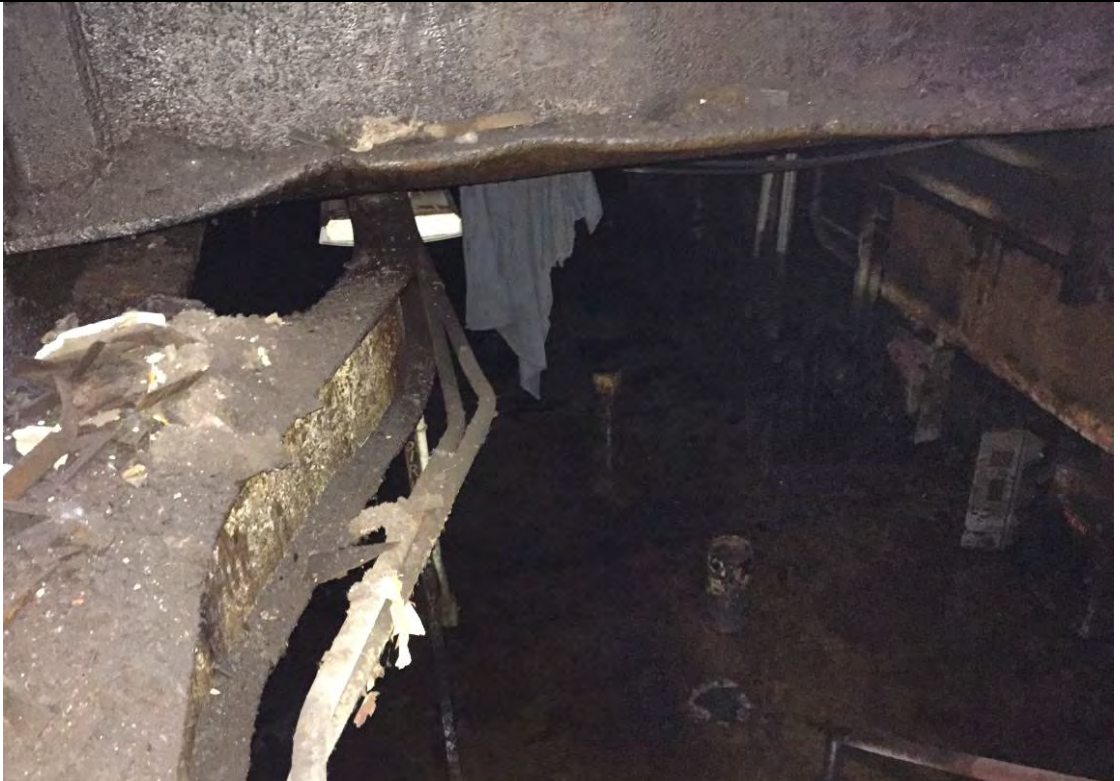
Client Name: City of Trenton		Site Location: 1491 W. Jefferson Avenue, Trenton, MI 48183	Project No. 170443-0100
Photo No. 111	Date: 7/17/17

Direction Photo Taken: North			
Description: Area 2 Flooded basement with equipment near Switch Gear Room.

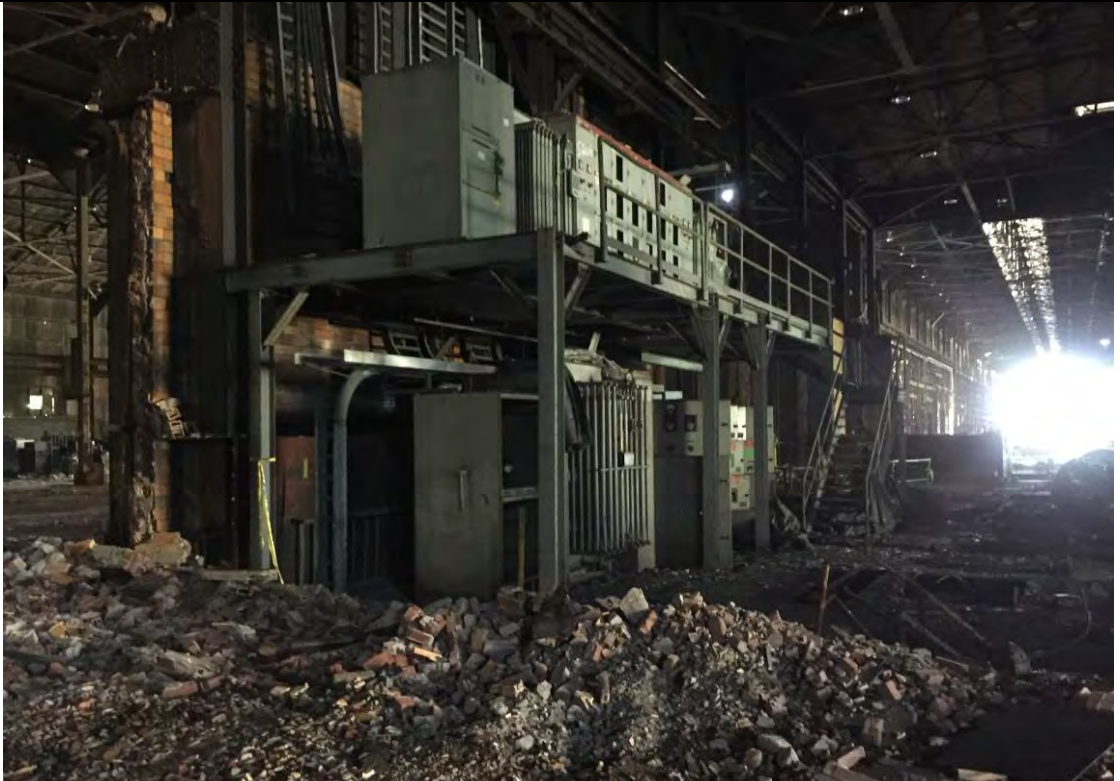
Client Name: City of Trenton		Site Location: 1491 W. Jefferson Avenue, Trenton, MI 48183	Project No. 170443-0100
Photo No. 113	Date: 7/17/17

Direction Photo Taken: Northwest			
Description: Area 2 One of many transformers. Near south end of Slab Handling and Storage (same group visible in Photo No. 22).

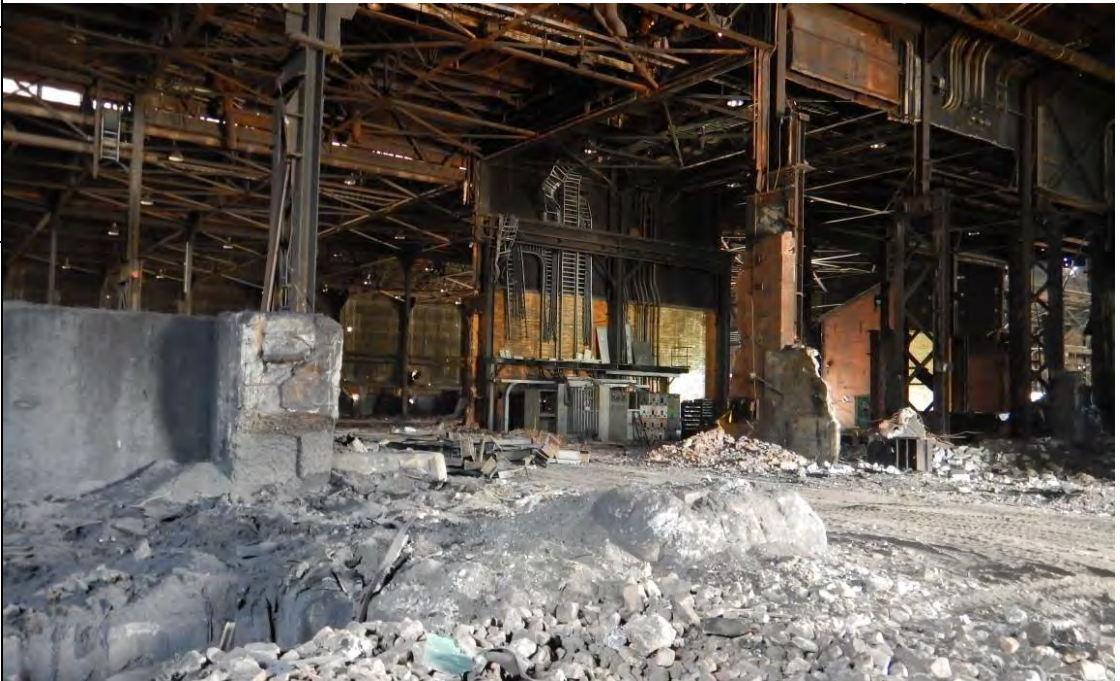
Photo No. 114	Date: 7/21/17

Direction Photo Taken: Northwest		
Description: Area 2 Same area as Photo No. 113 from farther away. Note the upper level equipment and the support platform has been removed between July 17 and July 21.

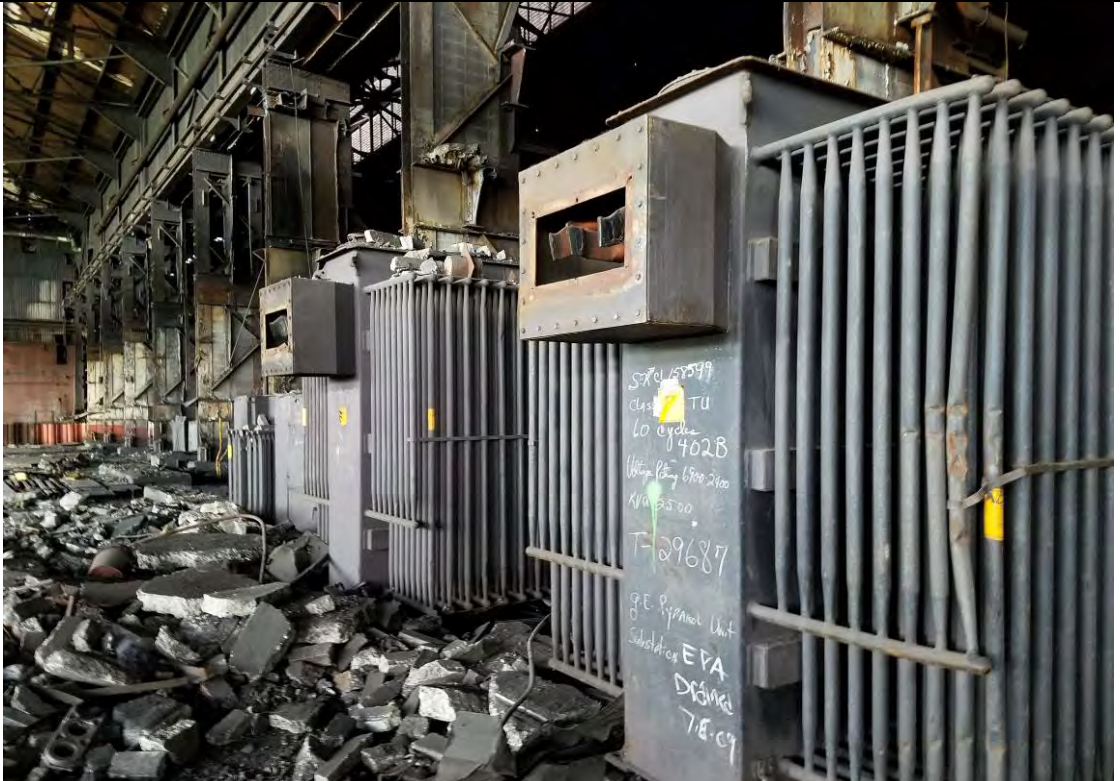
Client Name: City of Trenton		Site Location: 1491 W. Jefferson Avenue, Trenton, MI 48183	Project No. 170443-0100
Photo No. 115	Date: 7/17/17

Direction Photo Taken: North			
Description: Area 2 Transformers in No. 2 Finishing and Shipping.

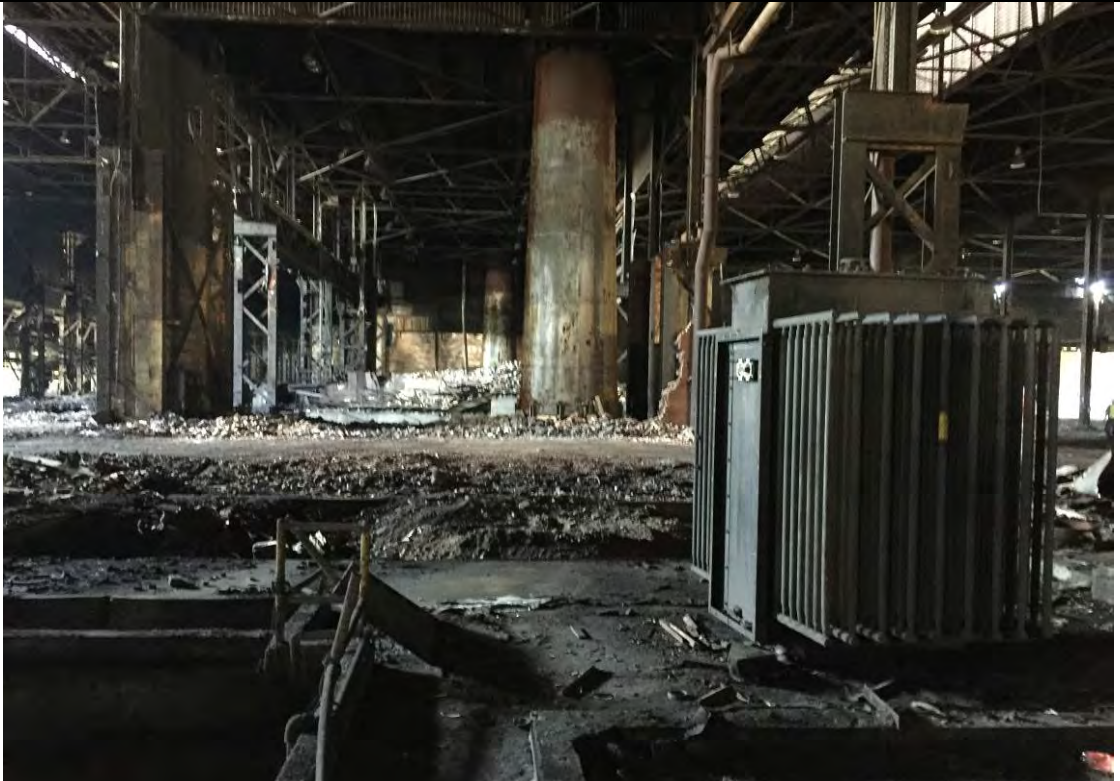
Client Name: City of Trenton		Site Location: 1491 W. Jefferson Avenue, Trenton, MI 48183	Project No. 170443-0100
Photo No. 117	Date: 7/17/17

Direction Photo Taken: South			
Description: Area 2 Transformer at south end of Slab Handling and Storage.

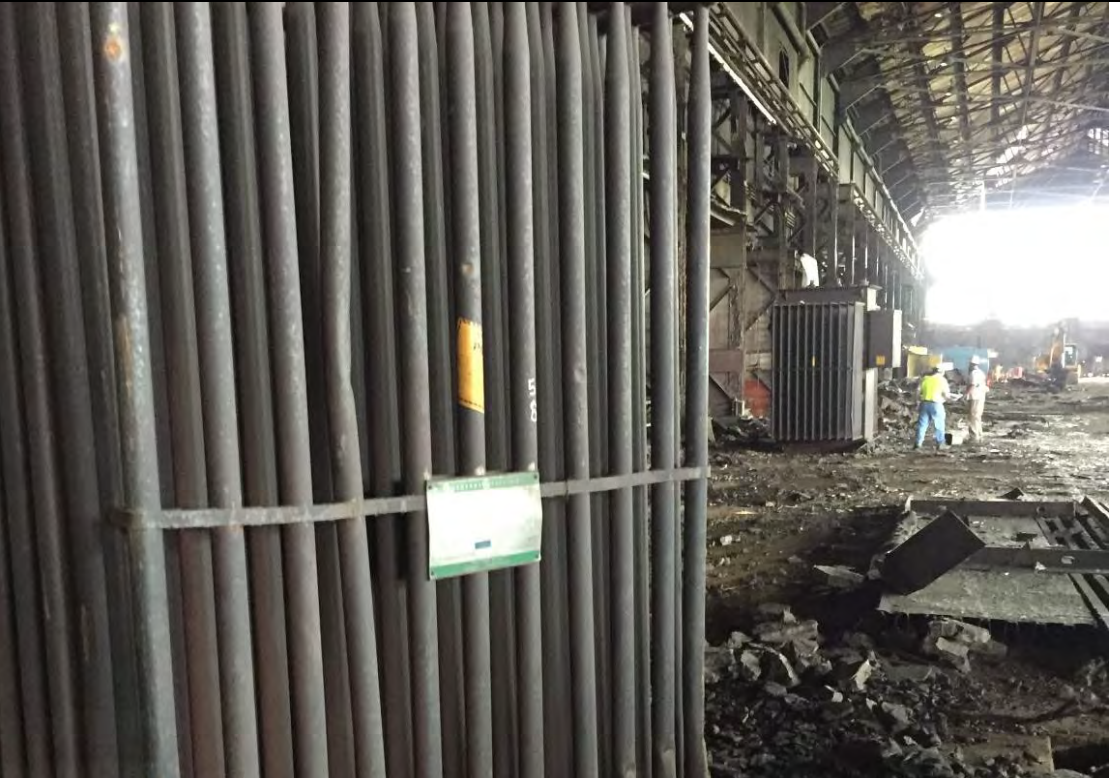
Photo No. 120	Date: 7/17/17

Direction Photo Taken: South		
Description: Area 2 No. 2 Finish and Shipping Building – several transformers along columns.

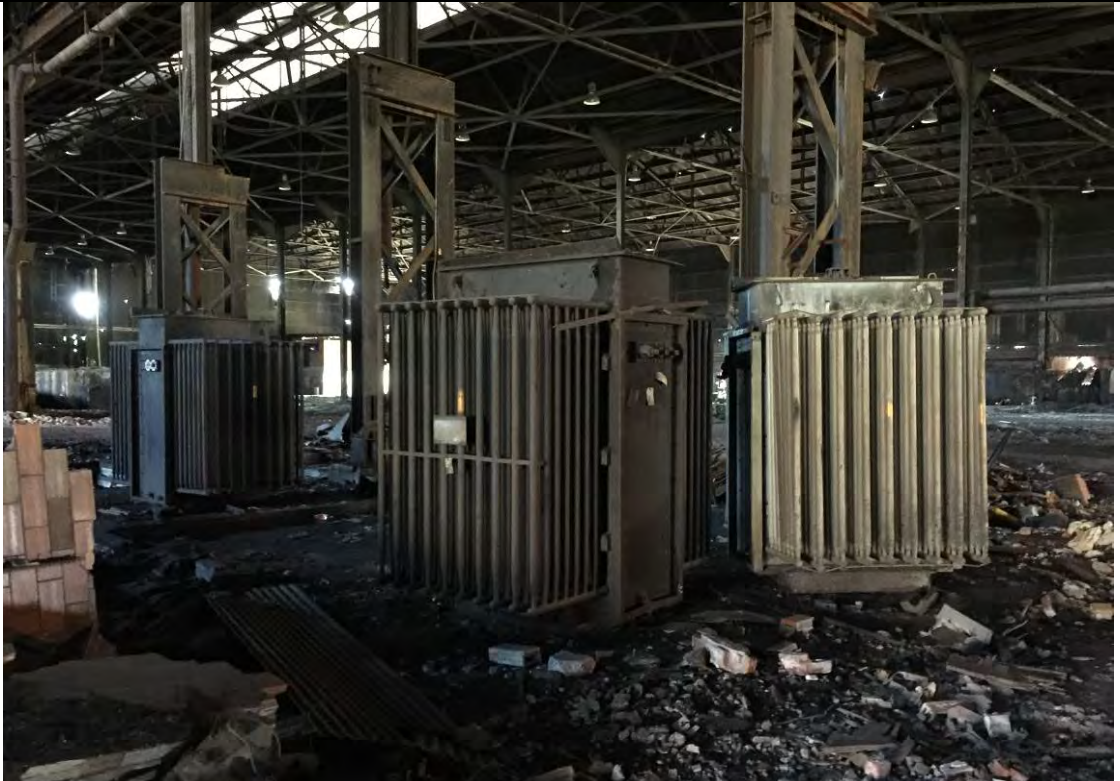
Client Name: City of Trenton		Site Location: 1491 W. Jefferson Avenue, Trenton, MI 48183	Project No. 170443-0100
Photo No. 121	Date: 7/17/17

Direction Photo Taken: Southwest			
Description: Area 2 Slab Storage Building – transformers located south of AST/drum staging area.

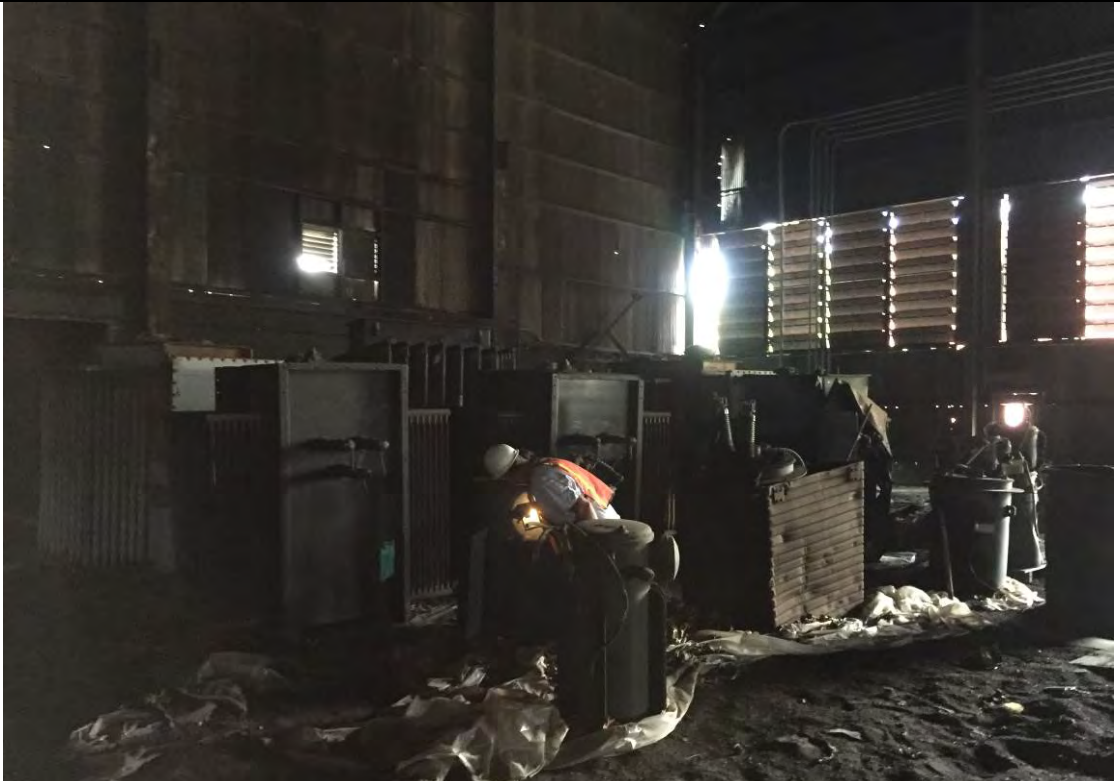
Client Name: City of Trenton		Site Location: 1491 W. Jefferson Avenue, Trenton, MI 48183	Project No. 170443-0100
Photo No. 123	Date: 7/17/17

Direction Photo Taken: Northwest			
Description: Area 2 Soaking Pit Building - north end transformer staging area with a number of transformers. Some were labeled drained, while others were not. Some had evidence of leaks onto plastic sheeting.

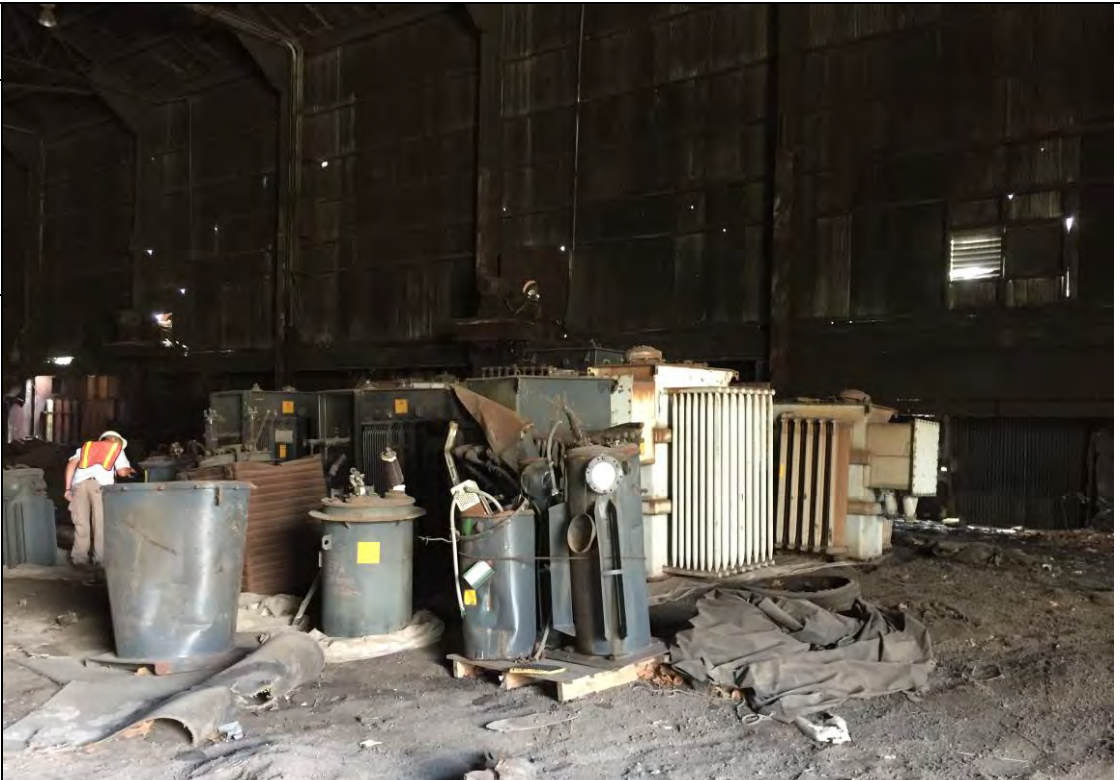
Photo No. 124	Date: 7/17/17

Direction Photo Taken: Southwest		
Description: Area 2 Same as Photo No. 123 from different perspective.

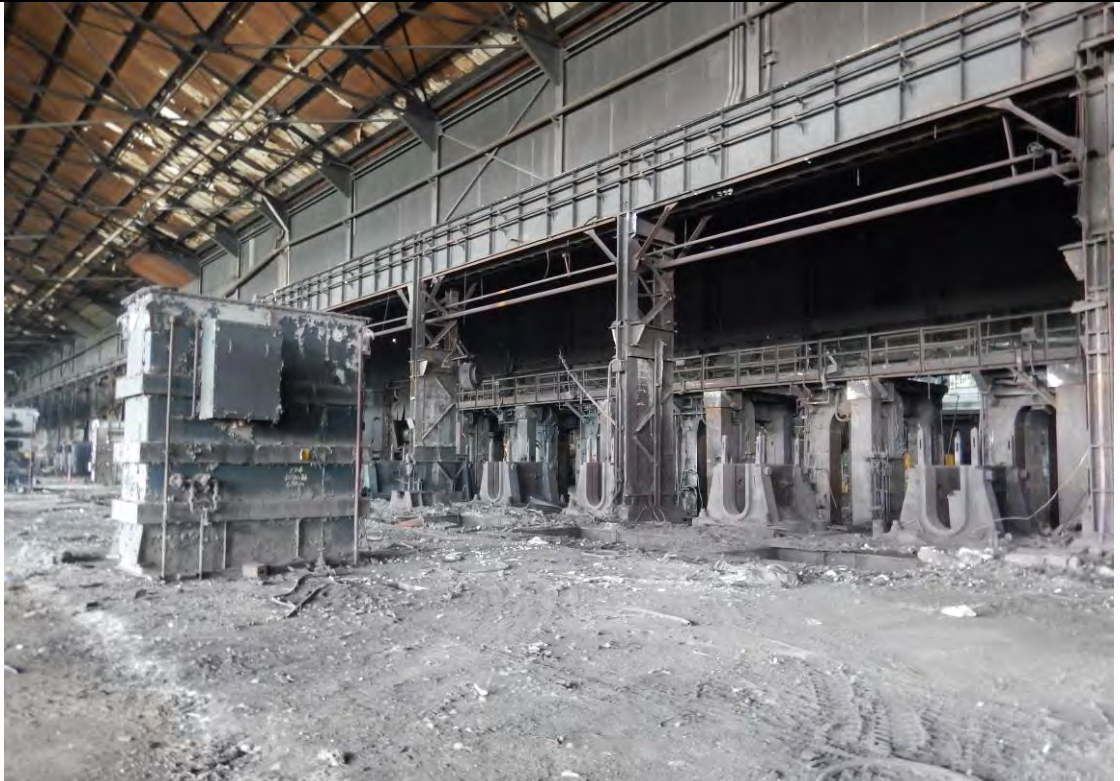
Client Name: City of Trenton		Site Location: 1491 W. Jefferson Avenue, Trenton, MI 48183	Project No. 170443-0100
Photo No. 127	Date: 7/21/17

Direction Photo Taken: Northeast			
Description: Area 2 No. 1 Finishing and Shipping Building – relocated transformer.

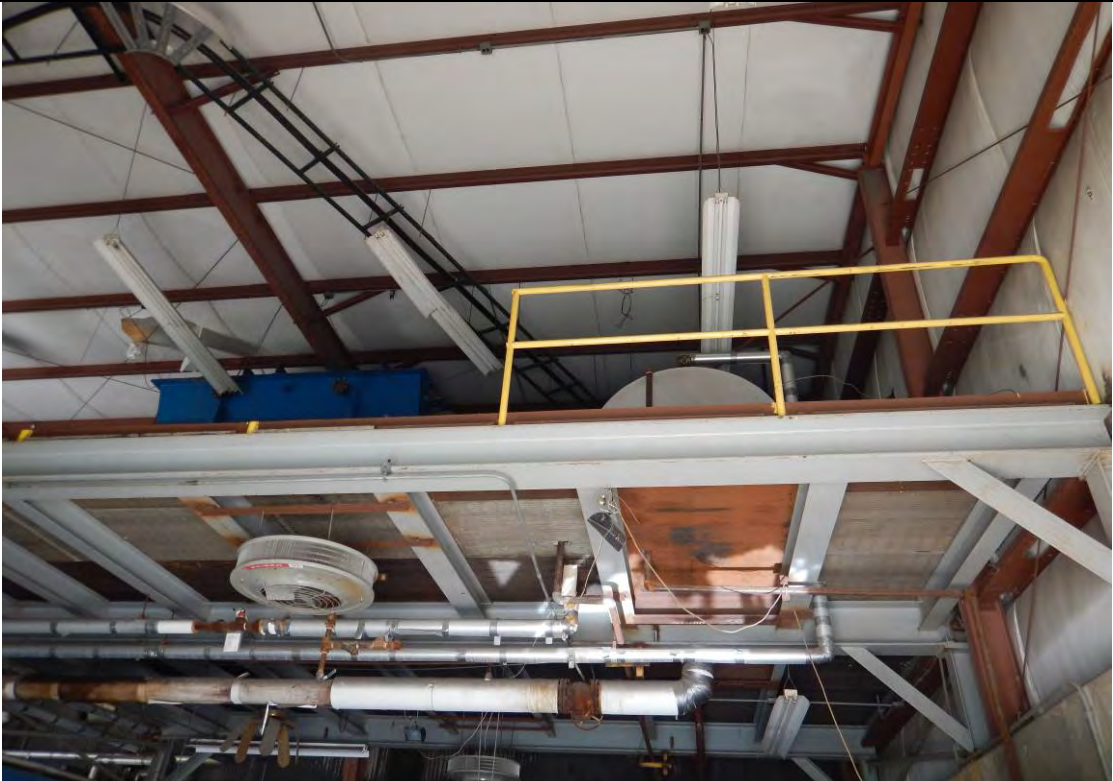
Client Name: City of Trenton		Site Location: 1491 W. Jefferson Avenue, Trenton, MI 48183	Project No. 170443-0100
Photo No. 131	Date: 7/21/17

Direction Photo Taken: West			
Description: Area 2 Upper level of north side of building shown in Photo No. 129. Contents of blue rectangular and white cylindrical tanks are unknown.

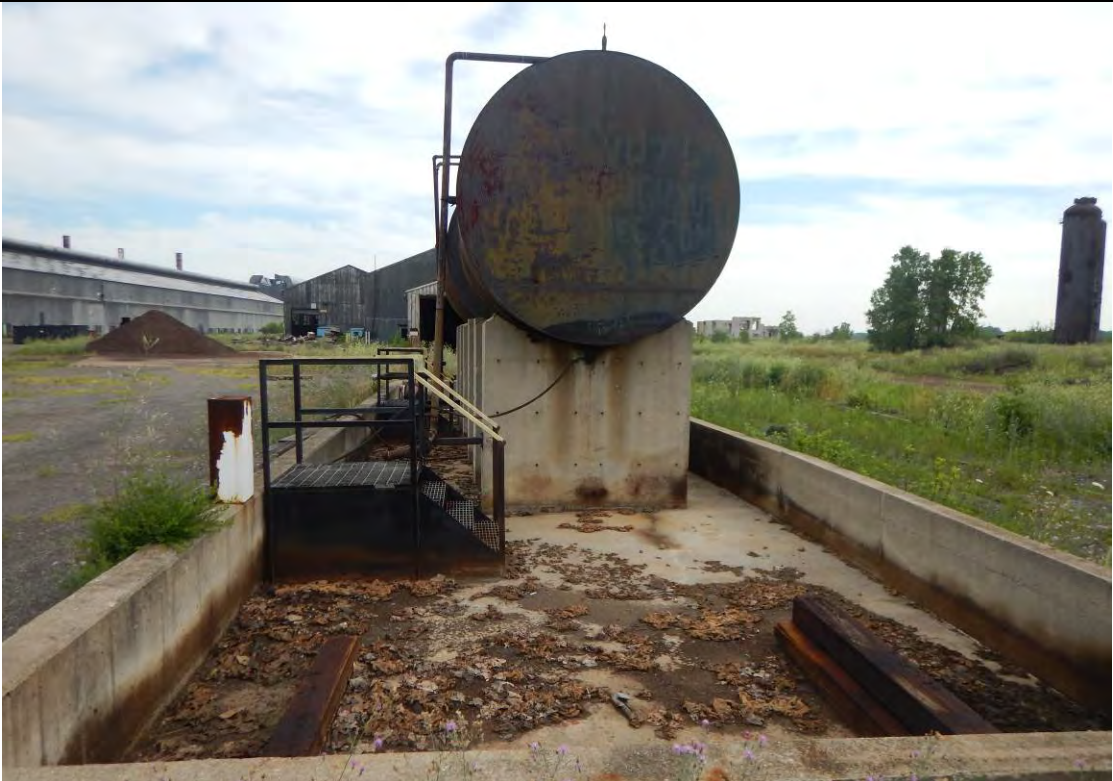
Client Name: City of Trenton		Site Location: 1491 W. Jefferson Avenue, Trenton, MI 48183	Project No. 170443-0100
Photo No. 1	Date: 7/21/17

Direction Photo Taken: North			
Description: Area 3 20,000-gallon diesel fuel AST.

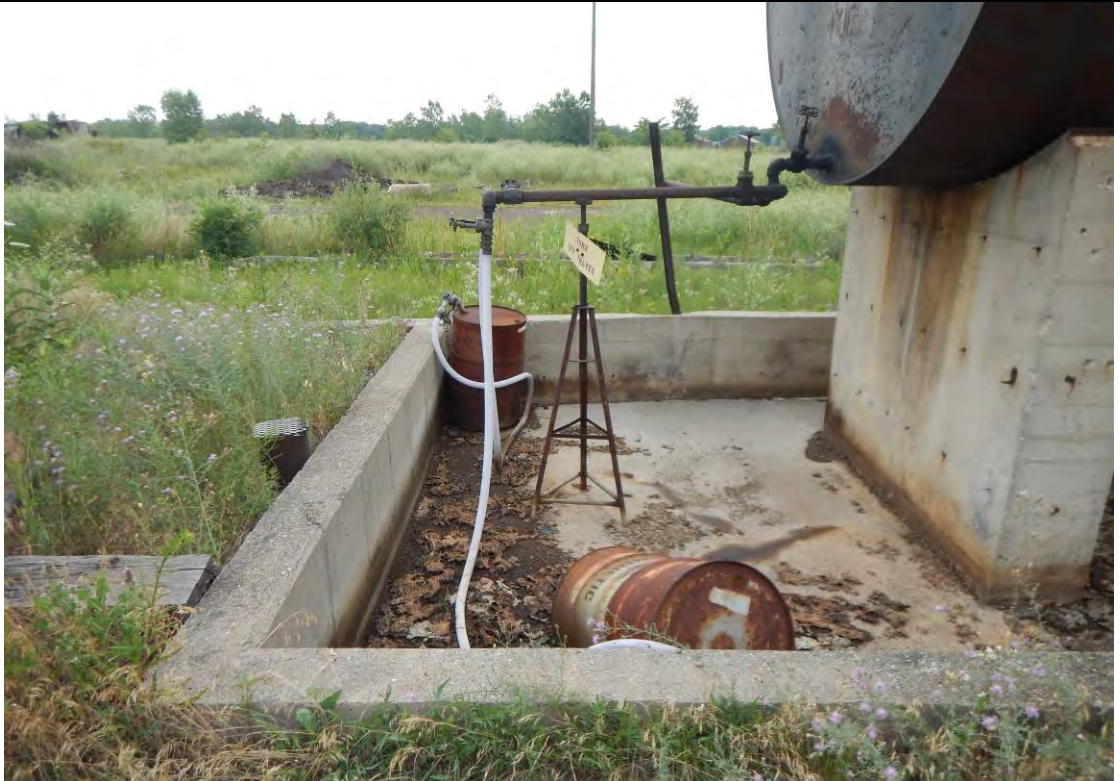
Client Name: City of Trenton		Site Location: 1491 W. Jefferson Avenue, Trenton, MI 48183	Project No. 170443-0100
Photo No. 3	Date: 7/21/17

Direction Photo Taken: East			
Description: Area 3 2 steel drums, 1 labeled synthetic, other not labeled, both 55 gallons within containment area of diesel ASTs. One drum partially full.

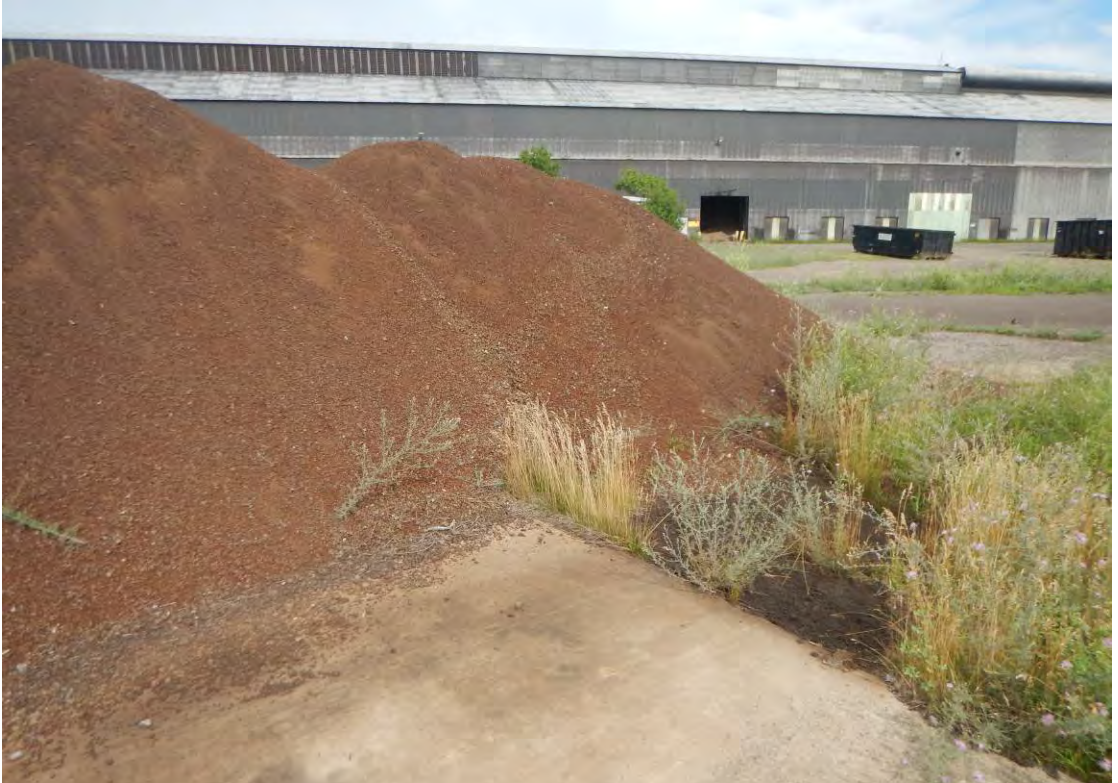
Client Name: City of Trenton		Site Location: 1491 W. Jefferson Avenue, Trenton, MI 48183	Project No. 170443-0100
Photo No. 9	Date: 7/21/17

Direction Photo Taken: North			
Description: Area 3 Soil stockpile with staining west of locomotive repair building.

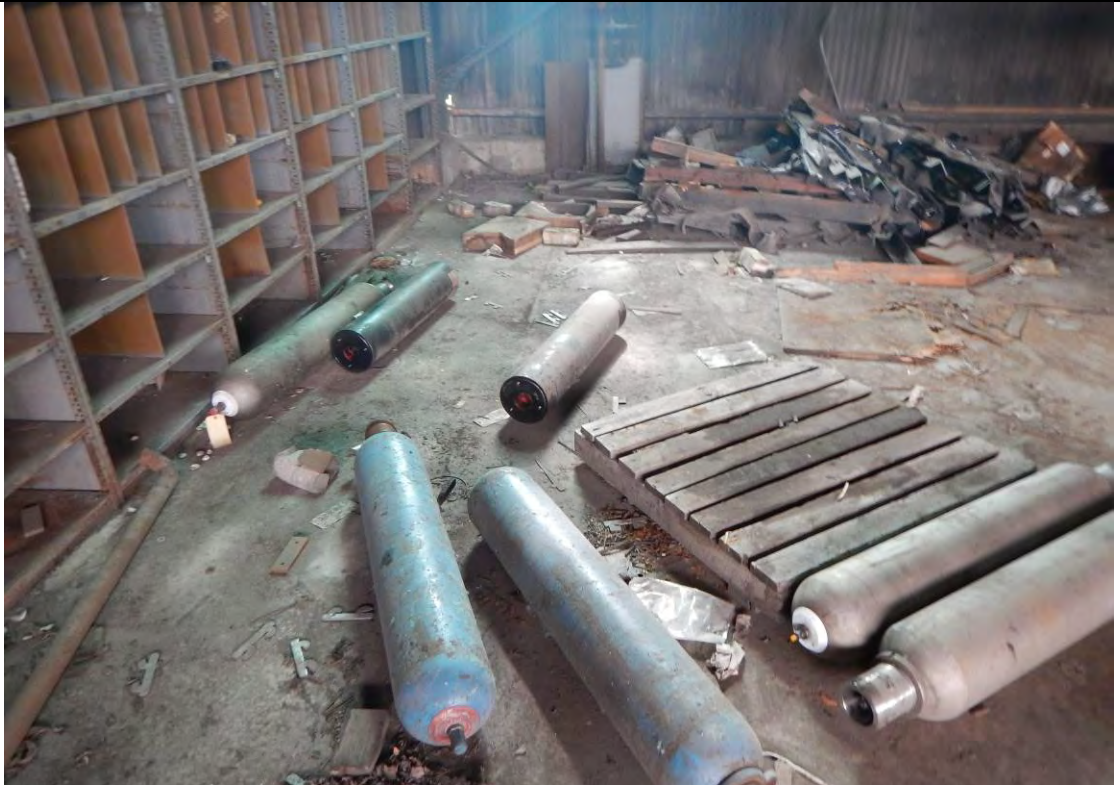
Client Name: City of Trenton		Site Location: 1491 W. Jefferson Avenue, Trenton, MI 48183	Project No. 170443-0100
Photo No. 13	Date: 7/21/17

Direction Photo Taken: East			
Description: Area 3 Unlabeled pressure canisters at maintenance building. Two hydraulic accumulation cylinders, staining throughout building.

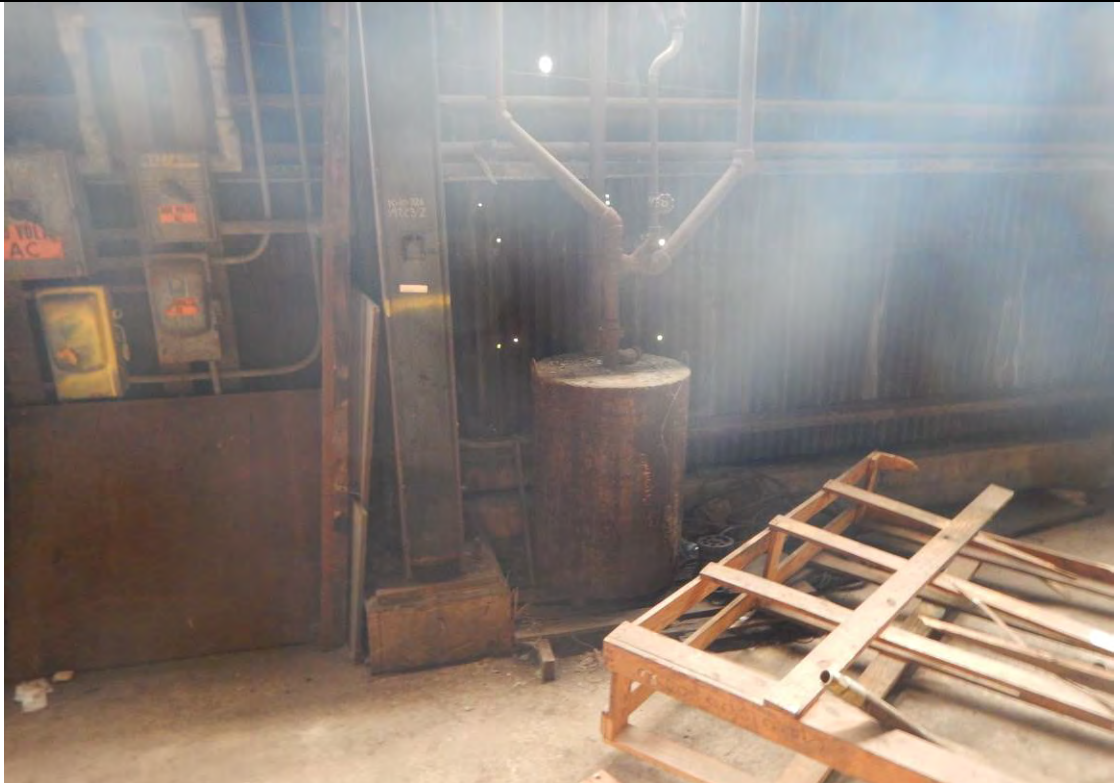
Client Name: City of Trenton		Site Location: 1491 W. Jefferson Avenue, Trenton, MI 48183	Project No. 170443-0100
Photo No. 15	Date: 7/21/17

Direction Photo Taken: West			
Description: Area 3 Fuel oil tank system at the maintenance building.

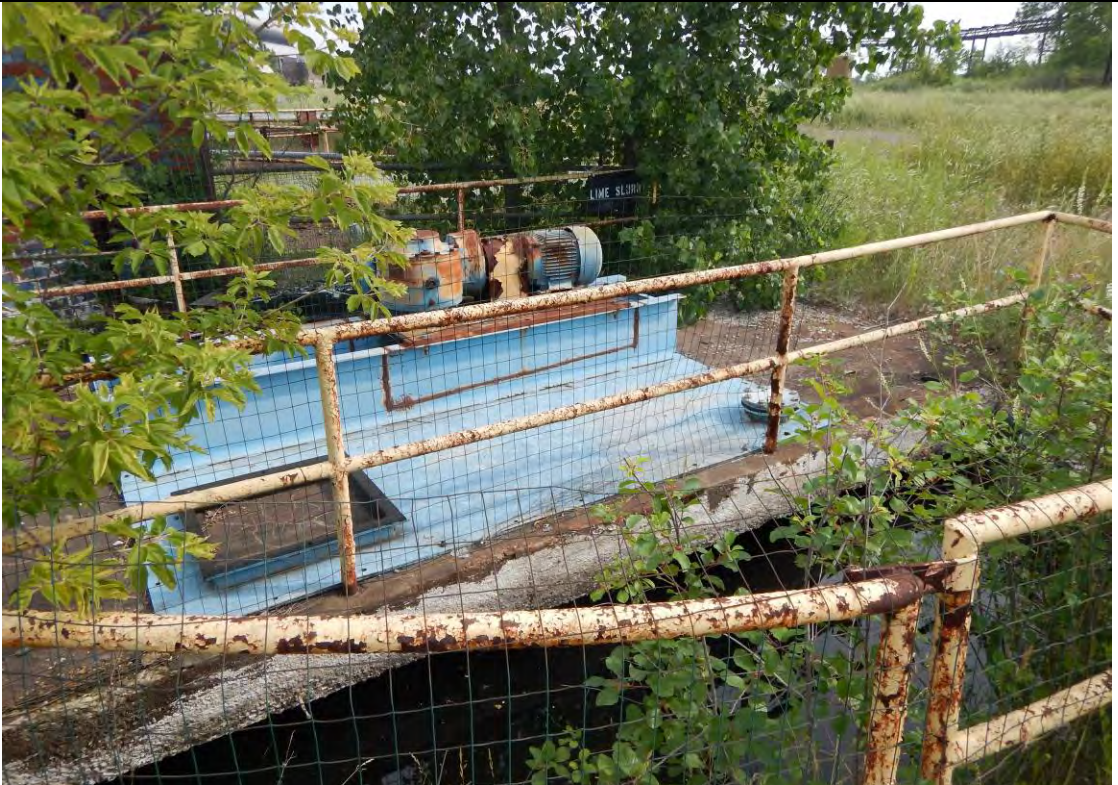
Client Name: City of Trenton		Site Location: 1491 W. Jefferson Avenue, Trenton, MI 48183	Project No. 170443-0100
Photo No. 17	Date: 7/21/17

Direction Photo Taken: Northwest			
Description: Area 3 Lime slurry basin at acid neutralization plant full of water.

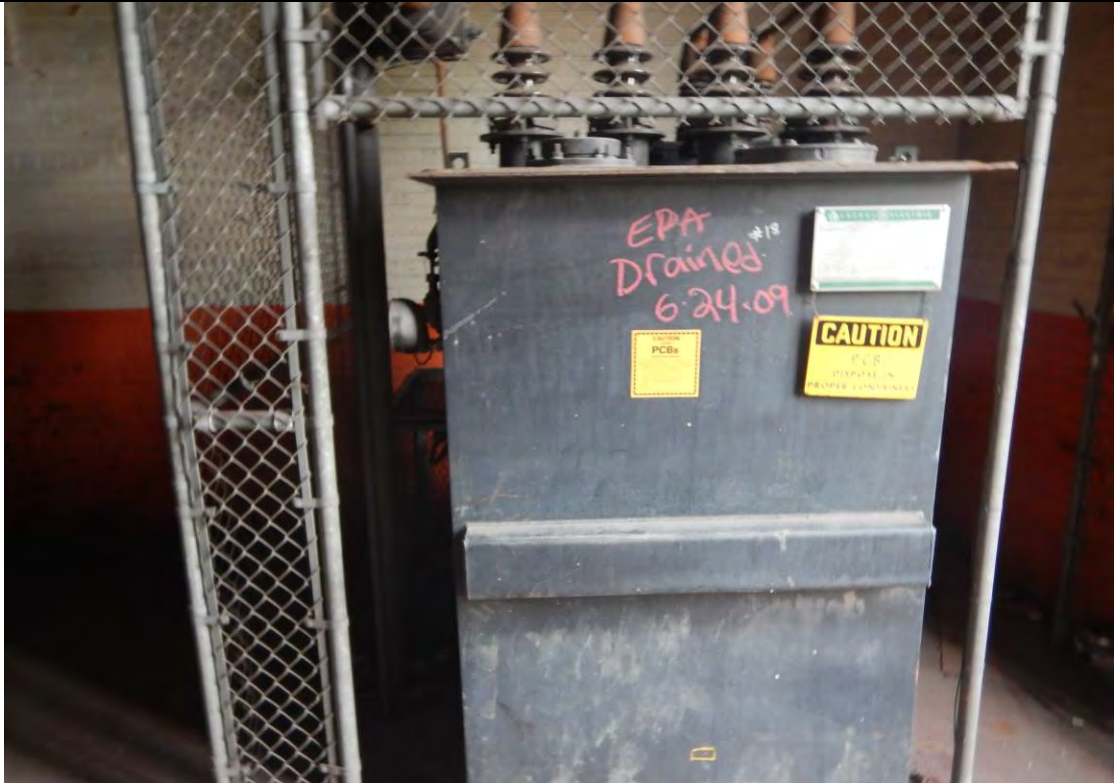
Client Name: City of Trenton		Site Location: 1491 W. Jefferson Avenue, Trenton, MI 48183	Project No. 170443-0100
Photo No. 21	Date: 7/21/17

Direction Photo Taken: East			
Description: Area 3 Transformer 18 at the substation. EPA drained 6/24/09.

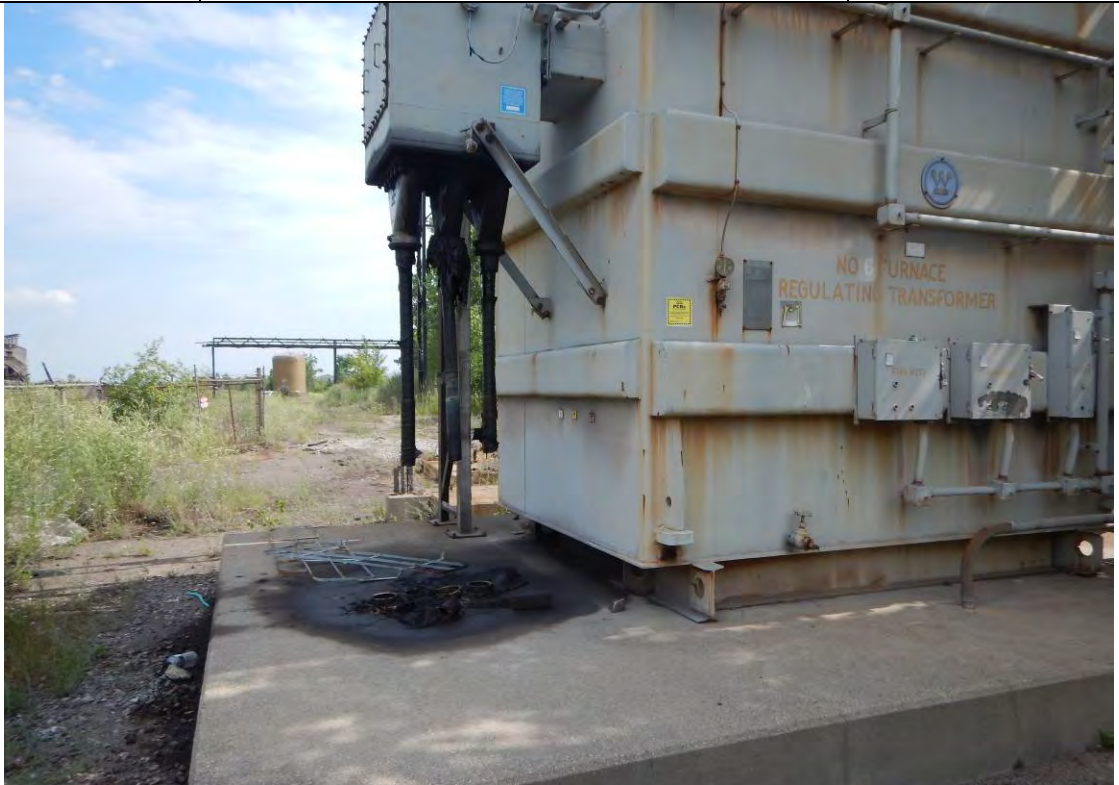
Client Name: City of Trenton		Site Location: 1491 W. Jefferson Avenue, Trenton, MI 48183	Project No. 170443-0100
Photo No. 25	Date: 7/21/17

Direction Photo Taken: North			
Description: Area 3 No. 6 furnace regulating transformer – EPA drained 7-28-09. Significant staining.

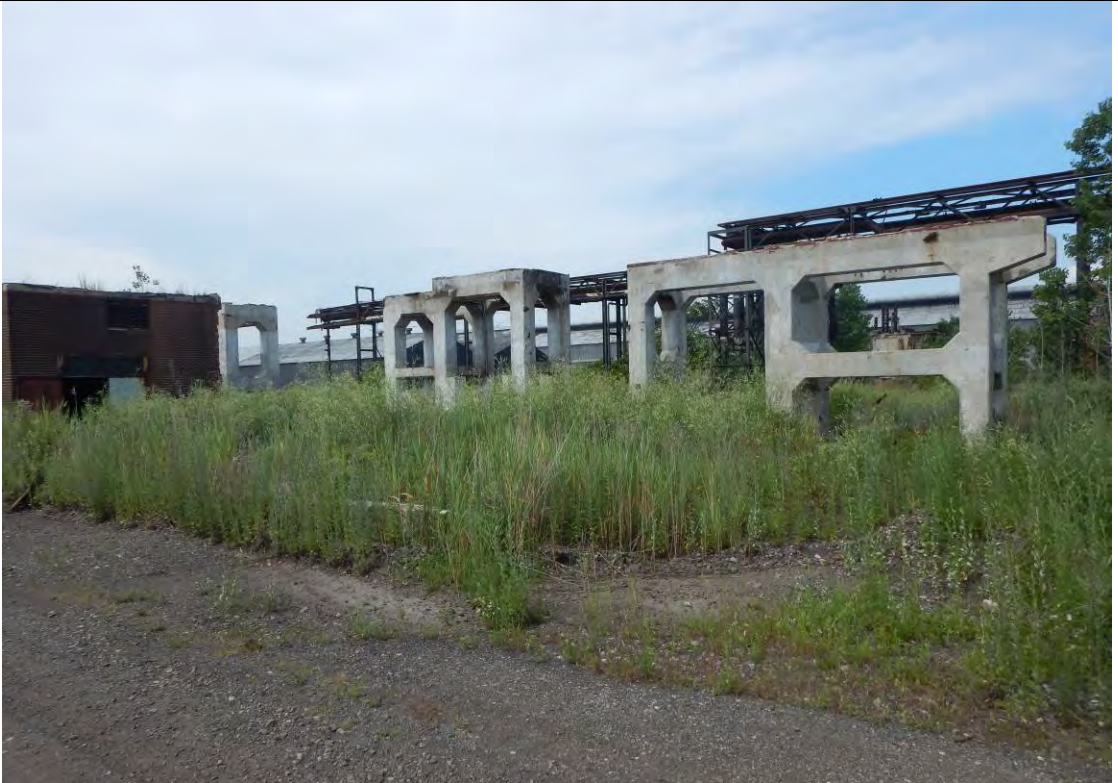
Client Name: City of Trenton		Site Location: 1491 W. Jefferson Avenue, Trenton, MI 48183	Project No. 170443-0100
Photo No. 27	Date: 7/21/17

Direction Photo Taken: West			
Description: Area 3 Former air separation plant.
