**PHASE I
ENVIRONMENTAL SITE ASSESSMENT**

FORMER McLOUTH STEEL FACILITY

**1491 WEST JEFFERSON AVENUE
TRENTON, MICHIGAN 48183**

August 8, 2017

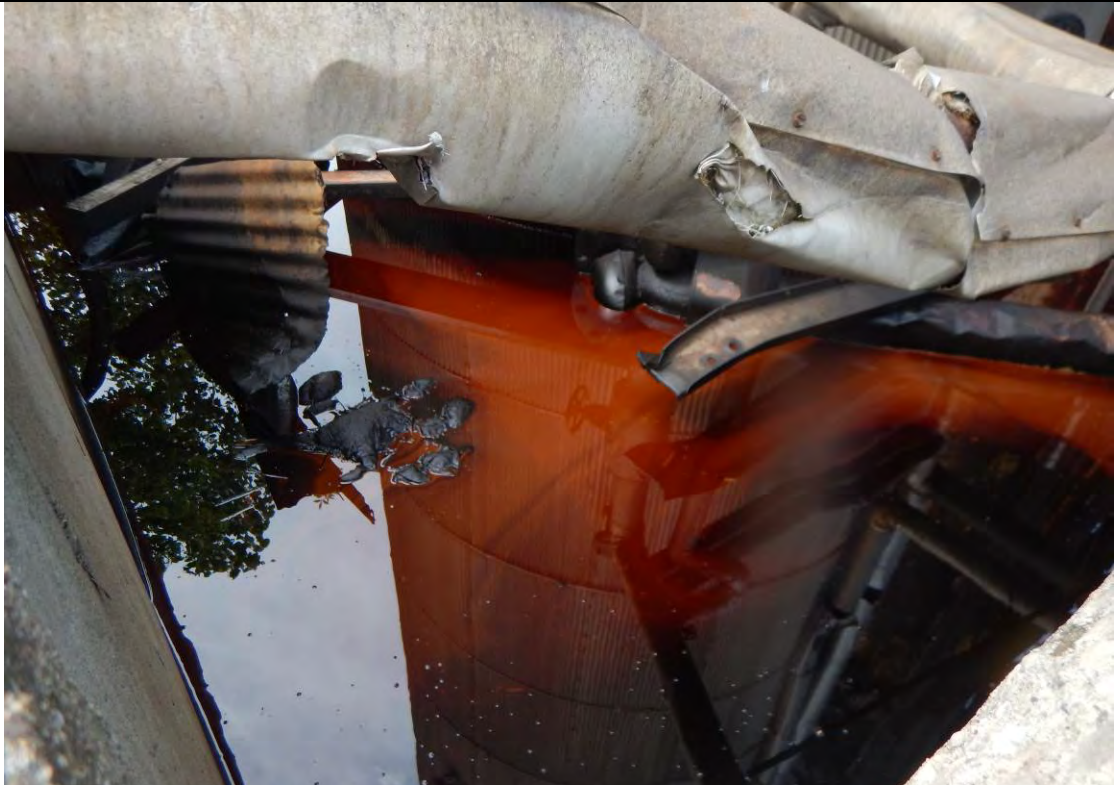
Client Name: City of Trenton		Site Location: 1491 W. Jefferson Avenue, Trenton, MI 48183	Project No. 170443-0100
Photo No. 29	Date: 7/21/17

Direction Photo Taken: Southwest			
Description: Area 3 Oily water within 2 oil AST's containment area at boiler house.

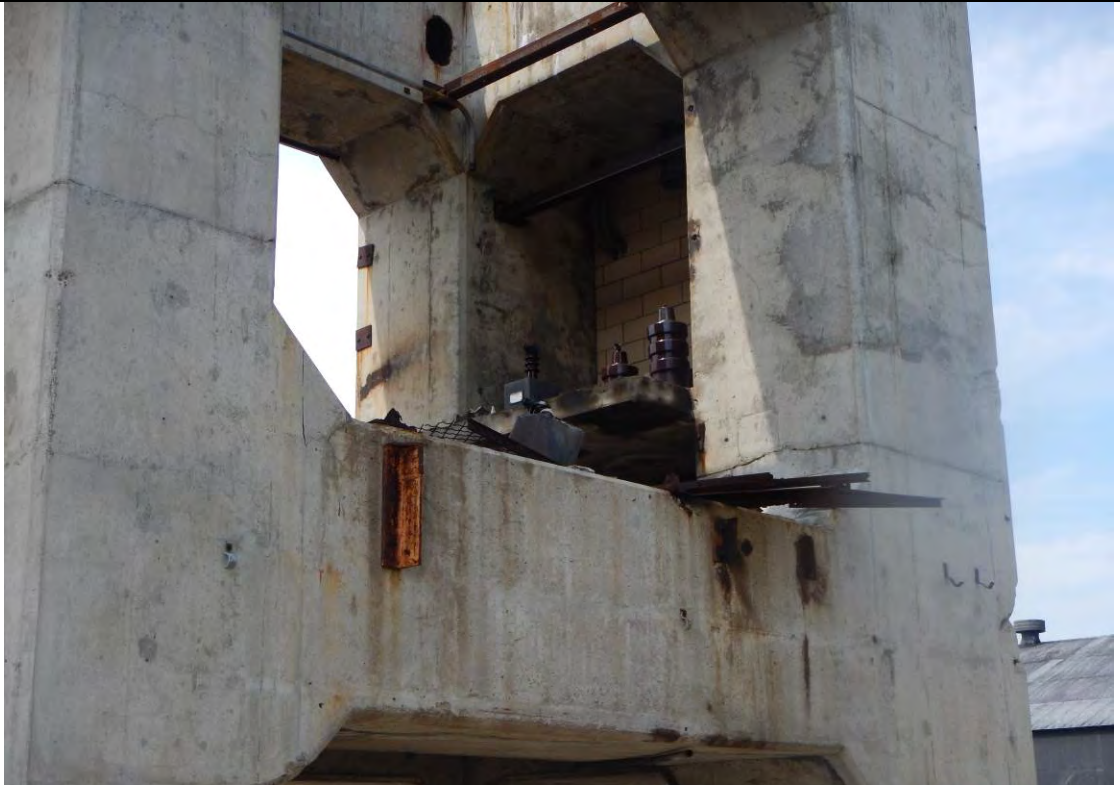
Client Name: City of Trenton		Site Location: 1491 W. Jefferson Avenue, Trenton, MI 48183	Project No. 170443-0100
Photo No. 31	Date: 7/21/17

Direction Photo Taken: West			
Description: Area 3 Electrical equipment on second level of former boiler house structure; staining on concrete.

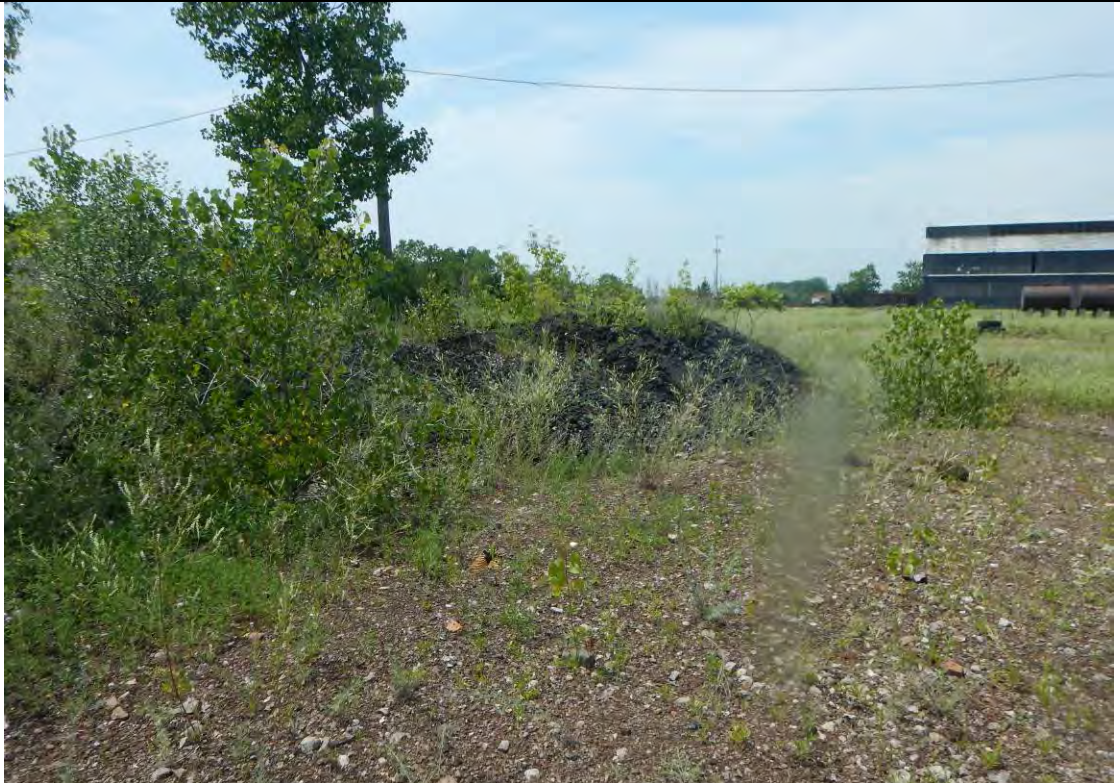
Client Name: City of Trenton		Site Location: 1491 W. Jefferson Avenue, Trenton, MI 48183	Project No. 170443-0100
Photo No. 35	Date: 7/21/17

Direction Photo Taken: N/A			
Description: Area 3 Slag stockpile pile at southern slag pit, south of blast furnace area.

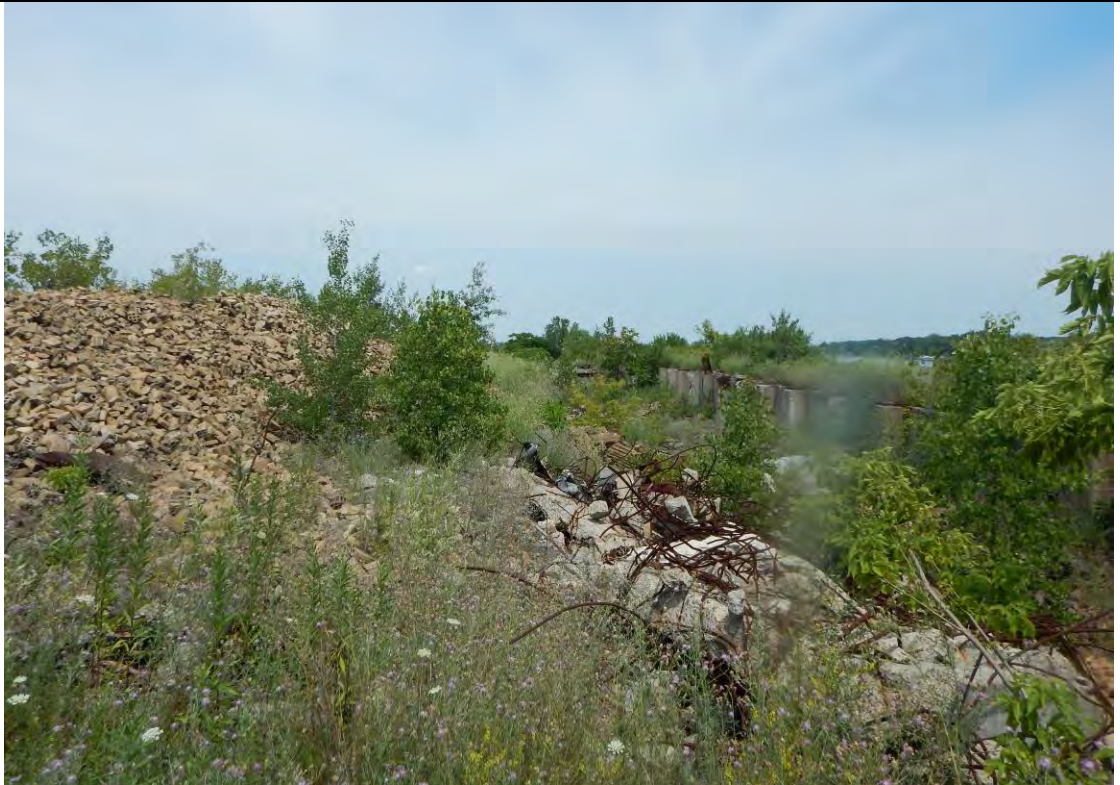
Client Name: City of Trenton		Site Location: 1491 W. Jefferson Avenue, Trenton, MI 48183	Project No. 170443-0100
Photo No. 37	Date: 7/21/17

Direction Photo Taken: North			
Description: Area 3 Former basement area full of demolition debris, south of blast furnace

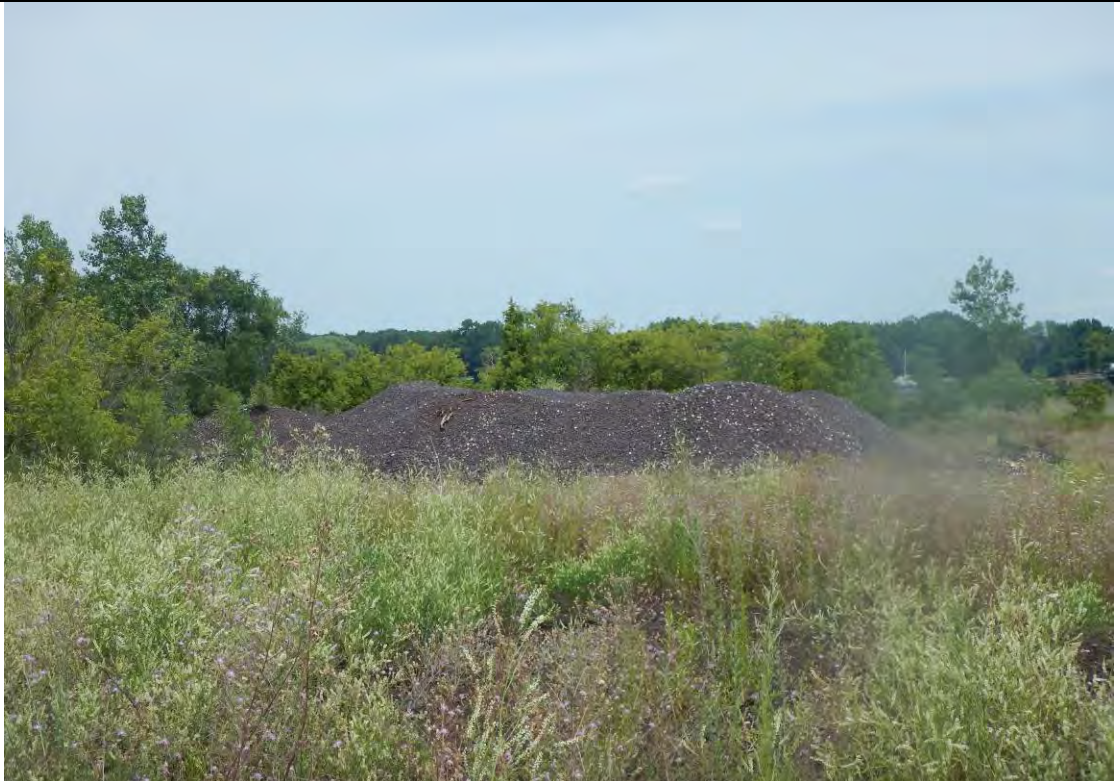
Client Name: City of Trenton		Site Location: 1491 W. Jefferson Avenue, Trenton, MI 48183	Project No. 170443-0100
Photo No. 1	Date: 7/21/17

Direction Photo Taken: East			
Description: Area 4 Slag stockpile north of ore yard No. 2.

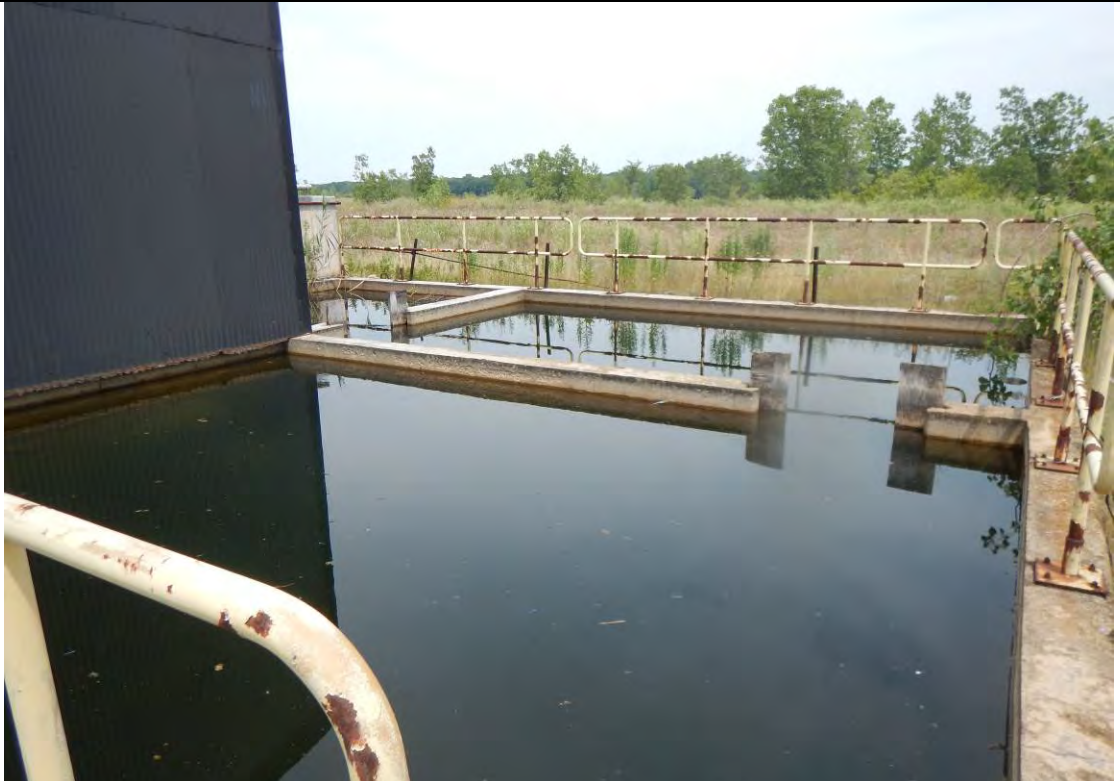
Client Name: City of Trenton		Site Location: 1491 W. Jefferson Avenue, Trenton, MI 48183	Project No. 170443-0100
Photo No. 3	Date: 7/21/17

Direction Photo Taken: East			
Description: Area 4 Open concrete vaults filled with water at railroad transfer station.

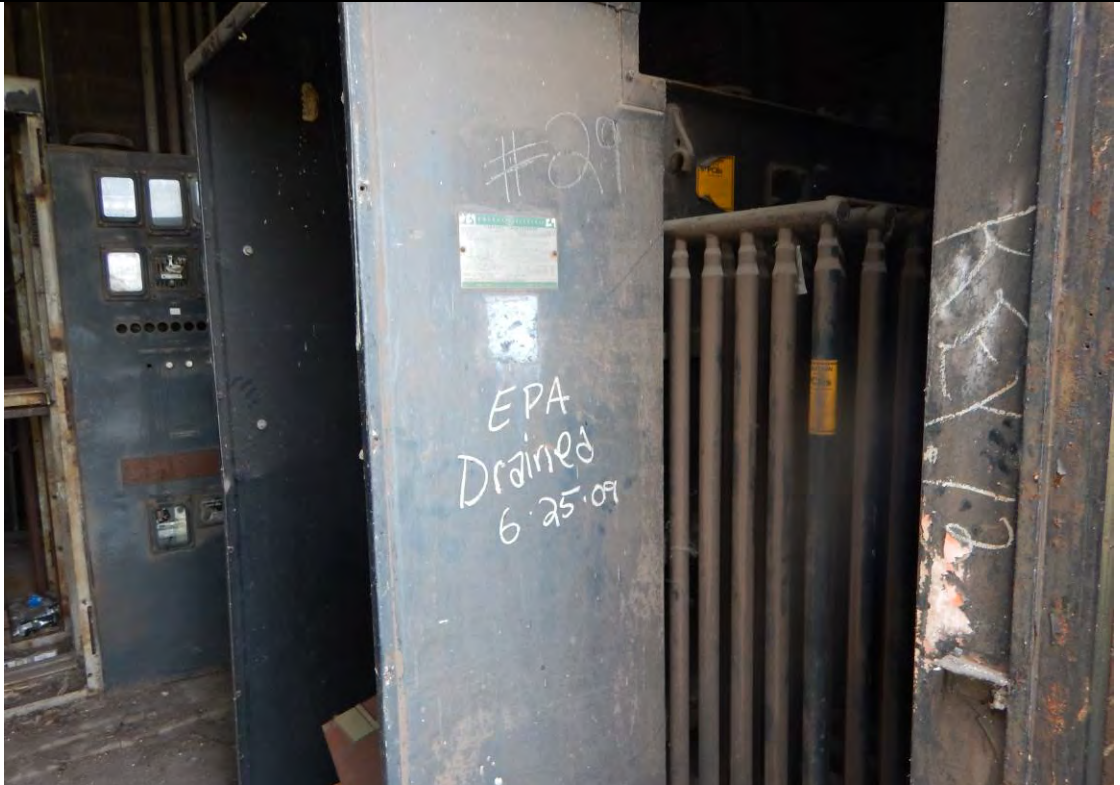
Client Name: City of Trenton		Site Location: 1491 W. Jefferson Avenue, Trenton, MI 48183	Project No. 170443-0100
Photo No. 5	Date: 7/21/17

Direction Photo Taken: West			
Description: Area 4 EPA drained transformer #29 on 6-25-09 in the gas cleaning area north of the railroad transfer station.

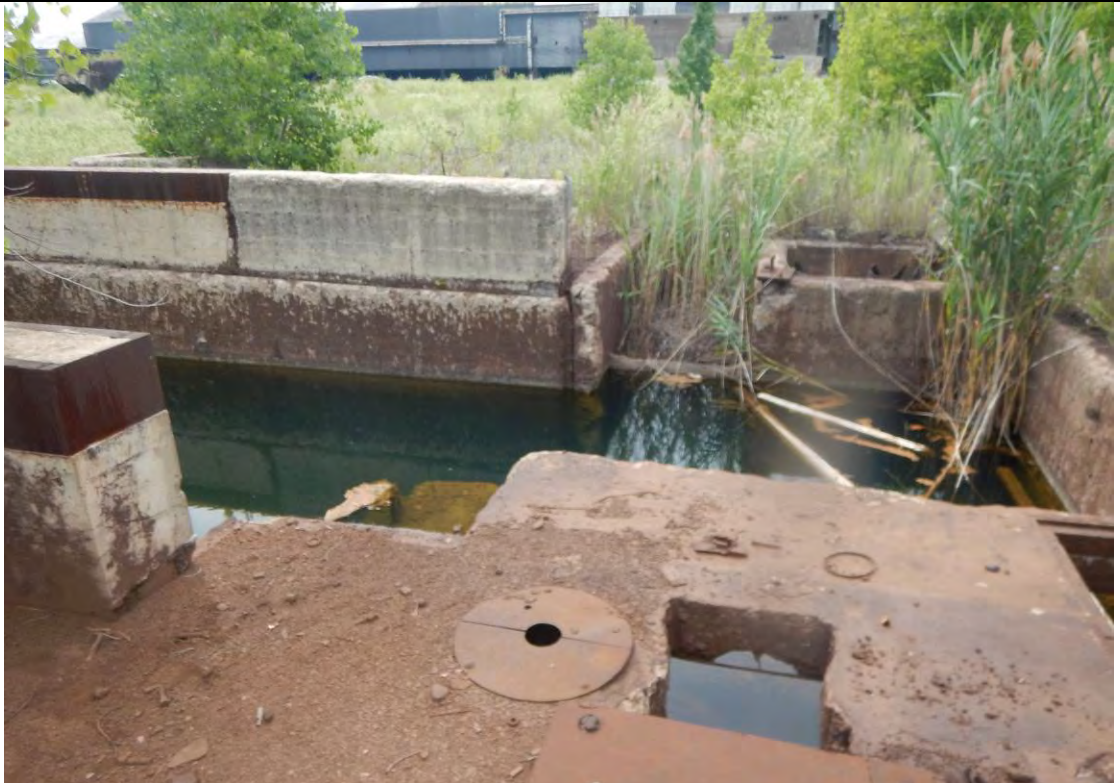
Client Name: City of Trenton		Site Location: 1491 W. Jefferson Avenue, Trenton, MI 48183	Project No. 170443-0100
Photo No. 9	Date: 7/21/17

Direction Photo Taken: West			
Description: Area 4 Former gas cleaning operations area, south of railroad transfer station. Subsurface basement filled with water.

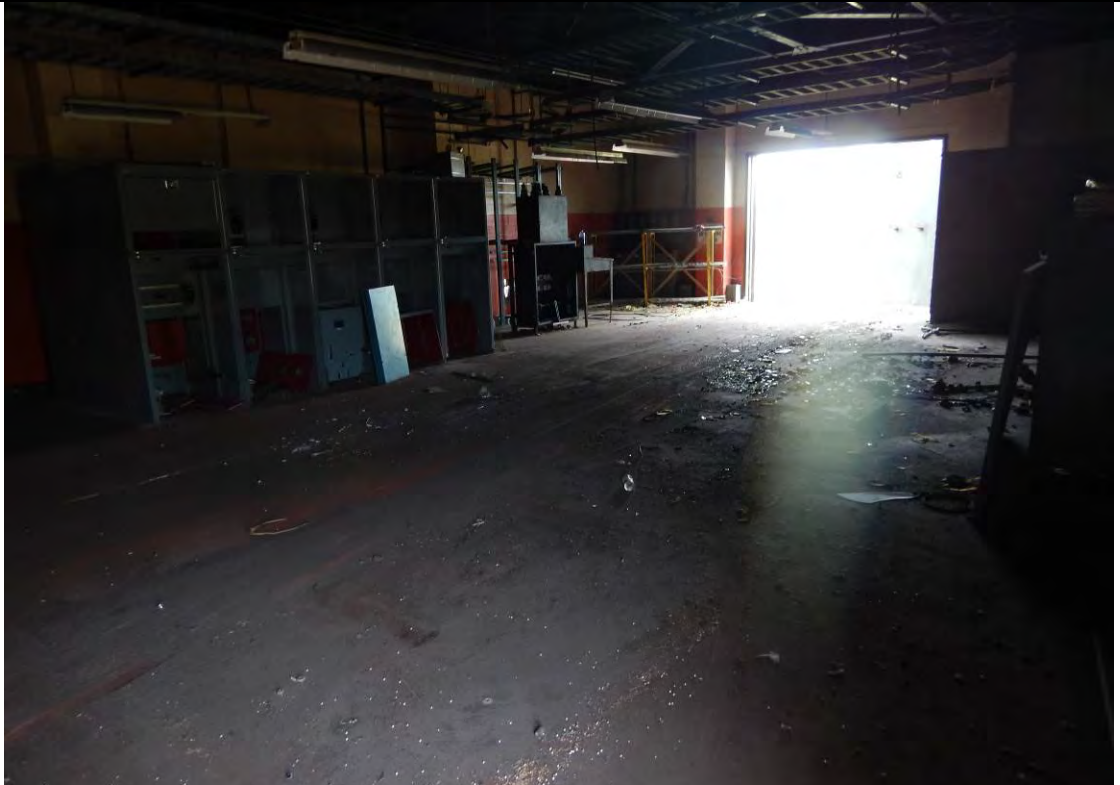
Client Name: City of Trenton		Site Location: 1491 W. Jefferson Avenue, Trenton, MI 48183	Project No. 170443-0100
Photo No. 15	Date: 7/21/17

Direction Photo Taken: Northwest			
Description: Area 4 Staining within building within former gas cleaning operations area.

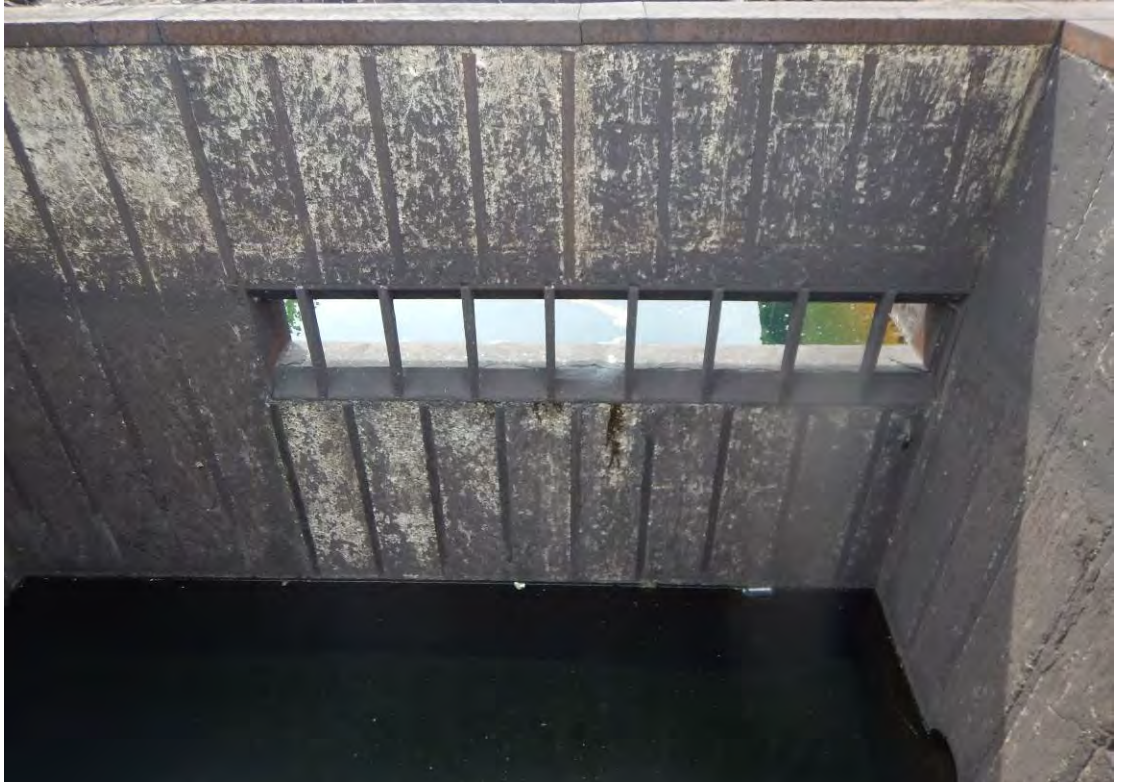
Client Name: City of Trenton		Site Location: 1491 W. Jefferson Avenue, Trenton, MI 48183	Project No. 170443-0100
Photo No. 17	Date: 7/21/17

A photograph showing the interior of a concrete vault. The walls are made of dark, textured concrete with vertical reinforcement lines. In the center, there is a rectangular opening with horizontal metal bars. Through the bars, a bright outdoor scene with greenery and a blue sky is visible. The floor of the vault is dark and appears to be covered in water or a wet surface.	
Direction Photo Taken: West			
Description: Area 4 Open concrete vaults at former gas cleaning operations area, filled with water.

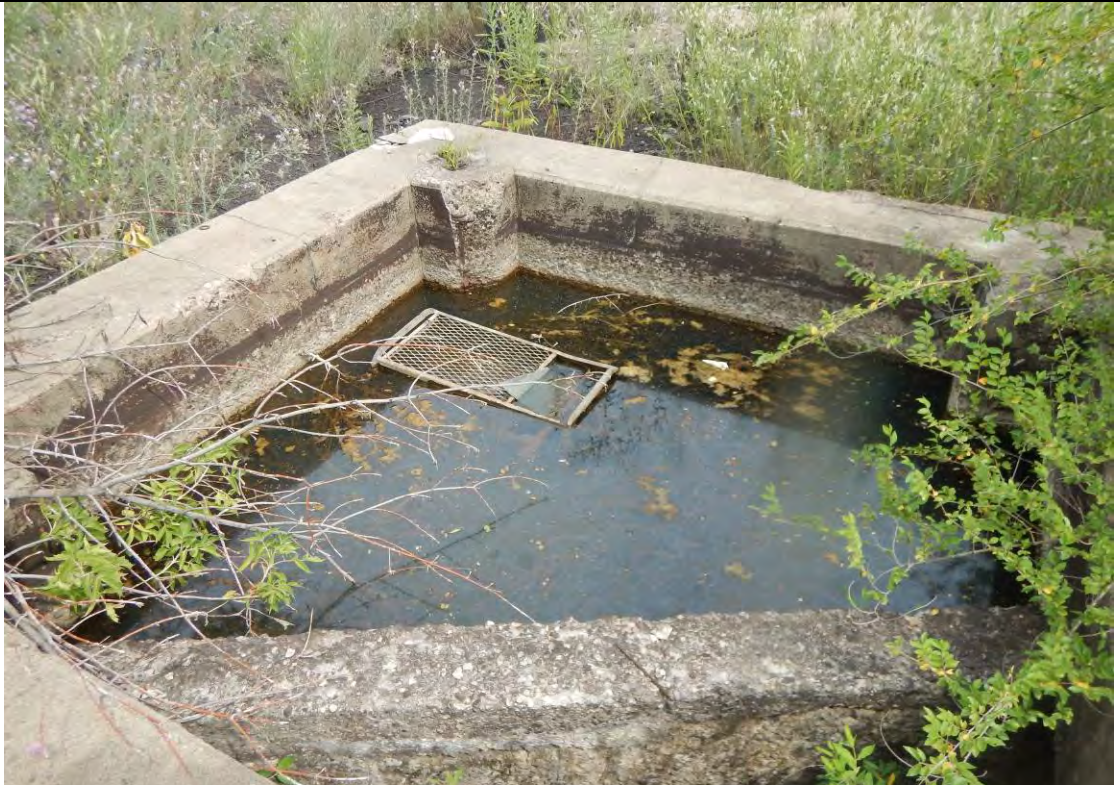
Client Name: City of Trenton		Site Location: 1491 W. Jefferson Avenue, Trenton, MI 48183	Project No. 170443-0100
Photo No. 19	Date: 7/21/17

Direction Photo Taken: Southwest			
Description: Area 4 Open concrete vault filled with water near former gas cleaning operations area.

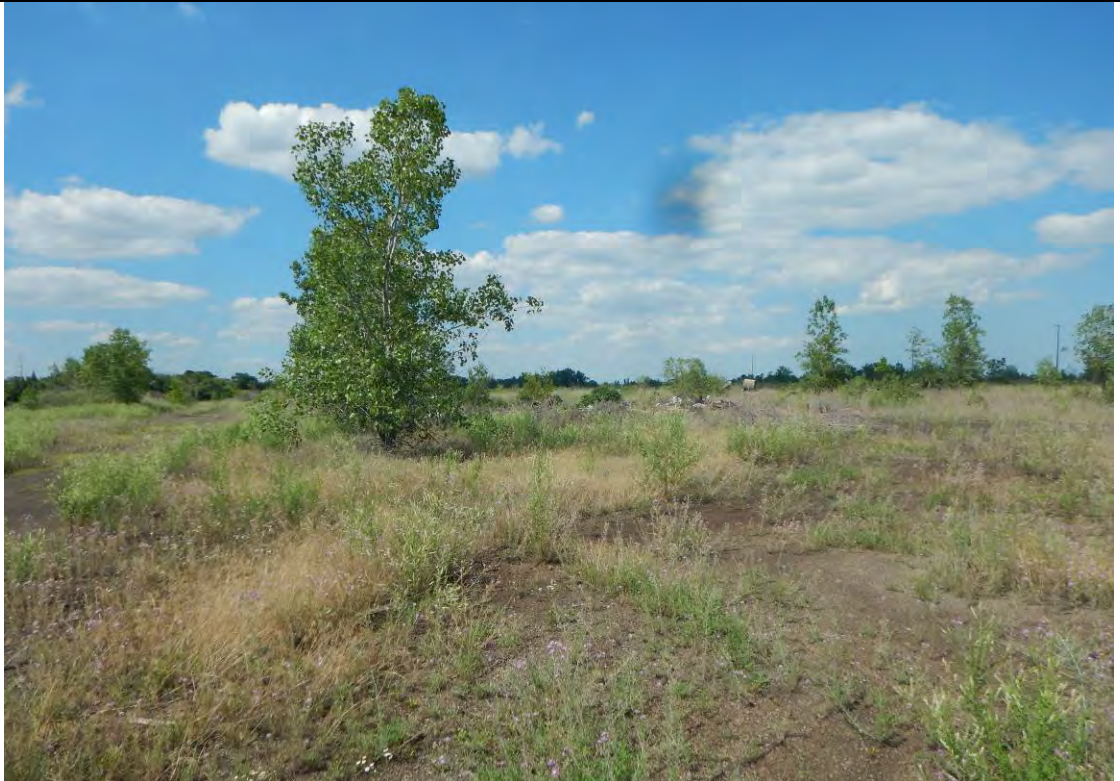
Client Name: City of Trenton		Site Location: 1491 W. Jefferson Avenue, Trenton, MI 48183	Project No. 170443-0100
Photo No. 3	Date: 7/17/17

Direction Photo Taken: North			
Description: Area 5 Former scrap storage area.

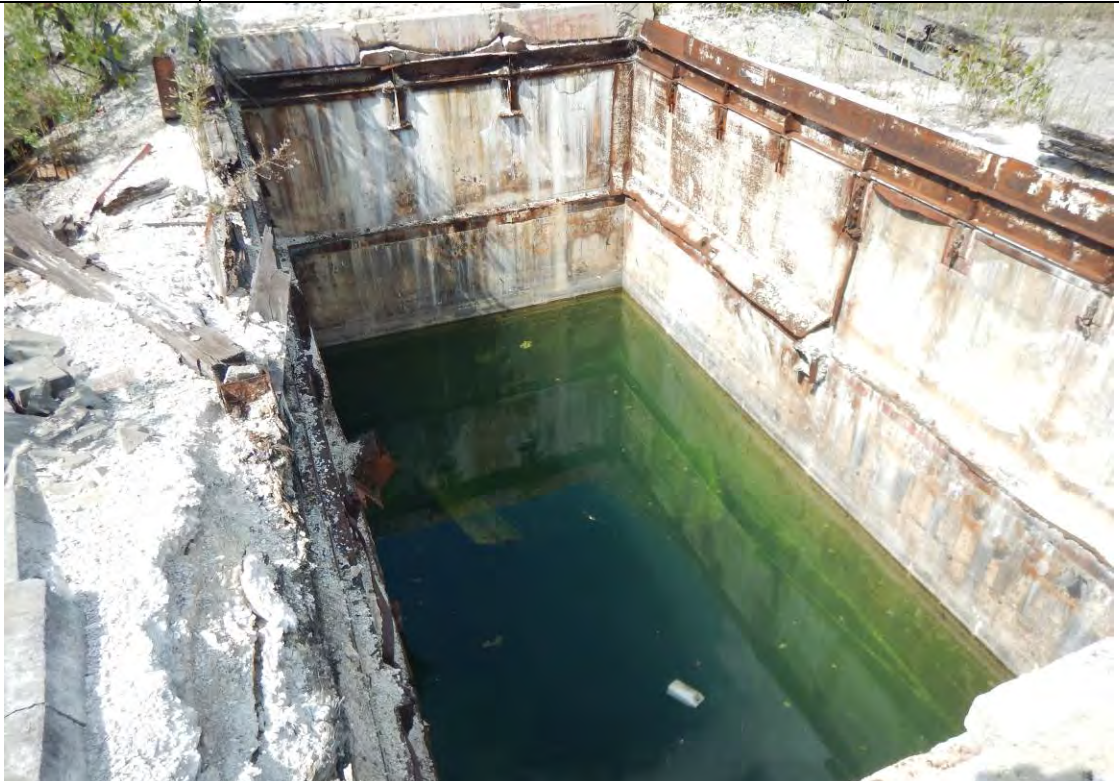
Client Name: City of Trenton		Site Location: 1491 W. Jefferson Avenue, Trenton, MI 48183	Project No. 170443-0100
Photo No. 7	Date: 7/17/17

Direction Photo Taken: North			
Description: Area 5 Former conveyor storage vault; filled with water.
