Field Report for Airborne Data Collected In Support of US EPA Region 6 Intercontinental Terminals Company LLC Fire 23 March 2019

Data Results Flight 10, 23 March 2019

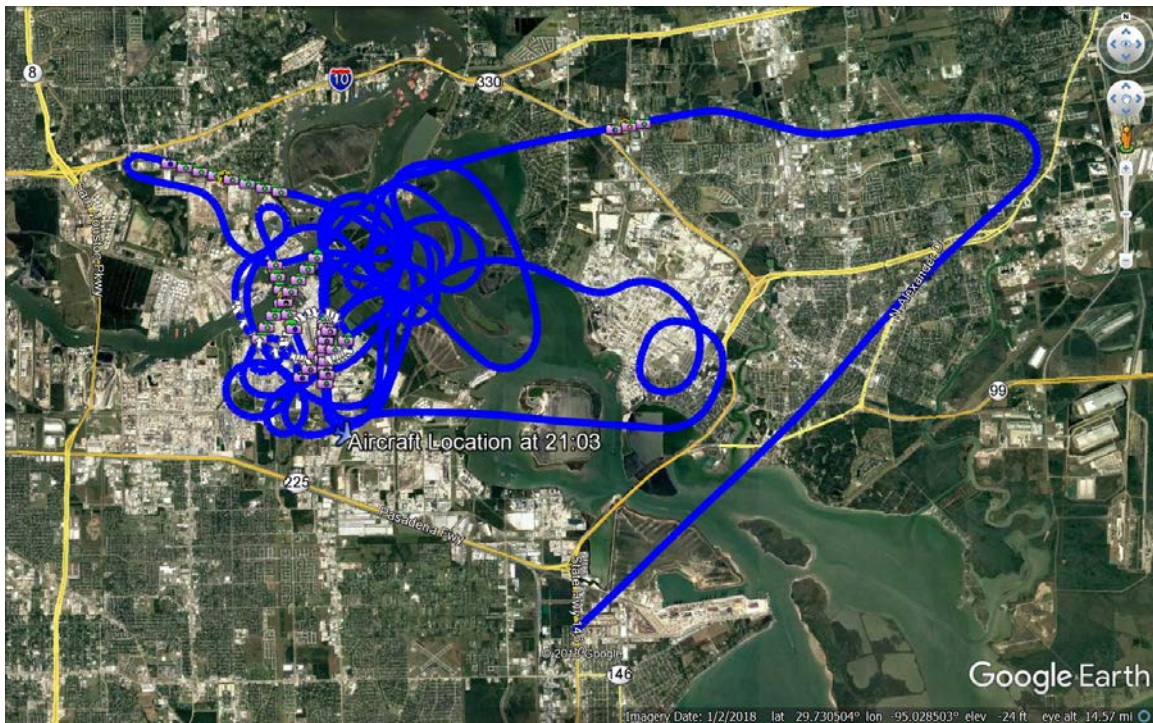
Figure 2: Flight line data for 23 March 2019, Flight 10. The blue lines represent the ASPECT flight path, green lines represent when the Infrared Line Scanner was actively collecting data, and the camera icons represent when a photo was taken.

The order to launch the aircraft was given at 1440 local on 23 March 2019 and the aircraft was airborne at 1500. The initial data collection run over the site was at 1510 (local) and the aircraft made a total of 8 data collection passes. No detections were observed on any passes. Flight information is summarized in Appendix A and Figure 2.

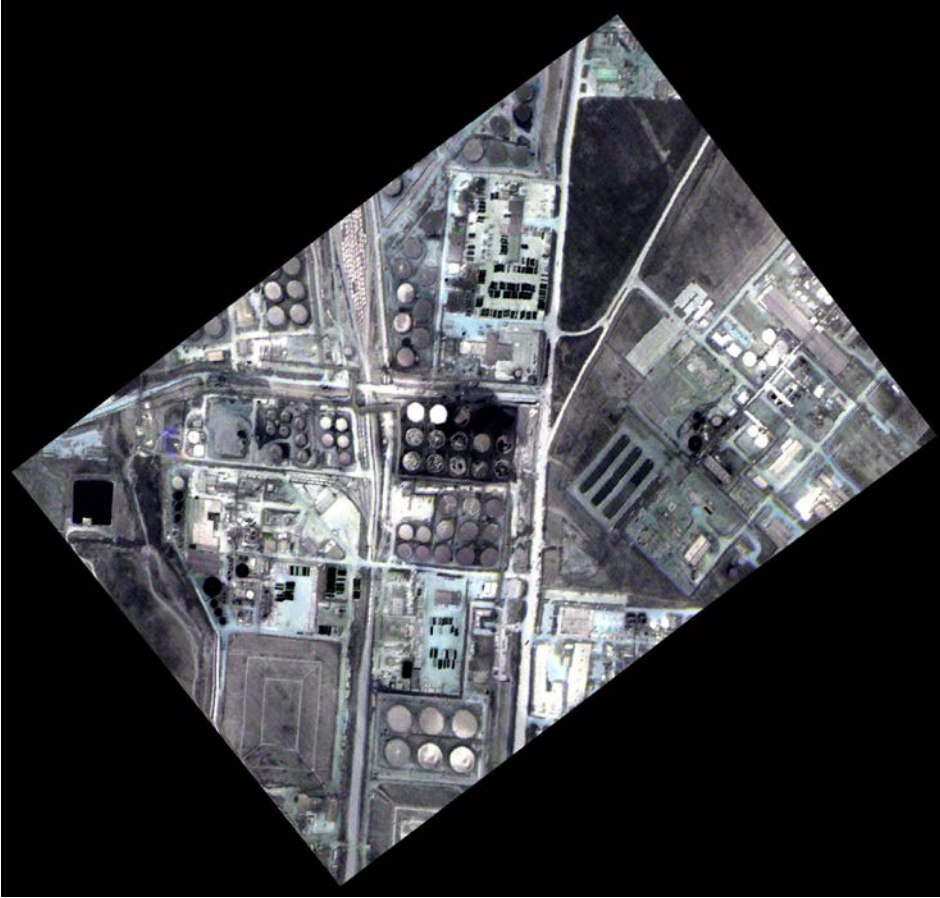
A total of 1 test and 8 data passes were made in the proximity of the impacted tank farm and also in extended areas surrounding the site and infrared line scanner images were generated for each pass. Figure 3 shows a typical 3-band infrared image obtained from data collected for Run 3. The image continues to show the tank farm with a black color within the secondary containment (oil/petroleum). As with the last flight, tanks in the northeast corner and center have the appearance of showing elevated temperature their white color. A thermal analysis using the RS00 line scanner was conducted on a same image (Figure 4) and tends to support this finding however the estimated temperatures are only a few degrees warmer than the surround tanks. In general, the warmer tanks are 30°C to 40°C. This was further confirmed by collecting an image with the night vision camera which again showed that these two tanks are the warmest (figure 5).

Figure 3: IR image of ITC data for 23 March 2019, Flight 10 Run 3

ASPECT conducted flight 10 23 March 2019 with the goal to conduct a general survey at the tank farm and downwind of the site. Data continues to show that tanks in the NW corner are warmer than others in the tank farm with estimated temperatures being in the 30°C to 40°C range. IR images collected over the confluence into the ship channel continues to show boomed oil products with some leakage occurring. No chemical detections were observed on this flight.

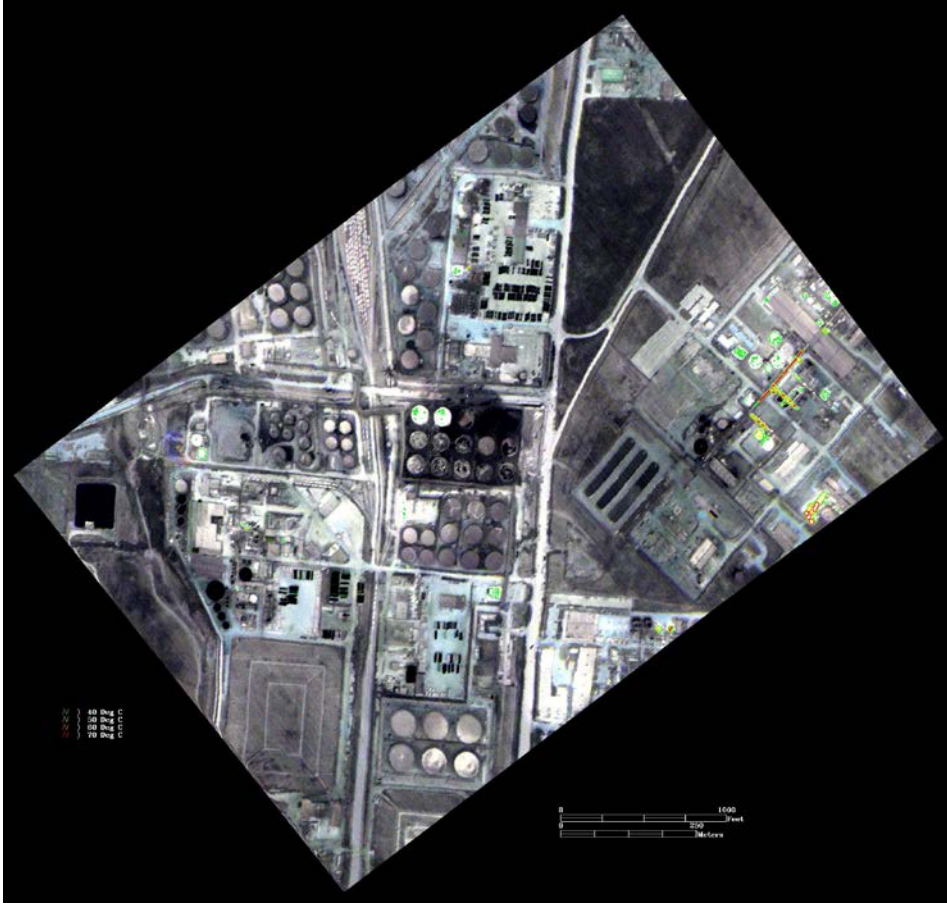
Figure 4: IR Thermal Analysis 23 March 2019, Flight 10, Run 3

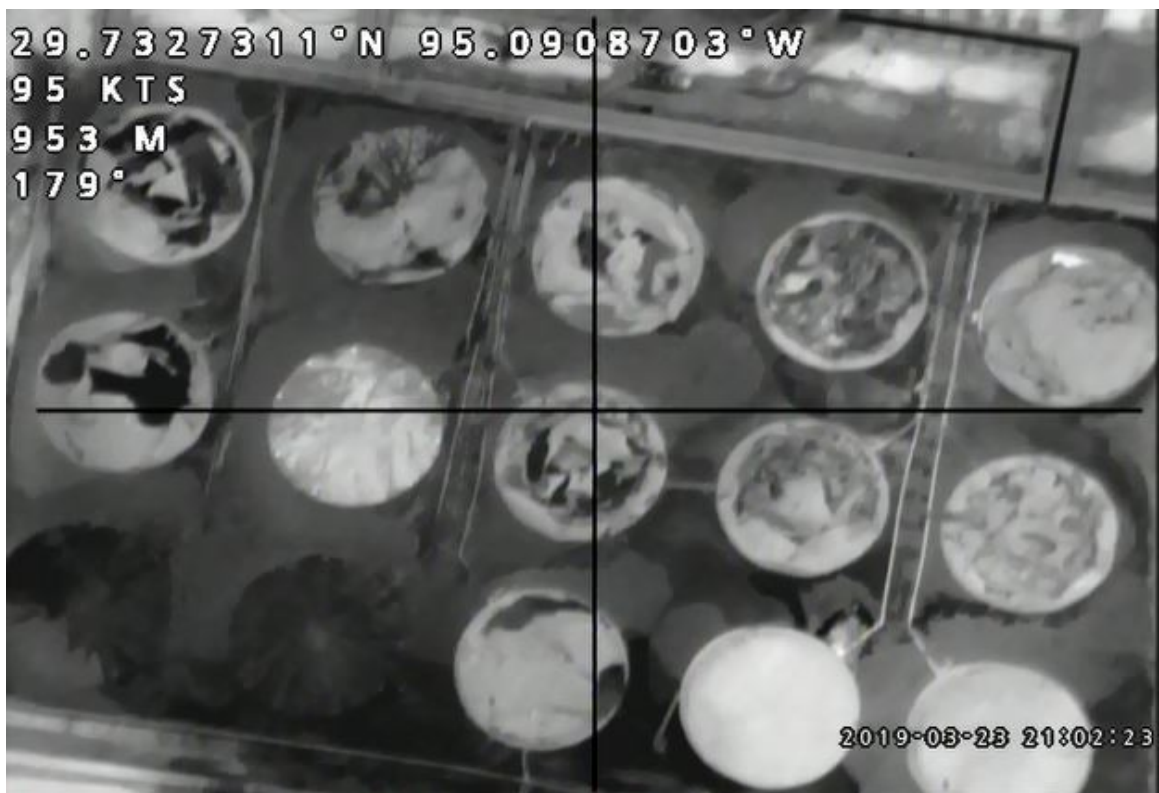
Figure 5: IR Image 22 March 2019, Flight 8, Run 5

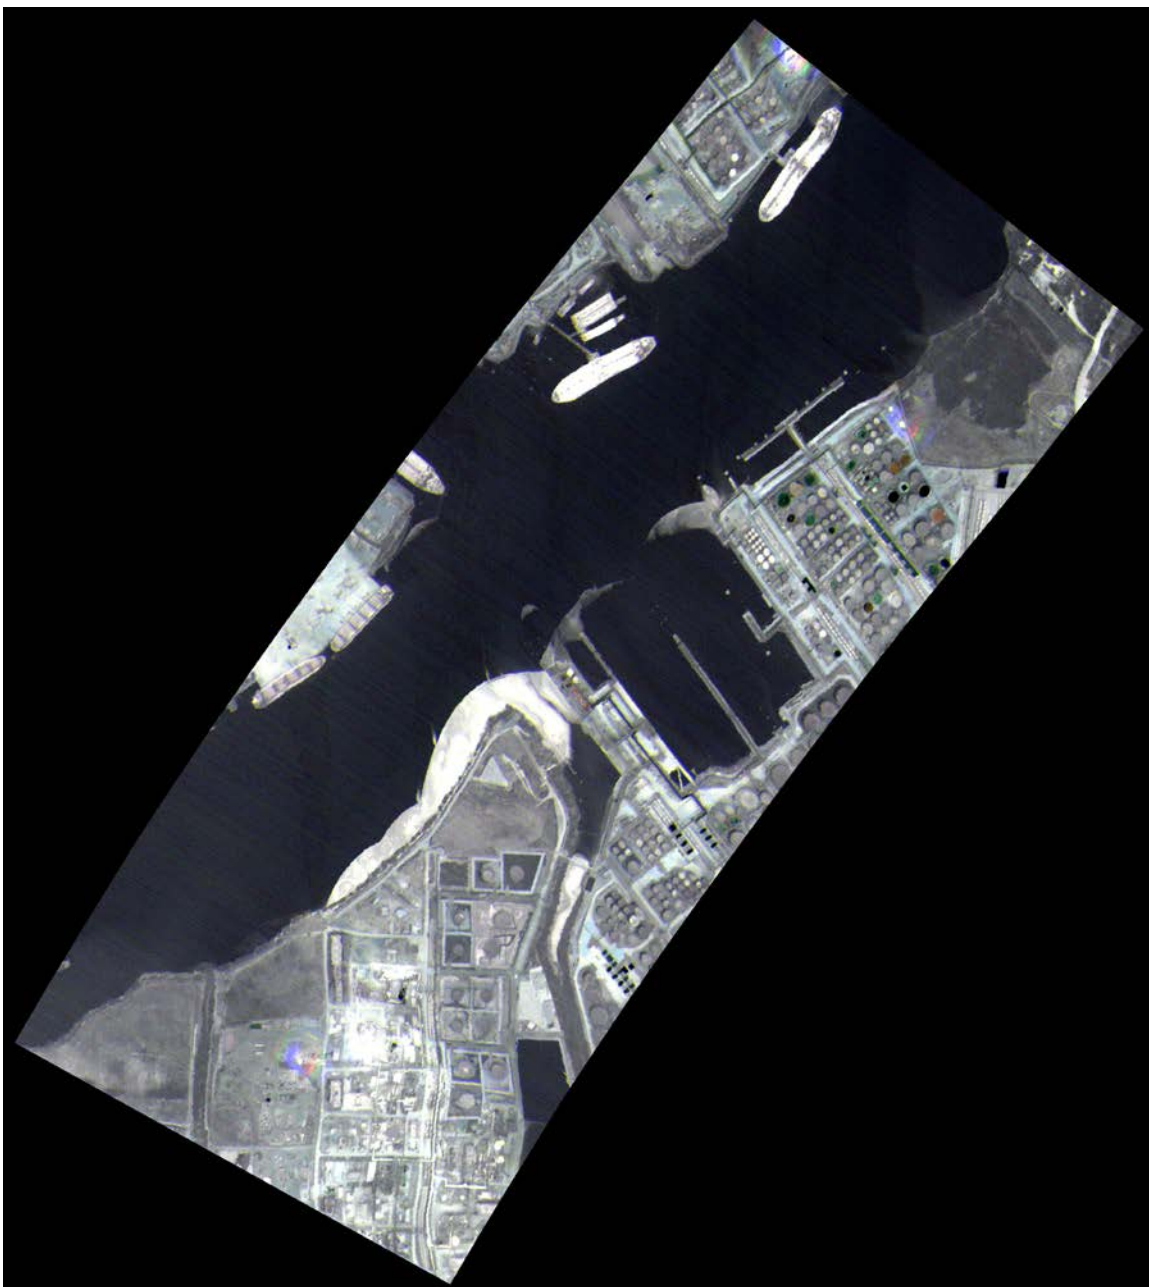
IR Run 5 was conducted over the confluence of the drainage creek into the ship channel. Containment boom has been fitted across the mouth of the creek and the white (warmer) oil can be seen behind the boom. A small amount of leakage can be seen breaking through the boom.

Figure 6: IR Image of Contained Oil 23 March 2019, Fight 10, Run 5

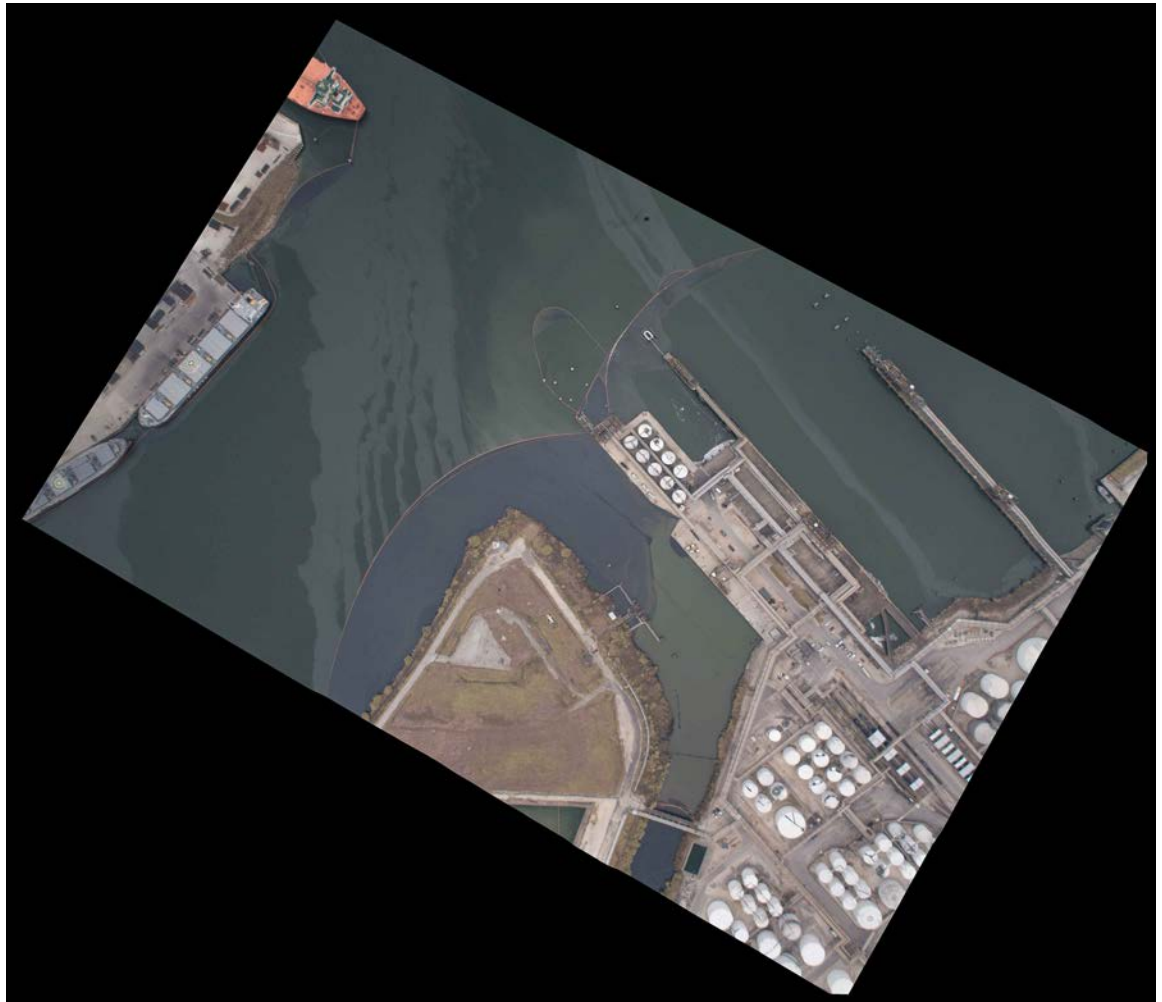
A full set of high resolution aerial digital photography was collected as part of the flight. Figure 7 shows a representative overhead image collected as part of each pass over the tank farm. Captured oil behind the boom is evident as is light sheen leakage moving into the channel. The same features can be seen in an oblique collected at about the same time (Figure 8)

Figure 7: Aerial Image of the Ship Channel Boom Area, 23 March 2019, Flight 10

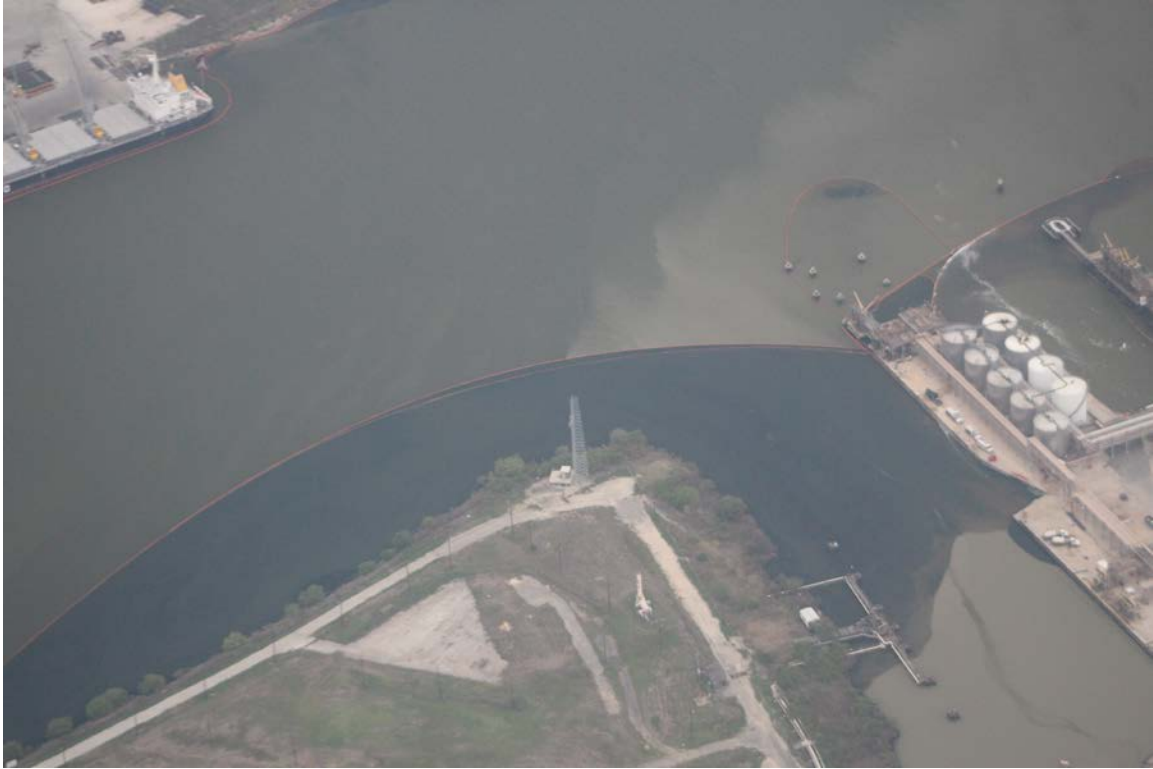
Figure 9: Oblique Image of the Ship Channel Boom Area, 23 March 2019, Flight 10
