Field Report for Airborne Data Collected In Support of US EPA Region 6 Intercontinental Terminals Company LLC Fire 25 March 2019

Data Results Flight 12, 25 March 2019

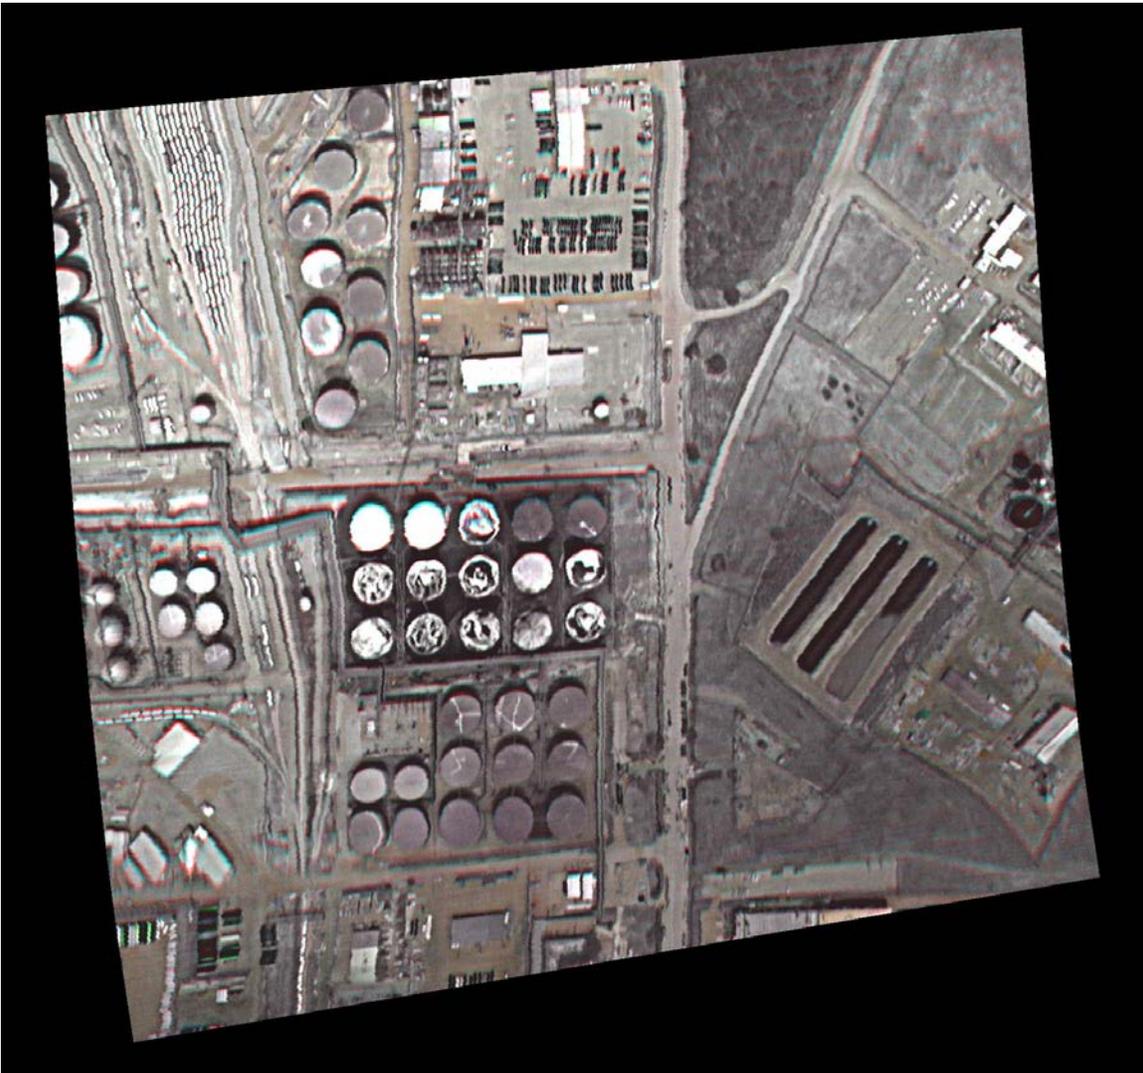
A total of 1 test and 6 data passes were made in the proximity of the impacted tank farm and also in extended areas surrounding the site and infrared line scanner images were generated for each pass. Figure 3 shows a typical 3-band infrared image obtained from data collected for Run 5. There is effectively little difference in the thermal character between this flight and flight 10 on 23 March 2019. A night vision image (Figure 4) continues to show the tanks in the NW corner of the farm (bottom right in the image due to the image being inverted) have slightly higher temperatures.

Figure 3: IR image of ITC data for 25 March 2019, Flight 12 Run 5

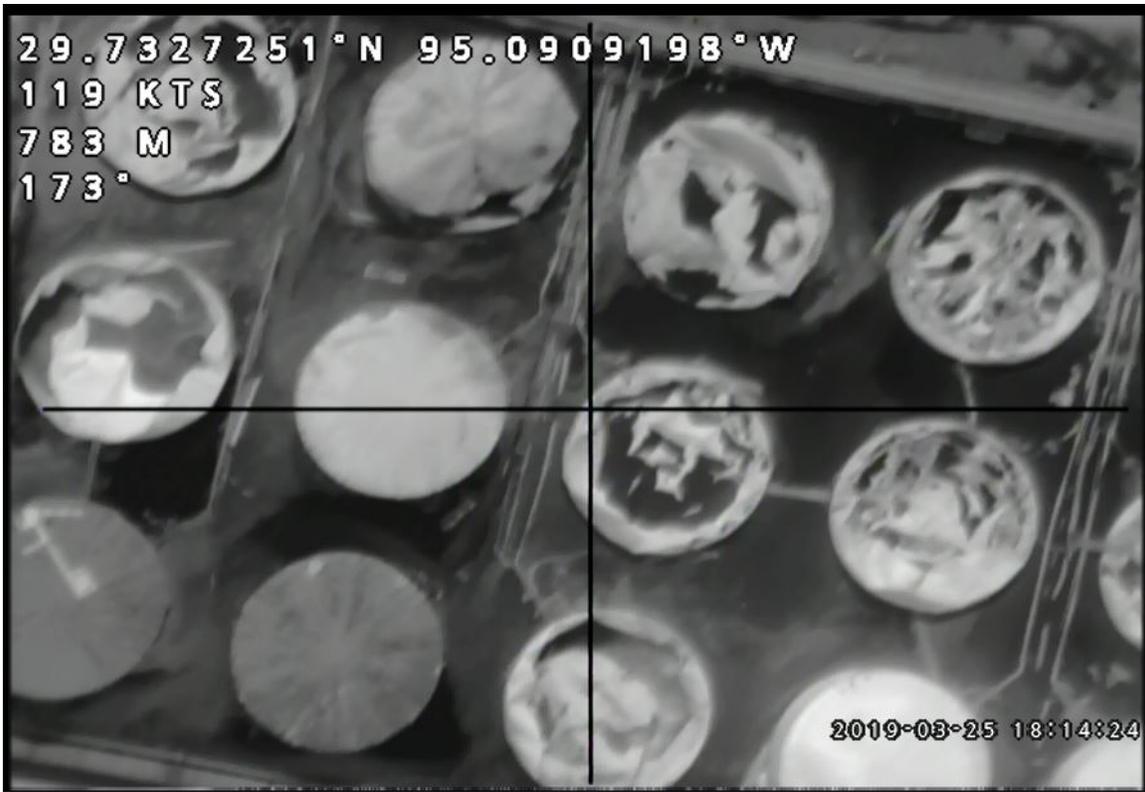
Figure 4: IR Thermal Analysis 25 March 2019, Flight 12, Run 5

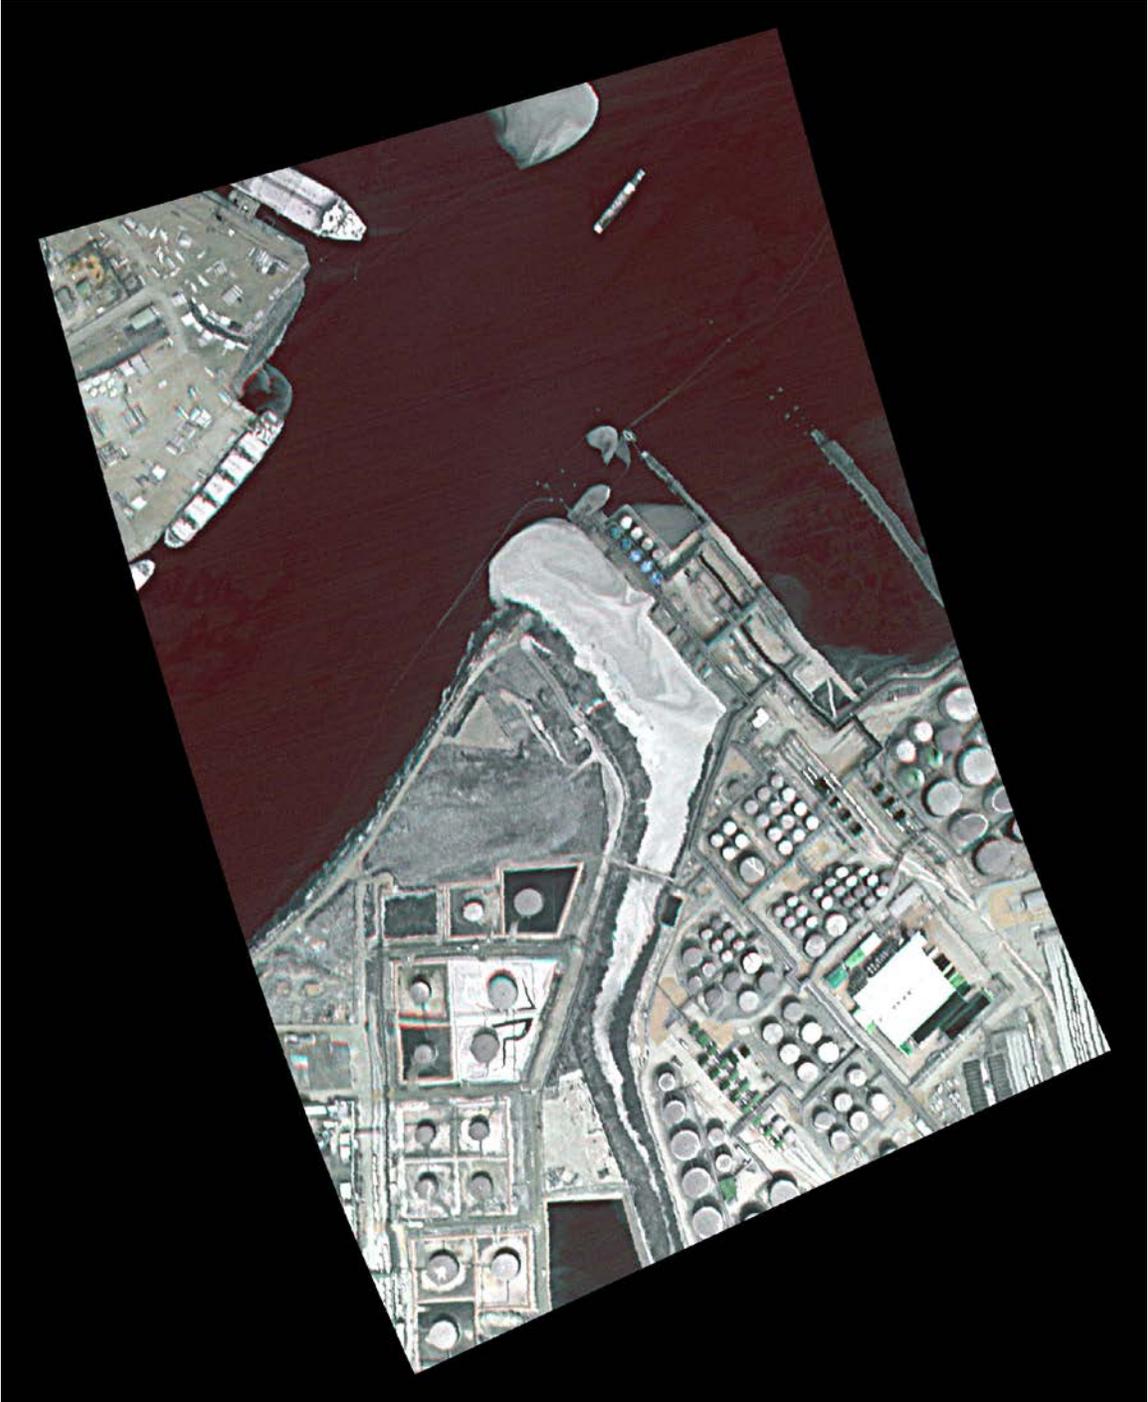
IR Run 6 was conducted over the confluence of the drainage creek into the ship channel. Containment boom has been fitted across the mouth of the creek and the white (warmer) oil can be seen behind the boom (Figure 5). No significant leakage is event in this image.

Figure 5: IR Image of Contained Oil 25 March 2019, Flight 12, Run 6

ASPECT conducted flight 12 on 25 March 2019 with the goal to conduct a general survey at the tank farm and downwind of the site. Data continues to show that tanks in the NW corner are warmer than others in the tank farm. IR images collected over the confluence into the ship channel continue to show boomed oil products with some leakage occurring with sheen being driven to the southwest due to winds. No significant chemical detections were observed on this flight.

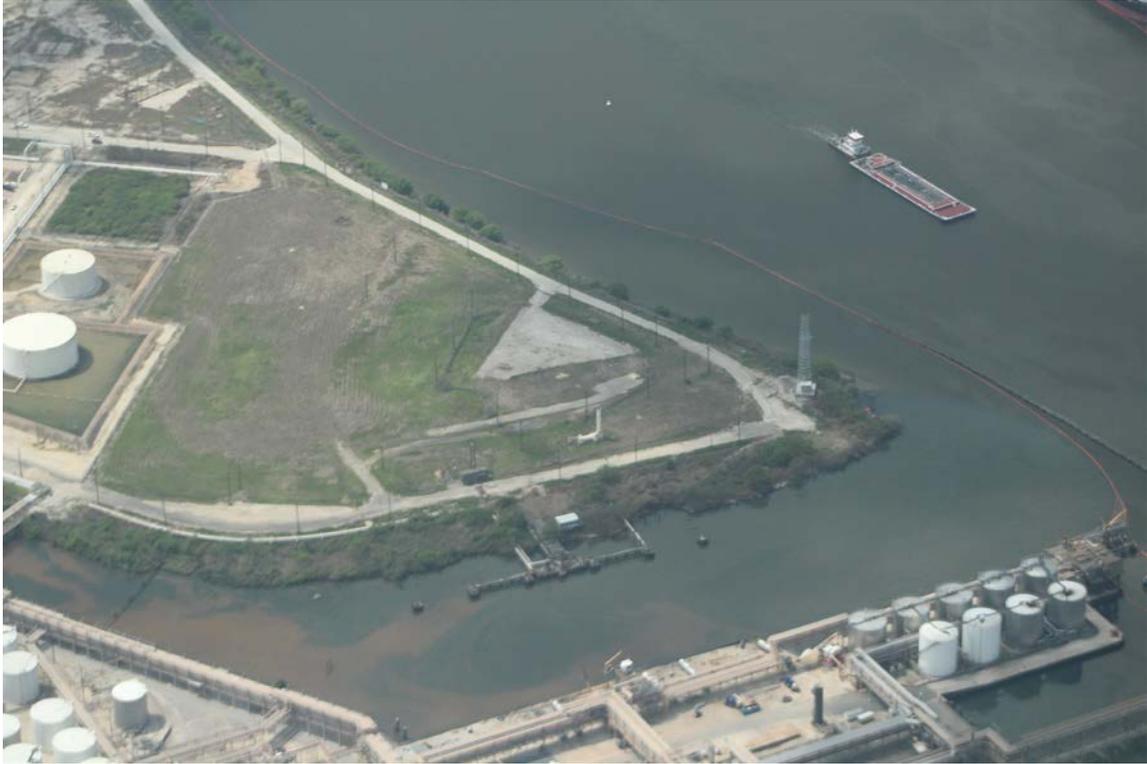
A full set of high resolution aerial digital photography was collected as part of the flight. Figure 6 shows a representative overhead image collected as part of each pass over the tank farm. As with prior flights, the image shows that oil product is captured behind the boom. Sheen can be seen escaping from the boom with movement toward the southwest as driven by the winds. The same area as viewed with an oblique does show captured product but the definition is much reduced as compared to the IR or aerial view (Figure 7). Some sheen can be seen in the right bottom corner of the image.

Figure 7: Oblique Image of the Ship Channel Boom Area, 23 March 2019, Flight 10
