Water Meter and Valve Boxes Soil Assessment and Removal Report

Factory Street Site Oahu, Hawaii

March 2018
Version: Final-Revision 1
EA Project No. 63112.01

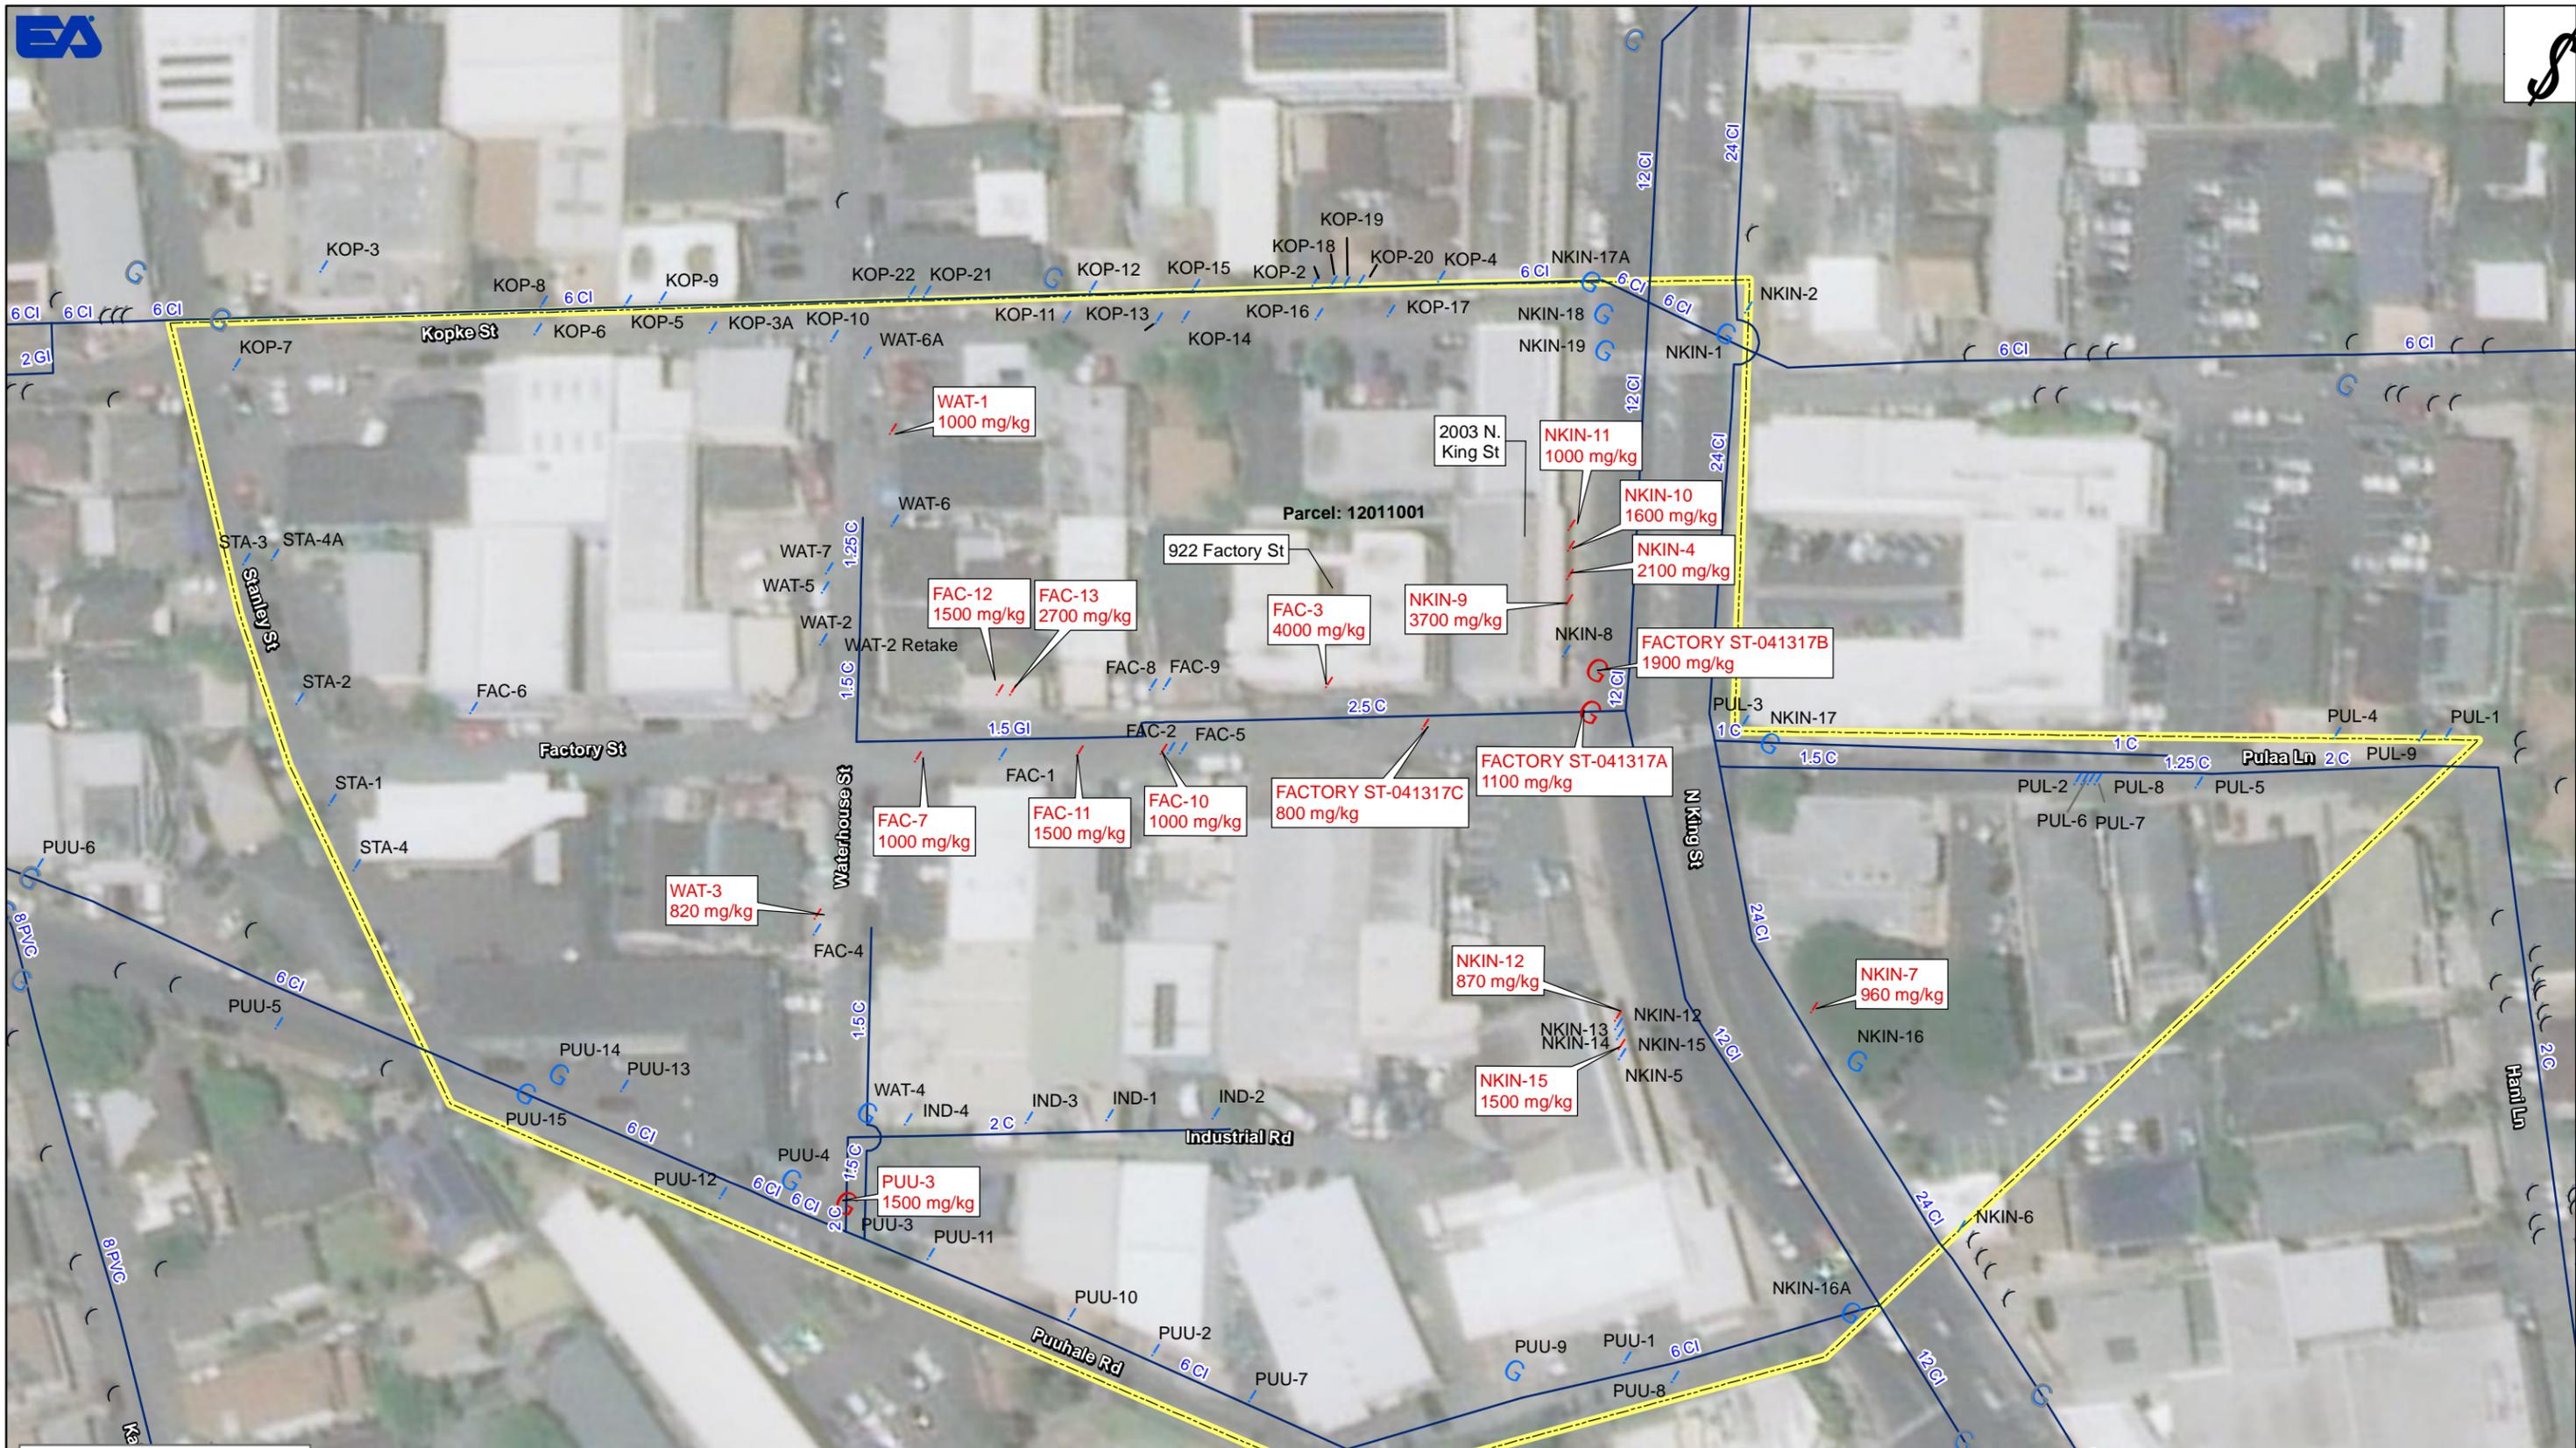
milligrams/kilogram (mg/kg)

Hawaii Department of Health (HDOH) Direct Exposure Action Level for Construction/Trench Worker Scenario Commercial/Industrial Land Use Table I-2 [Construction Trench/Worker Action Level] (HDOH Fall 2017)

Field activities occurred between 13 April and 4 October 2017. Discrete soil samples for lead analysis were collected from 99 water meter and valve box locations along Factory Street, Industrial Road, Kopke Street, North King Street, Pulaa Lane, Puuhale Road, Stanley Street, and Waterhouse Street (Figure 2).

As seen in Figure 2, three samples (PUU-5, PUU-6, and NKIN-2) were collected from locations outside the site boundary. PUU-5 and PUU-6 were selected due to a resident's comment that rainwater frequently travels down Stanley Street and pools along the western portion of Puuhale Road.

- The water meter boxes and lateral water lines for 1947 North King Street and 922, 922A, and 926 Kopke Street were slightly misaligned in the geospatial data. The actual locations found during field activities are further south along Kopke Street. Figure 2 shows the corrected water meter locations associated with these addresses.

- Three valve boxes (represented by samples NKIN-17A, NKIN-18, and NKIN-19) are located in the eastbound lane of North King St. Figure 2 has been updated to reflect these changes.

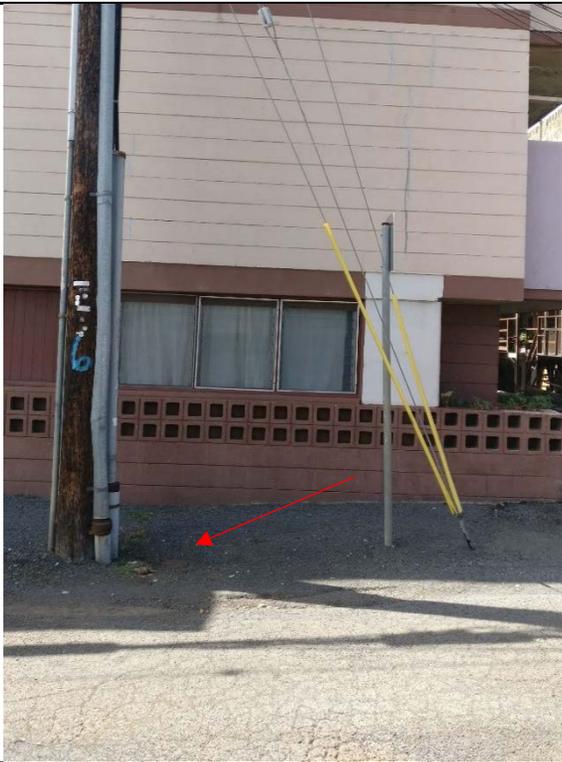
Project No. 1552801	Description: FAC-3: 922 Factory St.	Photo 1A
	Site Name: Factory St. Area, Kalihi, Honolulu, HI	
	Client: Board of Water Supply	April 13, 2017

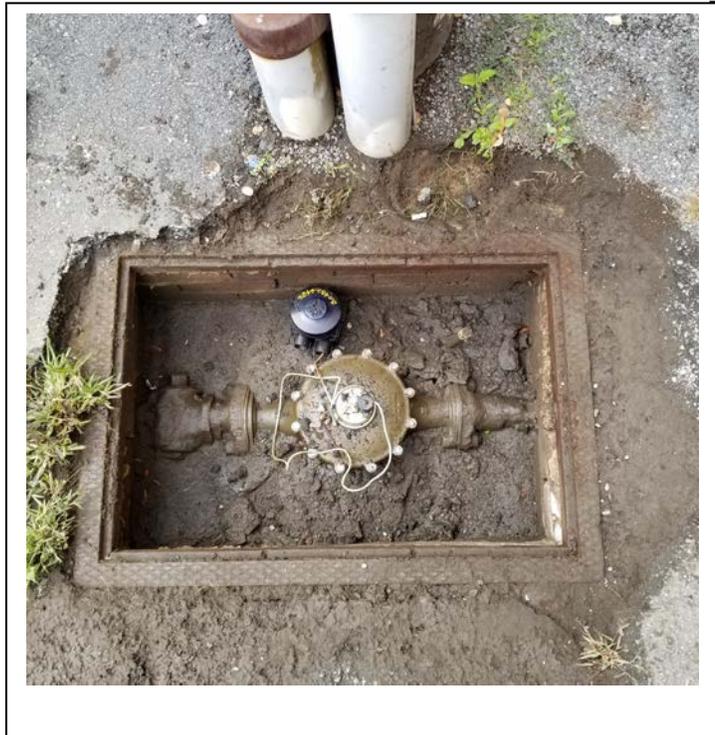
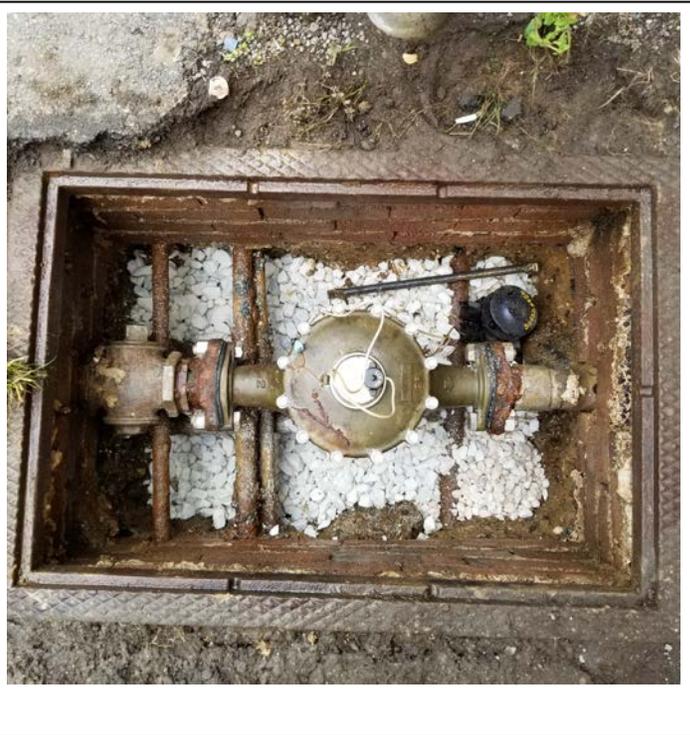
Project No. 1552801	Description: FAC-3: Before and After Soil Removal	Photo 1B
	Site Name: Factory St. Area, Kalihi, Honolulu, HI	
	Client: Board of Water Supply	Feb 13, 2018

At each site, the meter/valve box lids were vacuumed and removed, and a photograph of the water meter or valve box was taken prior to soil removal (Attachment A). The high pressure hose and hand tools were used to break up the soil to a depth of 4 to 8 inches. Good housekeeping was maintained by working within the boxes and limiting overspray. The soil and water was then removed from the water meter and valves boxes via vacuum. If a water meter or valve box was found to be co-located (WAT-3 and FAC-4), soil from both boxes was removed.

After soil and water removal approximately 0.5 cubic feet of marble or coral chips were used to backfill the water meter and valve boxes to within one to two inches below the pipes, allowing access for future repairs. The color was chosen to provide a highly visible contrast to existing soil and sediments. The meters and valves were rinsed or wiped to improve visibility. BWS workers then repaired the meters and/or valves as-needed. A final photograph of the water meter or valve box was taken (Attachment A). The water meter and valve box lids were replaced, and the surrounding pavement was rinsed and vacuumed of sediment.

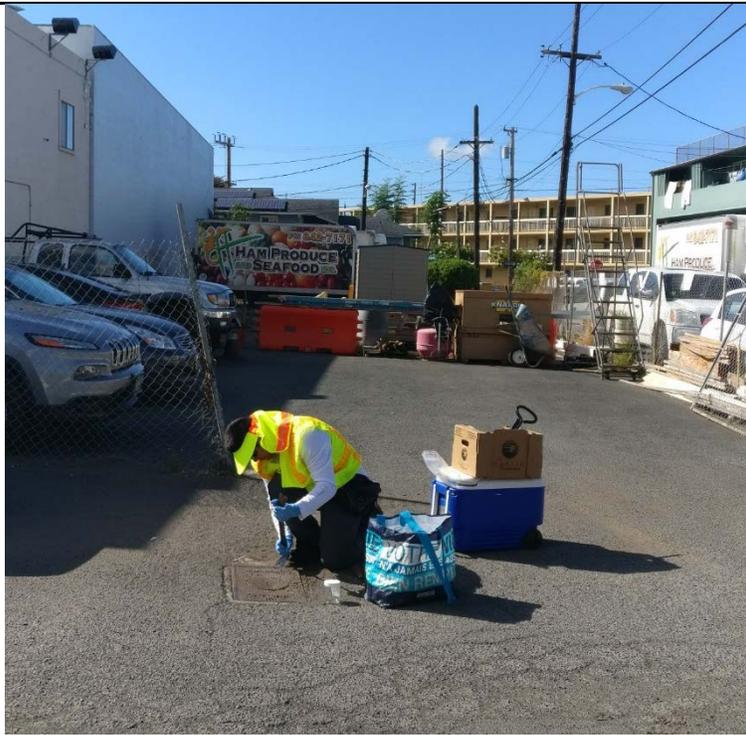
Project No. 1552801	Description:	FAC-7: 901 Factory St.	Photo 2A
	Site Name:	Factory St. Area, Kalihi, Honolulu, HI	Photo Date June 1, 2017
	Client:	Board of Water Supply

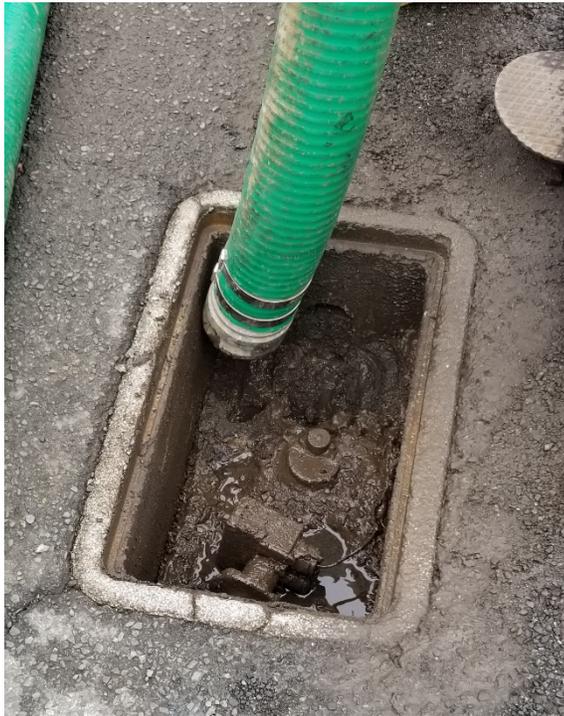
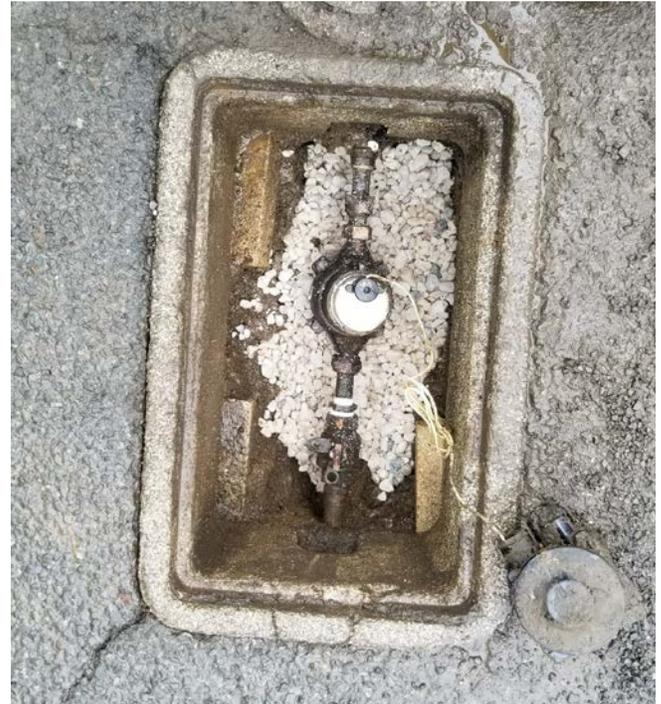
Project No. 1552801	Description:	FAC-7: Before and After Soil Removal	Photo 2B
	Site Name:	Factory St. Area, Kalihi, Honolulu, HI	Photo Date Feb 13, 2018
	Client:	Board of Water Supply

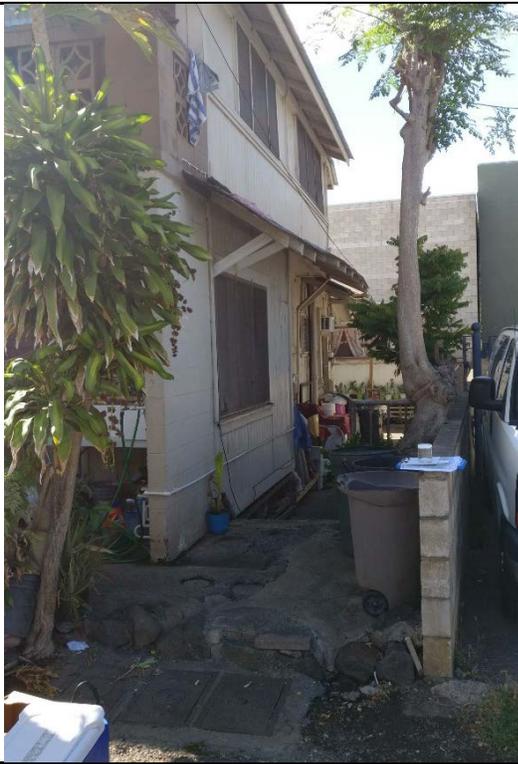
Project No. 1552801	Description:	FAC-10: 915A Factory St.	Photo 3A
	Site Name:	Factory St. Area, Kalihi, Honolulu, HI	Photo Date
	Client:	Board of Water Supply	June 1, 2017

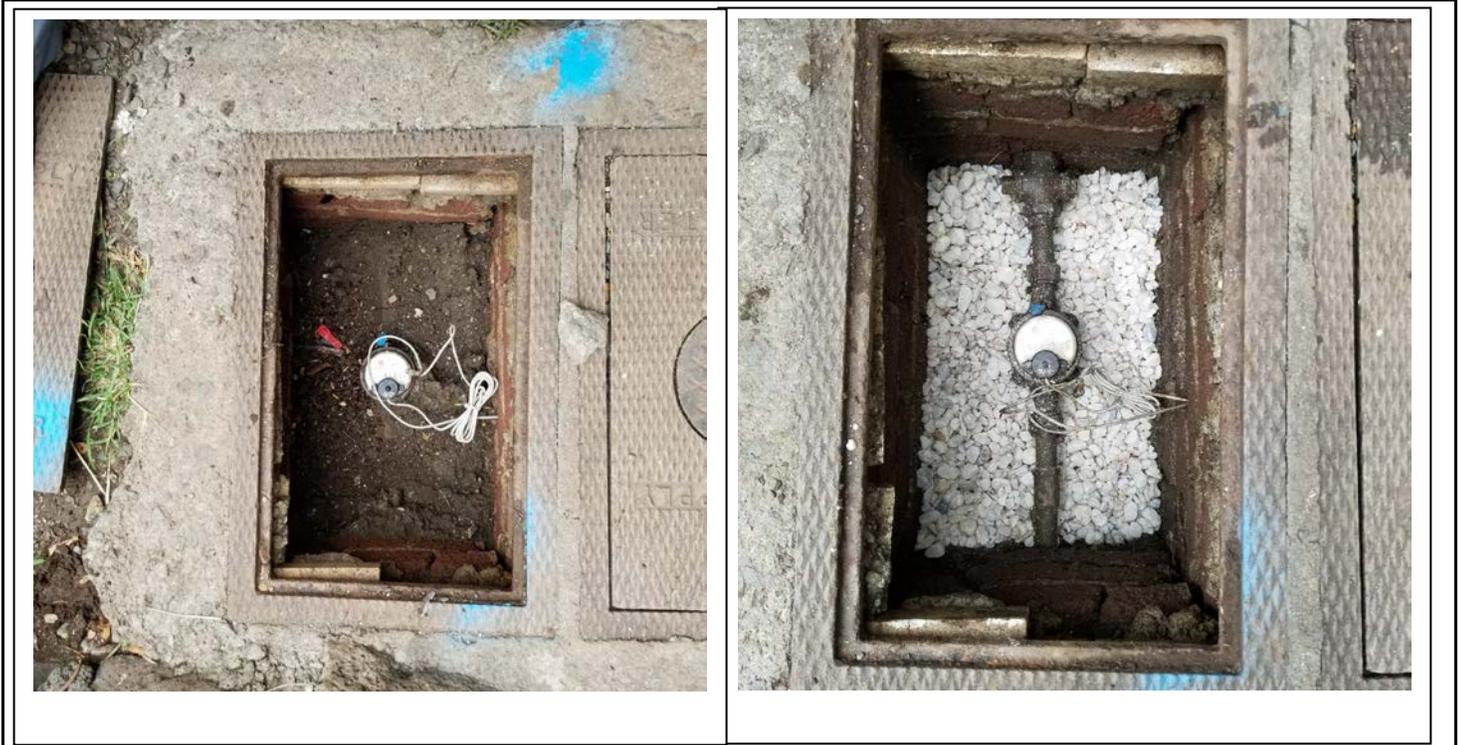
Project No. 1552801	Description:	FAC-10: Before and After Soil Removal	Photo 3B
	Site Name:	Factory St. Area, Kalihi, Honolulu, HI	Photo Date
	Client:	Board of Water Supply	Feb 13, 2018

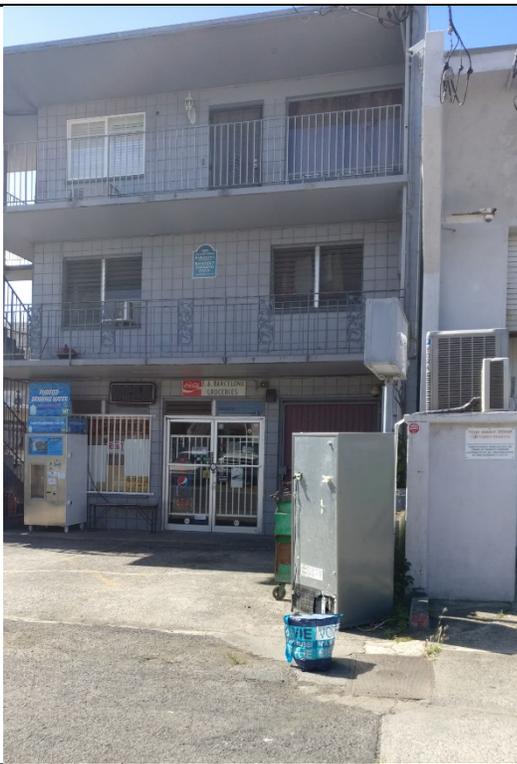
Project No. 1552801	Description:	FAC-11: 909 Factory St.	Photo 4A
	Site Name:	Factory St. Area, Kalihi, Honolulu, HI	Photo Date June 1, 2017
	Client:	Board of Water Supply

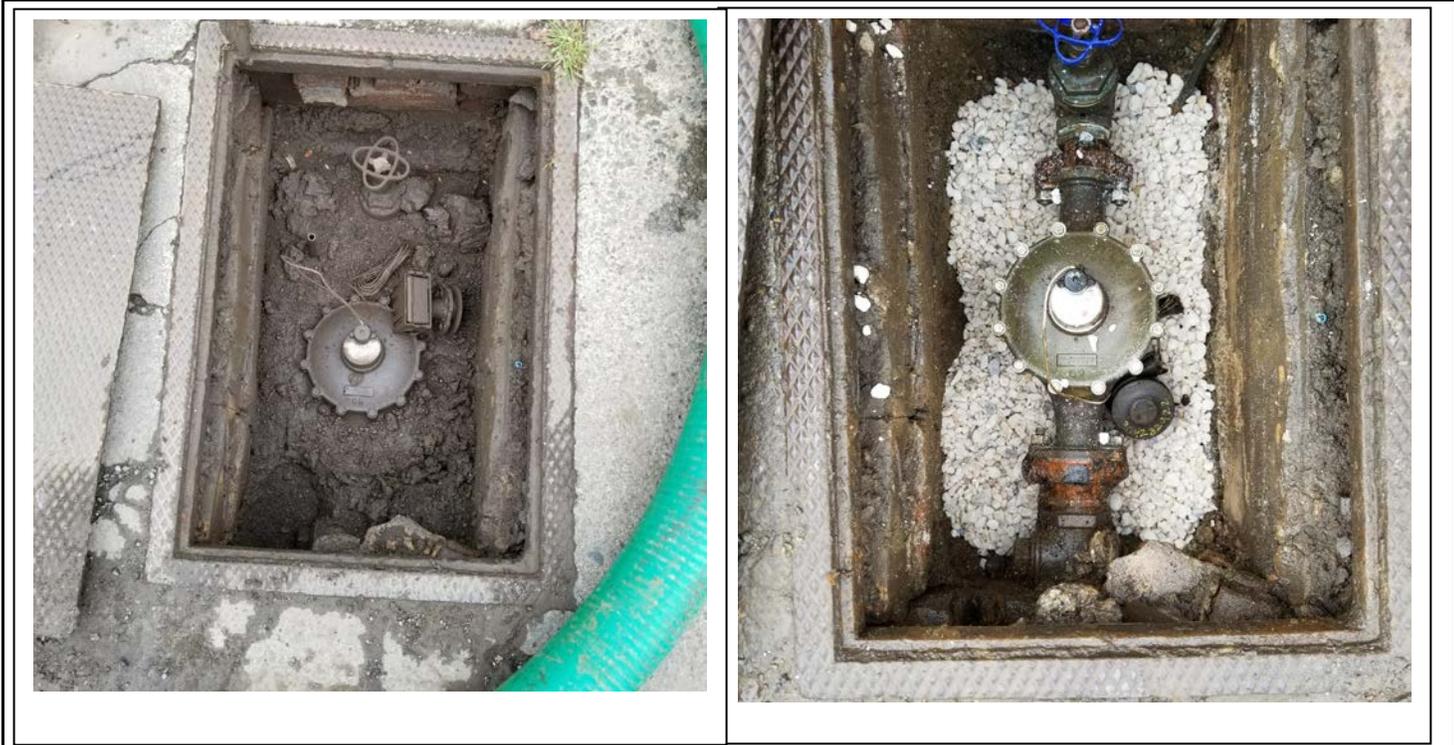
Project No. 1552801	Description:	FAC-11: Before and After Soil Removal	Photo 4B
	Site Name:	Factory St. Area, Kalihi, Honolulu, HI	Photo Date Feb 13, 2018
	Client:	Board of Water Supply

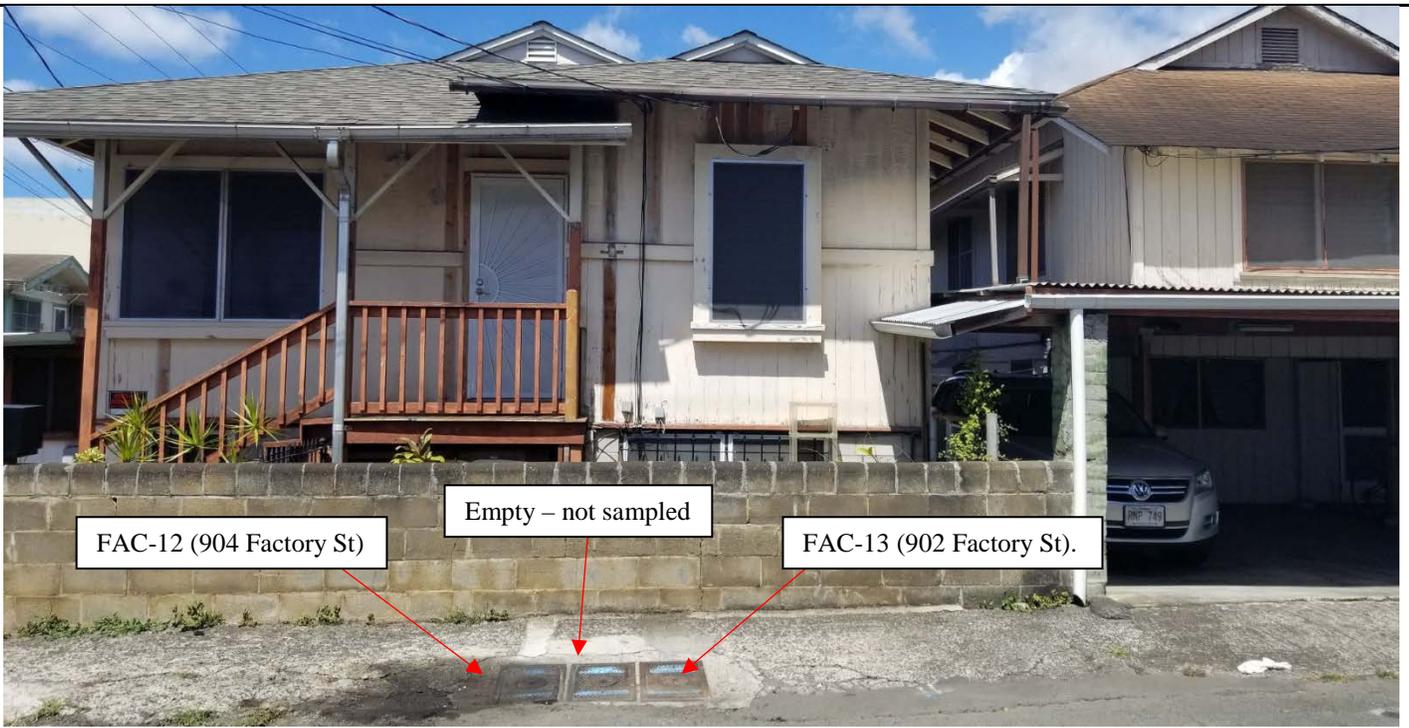
Project No. 1552801	Description: FAC-12 (904 Factory St.)	Photo 5A
	Site Name: Factory St. Area, Kalihi, Honolulu, HI	
	Client: Board of Water Supply

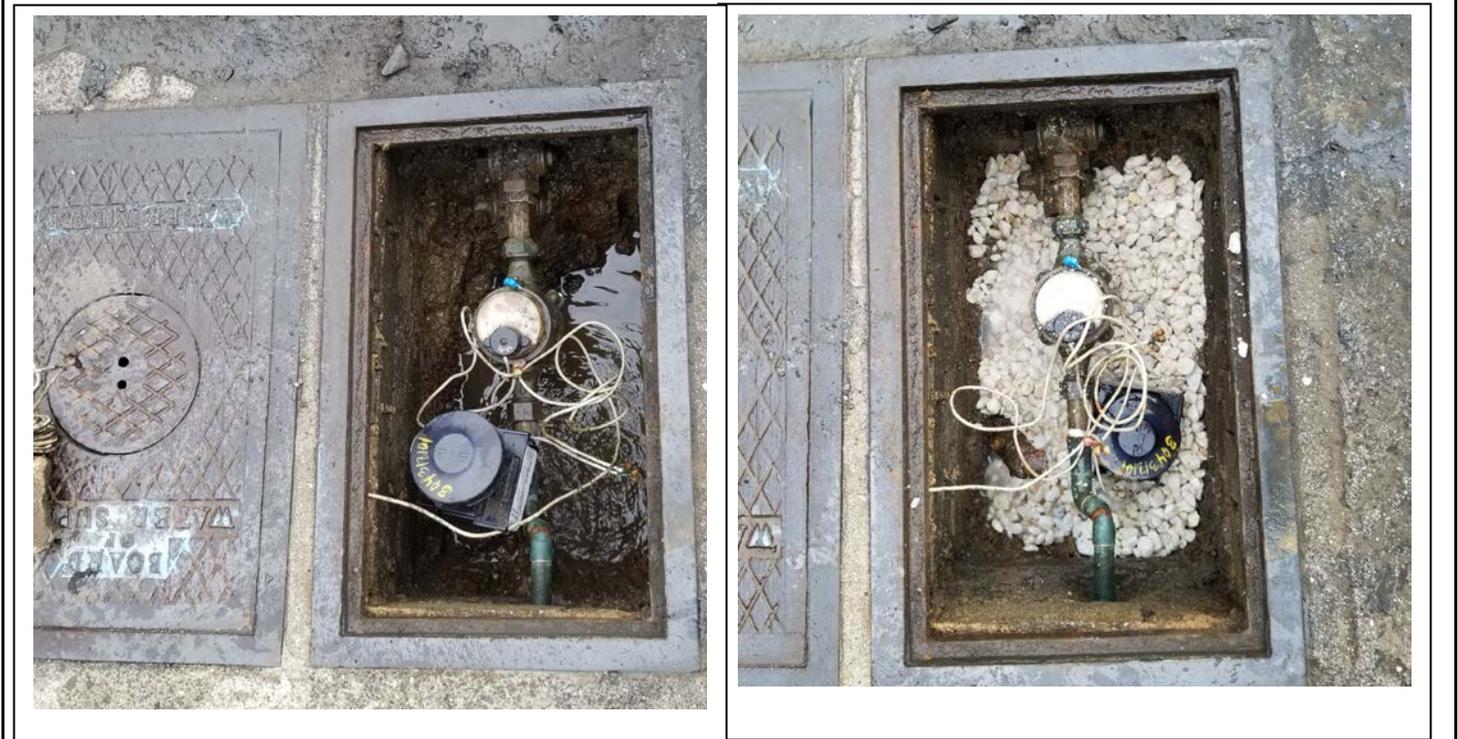
Project No. 1552801	Description: FAC-12: Before and After Soil Removal	Photo 5B
	Site Name: Factory St. Area, Kalihi, Honolulu, HI	
	Client: Board of Water Supply

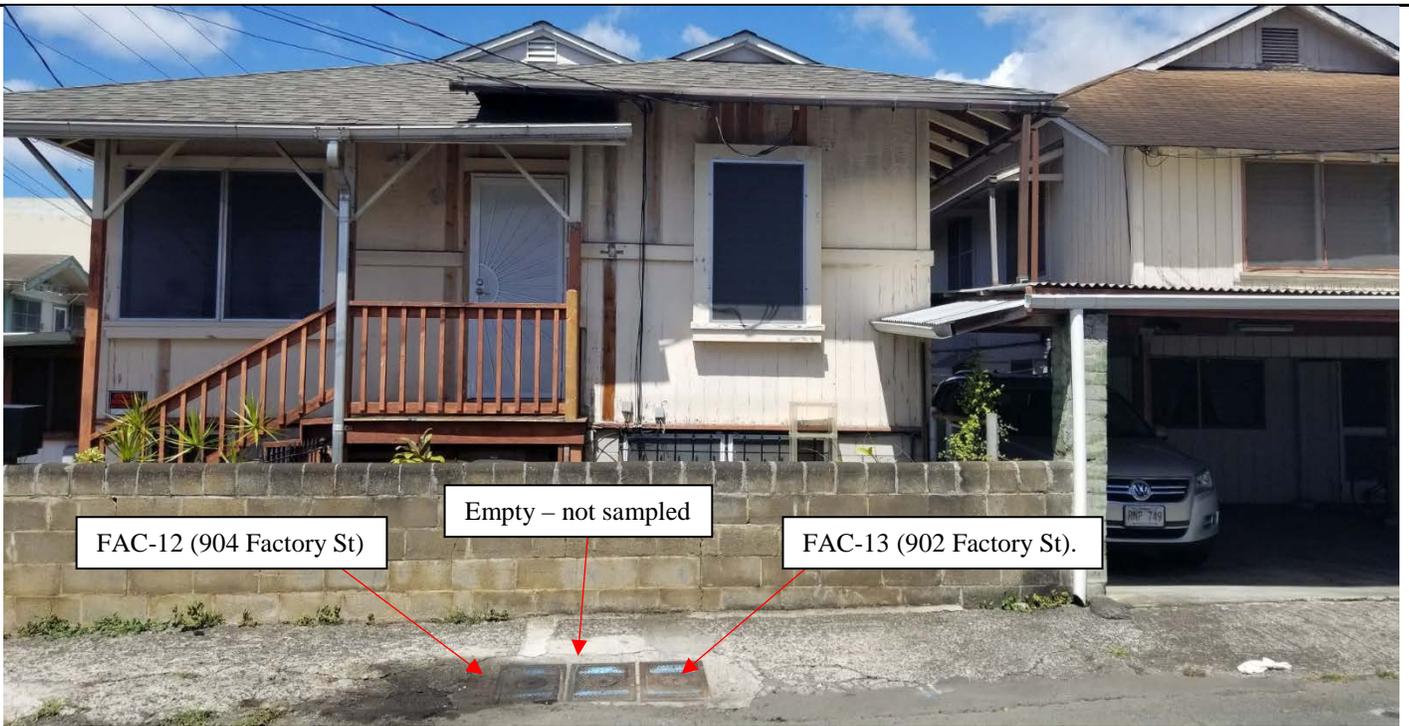
Project No. 1552801	Description: FAC-13: 902 Factory St.	Photo 6A
	Site Name: Factory St. Area, Kalihi, Honolulu, HI	
	Client: Board of Water Supply

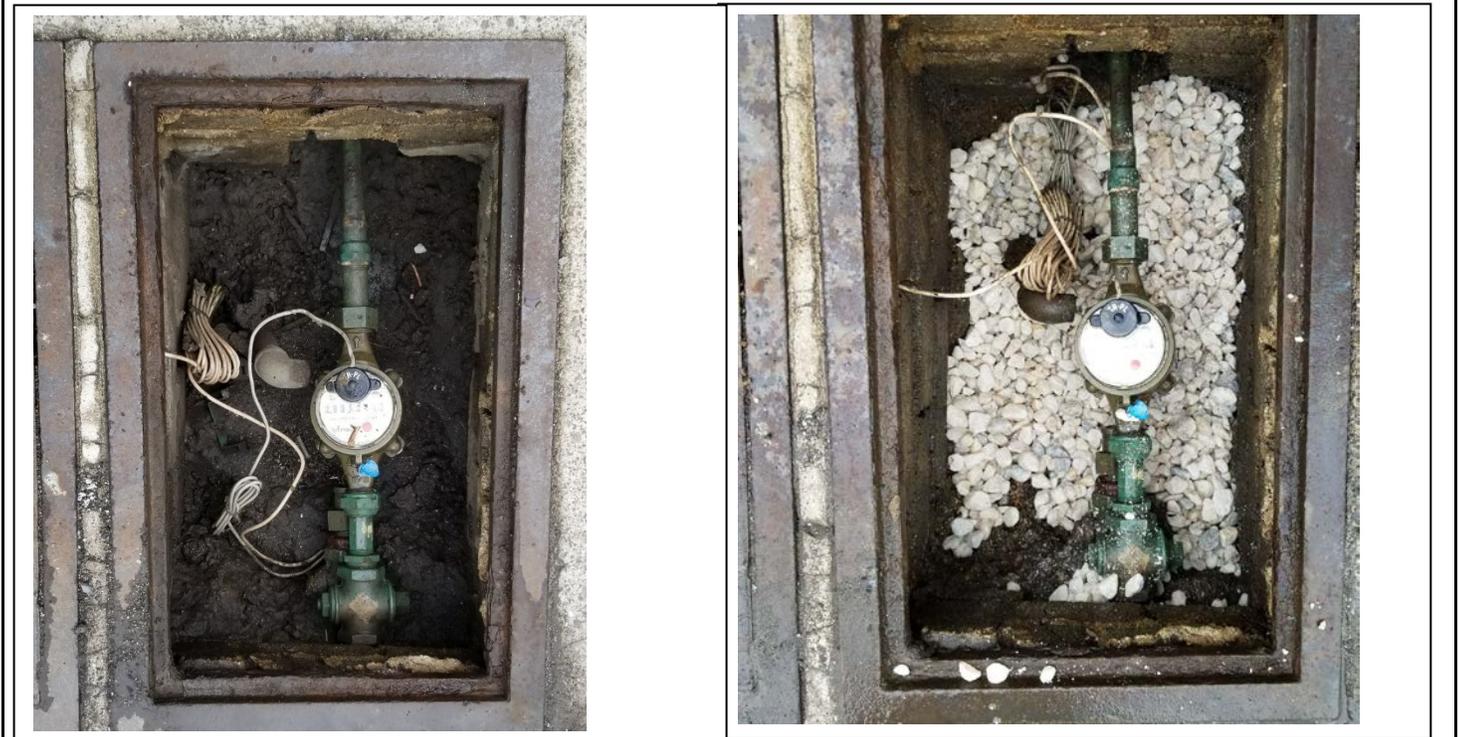
Project No. 1552801	Description: FAC-13: Before and After Soil Removal	Photo 6B
	Site Name: Factory St. Area, Kalihi, Honolulu, HI	
	Client: Board of Water Supply

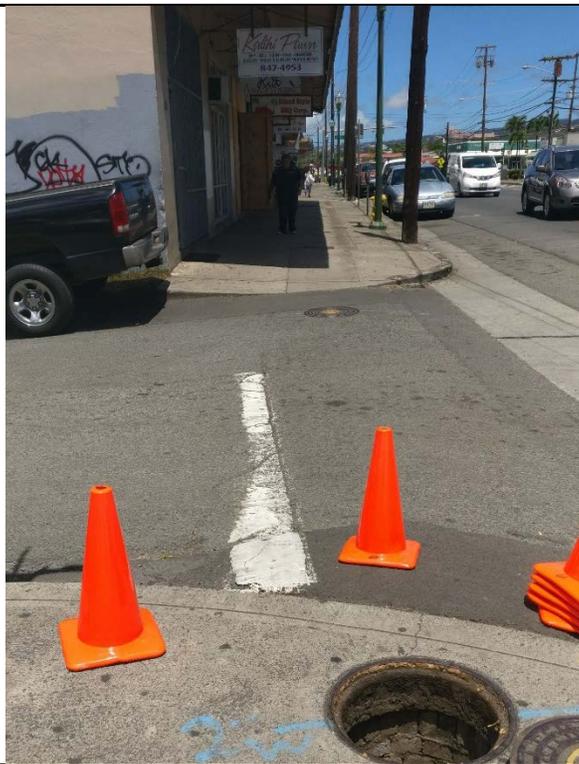
Project No. 1552801	Description:	Factory St-041317A: Corner of N. King and Factory St. (east corner)	Photo 7A
	Site Name:	Factory St. Area, Kalihi, Honolulu, HI	Photo Date
	Client:	Board of Water Supply	April 13, 2017

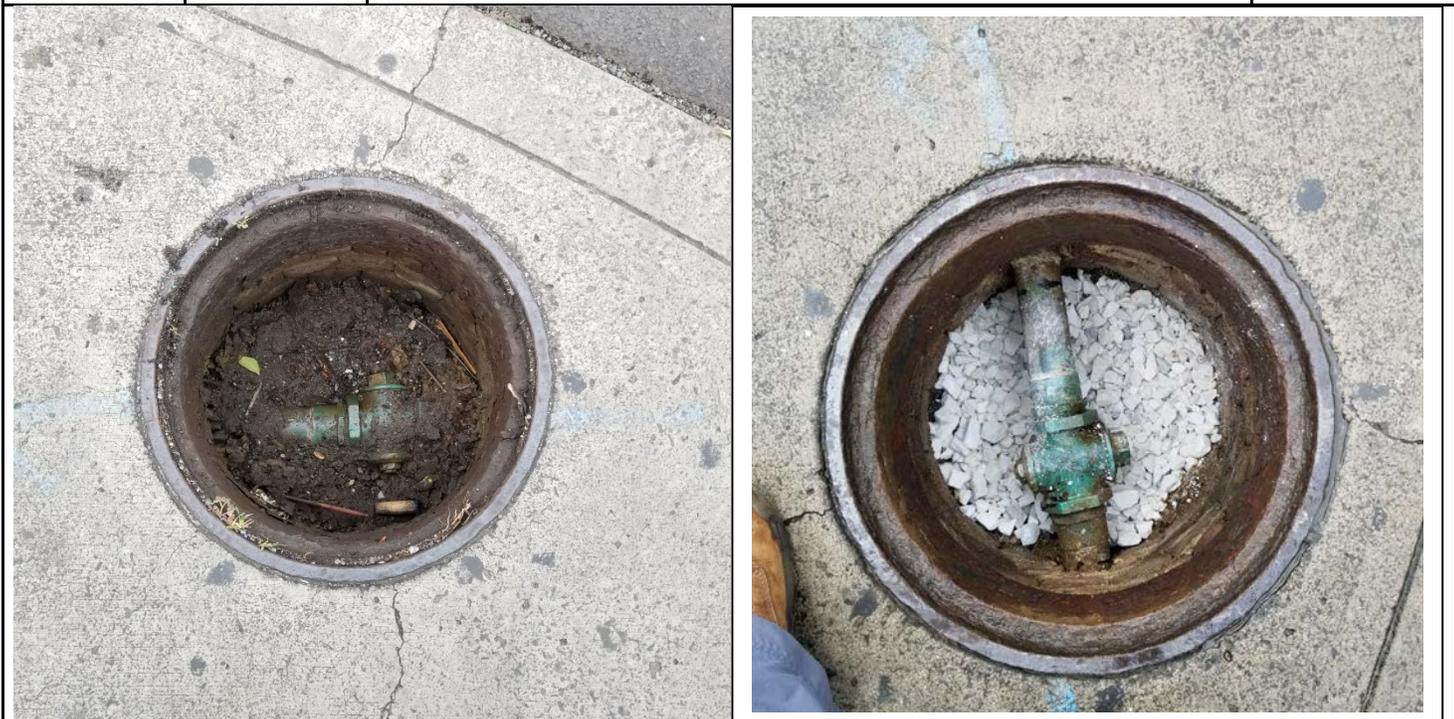
Project No. 1552801	Description:	Factory St-041317A Before and After	Photo 7B
	Site Name:	Factory St. Area, Kalihi, Honolulu, HI	Photo Date
	Client:	Board of Water Supply	Feb 13, 2017

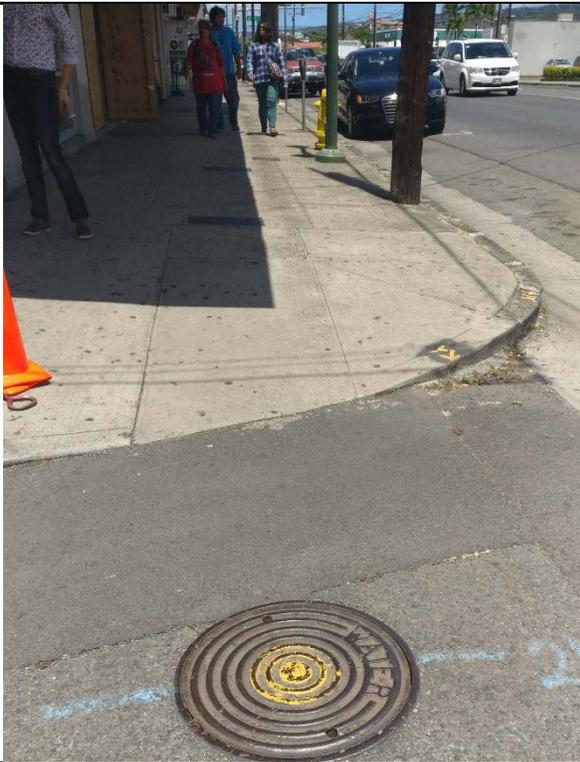
Project No. 1552801	Description:	Factory St-041317B: Corner of N. King and Factory St (west corner) Kalihi Pawn	Photo 8A
	Site Name:	Factory St. Area, Kalihi, Honolulu, HI	Photo Date April 13, 2017
	Client:	Board of Water Supply

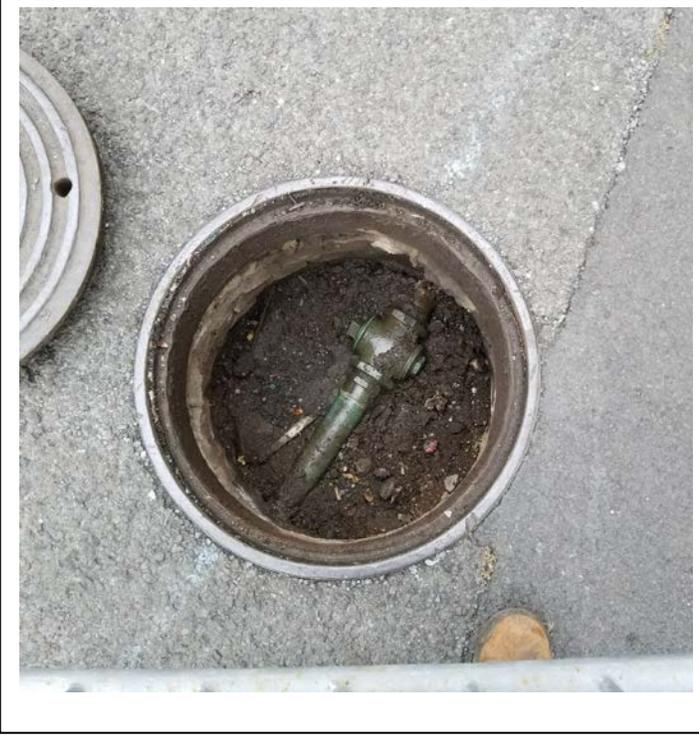
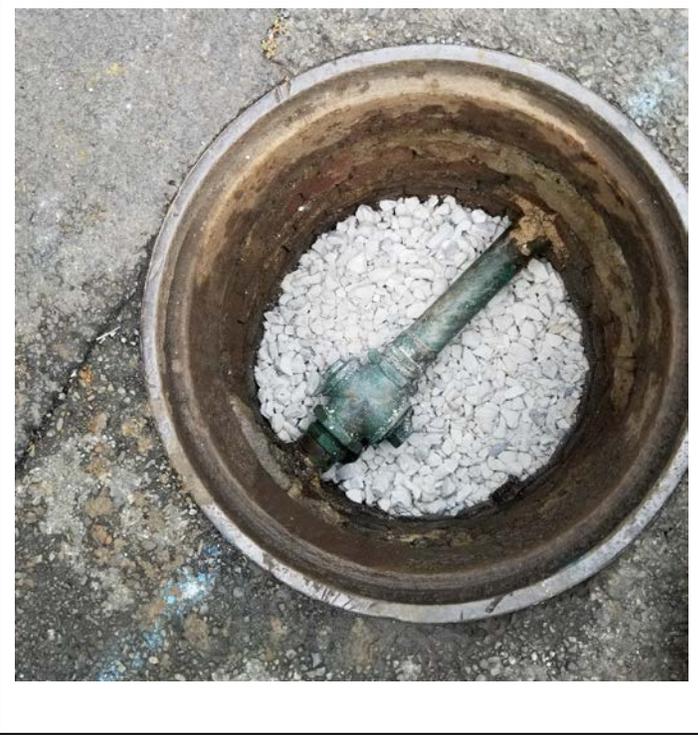
Project No. 1552801	Description:	Factory St-041317B: Before and After Soil Removal	Photo 8B
	Site Name:	Factory St. Area, Kalihi, Honolulu, HI	Photo Date Feb 13, 2017
	Client:	Board of Water Supply

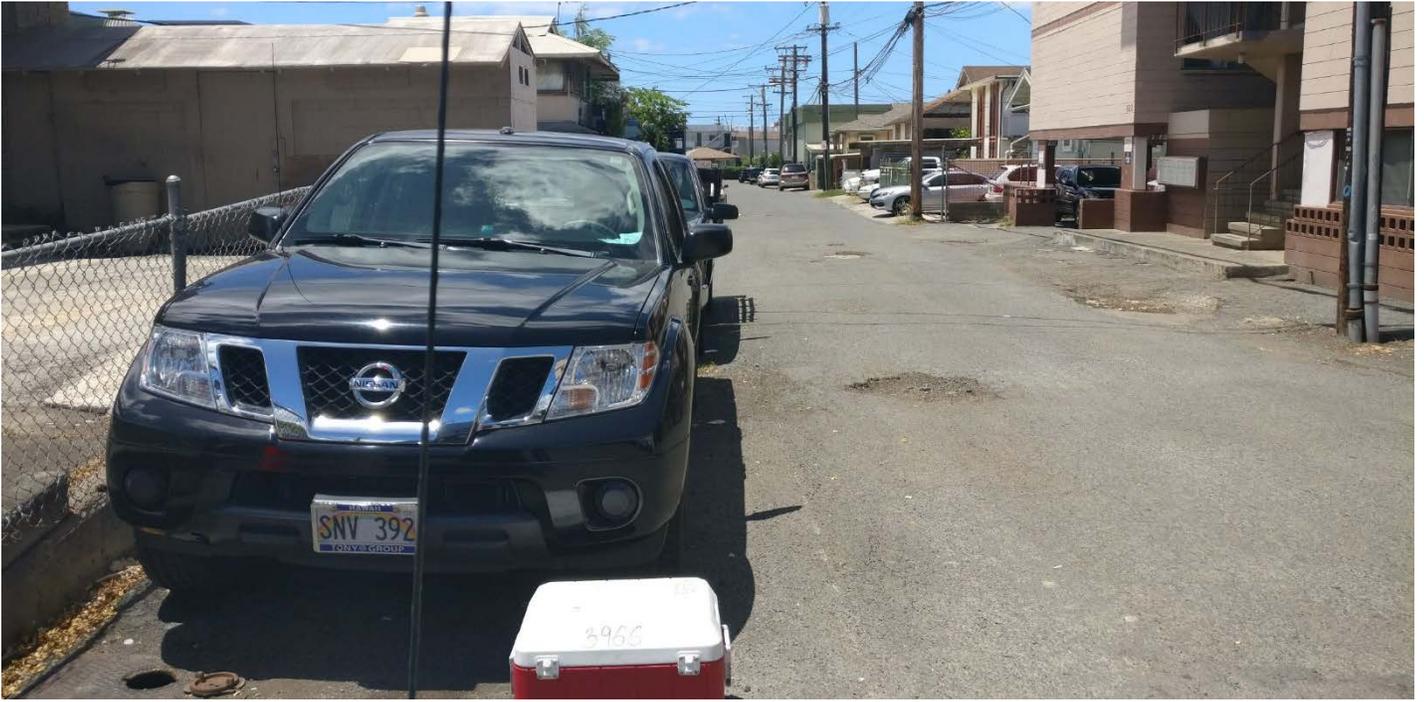
Project No. 1552801	Description:	Factory St-041317C: 1955 N. King St.	Photo 9A
	Site Name:	Factory St. Area, Kalihi, Honolulu, HI	Photo Date
	Client:	Board of Water Supply	April 13, 2017

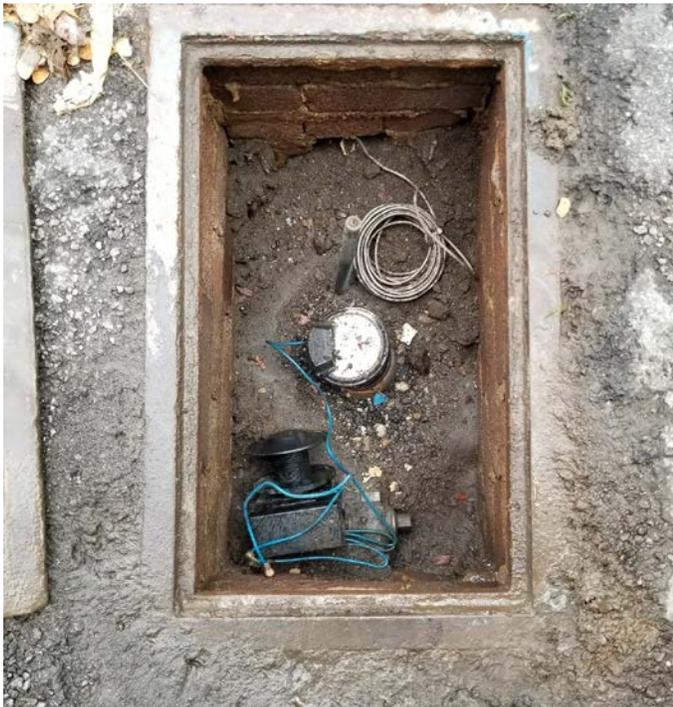
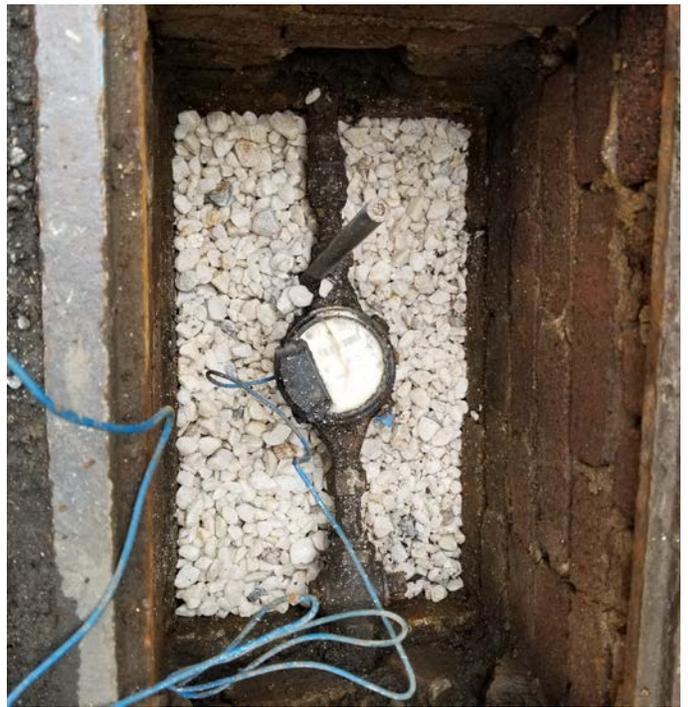
Project No. 1552801	Description:	Factory St-041317C: Before and After Soil Removal	Photo 9B
	Site Name:	Factory St. Area, Kalihi, Honolulu, HI	Photo Date
	Client:	Board of Water Supply	Feb 13, 2018

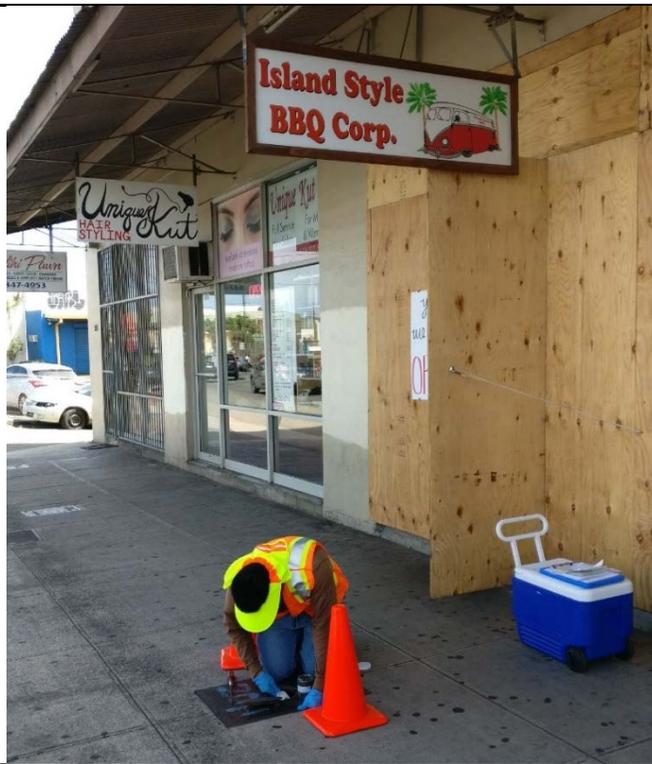
Project No. 1552801	Description:	NKIN-4: 2011 N. King St.	Photo 10A
	Site Name:	Factory St. Area, Kalihi, Honolulu, HI	Photo Date
	Client:	Board of Water Supply	April 24, 2017

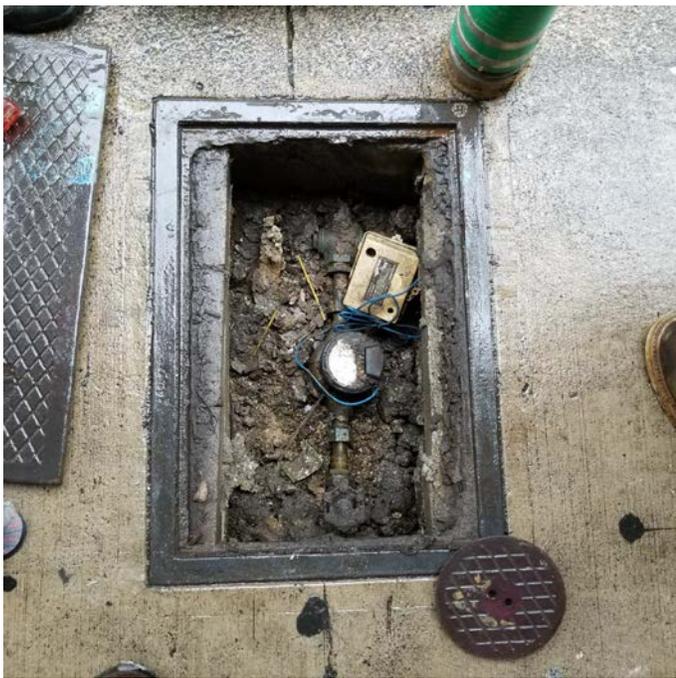
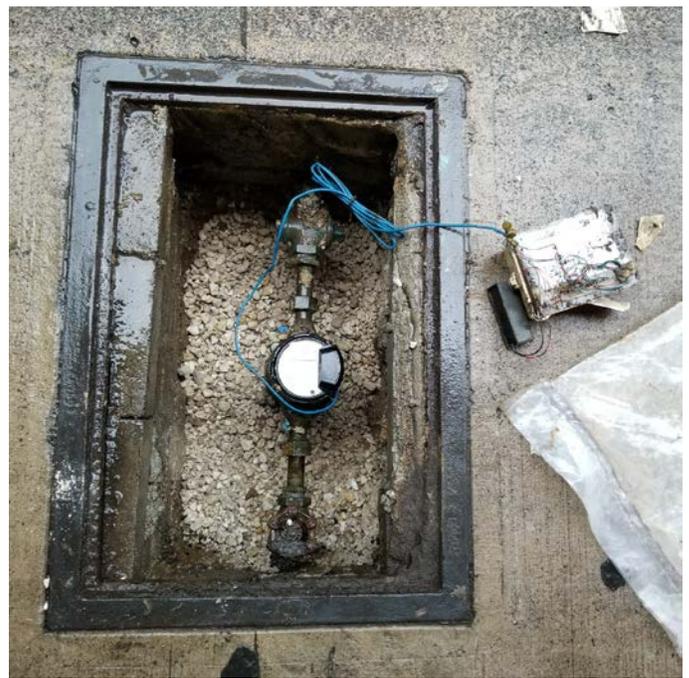
Project No. 1552801	Description:	NKIN-4: Before and After Soil Removal	Photo 10B
	Site Name:	Factory St. Area, Kalihi, Honolulu, HI	Photo Date
	Client:	Board of Water Supply	Feb 13, 2018

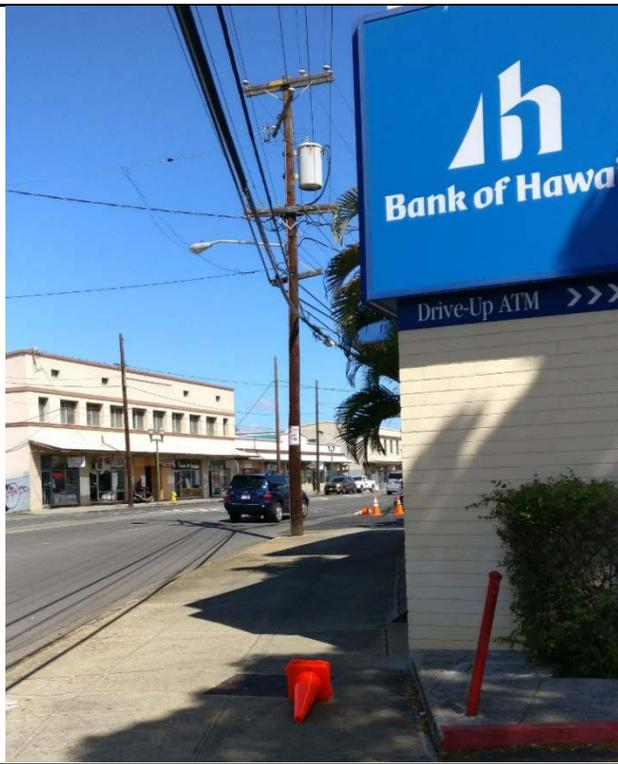
Project No. 1552801	Description: NKIN-7: 1950 N. King St.	Photo 11A
	Site Name: Factory St. Area, Kalihi, Honolulu, HI	
	Client: Board of Water Supply	April 25, 2017
