Water Meter and Valve Boxes Soil Assessment and Removal Report

Factory Street Site Oahu, Hawaii

March 2018
Version: Final-Revision 1
EA Project No. 63112.01

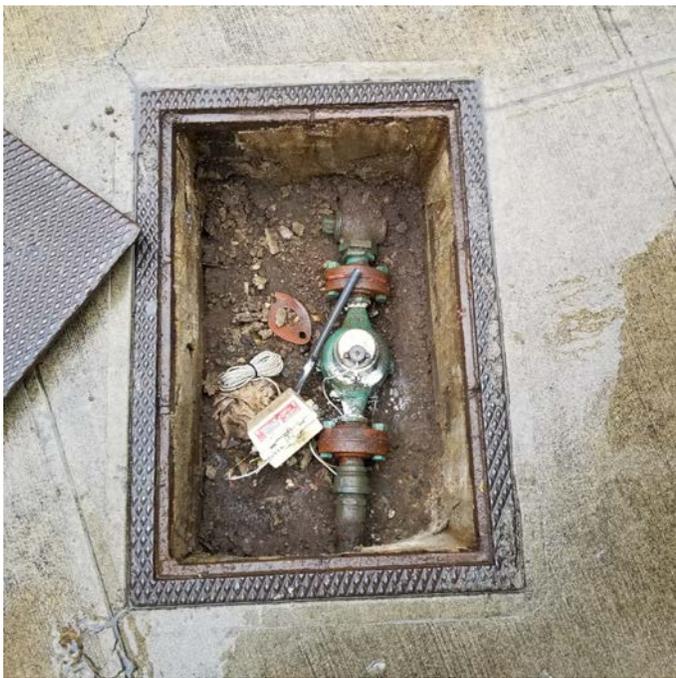
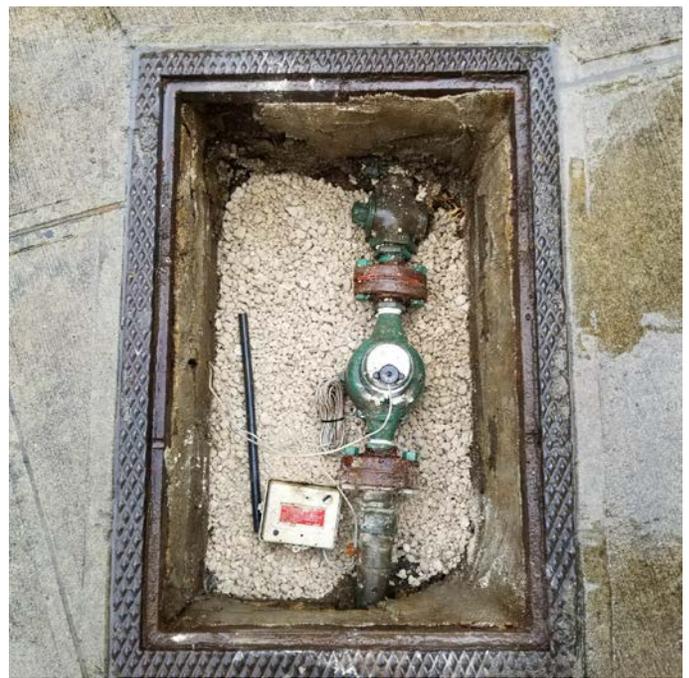
Project No. 1552801	Description: NKIN-7: Before and After Soil Removal	Photo 11B
	Site Name: Factory St. Area, Kalihi, Honolulu, HI	
	Client: Board of Water Supply	Feb 14, 2018

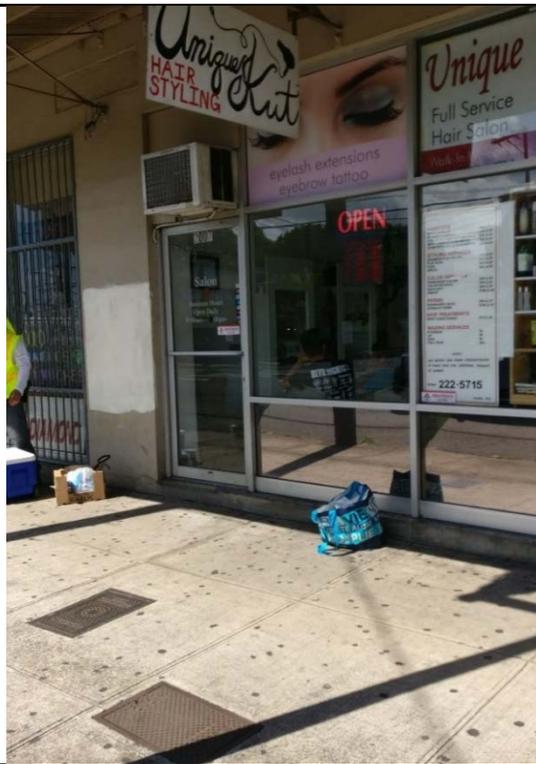
Project No. 1552801	Description: NKIN-9: 2007 N. King St.	Photo 12A
	Site Name: Factory St. Area, Kalihi, Honolulu, HI	
	Client: Board of Water Supply	April 24, 2017

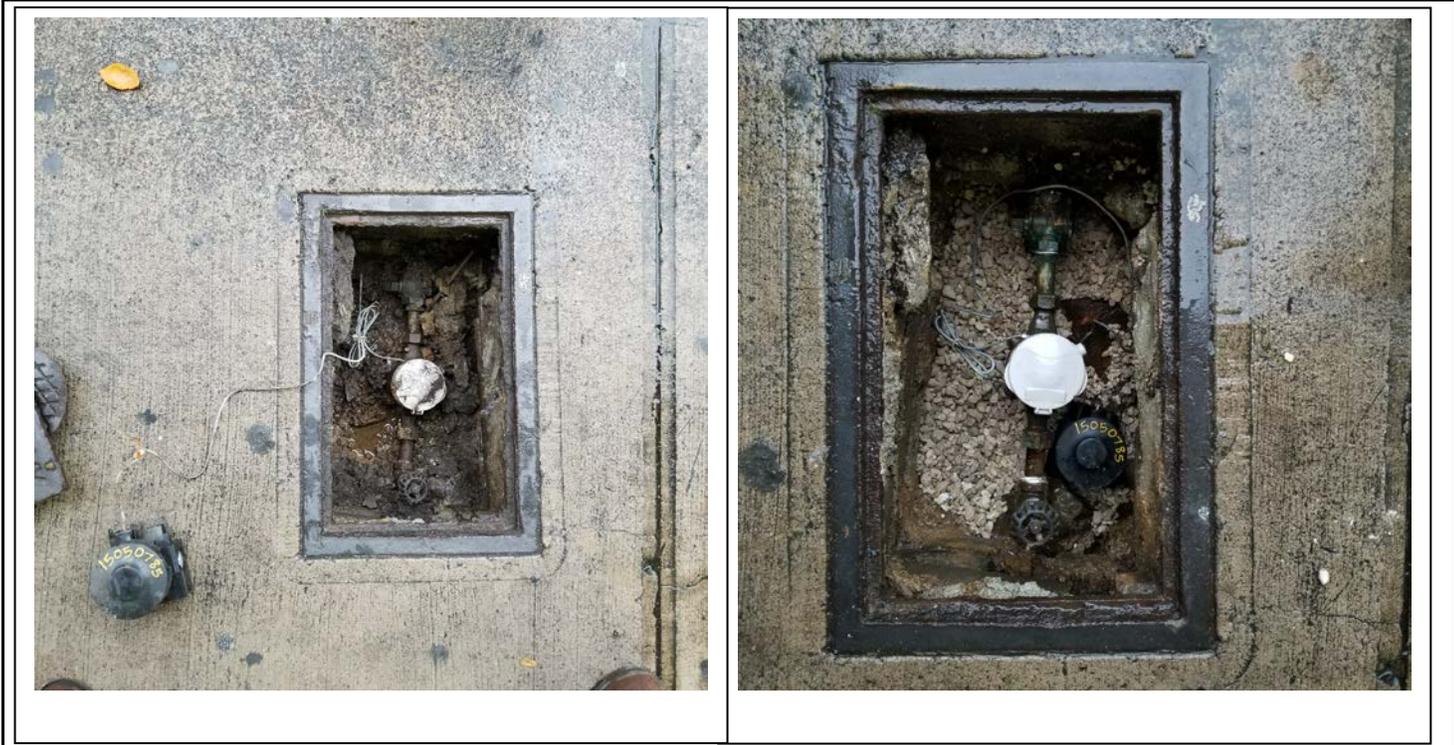
Project No. 1552801	Description: NKIN-9: Before and After Soil Removal	Photo 12B
	Site Name: Factory St. Area, Kalihi, Honolulu, HI	
	Client: Board of Water Supply	Feb 14, 2018

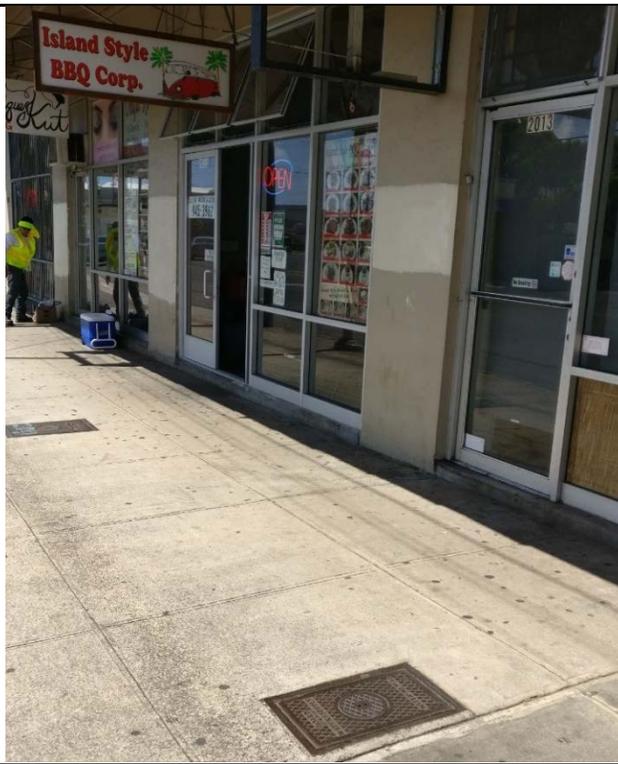
Project No. 1552801	Description: NKIN-10: 2013 N. King St.	Photo 13A
	Site Name: Factory St. Area, Kalihi, Honolulu, HI	
	Client: Board of Water Supply

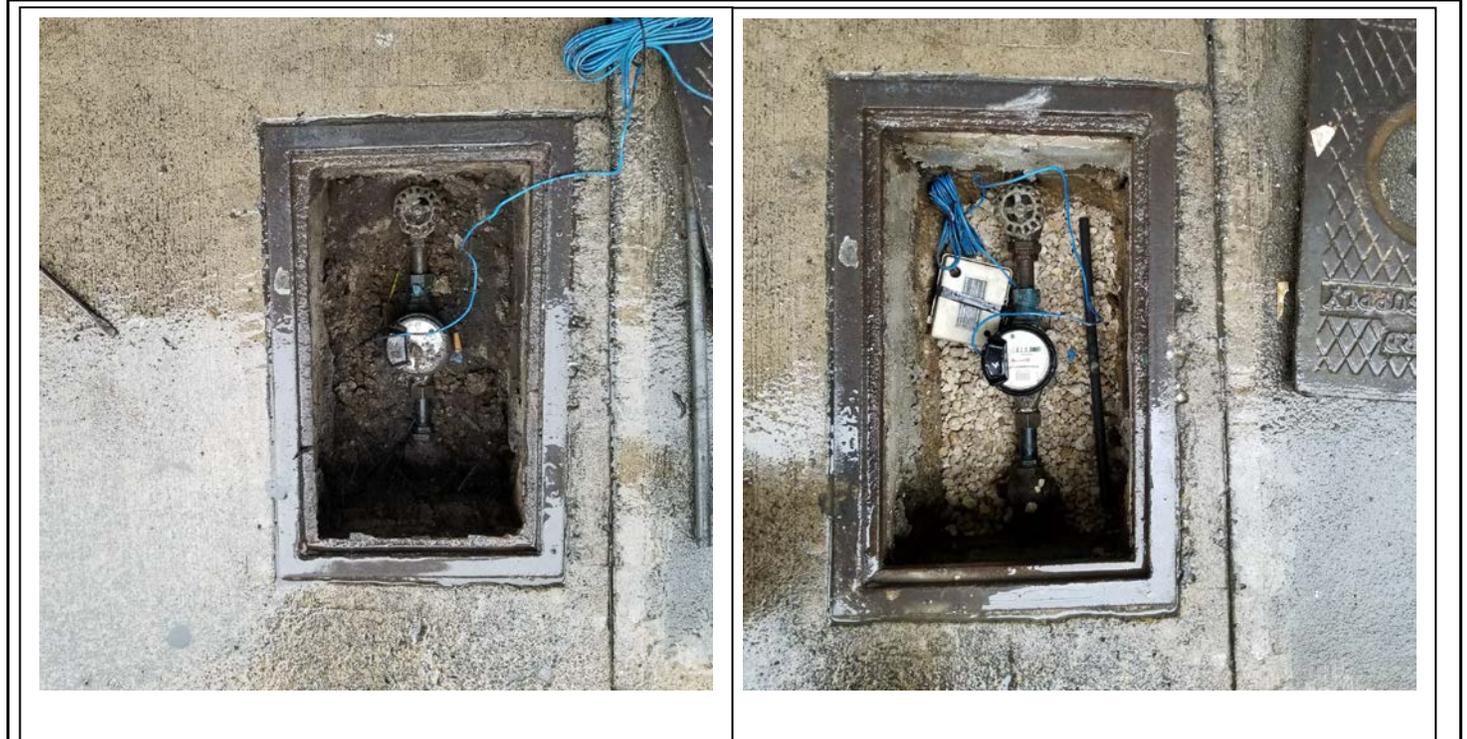
Project No. 1552801	Description: NKIN-10: Before and After Soil Removal	Photo 13B
	Site Name: Factory St. Area, Kalihi, Honolulu, HI	
	Client: Board of Water Supply

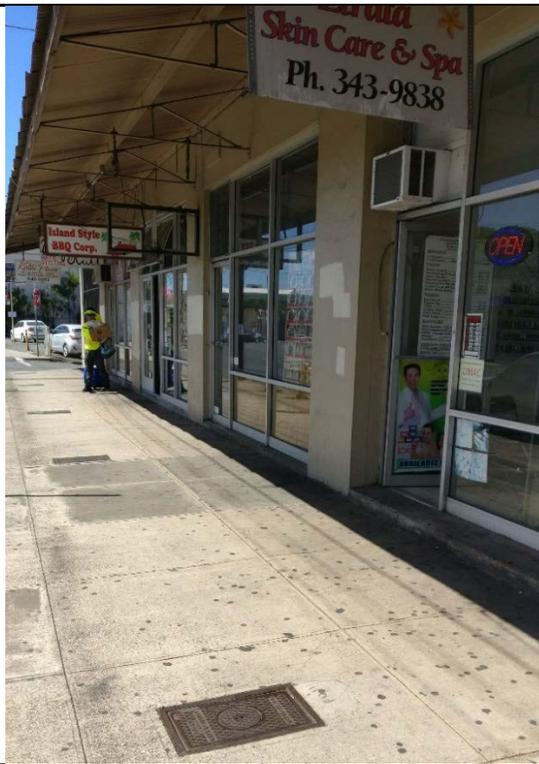
Project No. 1552801	Description: NKIN-11: 2015 N. King St.	Photo 14A
	Site Name: Factory St. Area, Kalihi, Honolulu, HI	
	Client: Board of Water Supply

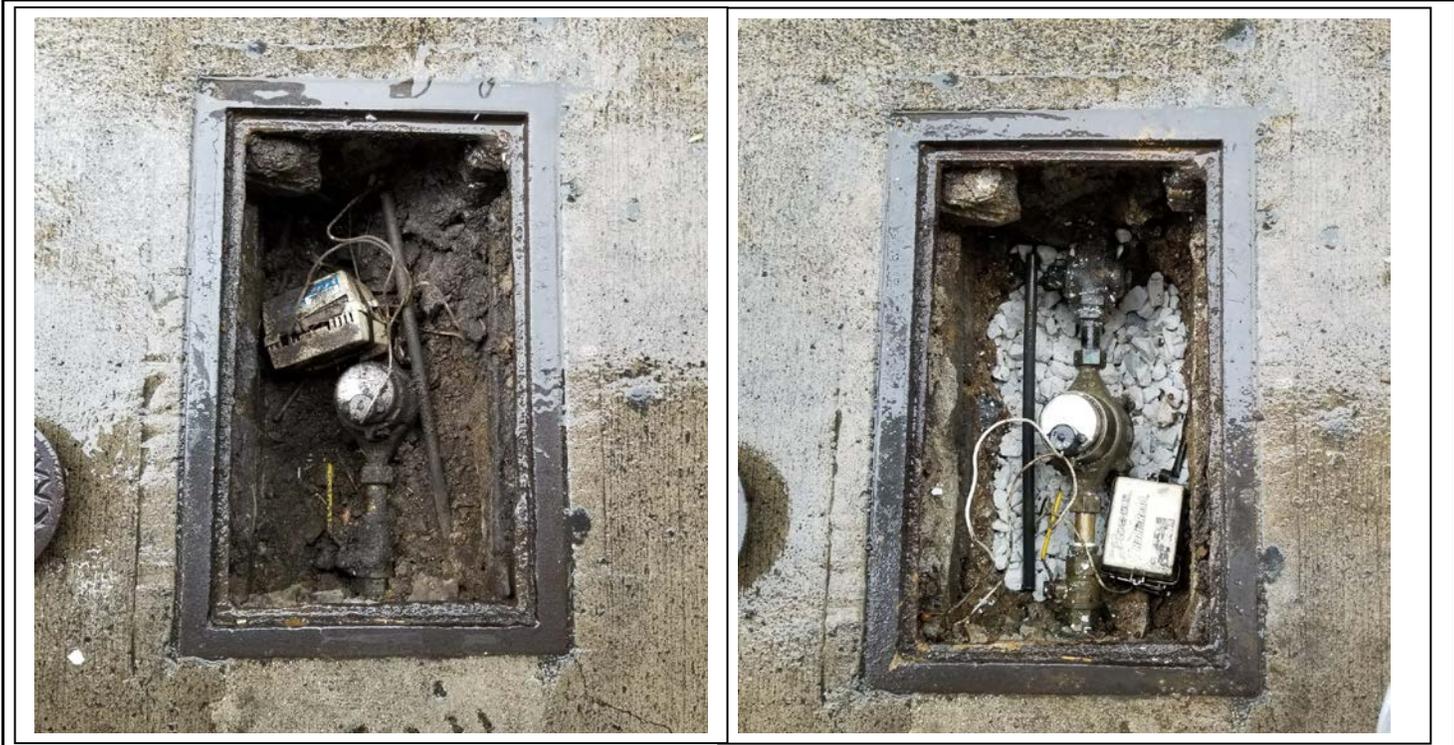
Project No. 1552801	Description: NKIN-11: Before and After Soil Removal	Photo 14B
	Site Name: Factory St. Area, Kalihi, Honolulu, HI	
	Client: Board of Water Supply

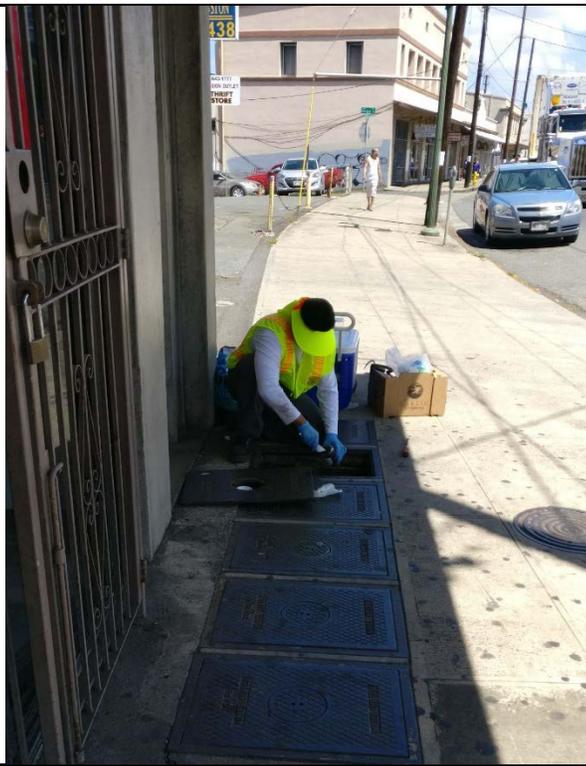
Project No. 1552801	Description:	NKIN-12: 1943 N. King St. #1	Photo 15A
	Site Name:	Factory St. Area, Kalihi, Honolulu, HI	Photo Date
	Client:	Board of Water Supply	June 1, 2017

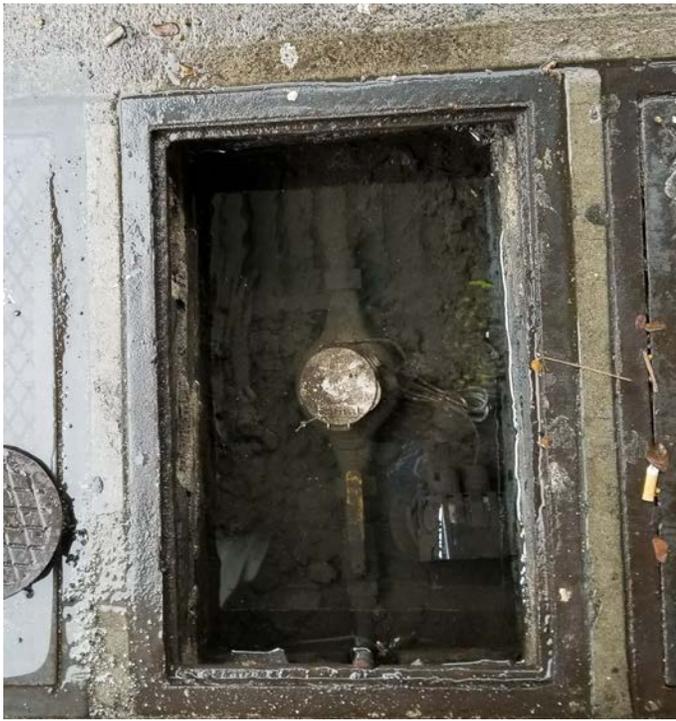
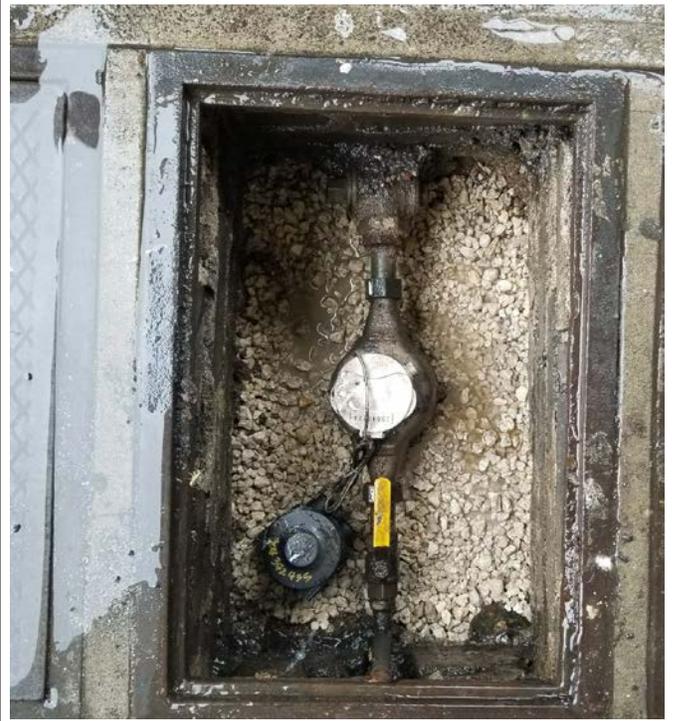
Project No. 1552801	Description:	NKIN-12: Before and After Soil Removal	Photo 15B
	Site Name:	Factory St. Area, Kalihi, Honolulu, HI	Photo Date
	Client:	Board of Water Supply	Feb 14, 2018

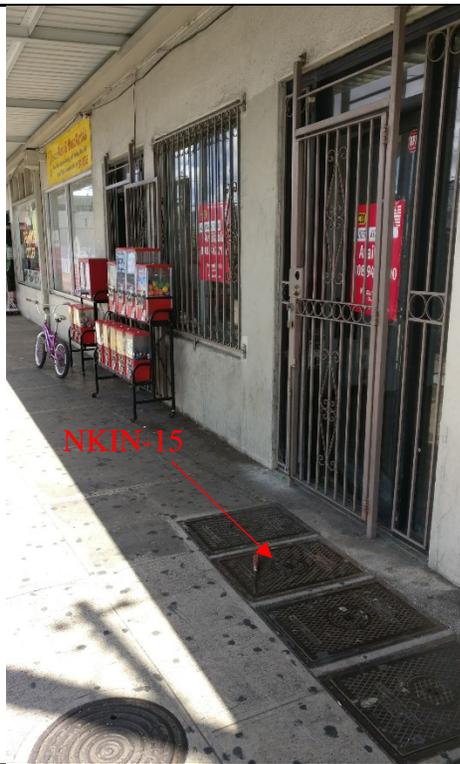
Project No. 1552801	Description:	NKIN-15: 1935 N. King St. #A	Photo 16A
	Site Name:	Factory St. Area, Kalihi, Honolulu, HI	Photo Date
	Client:	Board of Water Supply	June 1, 2017

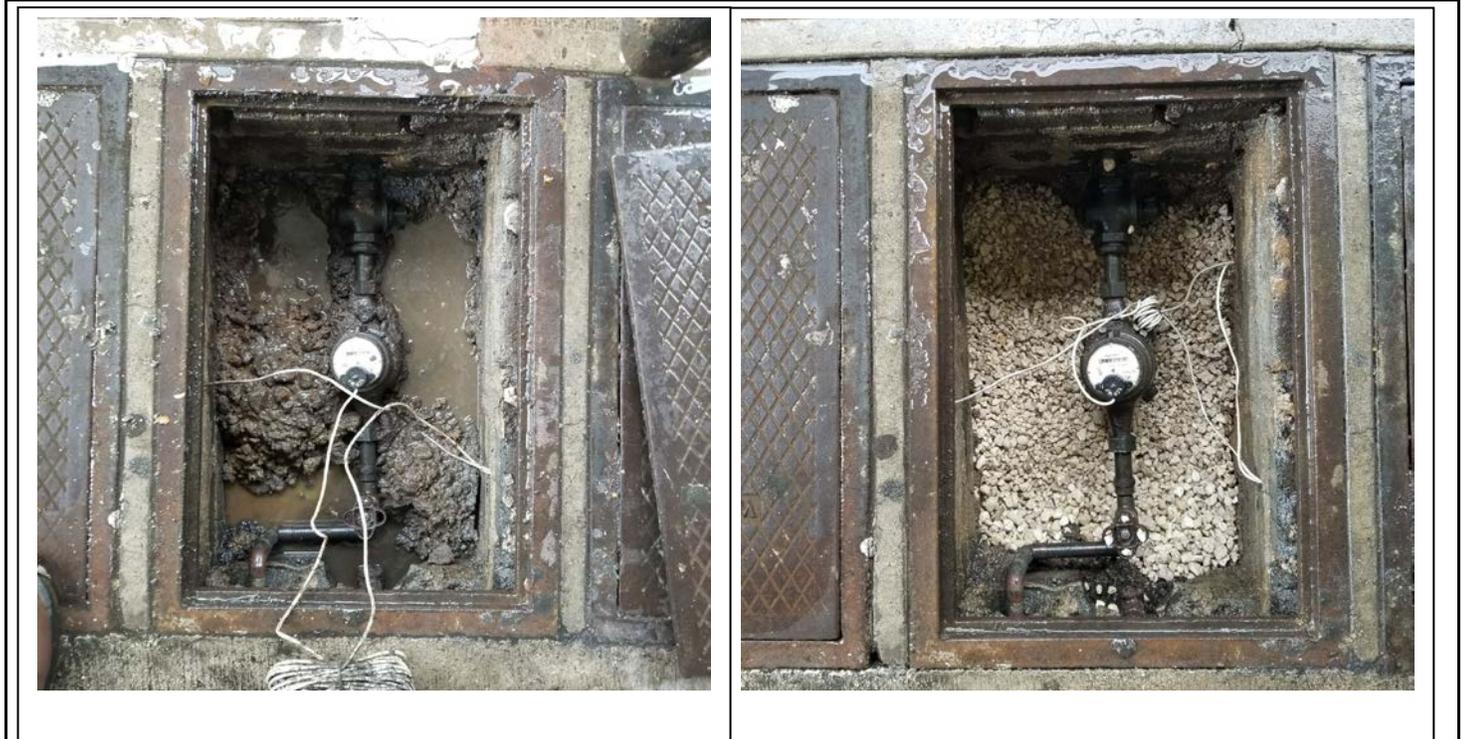
Project No. 1552801	Description:	NKIN-15: Before and After Soil Removal	Photo 16B
	Site Name:	Factory St. Area, Kalihi, Honolulu, HI	Photo Date
	Client:	Board of Water Supply	Feb 14, 2018

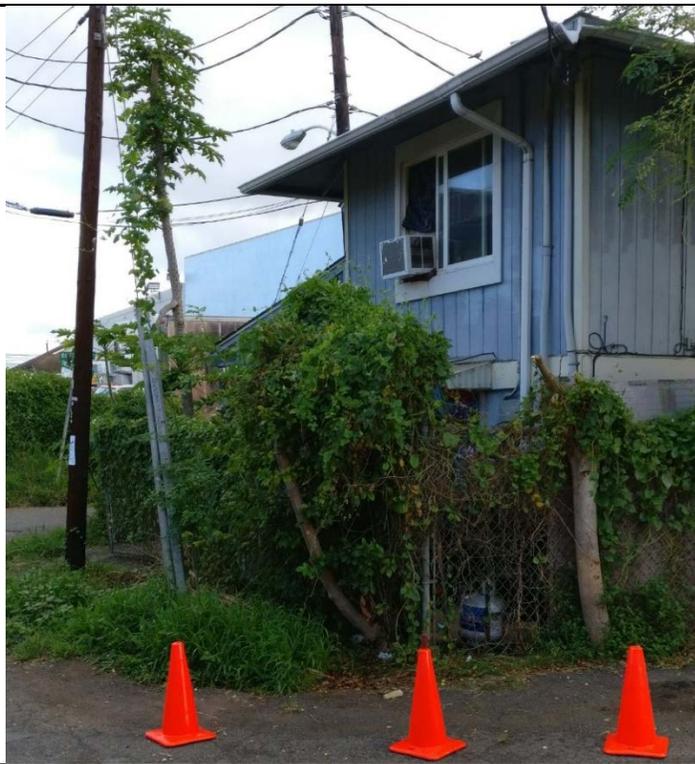
Project No. 1552801	Description:	PUU-3: Mauka Corner of Waterhouse and Puuhale	Photo 17A
	Site Name:	Factory St. Area, Kalihi, Honolulu, HI	Photo Date
	Client:	Board of Water Supply	April 25, 2017

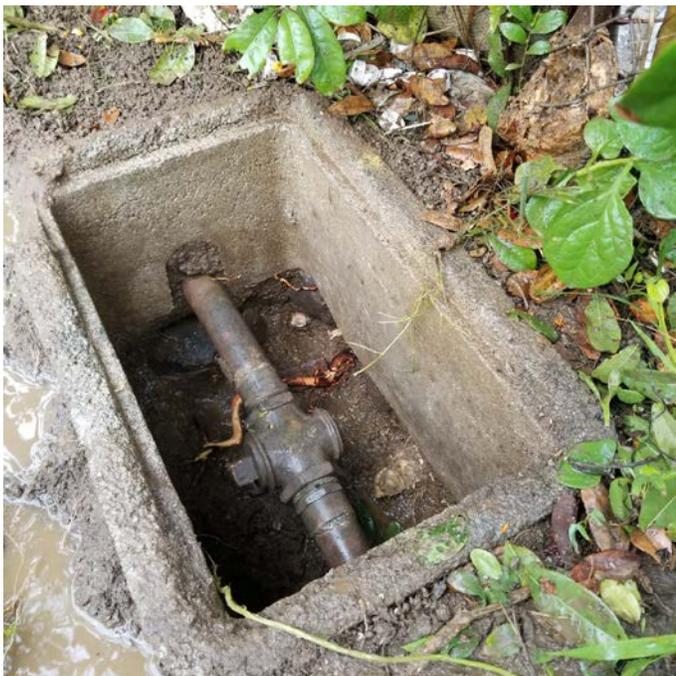
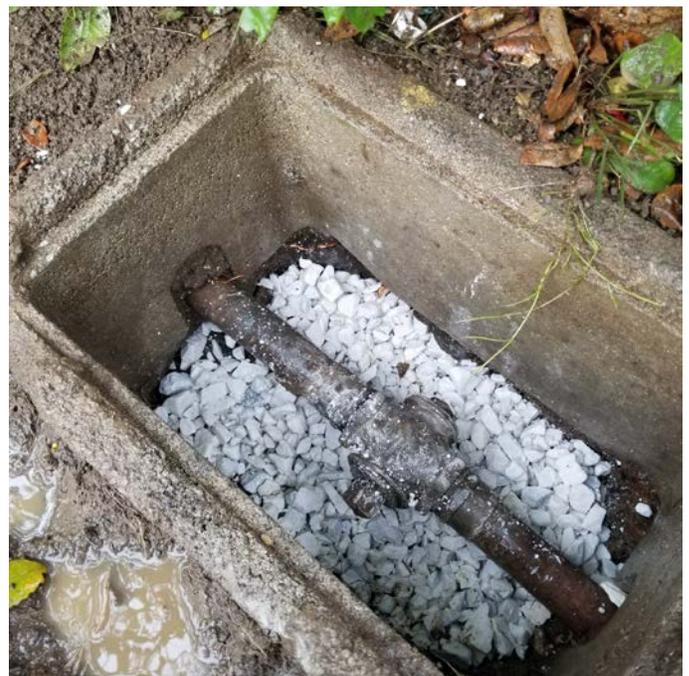
Project No. 1552801	Description:	PUU-3: Before and After Soil Removal	Photo 17B
	Site Name:	Factory St. Area, Kalihi, Honolulu, HI	Photo Date
	Client:	Board of Water Supply	Feb 14, 2018

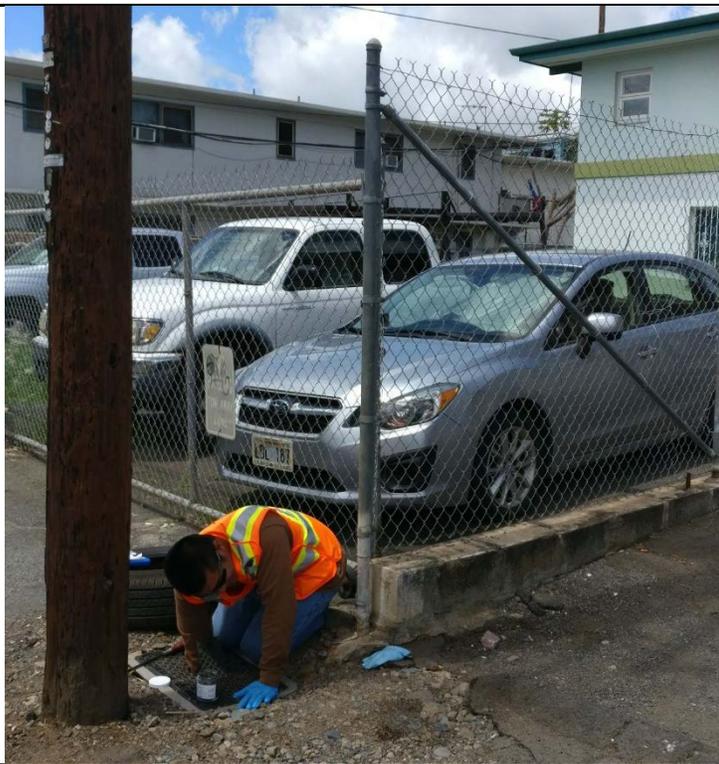
Project No. 1552801	Description: WAT-1: 2010 Waterhouse St. .	Photo 18A
	Site Name: Factory St. Area, Kalihi, Honolulu, HI	
	Client: Board of Water Supply	April 24, 2017

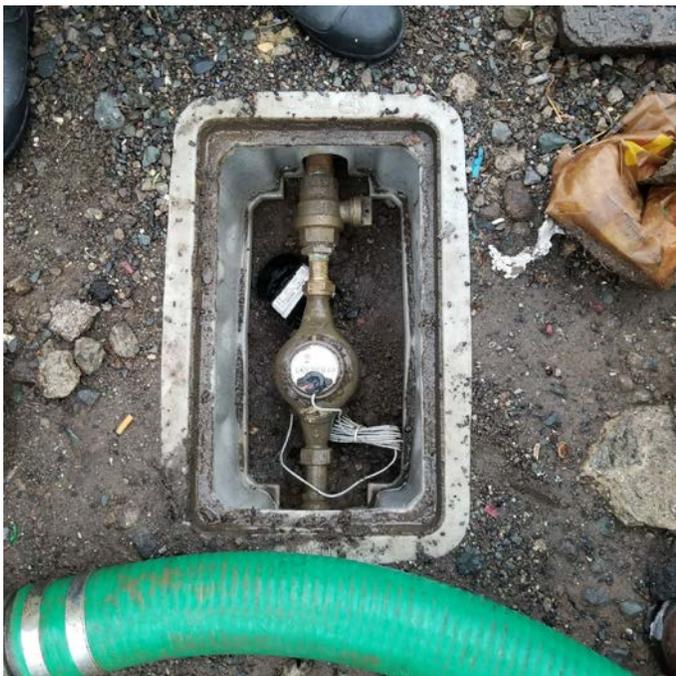
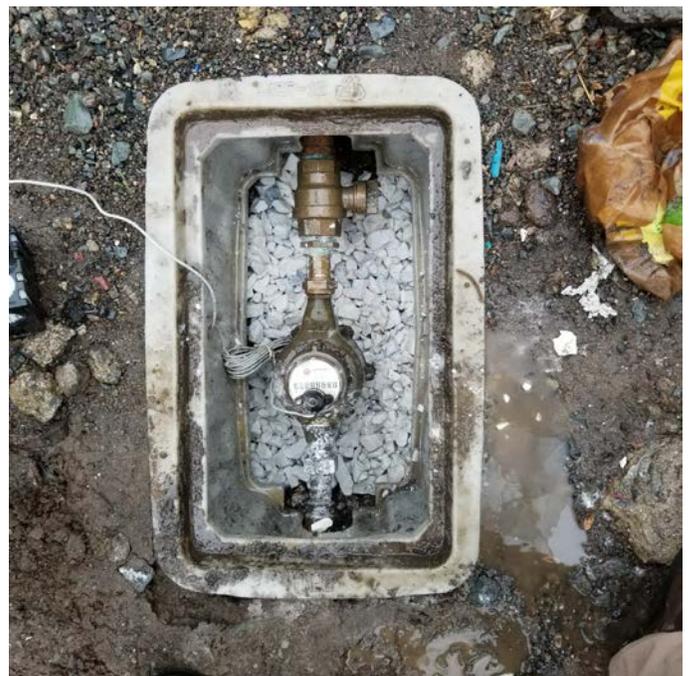
Project No. 1552801	Description: WAT-1: Before and After Soil Removal	Photo 18B
	Site Name: Factory St. Area, Kalihi, Honolulu, HI	
	Client: Board of Water Supply	Feb 13, 2018

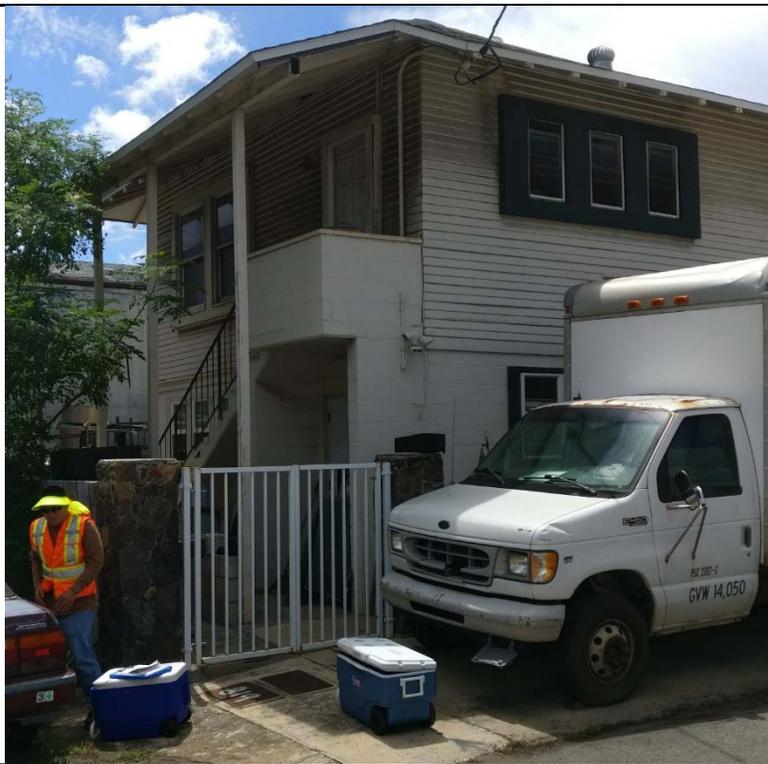
Project No. 1552801	Description: WAT-3: 819 Factory St. (Shared with FAC-4: 817 Factory St.)	Photo 19A
	Site Name: Factory St. Area, Kalihi, Honolulu, HI	
	Client: Board of Water Supply	April 24, 2017

At each site, the meter/valve box lids were vacuumed and removed, and a photograph of the water meter or valve box was taken prior to soil removal (Attachment A). The high pressure hose and hand tools were used to break up the soil to a depth of 4 to 8 inches. Good housekeeping was maintained by working within the boxes and limiting overspray. The soil and water was then removed from the water meter and valves boxes via vacuum. If a water meter or valve box was found to be co-located (WAT-3 and FAC-4), soil from both boxes was removed.

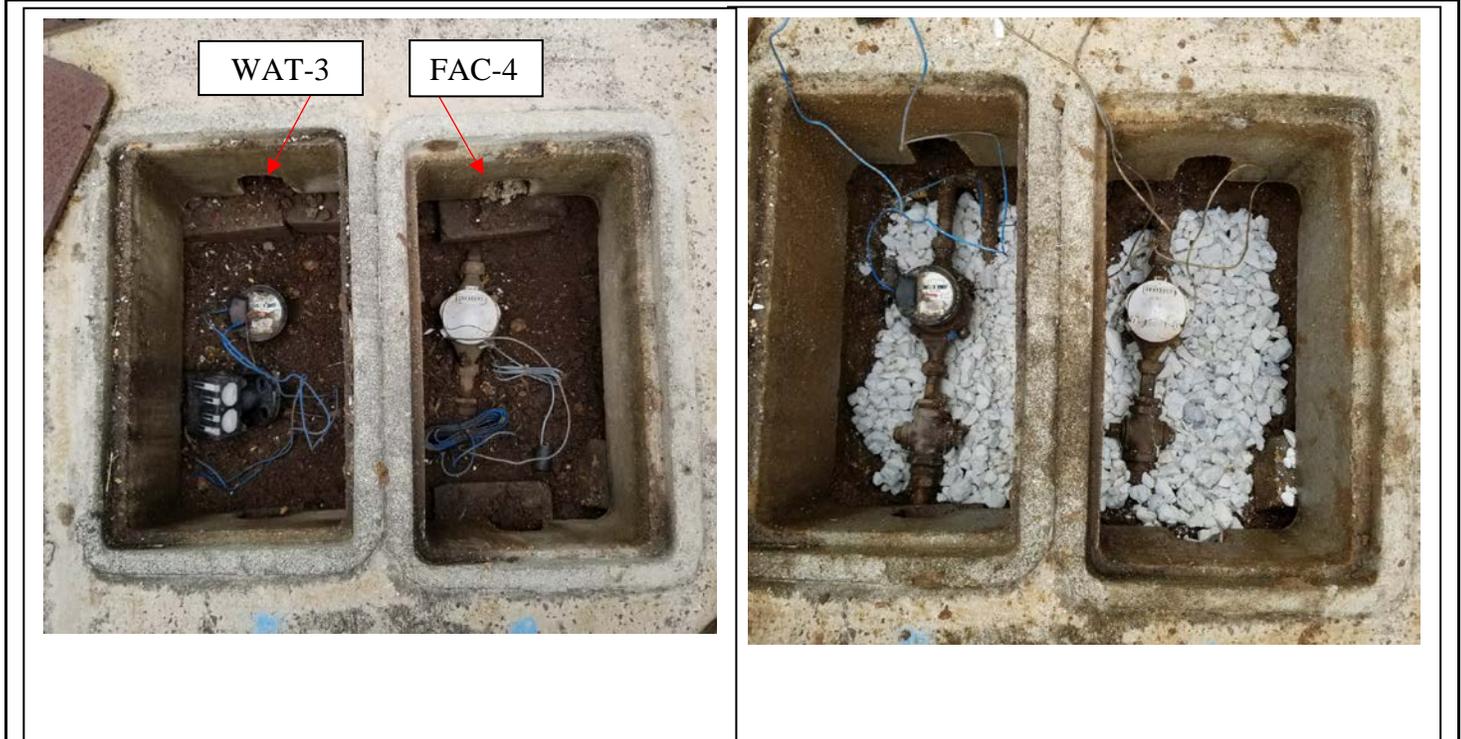
Project No. 1552801	Description: WAT-3: Before and After Soil Removal	Photo 19B
	Site Name: Factory St. Area, Kalihi, Honolulu, HI	
	Client: Board of Water Supply	Feb 13, 2018
