PRELIMINARY ASSESSMENT

**Globe-Union Battery
Garland, Dallas County, Texas
TXD980626642**

September 2019

Globe-Union Battery
1111 S. Shiloh Rd.
Dallas, Dallas County, Texas
TXD980626642

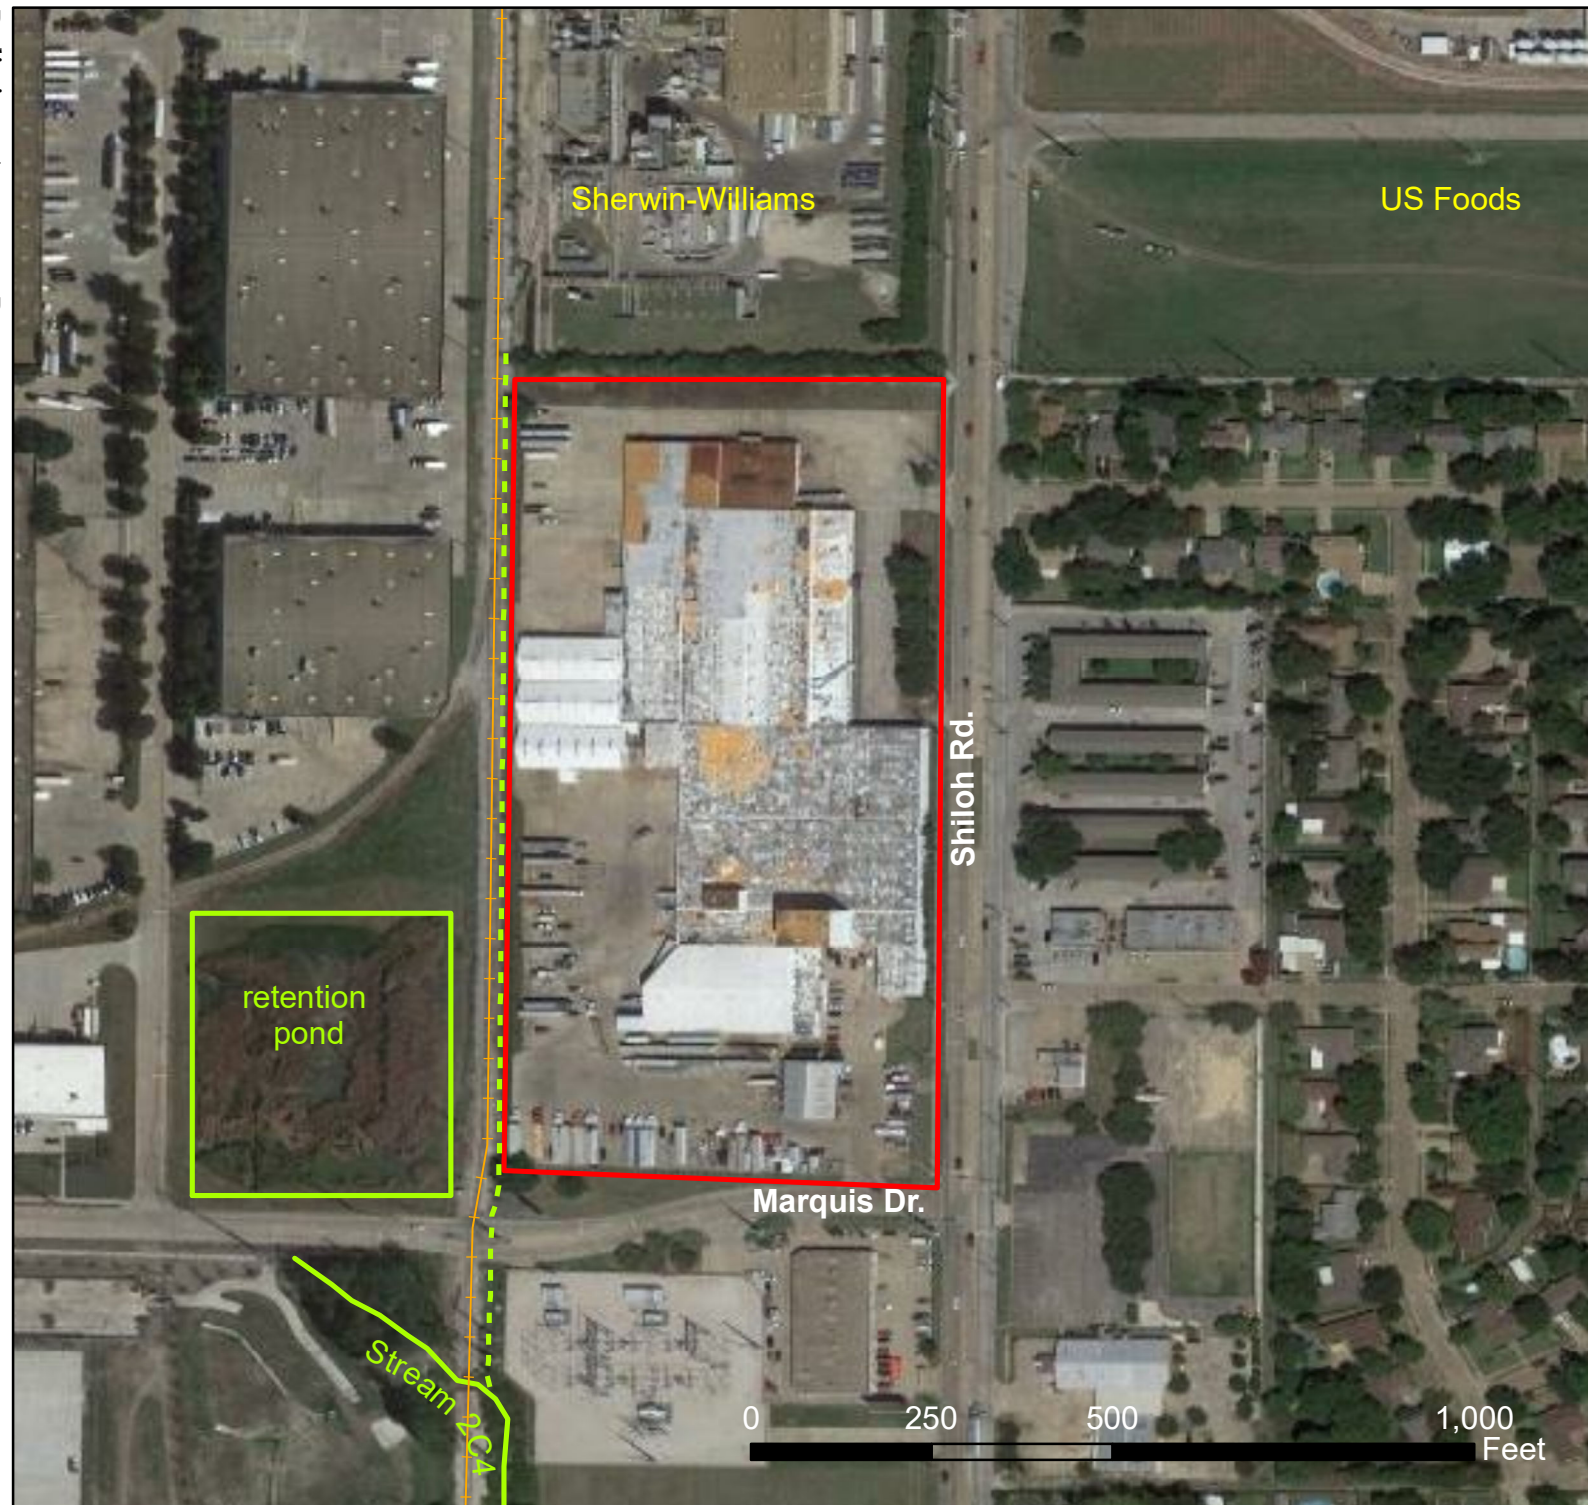
FIGURE 2. SITE FEATURES MAP

The building footprint at the facility expanded over the course of operations so that by 1979 the contiguous warehouse and office was greater than 225,000 square feet (Ref. 3, p. 2; Ref. 6, p. 9). A separate 4,800 square foot garage was constructed in the southern portion of the property by 1968. As operations at the site expanded, so too did the amount of impervious concrete cover such that only a few narrow strips of vegetation along Shiloh Road remain unpaved (Ref. 5 pp. 1-4; Ref. 9, p. 7; Ref. 10, pp. 1-3; Ref. 11, p. 5, 7-9, 13-16). The site is essentially flat with a slight slope to the west in the direction of a creek known as stream 2C4, an intermittently flowing tributary to Duck Creek (Figures 1 and 2).

Drainage is to the east on the east side of the property, where it flows into street drains. Runoff on the west and south sides of the facility drains to the west until immediately off site, then flows south along railroad tracks, passes through a culvert under Marquis Street, and continues along the railroad tracks until it enters stream 2C4 (Figure 2; Ref. 9, p. 2; Ref. 12, p. 2). A stormwater retention pond west of the site and the railroad tracks receives water from points north and west. It drains into a large culvert under Marquis Street (west of the previously-mentioned culvert) and forms the beginning of stream 2C4 (Figure 2; Ref. 10, p. 3; Ref. 12, pp. 2-3).

All runoff from the west side of the site flows west across the parking lot until reaching a grassy area adjacent to railroad tracks, which force all runoff to the south. From the southwest corner of the site property, runoff continues to flow for approximately 300 feet until entering stream 2C4, an intermittent creek (Figure 2; Ref. 12, p. 2). The overland route continues to the southeast for approximately 1.5 miles until stream 2C4 joins Ruperts Branch, a perennial creek which is the probable point of entry (PPE). Ruperts Branch flows approximately 0.7 mile to the east until joining Duck Creek (Ref. 33, p. 2). The 15-Mile TDL ends approximately 1.5 miles before Duck Creek empties into the East Fork of the Trinity River (Figure 4).

Potentially contaminated soils in the drainage ditch on the west side of the property could be transported south via overland flow following precipitation to stream 2C4 and along the surface water pathway as detailed in section 3.2.1 (Figure 2).
