UNITED STATES ENVIRONMENTAL PROTECTION AGENCY

MEMORANDUM

SUBJECT: Approval for a Time-Critical Removal Action at the Trowbridge Dam Area of the Allied Paper, Inc./Portage Creek/Kalamazoo River Superfund Site, Allegan County, Michigan (EPA ID MID006007306)

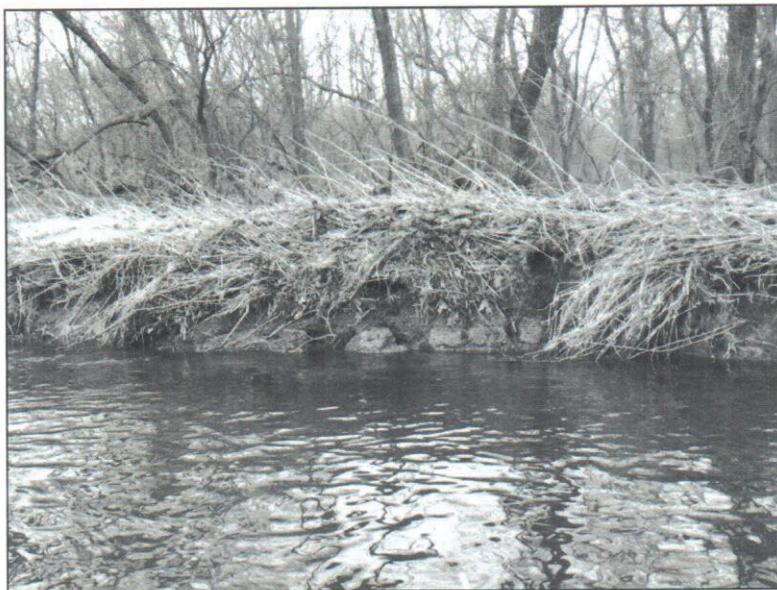
Photograph No.: 1

sediments and soils. Undercutting progresses until the overlying sediments fall into the river, typically in blocks. These blocks, or portions thereof, remain along the toe of the river at the Trowbridge Dam Area (see photographs in Attachment 3).

Subject: Riverbank erosion of contaminated soils into Kalamazoo River on north bank.

- 3) Cut-back and stabilization of riverbanks to mitigate exposures to PCB-contaminated riverbank/floodplain soils and future erosion;
- 4) Dewatering, as necessary, and disposal off-site of all PCB-contaminated instream sediments and riverbank/floodplain soils removed pursuant to proposed actions 1, 2 & 3 above. PCB-contaminated material with PCB concentrations ≥ 50 mg/kg shall be transported off-site to a TSCA waste landfill compliant with all state and federal regulatory requirements. PCB-contaminated material with PCB concentrations < 50 mg/kg shall be transported off-site and disposed in an appropriately licensed and permitted commercial landfill in compliance with all state and local laws, including EPA's Off-Site Rule (40 CFR § 300.440);

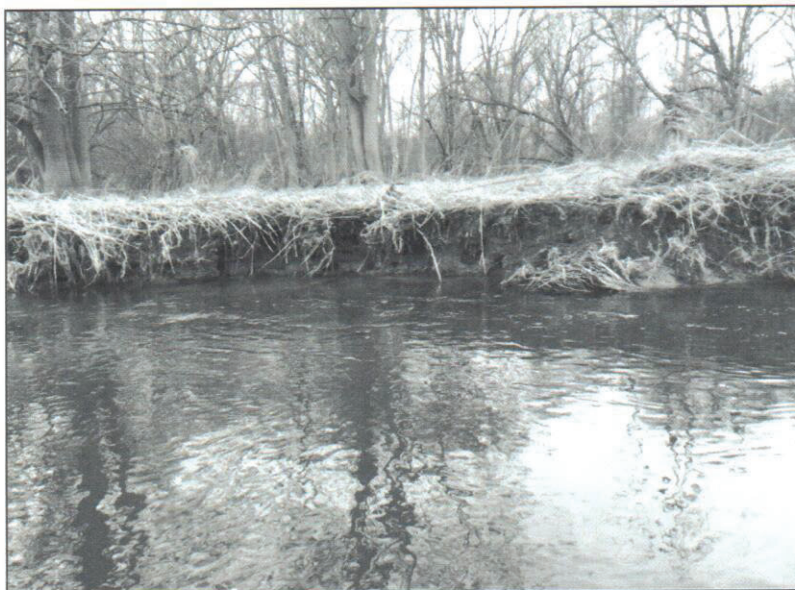
Photograph No.: 2

Subject: Riverbank erosion of contaminated soils into Kalamazoo River on south bank.

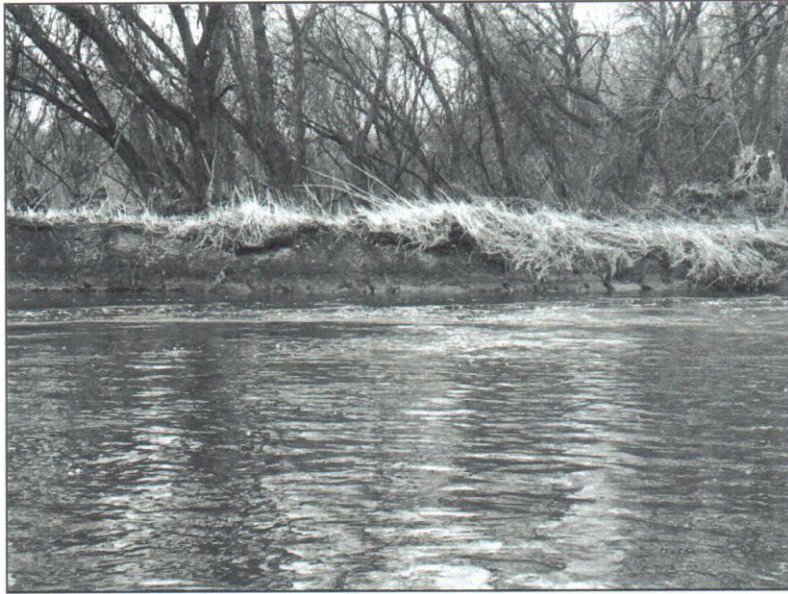
Photograph No.: 3

Subject: Riverbank erosion of contaminated soils into Kalamazoo River on north bank.

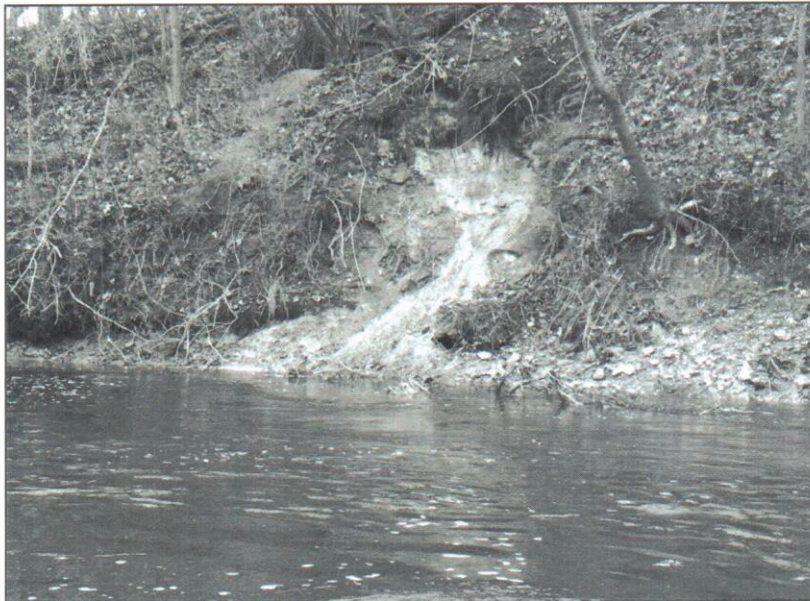
Photograph No.: 4

Subject: Riverbank erosion of contaminated soils into Kalamazoo River on south bank.
