Illinois Gulch

Site Assessment Summary – August 2019

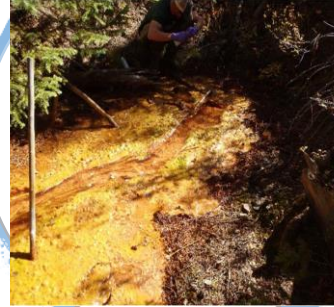
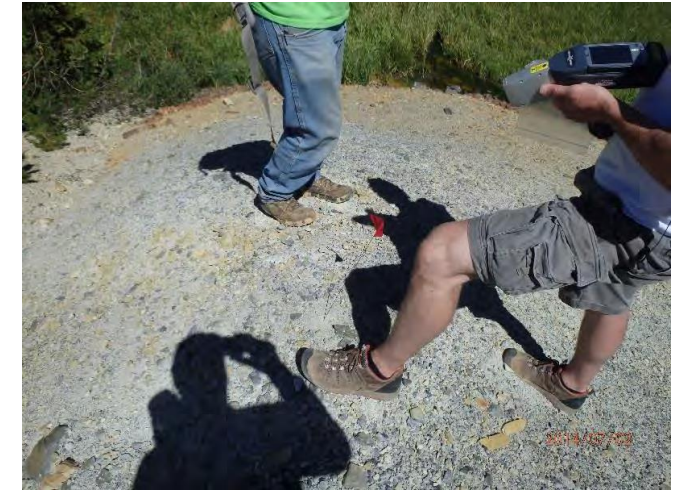
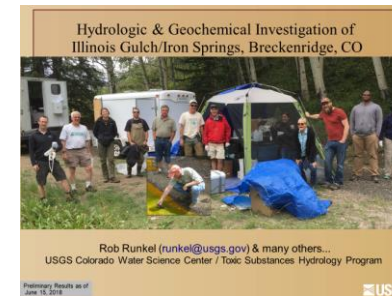
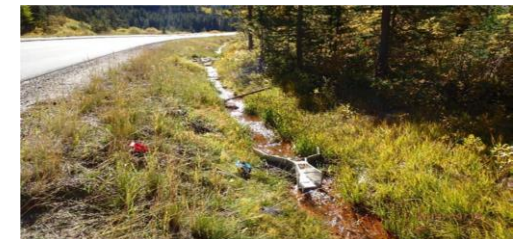
Willard Pile Source Definition

Willard Waste
Pile/Soil

Willard Adit 1

Willard
Adit/Seep 2

Willard Waste Pile/Soil

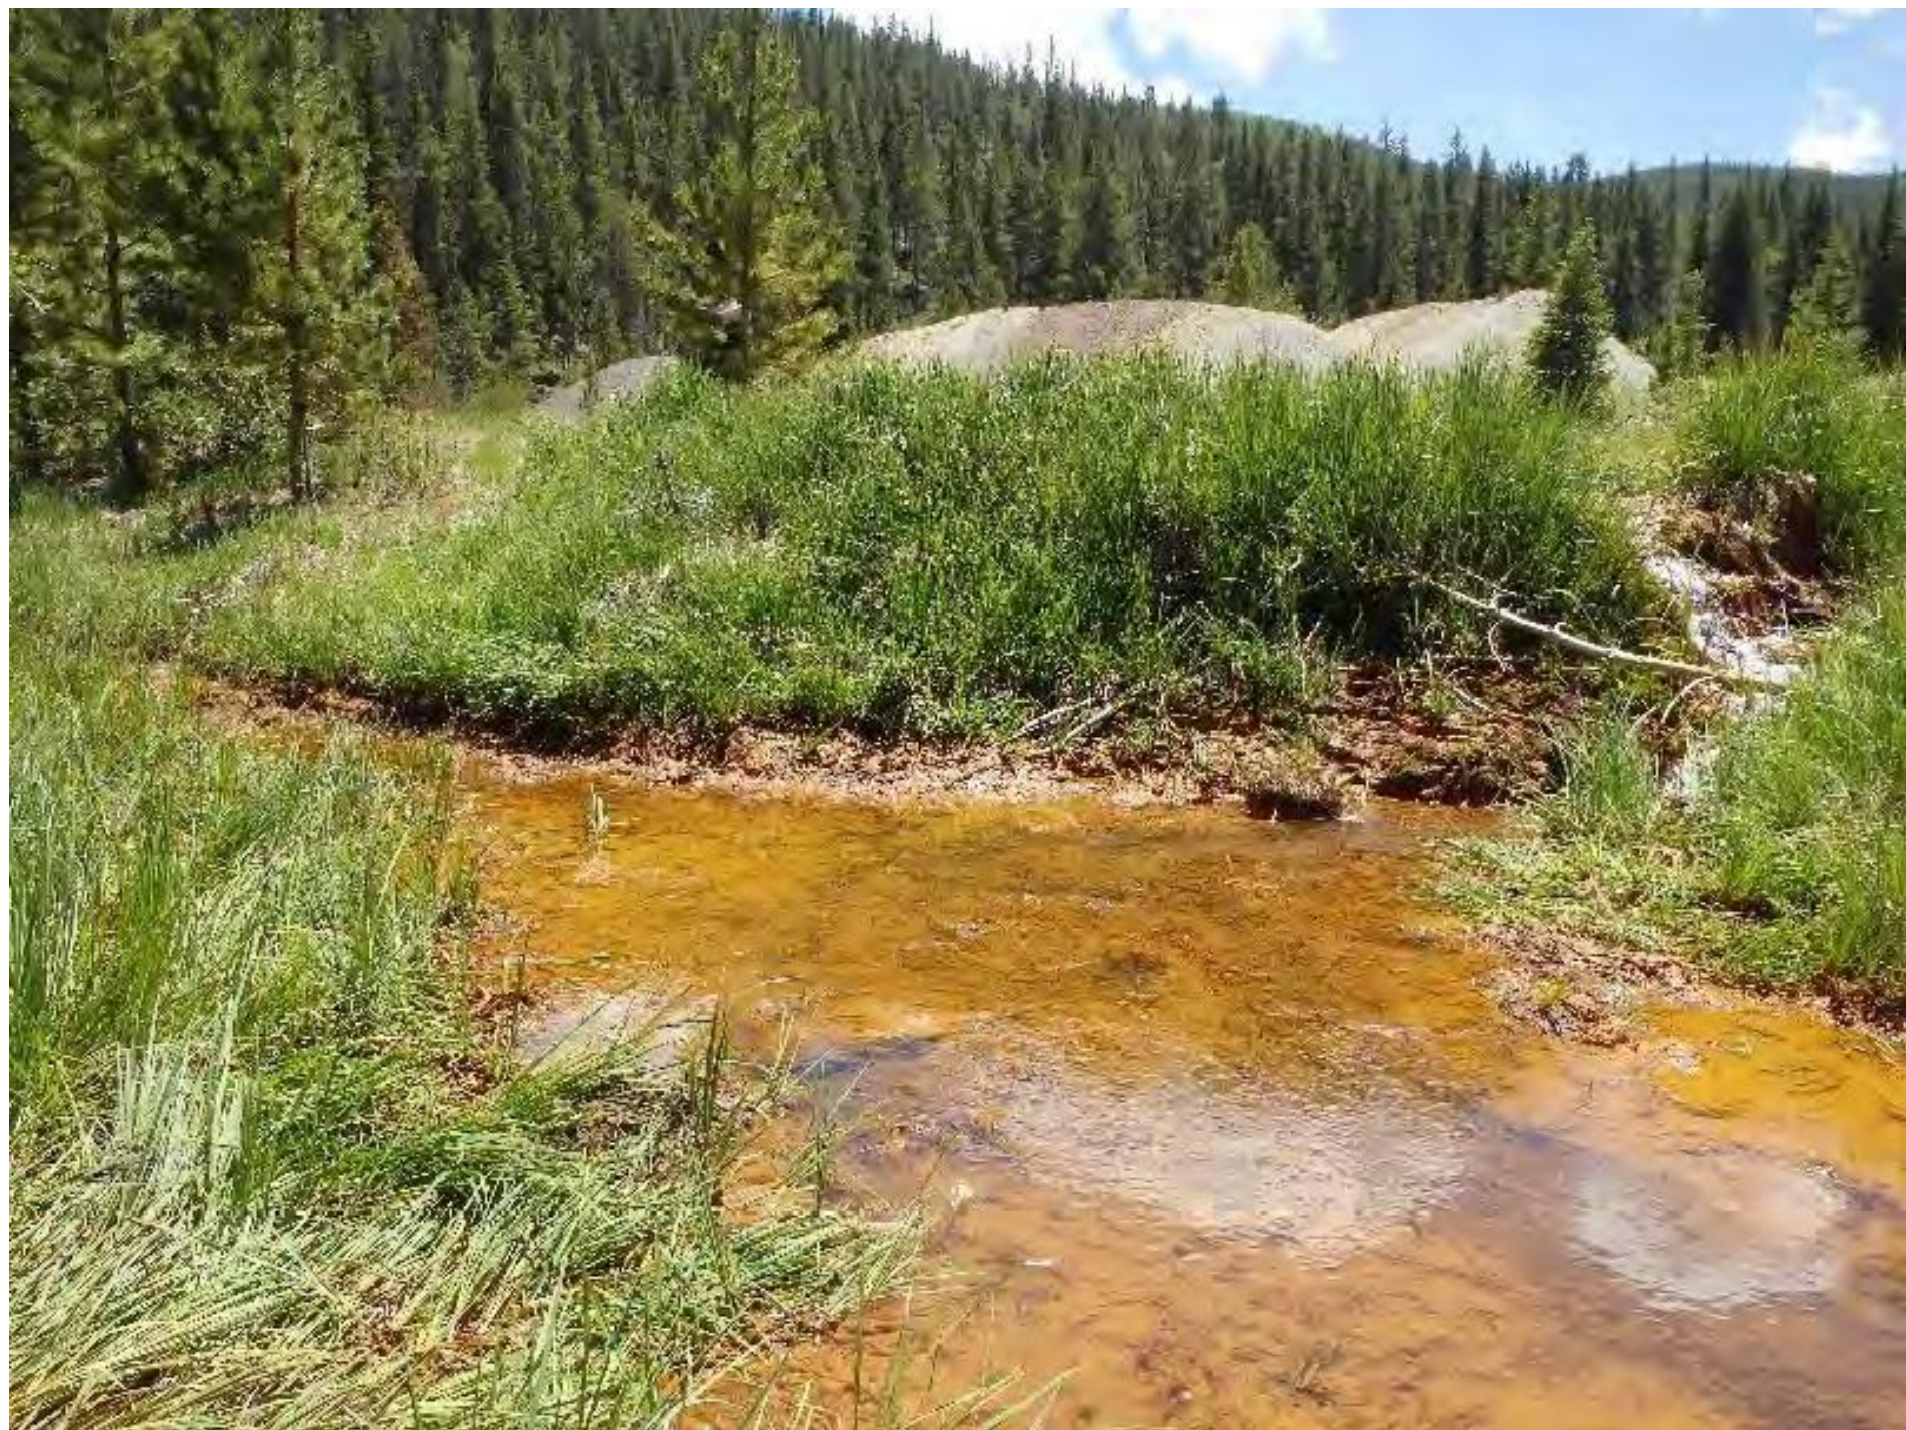
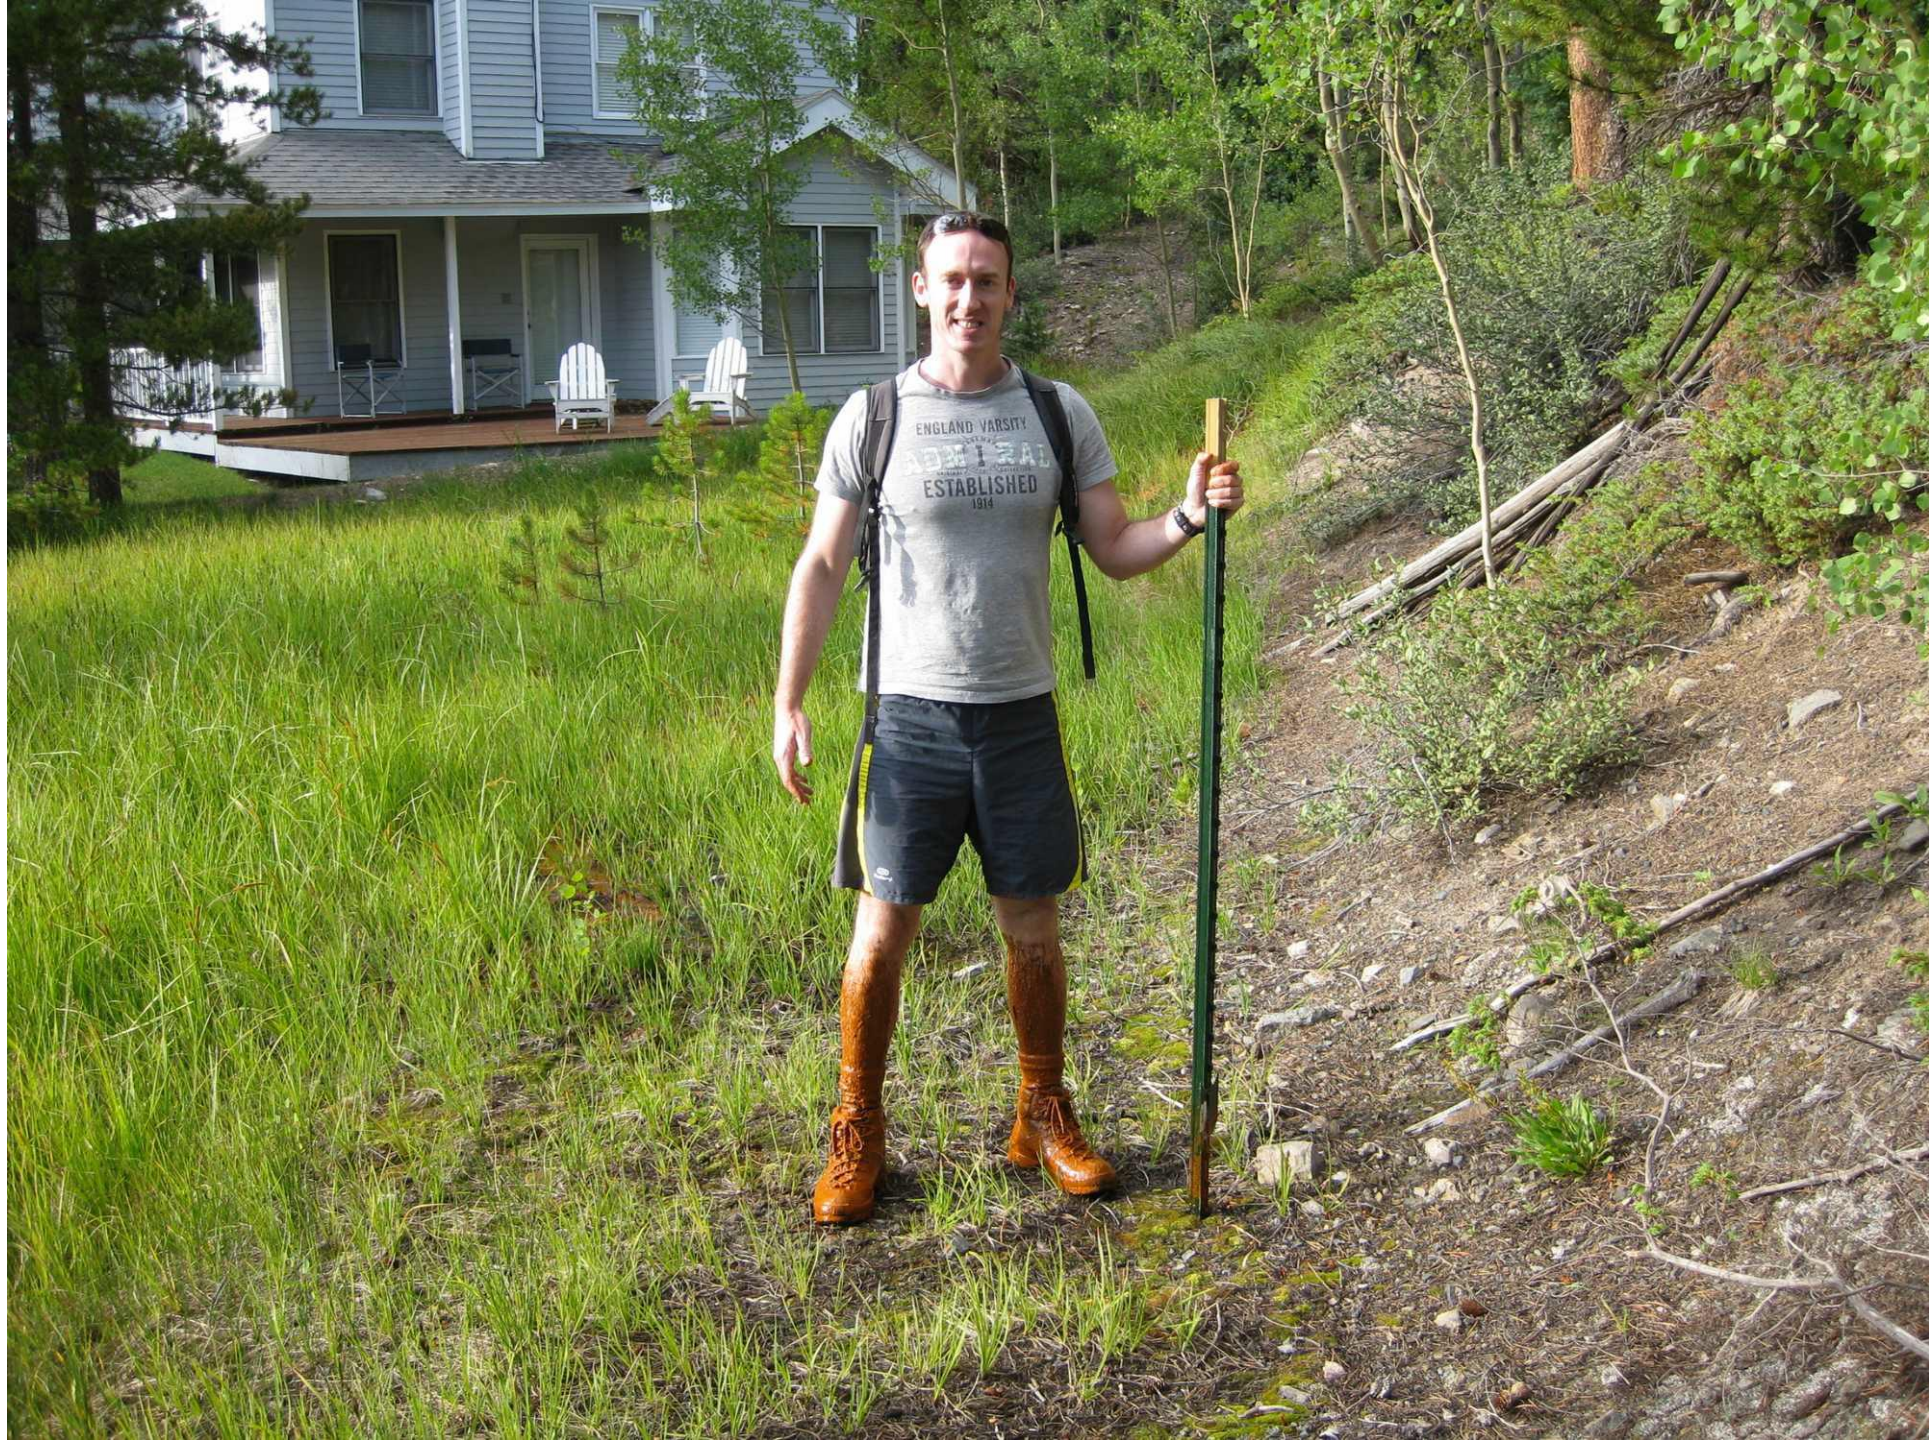
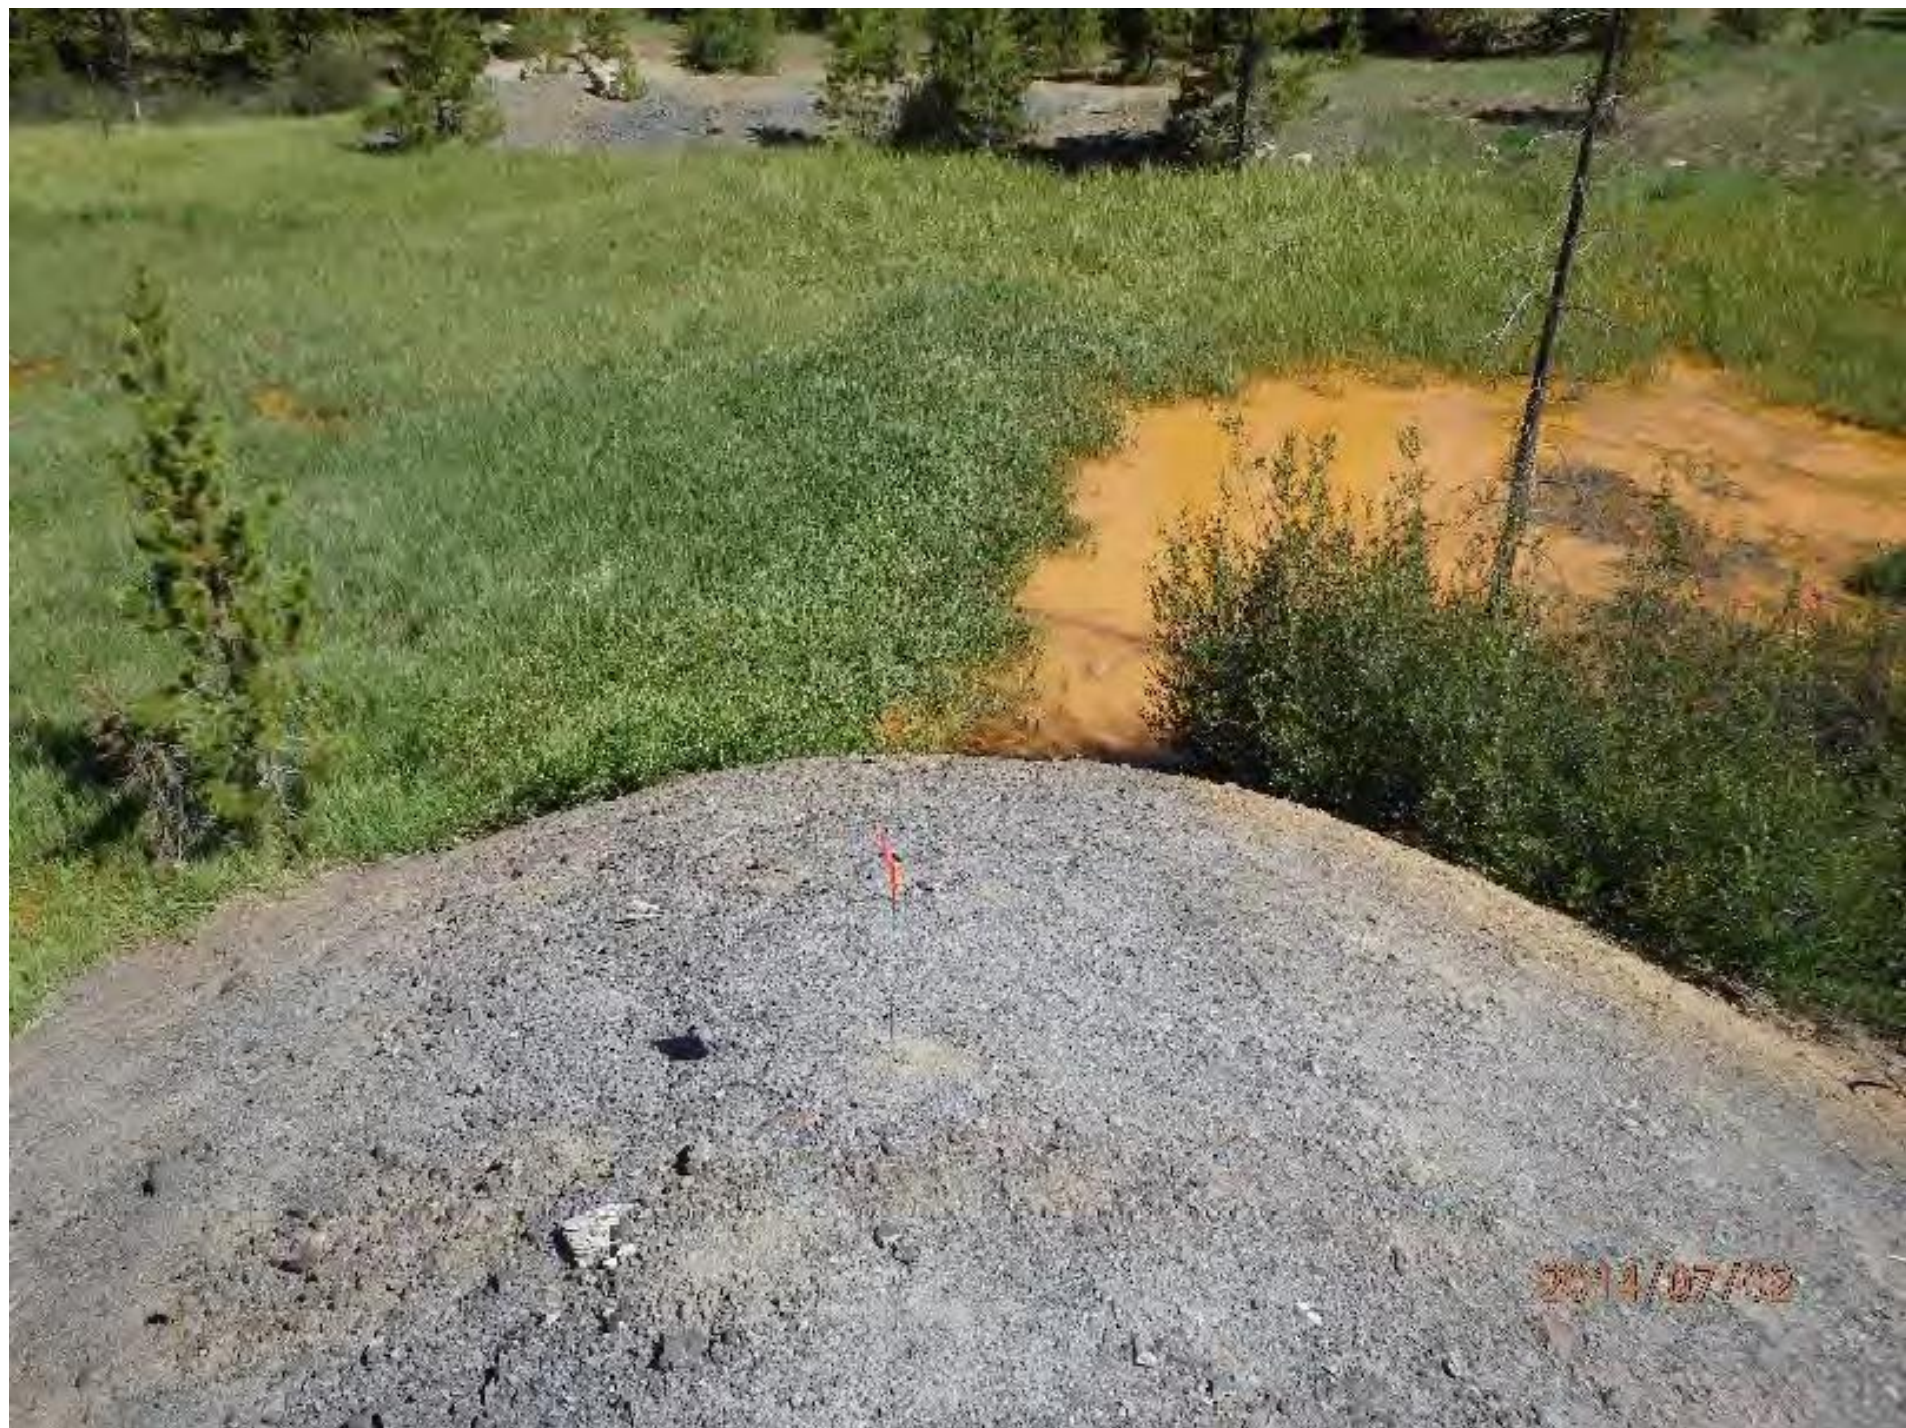
Mine Pile Soil Concentrations

- Arsenic concentrations range up to 3,357 mg/kg
- Lead concentrations over 90,000 mg/kg

Run-off Observed

- Fine/silty, iron-stained, metals-laden sediment
- Deposited/intermingle within on-site wetland
- Observed in Iron Springs; Illinois Gulch; Blue River

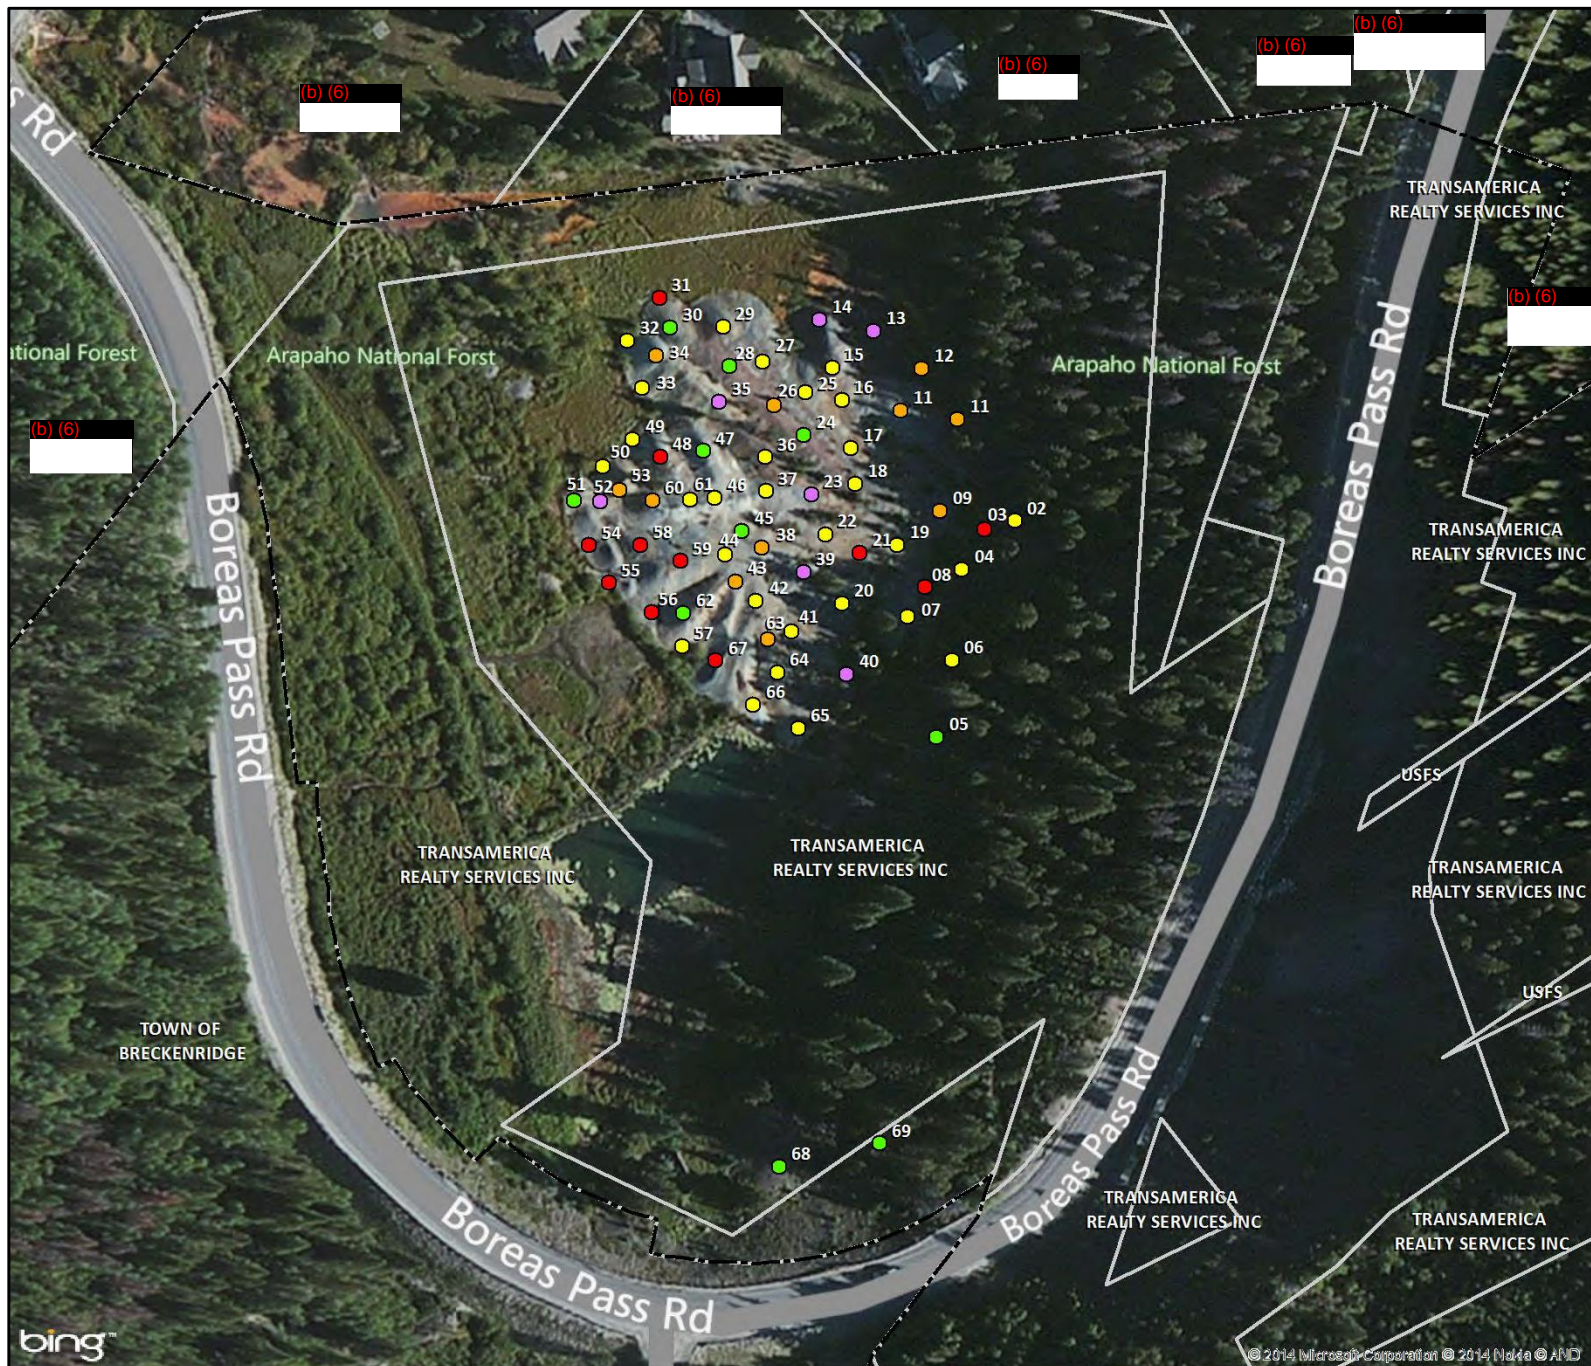
Figure 5.
Illinois Gulch - Willard Pile XRF
Arsenic Results

Arsenic (As) Units in ppm

- 0 - 67
- >67 - 100
- >100 - 300
- >300 - 500
- >500 - 3,357

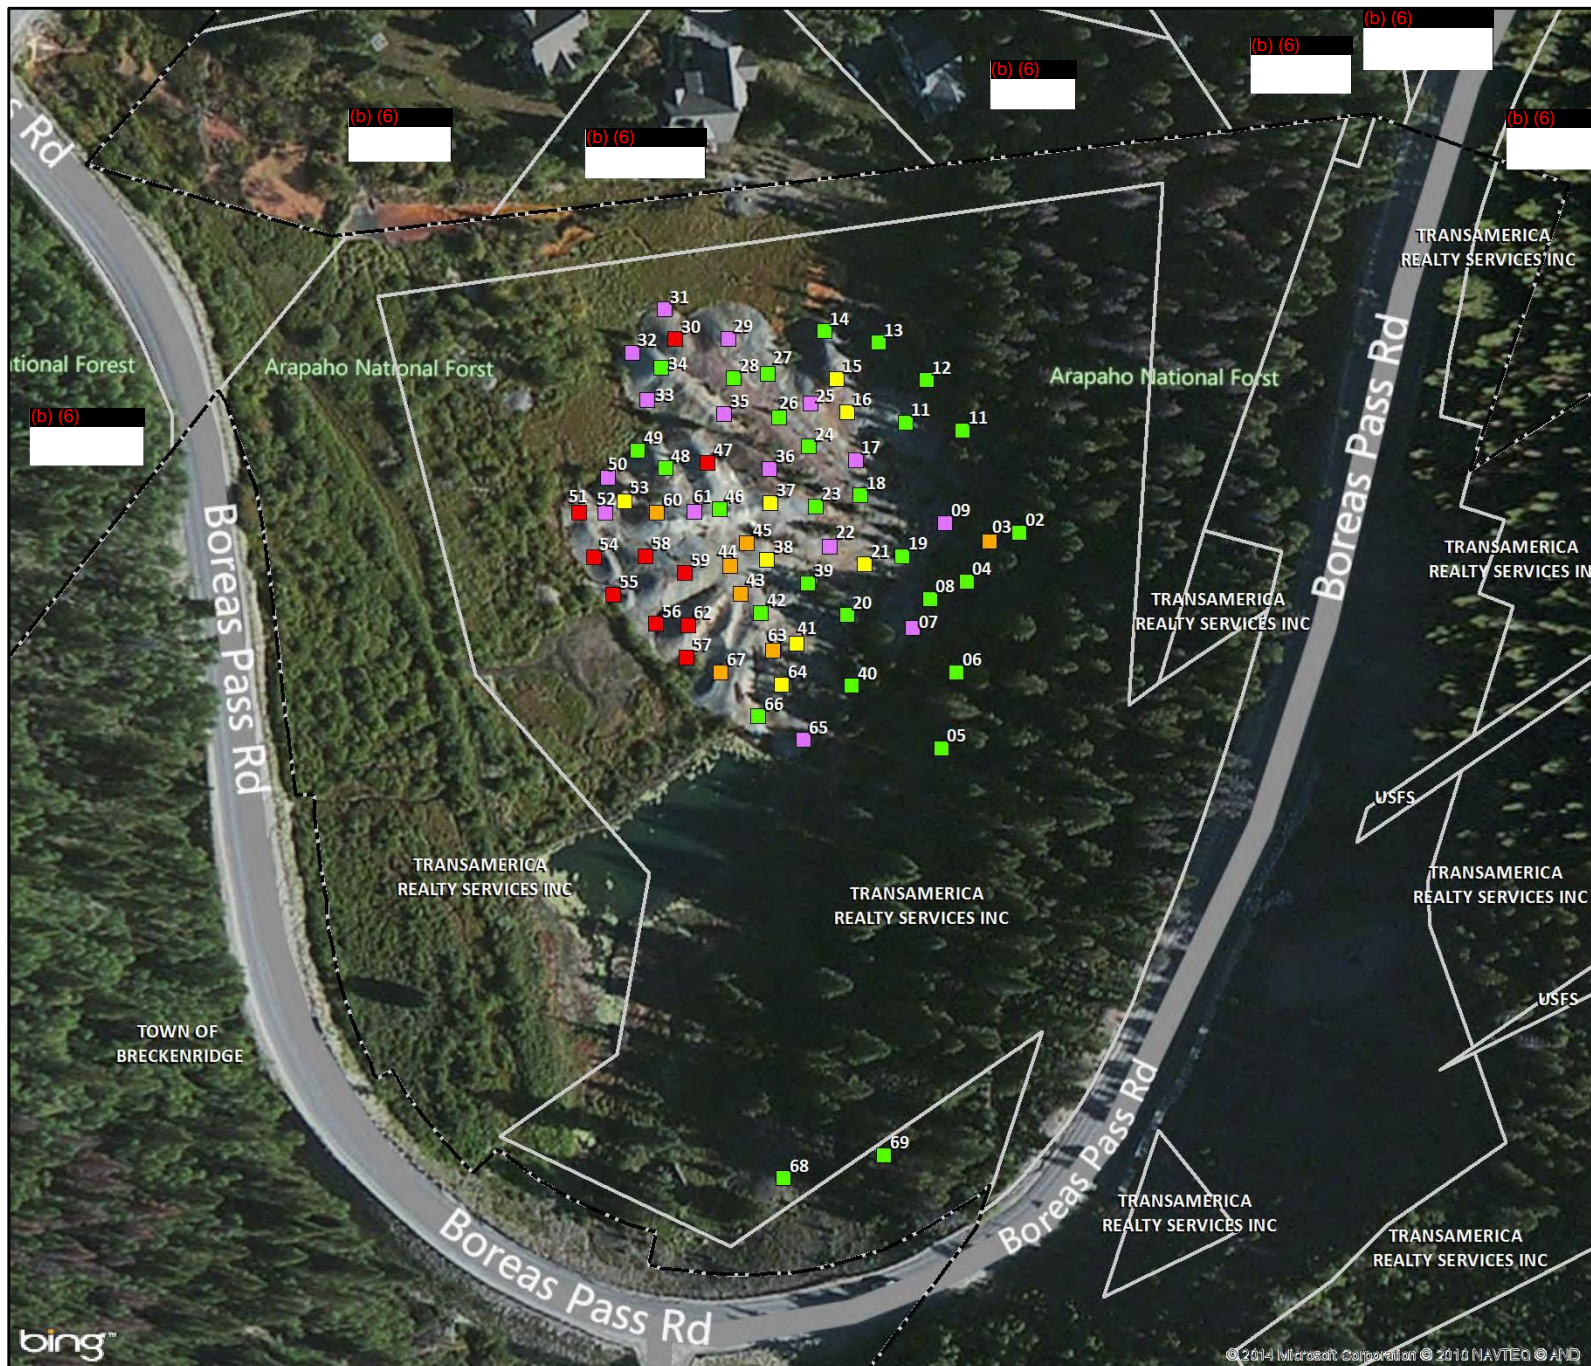
Figure 6.
Illinois Gulch - Willard Pile XRF
Lead Results

Lead (Pb) Units in ppm

- >500 - 1,500
- >1,500 - 3,000
- >3,000 - 5,000
- >5,000 - 10,000
- >10,000 - 99,311
-

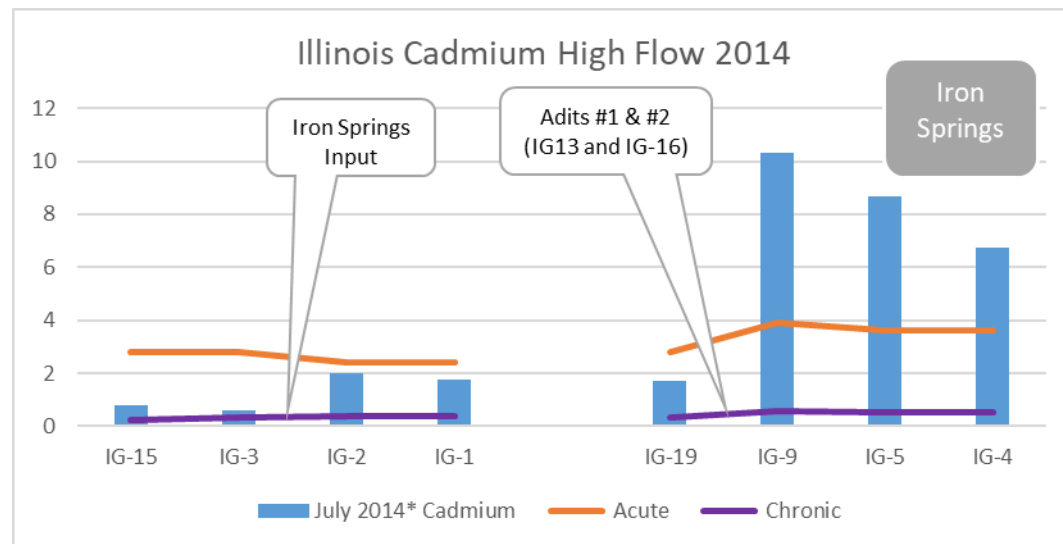
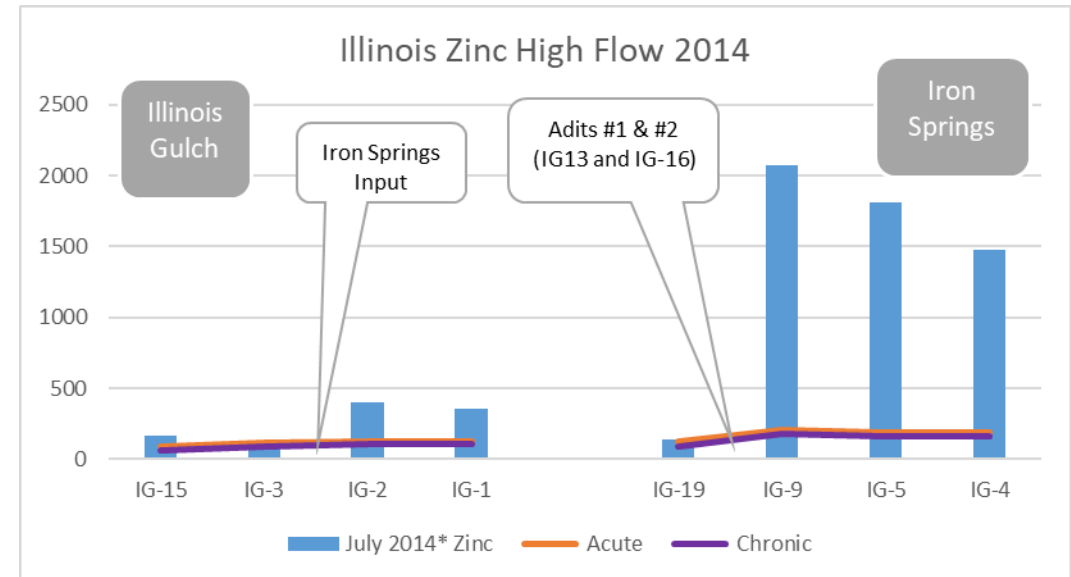
Dissolved Cadmium

Water Quality Results – Illinois Gulch

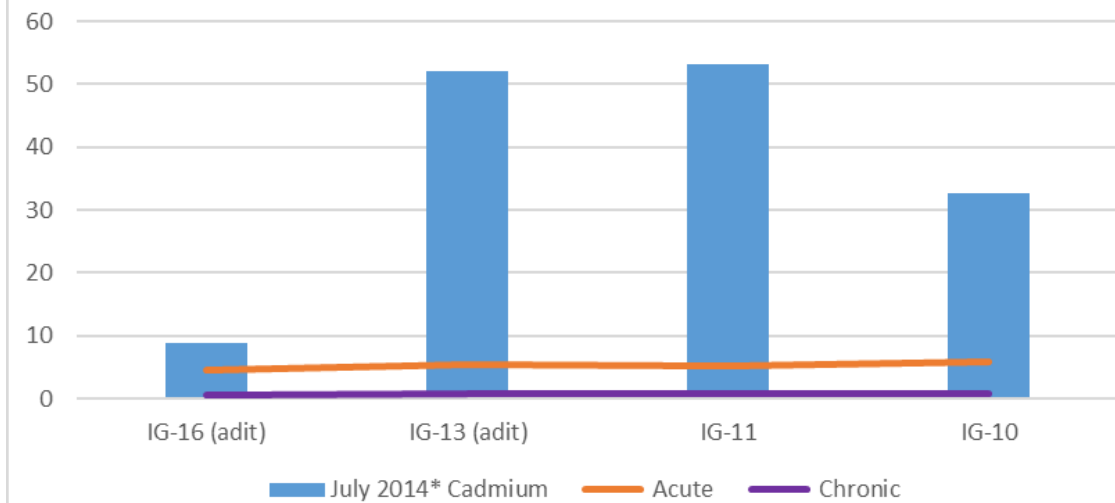
Illinois Cadmium High Flow Exerpt 2014

- Not connected to Willard Adit #1 or the Puzzle Willard Extension Shaft
- Continuous discharge from Willard Adit #2 found to contain similar constituents (cadmium and zinc) and other heavy metals as Adit #1, well as low pH.
- Discharge combines with flow from Willard Adit 1 and flow through wetland prior to entering Iron Springs.

Discharge from Willard Adits

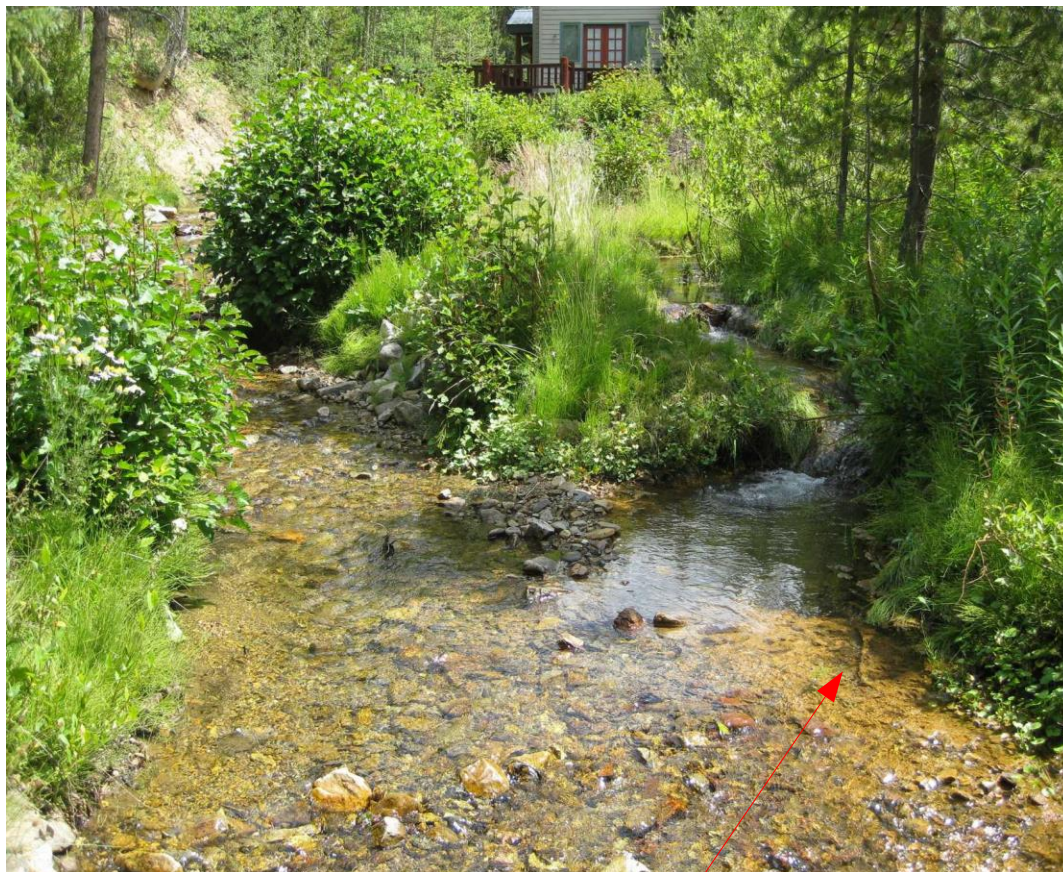
ILL-2126, Iron Springs at Mouth

Illinois Gulch Results (2016)

Largest source: Iron Springs

- #1 Source: Al, Cd, Cu, Fe, Mn, Ni, Pb, U, Zn

Rank	Constituent	Contribution
1	Al	42%
1	Cd	65%
1	Cu	51%
1	Fe	67%
1	Mn	89%
1	Ni	78%
1	Pb	31%
1	U	36%
1	Zn	76%
2	As	29%
2	Cr	13%
