Division of Reclamation,  
Mining and Safety

DATE: June 25, 2017

RE: Report of Mine Hydrology Investigations and Dye Tracer Study, Illinois Gulch, Summit County, Colorado

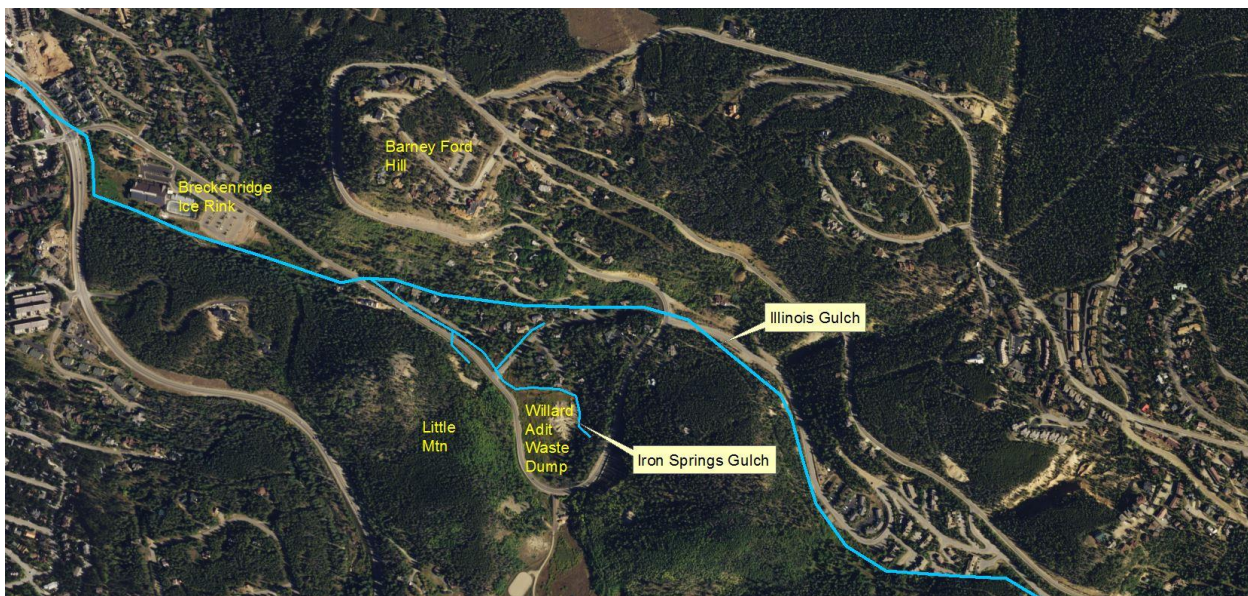
Figure 1: Location of Illinois Gulch

Illinois Gulch headwaters are on the northwest flank of Bald Mountain located to the southeast of the Town of Breckenridge in Summit County, Colorado. Illinois Creek flows in a west-northwesterly direction from the headwaters approximately 4.1 miles to the confluence with the Blue River in Breckenridge. Approximately three-fourths mile above the confluence of Illinois Gulch with the Blue River is the confluence of Illinois Gulch with Iron Springs Gulch. The headwaters of Iron Springs Gulch are within a historic abandoned mine complex that includes the Willard adit waste rock dump and is surrounded by and north of a prominent horseshoe curve in Boreas Pass Road (figure 1).

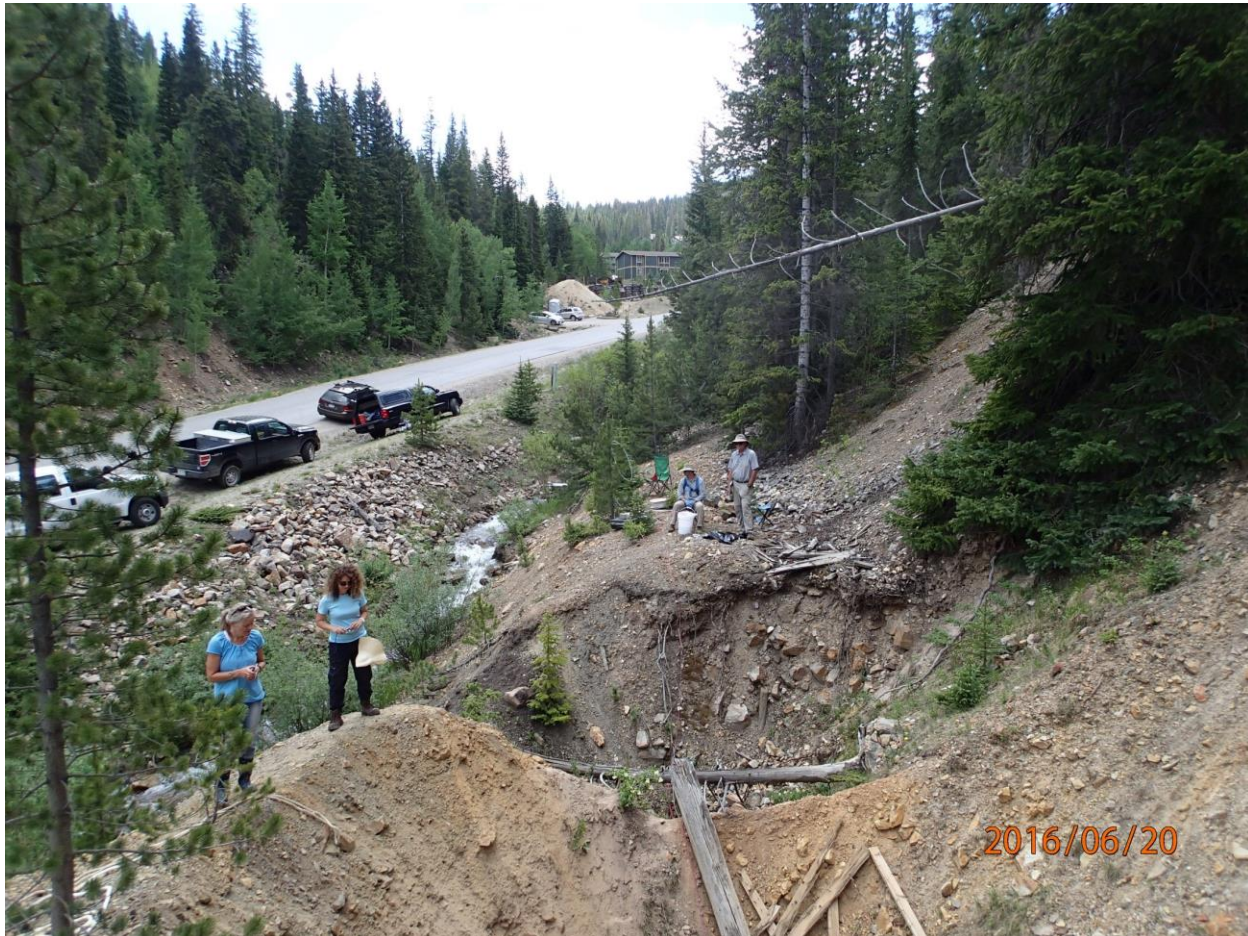
Figure 9: Photograph showing the Collapsed Two-Compartment Puzzle Extension Shaft, the Pumping and Dye Mixing Station Established at the Shaft Collar, and the Close Proximity of the Creek to the Shaft.

In order to prepare for dye injection into the Puzzle Extension shaft, a harnessed and roped-off crew accessed the collar of the north shaft compartment and hammered a soil sampling tube into the mine waste that fills the depression of the collapsed shaft compartment. The two foot column of mine waste collected in the sampling tube consisted of yellowish and reddish brown coarse grained sand sized material. The sample hole remained open, and a plastic sleeve was inserted. The sleeved hole would be used for injection of fluids for the duration of the dye tracer investigation.

A pumping and dye mixing station was established on top of the mine waste dump adjacent to the Puzzle Extension shaft collapse crater. A small battery powered peristaltic pump was setup with intake and discharge tubing arranged so that creek water could be pumped into new, clean plastic buckets at the mixing station, or could be pumped directly into the injection point established in the shaft. Using a graduated bucket and stop watch, it was determined that the pump was operating at a rate of 9.2 gallons per hour drawing creek water up to the mixing station.

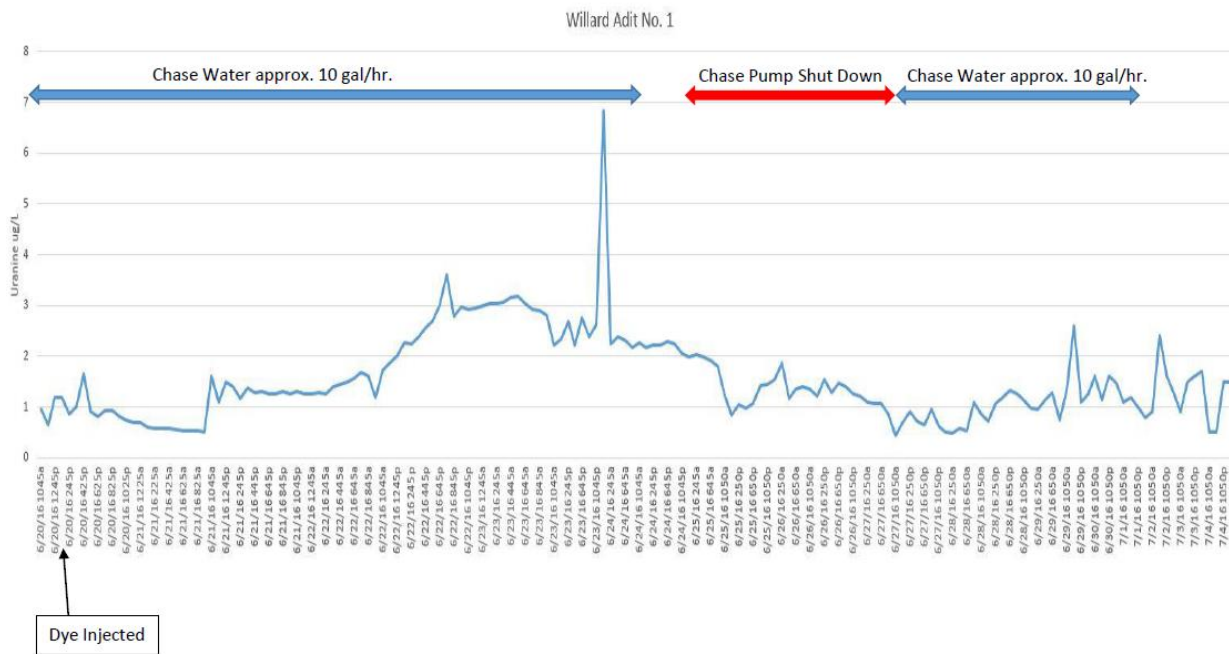
Figure 10: Plot of Uranine Concentration in the Willard Adit Discharge

Positive detection of uranine dye did occur in the Willard adit discharge. Figure 10 is a plot of uranine concentrations at the Willard adit over the course of the investigation. Very low concentrations of uranine dye were detected in the Willard adit discharge prior to the injection of dye into the Puzzle Extension shaft. Uranine dye is used in antifreeze and other common preparations, so the pre-existing uranine that was detected could be due to the presence of uranine in Illinois Gulch from paved surfaces runoff and other sources unrelated to the investigation. Uranine dye was detected in very low concentrations at the Willard adit throughout the course of the investigation. The concentrations were sufficiently low to prompt the consideration that the detections were not related to the injection of uranine into the Puzzle Extension shaft. However, the results of the salt tracer study conducted by USGS that is the subject of a separate report, combined with the consistency of the rise and fall in uranine concentrations as illustrated on the plot shown in figure 10 lend confidence to the conclusion that the elevated dye concentrations were from the dye that was injected.

1. First detection of the uranine dye injected into the Puzzle Extension shaft in the Willard adit discharge appears to have occurred approximately 46 hours following injection.
2. There is a hydrologic flow path from Illinois Creek through the Puzzle Extension mine and Puzzle mine workings to the Willard level of the Puzzle mine and the Willard adit portal to the headwaters of Iron Springs gulch.
3. Less than five percent of the dye injected into the Puzzle Extension shaft issued from the Willard adit during the course of the investigation. It is likely that much of the dye was deterred in the pore spaces of the mine waste collapsed into the shaft, and that additional chase water would have moved a greater percentage of the dye through the system.
