# Kaiser Time Critical Removal Action Container Inventory Observation Report

## SITE OBSERVATIONS

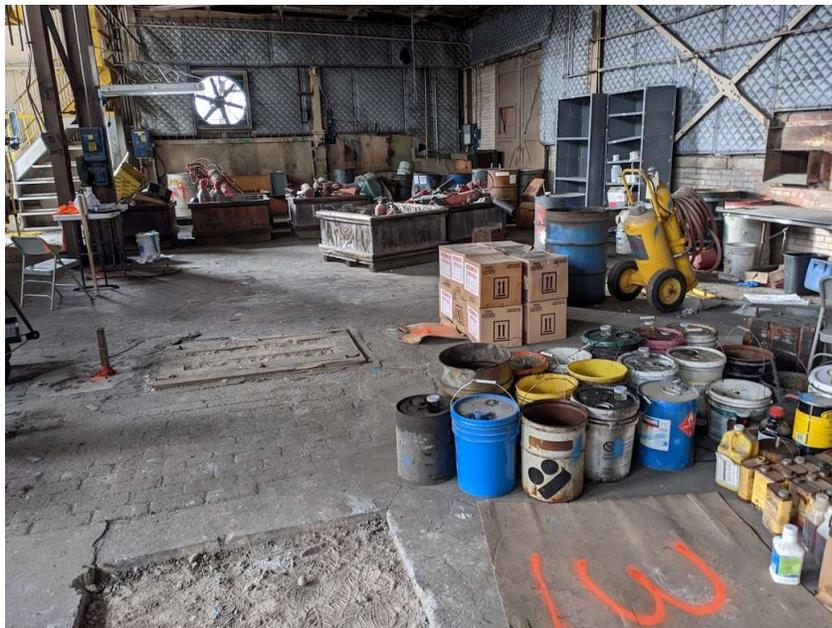
*Photo 1 - View of the northwest corner of Building 44*

This area contained 12 drums, 7 crates and a number of smaller containers staged. Each staging group was labeled with an ID corresponding to either an inventory code or a DOT hazard class.

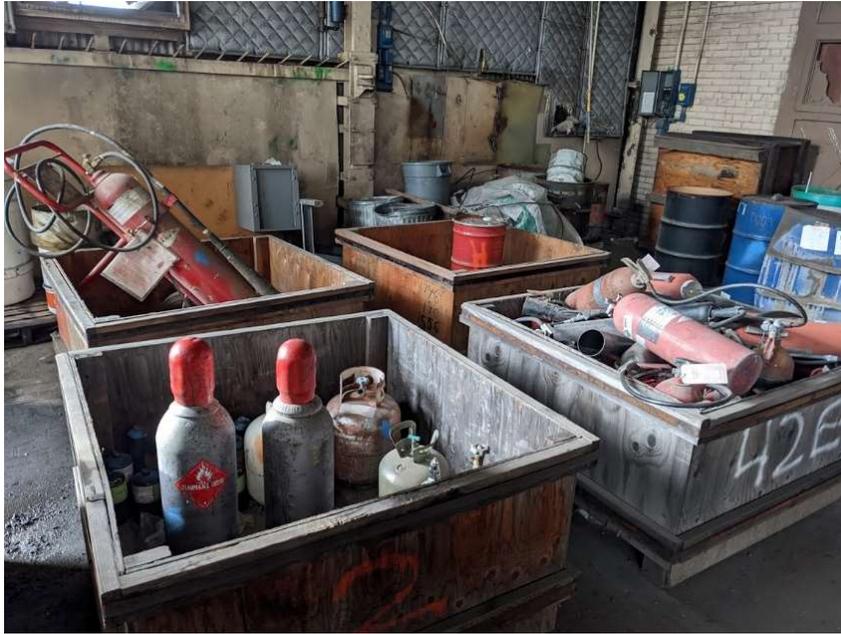
Crates containing multiple items were labeled with the DOT class of the items they contained. The crate containing compressed gas cylinders was labeled as DOT 2. Two gray cylinders with red cylinder caps within this crate were suspected by START to be props; however, that could not be confirmed, and the cylinders were documented as DOT 2. The crate labeled 42 E contained 42 fire extinguishers. A single large fire extinguisher was staged in its own crate. All the fire extinguishers identified on site were grouped and inventoried; however, many were pressurized, and will require depressurization prior to disposal. A single 30-gallon drum labeled D010 was staged in the last crate and contains a DOT class 3, flammable solvent.

*Photo 2 - Crates with compressed gasses*

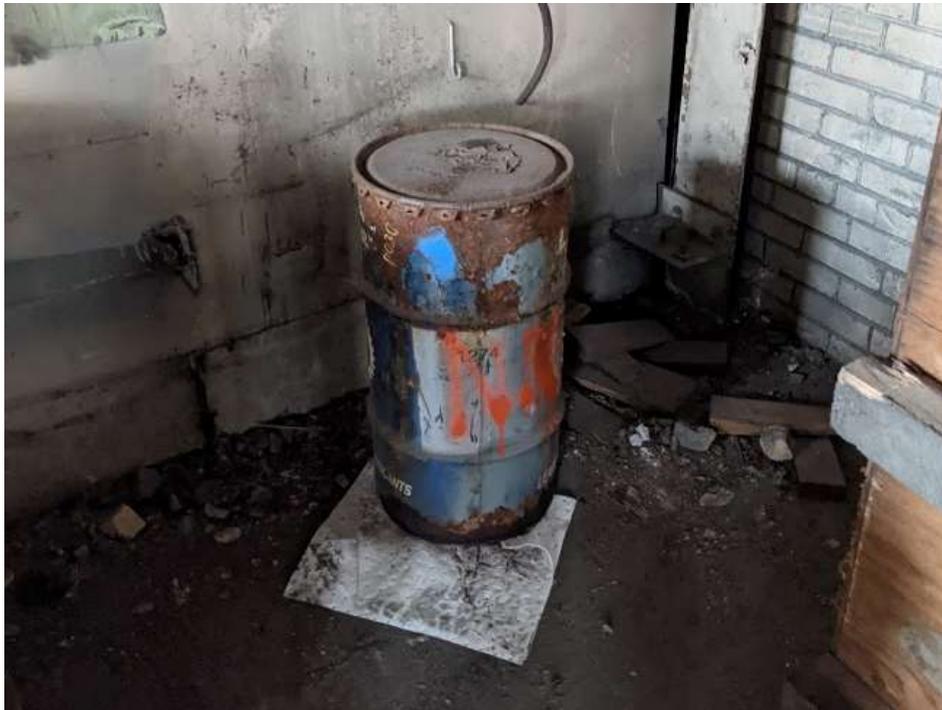
D030 was in the northwest corner of the building and was determined through visual observation and SDS research to be a non-DOT-regulated lubricant. During initial inspection, the drum appeared to be leaking, but it was later determined to be residue left by another container. A sorbent pad was placed underneath the container to contain the liquid.

*Photo 3 – Drum D030 containing lubricant*

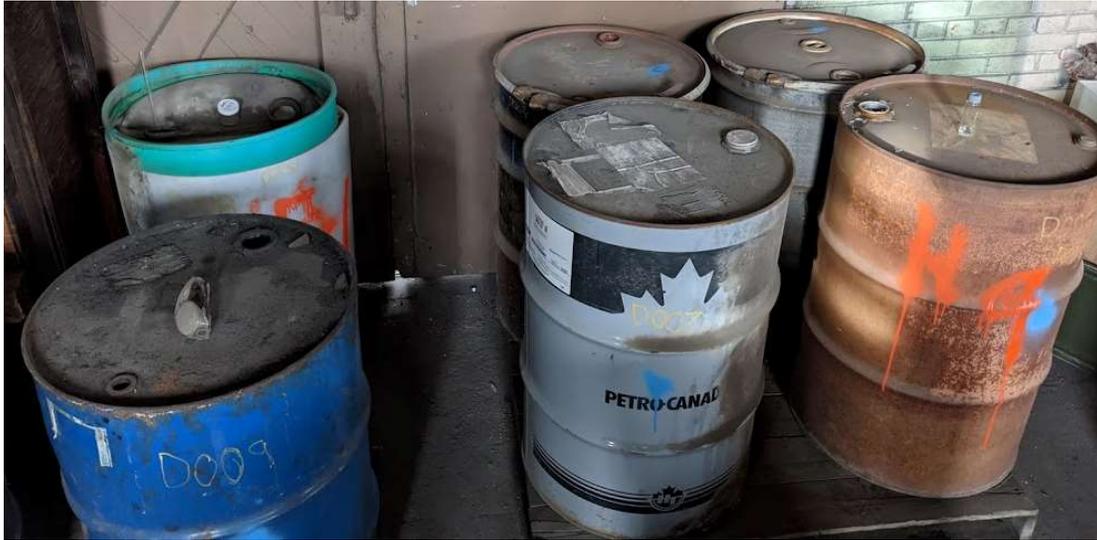
Six 55-gallon drums were located along the north wall on the west side of building 44, behind the fire extinguisher totes. Drums D006, D007, and D009 had good labels and were categorized as non-DOT regulated by SDS research and visual observations. Drum D008 was determined by First Step Hazard Categorization to be a DOT Class 5.1. D004 and D005

were opened by START and determined by visual observation to be green coke material and can be disposed on site with other site waste.

*Photo 4 - Drums containing nonregulated material, a 5.1 oxidizer and green coke material.*

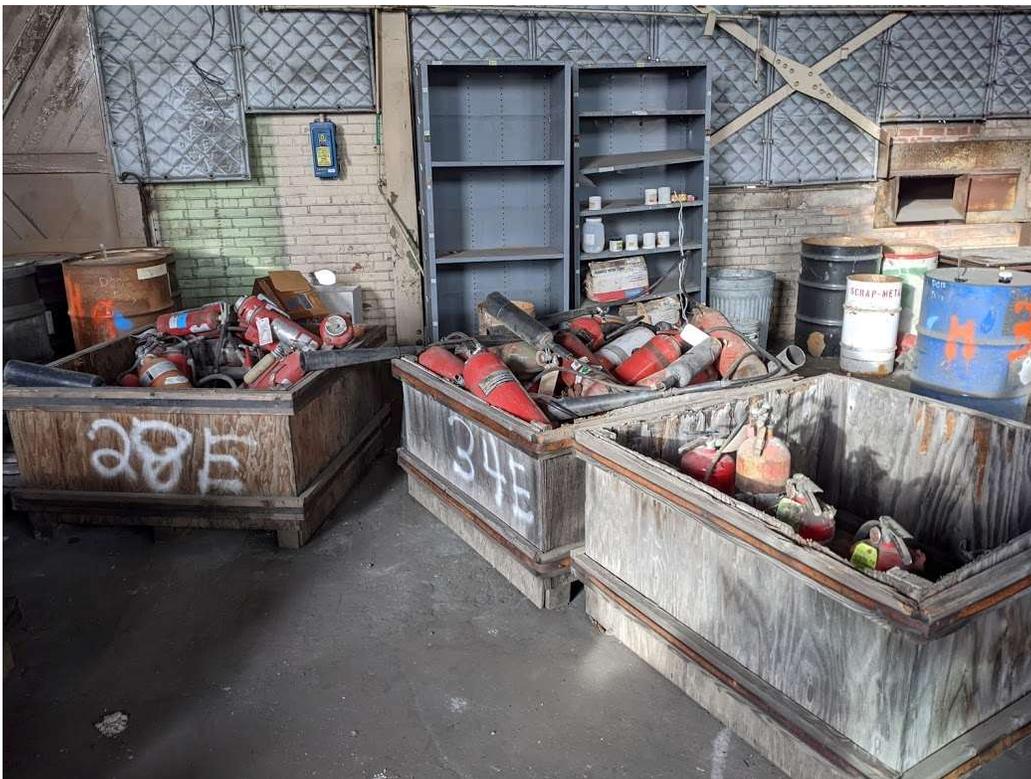
Three additional crates pictured below contained fire extinguishers. Crates with large number of fire extinguishers were counted and the quantity labeled on the outside of the crate. All the fire extinguishers identified on site were grouped and inventoried; however, many remained pressurized and will require depressurization before disposal.

*Photo 5 - Crates containing fire extinguishers*

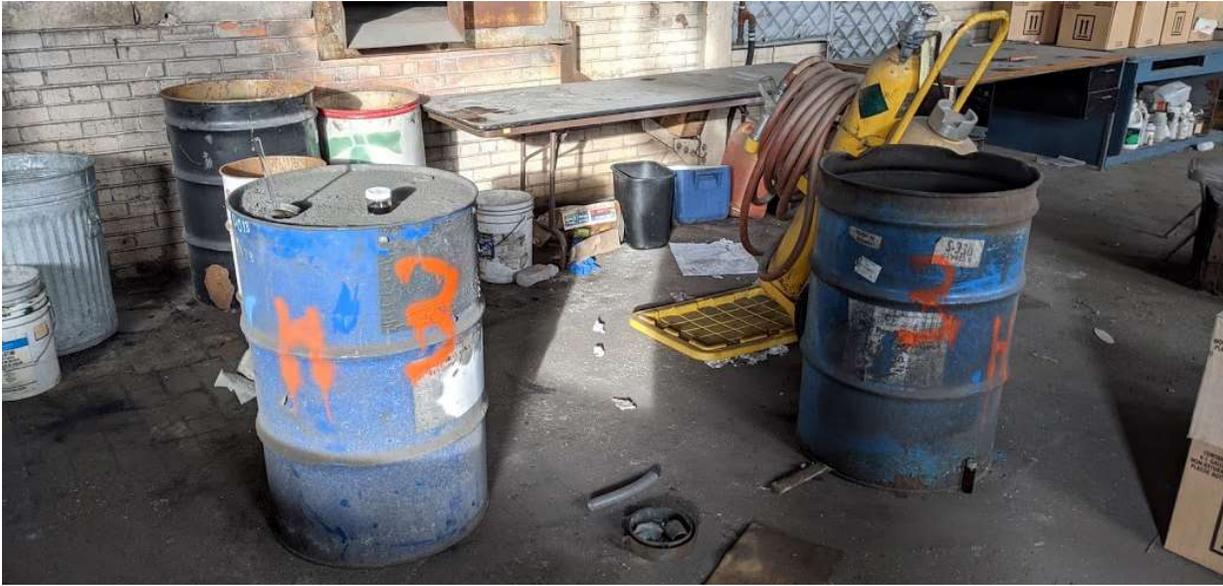
Drums D013 and D014 were sampled by START and determined to be DOT class 3 by First Step Hazard Categorization. Drum D014 was open and had no lid. The open drums behind Drums D013 and D014 along the wall were visually inspected by START and contained trash and other debris .

*Photo 6 - Drums containing DOT 3 Flammable liquids*

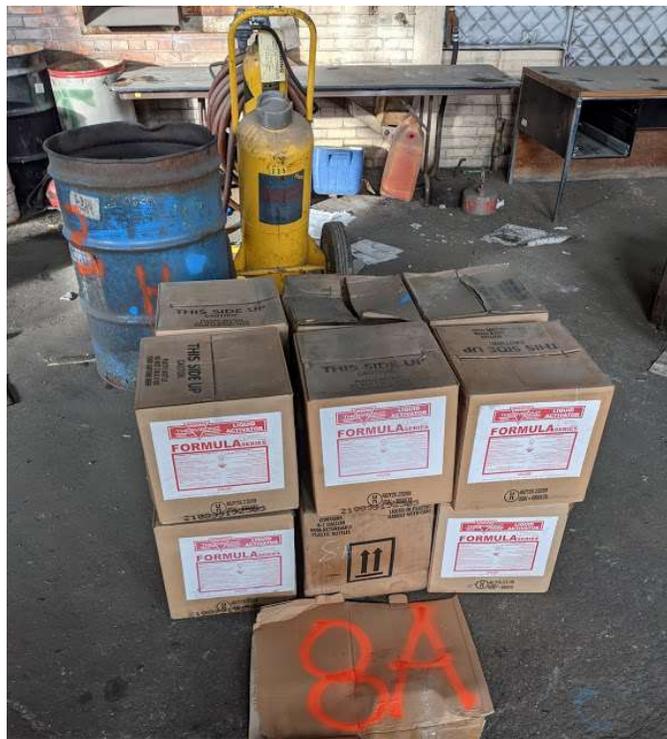
Twelve cases of liquid activator with “Corrosive” labels were categorized through SDS research as DOT 8A acidic liquids. The yellow cylinder behind the liquid activator pile is a fire extinguisher.

*Photo 7 - Boxes of corrosive liquid activator (acidic)*

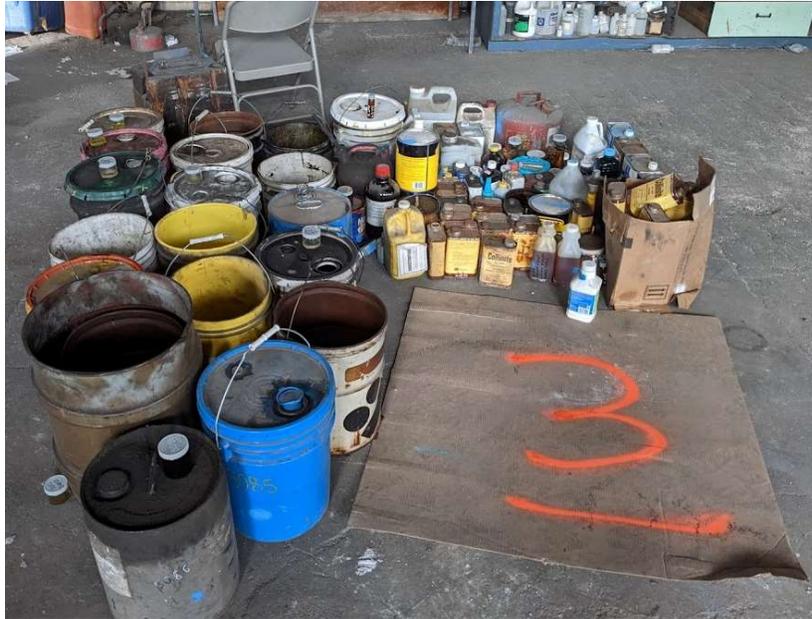
All identified DOT class 3 flammable liquid containers with the exception of the 55-gallon drums were staged together by START. This pile consisted of a variety of container types and sizes. Several five gallon buckets were partially full without lids and would require cautious handling to avoid potential spills of flammable liquids. Unlabeled containers were classified using the First Step Hazard Categorization system. Labeled containers were classified through SDS research and visual observation.

*Photo 8 - DOT class 3 containers*

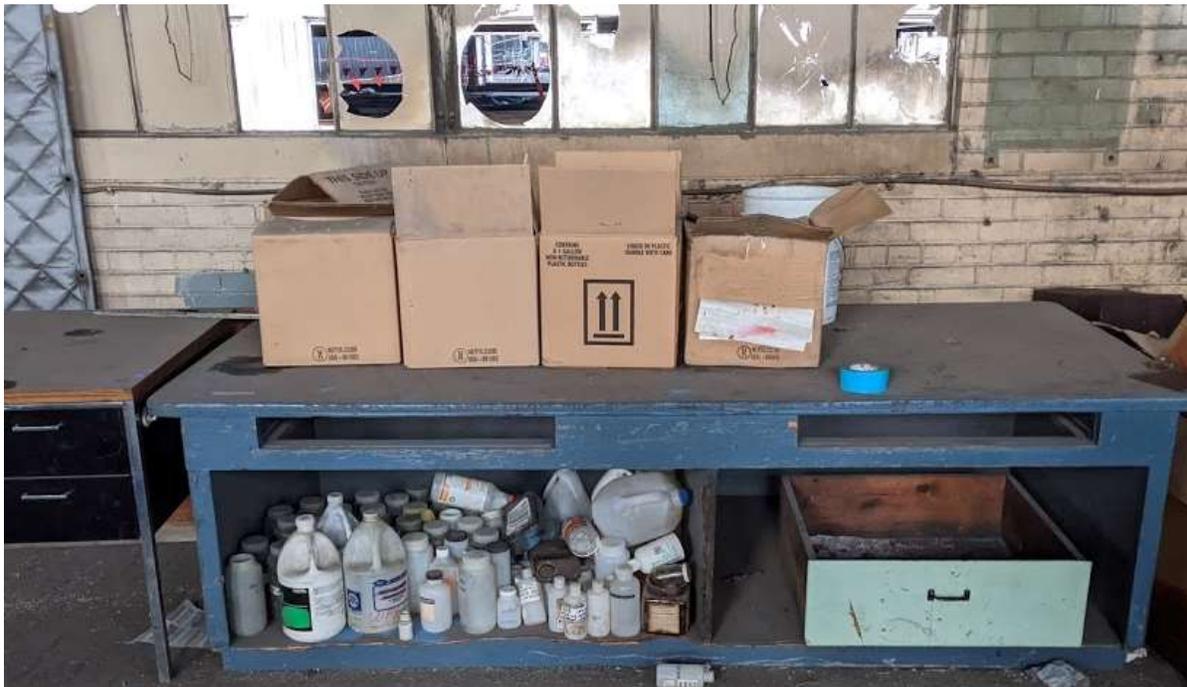
The desk along the north wall on the west side of Building 44 contained empty containers and boxes. Other Empty containers were found in a crate near the western garage door of Building 44.

*Photo 9 - Empty containers and boxes*

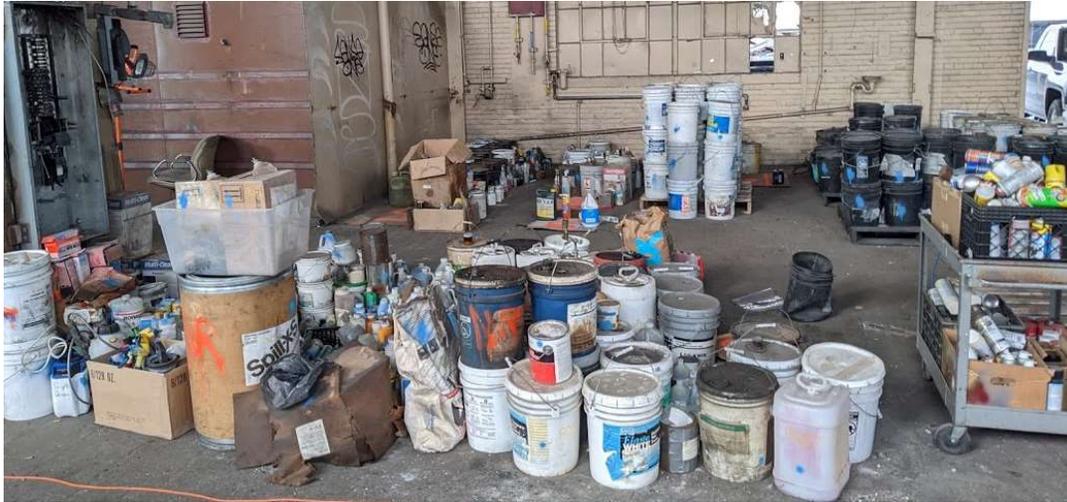
This area was the staging area for the following: non-regulated material, DOT Classes 5.1, 5.2, 6, 8A, 8B and 9 and miscellaneous paint containers. These container classes were determined by SDS research or First Step Hazard Categorization.

*Photo 10 - Small chemical containers staged next to the north entrance of Building 44*

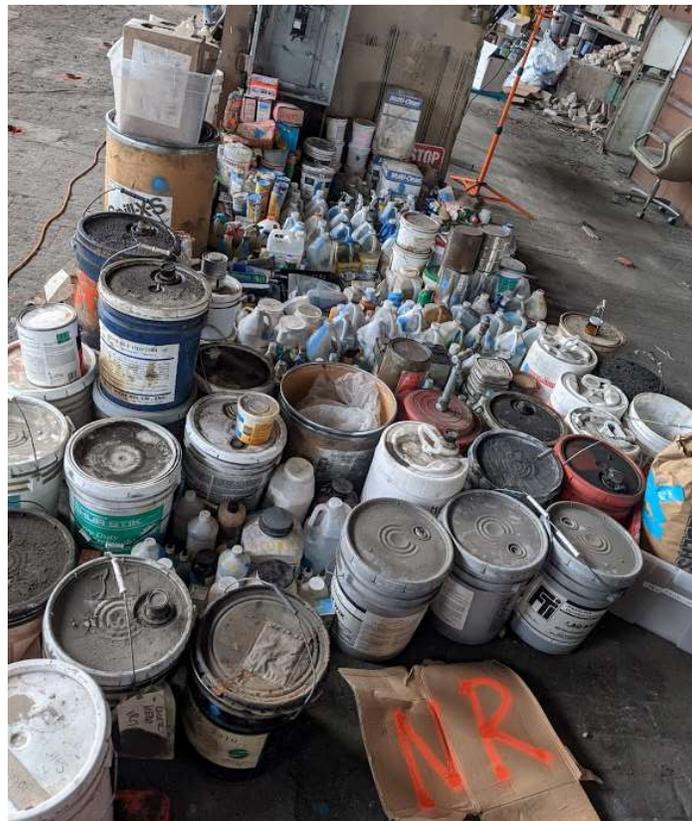
All the non-DOT-regulated chemicals are staged in an area by the north entrance. The disposal pathway was yet to be determined as of the START-V demobilization from the site. Container types, sizes, and integrity varied. Several containers had open tops and were susceptible to spilling.

*Photo 11 - Miscellaneous non-regulated materials*

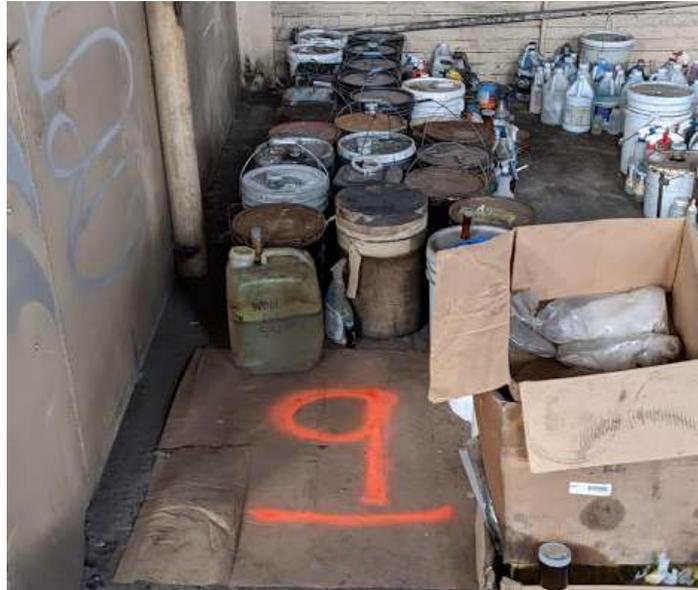
All DOT class 9 containers except for 55-gallon drums were staged along the wall by the north entrance. Most of these containers were five-gallon buckets, however there were several smaller containers as well. Visible in front of the area were three boxes containing loose, solid material in the open boxes. The bags were labeled as a respiratory hazard if inhaled. Caution should be used while moving or disposing of the chemicals.

*Photo 12 - DOT class 9 containers*

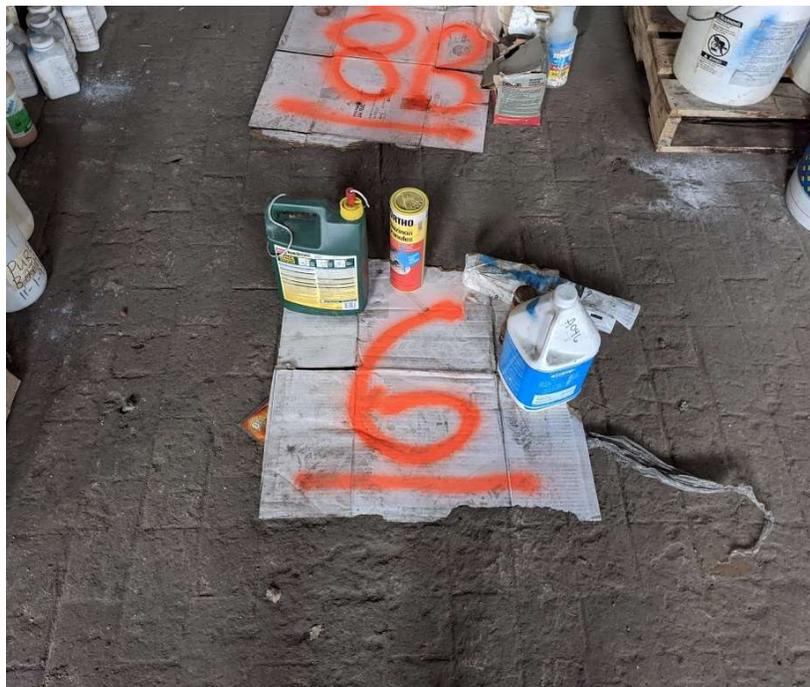
A small pile of items near the north entrance, beside the DOT class 9, DOT class 8B, and non-regulated materials, were designated as DOT Class 6 containers.

*13 - DOT class 6 containers*

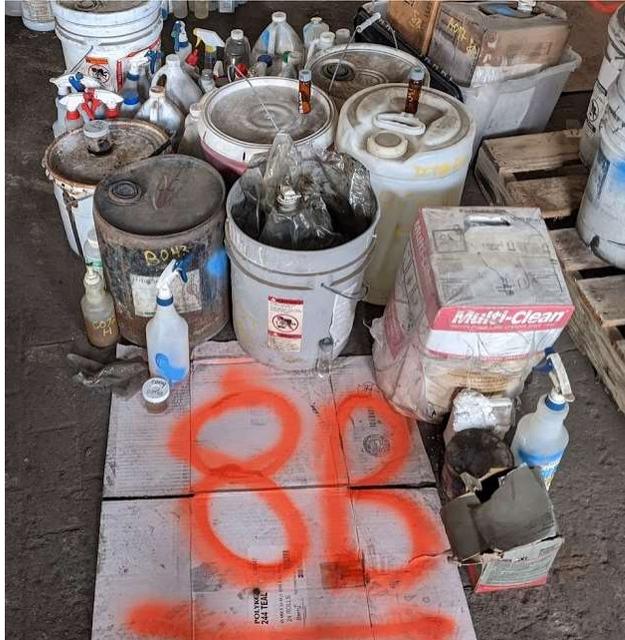
The DOT class 8B containers were grouped beside the DOT class 9 chemicals. There was a variety of container types and sizes (the Multi-Clean box is fragile and needs to be handled with caution to avoid a potential spill of corrosive liquid). This pile was located near the north wall near the north entrance.

*Photo 14 - DOT class 8B containers (basic)*

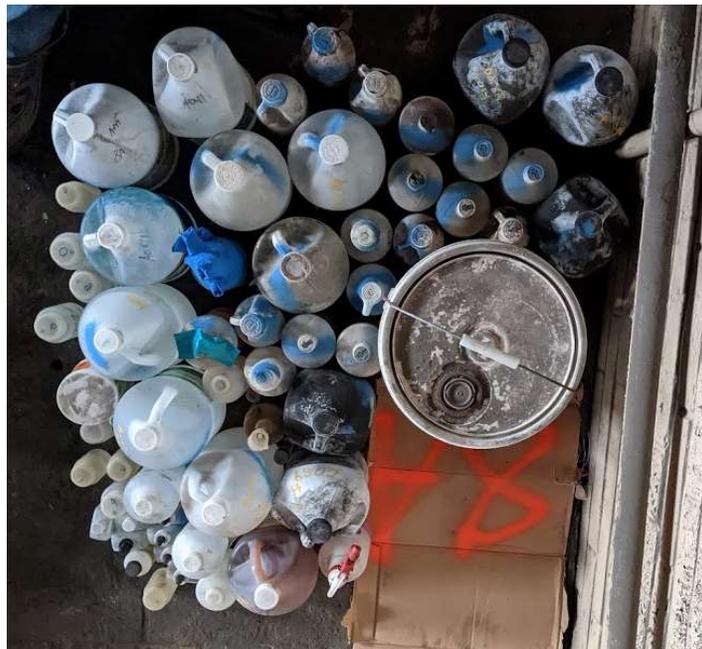
The DOT class 8A: acidic containers were grouped along the north wall. There were a variety of container types and sizes. Some containers lacked caps and were closed with either a latex glove or duct tape. (These containers require cautious handling avoid spills of corrosive materials. This pile was located along the north wall near the north entrance.

*Photo 15 - DOT class 8A containers (acidic)*

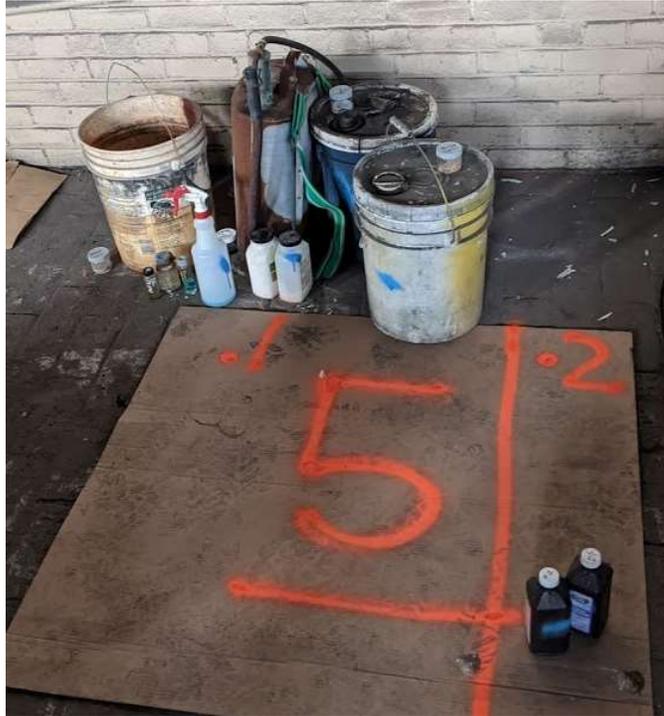
DOT 5.1 and DOT 5.2 chemicals were grouped together along the north wall next to the north entrance. One of the five-gallon buckets in the 5.1 section did not have a lid and requires cautious handling to avoid a potential spill of oxidizing material. The two 5.2 containers were placed on the bottom right of the cardboard on the side labeled as "5.2".

*Photo 16 - DOT class 5.1 and 5.2 oxidizers*

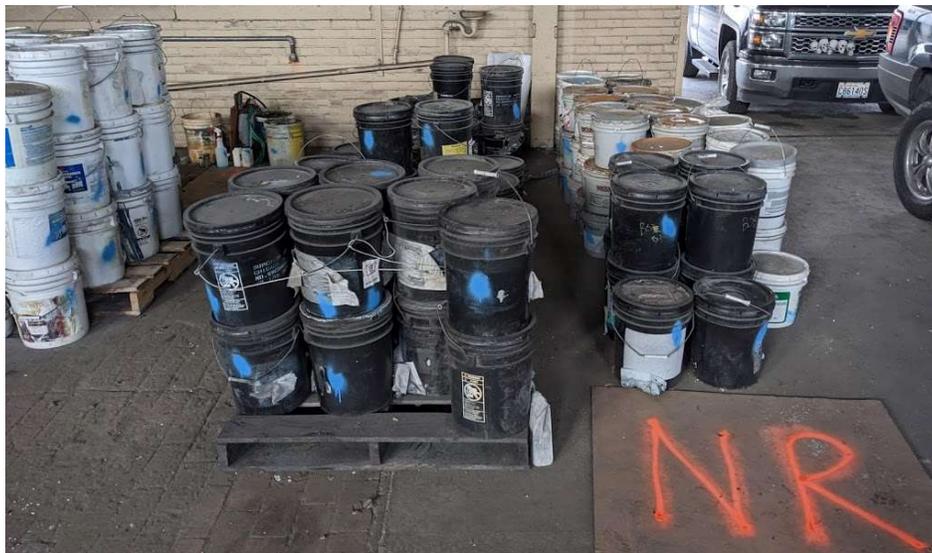
Containers identified as DOT non-regulated material in five-gallon buckets were located inside the north door. These containers hold non-hazardous material and may be left on site if deemed appropriate.

*Photo 17 - DOT non-regulated materials*

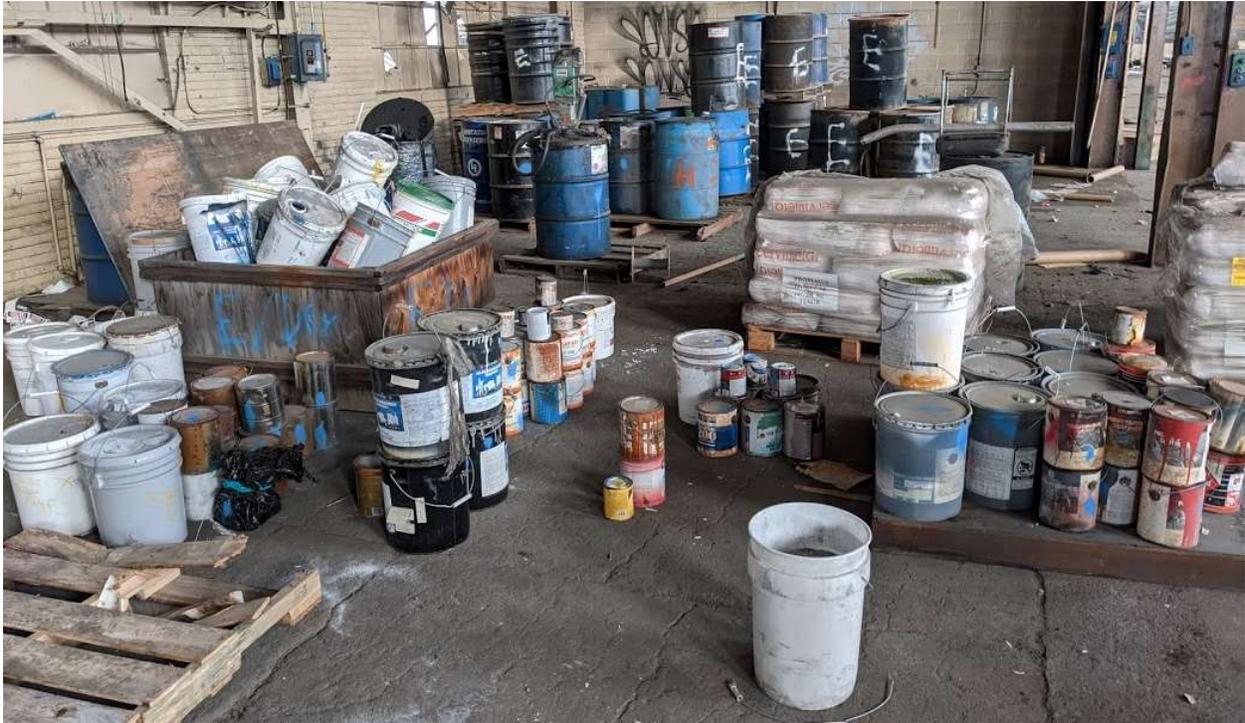
A number of paint and paint related materials can be found in near the north entrance of building 44 and were staged by the following categorizations: polyurethane-based paint, latex paint, oil-based paint, unknown/unlabeled paint cans or buckets, high-solvent mixtures, and epoxies/adhesives. The crate next to these piles contained dry or empty paint cans and buckets that may be crushed and disposed of as solid waste.

*Photo 18 - Miscellaneous paint containers*

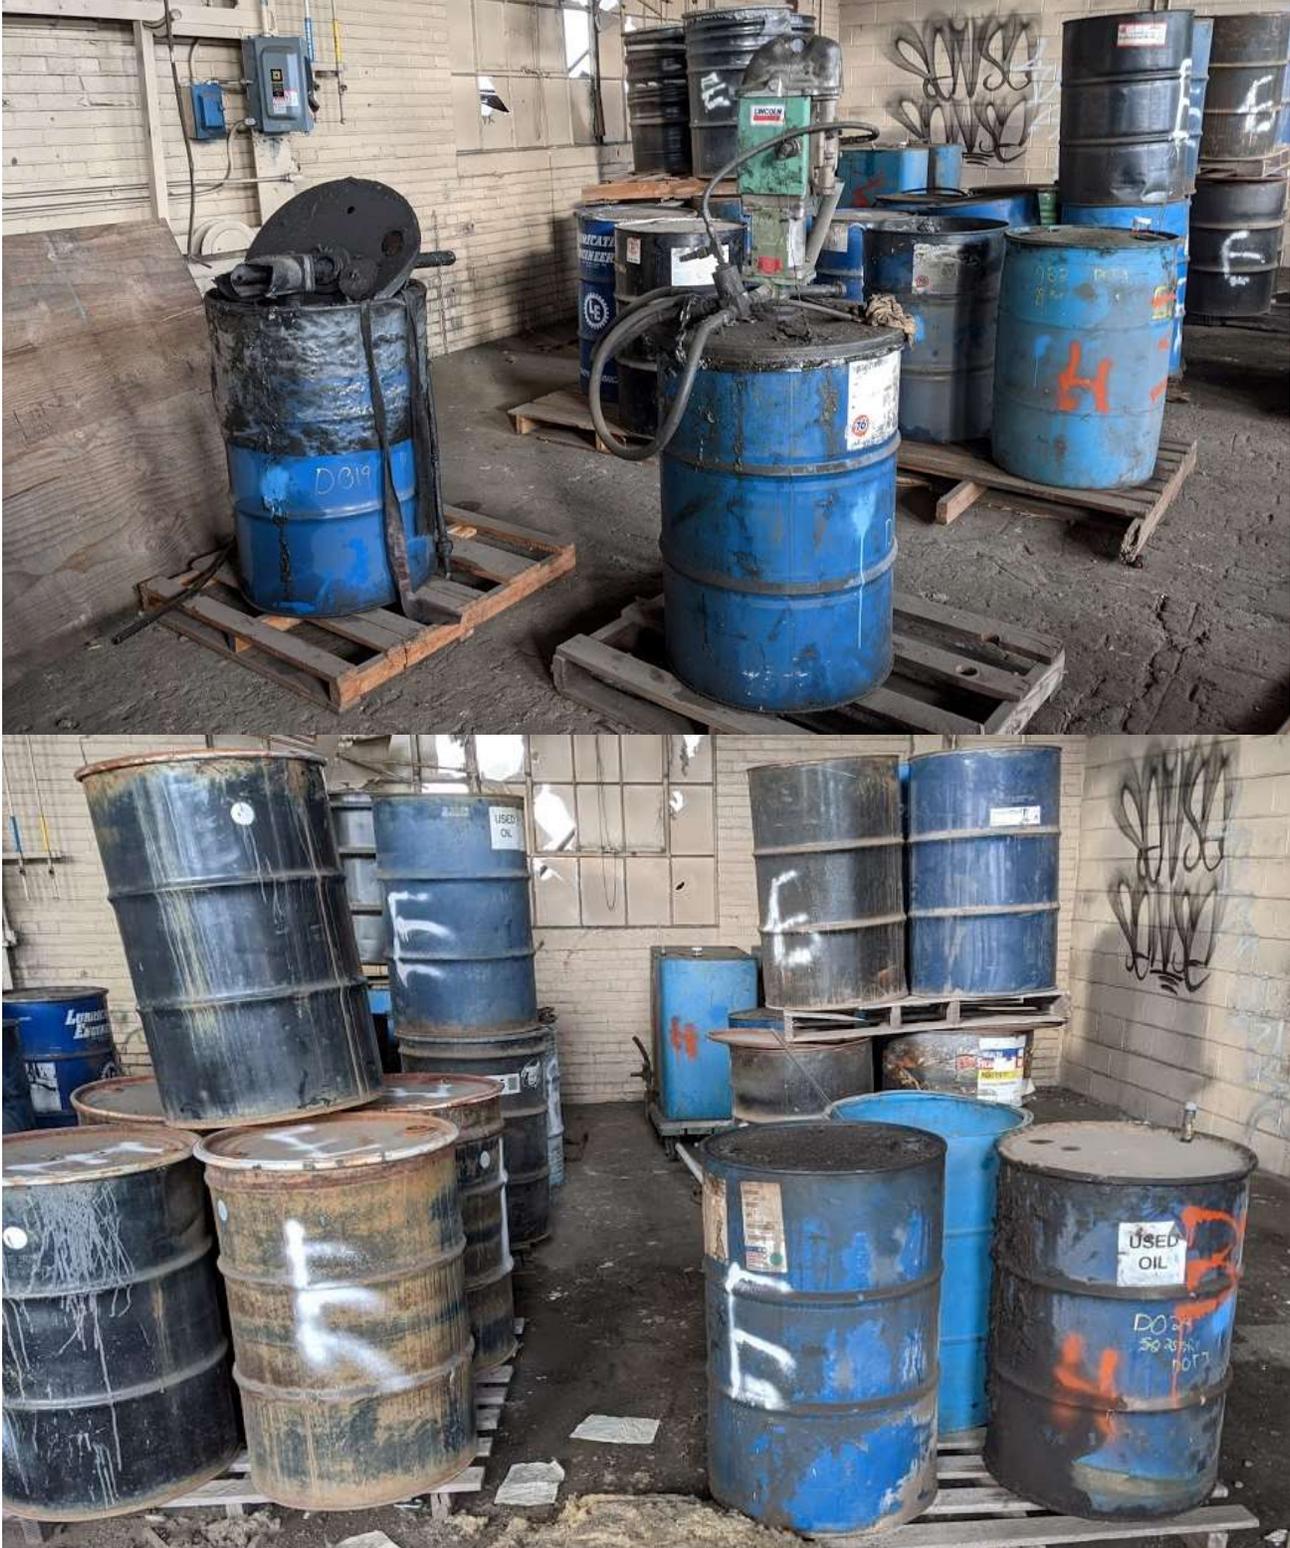
Several 55-gallon drums were located east of the north entrance. Most were empty and were indicated as empty with an "E" marked on the drum's side. Drum D020 was determined by START by the label and appearance as DOT Class 3 material. Drums D018, D019, D021 and D022 were determined by START by visual observation and SDS research as DOT non-regulated material. Drums D023, D024, and D025 shown with an orange "H" were also categorized as DOT class 3 as determined by First Step Hazard Categorization.

Photo 19 - Miscellaneous drums

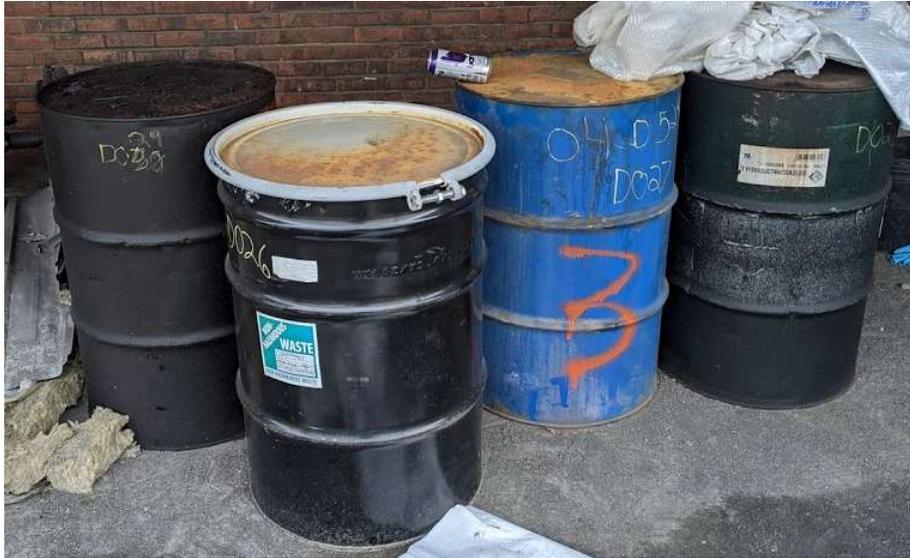
Outside the north entrance of building 44 were four 55-gallon drums. Drum D027 was determined by First Step Hazard Categorization as DOT Class 3 material, and drums D026 and D028 was categorized by visual observation as DOT non-regulated material (soil cuttings). Drum D029 was categorized by visual observation as green coke.

*Photo 20 - One DOT 3 drum, two with green coke, and one with soil cuttings.*

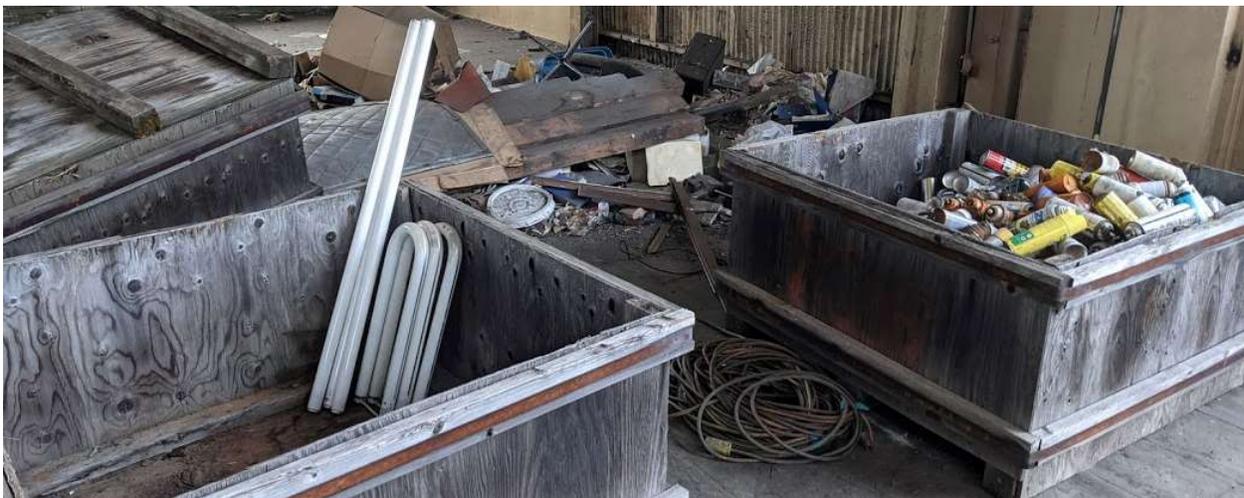
The two crates were in the southwest portion of Building 44 near the west entrance. One crate contained fluorescent light bulbs and the other crate contained about 500 aerosol canisters. The aerosol canisters range from empty to full

*Photo 21 - Crates containing fluorescent light bulbs and miscellaneous aerosol canisters.*

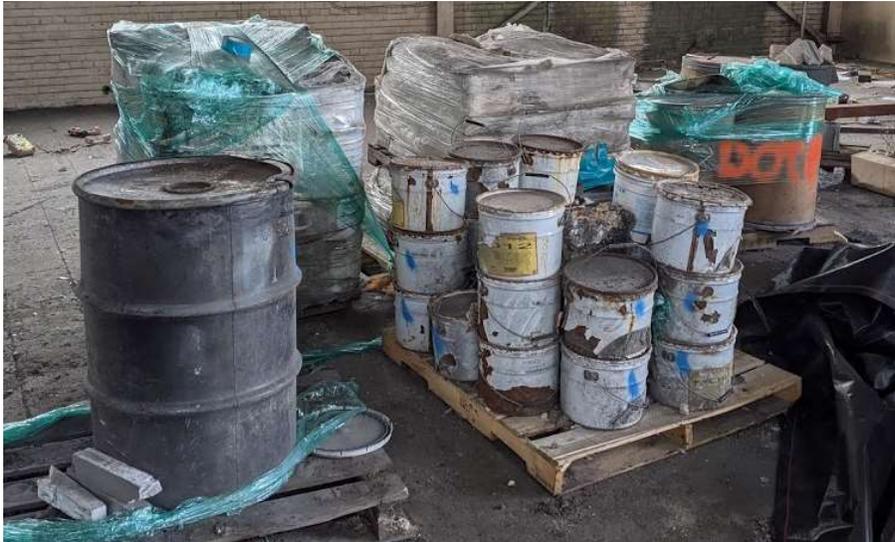
Drum D015 was determined by visual observation to be green coke material and can be disposed with other site waste streams. The pallets of 2-gallon buckets beside and are non-regulated mortar material determined by visual observation and may be left on site. The pallet with the orange spray paint labeled "DOT 9" is class 9 material determined by First Step Hazard Categorization.

*Photo 22 - Miscellaneous mortar materials, green coke, and DOT 9 containers*

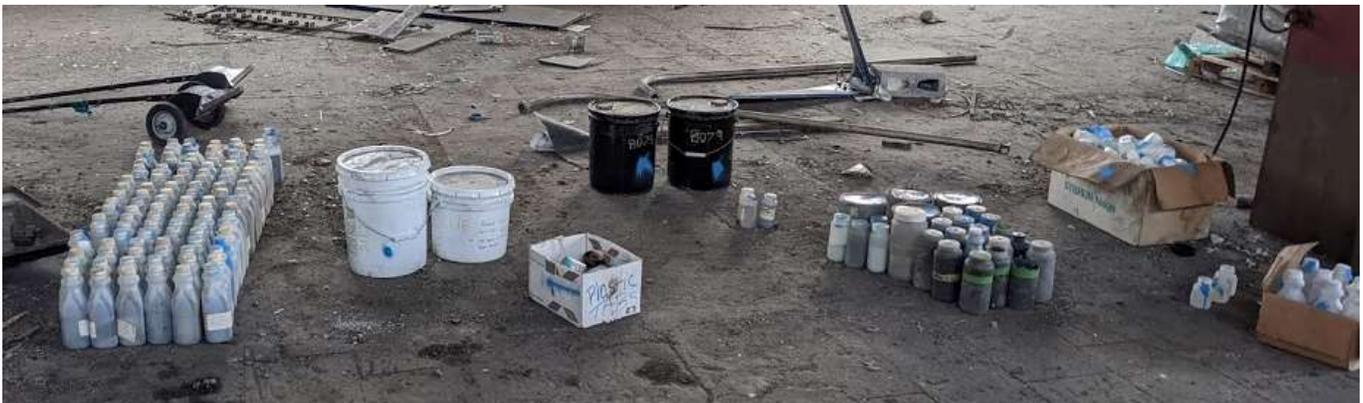
The containers located in the southwest portion of building 44 east of the pallets contained small quantities of process samples collected from materials found elsewhere on site. These containers may be disposed in other site waste streams.

*Photo 23 - Lab process samples*
