Airborne Spectral Photometric Environmental Collection Technology

ASPECT Texas Air Quality Survey Corpus Christi and Houston, TX 9 March 2021

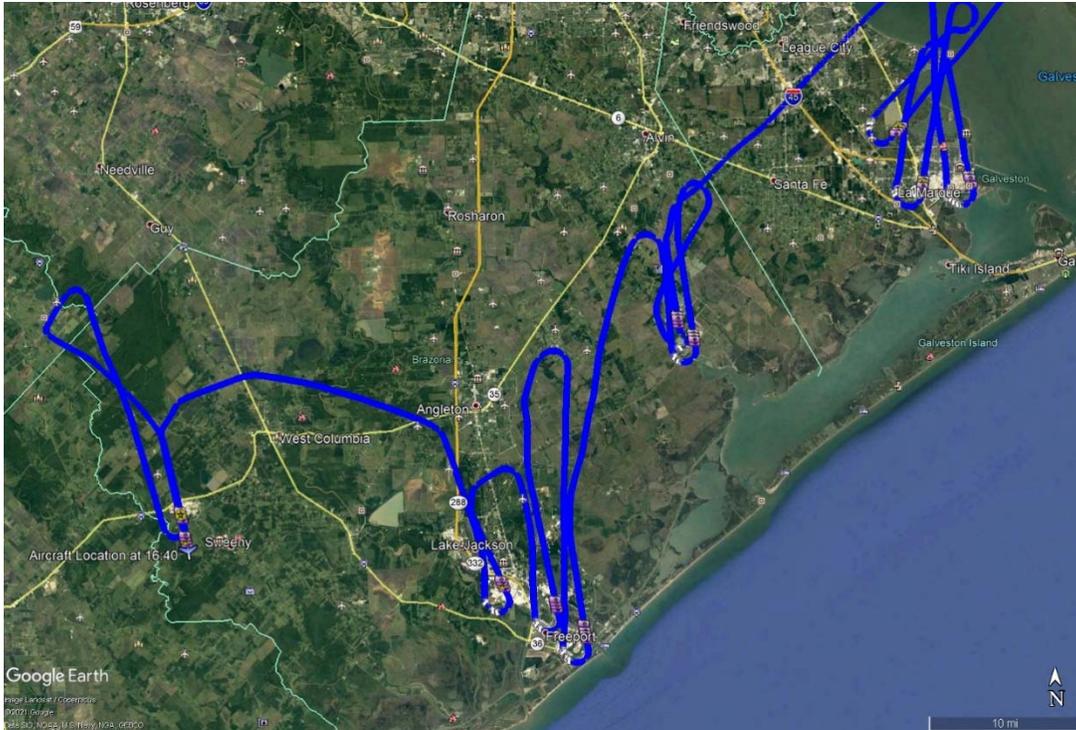
Figure 5. Data Collection Flight Path over the Houston/Freeport Areas, Flight 18, 9 March 2021

Wide, slow turns are required to be made in between runs to keep the instruments stable. The blue lines indicate the flight path while the green lines indicate the specific sections of the flight where chemical data was collected and processed. Areas surveyed on Flight 18 included facilities near Houston and Freeport, TX (Figure 5). On the afternoon of 9 March 2021 ASPECT conducted a mission over the Corpus Christi and extended areas (Figure 6).

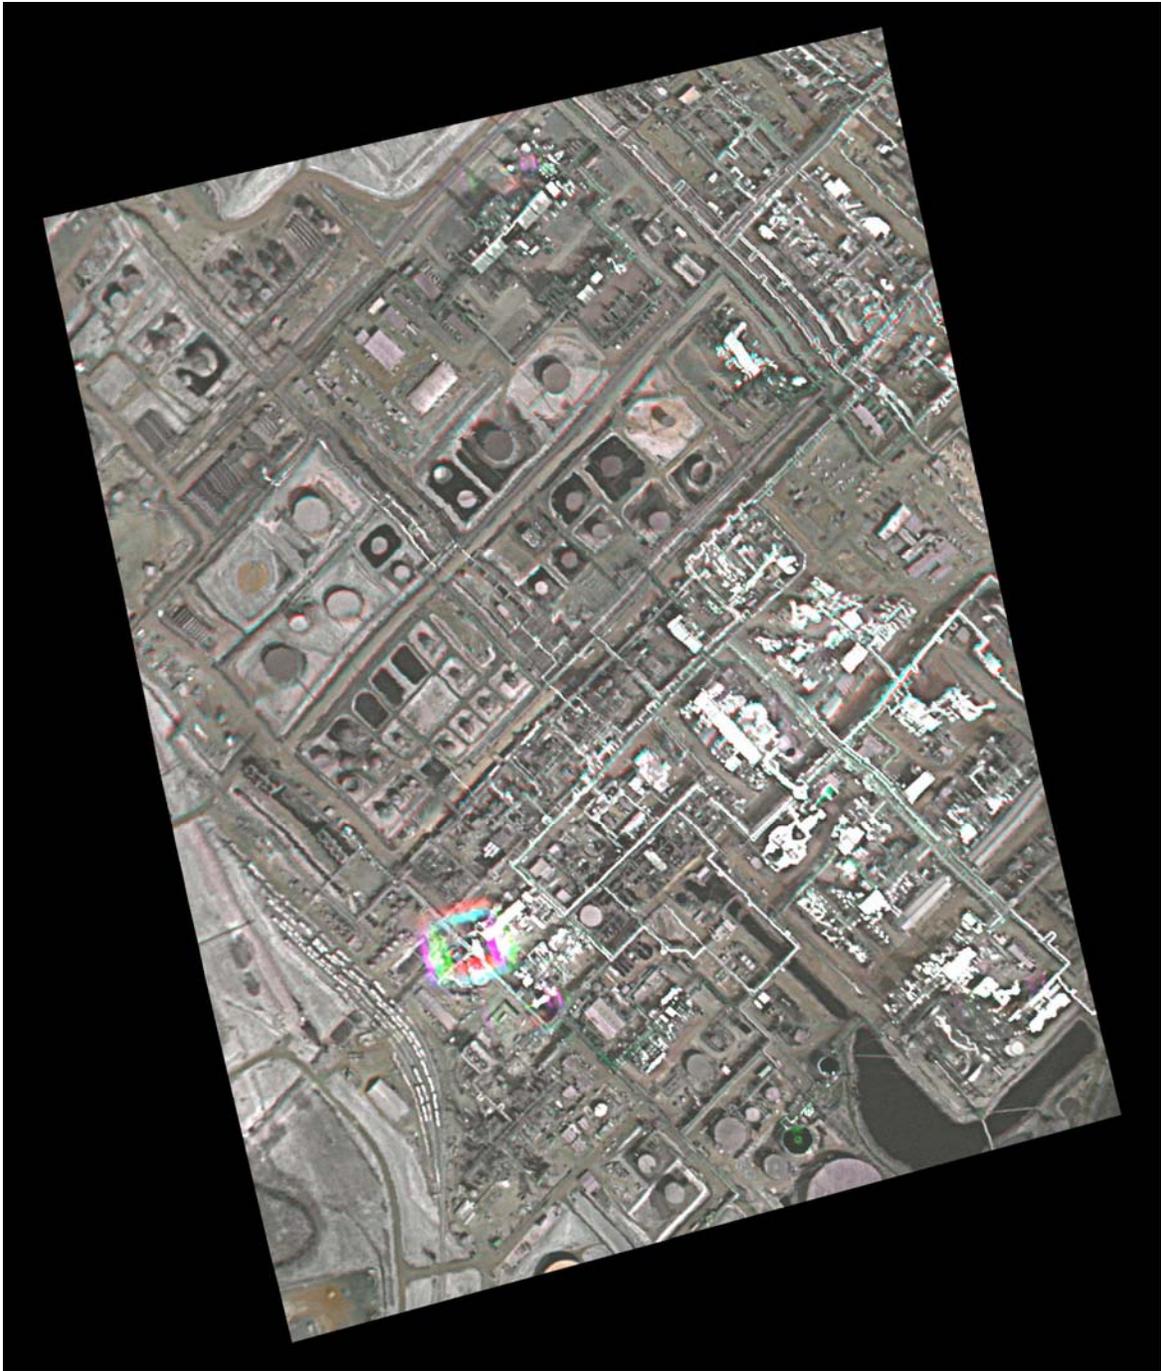
Figure 7. Three band IR image, Freeport Area, Run 10, Flight 18, 9 March 2021

A total of 10 data collection runs were made over the Houston/Freeport area and during each collection run an infrared line scanner image was generated. Figure 7 shows a 3-band infrared image collected over the Freeport area. A large area of elevated temperature is evident in the lower left portion of the image, most likely a flare. Other signatures include hot process units and piping. No chemical plumes can be observed being emitted from the facility.

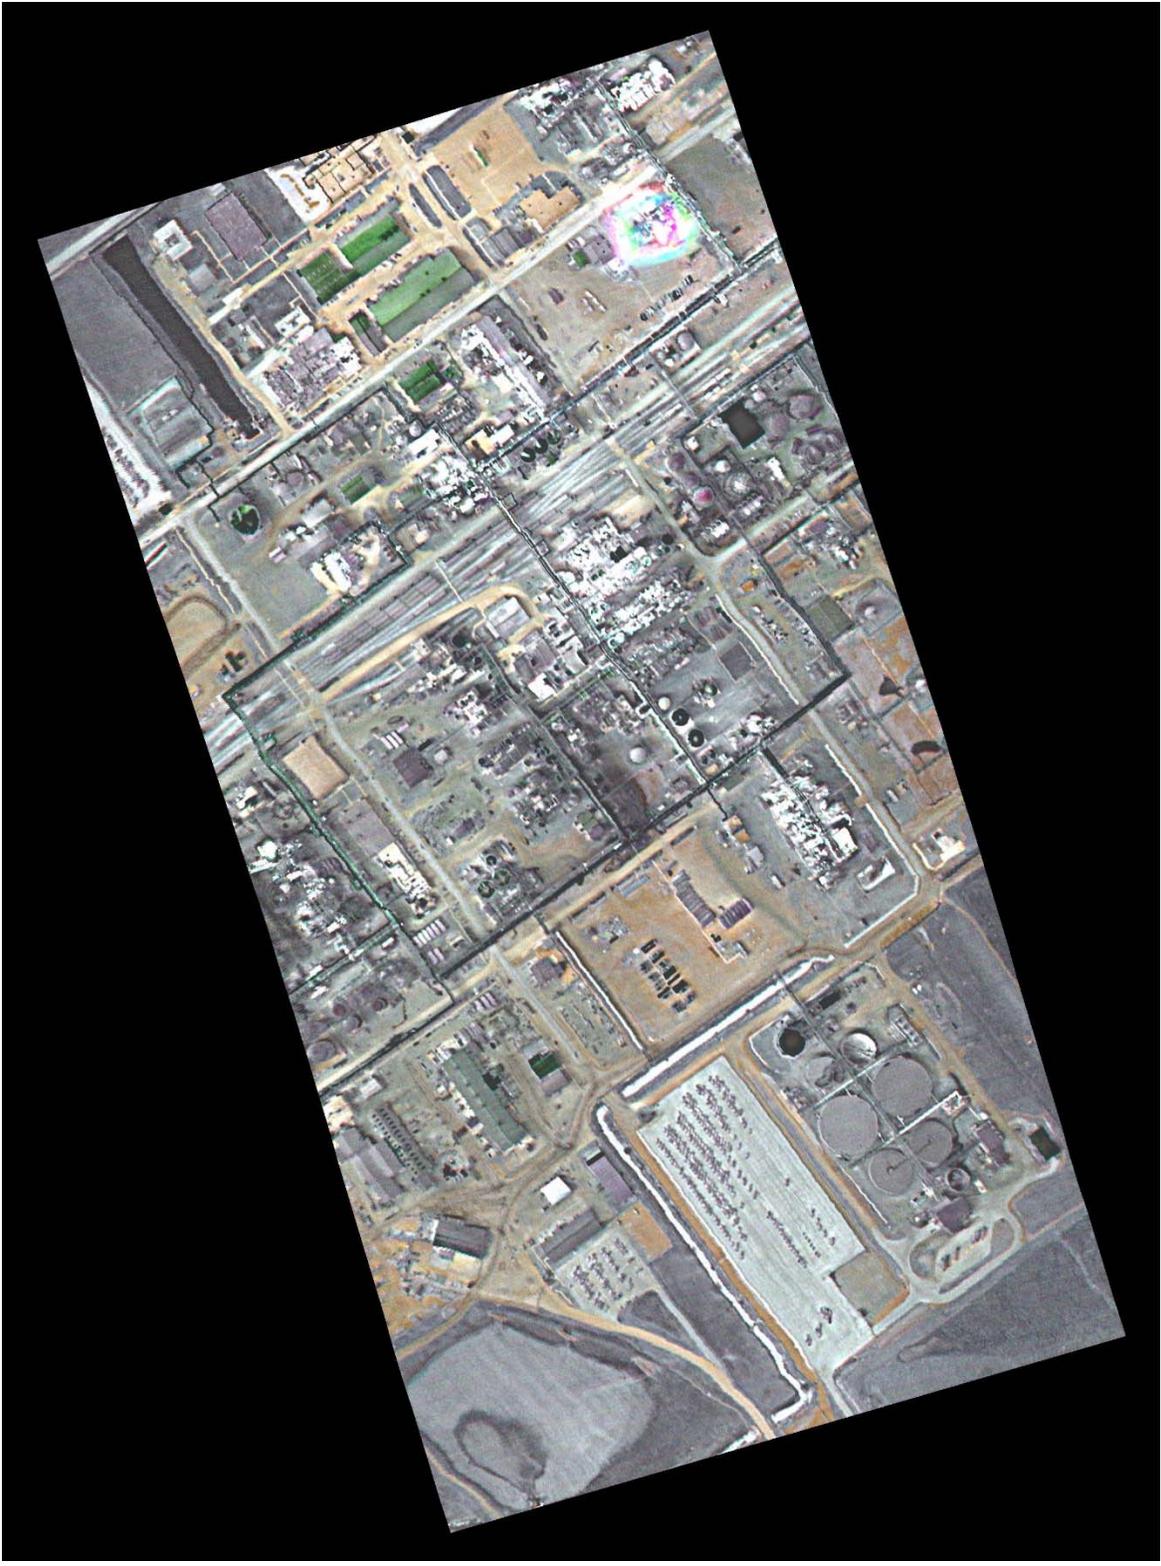
Figure 8. Three band IR image, Victoria Area, Run 8, Flight 19, 9 March 2021

As part of the second flight on 9 March 2021, ASPECT collected 10 IR images over selected sites with a representative image over the Victoria, TX area given in Figure 8. This facility appears to be active as evident by hot piping and process units and a hot flare. No chemical plumes can be seen being emitted from the facility. Other images in the areas showed similar results.

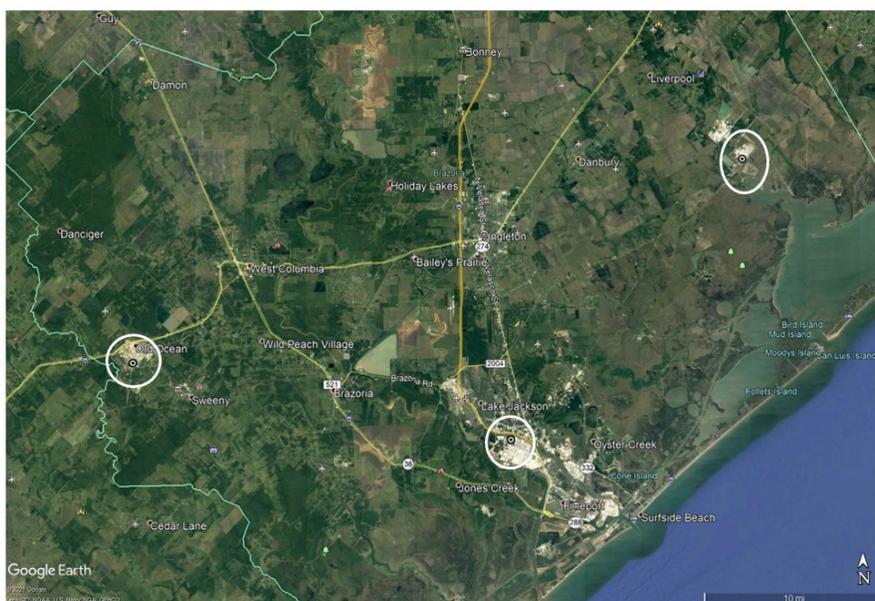
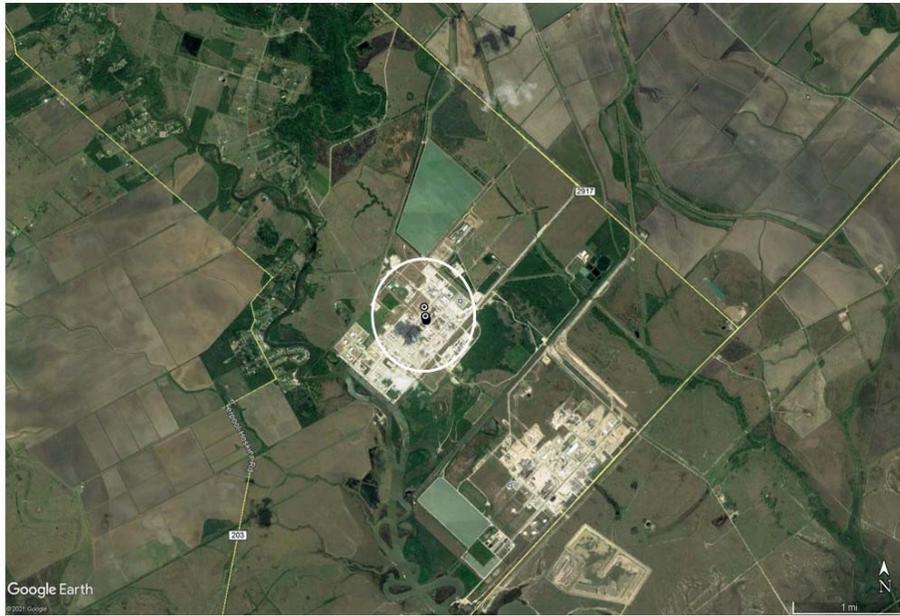
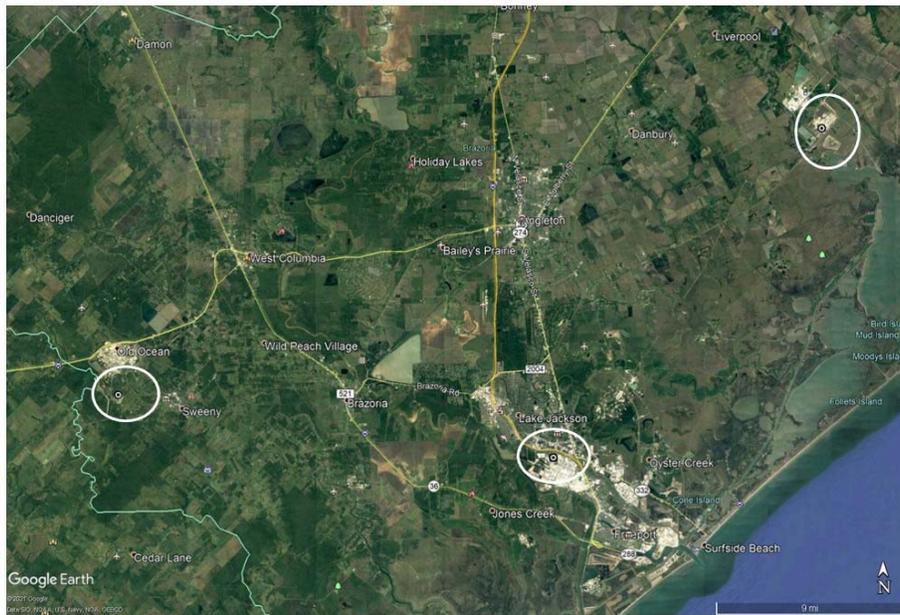
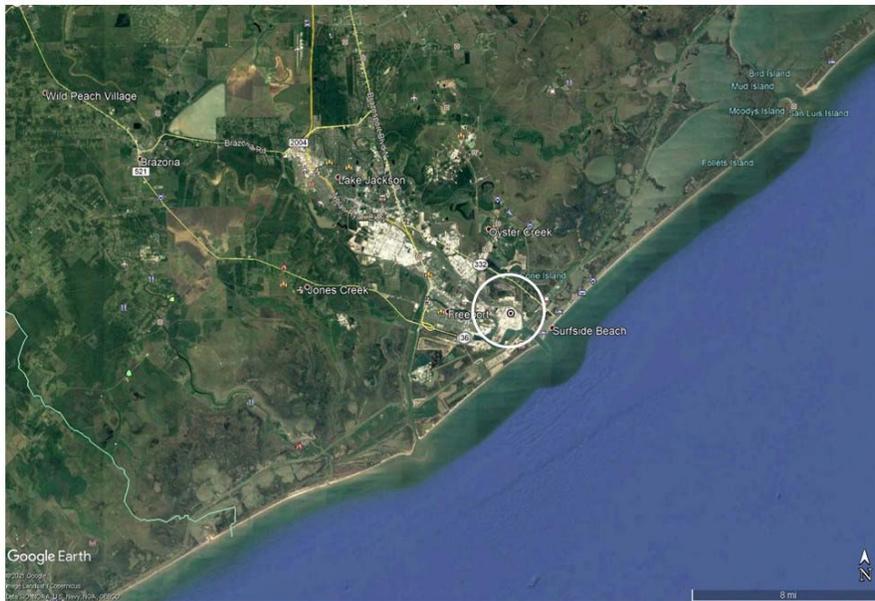
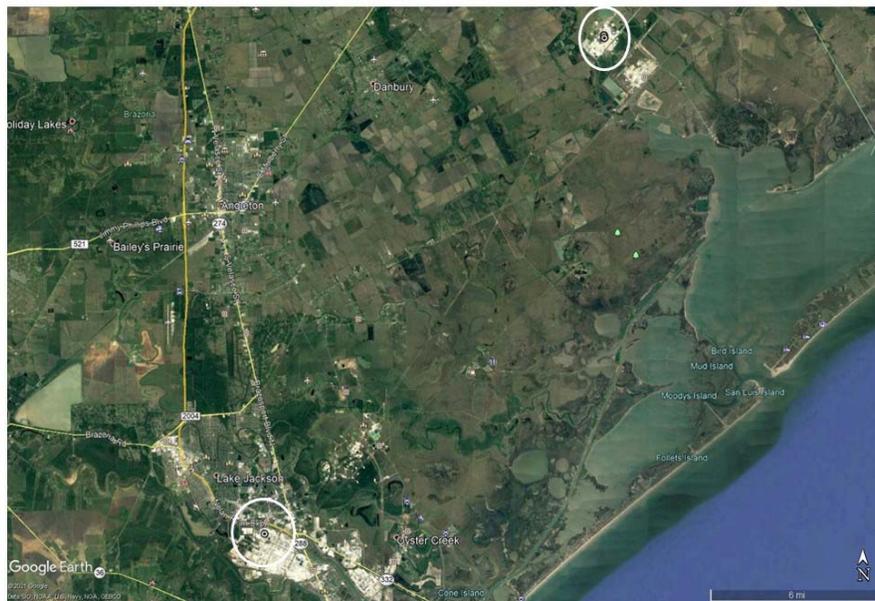
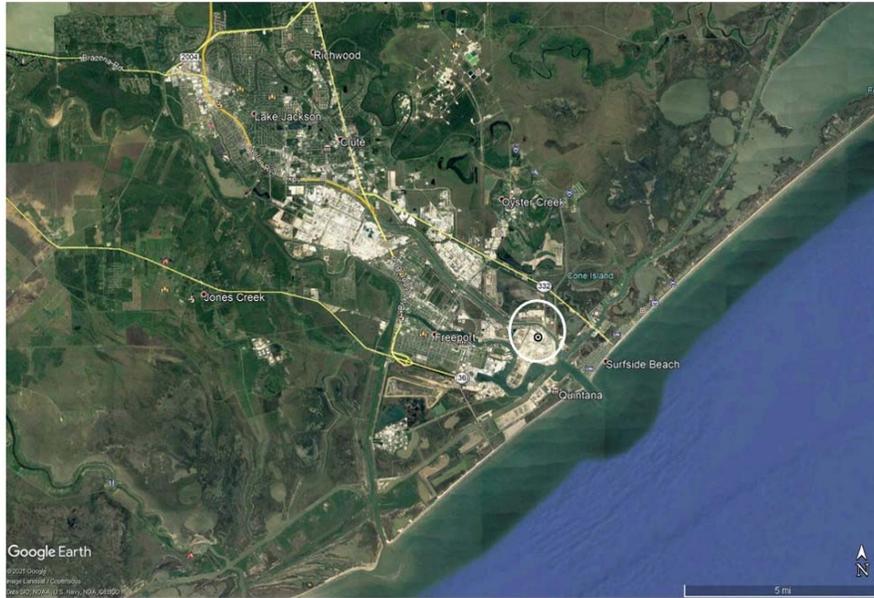
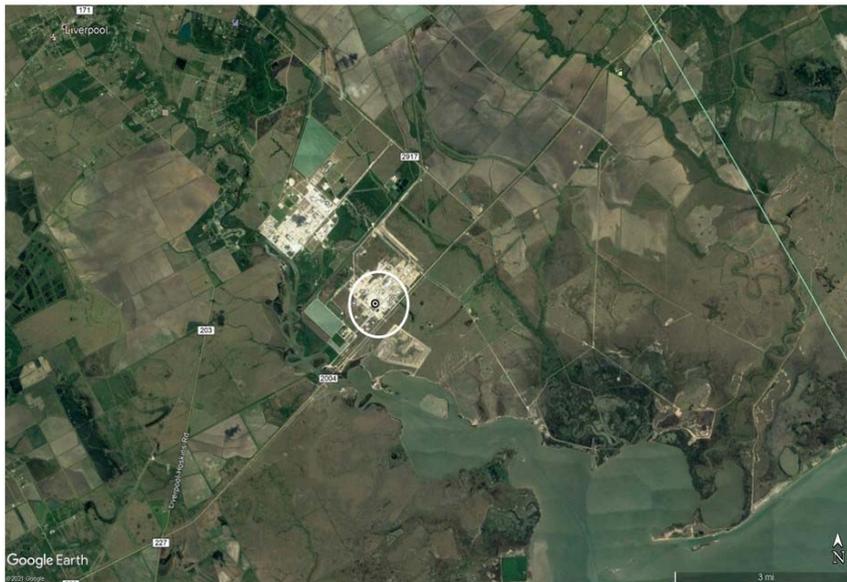
Compounds detected on the mission over the Houston and Freeport areas included acetone (0.655 ppm), ammonia (10.19 ppm), 1-butene (1.250 ppm), 2-butene (1.921 ppm), 1,3-butadiene (0.514 ppm), isobutylene (1.788 ppm) and isoprene (0.682 ppm). The locations of these detections are given in Figures 9A through 9G. A representative spectrum of ammonia is given in Figure 10. Details of these detections can be found in Table 4.

Figure 9A. Acetone Detection Location, Houston/Freeport Areas, TX, Flight 18, 9 March 2021

Figure 9B. Ammonia Detection Locations, Houston/Freeport Areas, TX, Flight 18, 9 March 2021

Figure 9C. 1-Butene Detection Locations, Houston Freeport Areas, Flight 18, 9 March 2021

Figure 9D. 2-Butene Detection Location, Houston Freeport Areas, Flight 18, 9 March 2021

Figure 9E. 1,3-Butadiene Detection Location, Houston Freeport Areas, Flight 18, 9 March 2021

Figure 9F. Isobutylene Detection Location, Houston Freeport Areas, Flight 18, 9 March 2021

Figure 9G. Isoprene Detection Locations, Houston/Freeport Areas, Flight 18, 9 March 2021

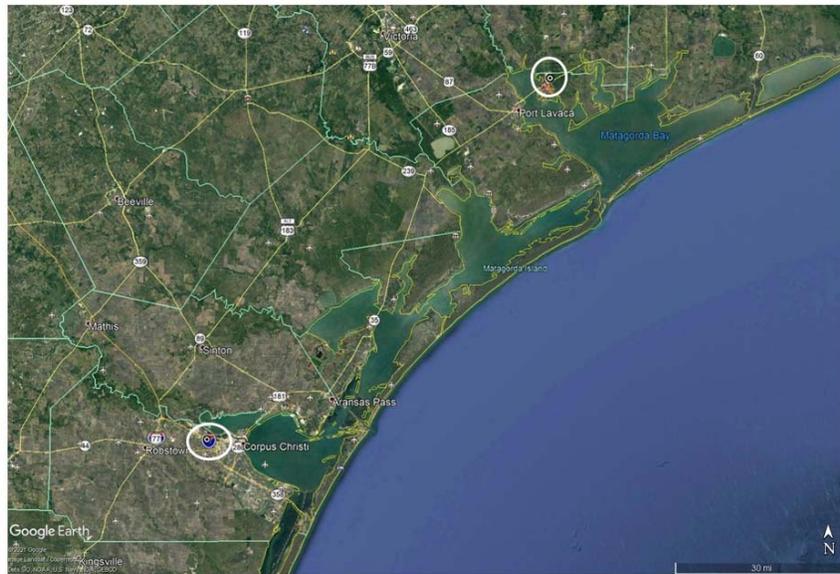
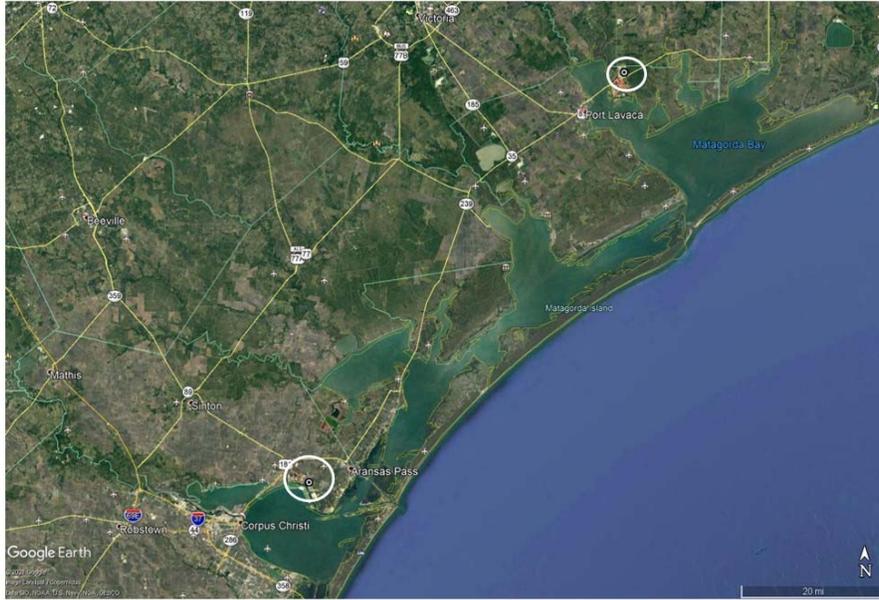
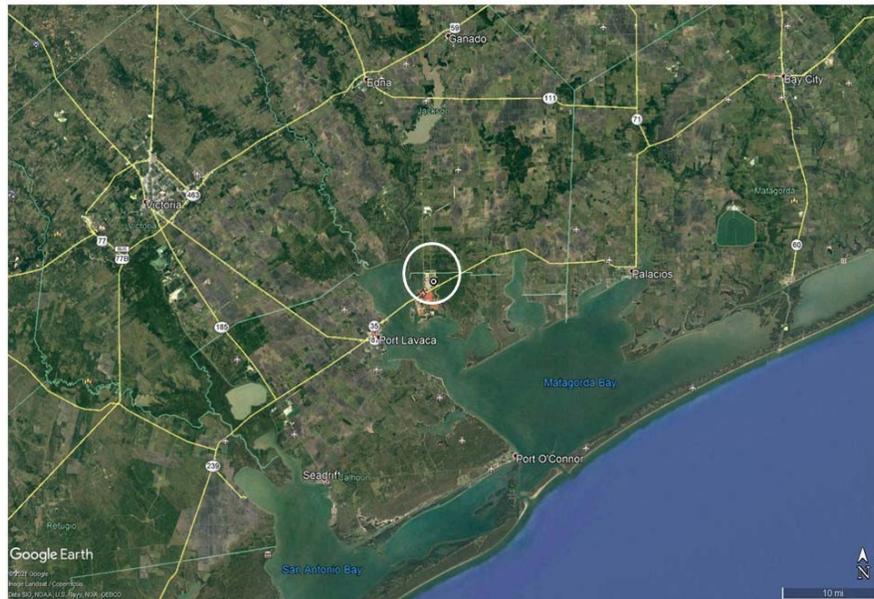
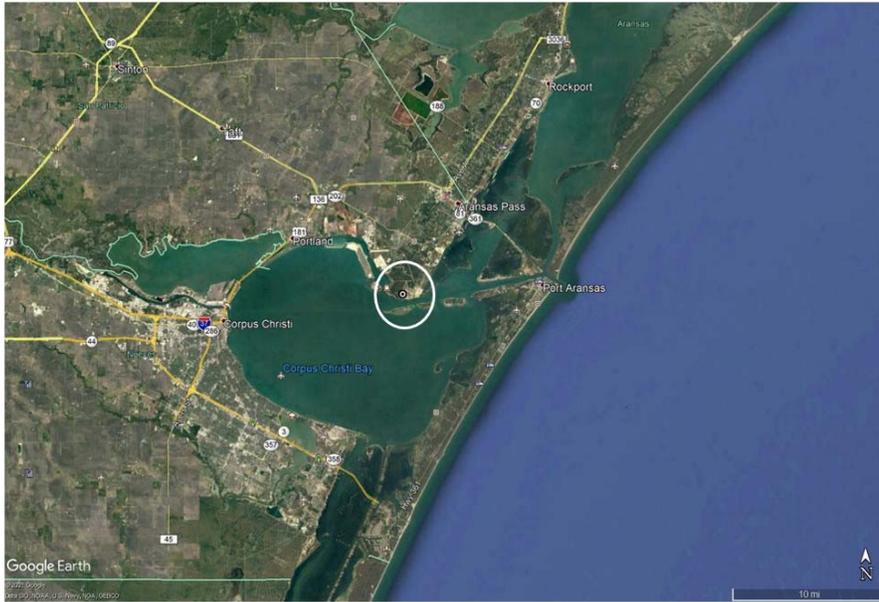
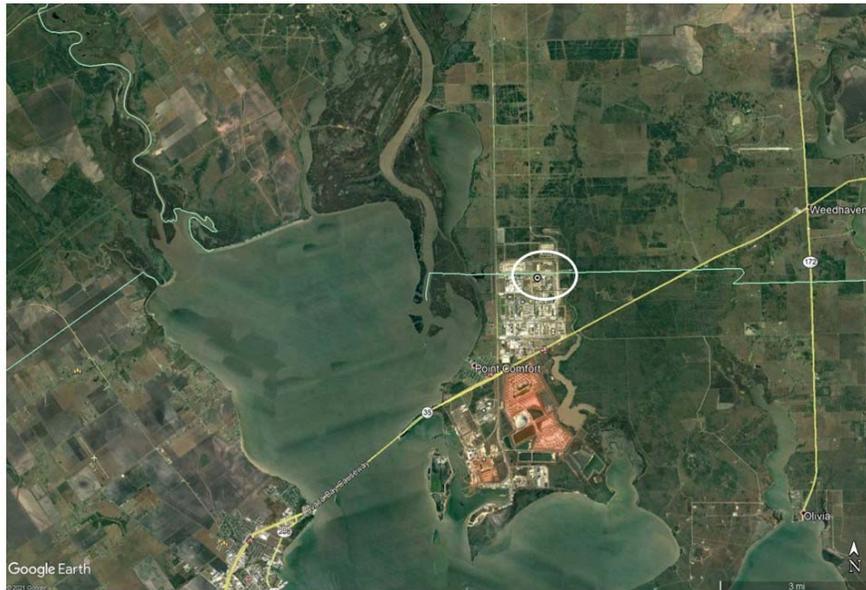
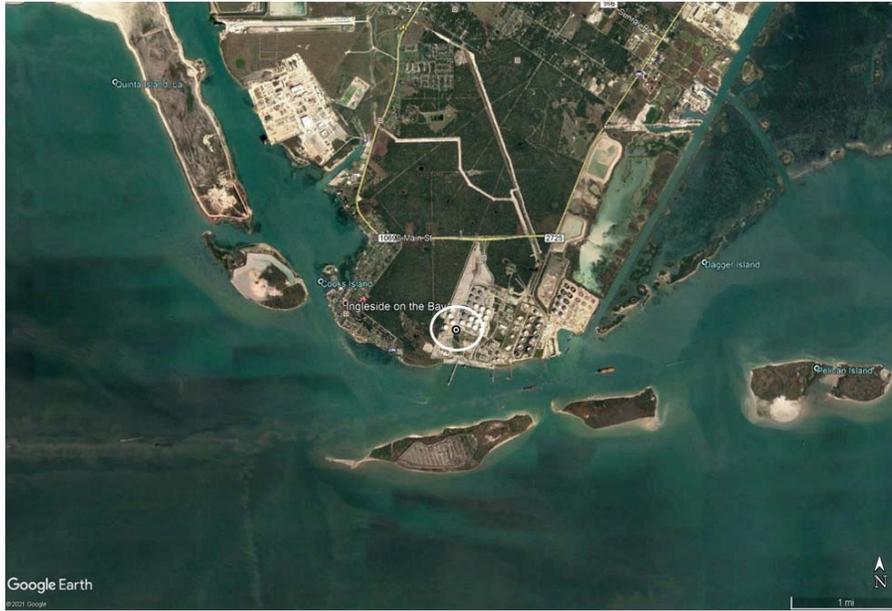
The air monitoring mission conducted over the Corpus Christi and extended areas resulted in compounds including acetone (0.611 ppm), 1-butene (2.352 ppm), 2-butene (2.242 ppm), isobutylene (1.531 ppm), isoprene (1.016 ppm) and n-butyl alcohol (1.327 ppm). Details of these detections are found in Table 5. The locations of the Flight 19 detections are shown in Figures 11A through 11F.

Figure 11A. Acetone Detection Locations, Corpus Christi and Extended Areas, TX area, Flight 19, 9 March 2021

Figure 11B. 1-Butene Detection Locations, Corpus Christi and Extended Areas, TX area, Flight 19, 9 March 2021

Figure 11C. 2-Butene Detection Location, Corpus Christi and Extended Areas, TX area, Flight 19, 9 March 2021

Figure 11D. Isobutylene Detection Location, Corpus Christi and Extended Areas, TX area, Flight 19, 9 March 2021

Figure 11E. Isoprene Detection Location, Corpus Christi and Extended Areas, TX area, Flight 19, 9 March 2021

Figure 11F. n-Butyl Alcohol Detection Location, Corpus Christi and Extended Areas, TX area, Flight 19, 9 March 2021

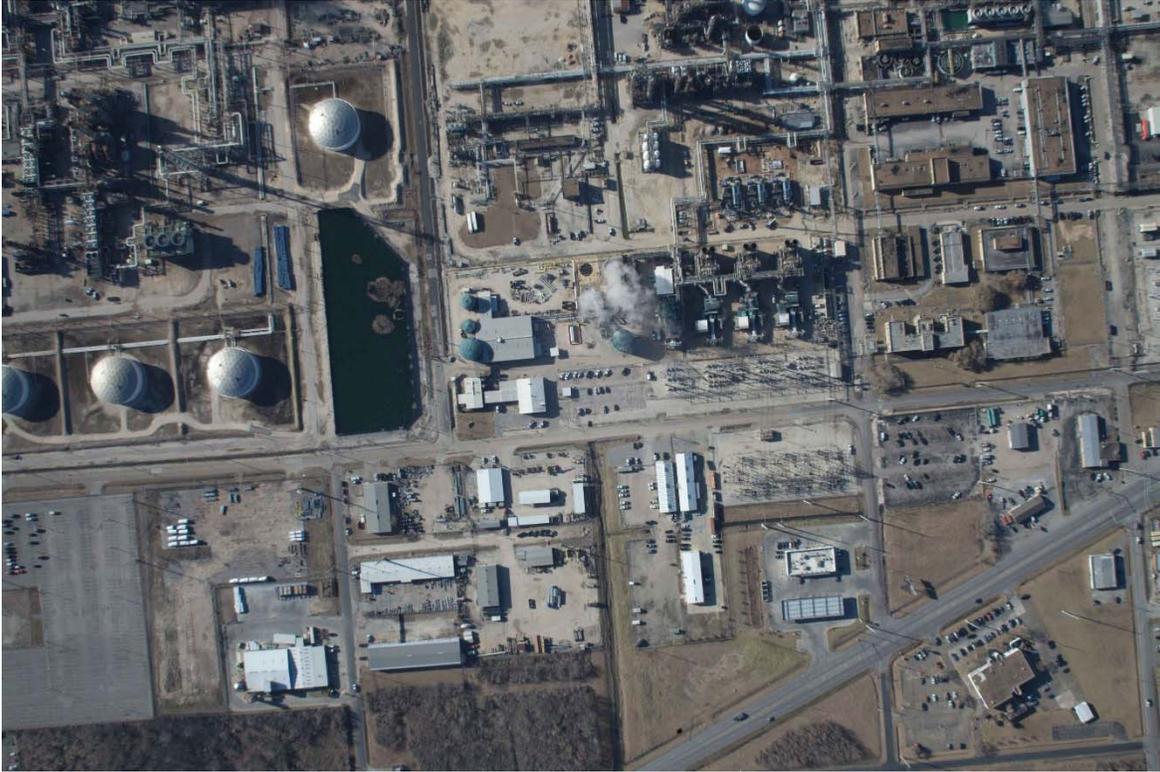
Figure 12. MSIC Aerial Image, Freeport Area, Flight 18

A full set of high-resolution aerial digital photography were collected as part of each data collection pass. Weather conditions over the Houston/Freeport areas allowed high quality aerial images to be collected. Figure 12 shows a representative frame of a facility collected in the Freeport area. Inspection of the frame shows steam emissions suggesting operation of the facility. Figure 13 shows an oblique image collected during the morning flight showing what appears to be normal plant operations.
