# Airborne Spectral Photometric Environmental Collection Technology

## ASPECT Texas Air Quality Survey Beaumont and Houston, TX 10 March 2021

# **ASPECT Texas Air Quality Survey**

### **10 March 2021**

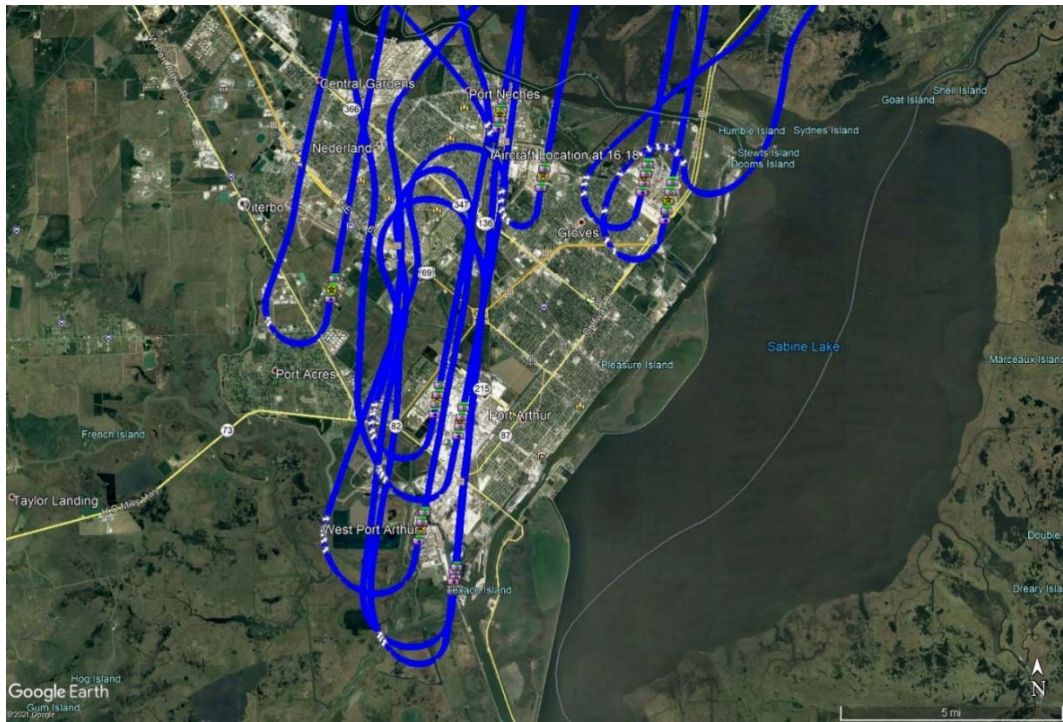
Figure 5. Data Collection Flight Path over the Beaumont/Port Arthur, Flight 20, 10 March 2021

Wide, slow turns are required to be made in between runs to keep the instruments stable. The blue lines indicate the flight path while the green lines indicate the specific sections of the flight where chemical data was collected and processed. On Flight 20 the Beaumont/Port Arthur was surveyed, and the flight path is shown in Figure 5. On the afternoon of 10 March 2021 ASPECT conducted a mission, Flight 21, over the Houston area which is shown in Figure 6.

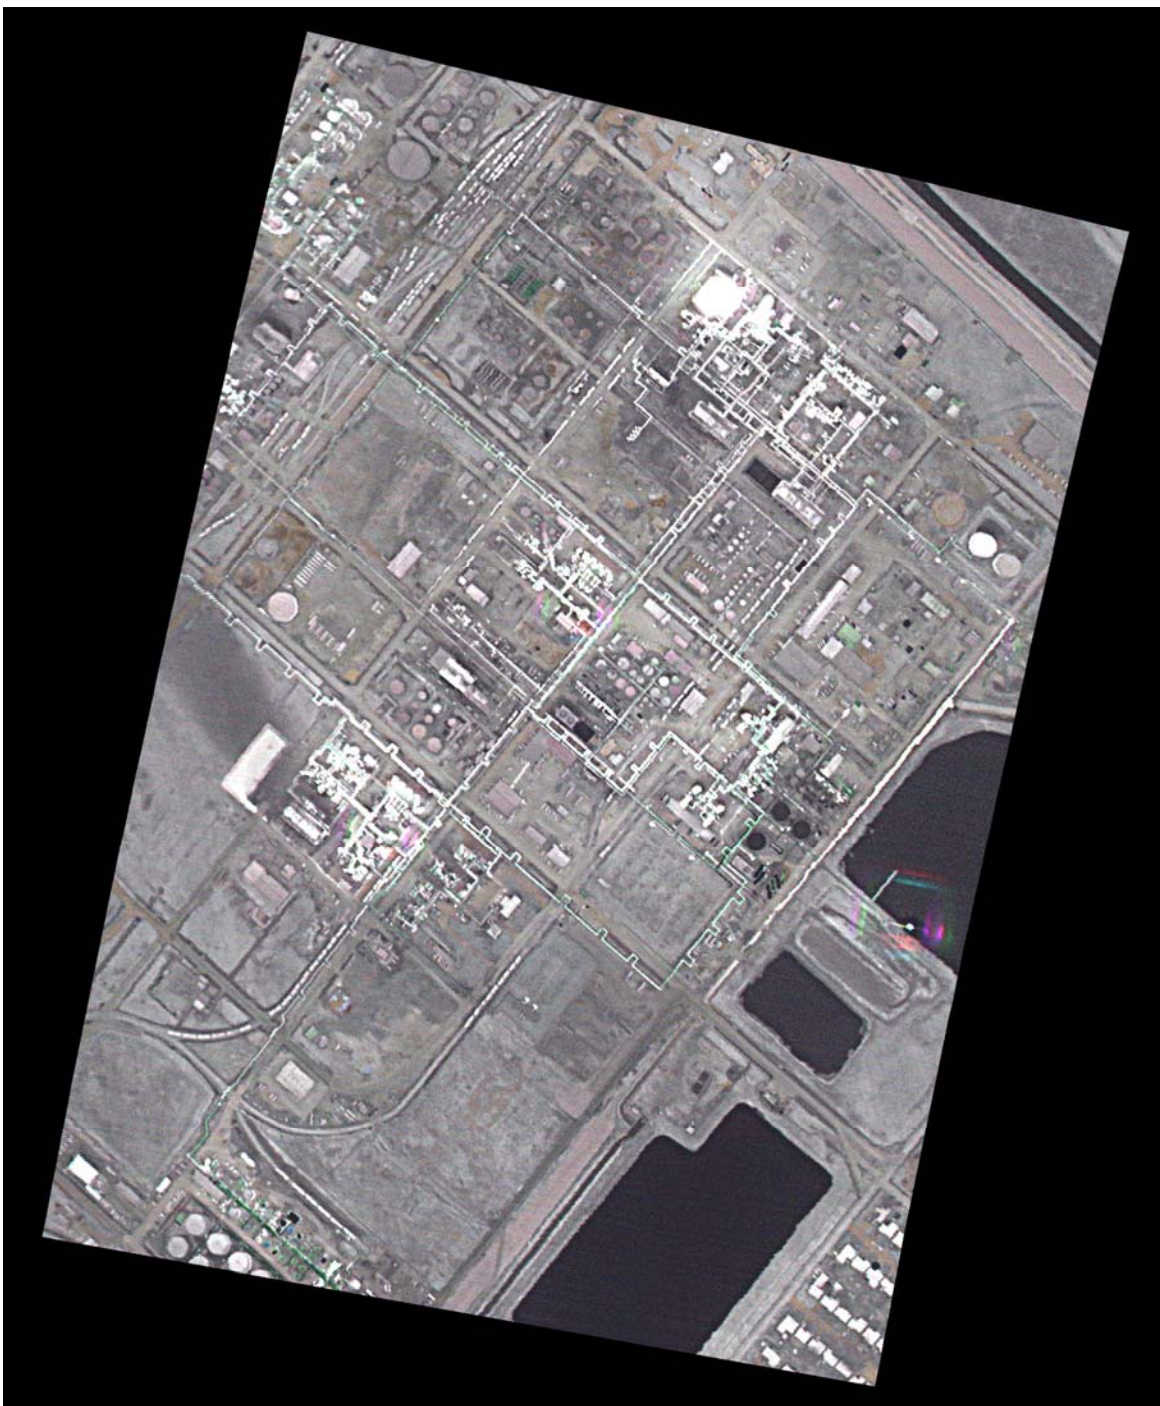
Figure 7. Three band IR image, Port Arthur Area, Run 12, Flight 20, 10 March 2021

A total of 13 data collection runs were made over the Beaumont/Port Arthur areas and during each collection run an infrared line scanner image was generated. Figure 7 shows a 3-band infrared image collected over the Port Arthur area. Examination of the image shows a small flare on the right middle portion of the frame and hot process units and piping throughout the facility. No chemical plumes can be observed being emitted from the facility.

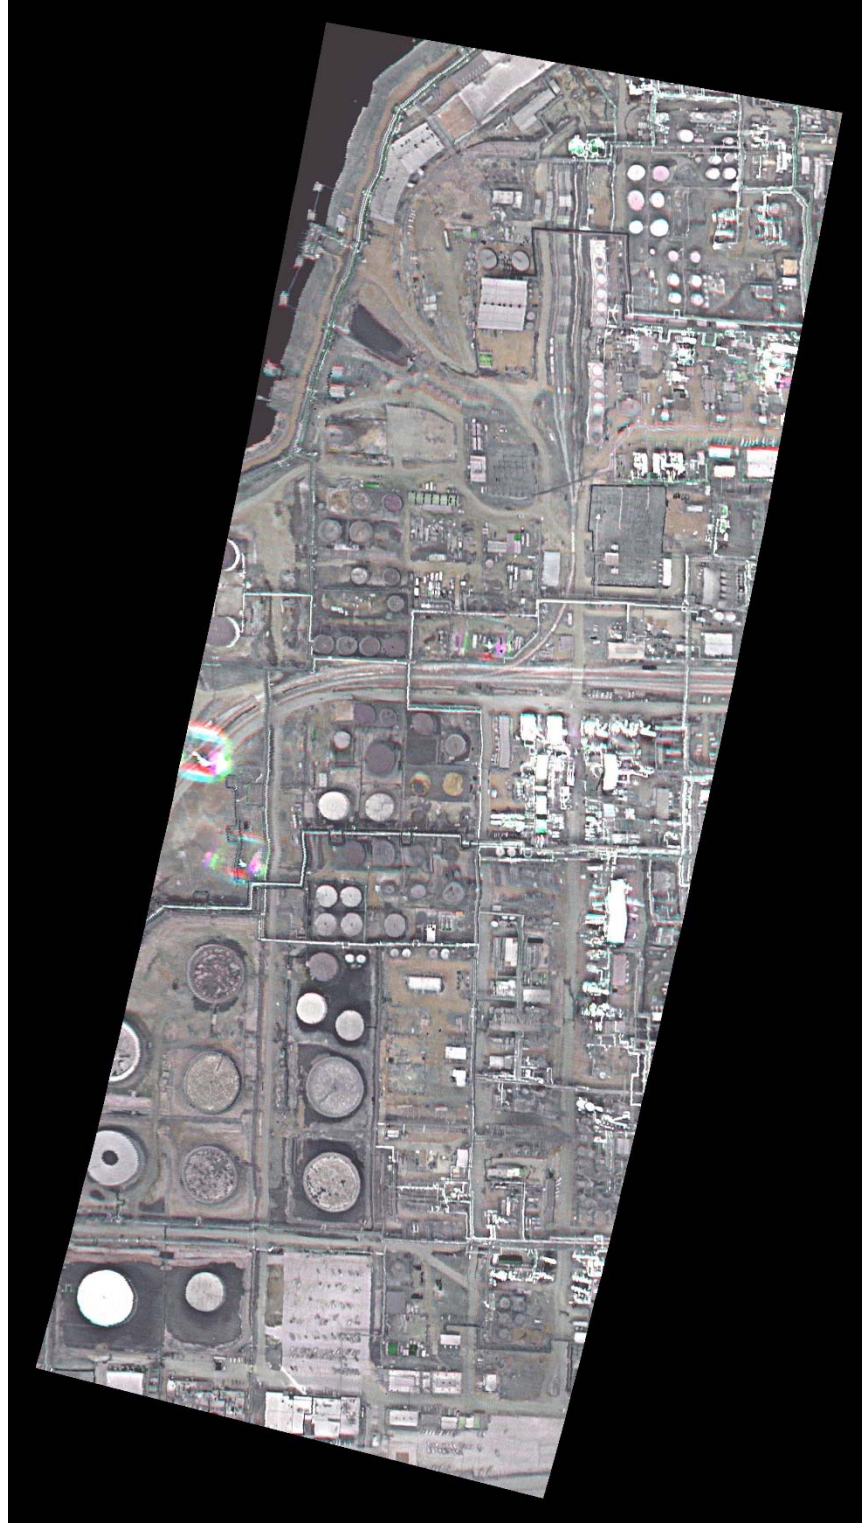
Figure 8. Three band IR image, Houston Area, Run 5, Flight 21, 10 March 2021

During the afternoon mission on 10 March 2021, ASPECT collected 10 IR images over selected sites within the Houston area. Due to a low ceiling, the imagery is distorted in the direction of flight. An image collected on pass 5 is given in Figure 8. Features of this image include one large and two small flares and many elevated thermal signatures of piping and process units. No chemical plumes can be seen being emitted from the facility.

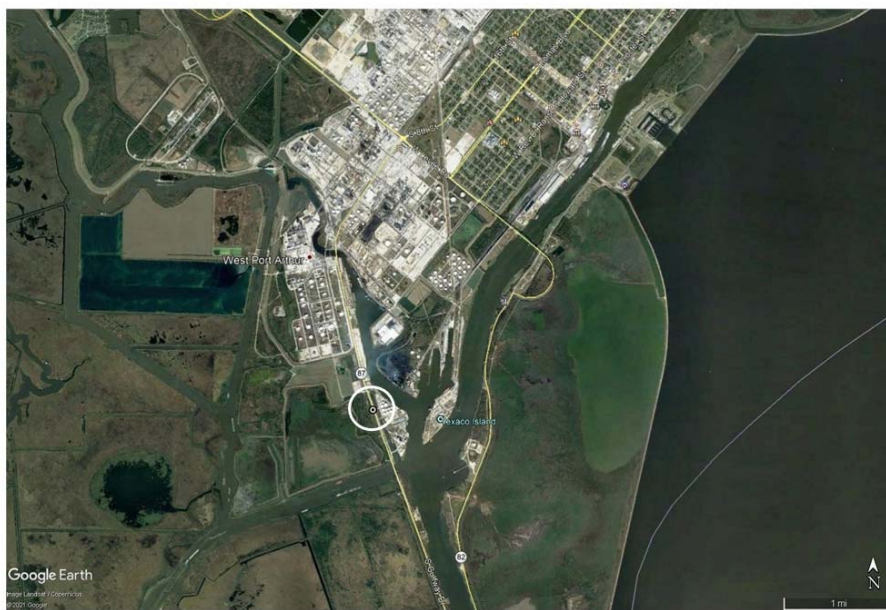
Figure 9. 1-Butene Detection Location, Beaumont/Port Arthur Areas, TX, Flight 20, 10 March 2021

Only one compound was detected on the mission over the Beaumont/Port Arthur areas and consisted of 1-butene (1.238 ppm). The location for this detection is given in Figure 9. A representative spectrum of 1-butene is given in Figure 10. Details of these detections can be found in Table 4.

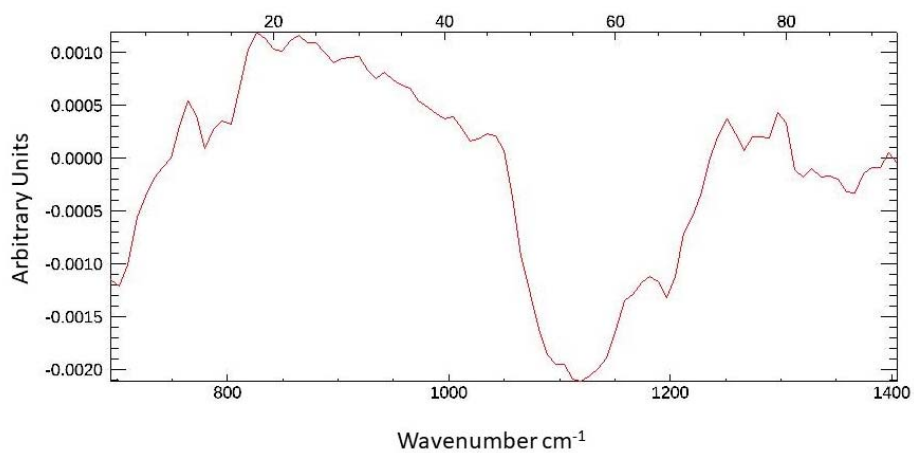
Figure 11. PAN Spectrum, Houston Area, Flight 21,  
10 March 2021

ASTECT did not detect any programmed compounds (those found in Appendix B, Table 1) but the sensor did detect common air pollutants. Figure 11 shows peroxyacetyl nitrate (PAN) with the large feature centered at approximately  $1120\text{ cm}^{-1}$ . Details of the monitoring results can be found in Table 5.

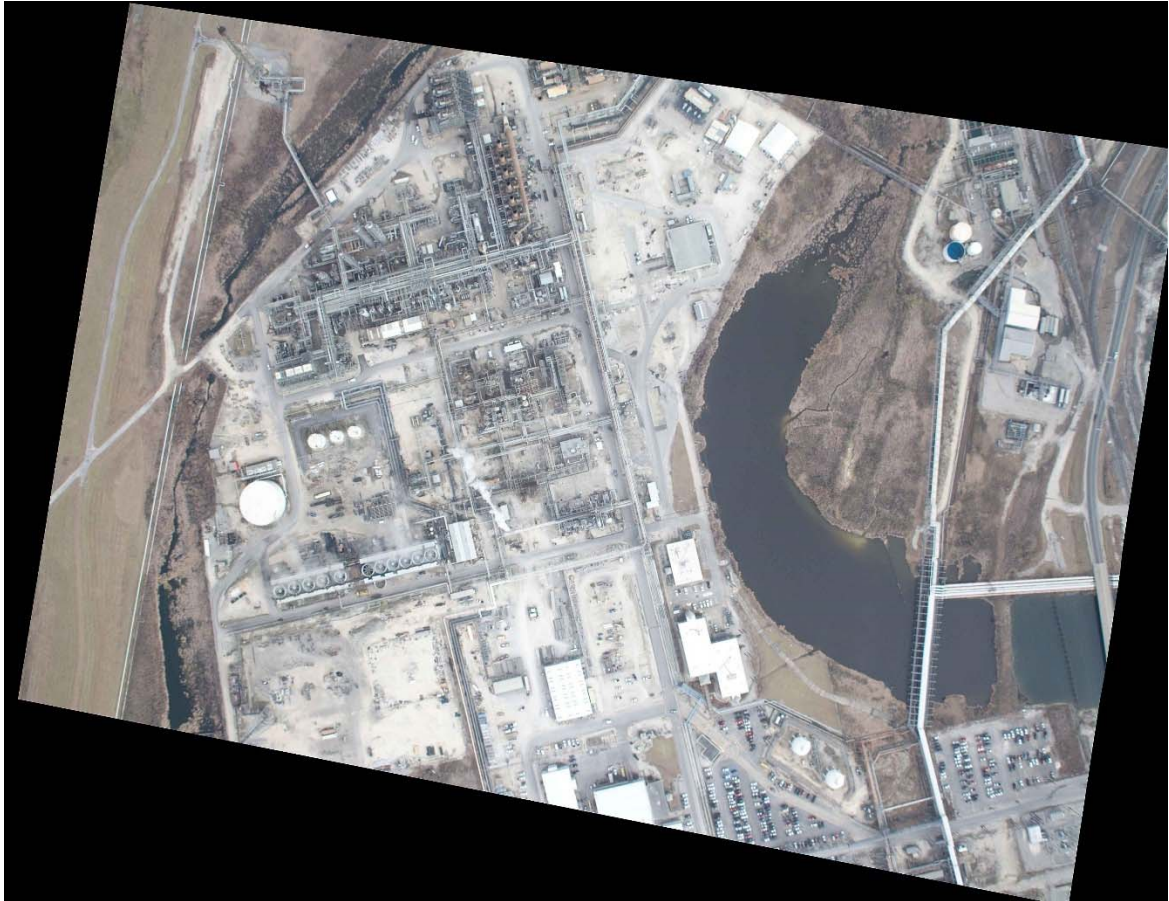
Figure 12. MSIC Aerial Image, Port Arthur Area, Flight 20

A full set of high-resolution aerial digital photography were collected as part of each data collection pass. Weather conditions over the Beaumont/Port Arthur areas allowed acceptable quality aerial images to be collected. Figure 12 shows a representative frame of a facility imaged during that air monitoring survey with a visible steam vent in the middle of the frame. Figure 13 shows an oblique image collected during the flight over Houston showing evidence that the plant is in operation.
