Airborne Spectral Photometric Environmental Collection Technology

ASPECT Texas Air Quality Survey Corpus Christi and Point Comfort, TX 12 March 2021

The collection objectives for 12 March 2021 included a continuation of air monitoring collection activities at selected sites within the Corpus Christi and Point Comfort areas, pending weather. Weather conditions for the survey areas are marginal but forecast to improve by 1000. This report summarizes the results of the mission.

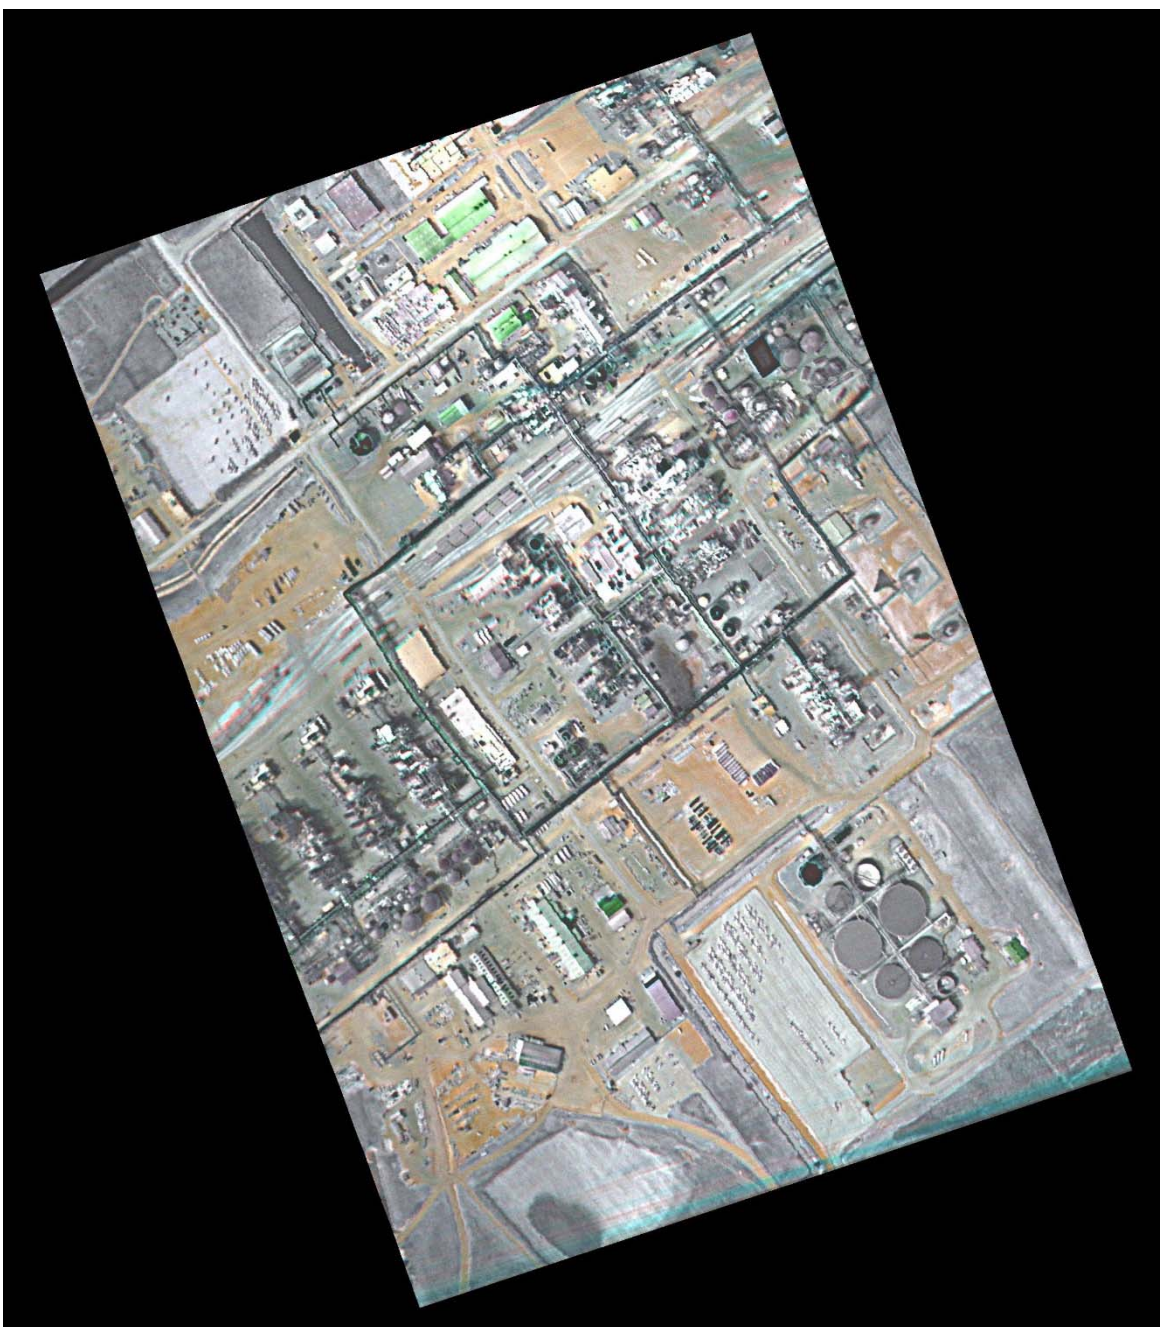
Figure 6. Three band IR image, Victoria/Point Comfort Area, Run 3, Flight 24, 12 March 2021

A total of 8 data collection runs were made over the Port Arthur area and during each collection run an infrared line scanner image was generated. Figure 6 shows a 3-band infrared image collected over the survey area. Examination of the image shows hot process/piping in the mid portion of the image. No chemical plumes can be observed being emitted from the facility.

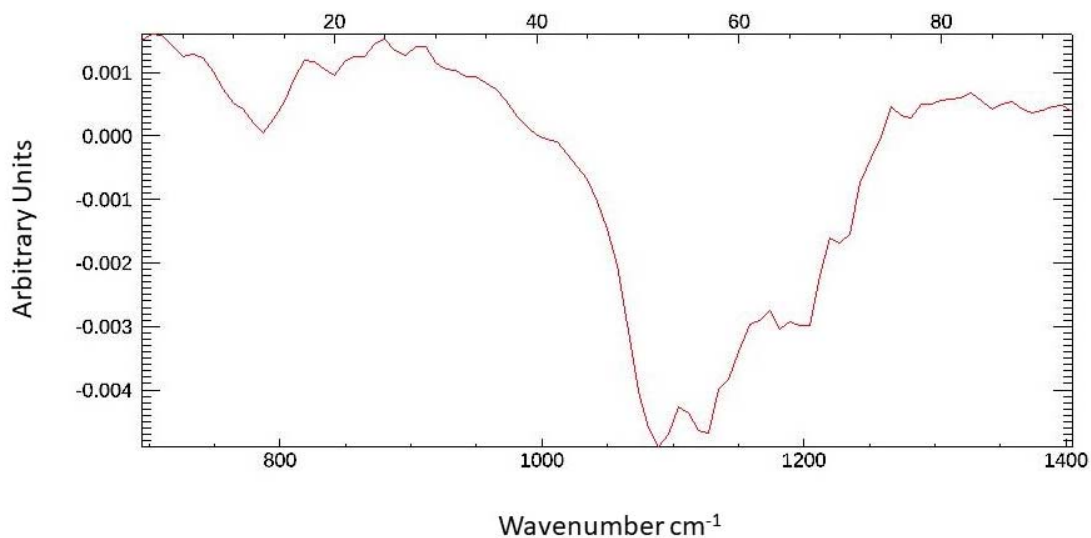
Figure 7. PAN Spectrum, Victoria/Point Comfort Area, Flight 24, 12 March 2021

ASPECT did not detect any programmed compounds (those found in Appendix B, Table 1) during the air monitoring survey over the Victoria/Point Comfort area but the sensor did detection common air pollutants. Figure 7 shows peroxyacetyl nitrate (PAN) with the large feature centered at approximately 1120 cm^{-1} . Details of the monitoring results can be found in Table 3.

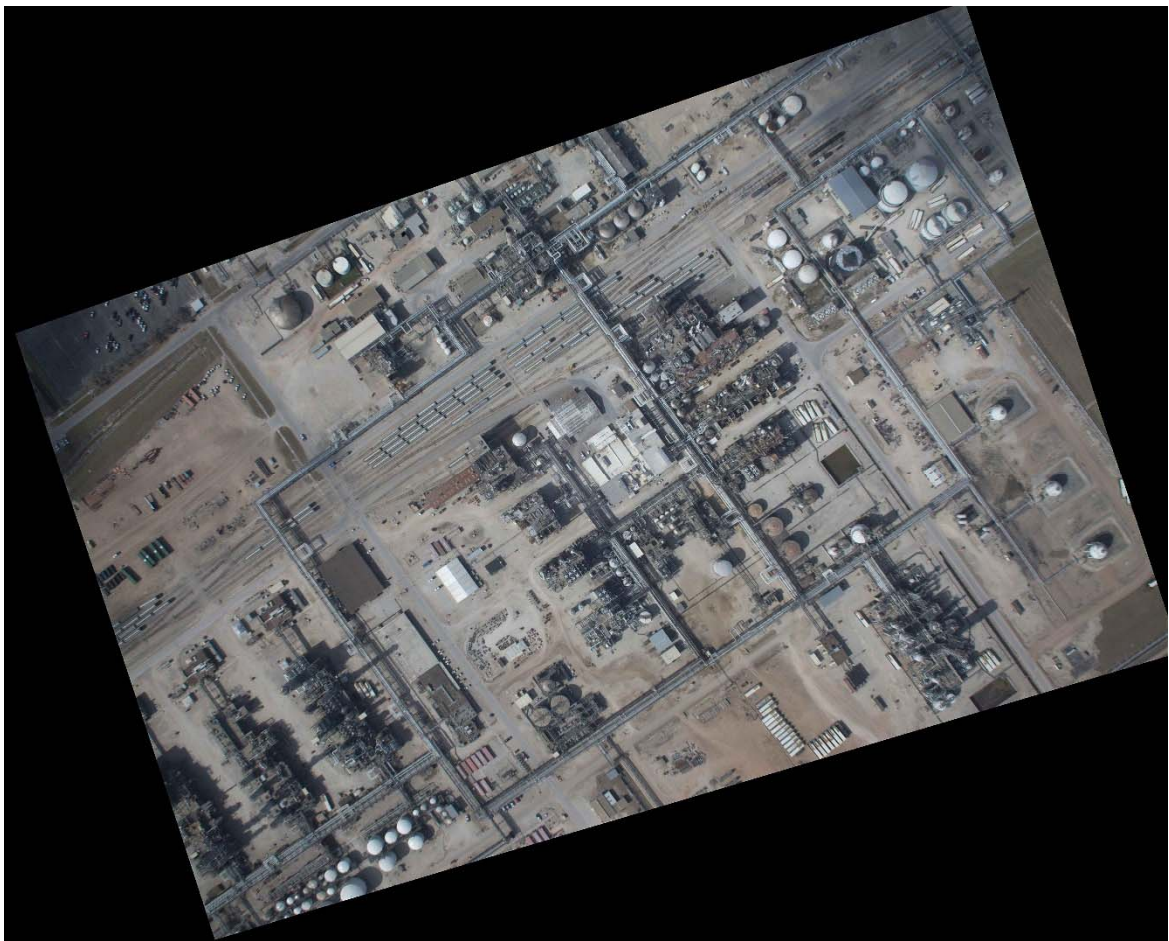
Figure 8. MSIC Aerial Image, Victoria/Point Comfort Area, Flight 24

A full set of high-resolution aerial digital photographs were collected as part of each data collection pass. Weather conditions over the Victoria/Point Comfort areas acceptable for visible image collection. Figure 8 shows an image collected in the survey area with little dynamic content in the frame. Figure 6 (IR image) above does indicate that the facility is in a state of operation, but no visible emissions such as steam are evident.
