2/24/2021 AI# 3106
Livermore Industrial Plating

by Scott, Curtis (EEC)

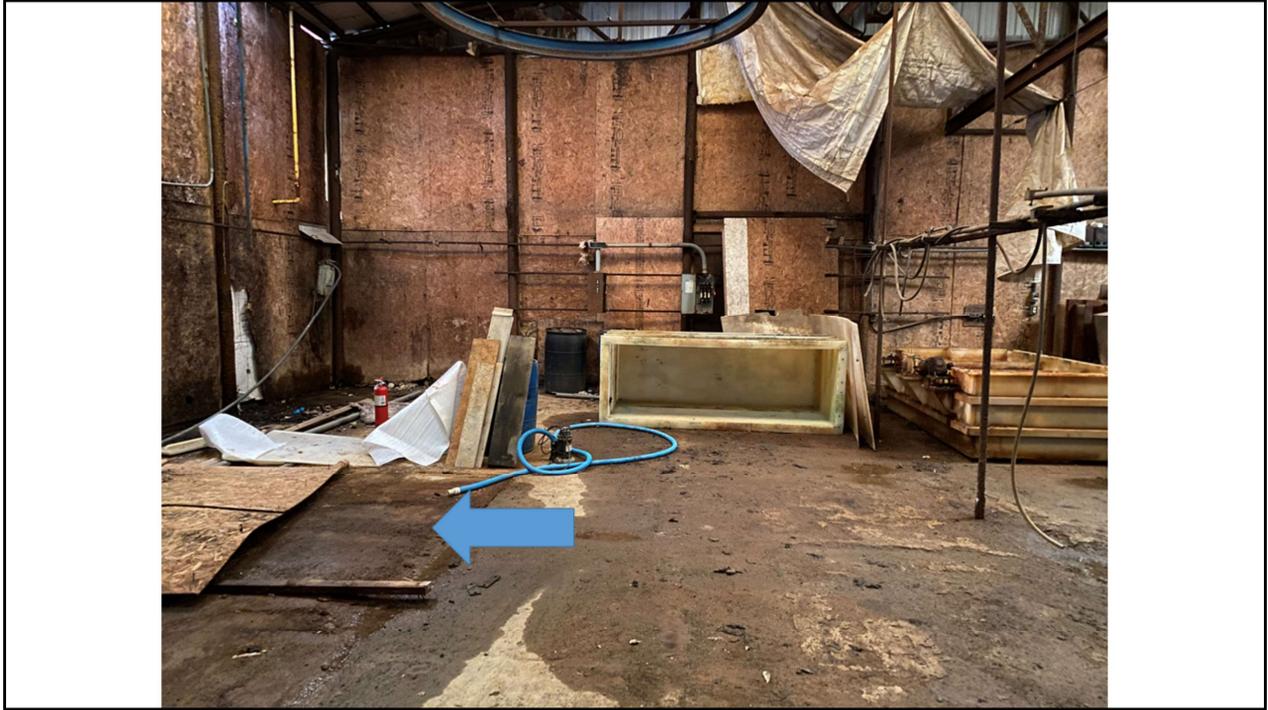
CCS, 2/24/2021, AI# 3106, Livermore Industrial Plating: The dip tank previously observed to contain plating solution has been emptied and the contents containerized. This particular dip tank was staged under a hole in the room and had minimal free board when previously observed. Arrow marks the location of dip tank during previous visits (and inspections) when it was located under the compromised roof.

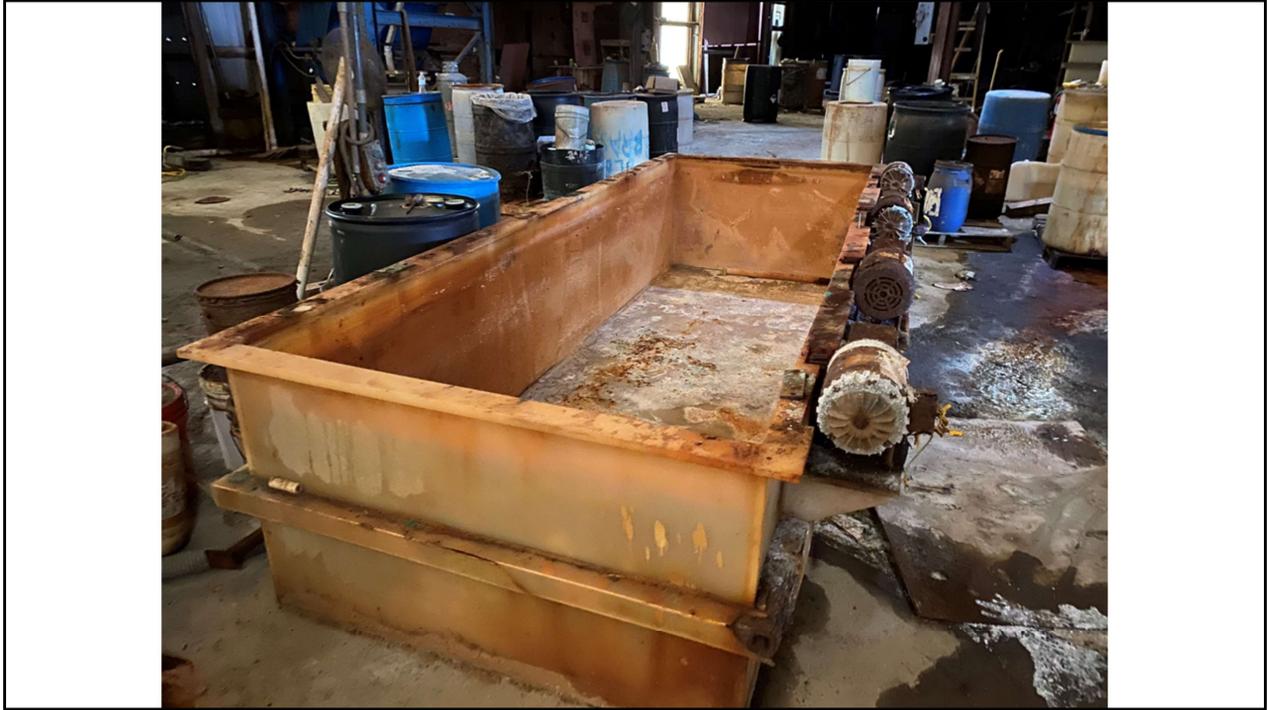
CCS, 2/24/2021, AI# 3106, Livermore Industrial Plating: The dip tank previously observed to contain plating solution has been emptied and the contents containerized. This particular dip tank was staged under a hole in the room and had minimal free board when previously observed.

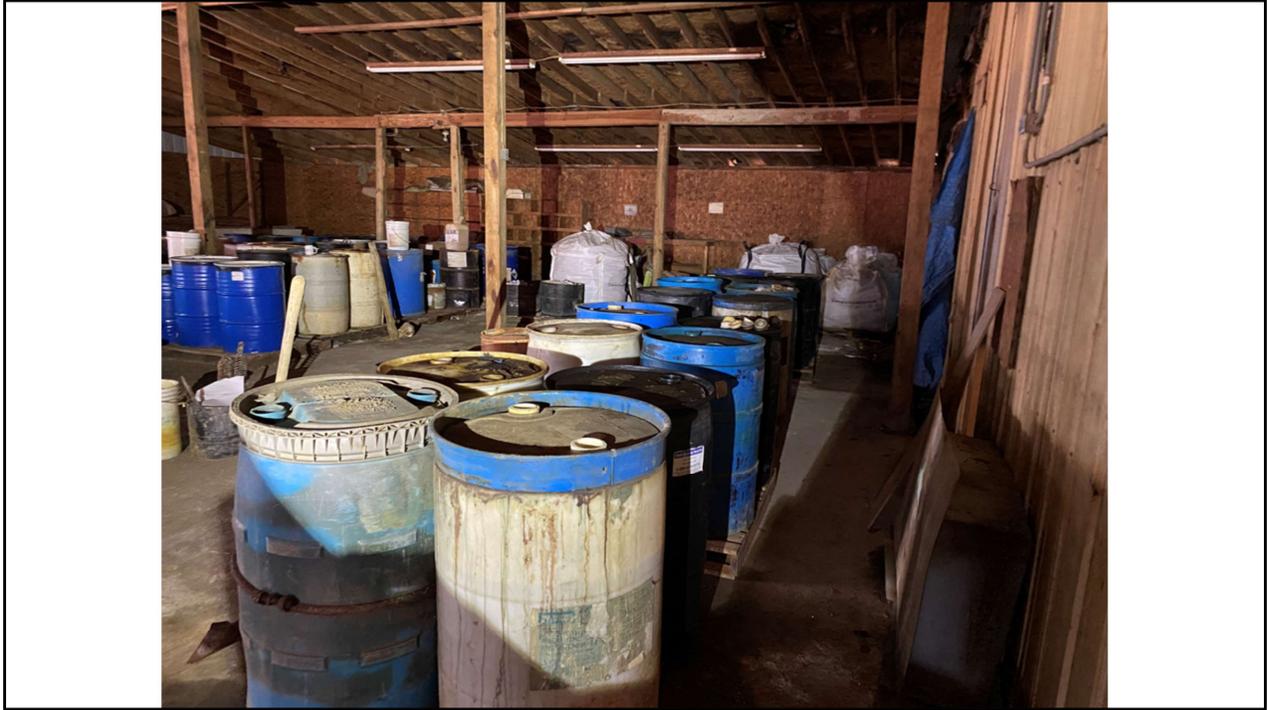
CCS, 2/24/2021, AI# 3106, Livermore Industrial Plating: The dip tank previously observed to contain plating solution has been emptied and the contents containerized. This particular dip tank was staged under a hole in the room and had minimal free board when previously observed. These are 16 drums that contain the plating solution previously held in the dip tank.

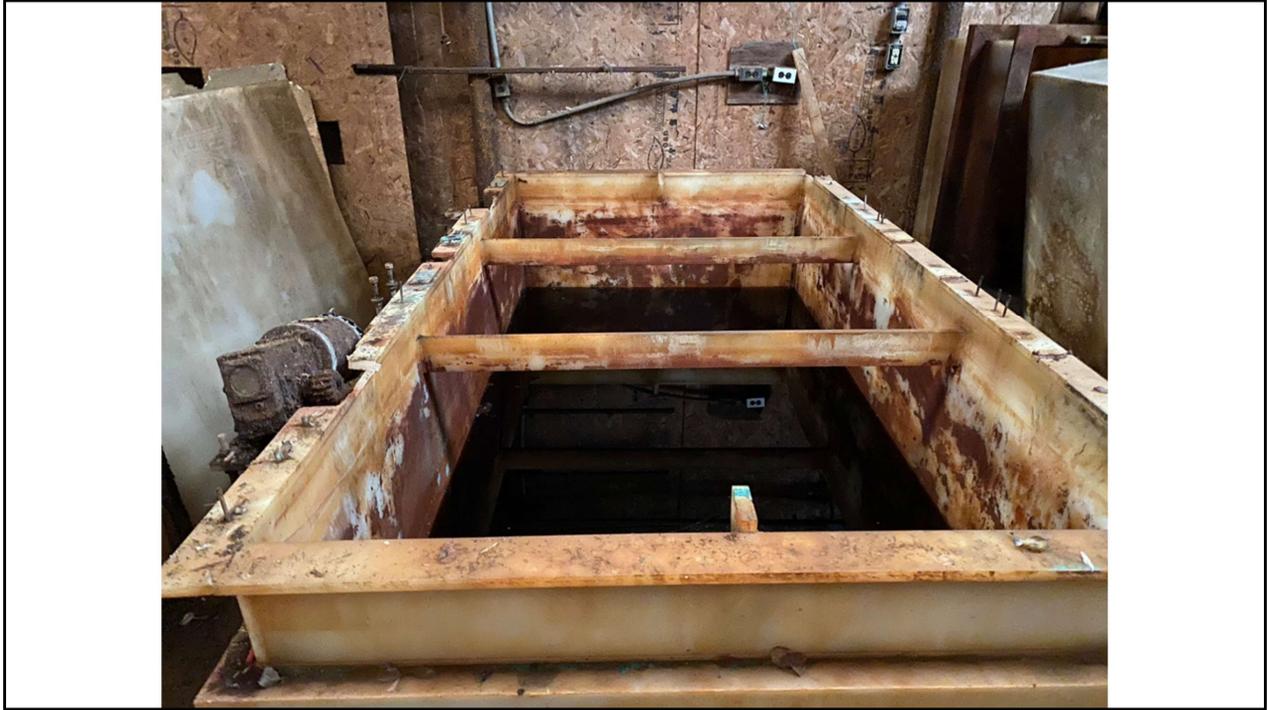
CCS, 2/24/2021, AI# 3106, Livermore Industrial Plating: Other dip tanks still contain plating solution. But they are currently staged away from water intrusion points in the roof.
