10/5/2020 CEI AI# 3106
Livermore Industrial Plating

by Scott, Curtis (EEC)

Unregistered site

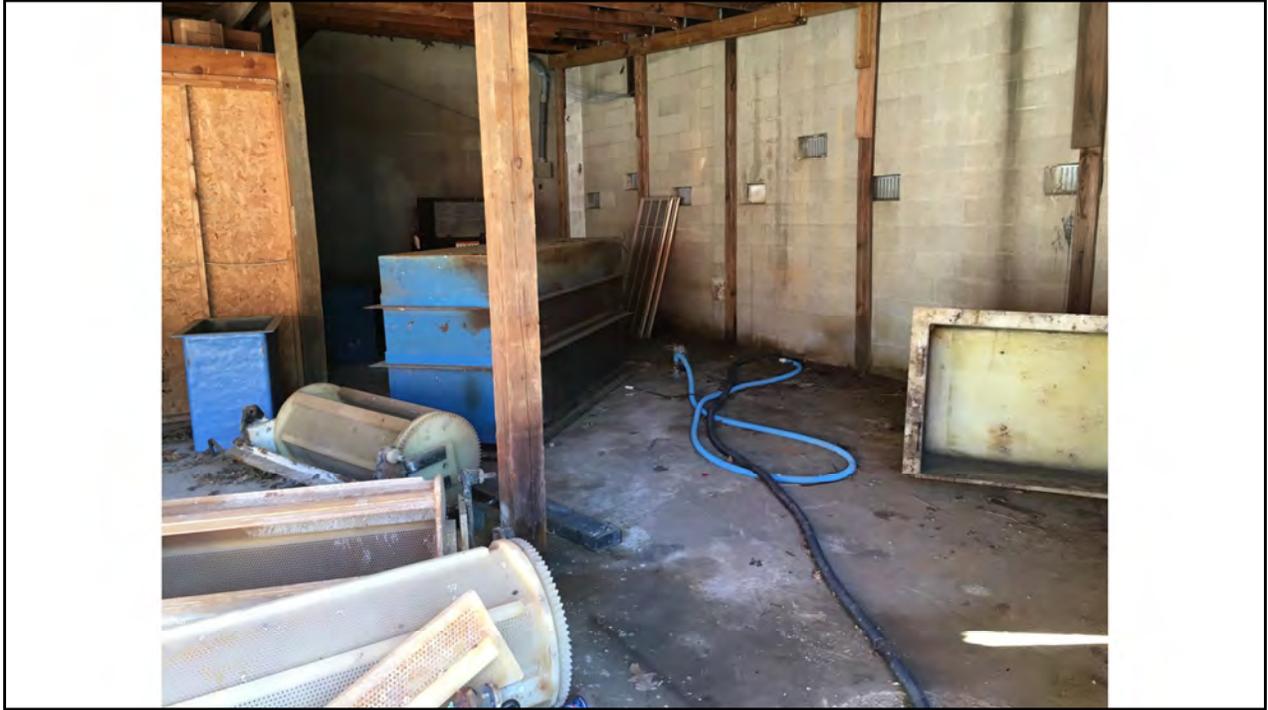
CCS, 10/5/2020, CEI AI# 3106, Livermore Industrial Plating: Site photo. Empty dip tanks.

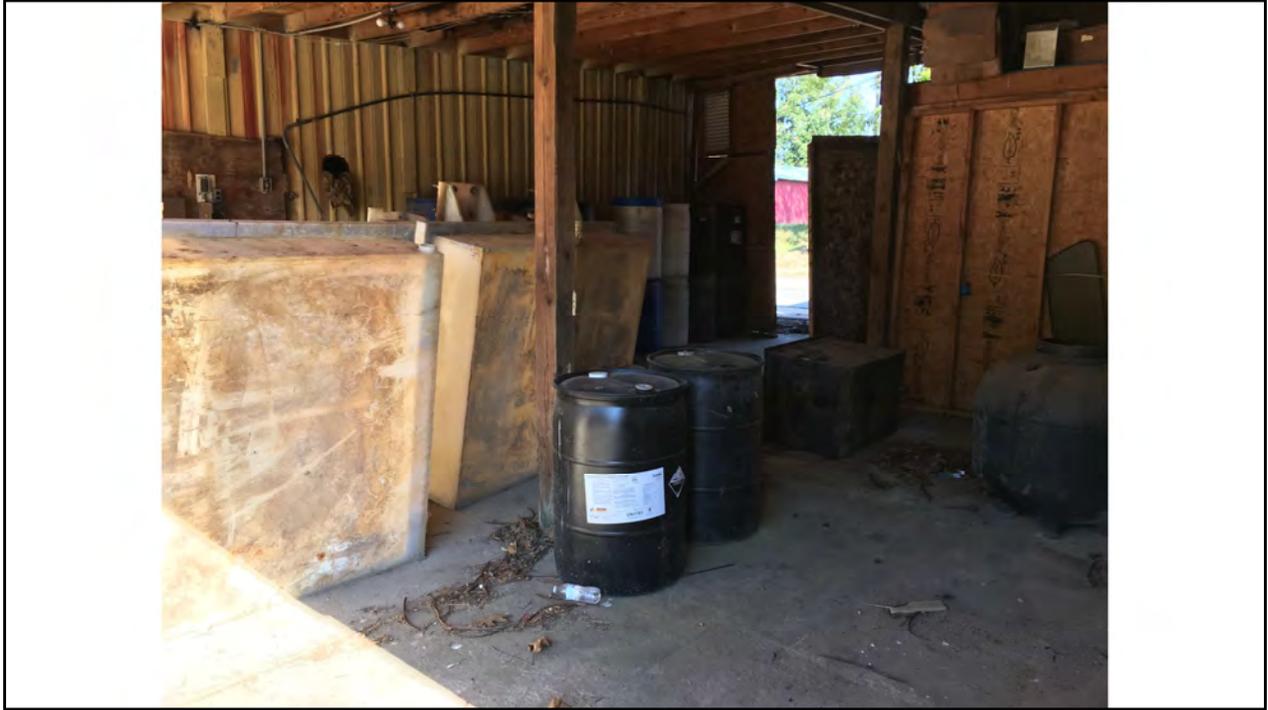
CCS, 10/5/2020, CEI AI# 3106, Livermore Industrial Plating: Site photo. Empty drums

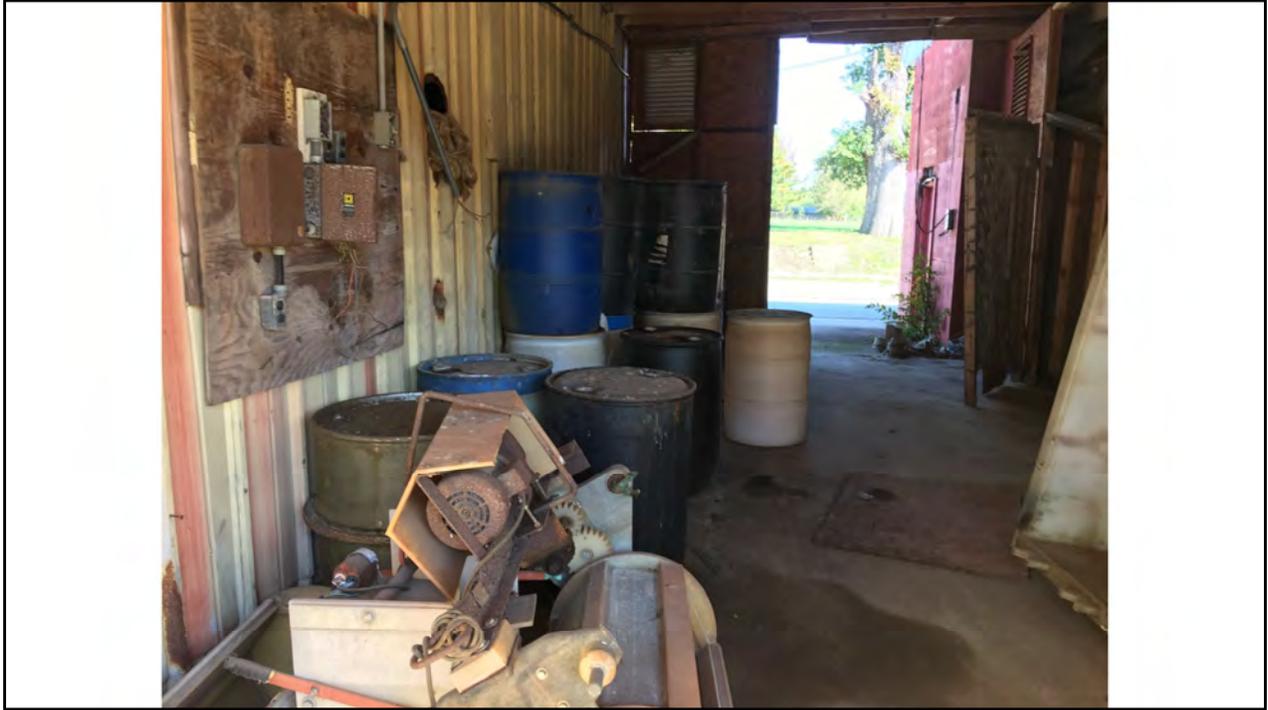
CCS, 10/5/2020, CEI AI# 3106, Livermore Industrial Plating: Site photo. Empty drums

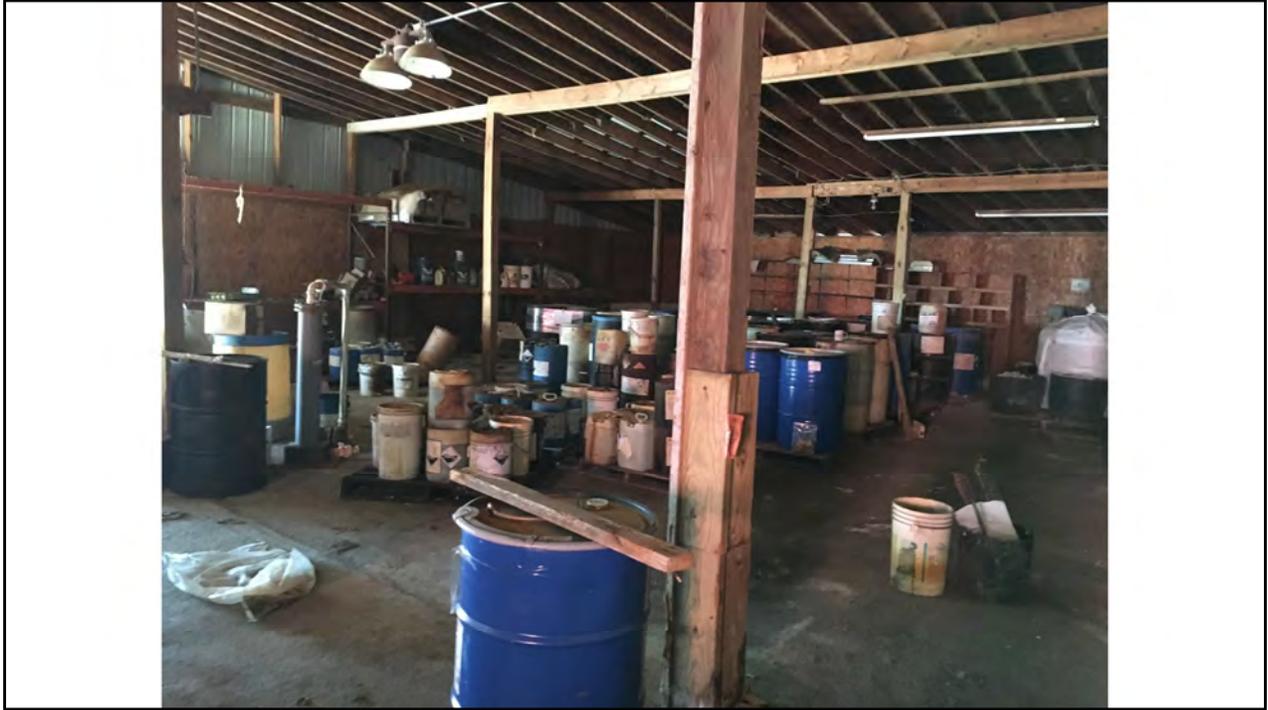
CCS, 10/5/2020, CEI AI# 3106, Livermore Industrial Plating: Site photo. The facility claims product status for all material.

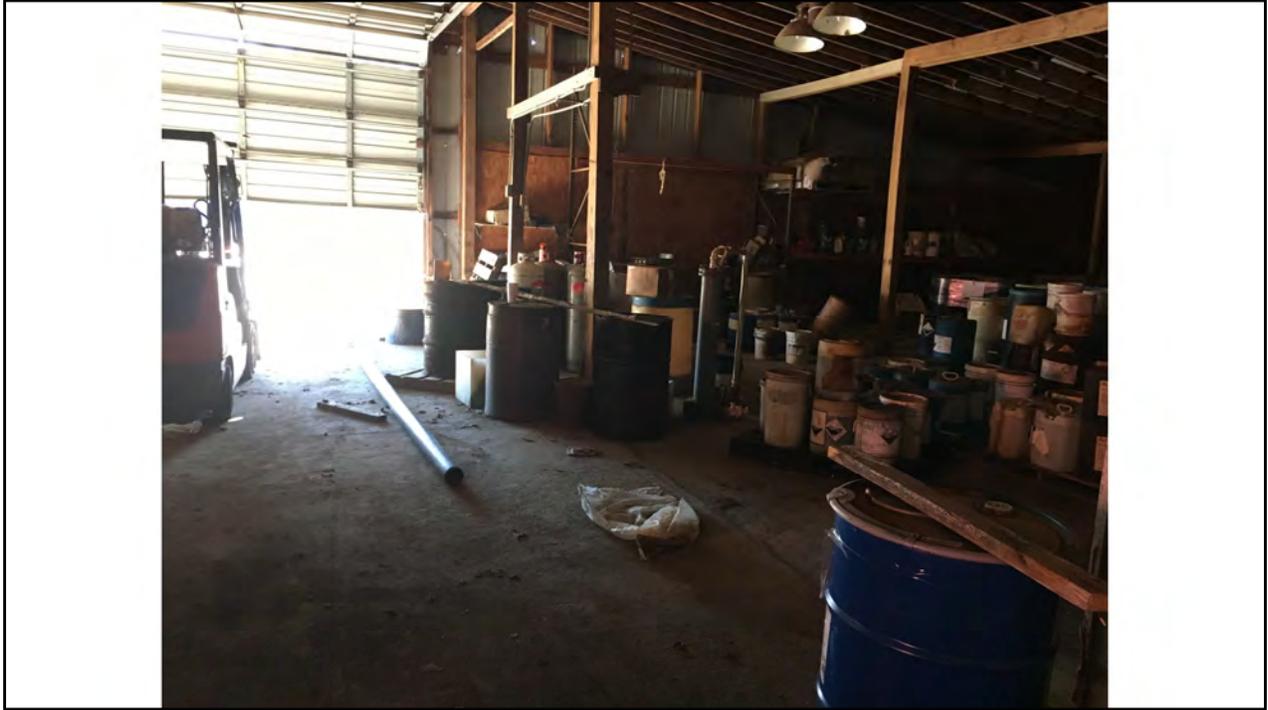
CCS, 10/5/2020, CEI AI# 3106, Livermore Industrial Plating: Site photo. The facility claims product status for all material.

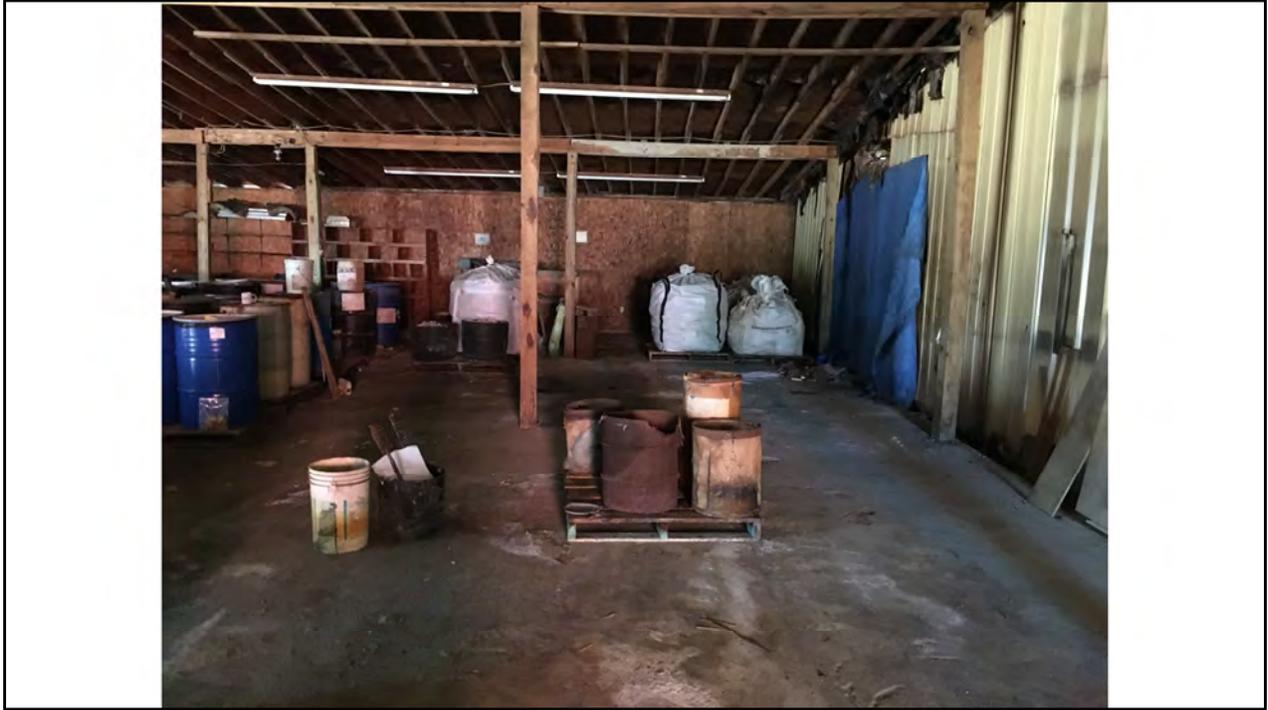
CCS, 10/5/2020, CEI AI# 3106, Livermore Industrial Plating: Site photo. The facility claims product status for all material.

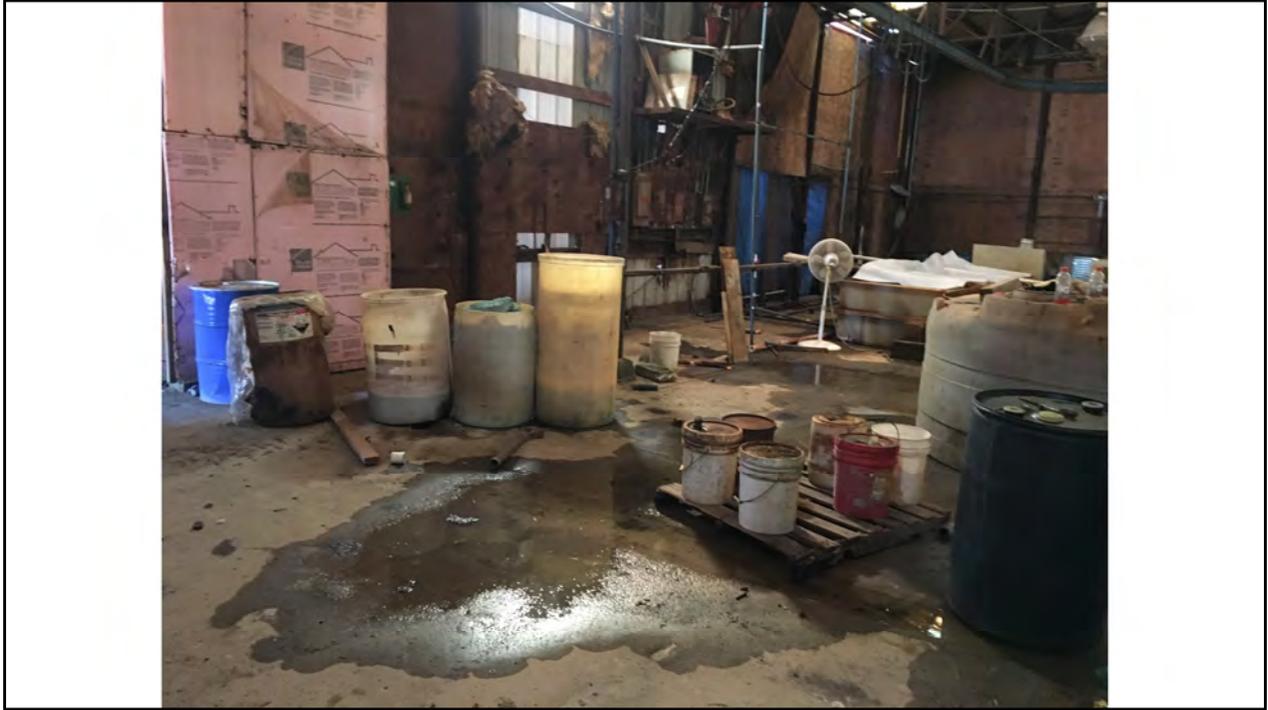
CCS, 10/5/2020, CEI AI# 3106, Livermore Industrial Plating: Site photo. The facility claims product status for all material. Floor is designed to drain to a sump then WWT operation. Sump and associated trenches are filled with liquid (reported to be rain water). Liquid stands on floor.

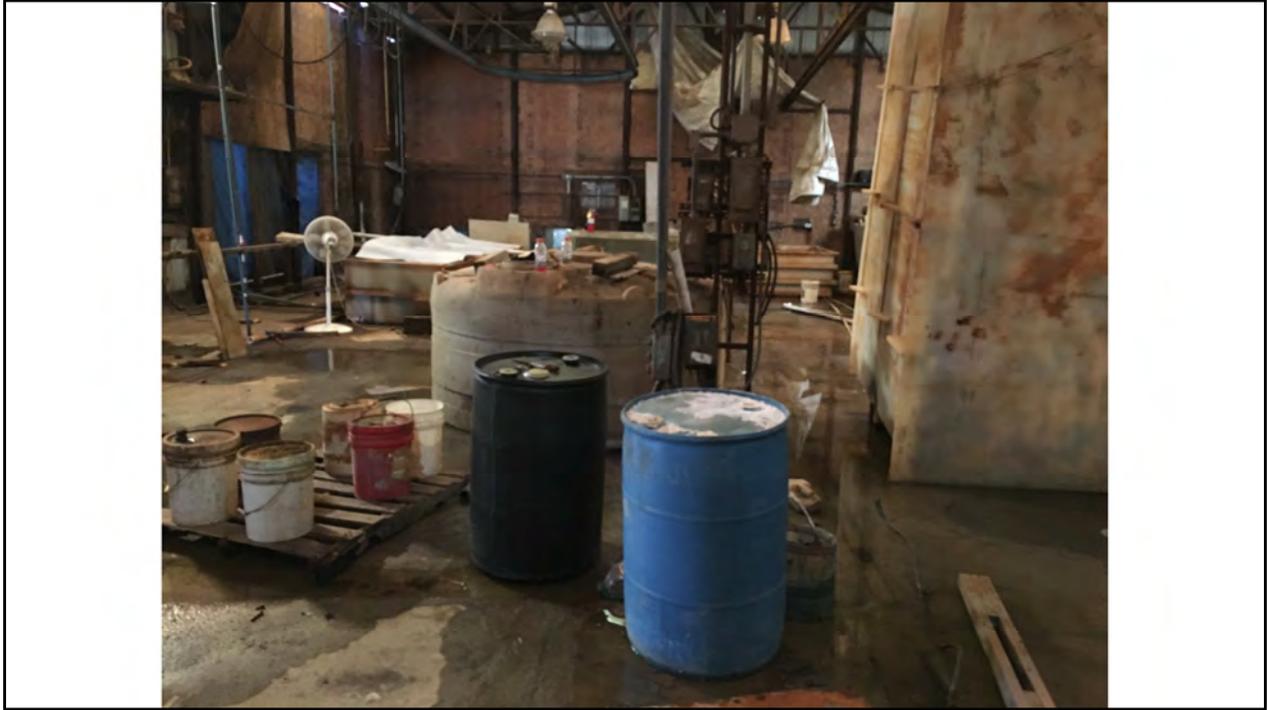
CCS, 10/5/2020, CEI AI# 3106, Livermore Industrial Plating: Site photo. The facility claims product status for all material. Floor is designed to drain to a sump then WWT operation. Sump and associated trenches are filled with liquid (reported to be rain water). Liquid stands on floor.

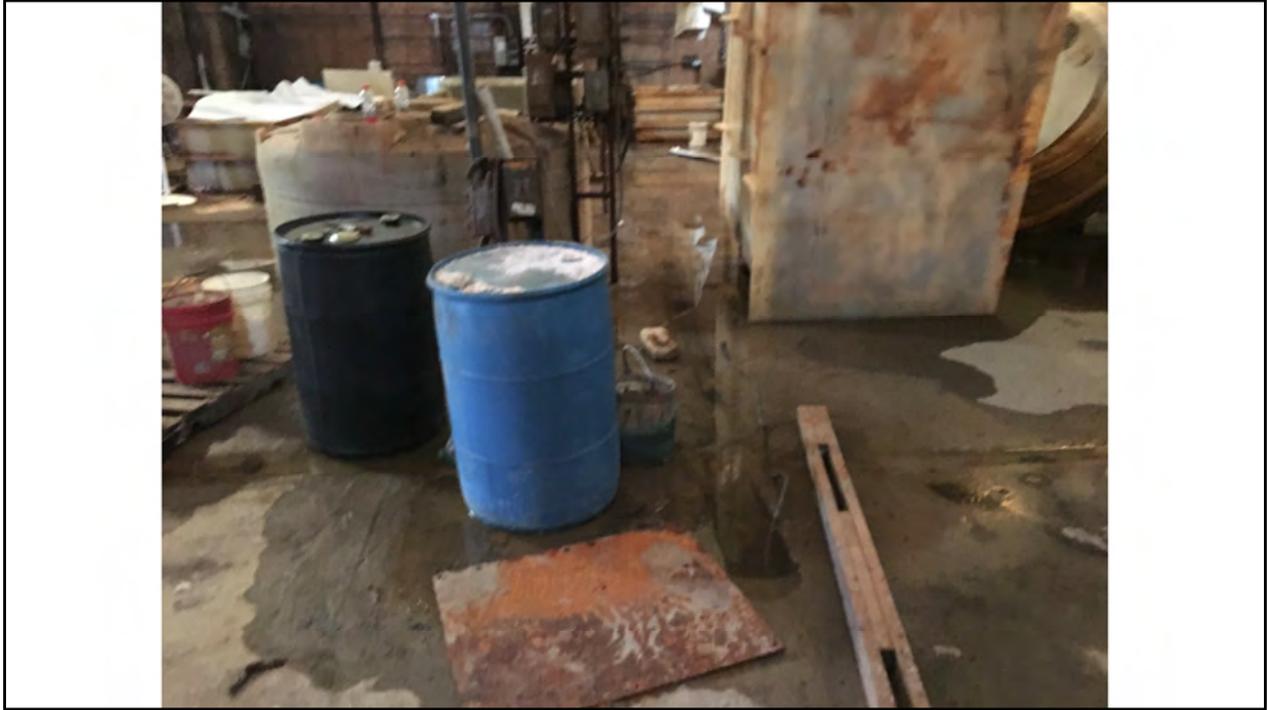
CCS, 10/5/2020, CEI AI# 3106, Livermore Industrial Plating: Site photo. The facility claims product status for all material. Floor is designed to drain to a sump then WWT operation. Sump and associated trenches are filled with liquid (reported to be rain water). Liquid stands on floor.

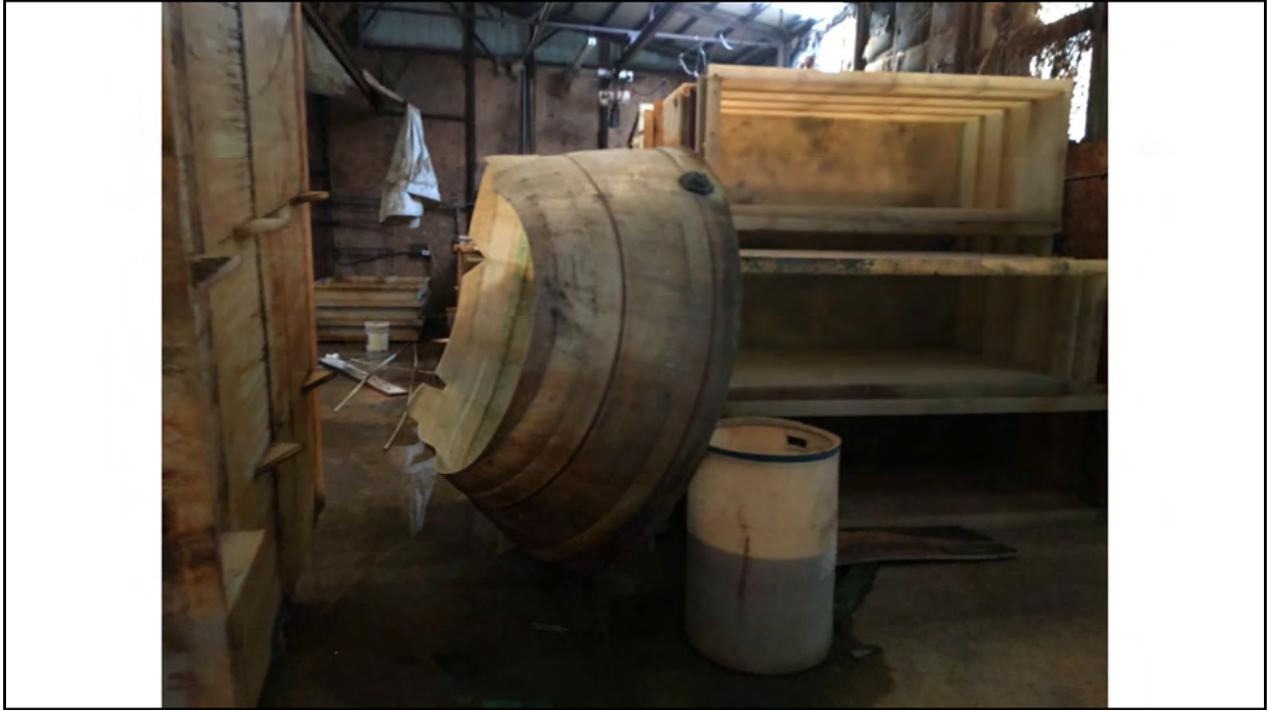
CCS, 10/5/2020, CEI AI# 3106, Livermore Industrial Plating: Site photo. The facility claims product status for all material. Floor is designed to drain to a sump then WWT operation. Sump and associated trenches are filled with liquid (reported to be rain water). Liquid stands on floor.

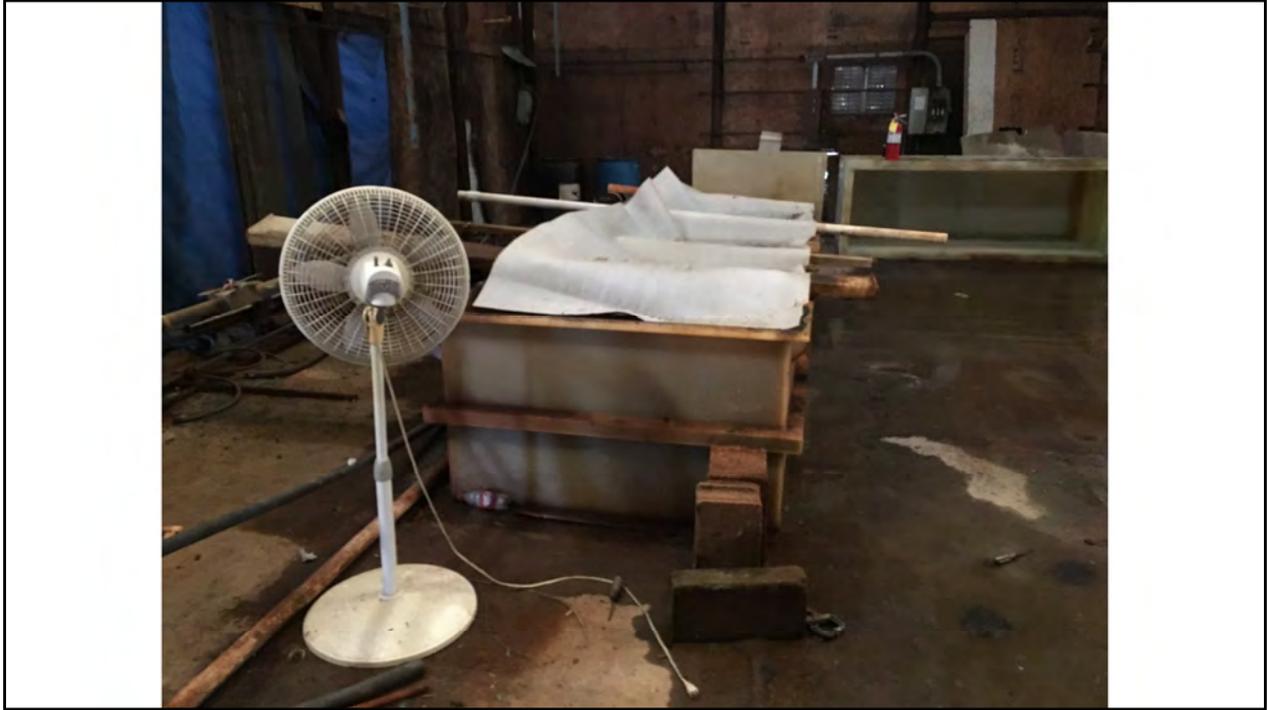
CCS, 10/5/2020, CEI AI# 3106, Livermore Industrial Plating: Site photo. The facility claims product status for all material. Floor is designed to drain to a sump then WWT operation. Sump and associated trenches are filled with liquid (reported to be rain water). Liquid stands on floor. This dip tank is about to run over. It is staged under a leaking roof. Zinc plating solution

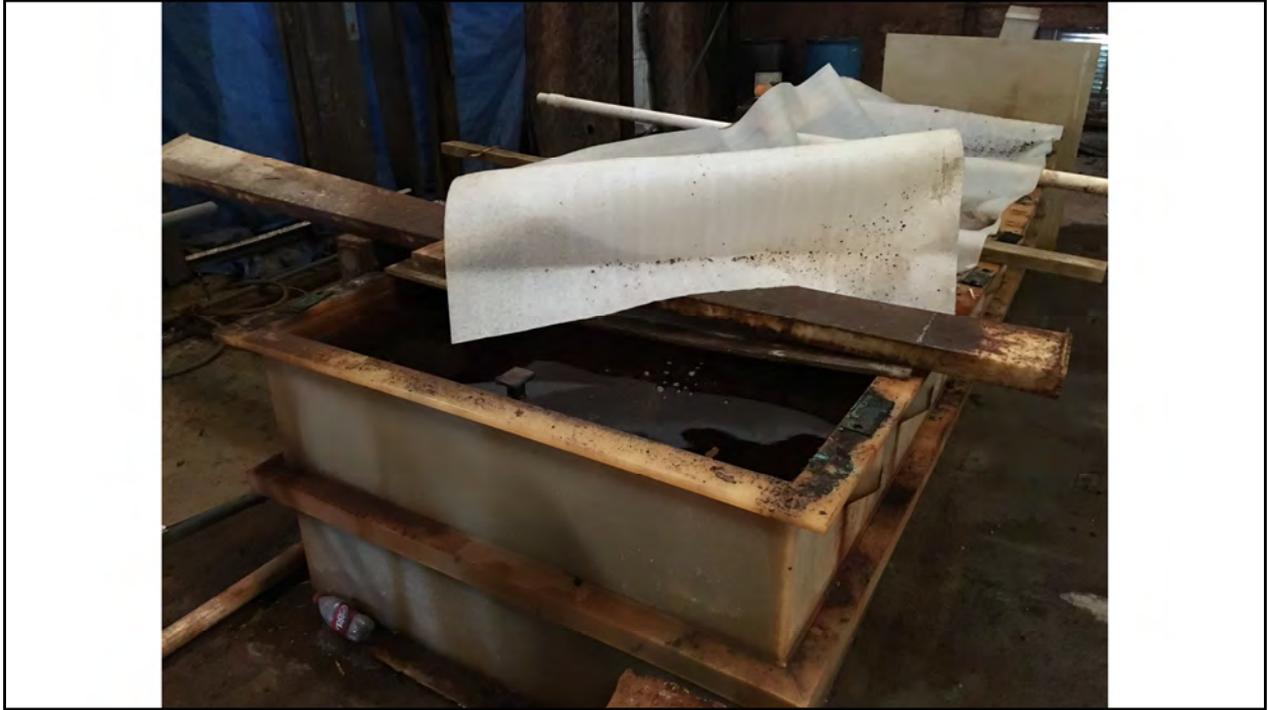
CCS, 10/5/2020, CEI AI# 3106, Livermore Industrial Plating: Site photo. The facility claims product status for all material. Floor is designed to drain to a sump then WWT operation. Sump and associated trenches are filled with liquid (reported to be rain water). Liquid stands on floor. This dip tank is about to run over. It is staged under a leaking roof. Zinc plating solution

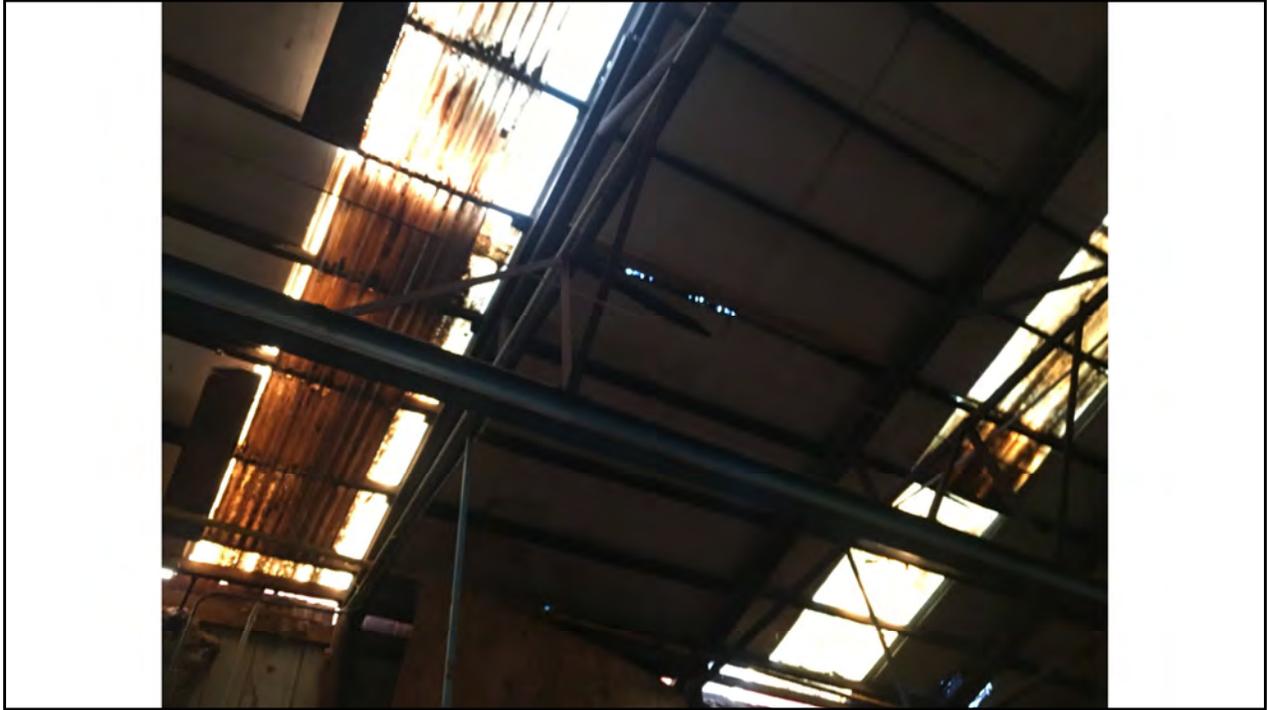
CCS, 10/5/2020, CEI AI# 3106, Livermore Industrial Plating: Site photo. Roof over dip tank (of zinc solution)

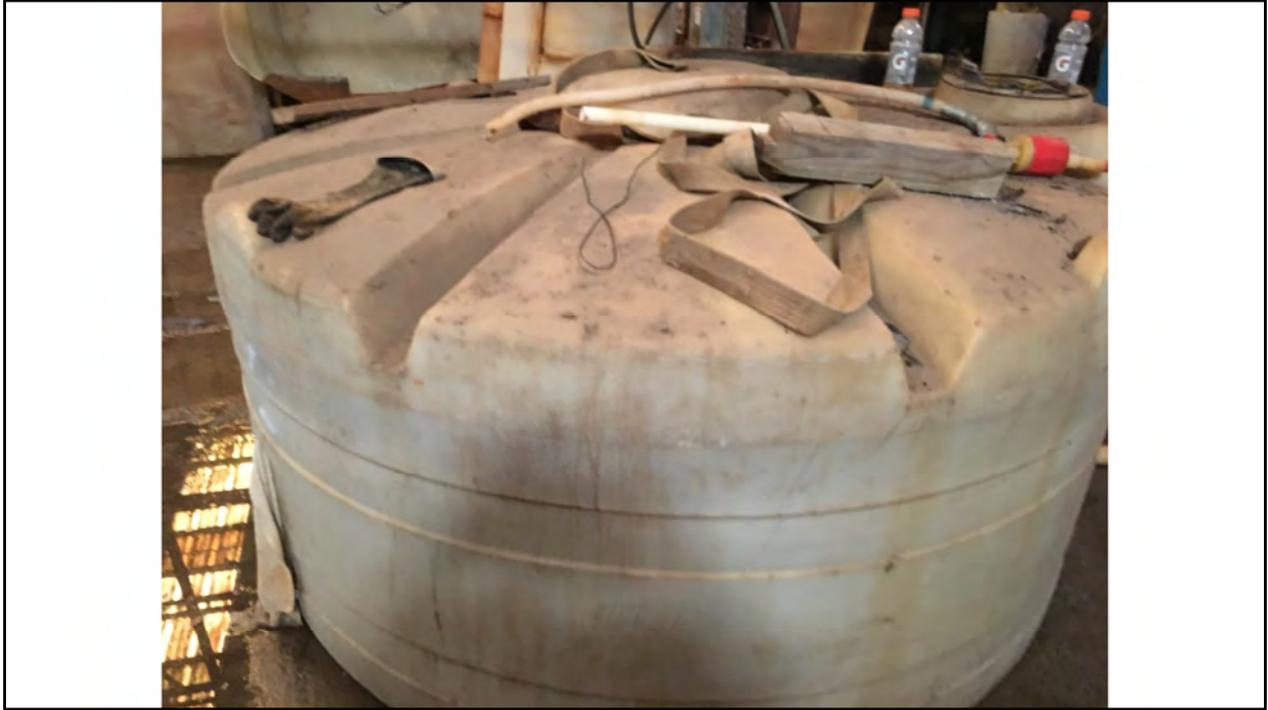
CCS, 10/5/2020, CEI AI# 3106, Livermore Industrial Plating: Site photo. The facility claims product status for all material. Floor is designed to drain to a sump then WWT operation. Sump and associated trenches are filled with liquid (reported to be rain water). Liquid stands on floor. Full tank (zinc plating solution)

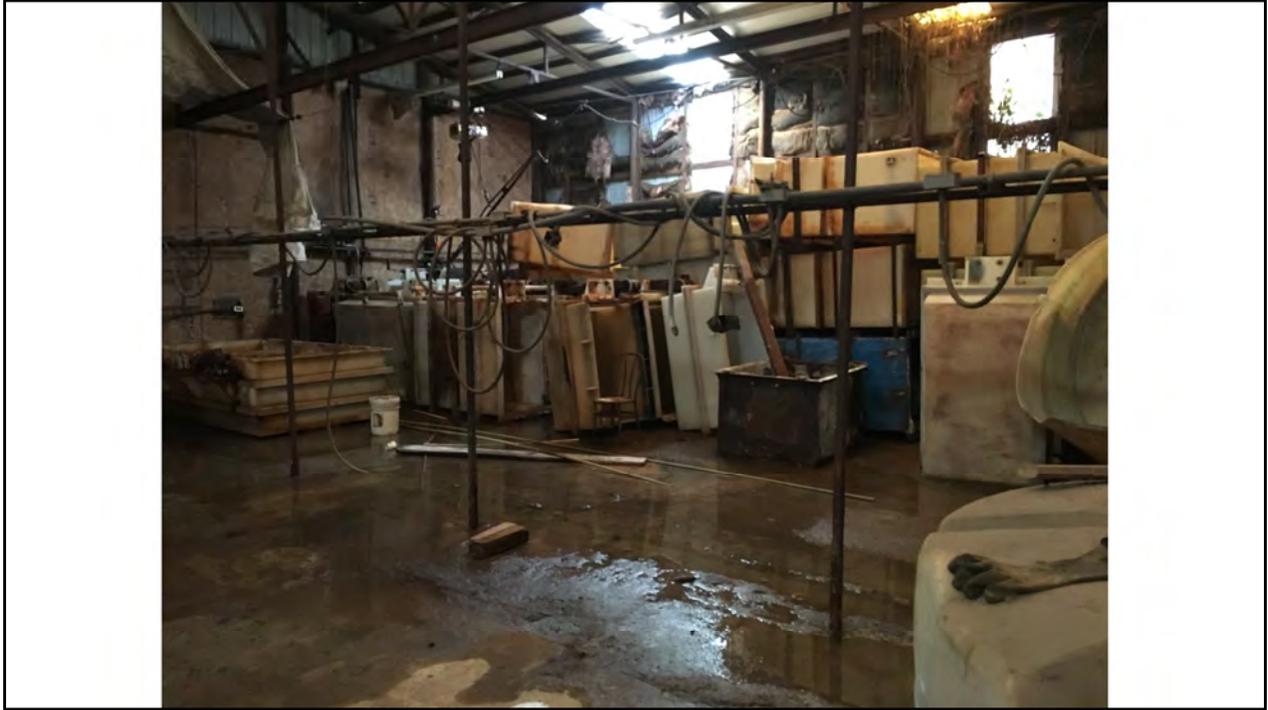
CCS, 10/5/2020, CEI AI# 3106, Livermore Industrial Plating: Site photo. The facility claims product status for all material. Floor is designed to drain to a sump then WWT operation. Sump and associated trenches are filled with liquid (reported to be rain water). Liquid stands on floor.

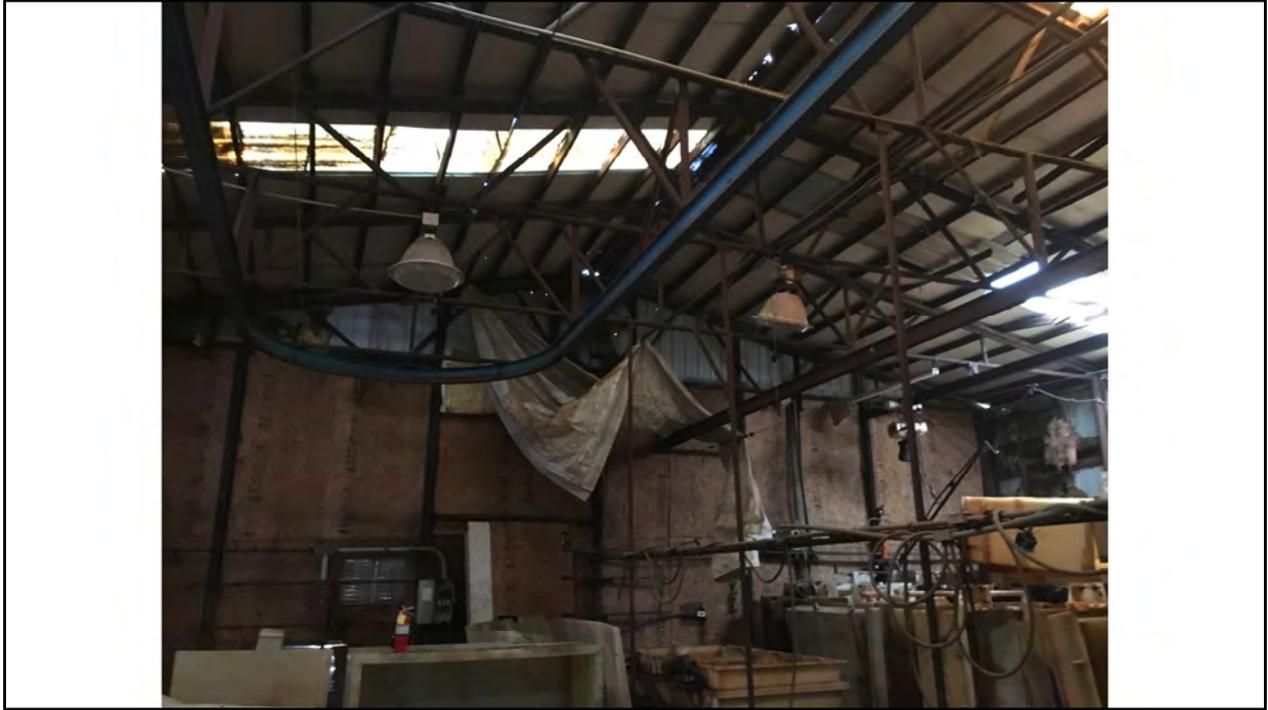
CCS, 10/5/2020, CEI AI# 3106, Livermore Industrial Plating: Site photo. The facility claims product status for all material. Floor is designed to drain to a sump then WWT operation. Sump and associated trenches are filled with liquid (reported to be rain water). Liquid stands on floor.

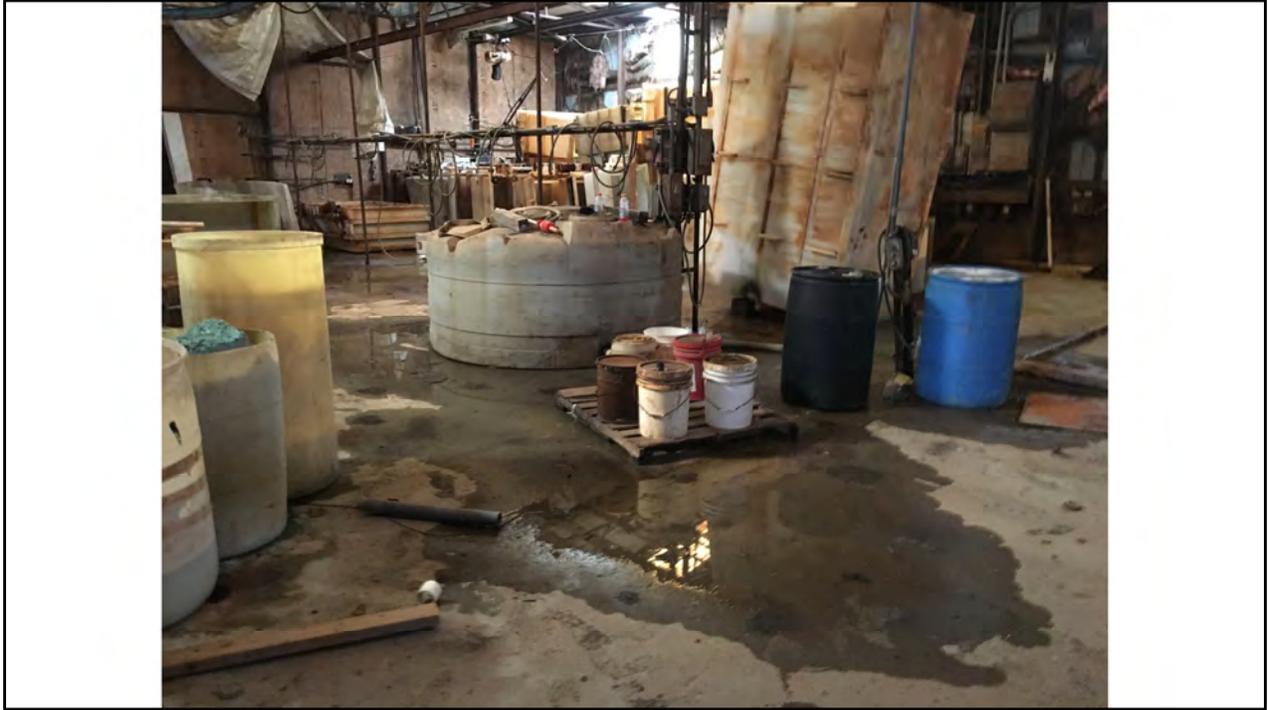
CCS, 10/5/2020, CEI AI# 3106, Livermore Industrial Plating: Site photo. The facility claims product status for all material. Floor is designed to drain to a sump then WWT operation. Sump and associated trenches are filled with liquid (reported to be rain water). Liquid stands on floor.

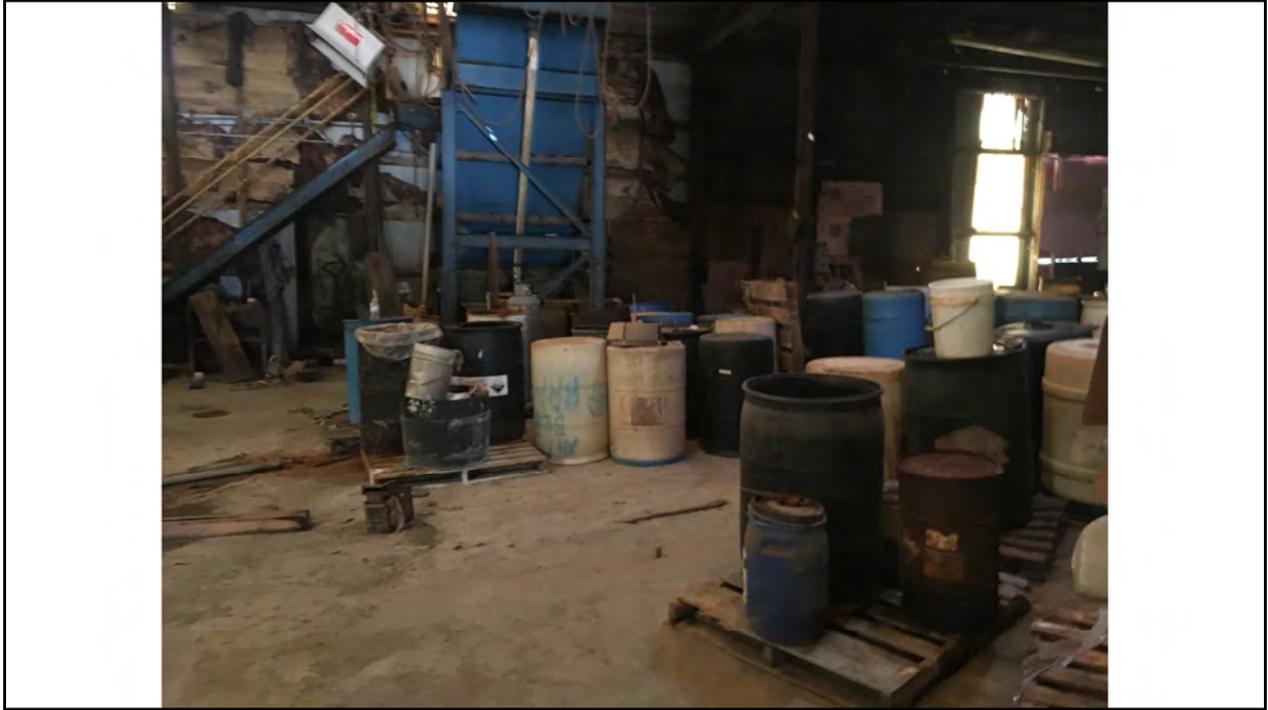
CCS, 10/5/2020, CEI AI# 3106, Livermore Industrial Plating: Site photo. The facility claims product status for all material. Floor is designed to drain to a sump then WWT operation. Sump and associated trenches are filled with liquid (reported to be rain water). Liquid stands on floor. The upside down containers are empty.

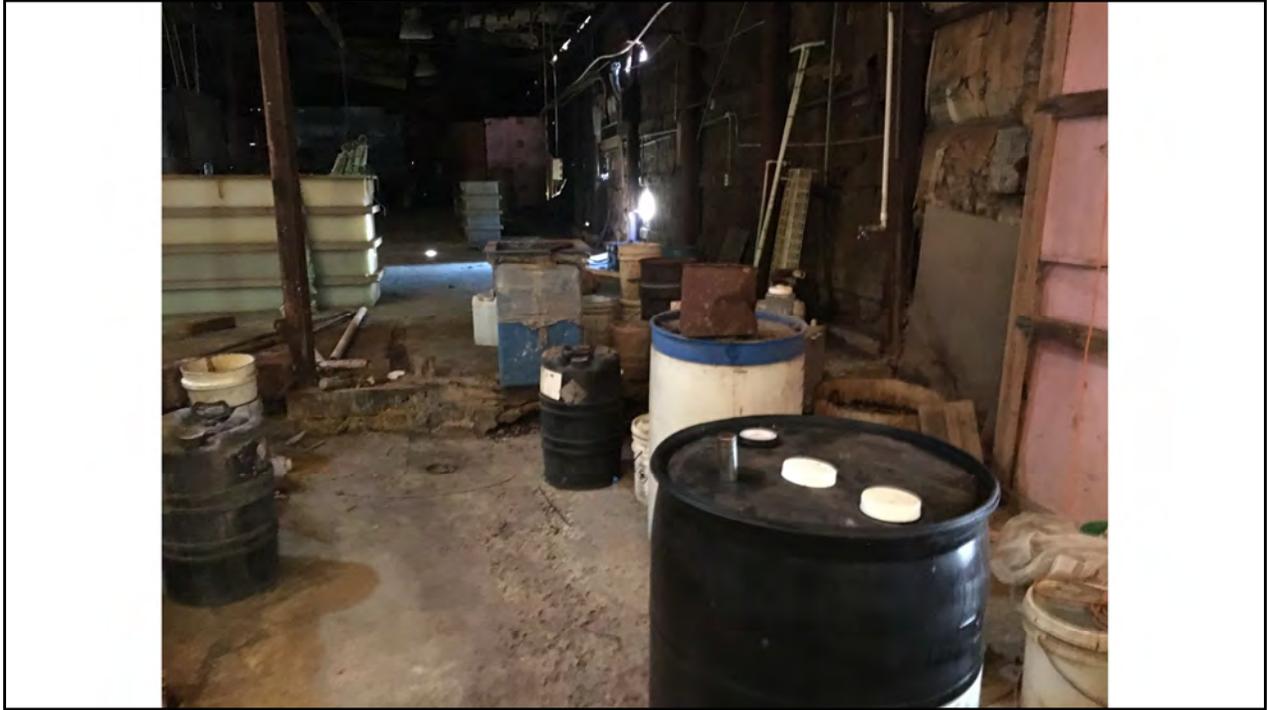
CCS, 10/5/2020, CEI AI# 3106, Livermore Industrial Plating: Site photo. The facility claims product status for all material. Floor is designed to drain to a sump then WWT operation. Sump and associated trenches are filled with liquid (reported to be rain water). Liquid stands on floor.

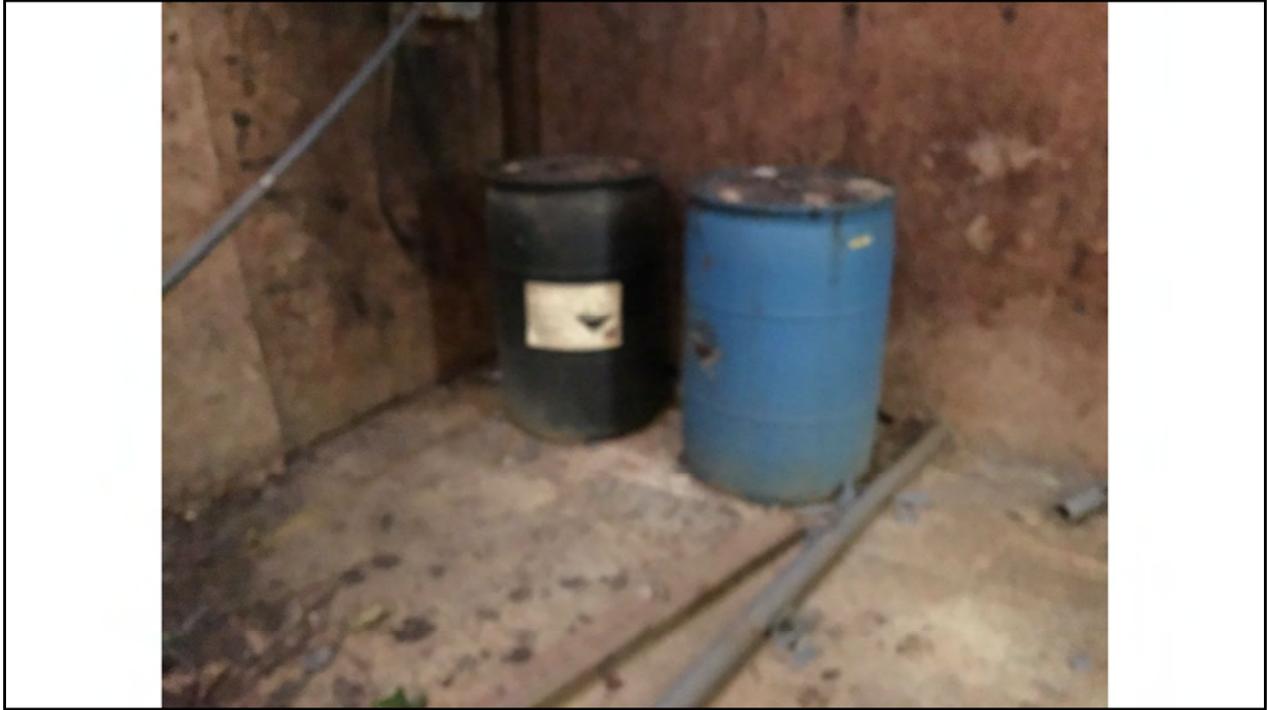
CCS, 10/5/2020, CEI AI# 3106, Livermore Industrial Plating: Site photo. The facility claims product status for all material.

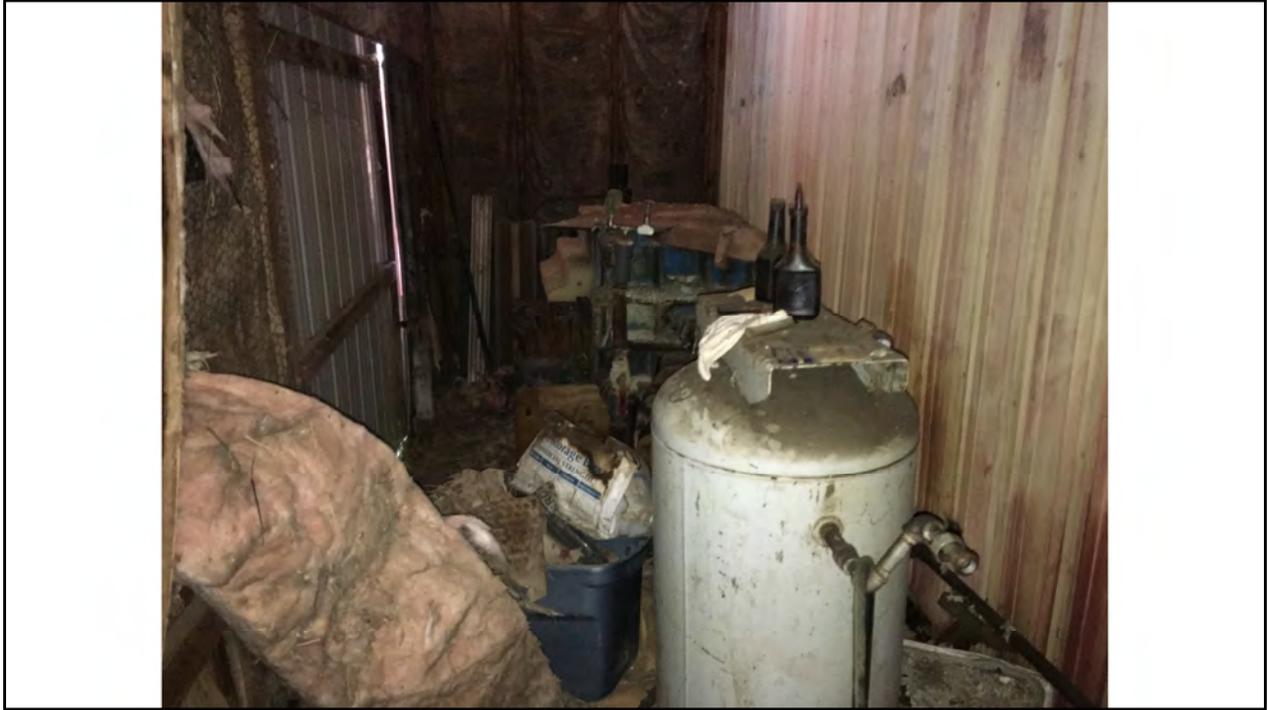
CCS, 10/5/2020, CEI AI# 3106, Livermore Industrial Plating: Site photo. The facility claims product status for all material.

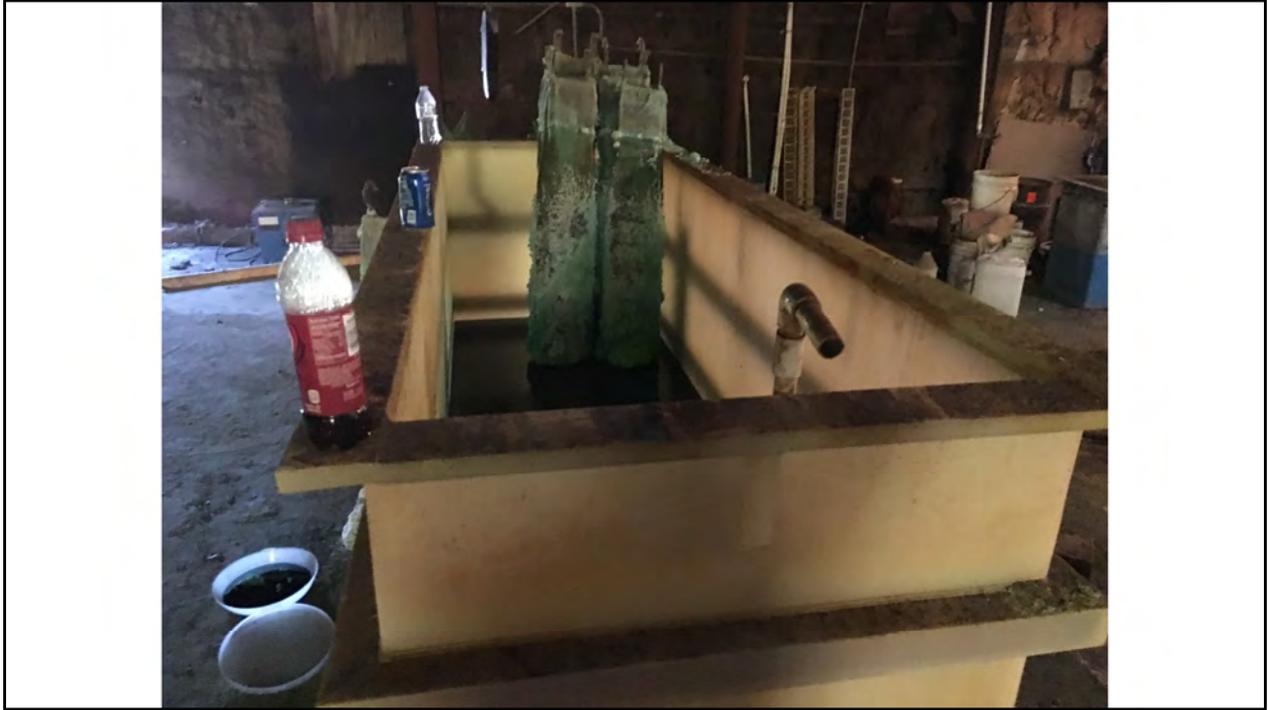
CCS, 10/5/2020, CEI AI# 3106, Livermore Industrial Plating: Site photo. The facility claims product status for all material in dip tank. This is nickel plating solution.

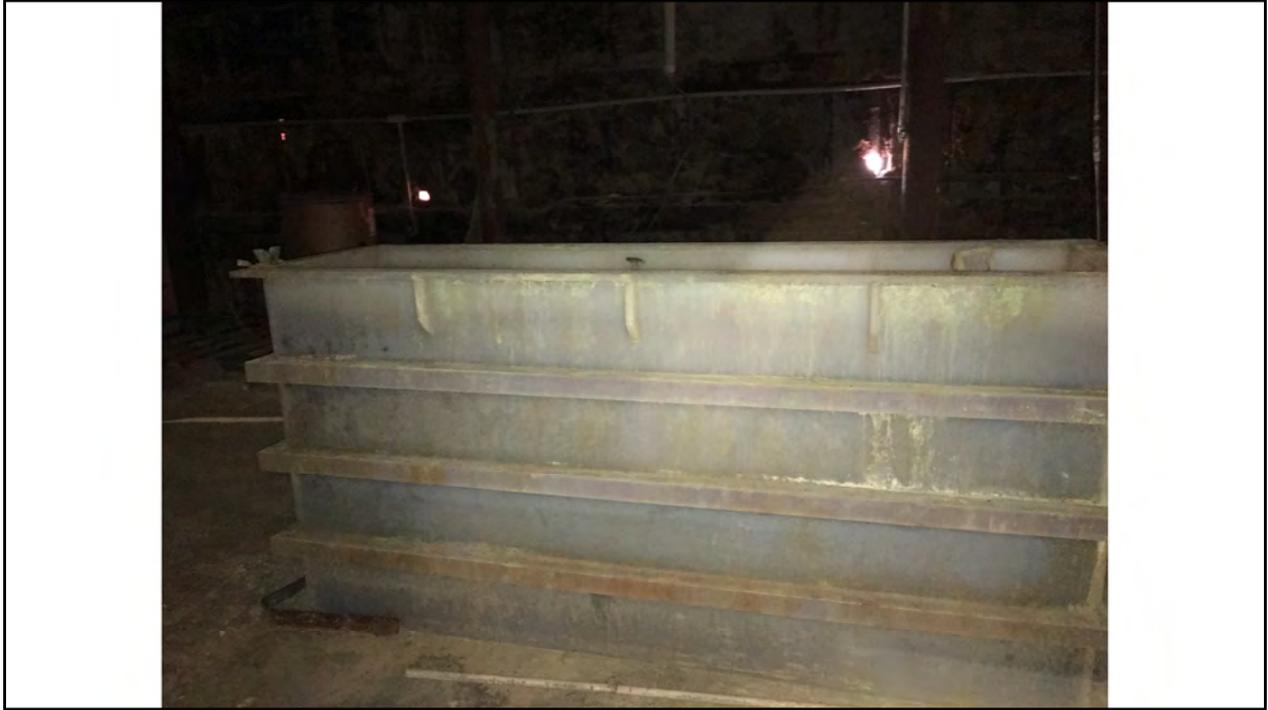
CCS, 10/5/2020, CEI AI# 3106, Livermore Industrial Plating: Site photo. The facility claims product status for all material in dip tank. This is nickel plating solution.

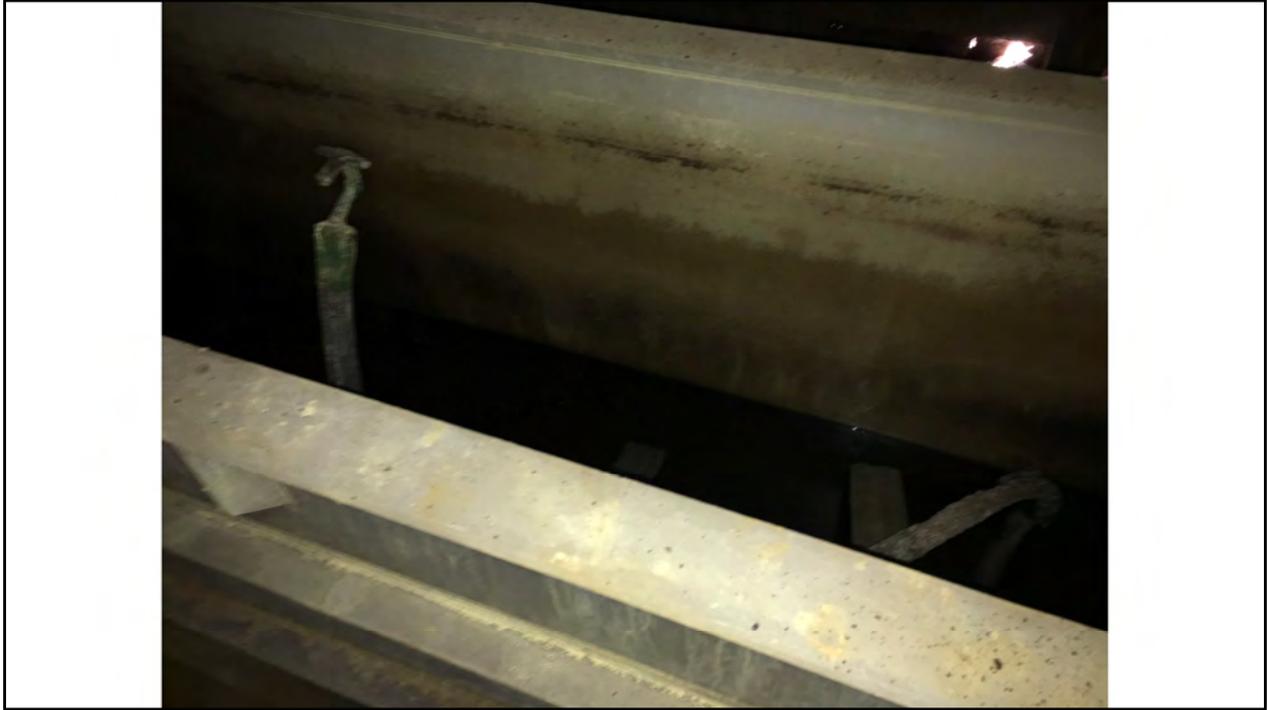
CCS, 10/5/2020, CEI AI# 3106, Livermore Industrial Plating: Site photo. The facility claims product status for all material in dip tank. This is nickel plating solution.
