10/5/2020 CEI AI# 3106
Livermore Industrial Plating

by Scott, Curtis (EEC)

Unregistered site

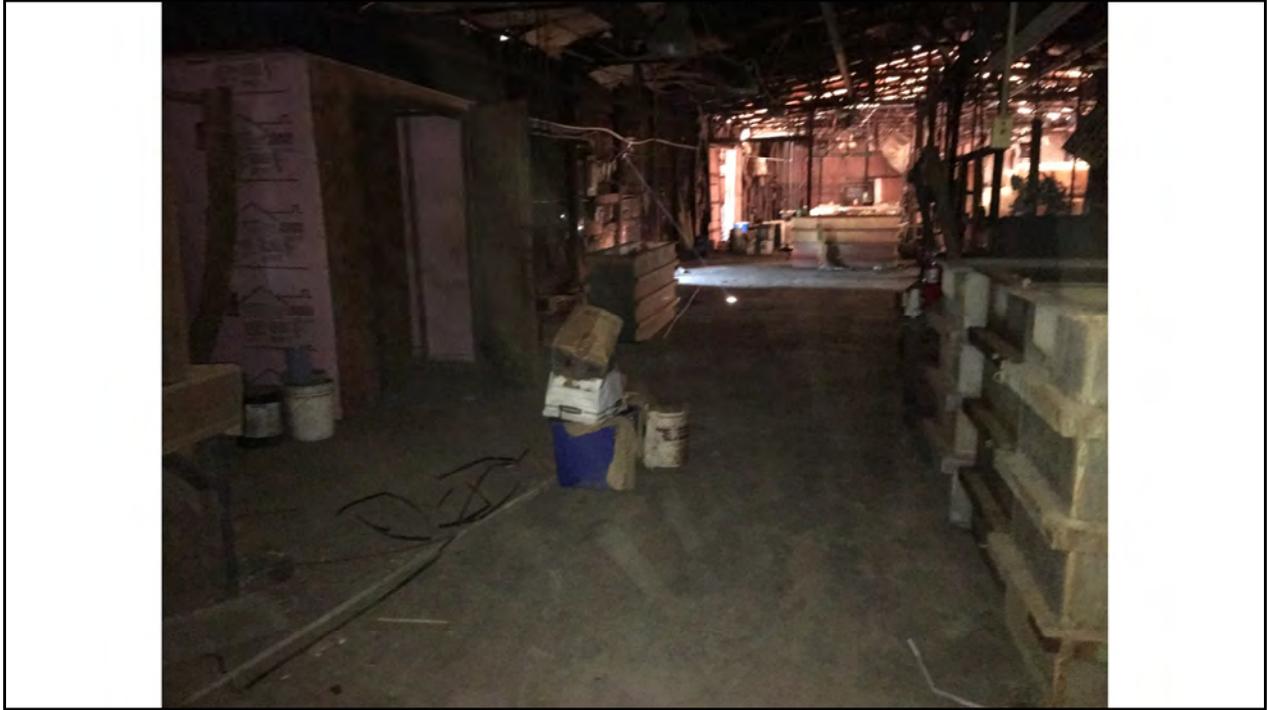
CCS, 10/5/2020, CEI AI# 3106, Livermore Industrial Plating: Site photo. The facility claims product status for all material in dip tank. This is nickel plating solution.

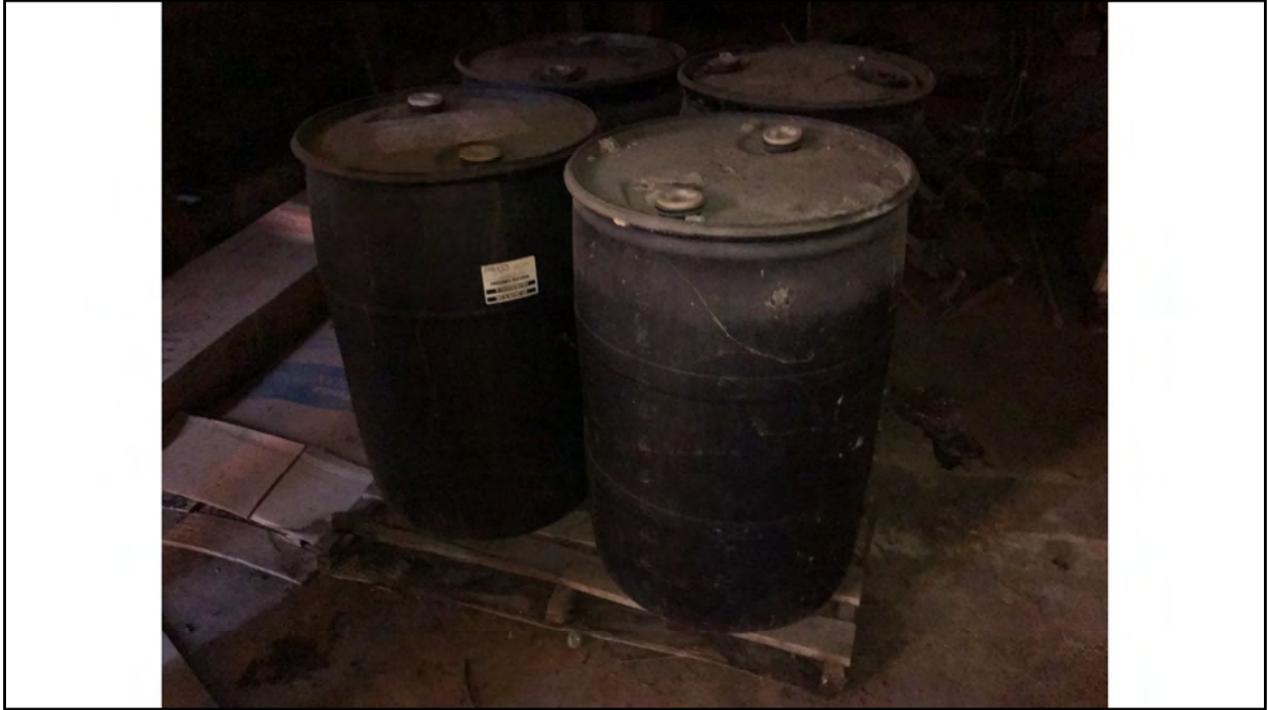
CCS, 10/5/2020, CEI AI# 3106, Livermore Industrial Plating: Site photo. The facility claims product status for all material.

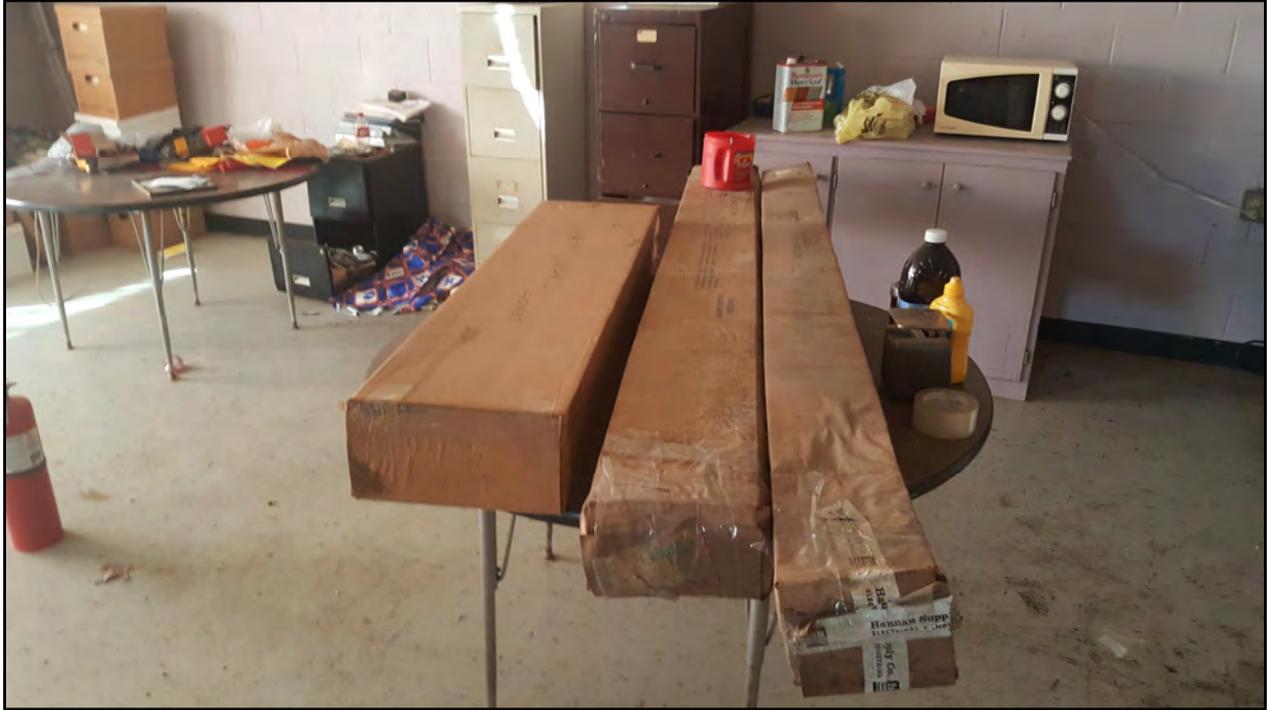
CCS, 10/5/2020, CEI AI# 3106, Livermore Industrial Plating: Universal Waste exceeds one year.
