Occurrence and Attempted Mitigation of Carbon Dioxide in a Home Constructed on Reclaimed Coal-Mine Spoil, Pike County, Indiana

Scientific Investigations Report 2010–5157

By Bret A. Robinson

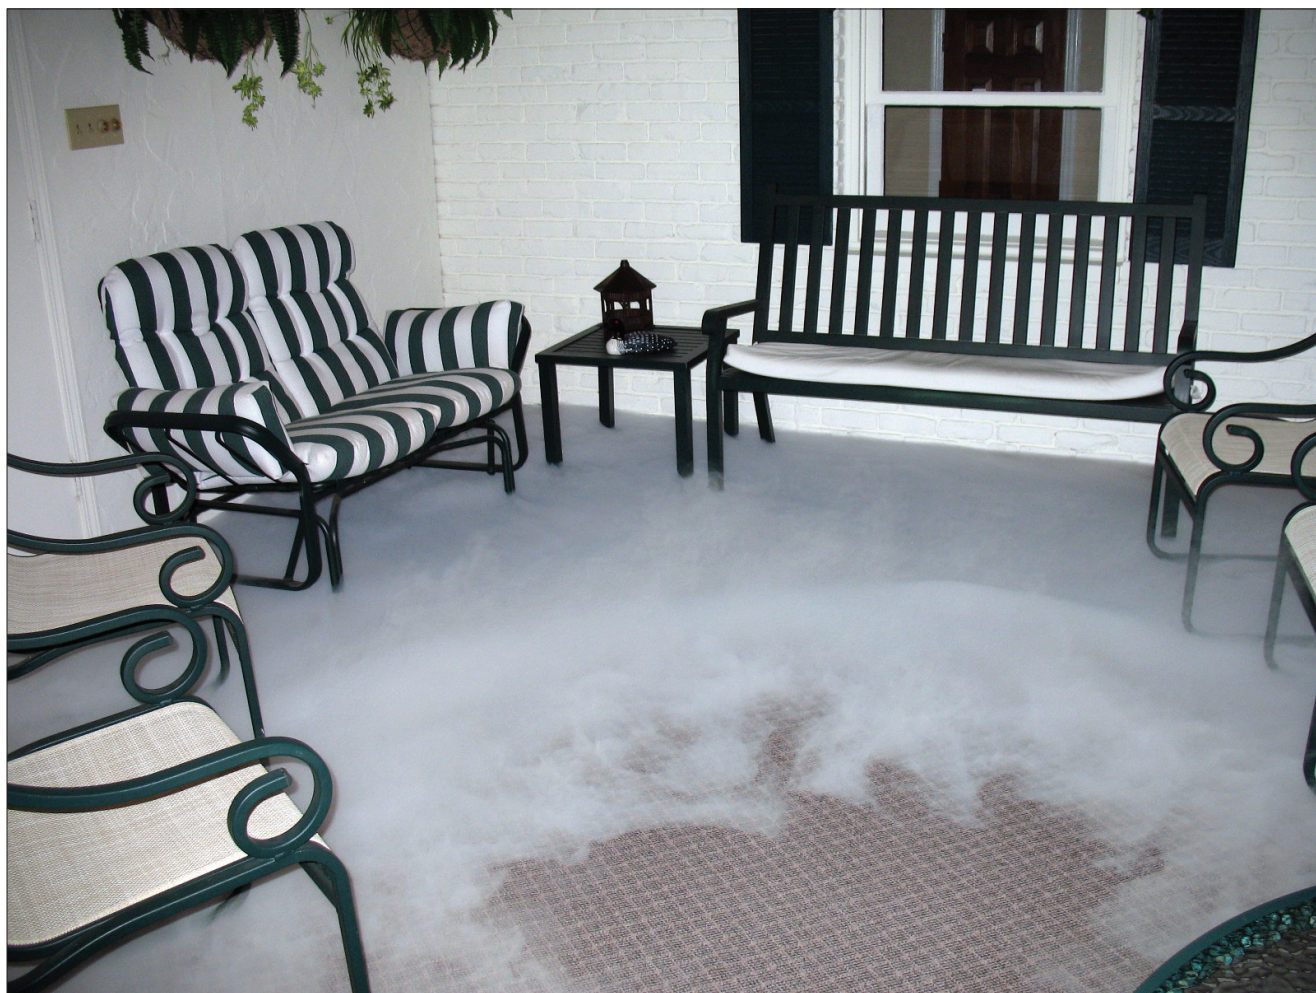
Figure 1. A carbon dioxide cloud that has settled to floor level. (In this photograph, condensation allows the dry-ice-generated carbon dioxide cloud to be visible; however, in most settings, carbon dioxide generated from natural soil processes will not be visible.)

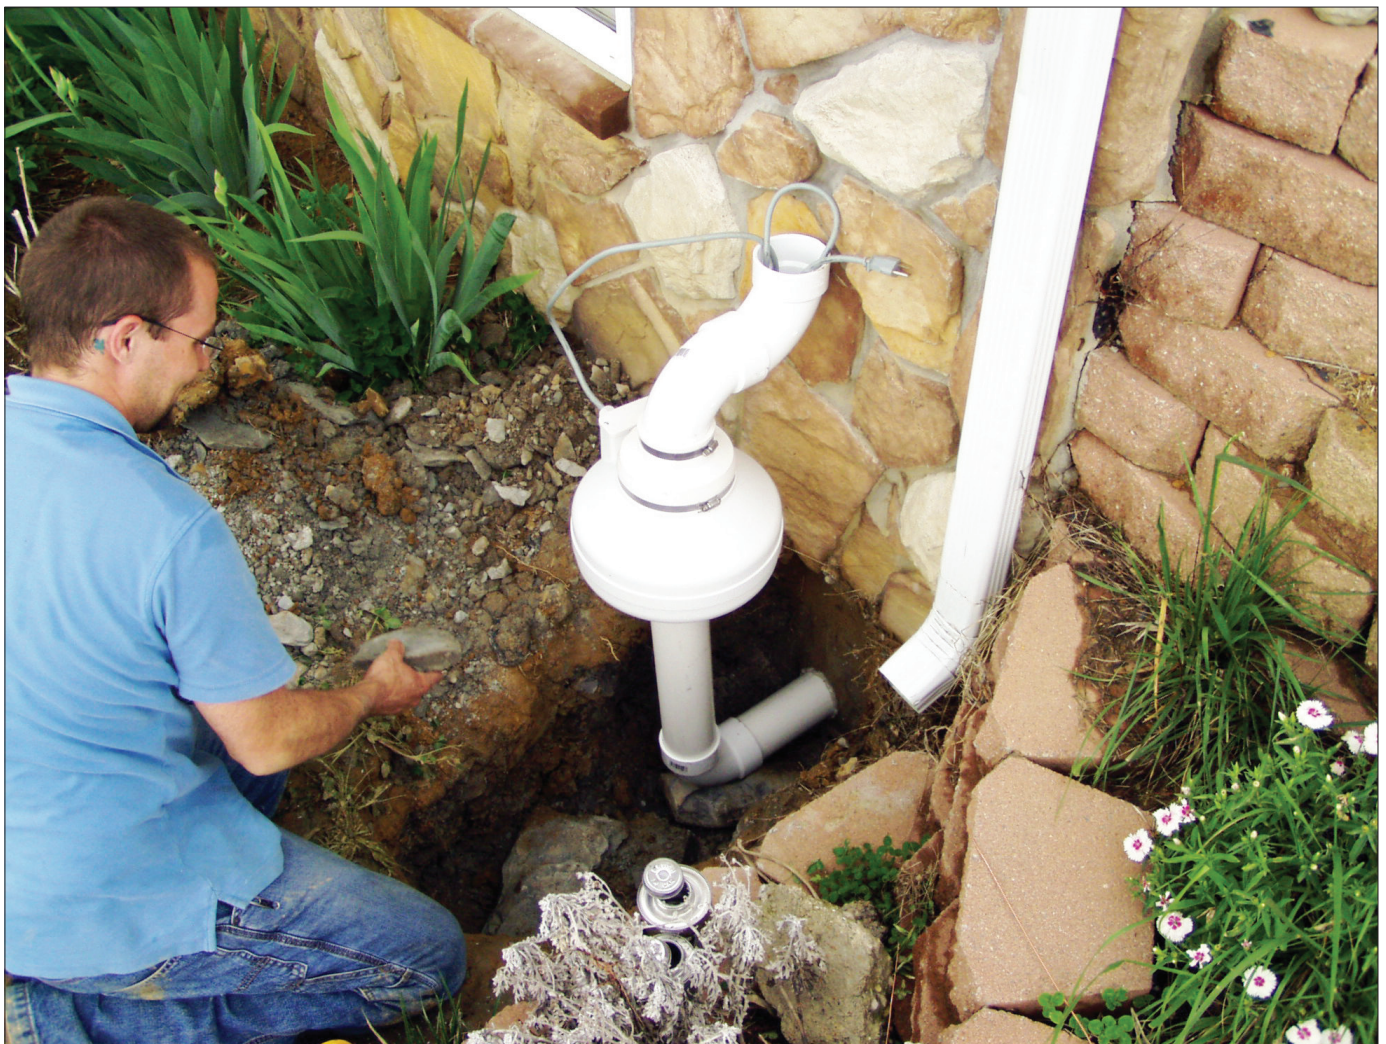
On April 28, 2009, a mitigation system was established to depressurize the block walls of the study-site basement. A small pit was excavated adjacent to the study-site home and an electric drill was used to remove a 4-in.-diameter core from one of the wall blocks. A length of 4-in. PVC pipe was inserted in the cavity of that block and a RadonAway RP 265 fan (RadonAway Inc., Ward Hill, Mass.) was connected to depressurize the basement's block walls (fig. 10) and exhaust the evacuated air to a point just below the home's roofline. The RP 265 fan is a high-volume fan rated to move air at up to 327 cubic feet per minute (ft³/min). To demonstrate that this device was effective at depressurizing the entire perimeter of the basement, a small hole was drilled in the basement wall at the opposite corner of the house and non-thermal smoke was puffed near that hole. The smoke was directly observed being drawn into the drilled hole, thereby confirming that the mitigation system was depressurizing the basement's block walls.

Figure 10. Mitigation system established to depressurize the block walls of the study-site home, Pike County, Ind.
