REMOVAL ASSESSMENT REPORT

**Waymire Drum Source Assessment
7702 Maie Avenue
Los Angeles, Los Angeles County, California**

**U.S. Environmental Protection Agency
Region 9**

June 25, 2020

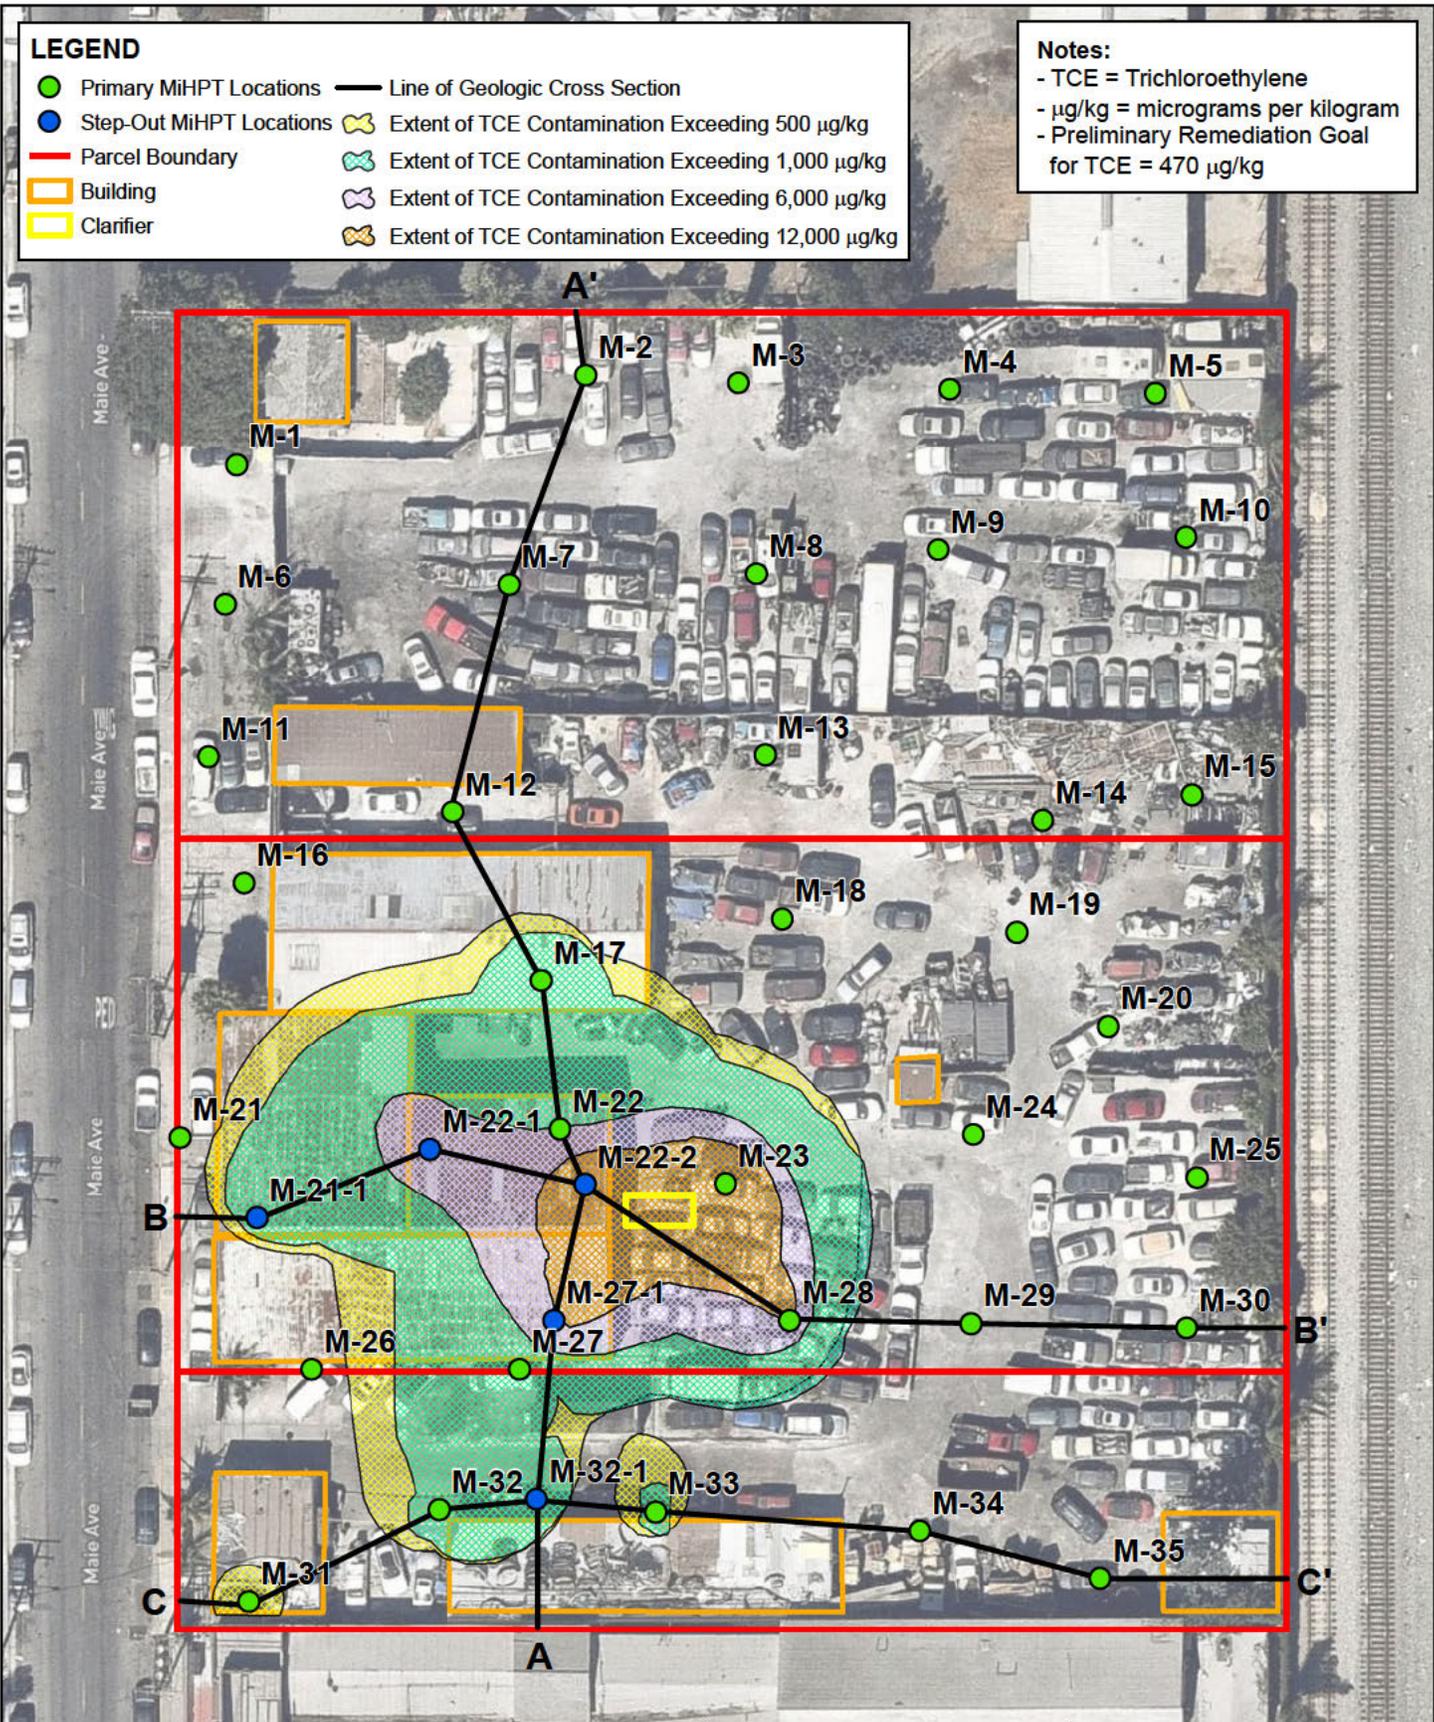
FIGURE 4
Extent of TCE Contamination
7702 Maie Ave.
Weymire Drum Source
Removal Assessment
Los Angeles, Los Angeles County, CA

- TCE = Trichloroethylene
- µg/kg = micrograms per kilogram
- Preliminary Remediation Goal for TCE = 470 µg/kg

Using MiHPT data combined with the correlation data from soil samples, START developed iso-concentration contours and three-dimensional shells for each TCE concentration stated above (Figure 4). COCs appear to be sorbed to the fine soils, clays and silts, and not present in the sands. Black staining was also observed only in the silts and clays, but not in the sands. COCs were in general were found at three depths: within the 10-15-foot silt layer (low readings, moderate concentrations), the silt lens at 21 feet (moderate readings, low to high concentrations) and in the interbedded silts and clays from 27 feet to 37 feet bgs (high readings and high concentrations). COCs were not identified in the sands, though vapor phase COCs have been detected in the sand layers during previous investigation. Additionally, due to the sensitivity of the ECD vapor phase COCs were detected some of the sands, but not detected by the other three detectors.

Using MiHPT readings combined with the correlation data from soil samples, iso-concentration contours and three-dimensional shells were developed for each TCE concentration stated in Section 5.5 (Figure 4 and Appendix I) COCs appear to be sorbed to the fine soils, clays and silts, and not present in the sands. Black staining was also observed only in the silts and clays, but not in the sands. COCs were generally found at three depths: within the 10to15-foot silt layer (low readings, moderate concentrations), the silt lens at 21 feet (moderate readings, low to high concentrations) and in the interbedded silts and clays from 27 feet to 37 feet bgs (high readings and high concentrations). COCs were not identified in the sands; although, vapor phase COCs had been detected in the sand layers during a previous investigation. Additionally, because of the sensitivity of the ECD vapor phase COCs were detected in some of the sands, but not identified by the other three detectors. Cross-sections of the lithology and TCE concentrations were developed and are presented on Figure 5 through Figure 10. The cross sections are mapped onto the extent of TCE contamination on Figure 4. Cross-section A to A' starts at the southern edge of the Site and passes through the clarifier as it extends to the northern edge of the Site. B-B' is from west to east in the central portion of the property going through the clarifier. C to C' is in the southern part of the Site extends from the western edge of the Site to the eastern edge of the Site.

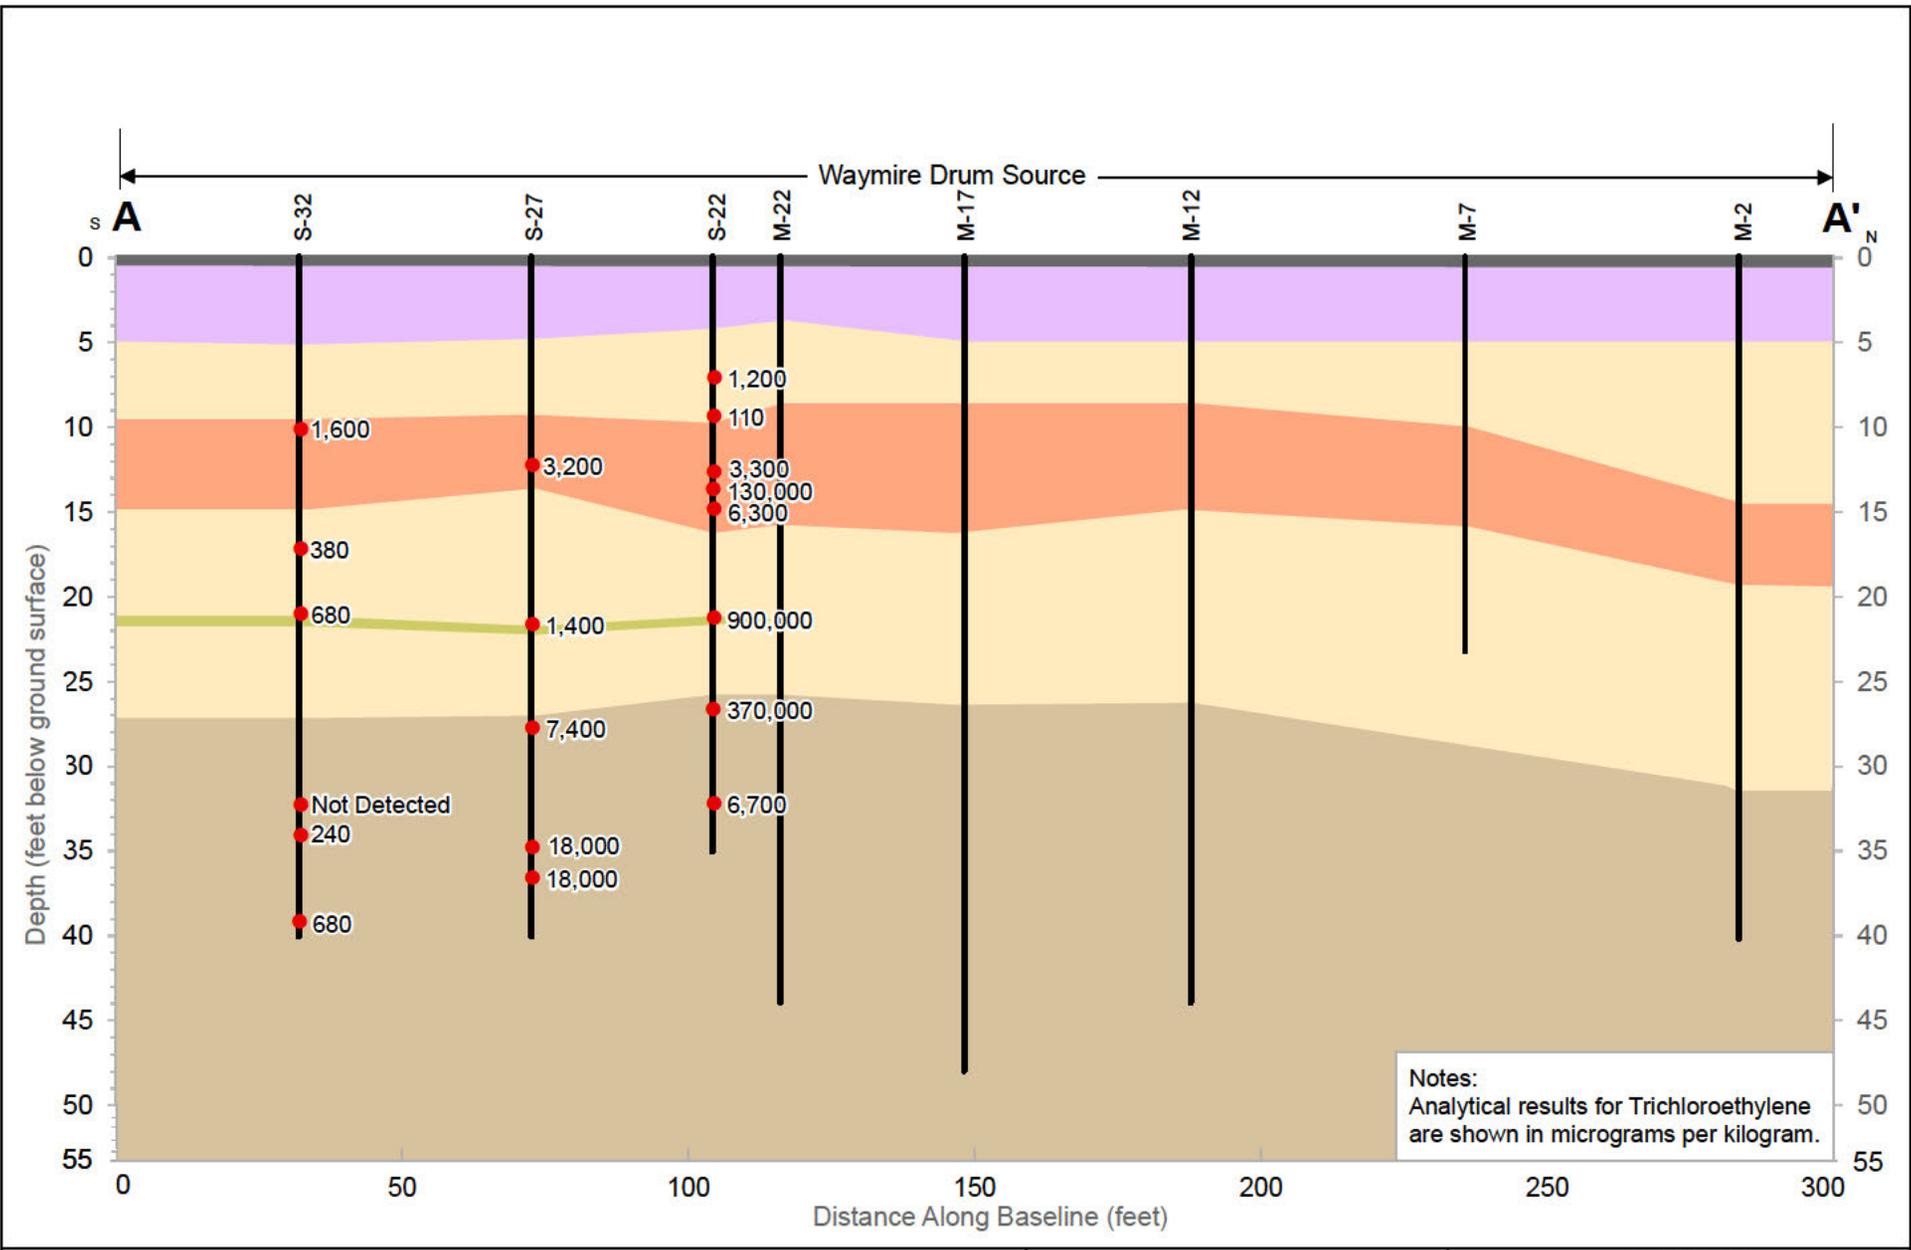
FIGURE 5
Cross Section A - A'
TCE Results in Soil
Waymire Drum Source
Removal Assessment
7702 Maie Ave.
Los Angeles, Los Angeles County, CA

Notes:
Analytical results for Trichloroethylene are shown in micrograms per kilogram.

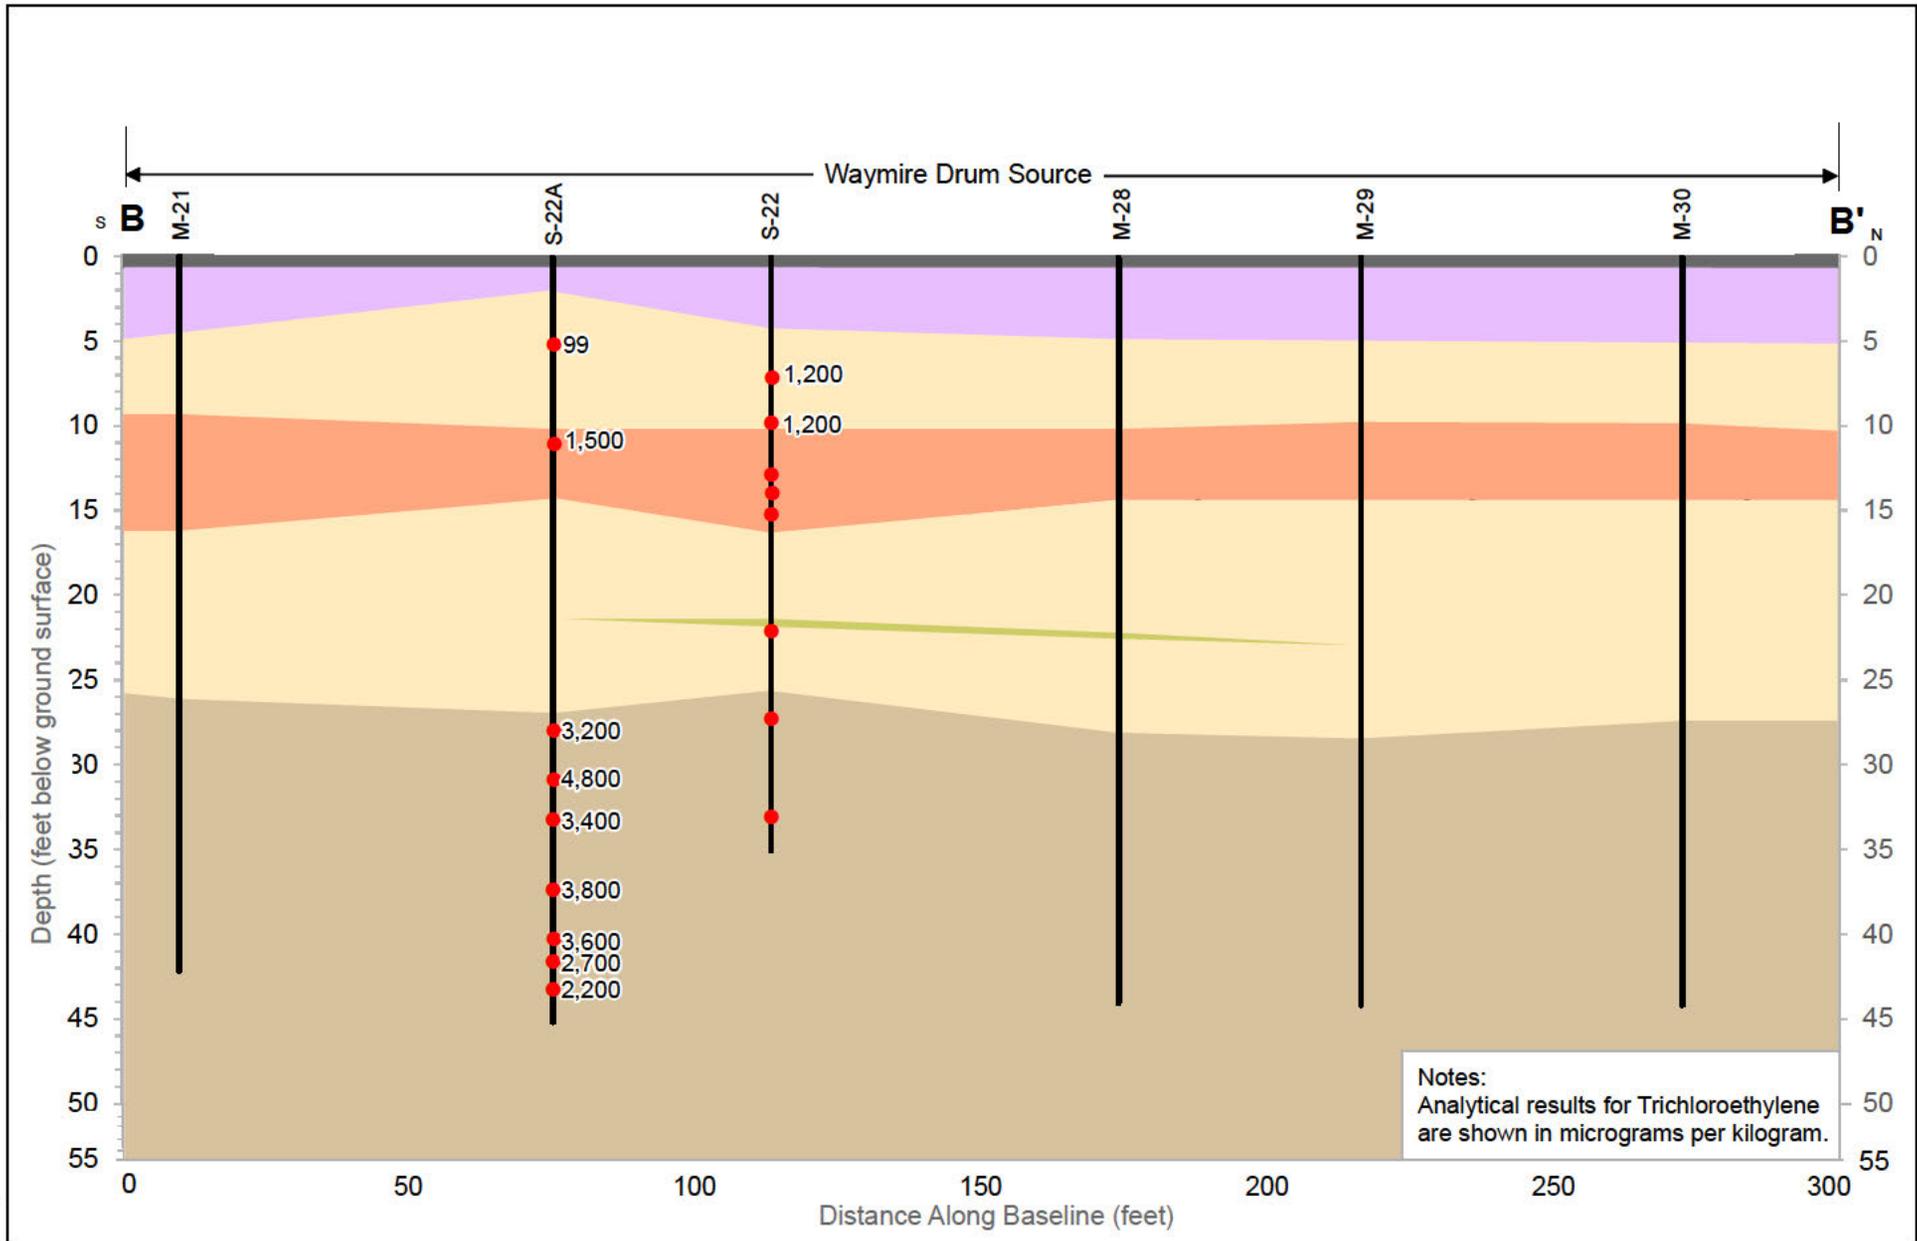
FIGURE 6
Cross Section B - B'
TCE Results in Soil
Waymire Drum Source
Removal Assessment
7702 Maie Ave.
Los Angeles, Los Angeles County, CA

Notes:
Analytical results for Trichloroethylene are shown in micrograms per kilogram.

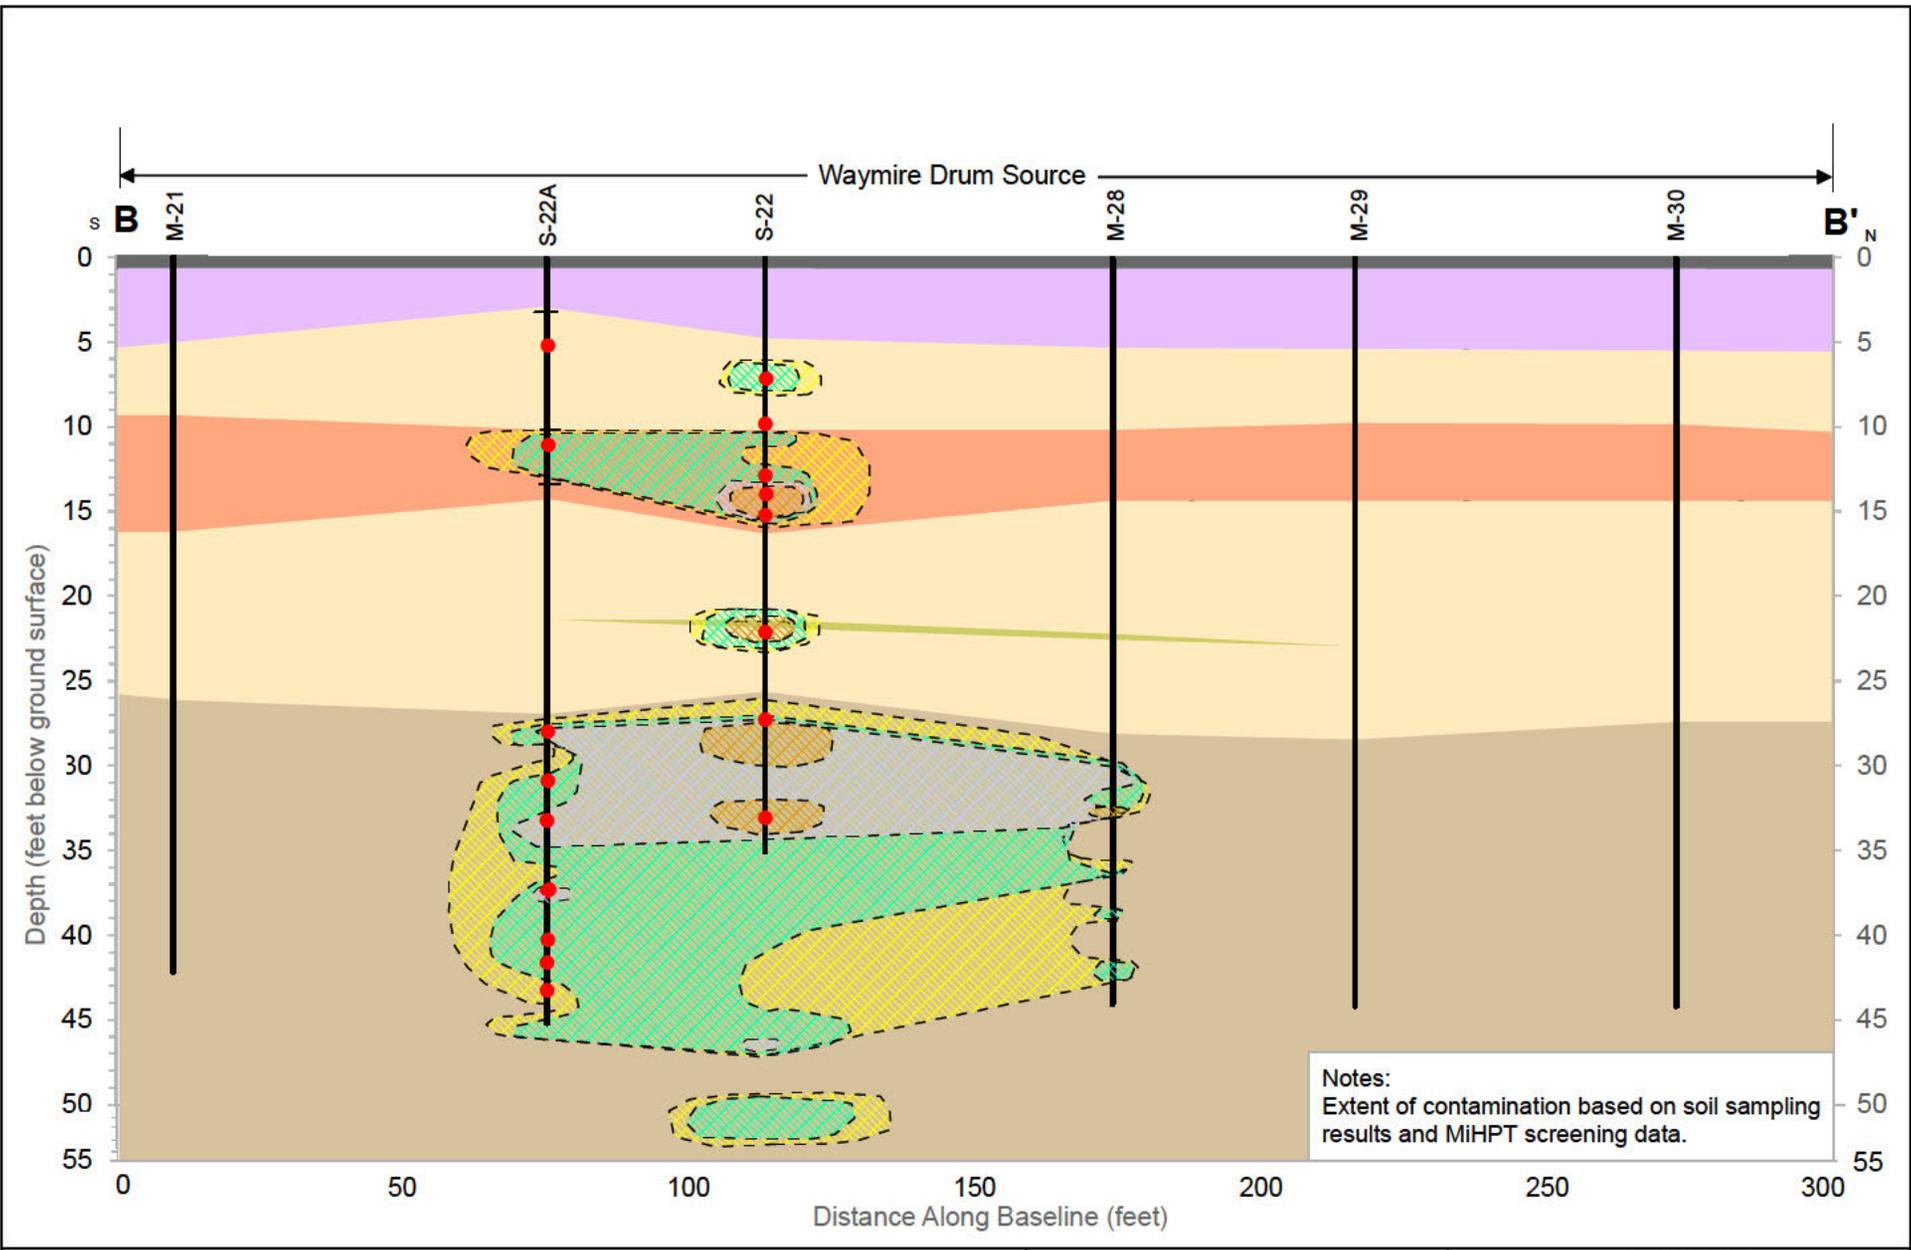
Notes:
Extent of contamination based on soil sampling results and MiHPT screening data.

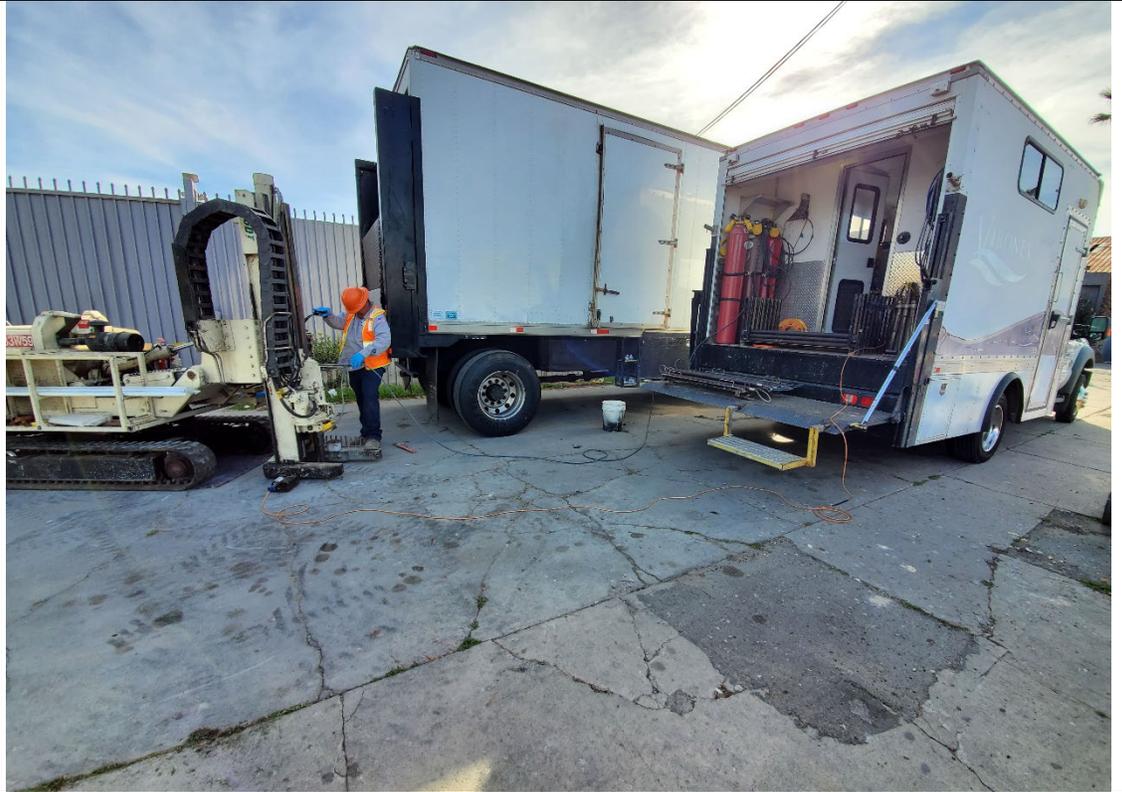
Southeast overview of MiHPT activities at location M-6

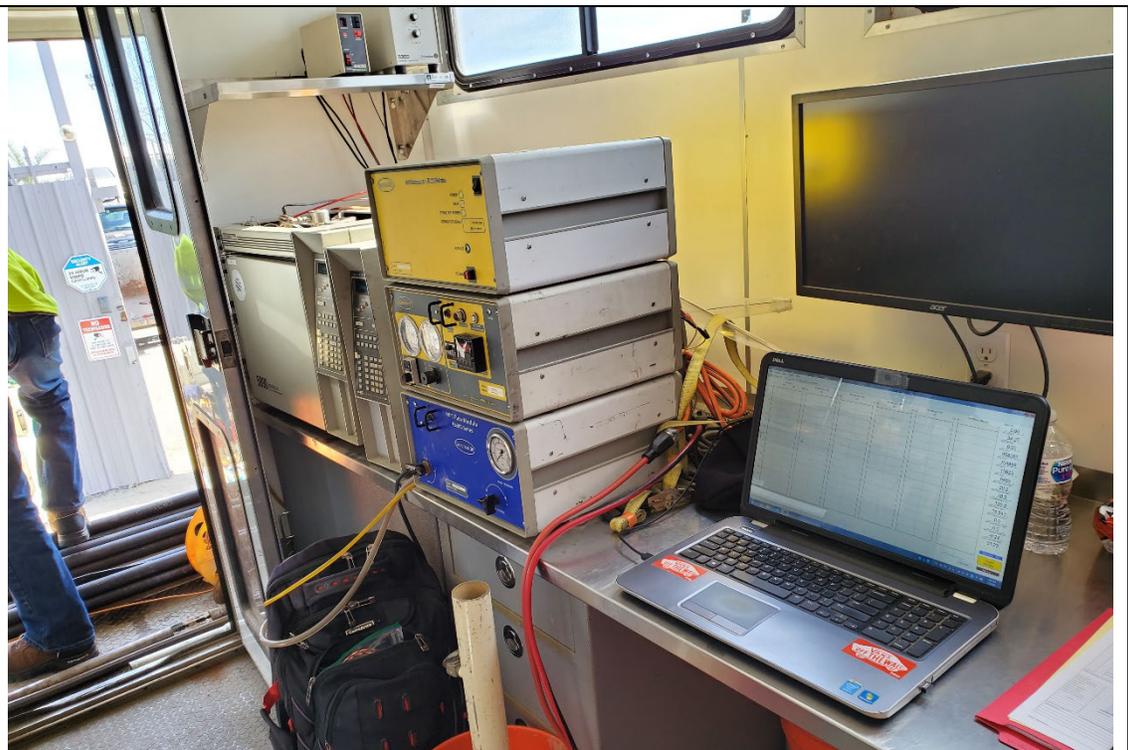
Photo No. 2 **Date:** 02/05/2020

Interior overview of MiHPT equipment

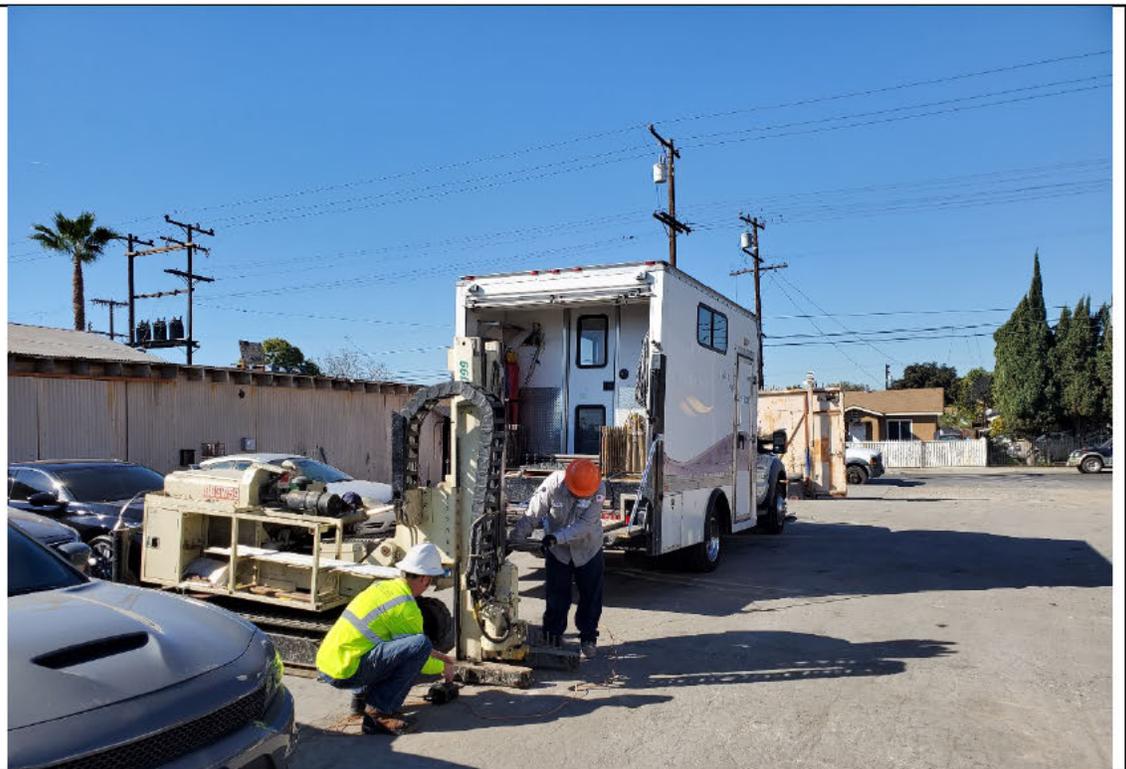
Photo No. 3	Date: 02/06/2020
Direction Photo Taken: West	
Description: West overview of MiHPT activities at location M-7

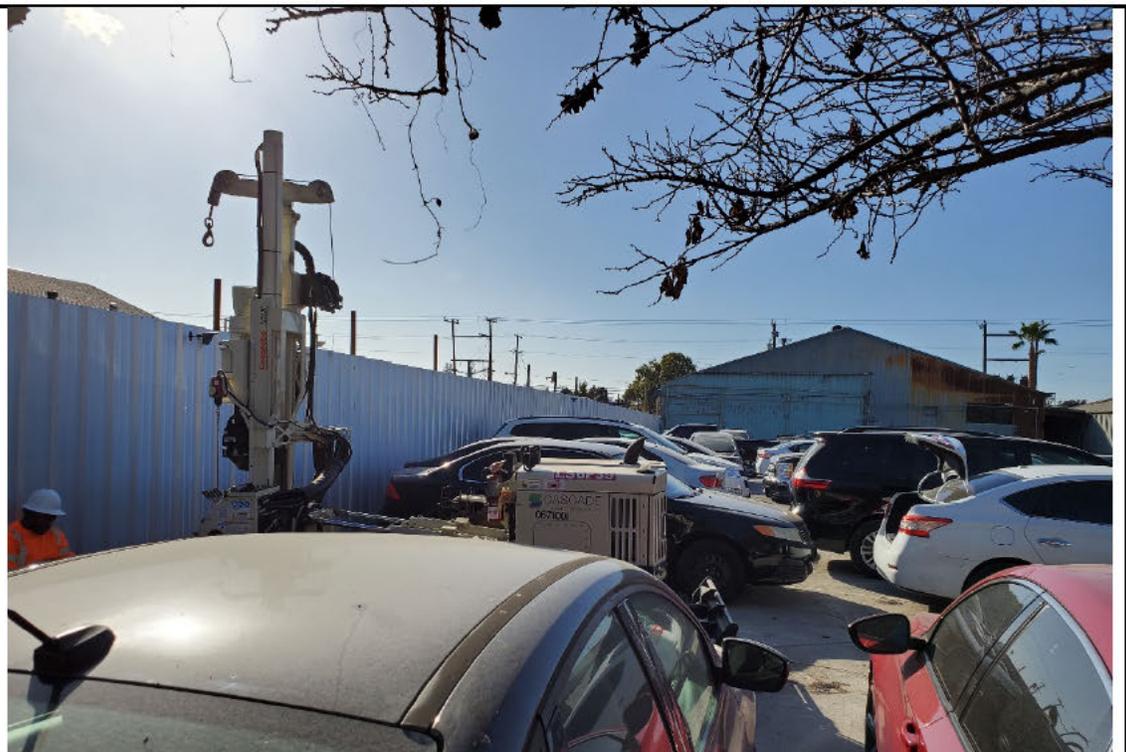
Photo No. 4	Date: 12/10/2019
Direction Photo Taken: West	
Description: West overview of MiHPT activities at location M-30

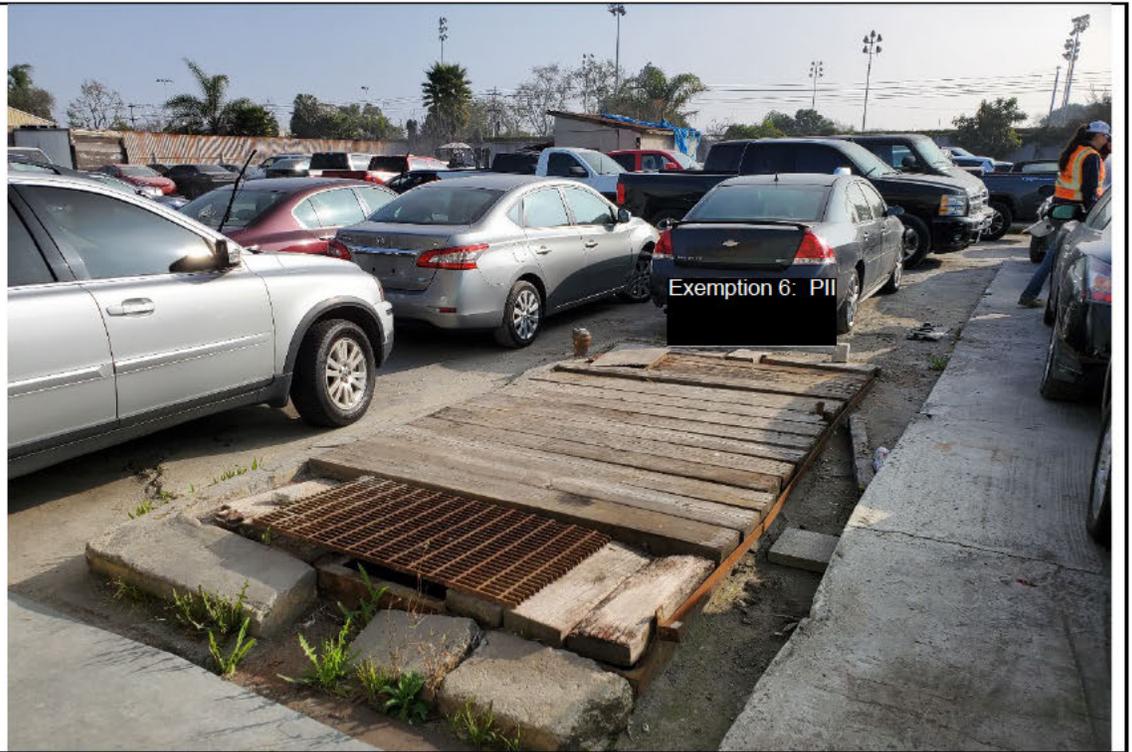
Photo No. 5	Date: 02/19/2020
Direction Photo Taken: Southeast	
Description: Southeast overview of clarifier within grid location 23

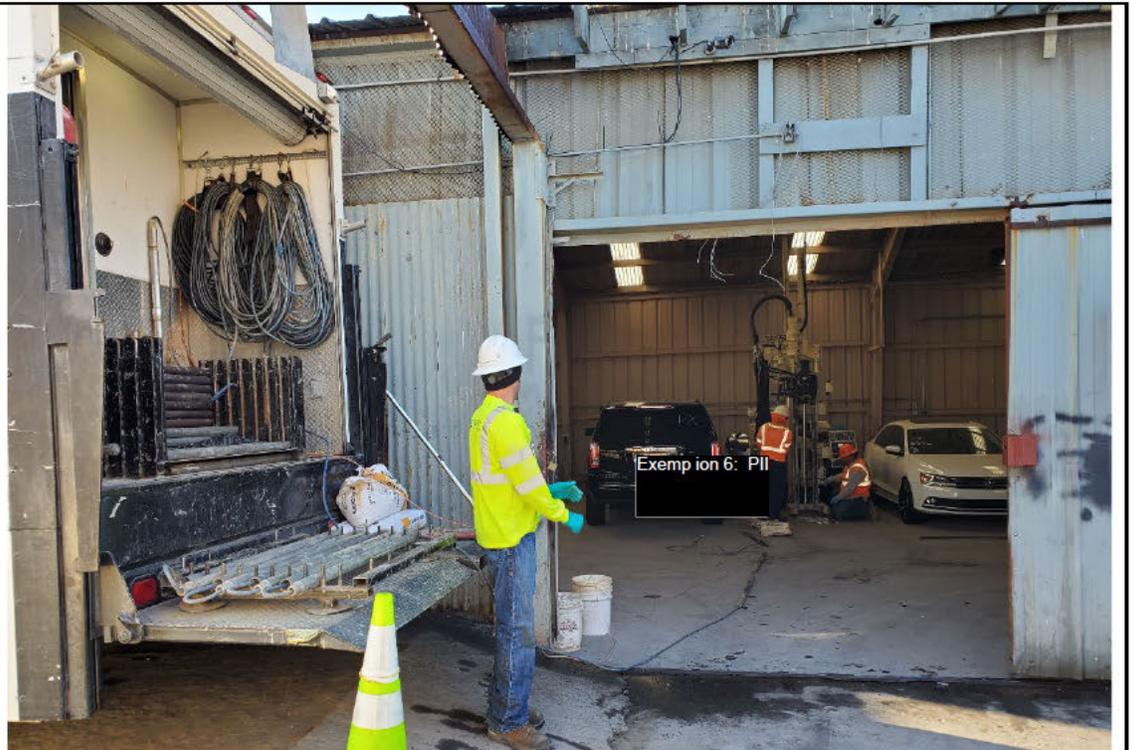
Photo No. 6	Date: 02/20/2020
Direction Photo Taken: South	
Description: Overview photo MiHPT activities at location M-17

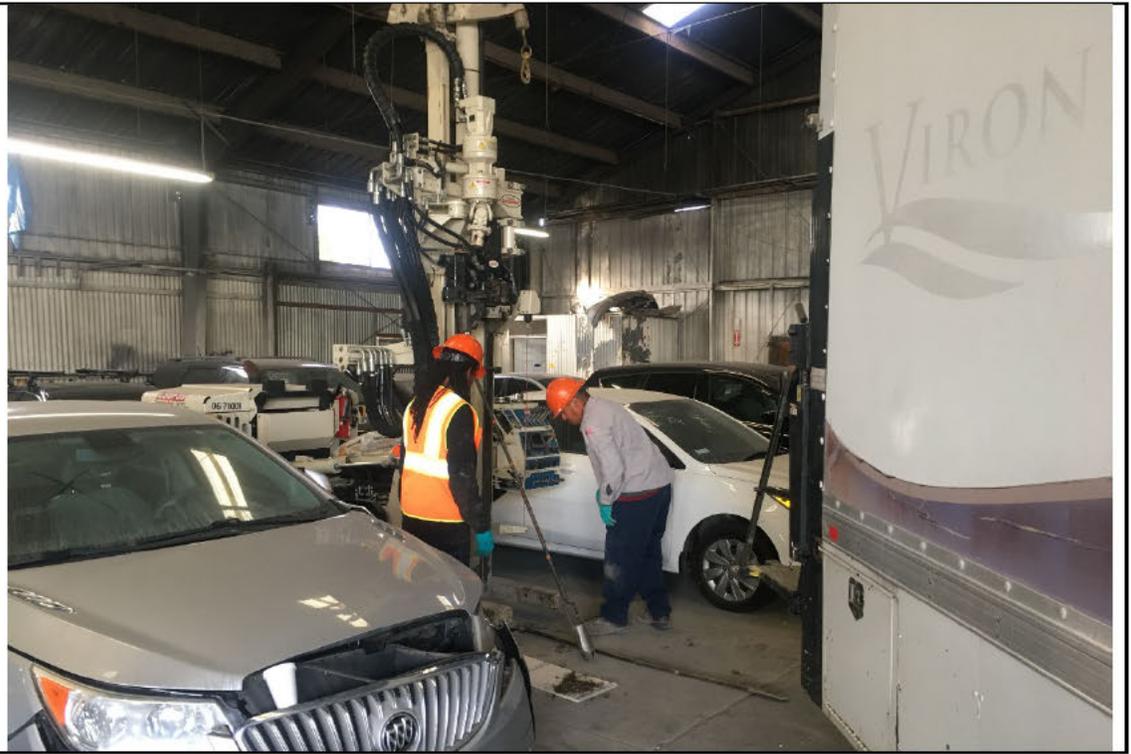
Photo No. 7	Date: 02/21/2020
Direction Photo Taken: Southwest	
Description: Southwest overview of MiHPT activities at location M-21-1

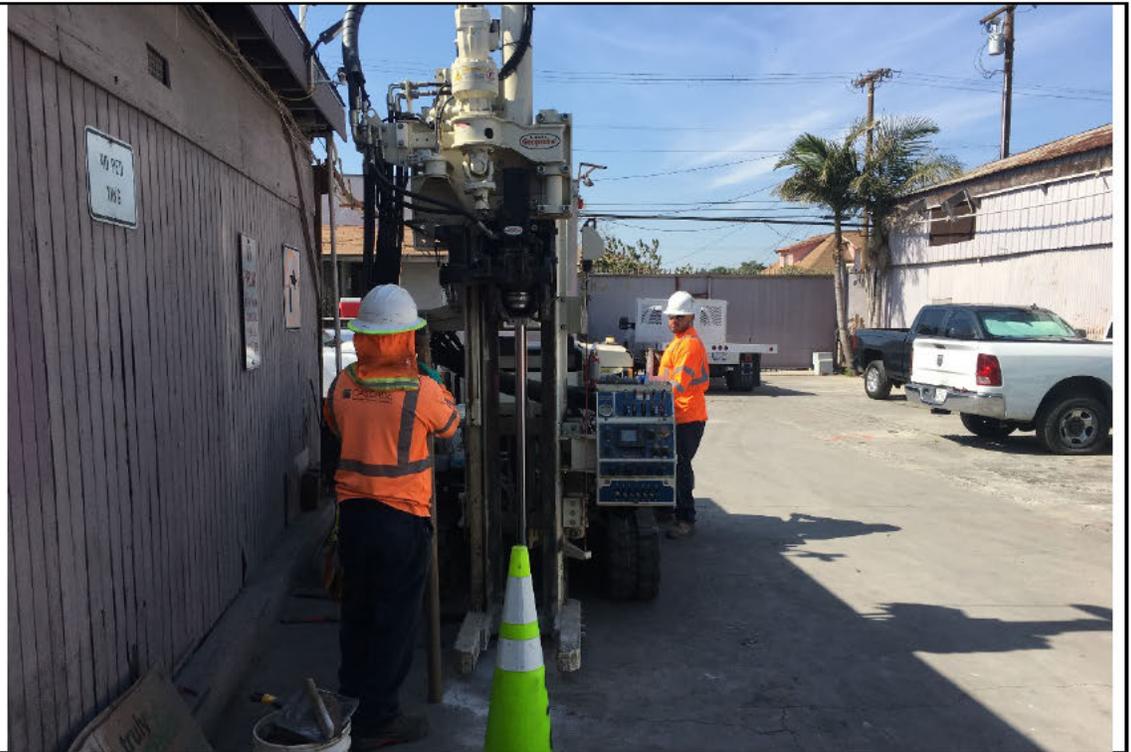
Photo No. 8	Date: 02/24/2020
Direction Photo Taken: West	
Description: West overview of soil sampling activities at location S-32

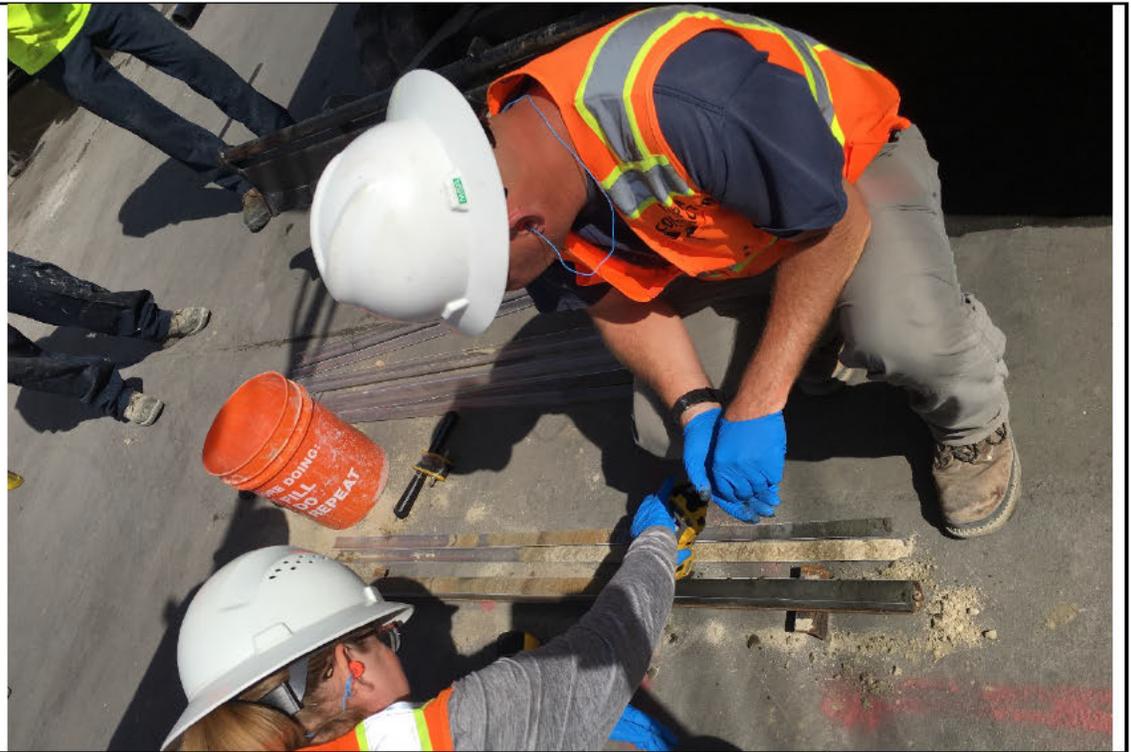
Photo No. 9	Date: 02/25/2020
Direction Photo Taken: Northwest	
Description: START collecting soil samples from location S-32

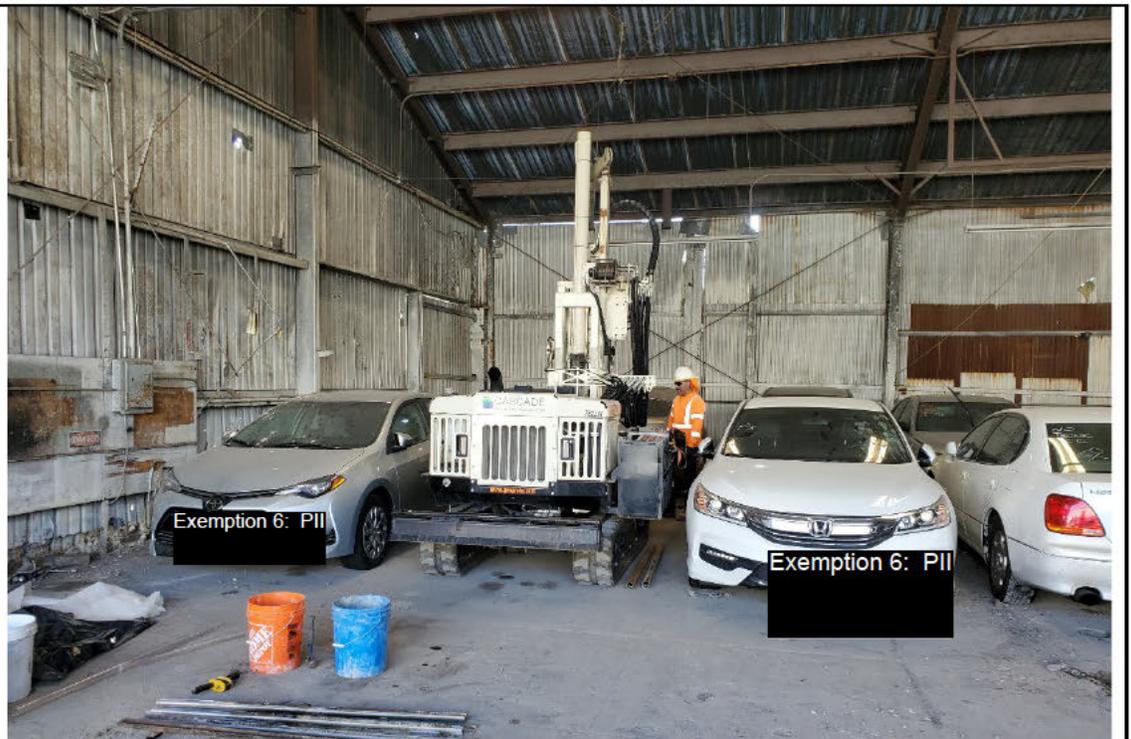
Photo No. 10	Date: 02/25/2020
Direction Photo Taken: South	
Description: South at soil sampling activities at location S-27

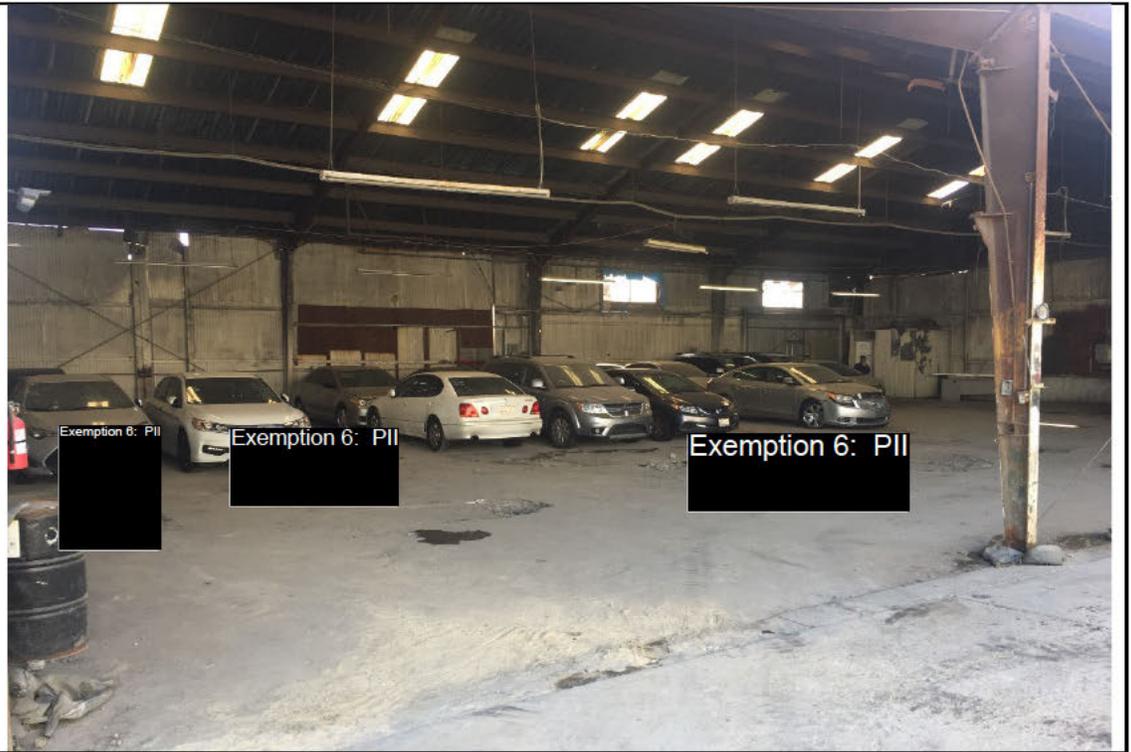
Photo No. 11	Date: 02/26/2020
Direction Photo Taken: Southwest	
Description: Southwest overview of sample grid location 22
