**MEMORANDUM**

**SUBJECT:** Approval and Funding for a Time-Critical Removal Action at the Onalaska Wood Pyrolysis Site, Onalaska, Lewis County, Washington

The purpose of this Action Memorandum is to request, and document approval of the selected Time-Critical Removal Action described herein for the Onalaska Wood Pyrolysis site (Site) located at 1674 State Highway 508, Chehalis, Lewis County, Washington.

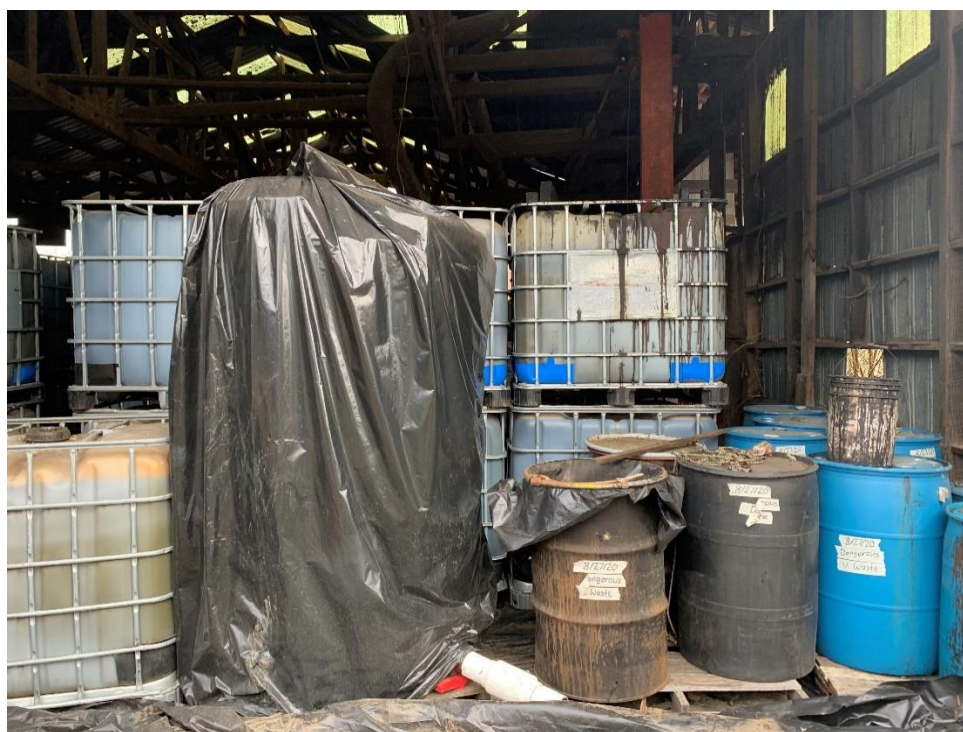
Figure 2: Various sized containers of wood tar and wood vinegar waste in the former warehouse/sawmill building.

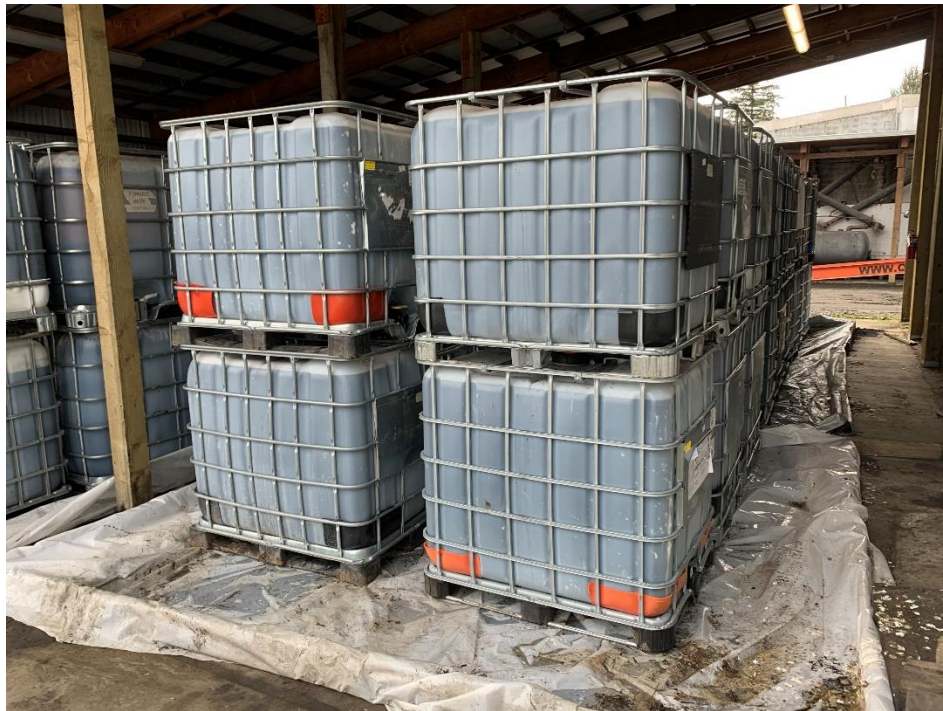
*Figure 3: Totes containing an estimated 24,000 gallons of waste located under the Lean-To with no security or secondary containment.*

After totes and other vessels have been decanted of liquids, the remaining solid tar material in totes, ASTs, and containment will be solidified using available sawdust material on site, loaded into one to one and a half cubic yard “wrangler” boxes designed to handle hazardous waste. This boxed material will be staged and transported on placarded trucks to an appropriate disposal facility. The leftover empty totes and ASTs will be crushed for disposal as non-regulated solid waste. The containment area will be decontaminated of tar residue and left with valves open to prevent the continued accumulation of rainwater.

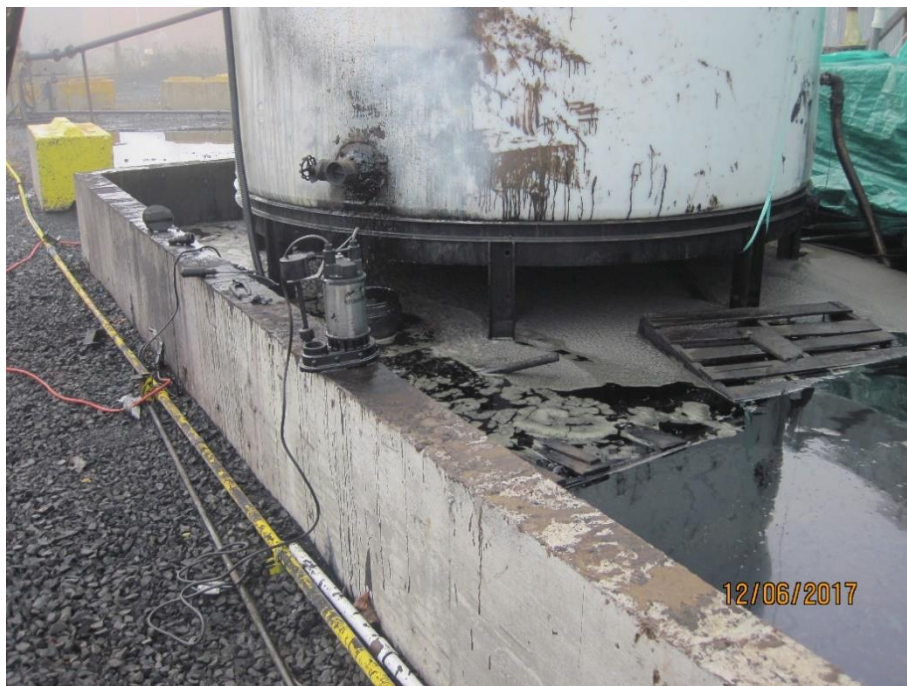
*Figure 4: Wood vinegar and wood tar accumulated within secondary containment observed by Ecology during a 2017 inspection.*

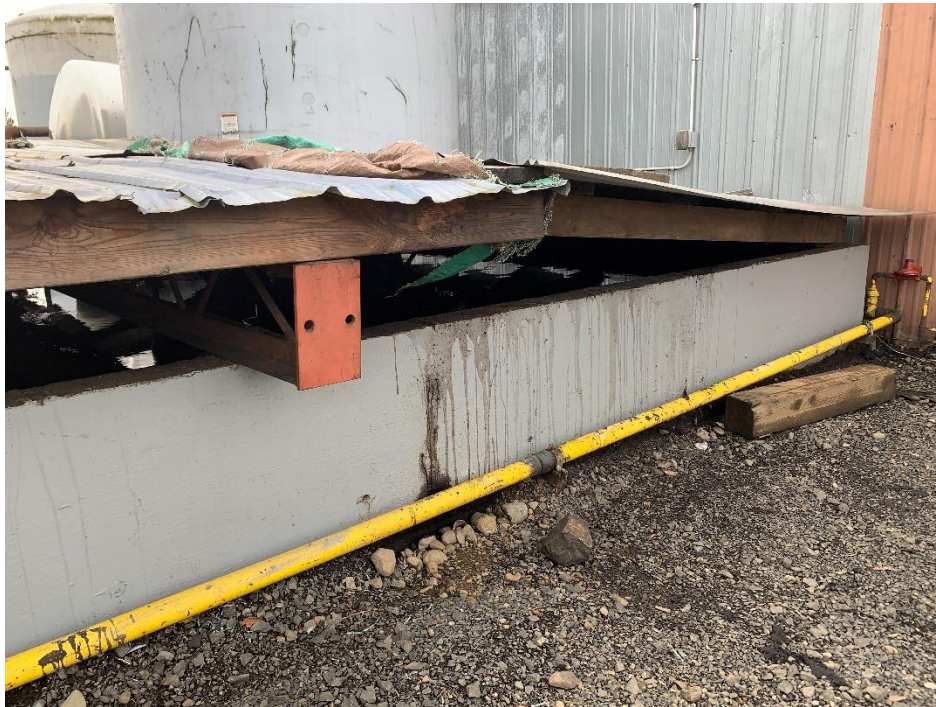
*Figure 5: Staining along containment sidewalls observed by EPA in 2021 suggests the potential for releases of hazardous substances from overflow and cracks in the walls.*

Visual staining of the soils in the area surrounding the secondary containment indicates that the walls of the secondary containment have been breached due to rain or other causes. Based on formal complaints and letters provided by Lewis County Water District #2 to Ecology there is reason to believe that poor past management of hazardous waste on the Site may have exposed surface soils in several areas of the property to contaminants from wood tar and wood vinegar including VOCs and SVOCs. Contaminants in surface soils would have likely migrated during storm events into stormwater ponds, which then discharge to Gheer Creek, a tributary of the South Fork of the Newaukum River. Infiltration of contaminants in surface soils is also a concern, particularly given that the Site resides above a Critical Aquifer Recharge Area. By removing source material, EPA will be preventing any continued releases to surface soils and allow Ecology's Toxic Cleanup Program to work with property owners to manage any existing soil contamination that may still be present from past releases.

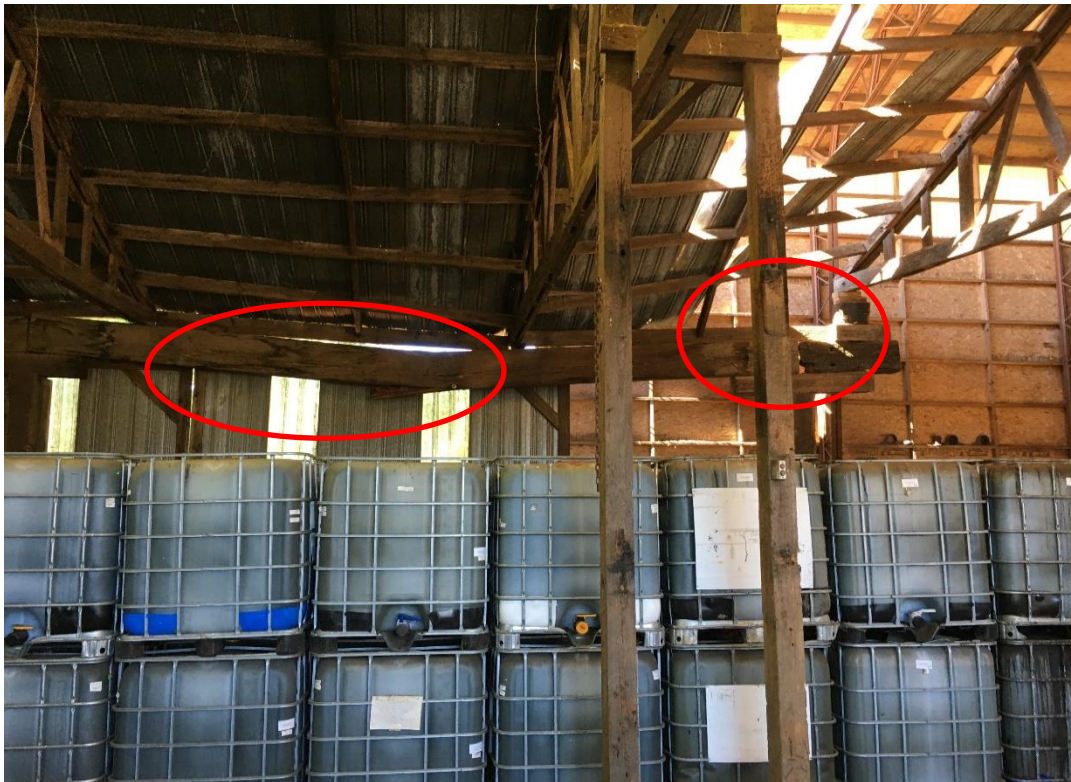
*Figure 6: Totes containing 43,675 gallons of hazardous substances stored in the structurally unsound sawmill building days before it collapsed. Two key areas of concern to the Lewis County Building Official are circled in red.*
