Telluride Valley Floor

A U.S. EPA Region 8 Story Map

July 31, 2021

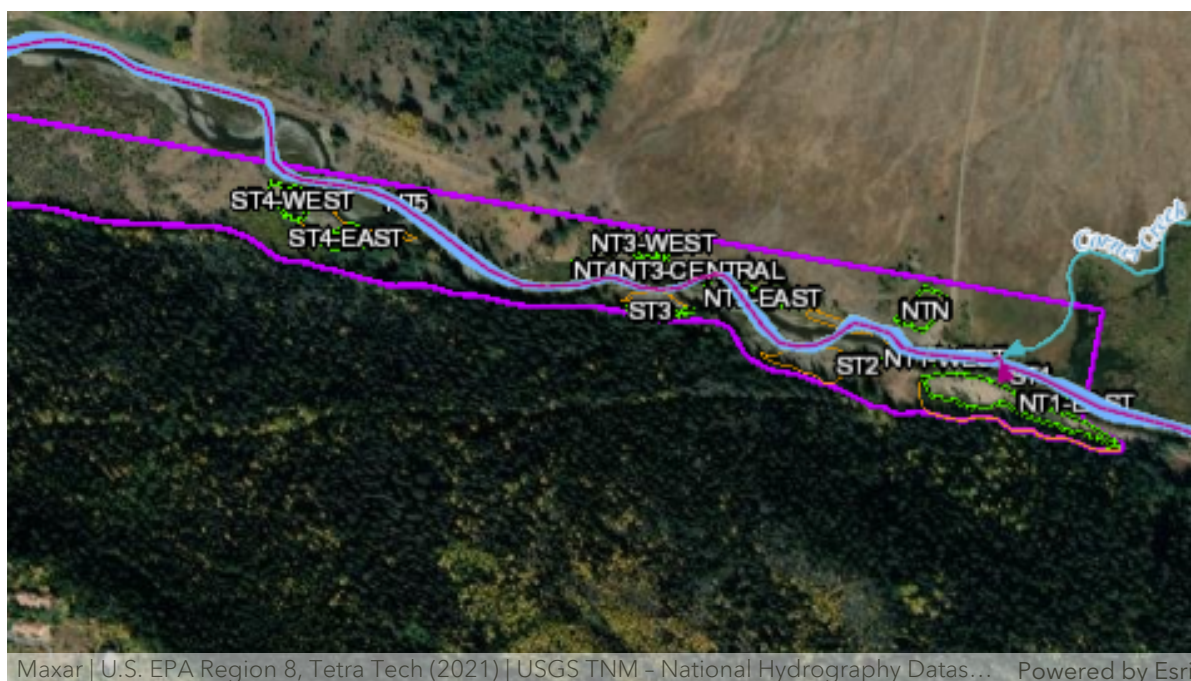
Site Layout

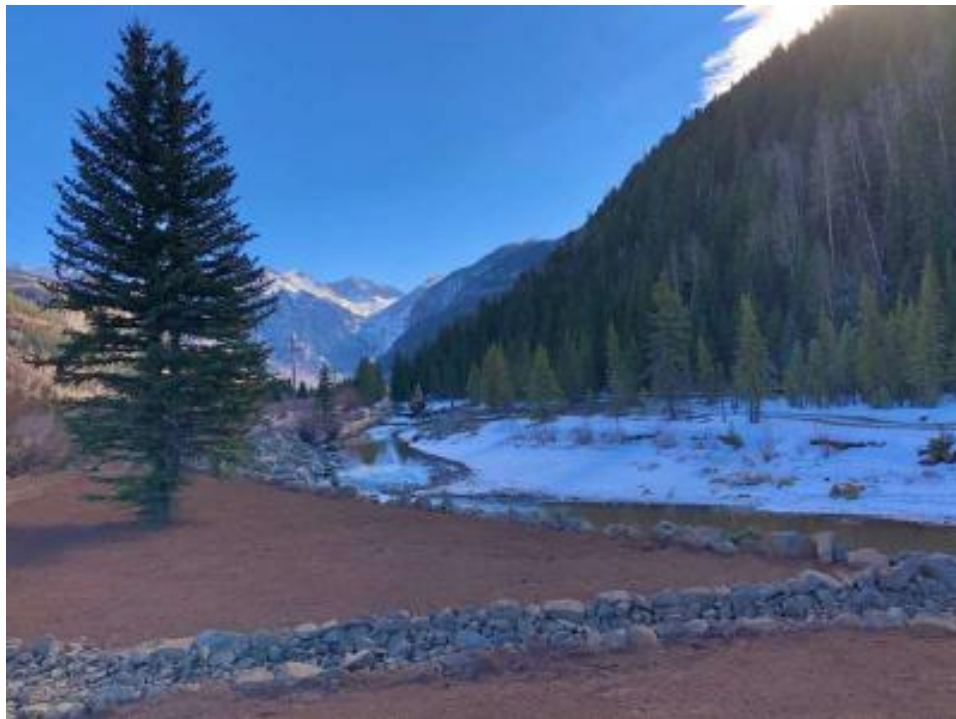
Completed North Riverbank Lining and Arm

- Removed up to 3,000 cubic yards of tailing and stabilized/armored bank area.
- Installed a low water crossing for moving equipment and material.
- Stabilized hike/bike area by placing a thin cap of gravel over the tailings.
- Placed barriers around contaminated areas, until mitigated or cleaned up.
- Hauled excavated contaminated material to state-designated, responsible party-owned on-site repository.

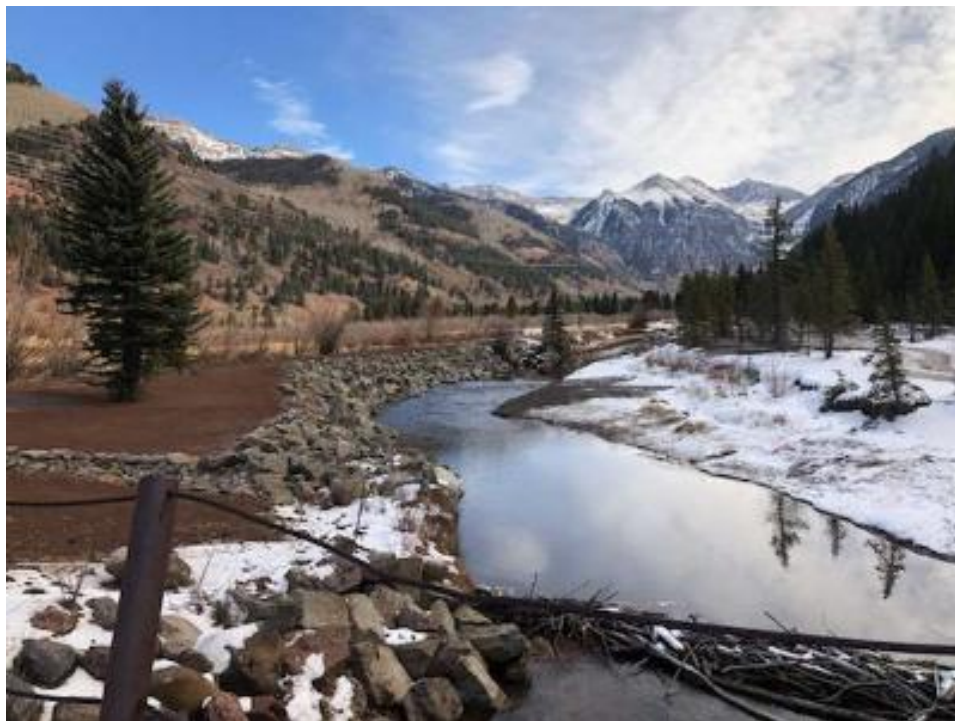
Installed Drainage Controls

- Installation of erosion controls to mitigate runoff from the excavation and stockpile operations.
