## Overview

U.S. Environmental Protection Agency, in conjunction with U.S. Forest Service, is conducting a joint Removal Action at the Telluride Valley Floor Site, which is located in Telluride, CO.

This Story Map will provide an up to date summary of work progress during the Phase 2 Time Critical Removal Action.

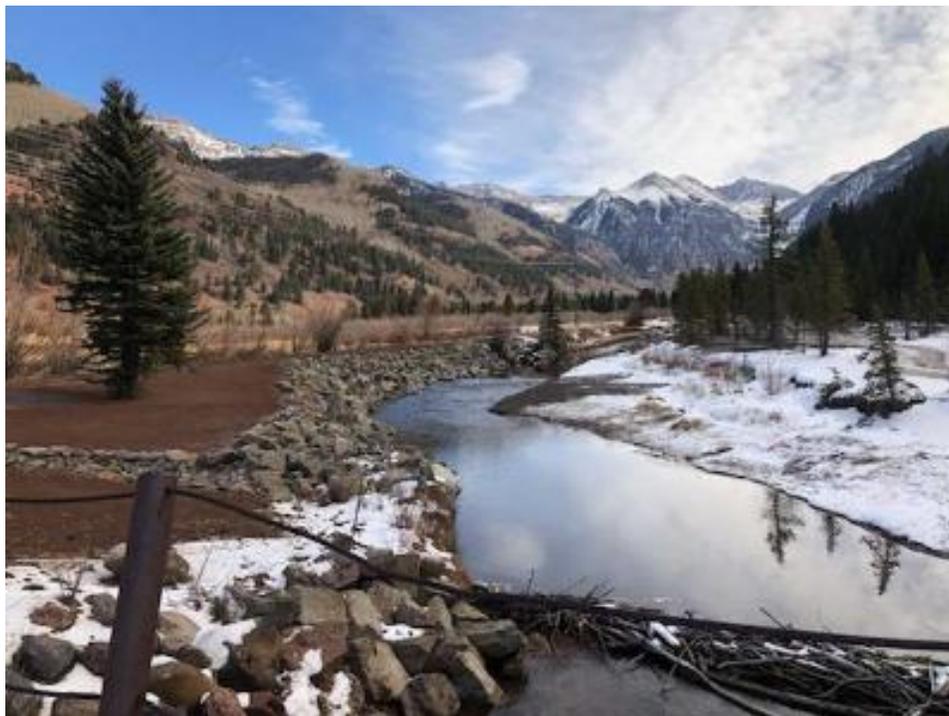
Installed Drainage Controls

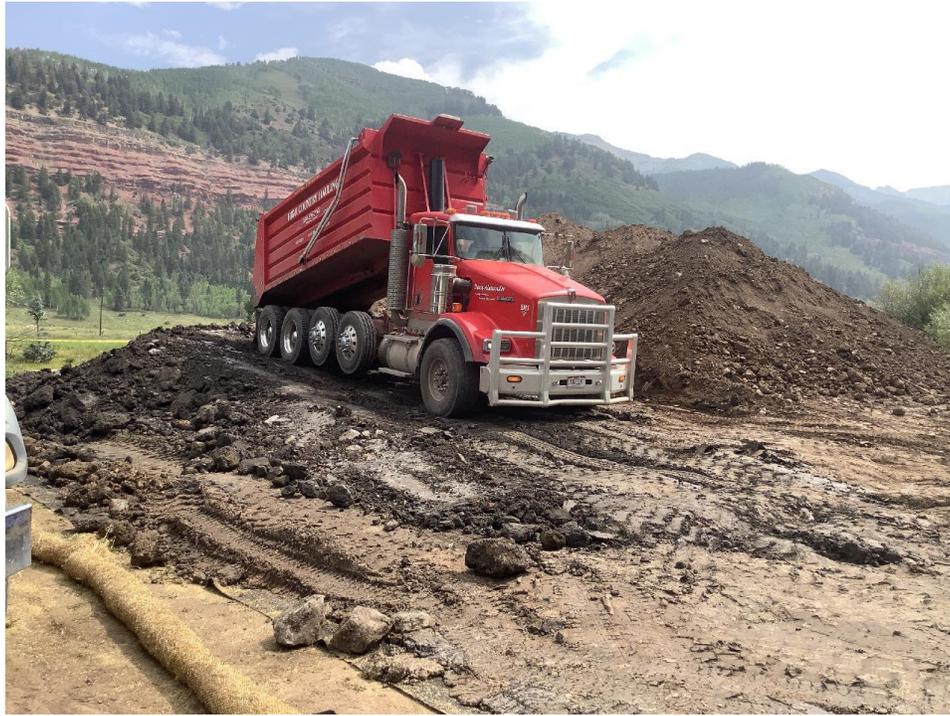
Dump trucks from local landslides delivering clean fill material/soil to site. Fill materials will be used for restoration and back filling excavation areas.

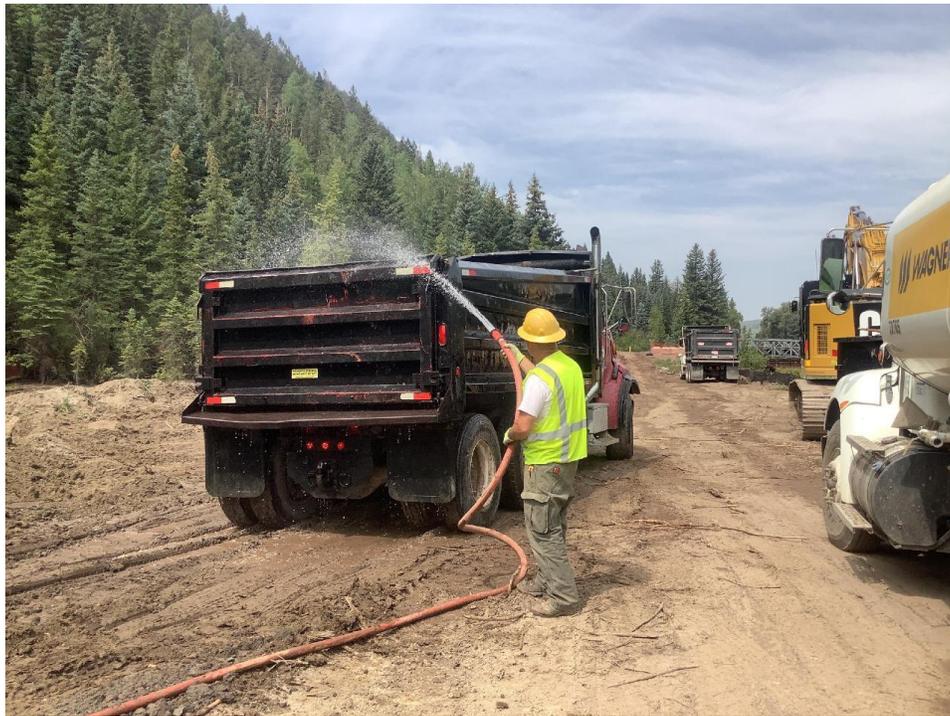
Dump truck operator washing down loaded truck and ensuring that the excavated tailings are watered down prior to departing.

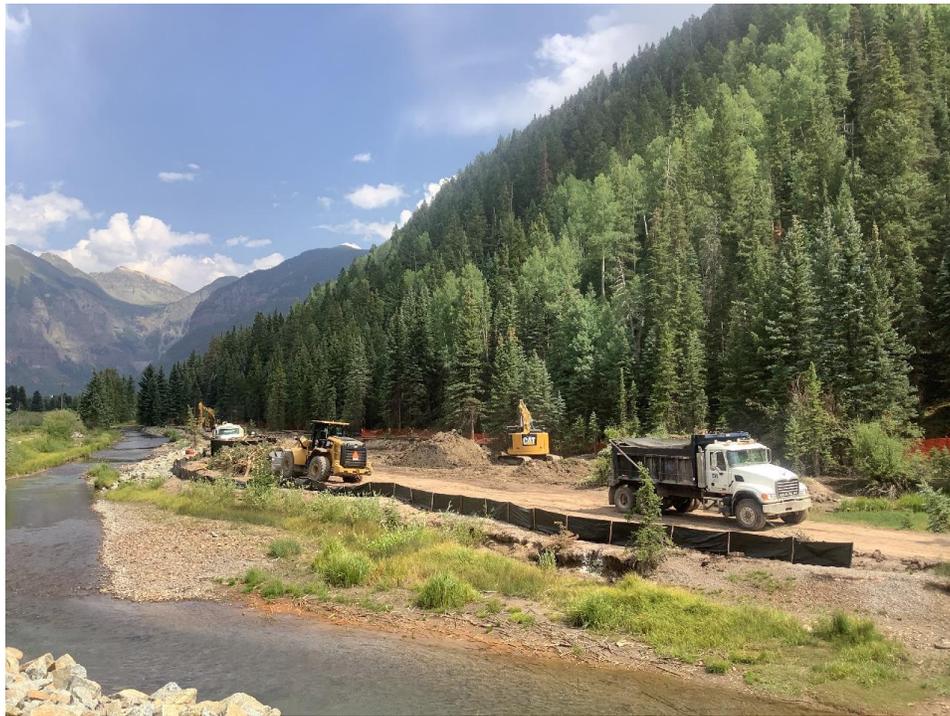
Dump truck with a load of tailings from ST1 heading to the Idarado repository. The loaded tailings are covered with a tarp and is watered down prior to the transport of tailings.

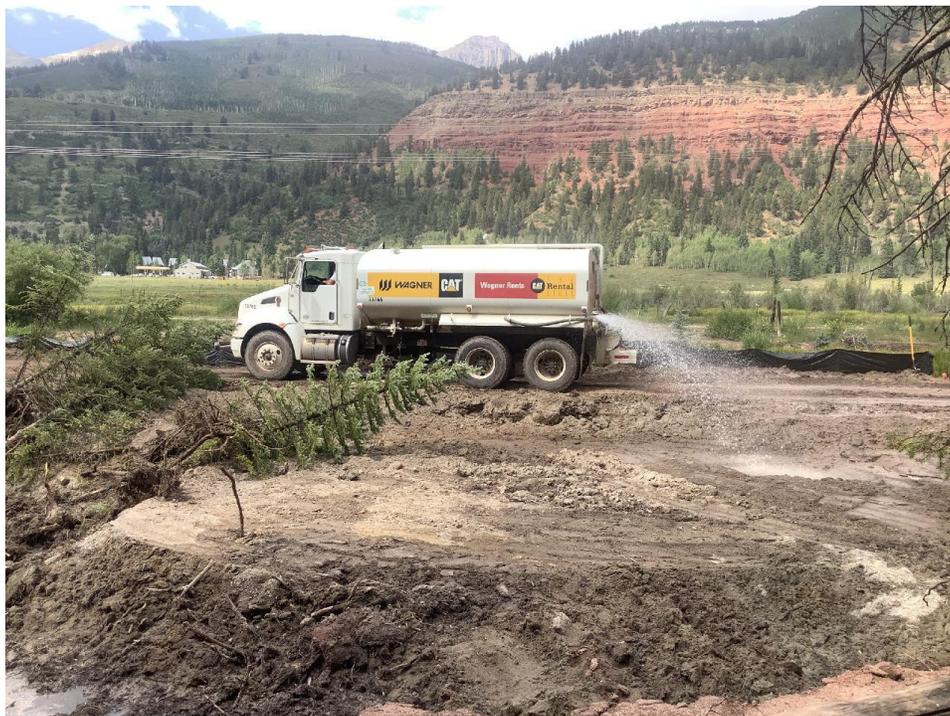
Water truck spraying water around ST1 to minimize dust particulates in the air.

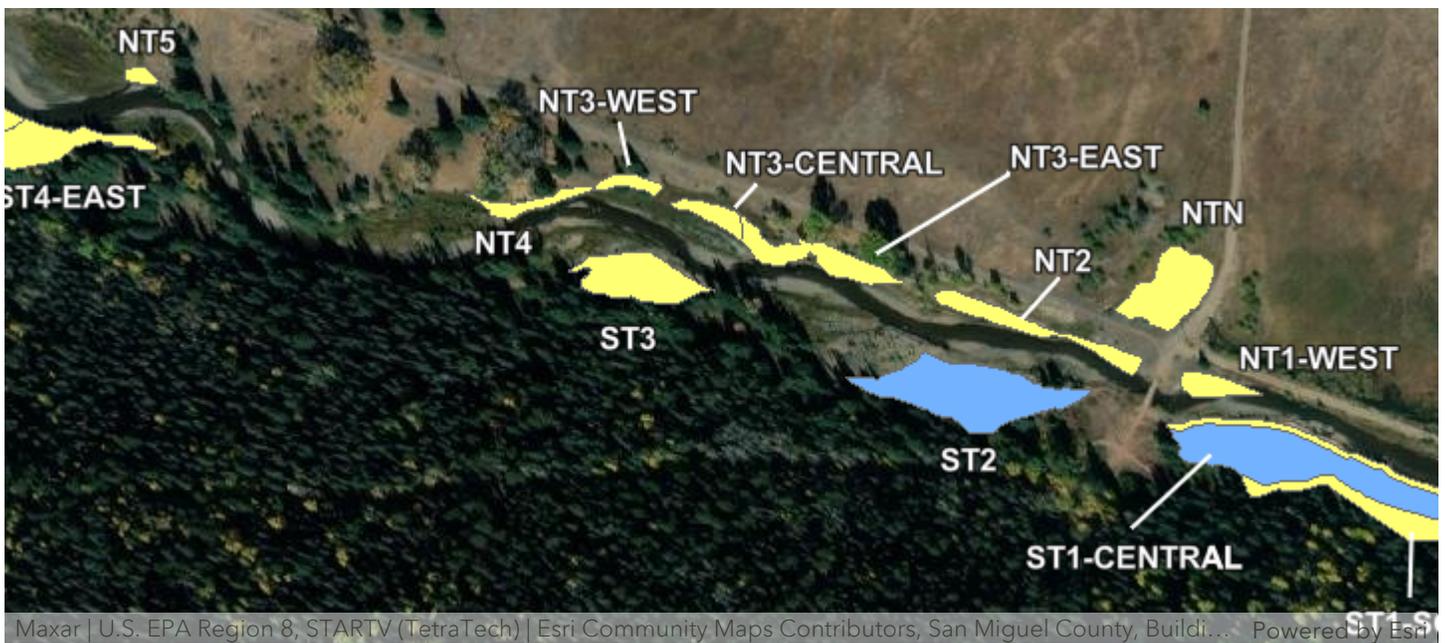
Excavation progress from the tailings piles is displayed here. The tailings areas are depicted in yellow to indicate that excavation progress has not yet started, blue to indicate that excavation is in progress, and green indicates it is complete.
