Date: March 26, 2021

**Interim Deliverable: Underground Storage Tank, Vessel and Drum Sampling Results
Route 203 Site
Nassau, New York**

ROUTE 203 SITE
NASSAU, NEW YORK

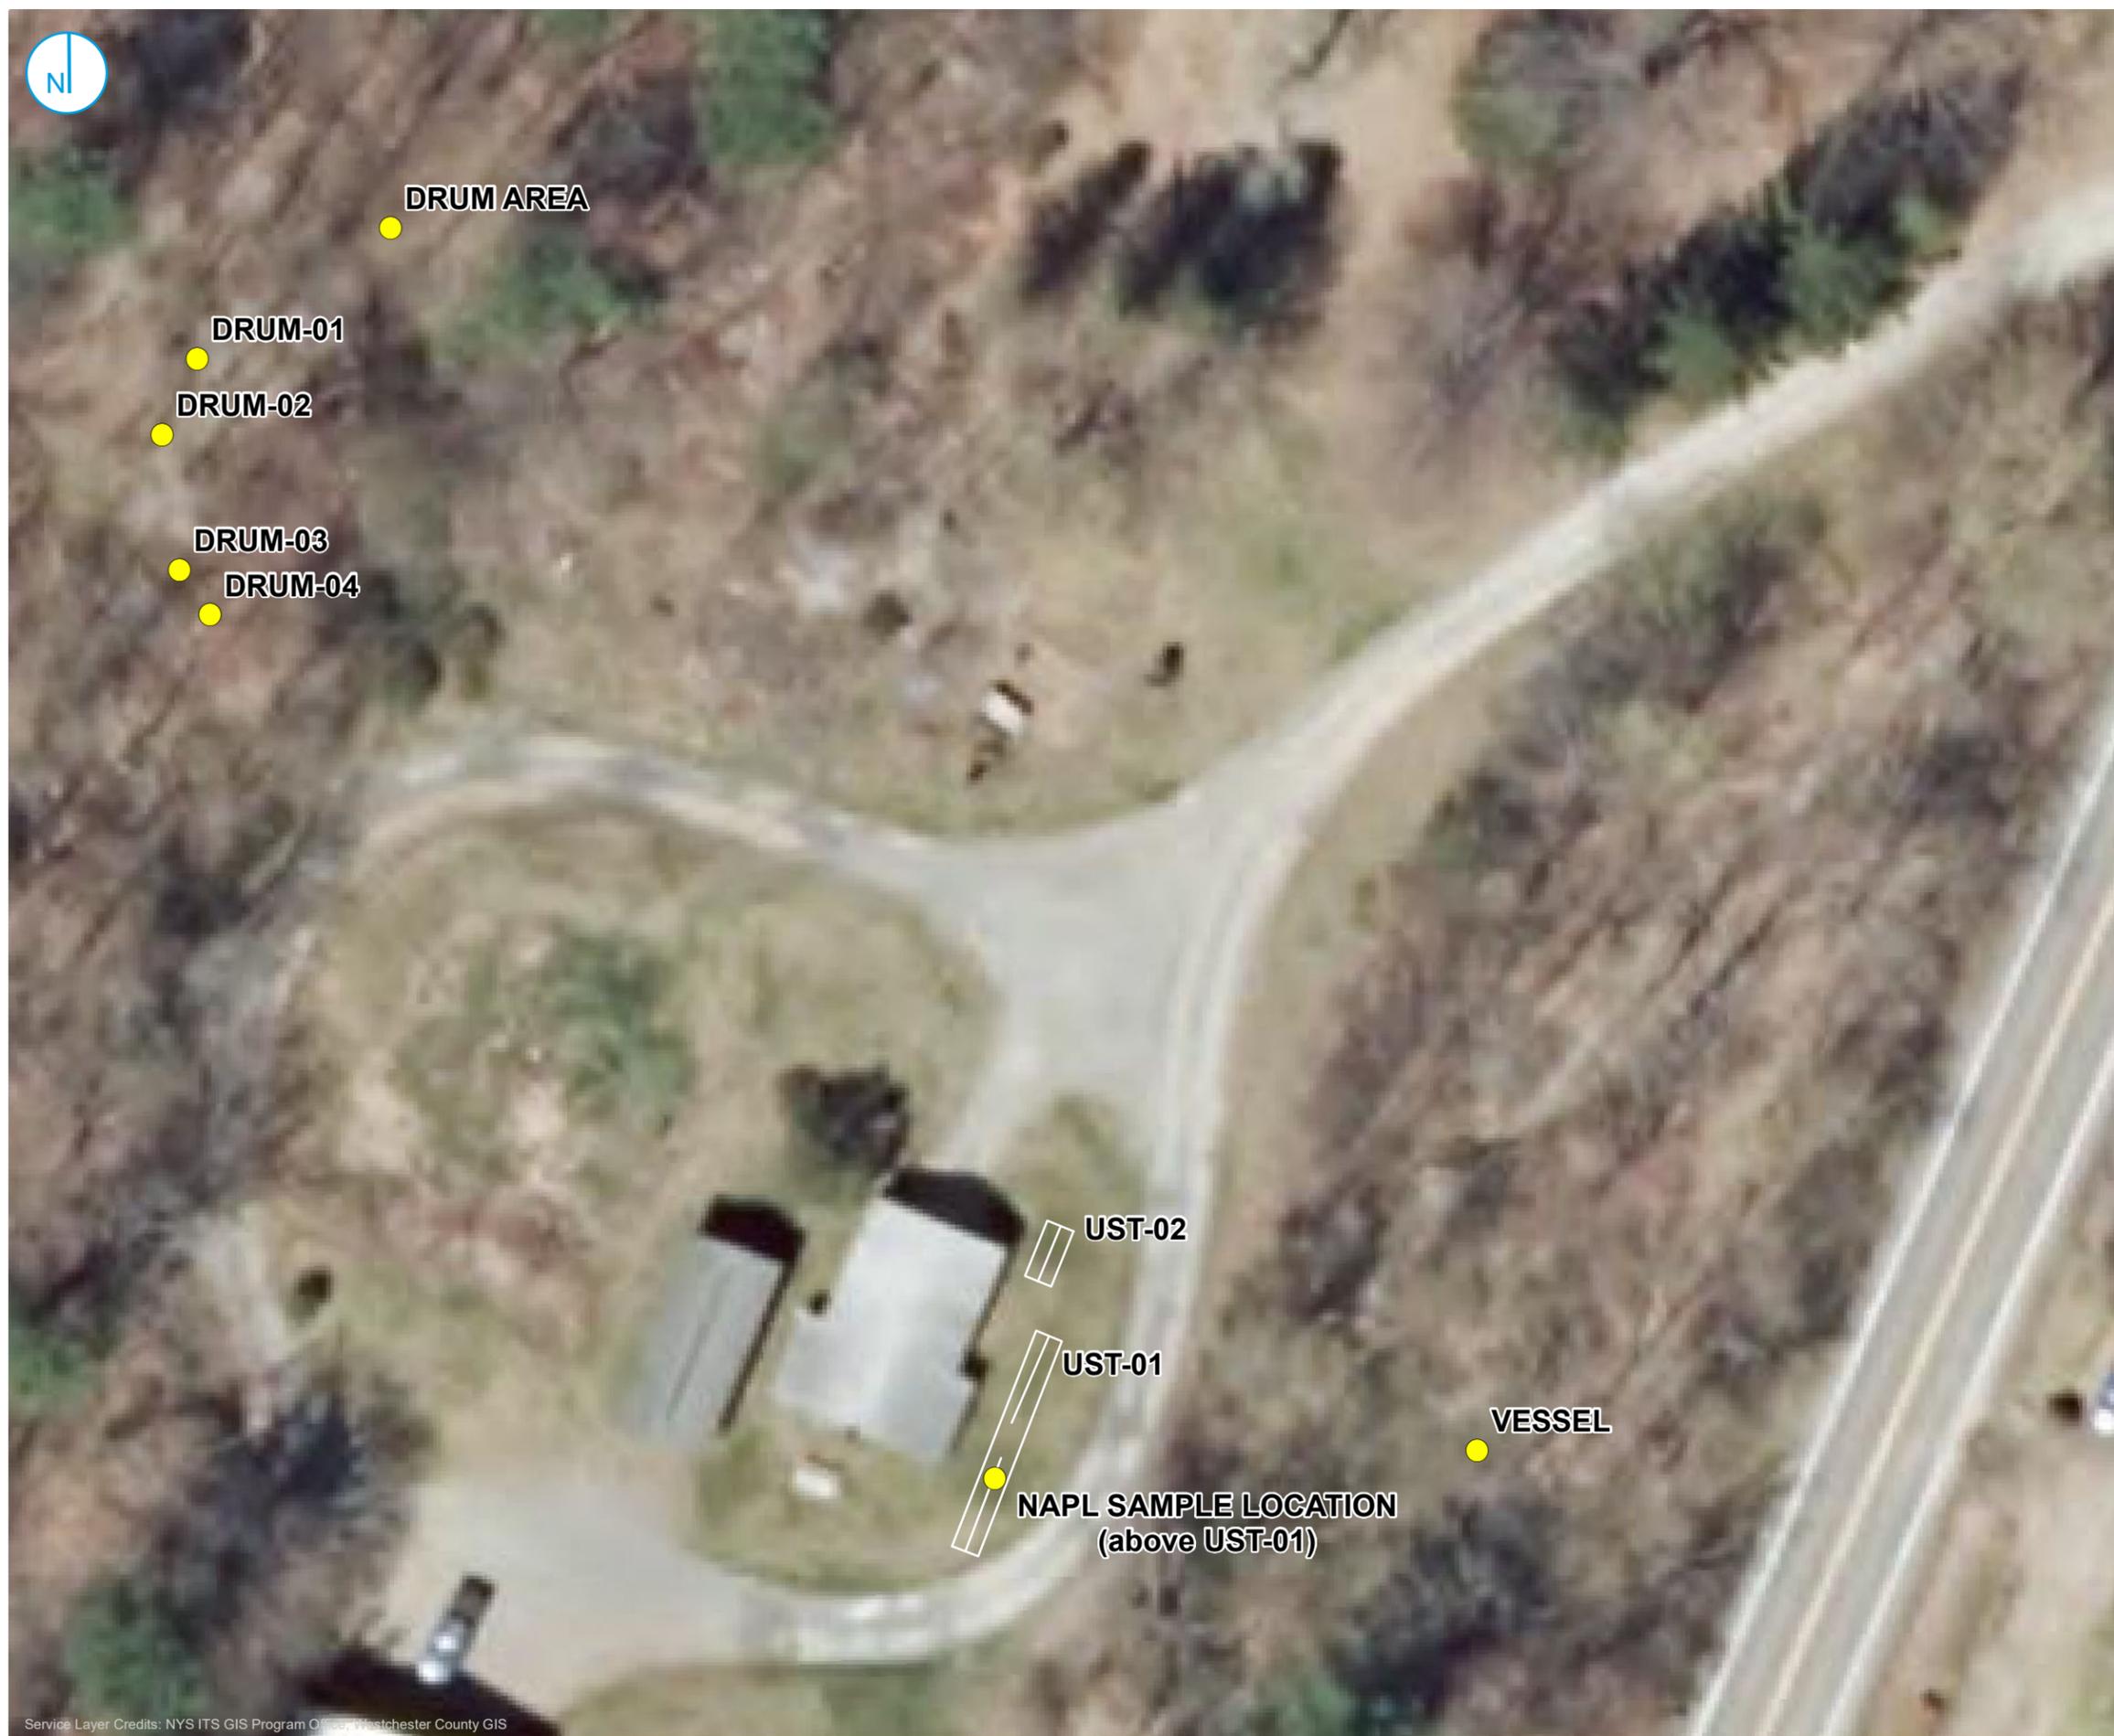
FIGURE 01

**UNDERGROUND STORAGE TANK,
DRUM AND VESSEL SAMPLING
LOCATIONS**

The UST, NAPL, vessel and drum locations are shown on the attached Figure 1. The analytical results are summarized on the attached Tables 1a through 1e and, for waste characterization parameters, including via the Toxicity Characteristic Leaching Procedure (TCLP), on the attached Tables 2a through 2e and Table 3. A summary of the drum and vessel sampling is included on the attached Table 4. The tables are also being provided to USEPA in a Microsoft Excel file. A Photo Log is included as Attachment 2.

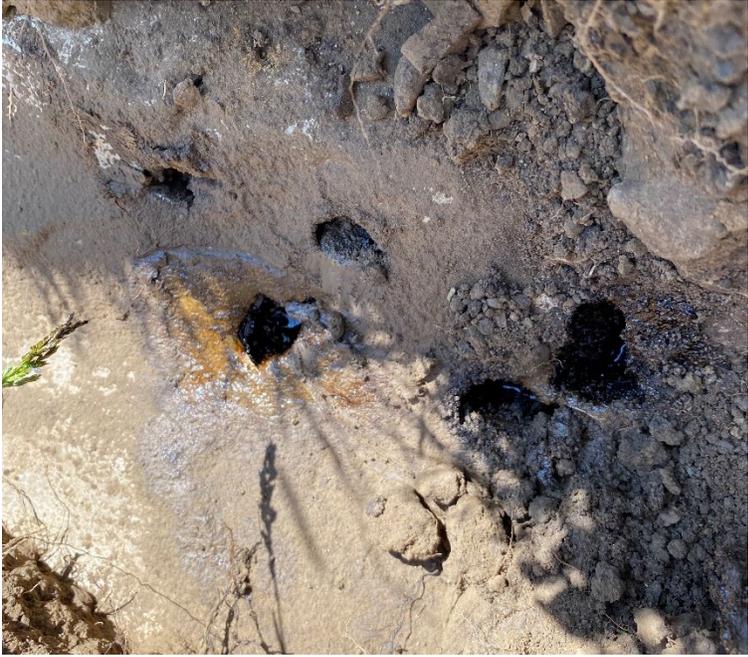
Project		Site location	Project no.
Route 203 Site		5225-5239 Route 203 Nassau, New York	73458
Photo no. 3	Date 5-26-2020

grade below a thin metal sheet and adjacent to a buried concrete slab. Below the metal sheet, which had several punctures approximately 1-inch in diameter, a shallow void was observed. This void contained a bi-phasic liquid consisting of a black, viscous NAPL and water. A photograph of the sample location is included in the Photo Log (see Photo 3, Attachment 2). Due to the location of this NAPL above the suspected UST, and the presence of metal sheeting above the NAPL, it was believed at that time to be the contents of the UST and was sampled accordingly. Additionally, buried debris consisting of a ridged plastic office mat and scrap pieces of carpet was observed buried above the UST approximately 3 feet away from the observed NAPL.

<u>Description</u> First UST Investigation/NAPL Sampling Perforations observed in thin metal sheet showing NAPL below.

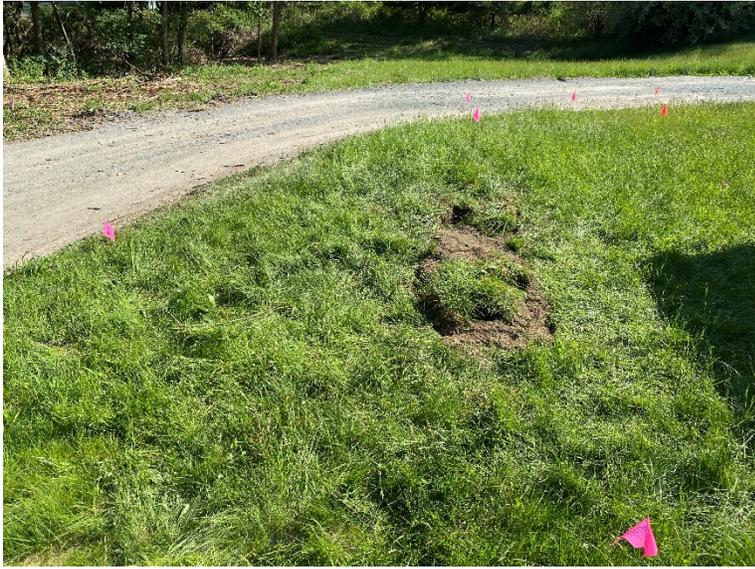
Project		Site location	Project no.
Route 203 Site		5225-5239 Route 203 Nassau, New York	73458
Photo no. 4	Date 5-26-2020

<u>Description</u> First UST Investigation/NAPL Sampling Restoration of soil/sod above UST-01.

After the completion of NAPL sampling activities above UST-01, the soft-dig excavations were backfilled with excavated soil and covered using separately segregated near-surface soil and sod pursuant to a May 21, 2020 conference call with USEPA. Traffic cones were placed over the disturbed soil locations (see Photo 4, Attachment 2).

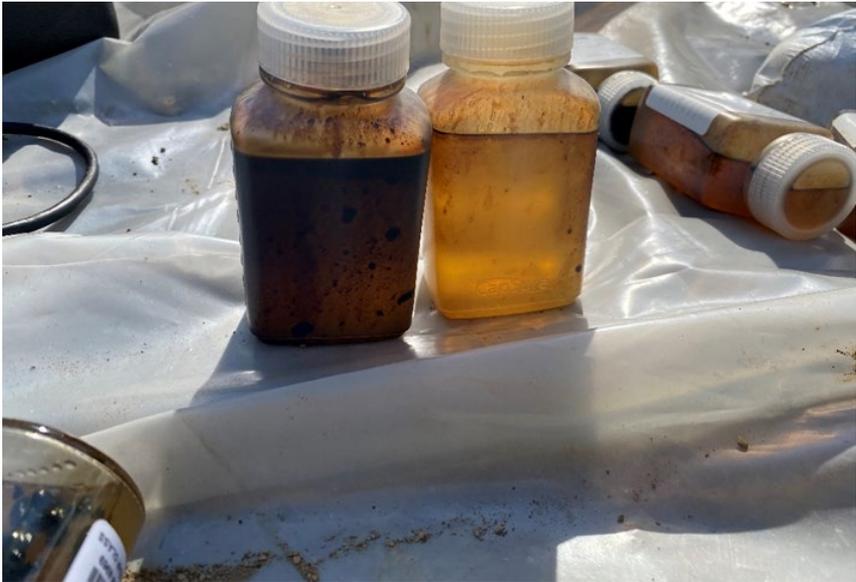
Project		Site location	Project no.
Route 203 Site		5225-5239 Route 203 Nassau, New York	73458
Photo no. 7	Date 10-21-2020

The sample from UST-01 contained two phases of liquid, a black, oily light non-aqueous phase liquid (LNAPL) layer and a clear liquid layer (see Photo 7, Attachment 2). The sample from UST-02 was a generally clear liquid with an oily sheen on the surface and a faint petroleum-like odor.

<p><u>Description</u></p> <p>Second UST Investigation</p> <p>Samples collected from UST-01 showing the bi-phasic liquid recovered from the UST. NAPL and globules visible in the containers.</p>

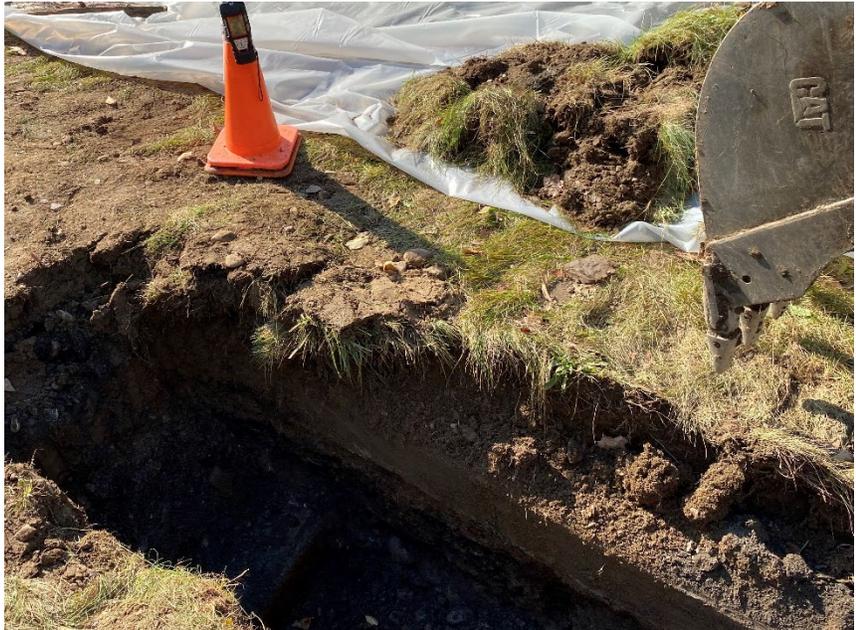
Project		Site location	Project no.
Route 203 Site		5225-5239 Route 203 Nassau, New York	73458
Photo no. 8	Date 5-26-2020

UST-01 was exposed for a portion of its length, with half of the tank lengthwise being overlain by a concrete slab. While excavating, a significant length of the tank was exposed to confirm it is a single UST and not two USTs as was indicated by the geophysical investigation. The visible areas of UST-01 were observed to be in generally good condition with no obvious defects or holes. A sample of liquid

<p><u>Description</u></p> <p>Second UST Investigation</p> <p>Soil excavation at the northern extent of UST-01 and concrete slab.</p>

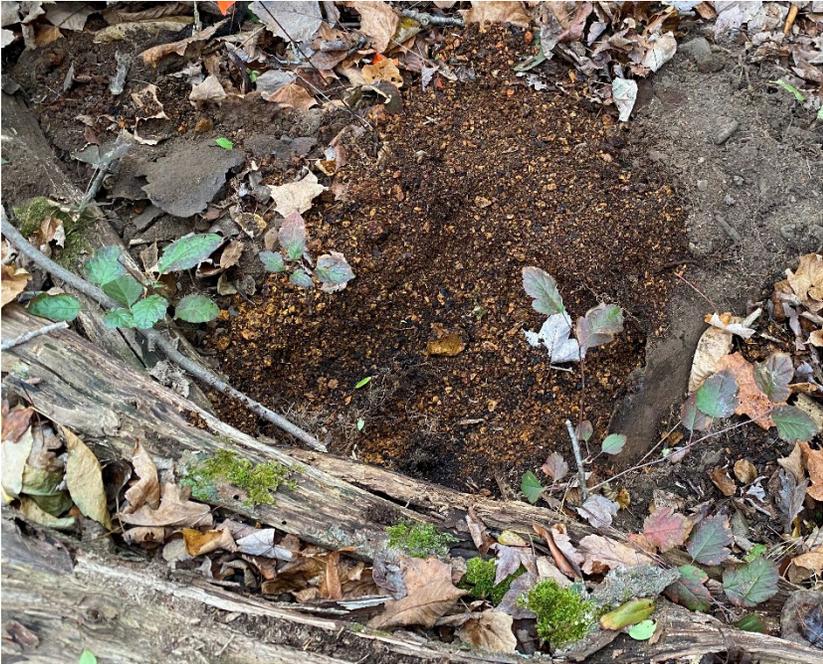
Project		Site location	Project no.
Route 203 Site		5225-5239 Route 203 Nassau, New York	73458
Photo no. 15	Date 10-20-2020

<p><u>Description</u></p> <p>Drum and Vessel Sampling</p> <p>Drum-03 as found and required no excavation. Drum sidewalls can be seen to the left and right of the material. Red-orange material is the drum contents.</p>

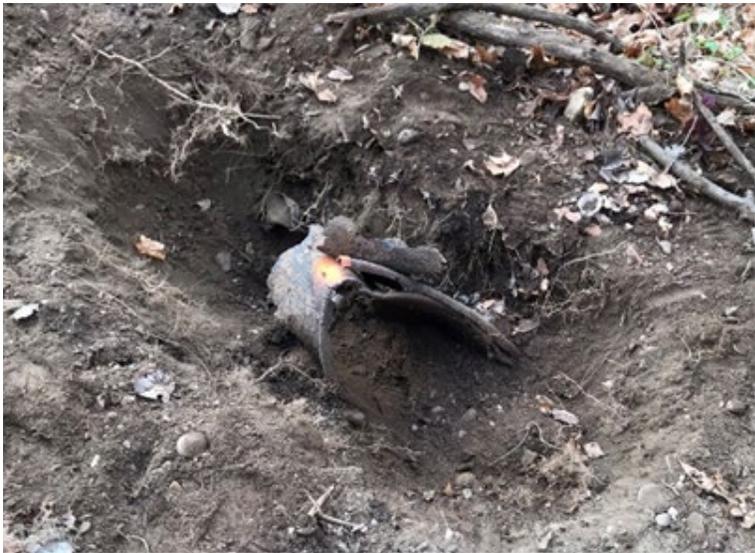
Project		Site location	Project no.
Route 203 Site		5225-5239 Route 203 Nassau, New York	73458
Photo no. 16	Date 10-20-2020

<p><u>Description</u></p> <p>Drum and Vessel Sampling</p> <p>Drum-04 post-excavation. No material was observed inside of the drum and no sample was collected.</p>

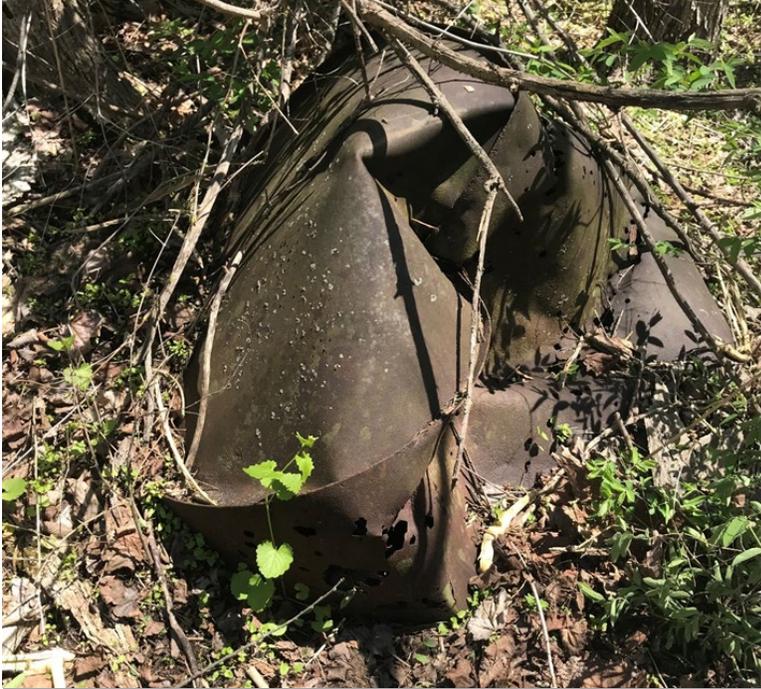
Project		Site location	Project no.
Route 203 Site		5225-5239 Route 203 Nassau, New York	73458
Photo no. 17	Date 10-20-2020

Vessel	200	On ground surface	Partially crushed, limited corrosion and holes	0.0	Slight	Vessel contains a small amount of black, waxy, brittle resin-like material.	No

<p><u>Description</u></p> <p>Drum and Vessel Sampling</p> <p>Vessel as found and required no excavation.</p>

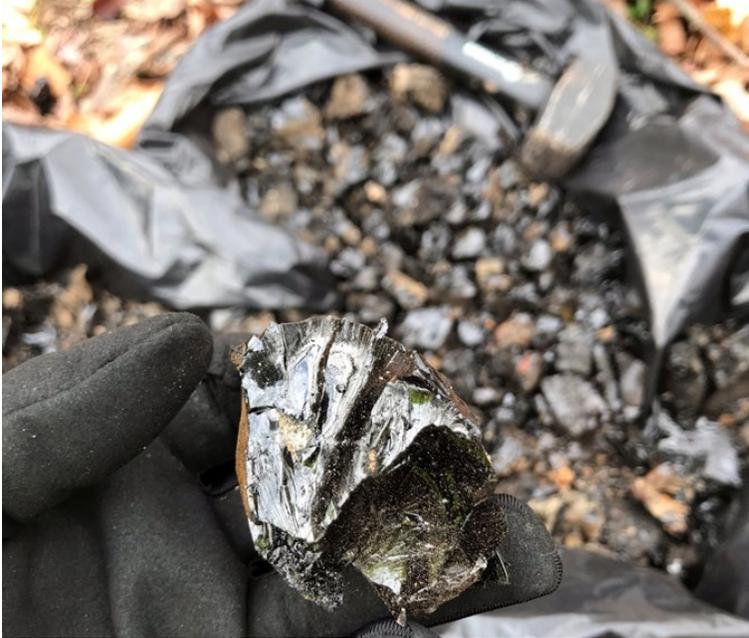
Project		Site location	Project no.
Route 203 Site		5225-5239 Route 203 Nassau, New York	73458
Photo no. 18	Date 10-20-2020

<p><u>Description</u></p> <p>Drum and Vessel Sampling</p> <p>Representative material of the vessel. A black, resin-like material was observed inside the vessel and a sample was collected.</p>

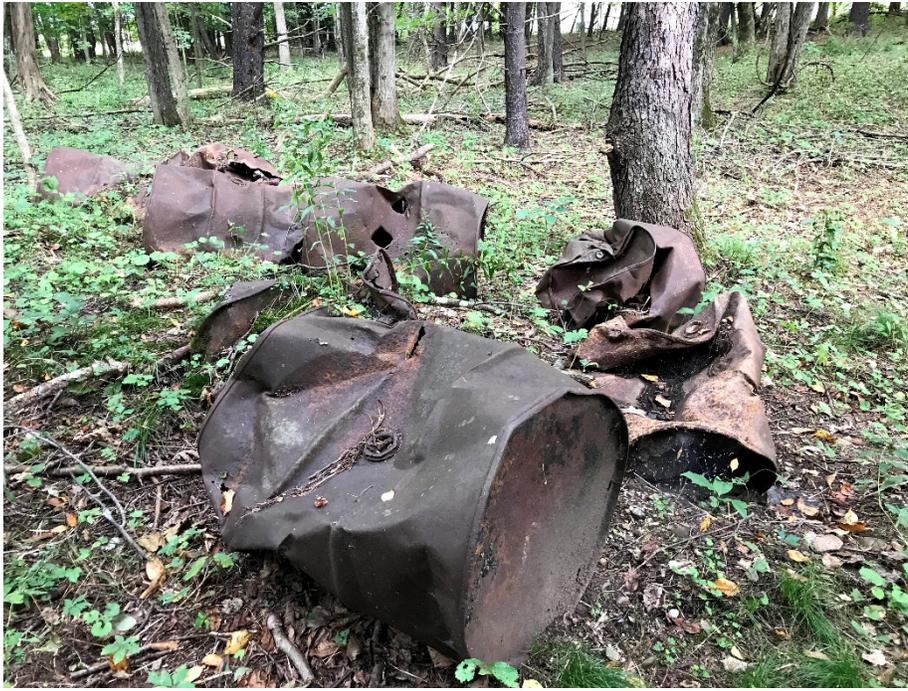
Project		Site location	Project no.
Route 203 Site		5225-5239 Route 203 Nassau, New York	73458
Photo no.	Date

As requested by USEPA during the field event, an additional sample was collected from the previously identified drum area (see Photo 19, Attachment 2). Four of the nine drums contained material that was accessible. The grab samples collected from each of these four drums (see Photo 20, Attachment 2) were composited into a single sample.

19	9-10-2019		
<p><u>Description</u></p> <p>Drum and Vessel Sampling</p> <p>Drum area as found (the same drum area that was previously sampled by USEPA). No excavation was required to access the drums.</p>

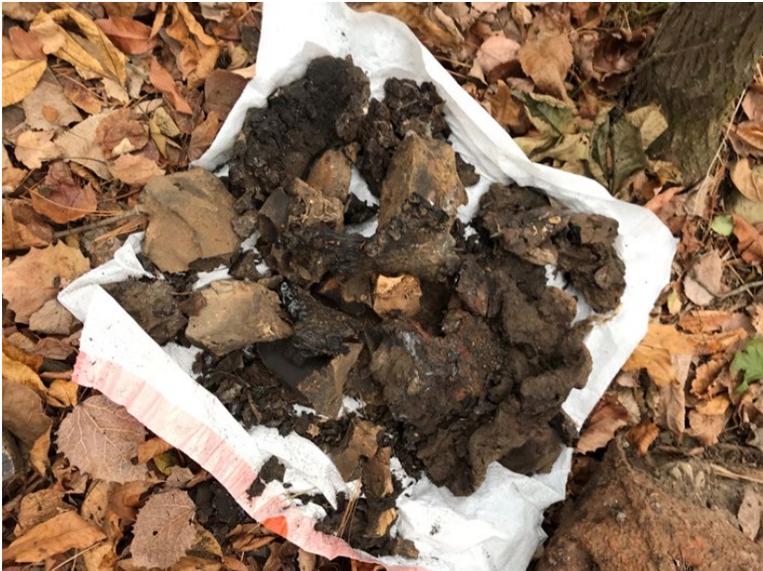
Project		Site location	Project no.
Route 203 Site		5225-5239 Route 203 Nassau, New York	73458
Photo no.	Date

20	10-20-2020		
<p><u>Description</u></p> <p>Drum and Vessel Sampling</p> <p>Drum area (the same drum area that was previously sampled by USEPA). Representative material collected from the drums located in the drum area used to collect a composite sample.</p>
