Telluride Valley Floor

A U.S. EPA Region 8 Story Map

September 16, 2021

This Story Map will provide an up to date summary of work progress during the Phase 2 Time Critical Removal Action.

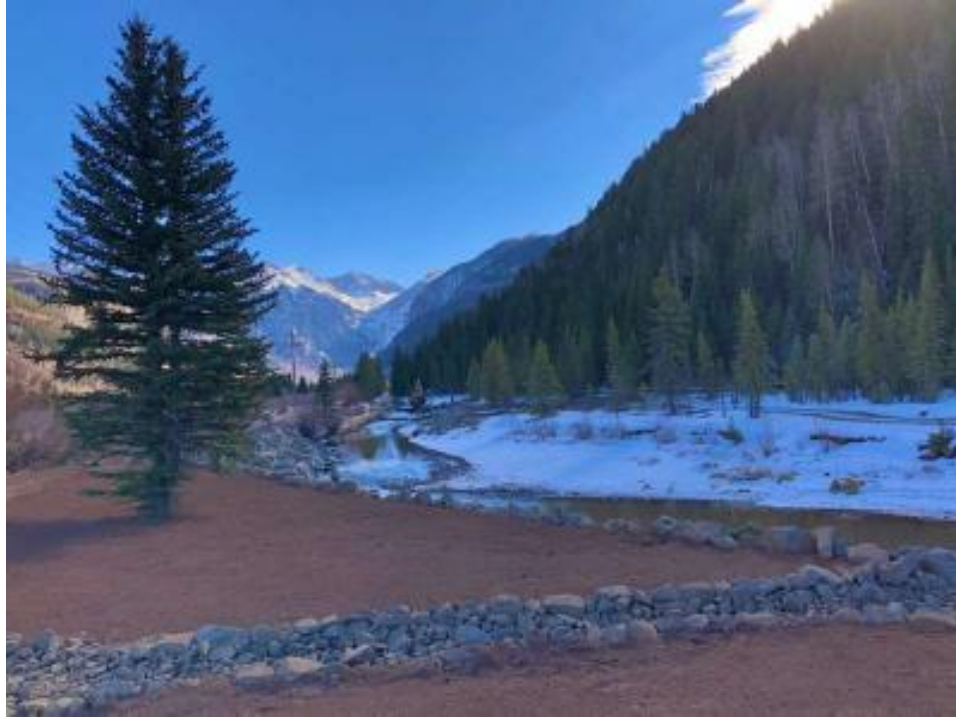
Completed North Riverbank Lining and Arm

- Installation of erosion controls to mitigate runoff from the excavation and stockpile operations.
- Removed up to 3,000 cubic yards of tailing and stabilized/armored bank area.

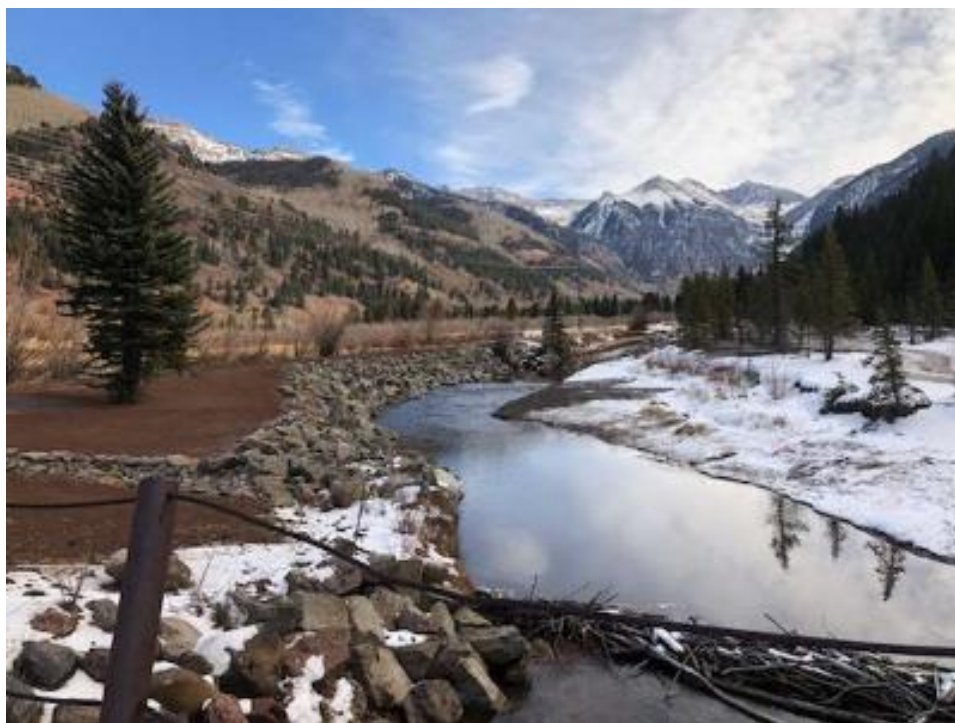
Installed Drainage Controls

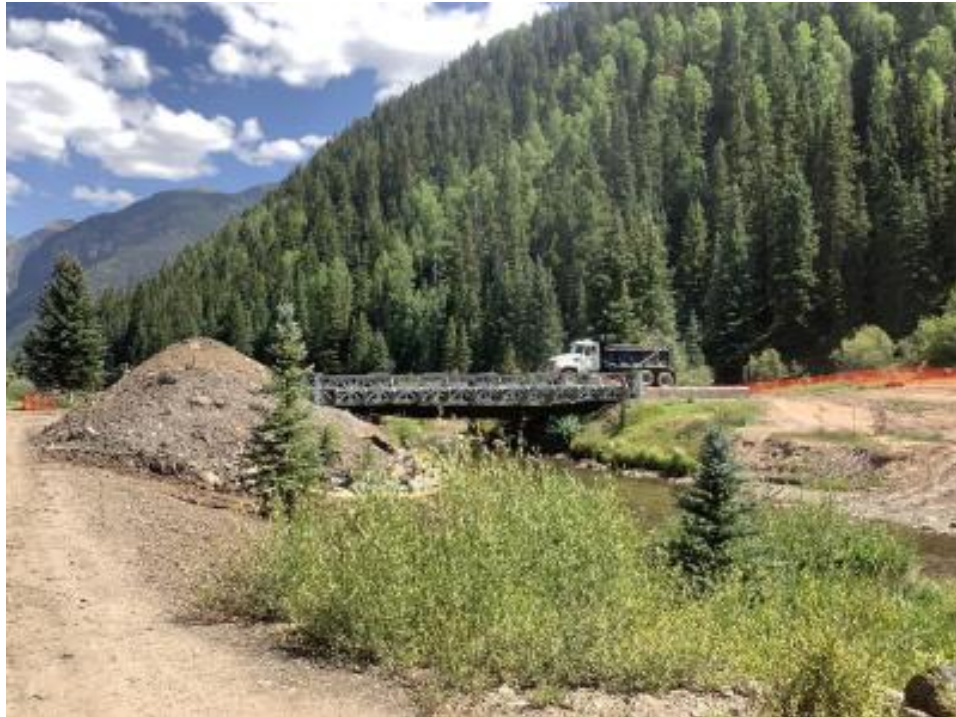
Eastward view of a fully loaded dump truck from ST1 leaving the site to deposit tailings at the Idarado repository.

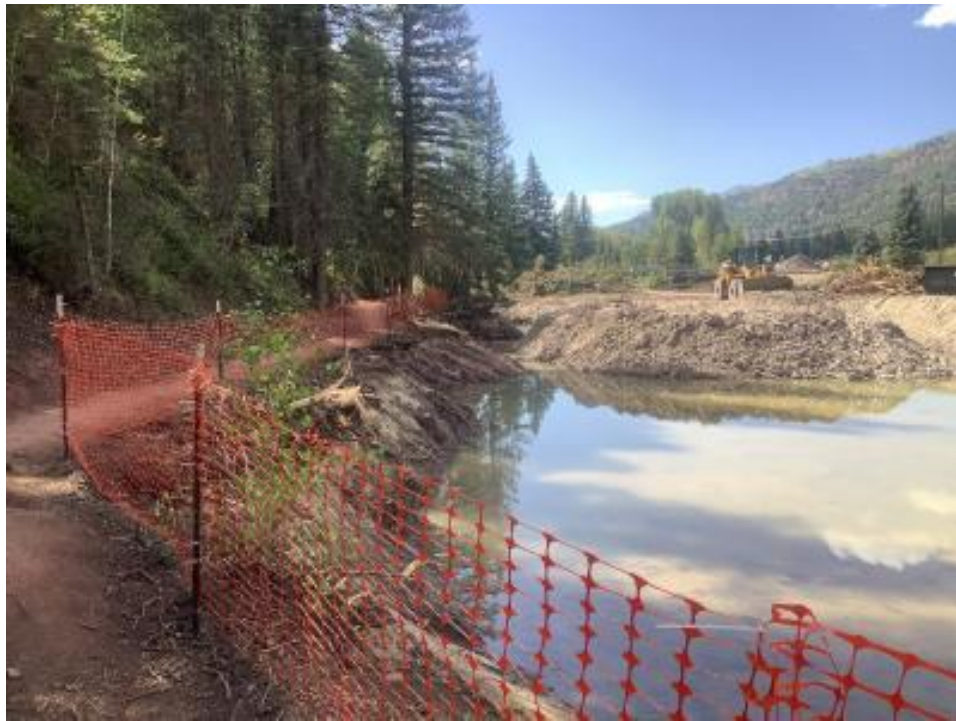
Backfill operations have begun in the western portion of ST1 Central, the excavated tailings are being replaced with clean soil.

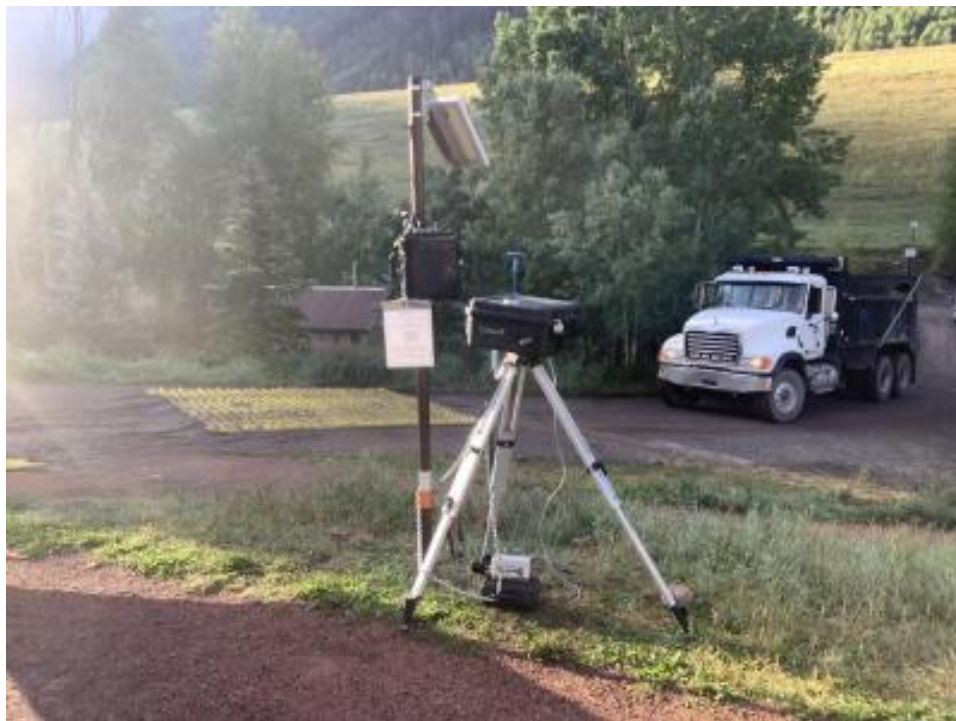
Air monitoring station three located near the entrance of the repository where contaminated soil is being dumped. Here you can see a haul truck after dropping off a load.

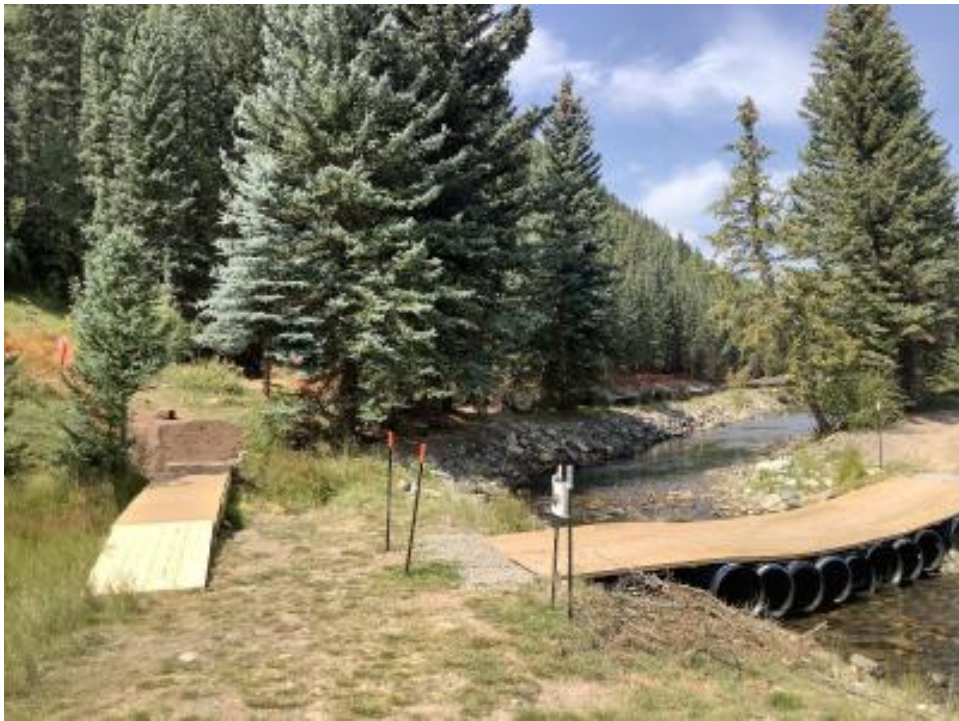
A western view of the San Miguel River Trail temporary re-route. The trail has been re-routed during operations to ensure the safety of the trail users.

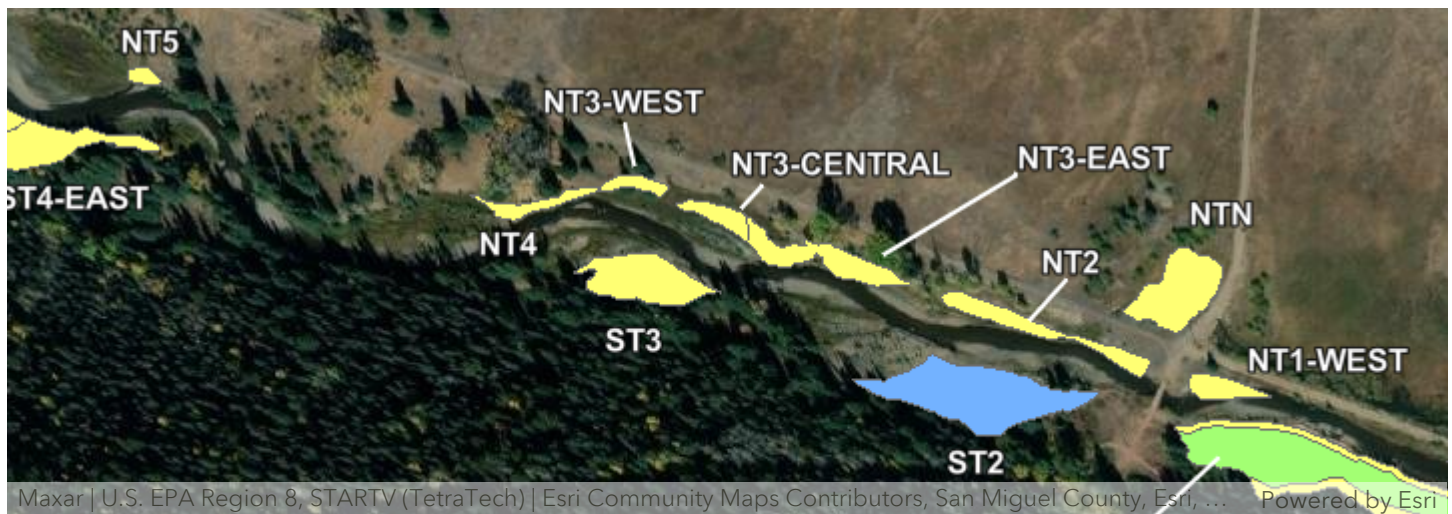
Excavation progress from the tailings piles is displayed here. The tailings areas are depicted in yellow to indicate that excavation progress has not yet started, blue to indicate that excavation is in progress, and green indicates it is complete.
