Telluride Valley Floor

A U.S. EPA Region 8 Story Map

September 21, 2021

This Story Map will provide an up to date summary of work progress during the Phase 2 Time Critical Removal Action.

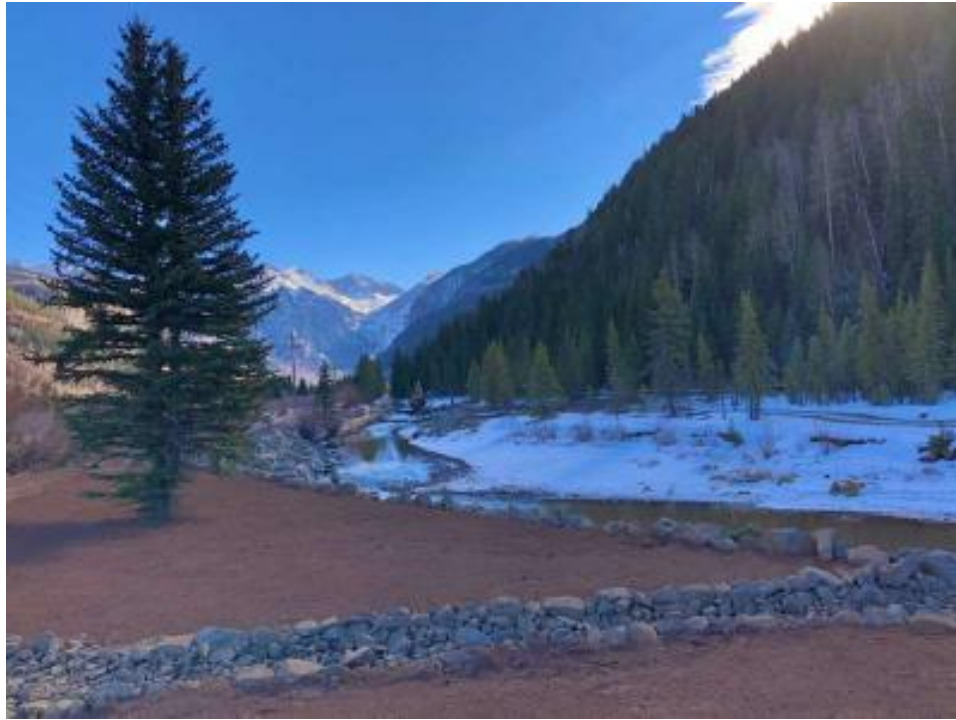
Completed North Riverbank Lining and Arm

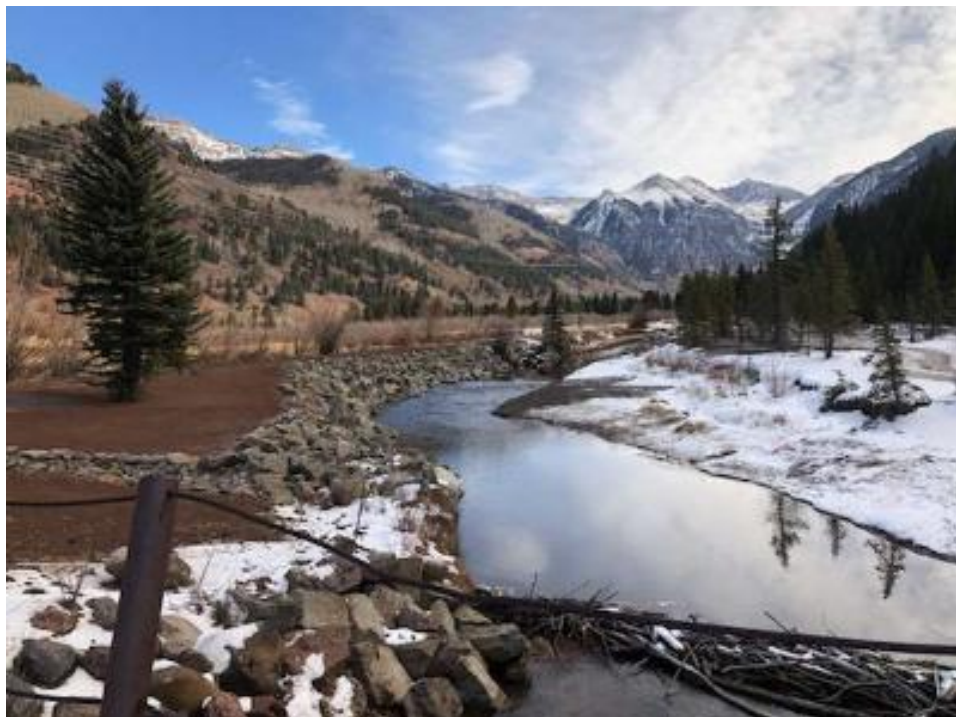
Installed Drainage Controls

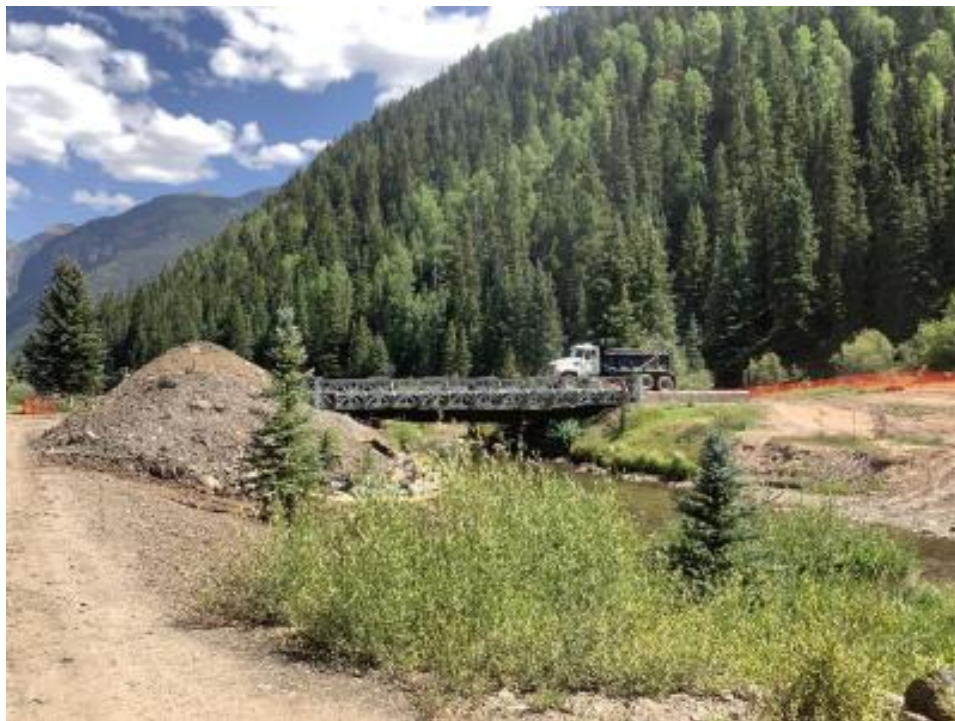
Eastward view of a fully loaded dump truck from ST1 leaving the site to deposit tailings at the Idarado repository.

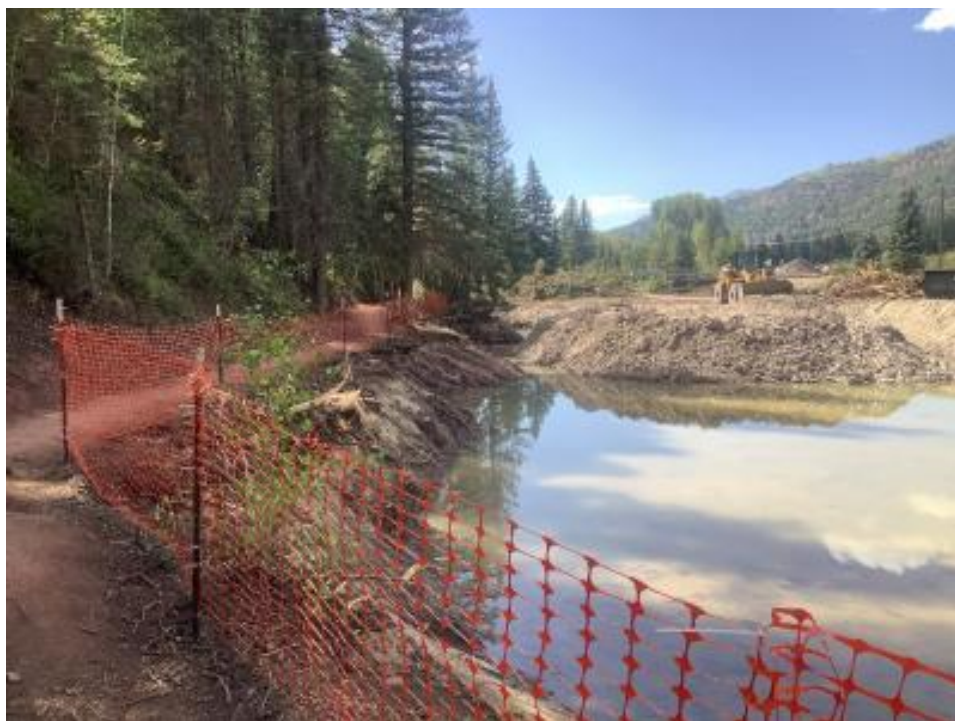
Backfill operations have begun in the western portion of ST1 Central, the excavated tailings are being replaced with clean soil.

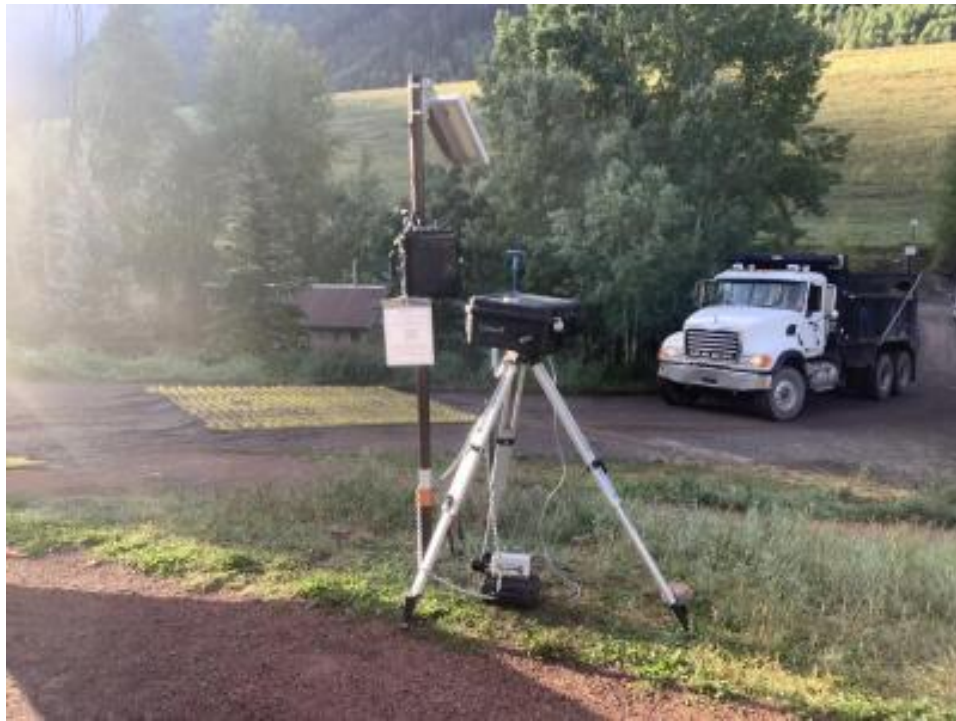
Air monitoring station three located near the entrance of the repository where contaminated soil is being dumped. Here you can see a haul truck after dropping off a load.

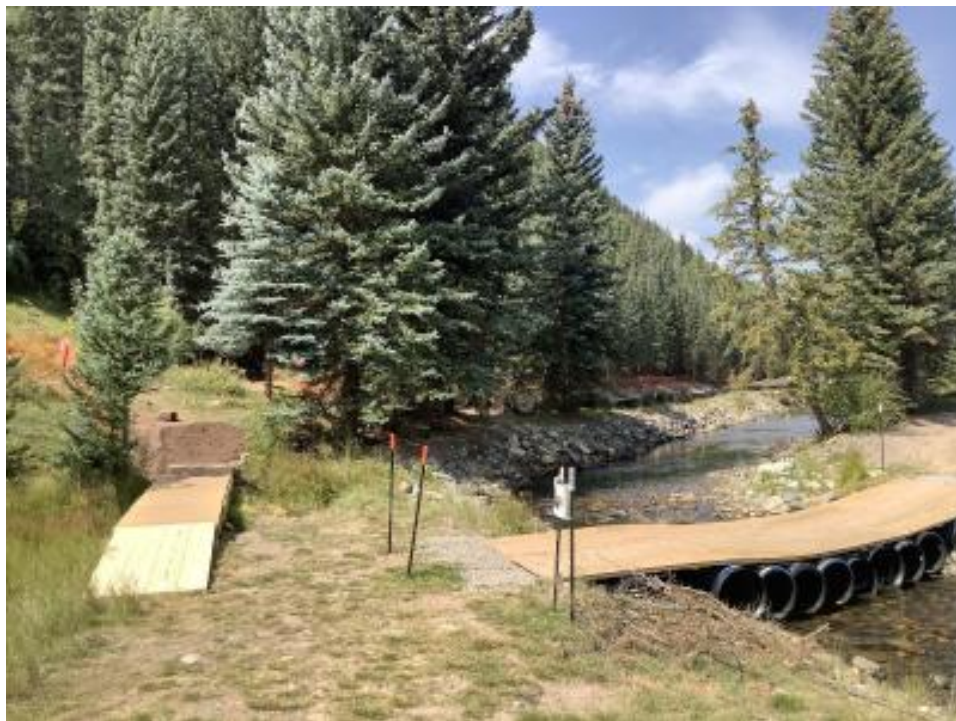
A western view of the San Miguel River Trail temporary re-route. The trail has been re-routed during operations to ensure the safety of the trail users.
