Telluride Valley Floor

Overview

U.S. Environmental Protection Agency, in conjunction with U.S. Forest Service, is conducting a joint Removal Action at the Telluride Valley Floor Site, which is located in Telluride, CO.

This Story Map will provide an up to date summary of work progress during the Phase 2 Time Critical Removal Action.

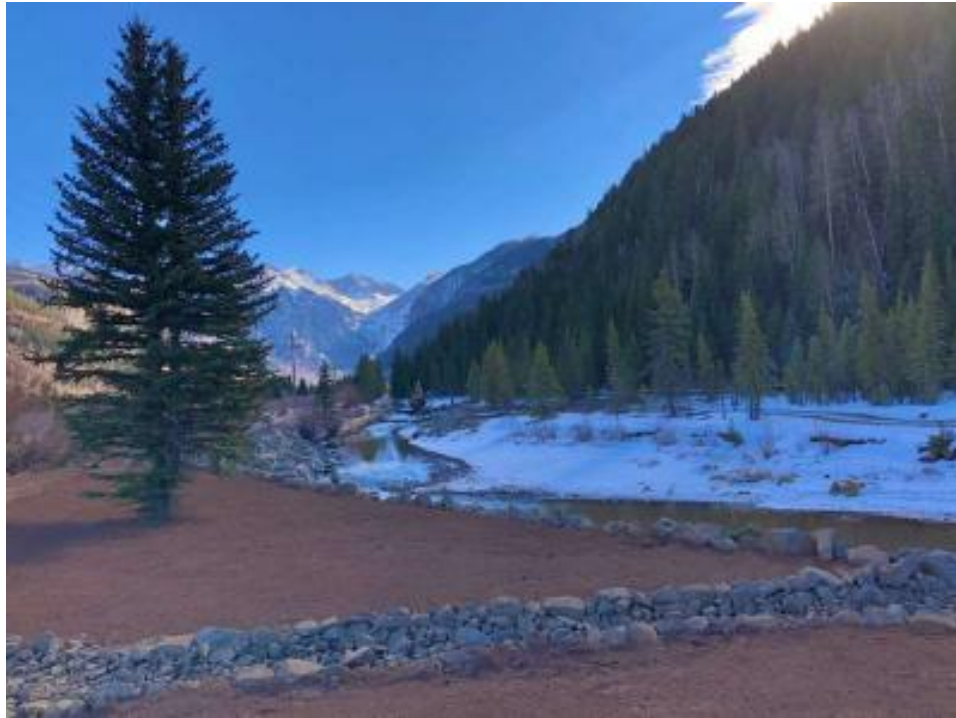
Completed North Riverbank Lining and Arm

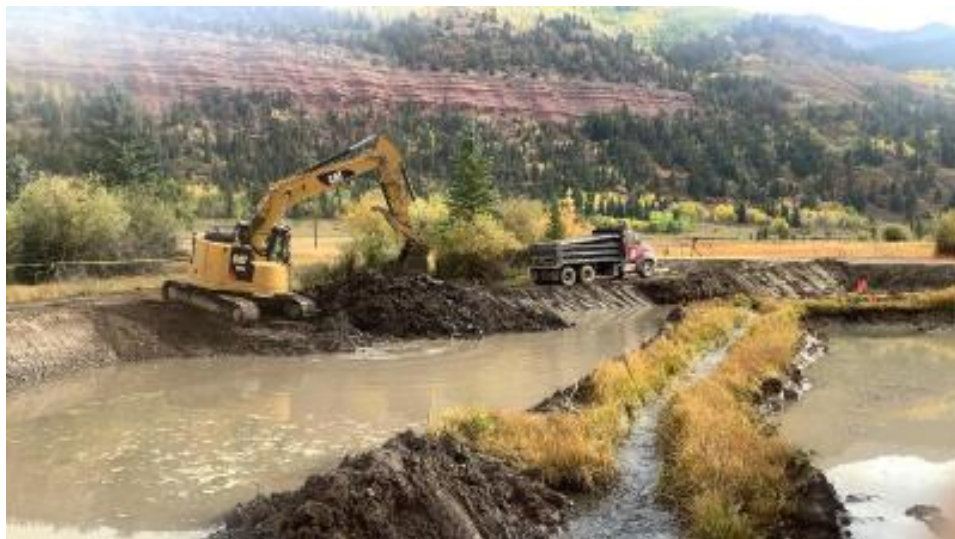
Excavator operator continues to remove mine tailings from NTN, while the fully loaded and tarp covered dump truck prepares to go to the Idarado repository.

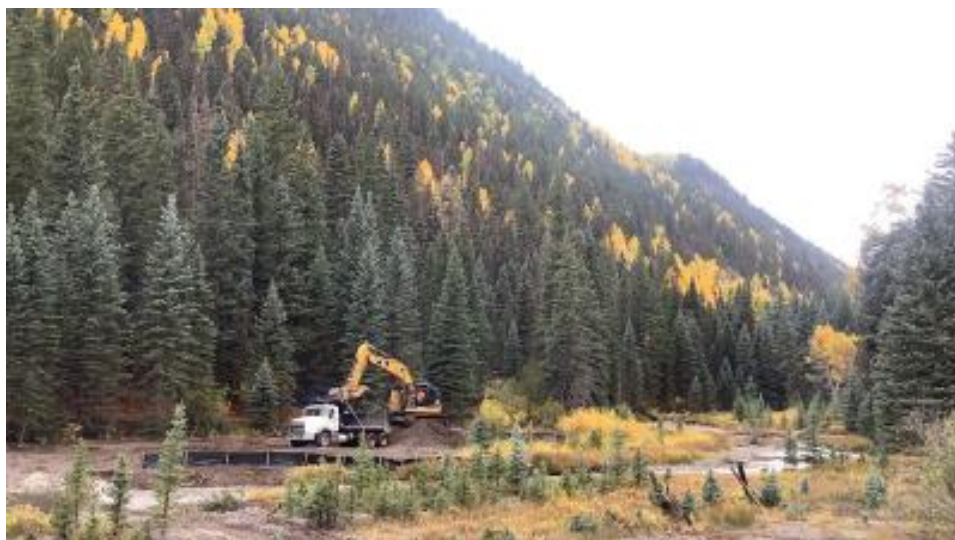
Excavator operator loads a dump truck with mine tailings from area ST3. The tailings will be hauled to the Idarado repository.

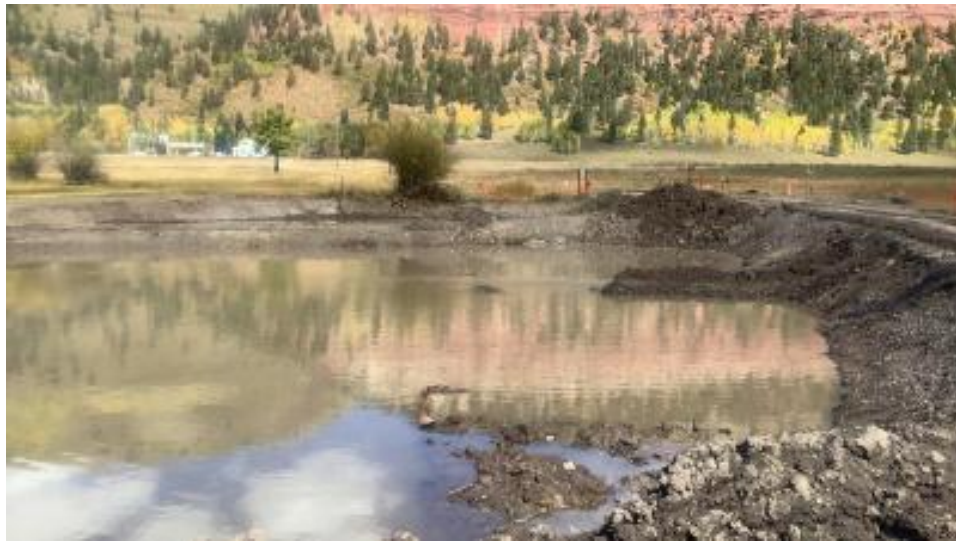
Excavation of NTN is complete, the excavator operator works to install a channel through the excavated area.

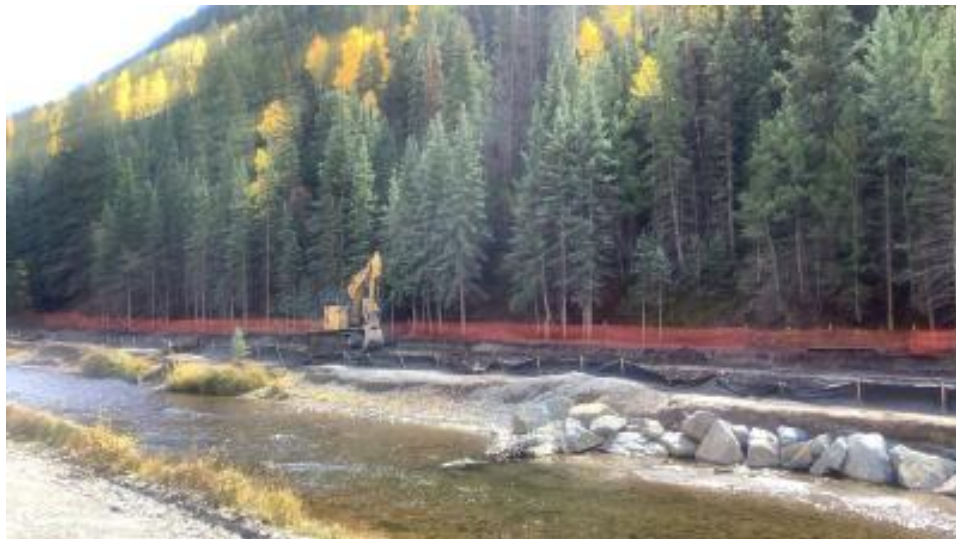
Excavator operator smooths out backfill in ST1 Central in order to create an access road to begin excavation of ST1 South.

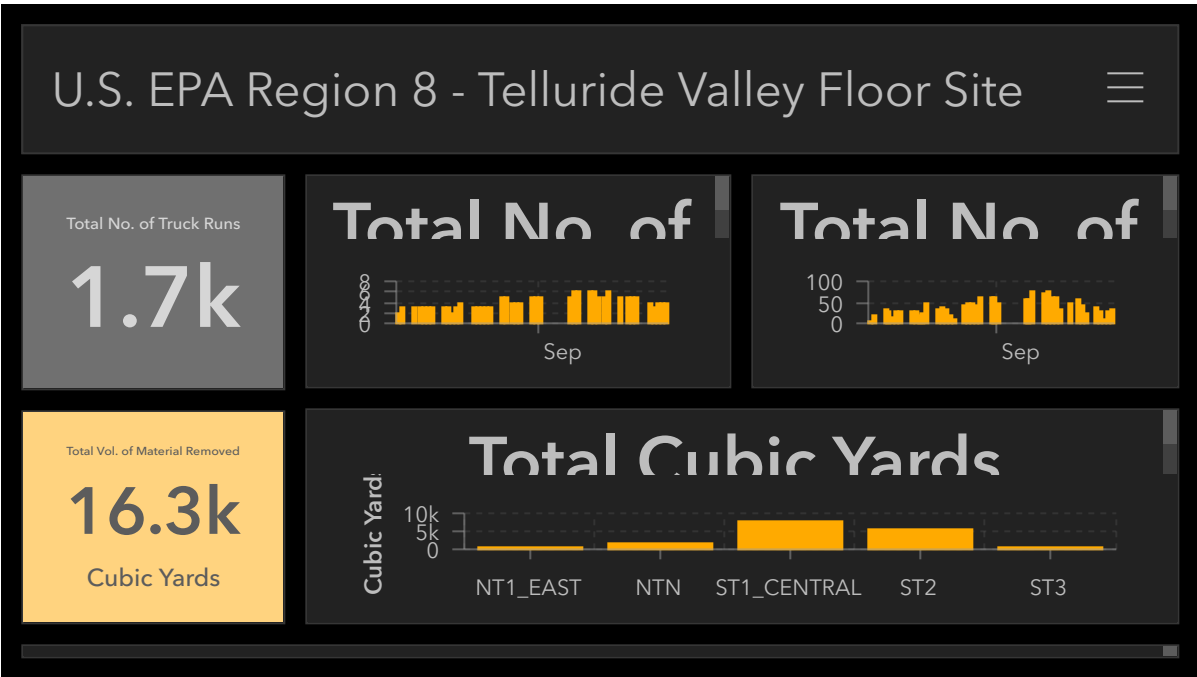
Truck Load Dashboard

A summary providing on overview of vehicle traffic and material transported to the repository is included below.

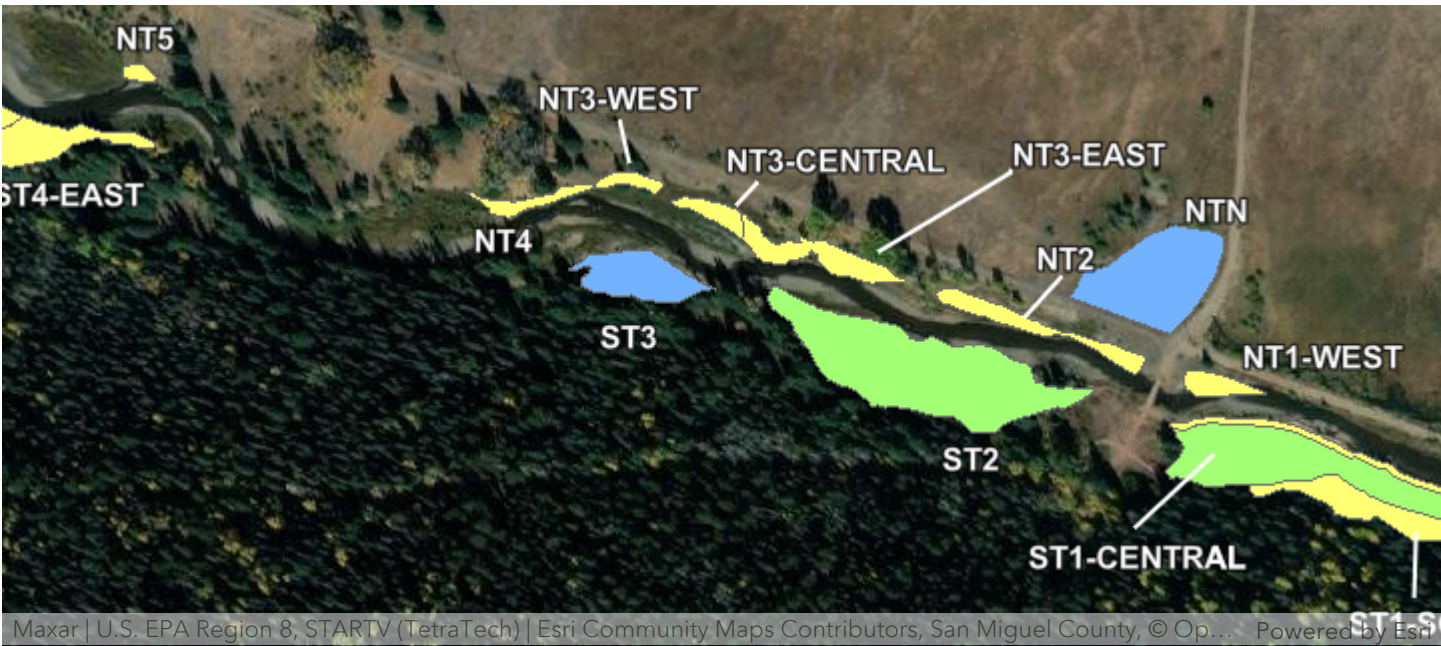
Excavation progress from the tailings piles is displayed here. The tailings areas are depicted in yellow to indicate that excavation progress has not yet started, blue to indicate that excavation is in progress, and green indicates it is complete.
