TIME-CRITICAL REMOVAL ACTION REPORT

*Former Kaiser Smelter Site
Mead, Spokane County, Washington*

November 2021
Rev. 2

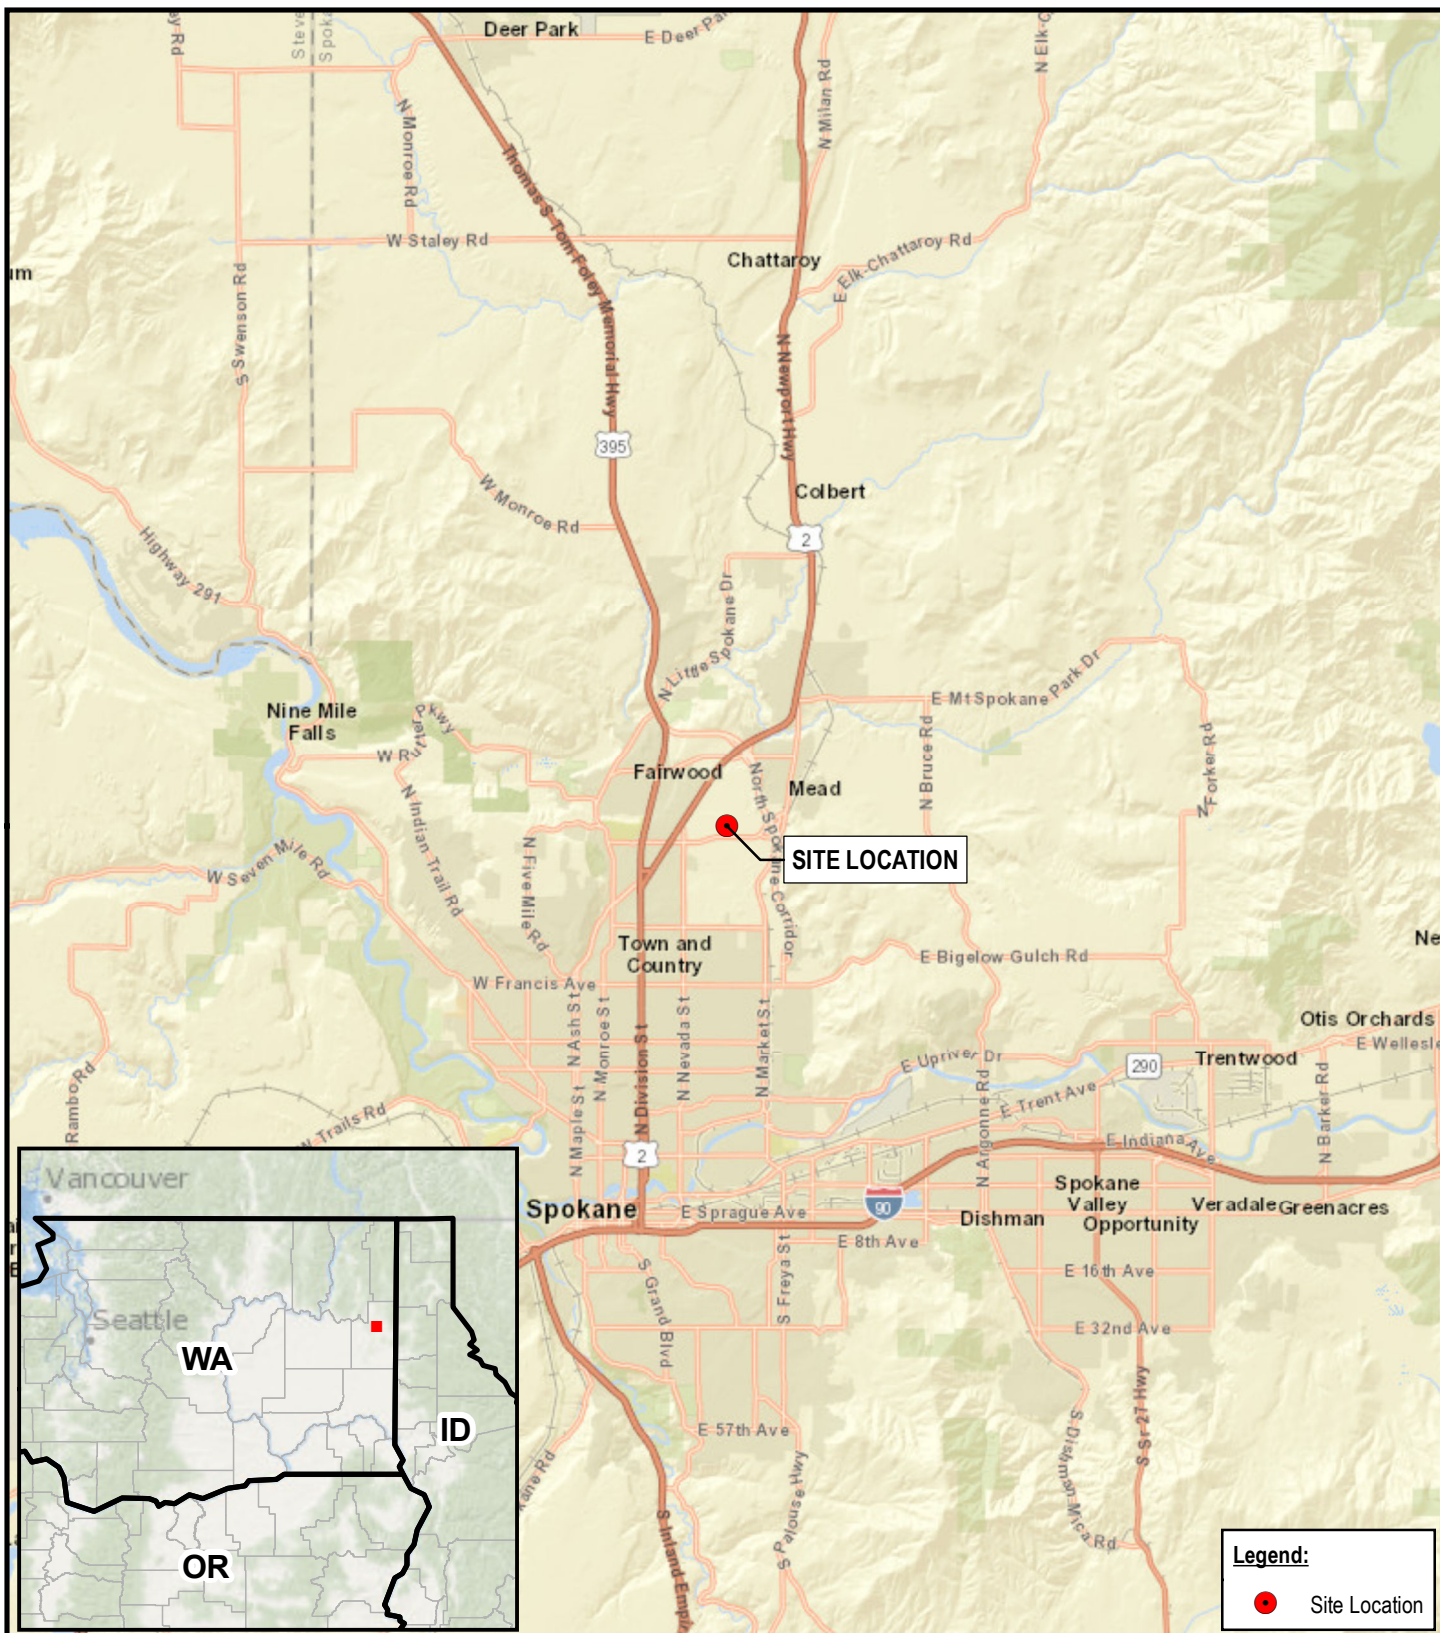
FIGURE 3-5
CATCH BASIN CLEANOUT MAP
FORMER KAISER SMELTER TCRA
2111 E HAWTHORNE ROAD
MEAD, SPOKANE COUNTY, WA
NOVEMBER 2021

EPA tasked ERRS with cleaning selected catch basins to remove sediment that could potentially have high concentrations of PCBs, PAHs, and asbestos. The targeted catch basins were located near and downstream of the Robertson Siding removal zone. ERRS arranged for the targeted catch basins to be cleaned by jet-rodding⁴ drainages and collecting the sediments with industrial vacuum trucks. Thirty-seven catch basins were cleaned during the TCRA, as depicted in Figure 3-5. The

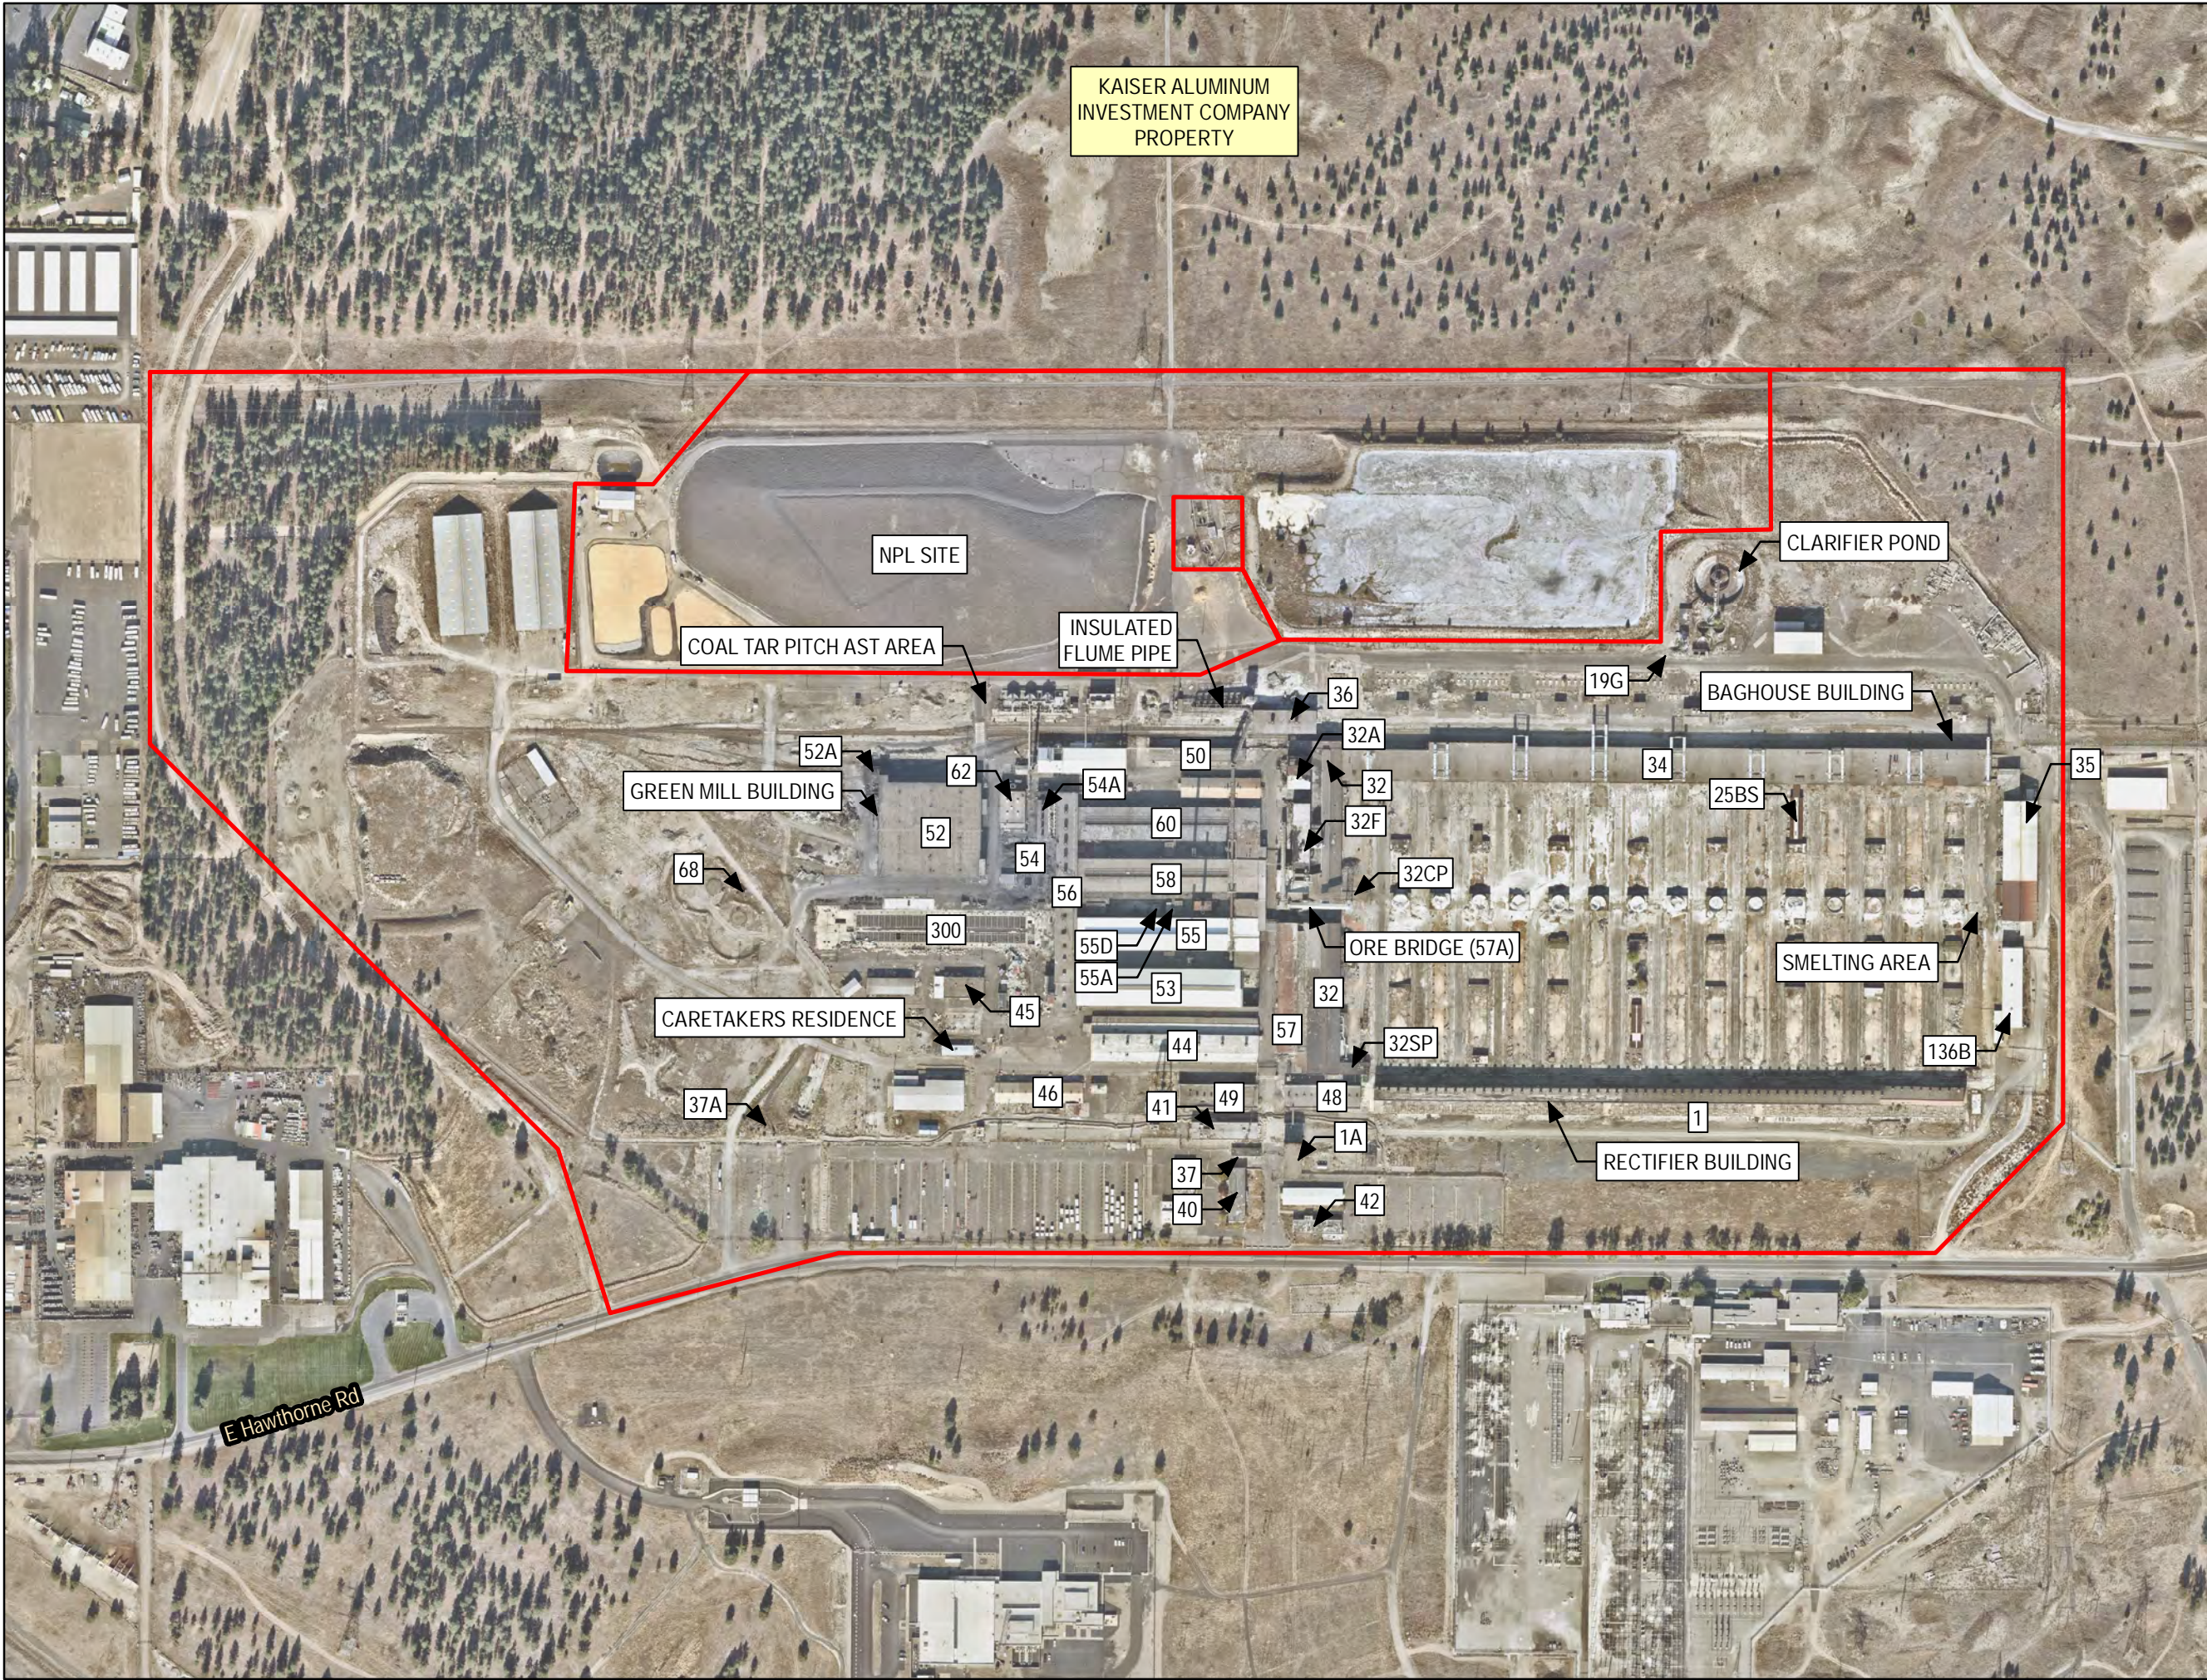
FIGURE 2-2
SITE PLAN
FORMER KAISER SMELTER TCRA
2111 E HAWTHORNE ROAD
MEAD, SPOKANE COUNTY, WA
NOVEMBER 2021

- LEGEND
- 52 Building No.
 - Property Boundary
- NPL Site - Kaiser Aluminum - Mead
Works Potliner Superfund Cleanup Site

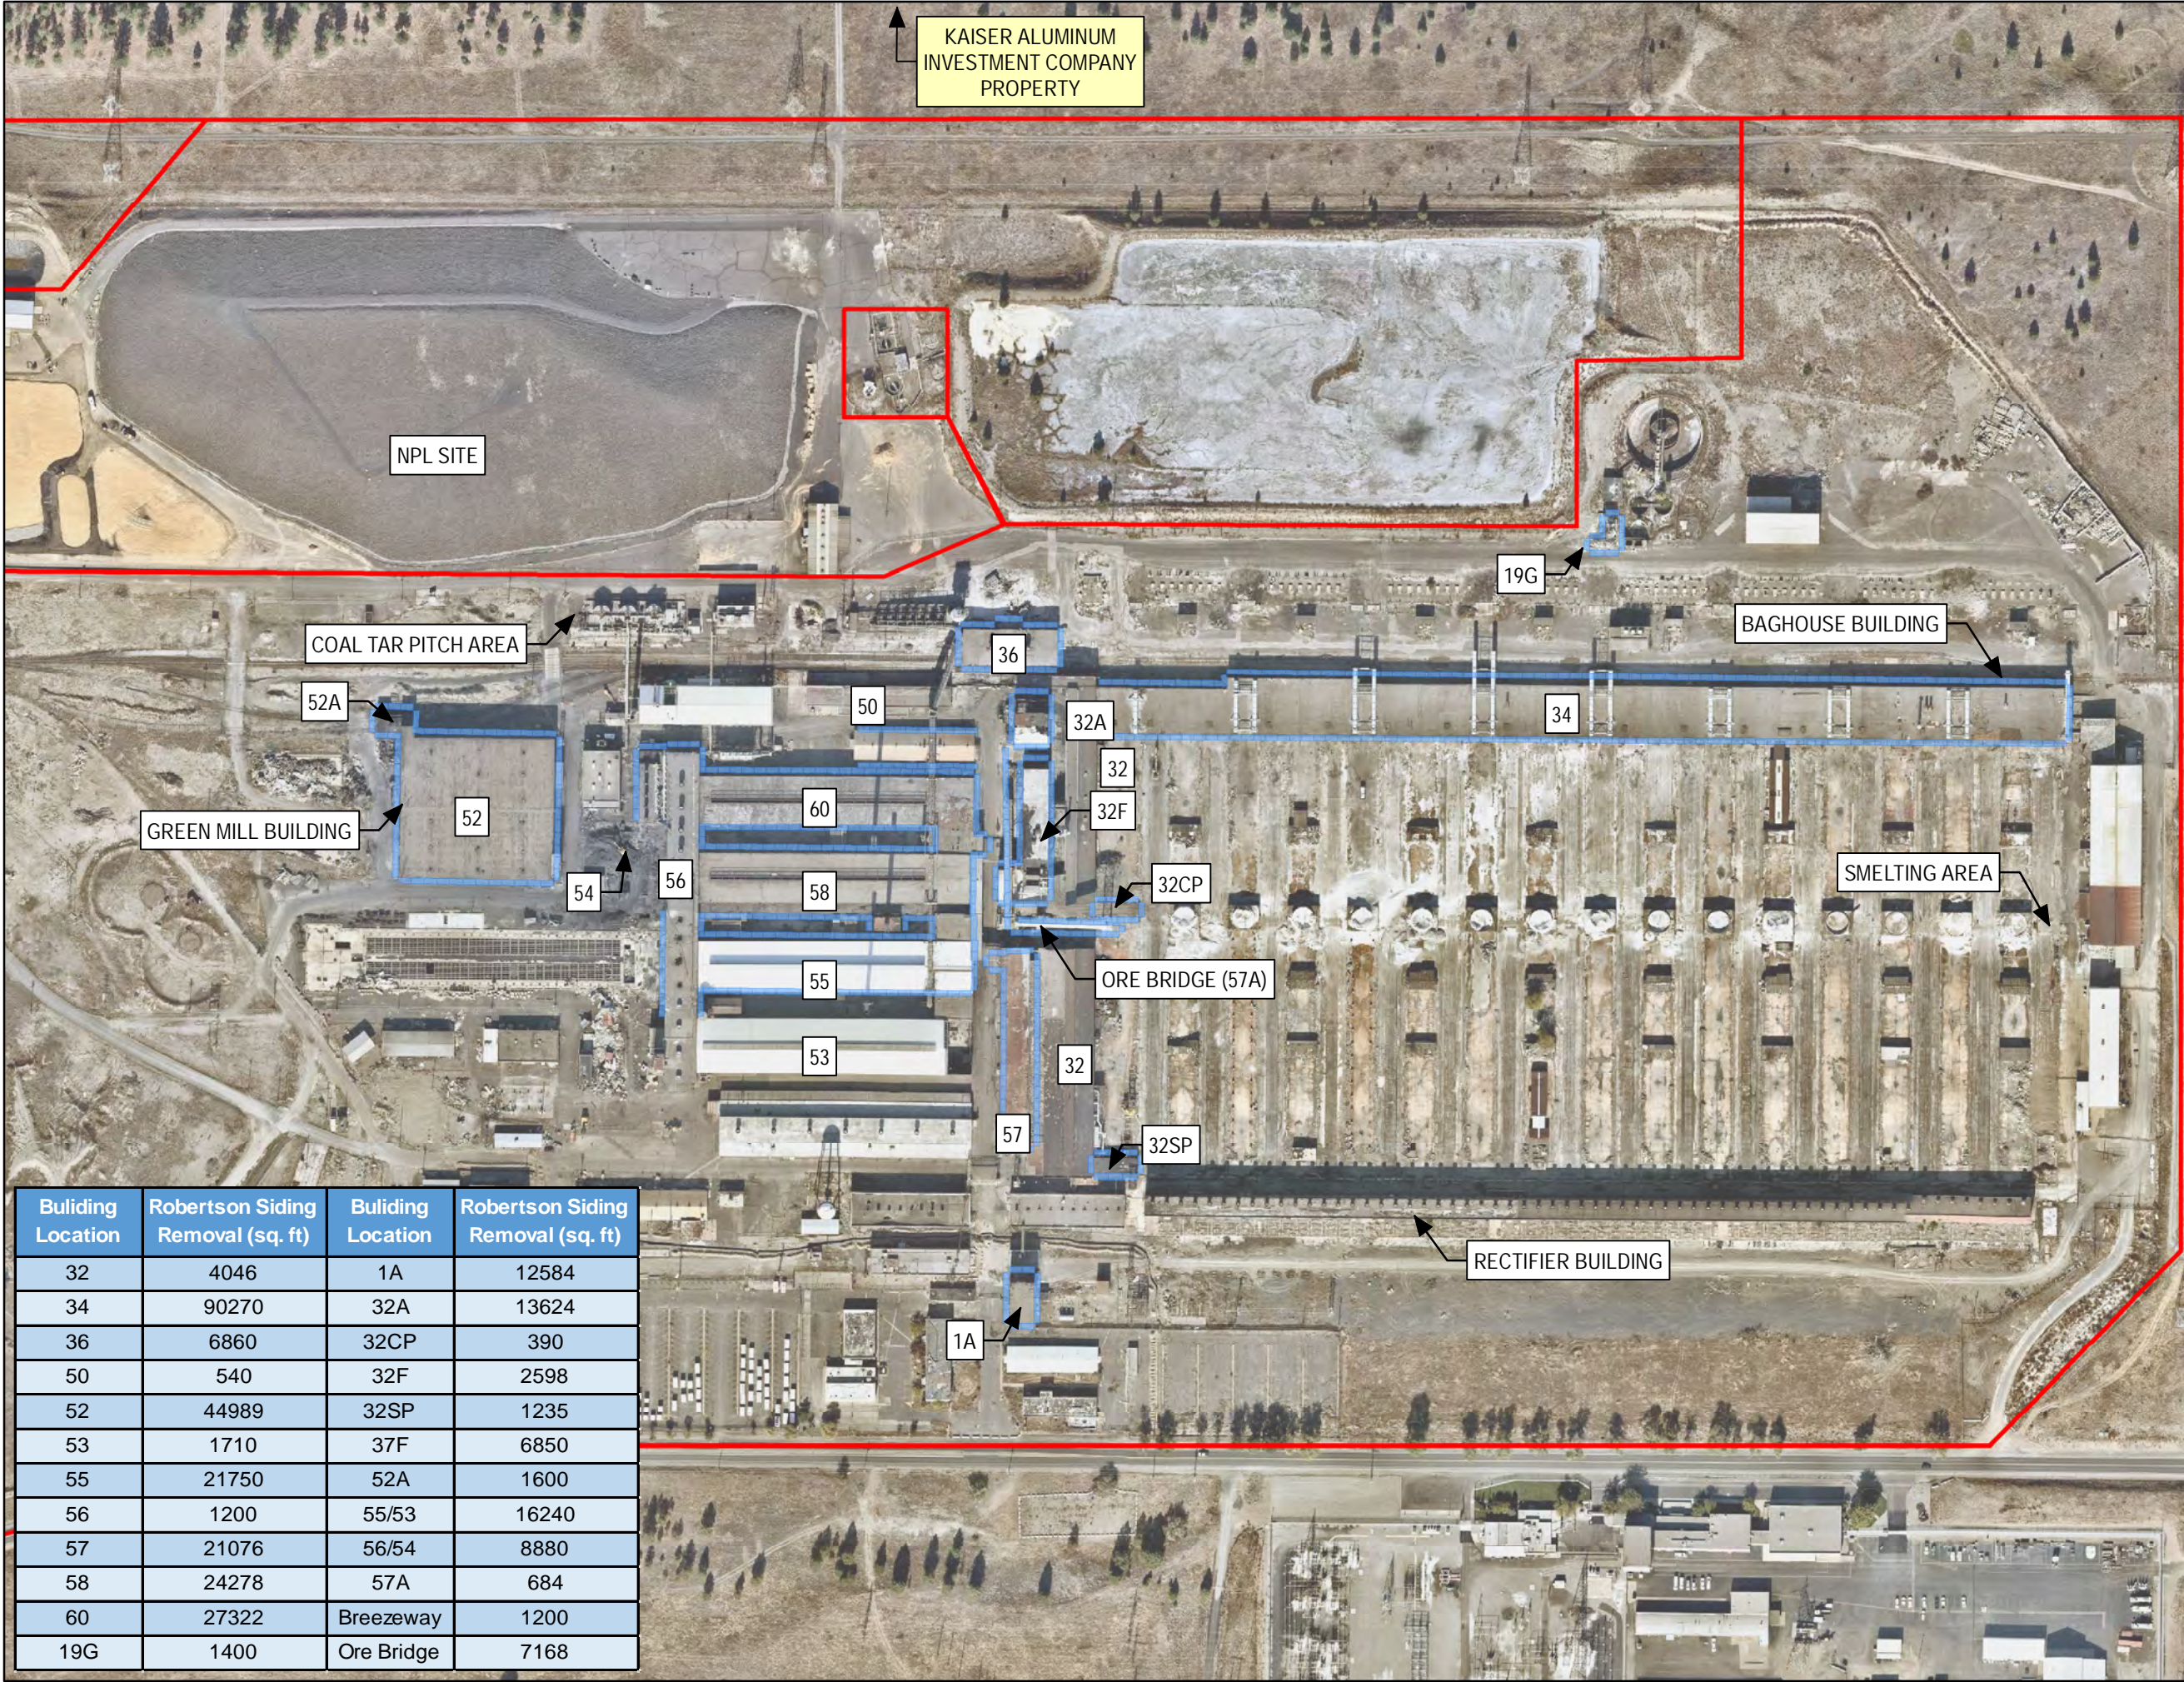
- LEGEND
- 52 Building No.
 - Area Where Robertson Siding Identified and Removed (Decision Unit 1)
 - Property Boundary
- NPL Site - Kaiser Aluminum - Mead Works Potliner Superfund Cleanup Site

Bulding Location	Robertson Siding Removal (sq. ft)	Bulding Location	Robertson Siding Removal (sq. ft)
32	4046	1A	12584
34	90270	32A	13624
36	6860	32CP	390
50	540	32F	2598
52	44989	32SP	1235
53	1710	37F	6850
55	21750	52A	1600
56	1200	55/53	16240
57	21076	56/54	8880
58	24278	57A	684
60	27322	Breezeway	1200
19G	1400	Ore Bridge	7168

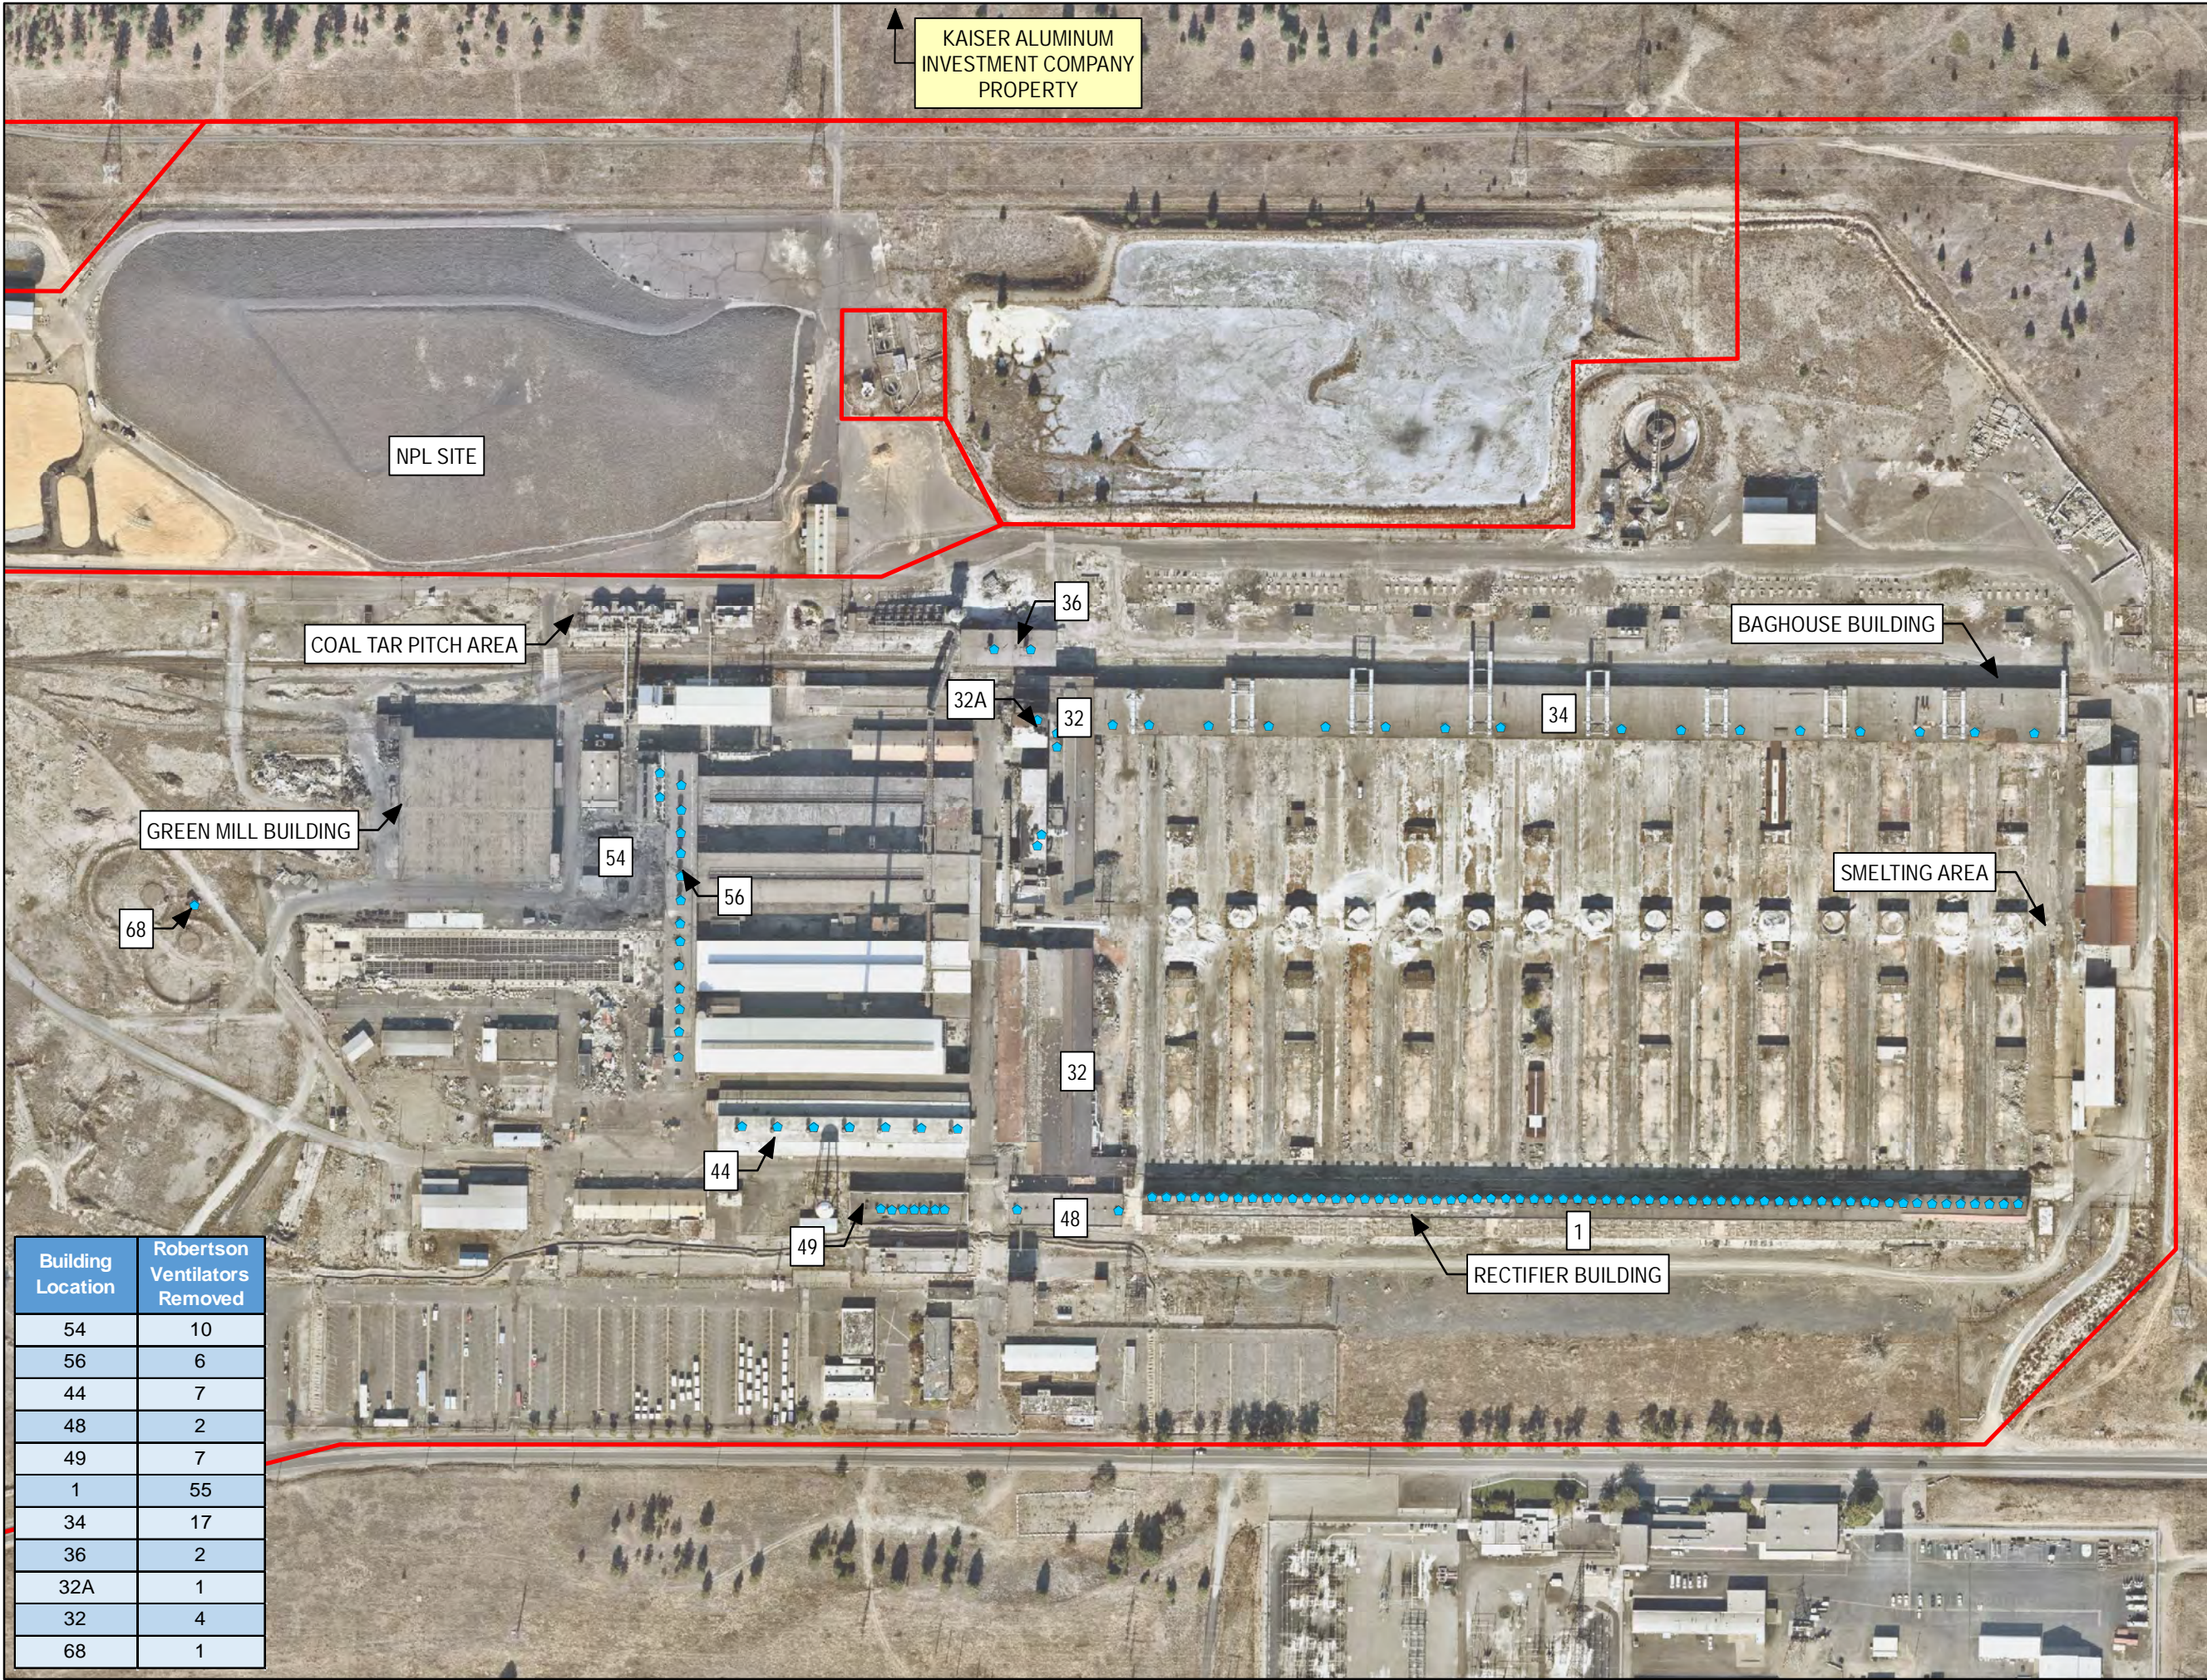
- LEGEND
- Robertson Ventilators Removed (Decision Unit 1)
 - 52 Building No.
 - Property Boundary

Building Location	Robertson Ventilators Removed
54	10
56	6
44	7
48	2
49	7
1	55
34	17
36	2
32A	1
32	4
68	1

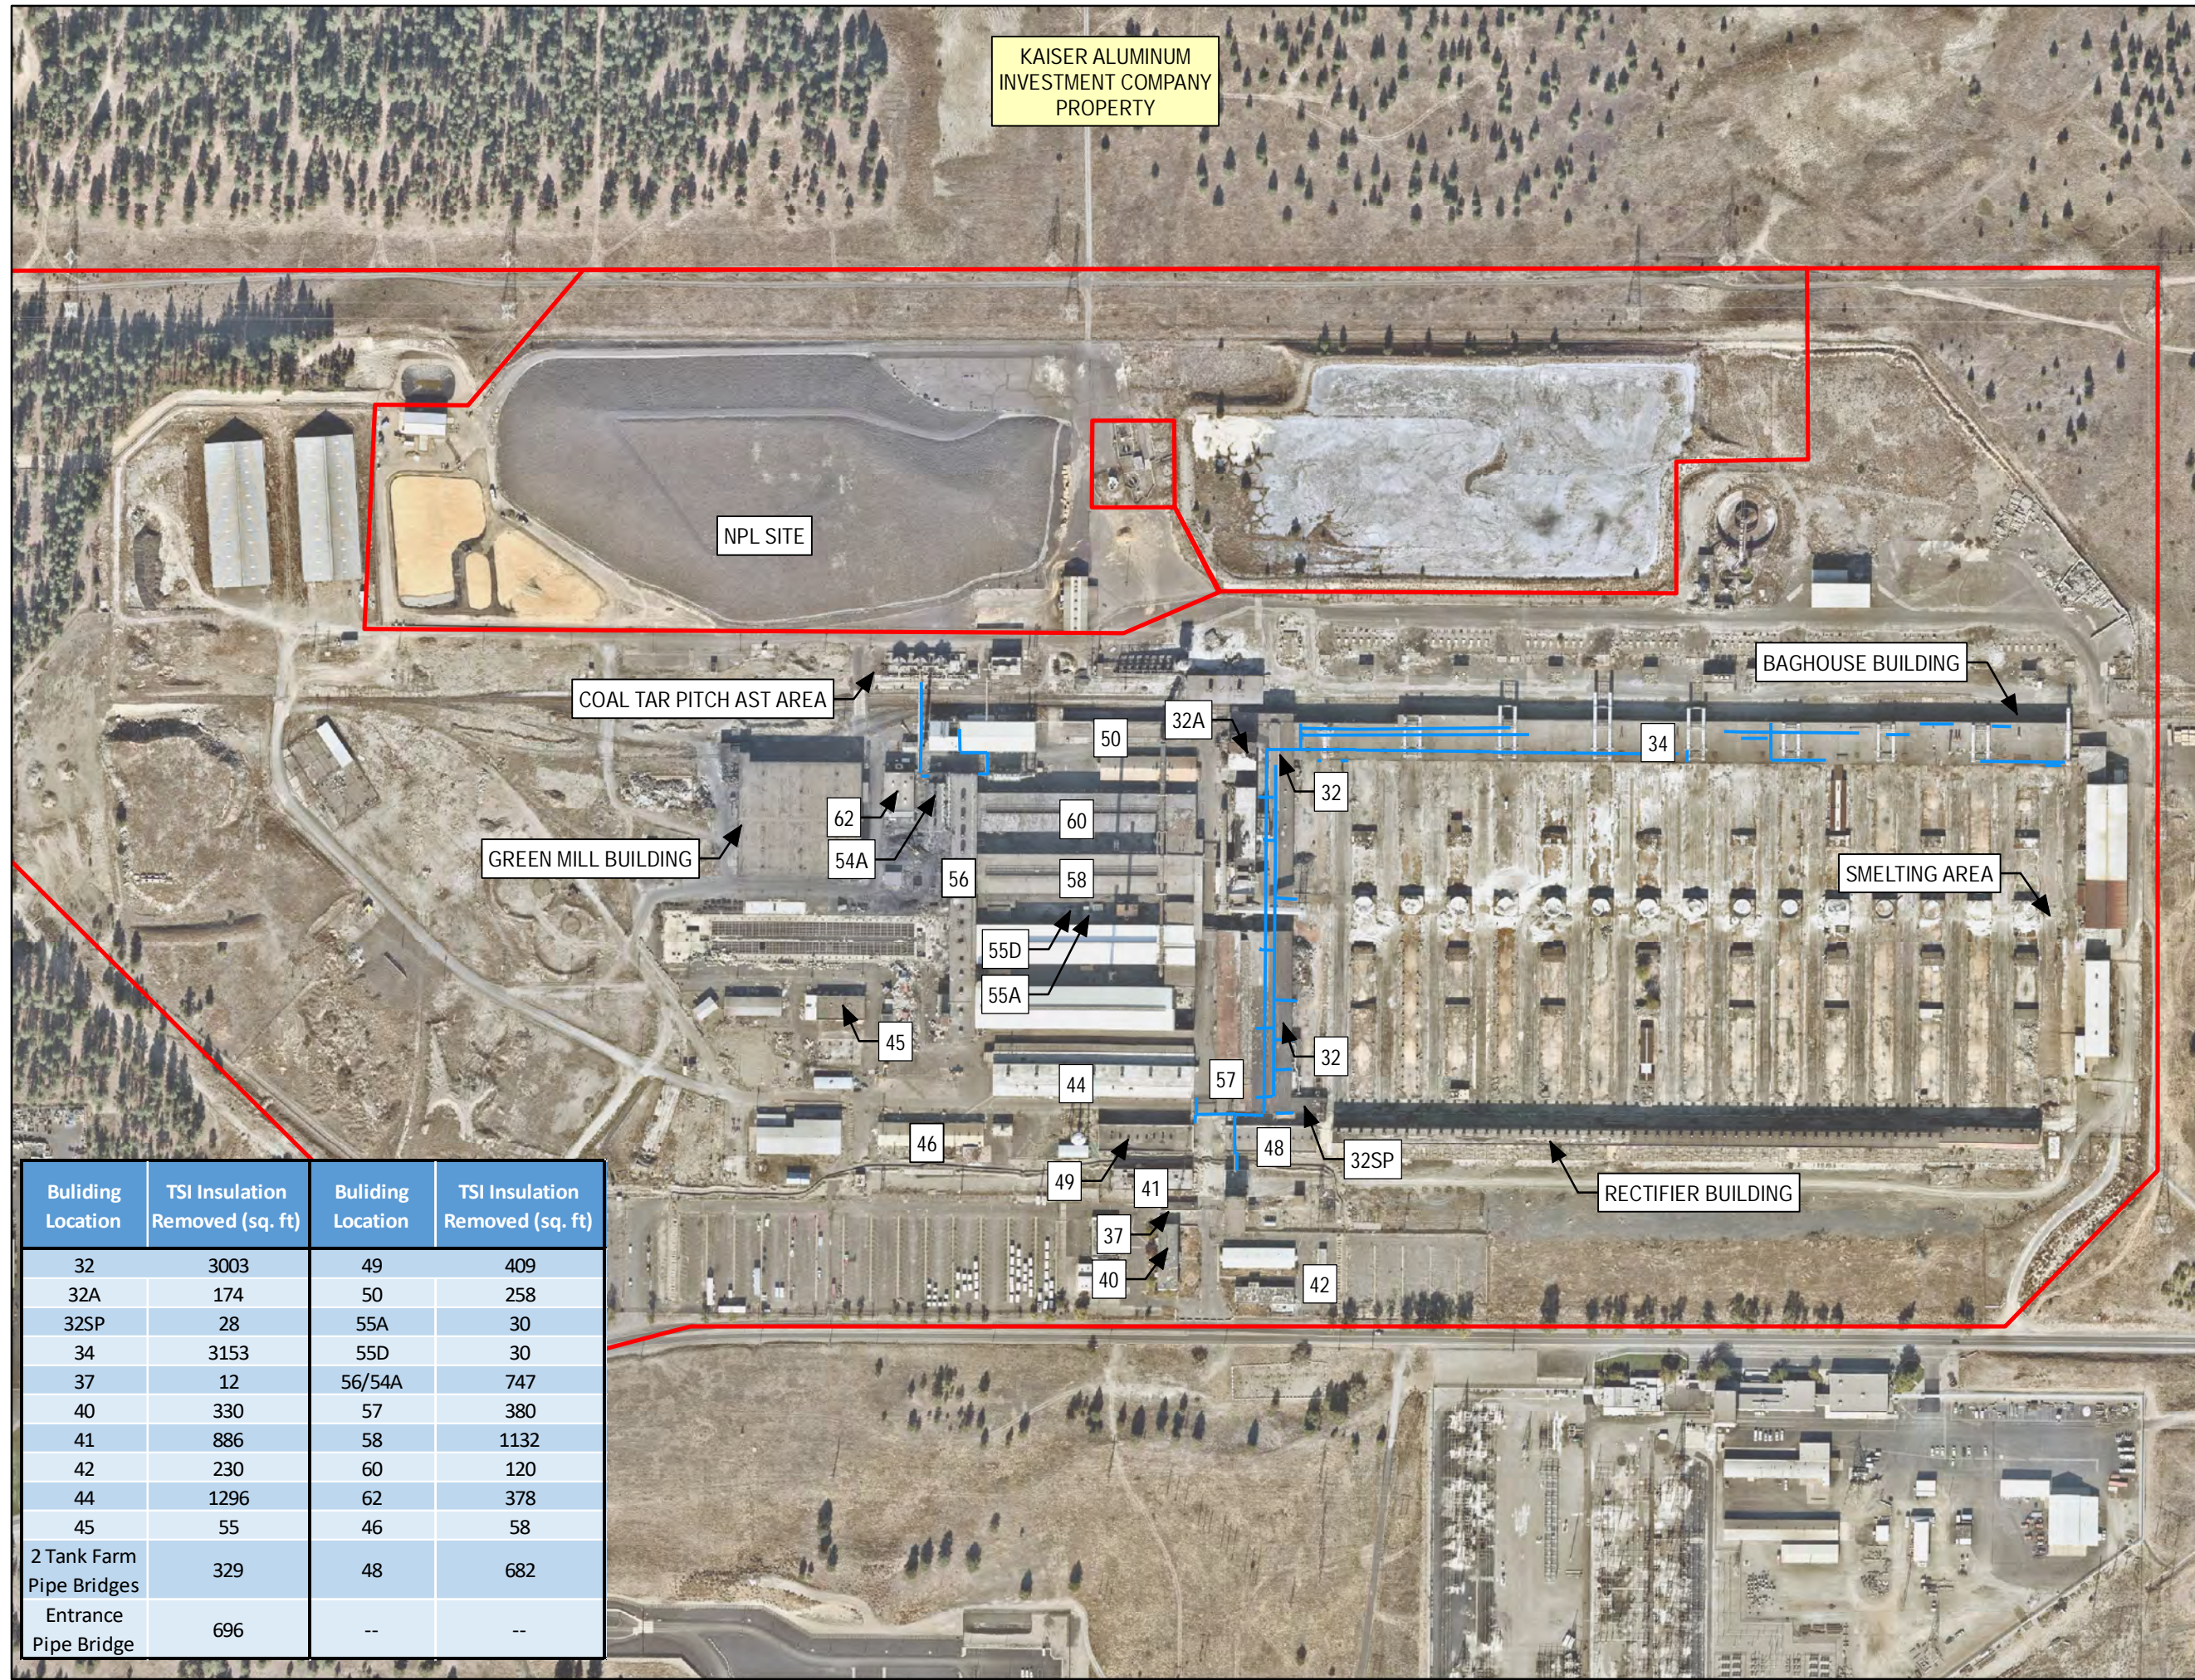
Buliding Location	TSI Insulation Removed (sq. ft)	Buliding Location	TSI Insulation Removed (sq. ft)
32	3003	49	409
32A	174	50	258
32SP	28	55A	30
34	3153	55D	30
37	12	56/54A	747
40	330	57	380
41	886	58	1132
42	230	60	120
44	1296	62	378
45	55	46	58
2 Tank Farm Pipe Bridges	329	48	682
Entrance Pipe Bridge	696	--	--

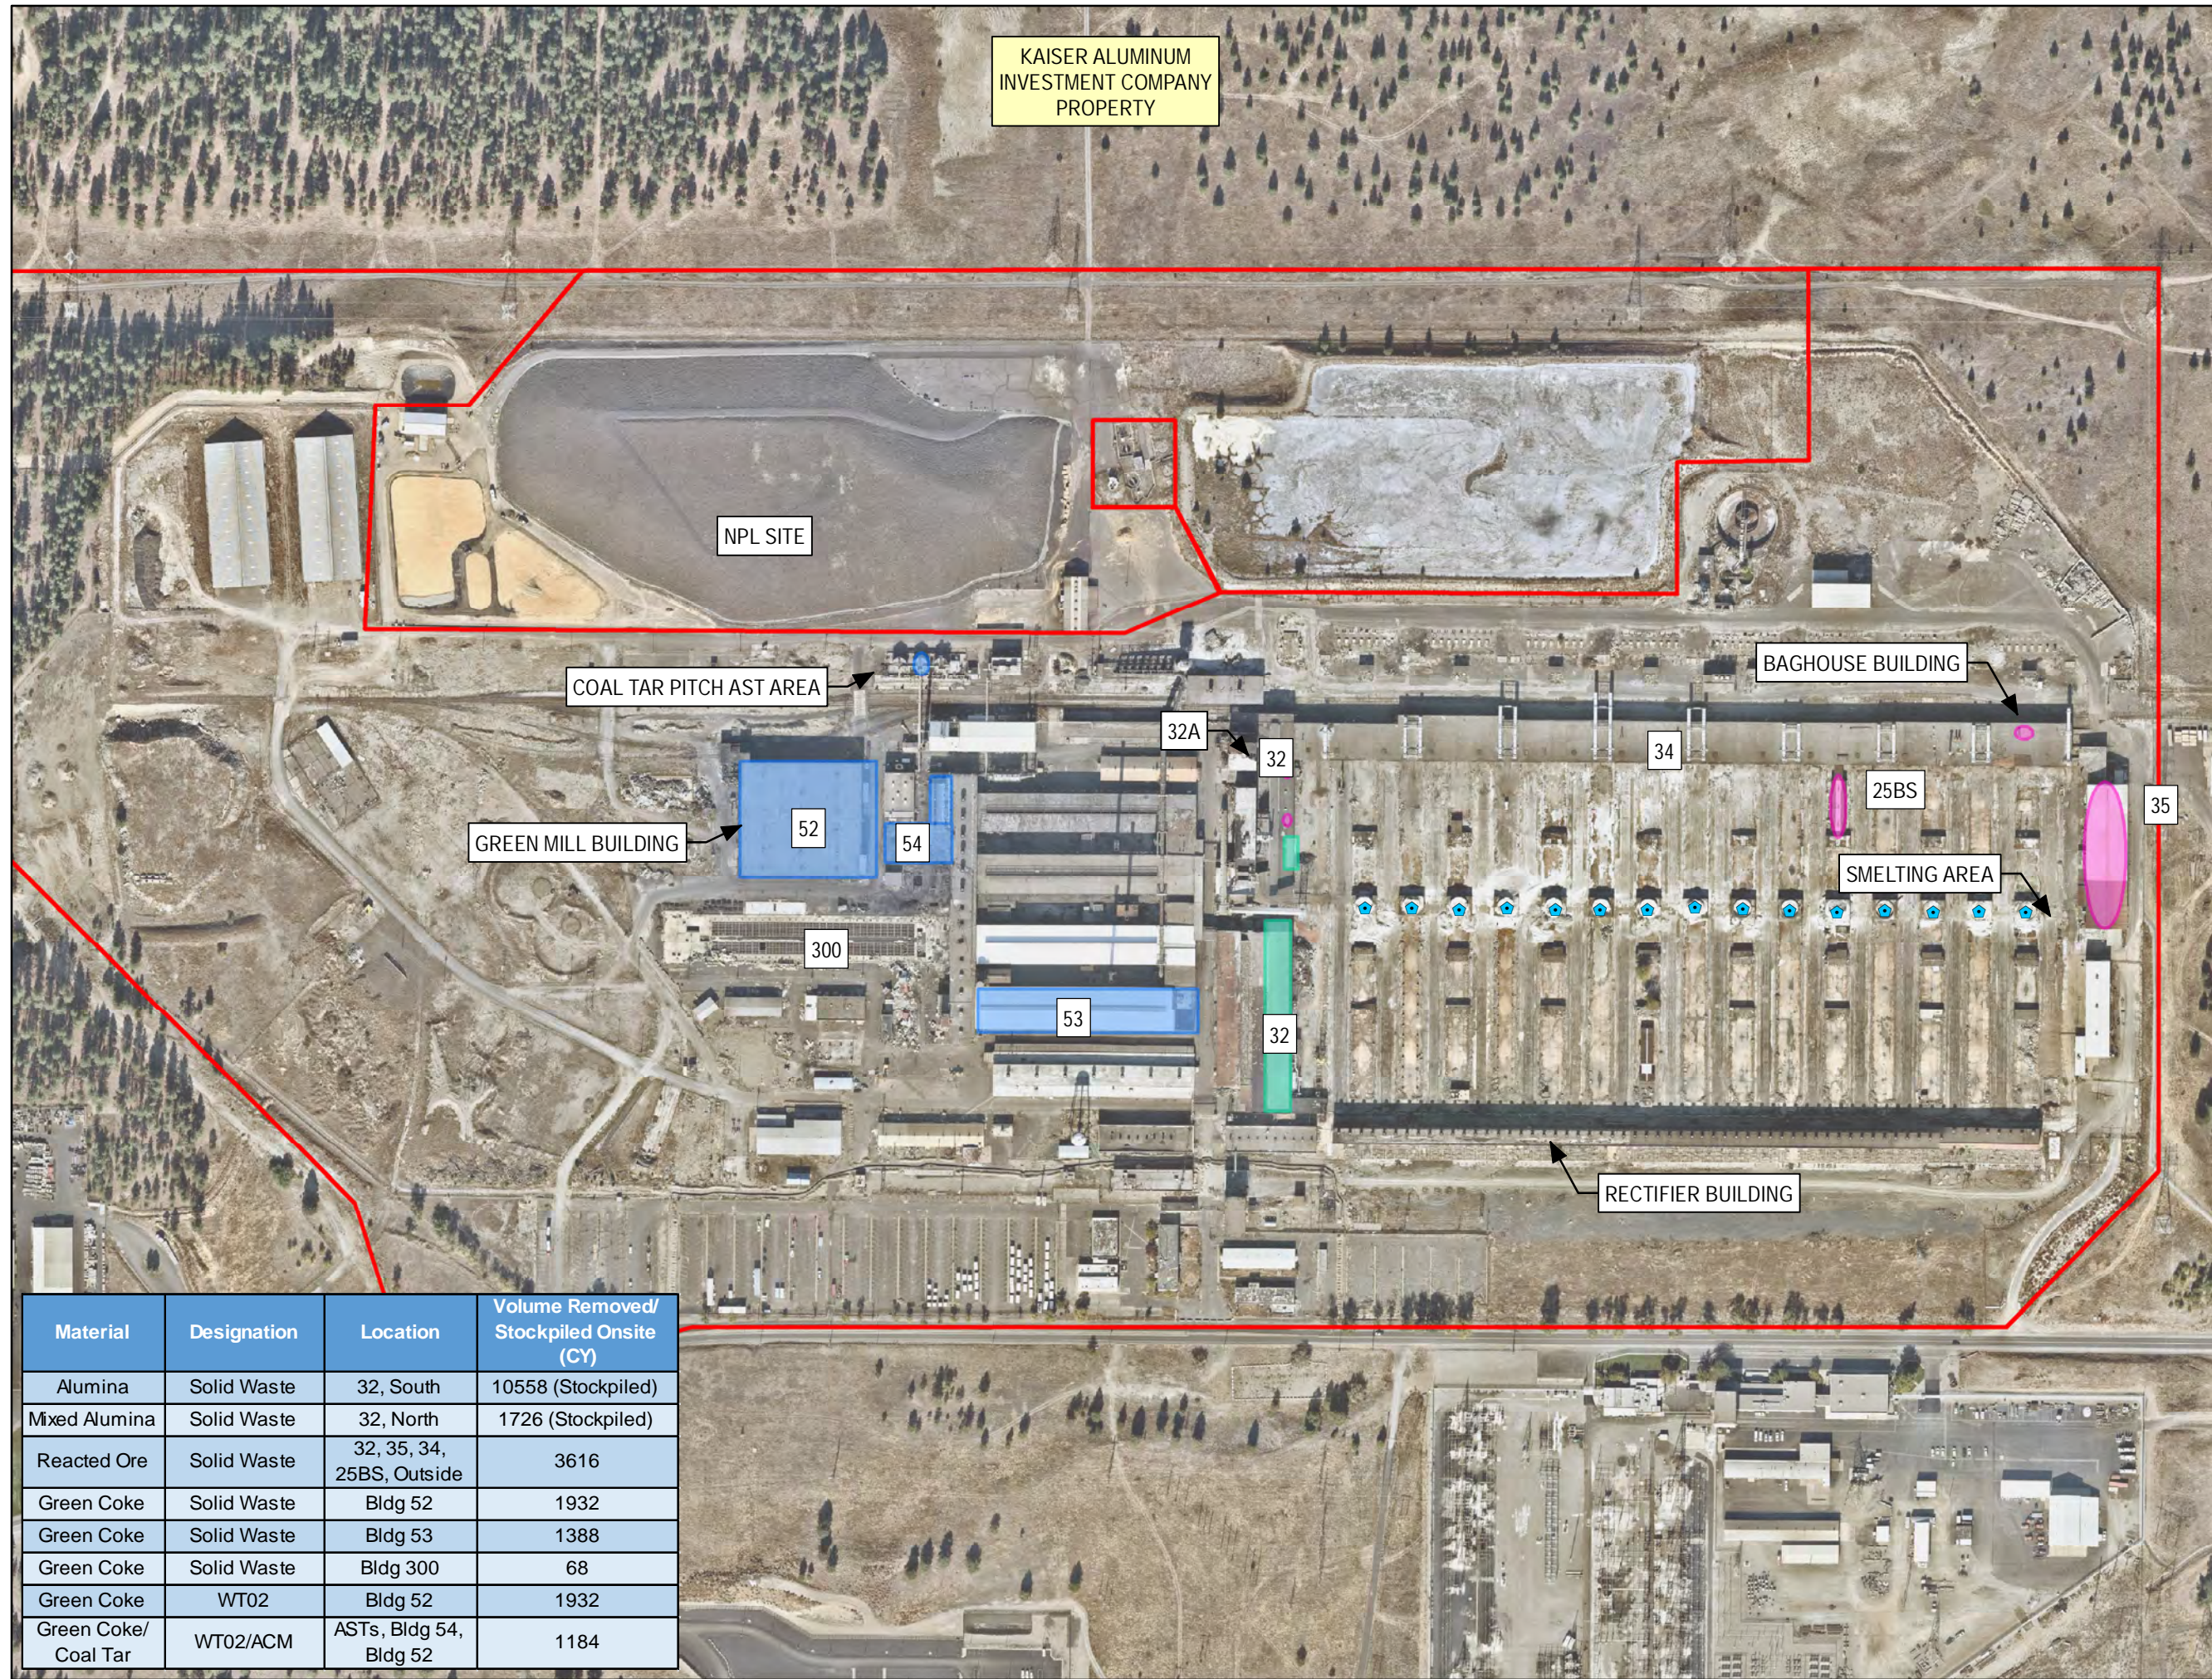
Material	Designation	Location	Volume Removed/ Stockpiled Onsite (CY)
Alumina	Solid Waste	32, South	10558 (Stockpiled)
Mixed Alumina	Solid Waste	32, North	1726 (Stockpiled)
Reacted Ore	Solid Waste	32, 35, 34, 25BS, Outside	3616
Green Coke	Solid Waste	Bldg 52	1932
Green Coke	Solid Waste	Bldg 53	1388
Green Coke	Solid Waste	Bldg 300	68
Green Coke	WT02	Bldg 52	1932
Green Coke/ Coal Tar	WT02/ACM	ASTs, Bldg 54, Bldg 52	1184
