TIME-CRITICAL REMOVAL ACTION REPORT

*Former Kaiser Smelter Site
Mead, Spokane County, Washington*

November 2021
Rev. 2

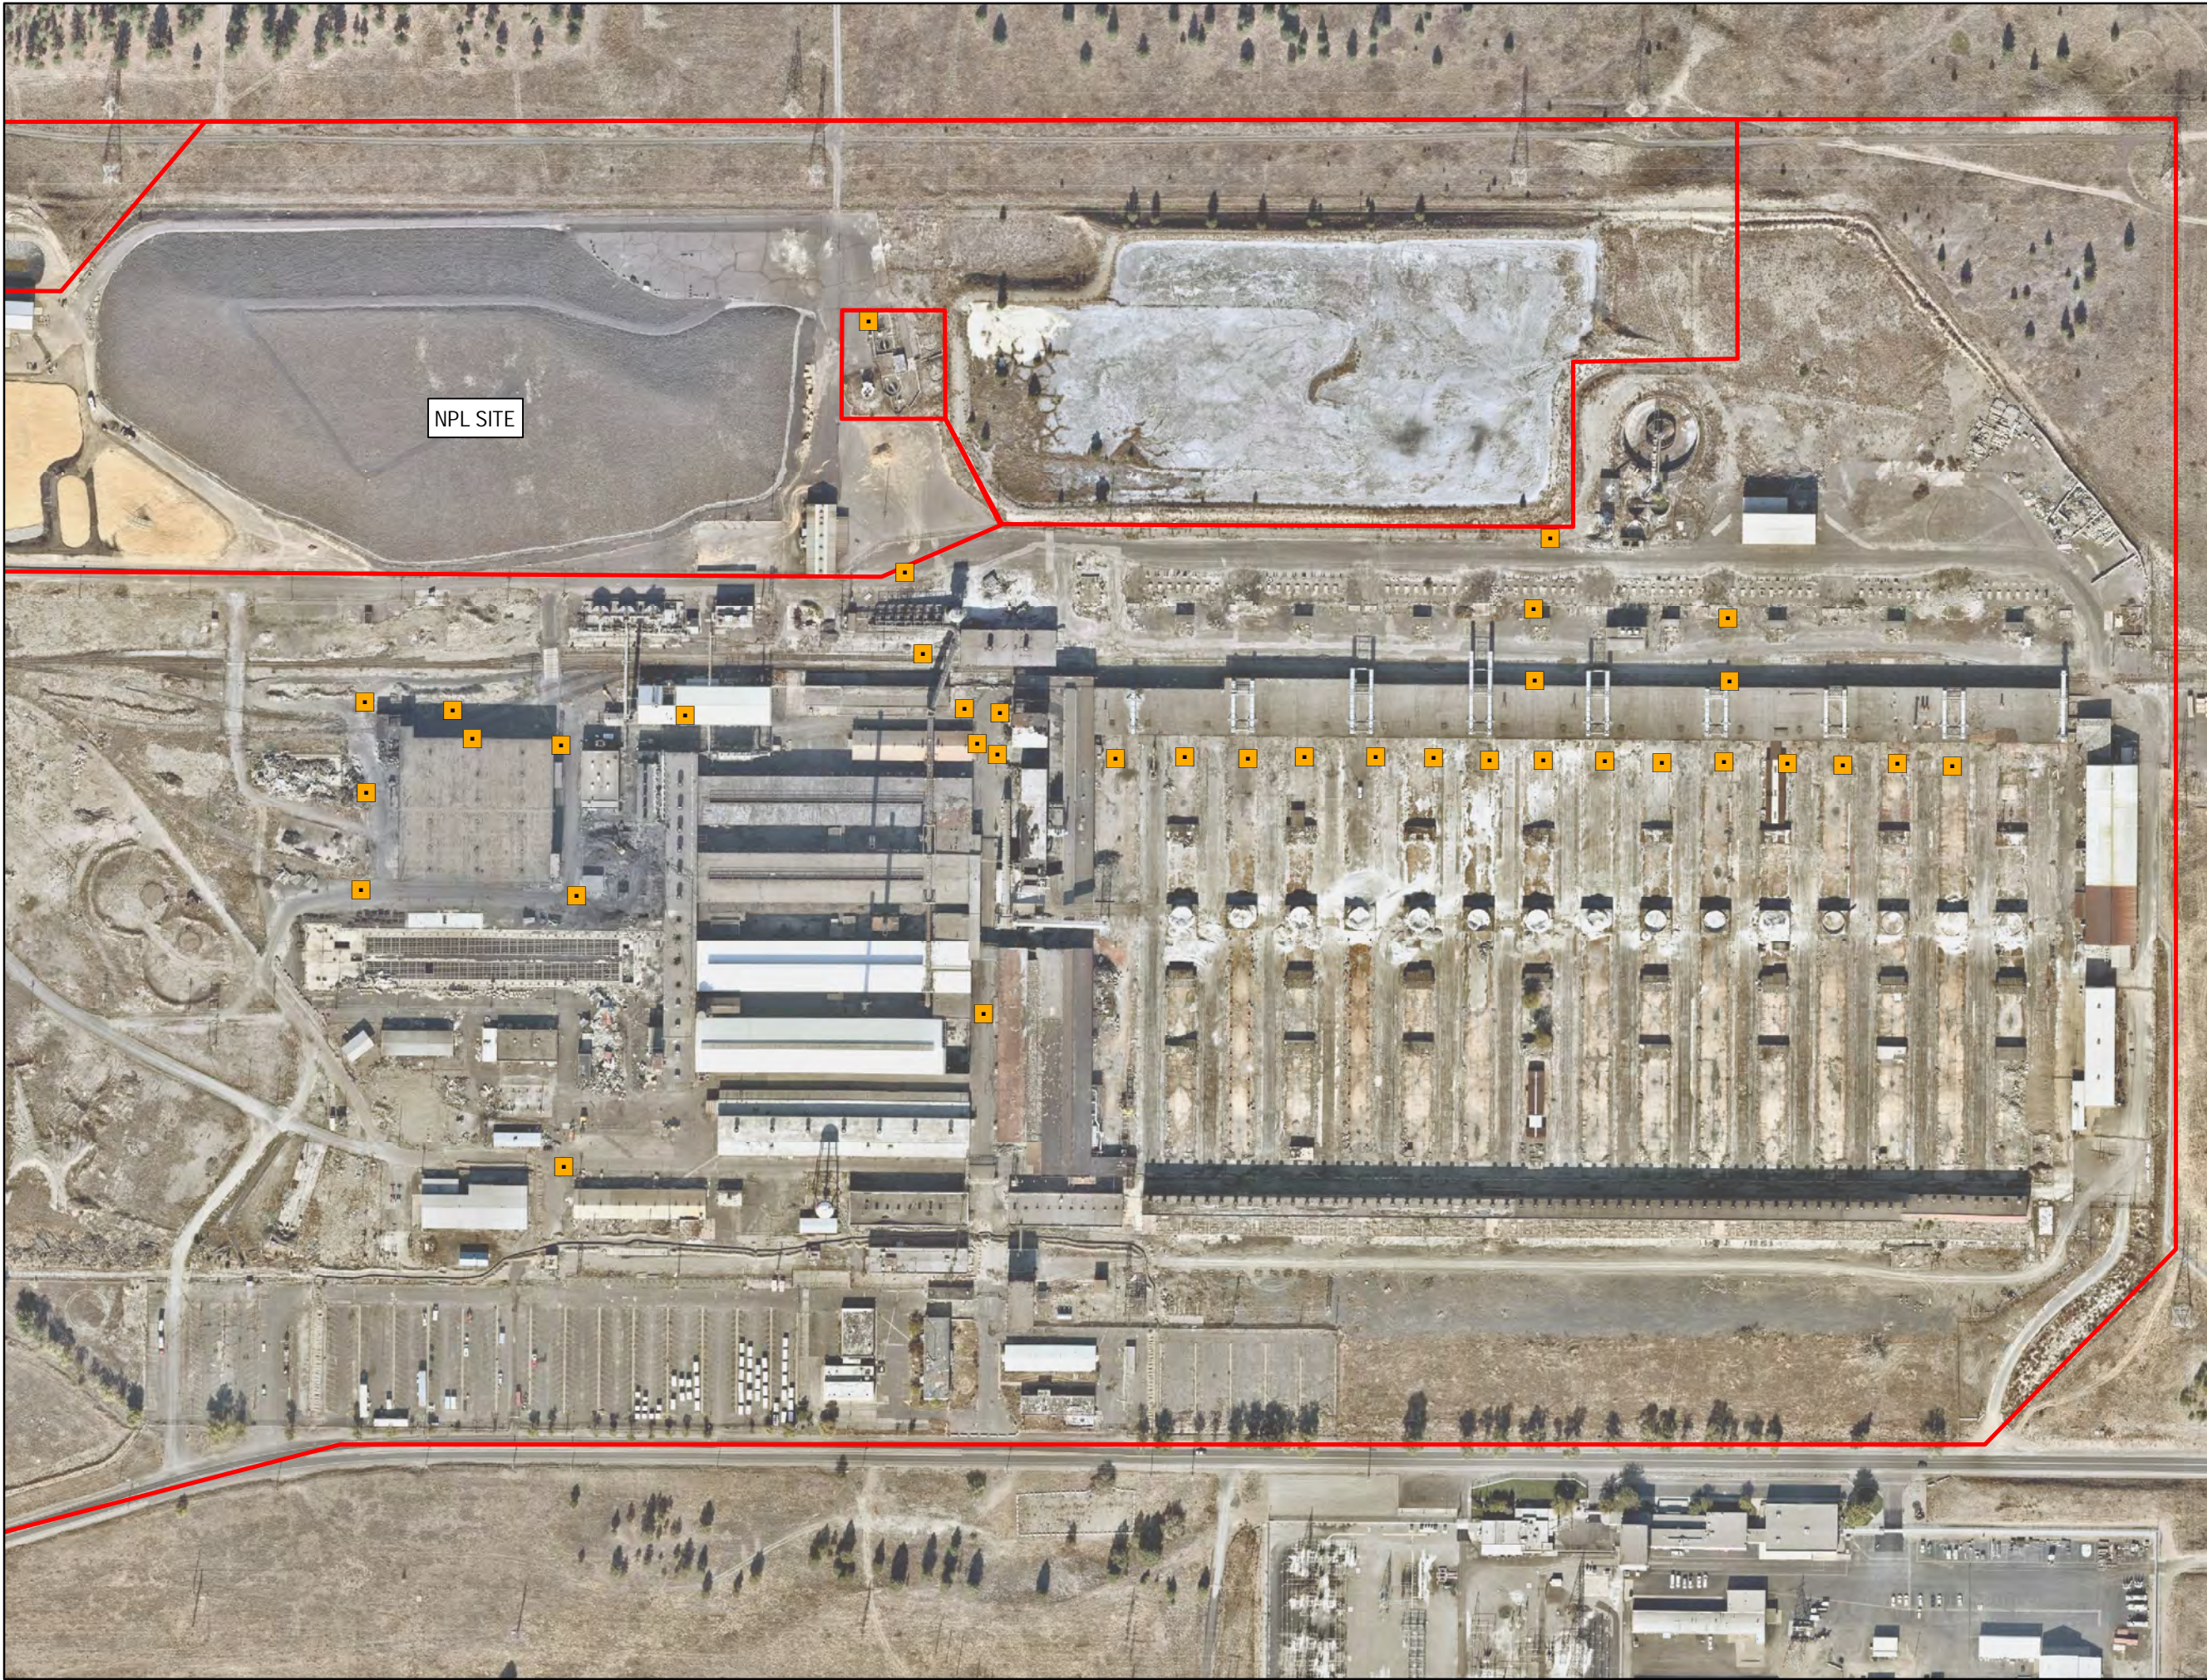
FIGURE 3-5
CATCH BASIN CLEANOUT MAP
FORMER KAISER SMELTER TCRA
2111 E HAWTHORNE ROAD
MEAD, SPOKANE COUNTY, WA
NOVEMBER 2021

- LEGEND
- Cleaned Catch Basin
 - Property Boundary

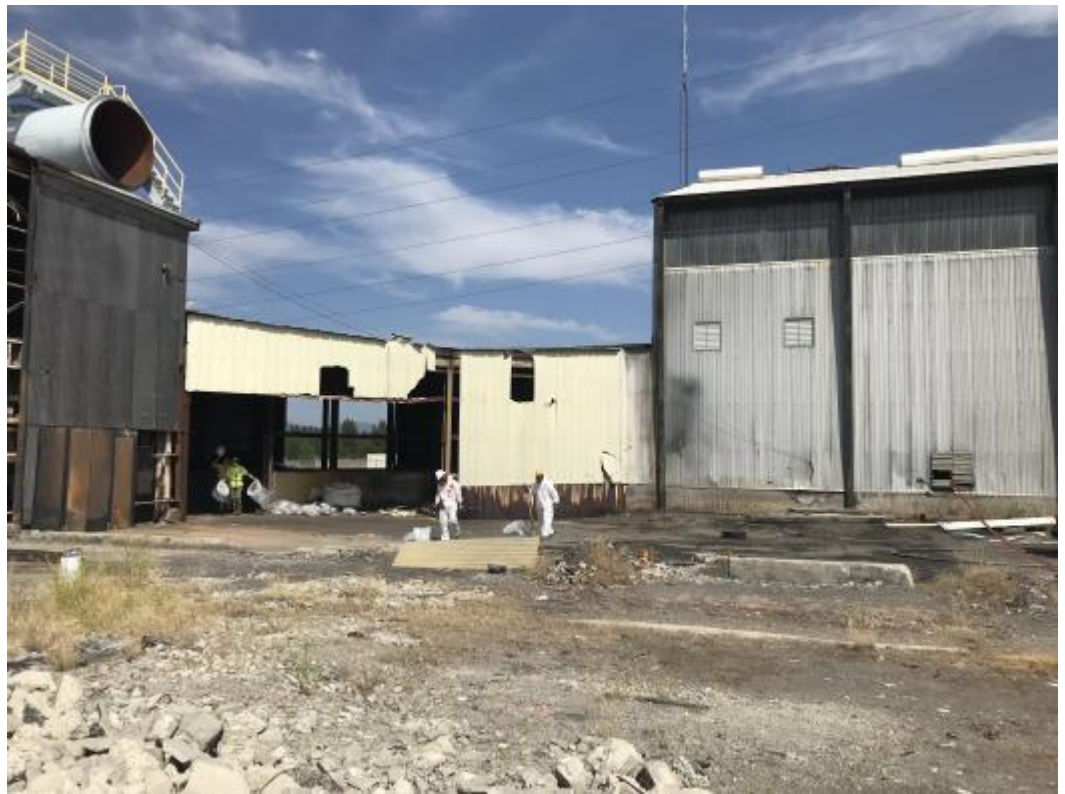
Photo No. 3	Date: 07/30/2020
Photo Coordinates	
Lat	47.755669
Long	-117.370942
Direction Photo Taken: East	
Description: ERRS prepping for Robertson Siding removal demonstration by removing large debris and laying out plastic sheeting.

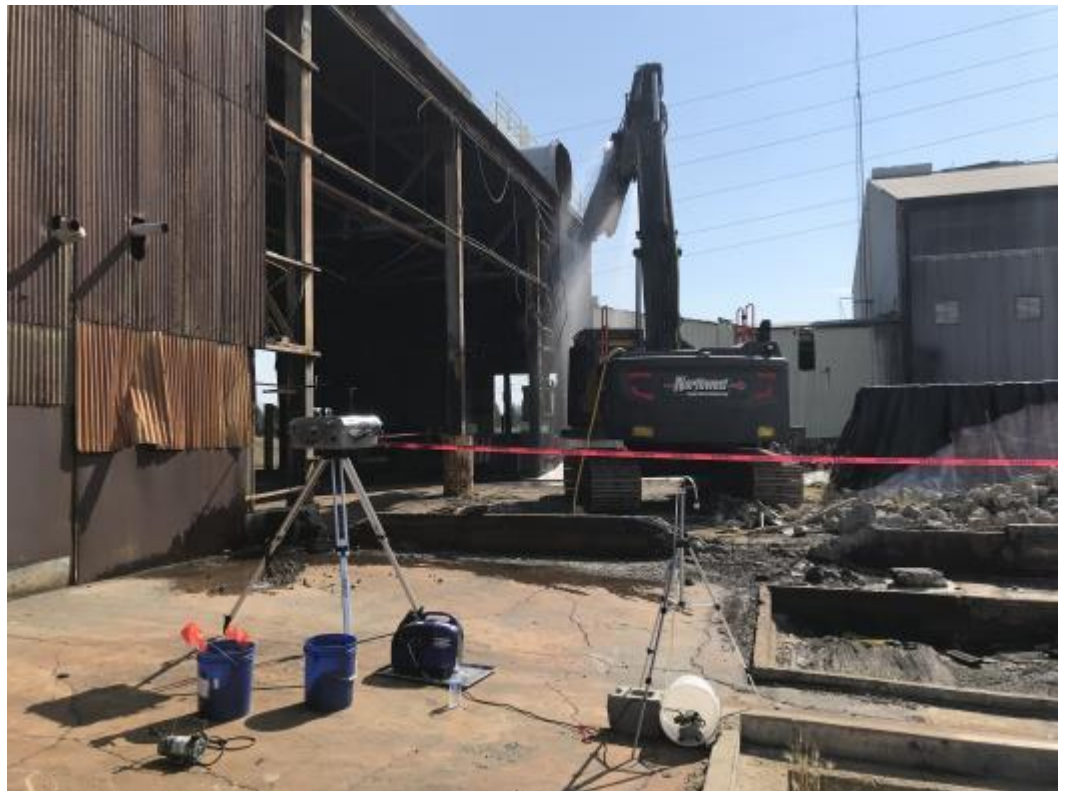
Photo No. 4	Date: 07/31/2020
Photo Coordinates	
Lat	47.755689
Long	-117.371253
Direction Photo Taken: Northeast	
Description: ERRS removing first panel of Robertson Siding.

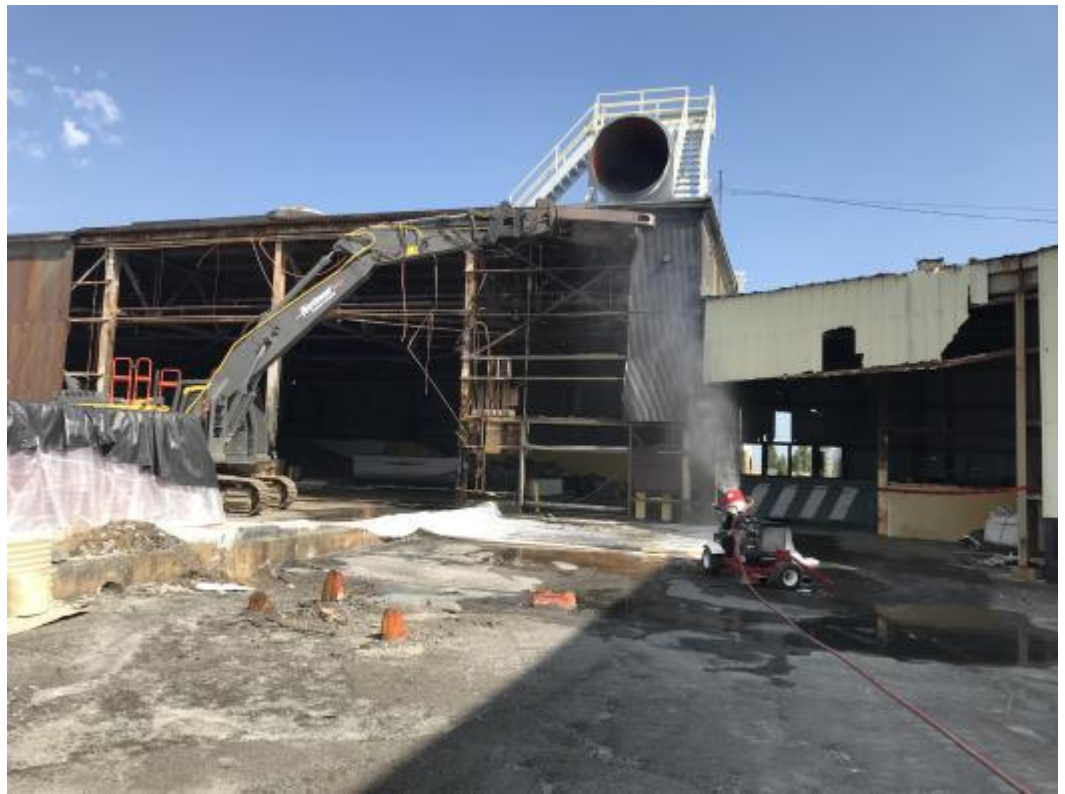
Photo No. 5	Date: 07/31/2020
Photo Coordinates	
Lat	47.755639
Long	-117.370797
Direction Photo Taken: Northwest	
Description: Robertson Siding removal demonstration using excavator and water mister.

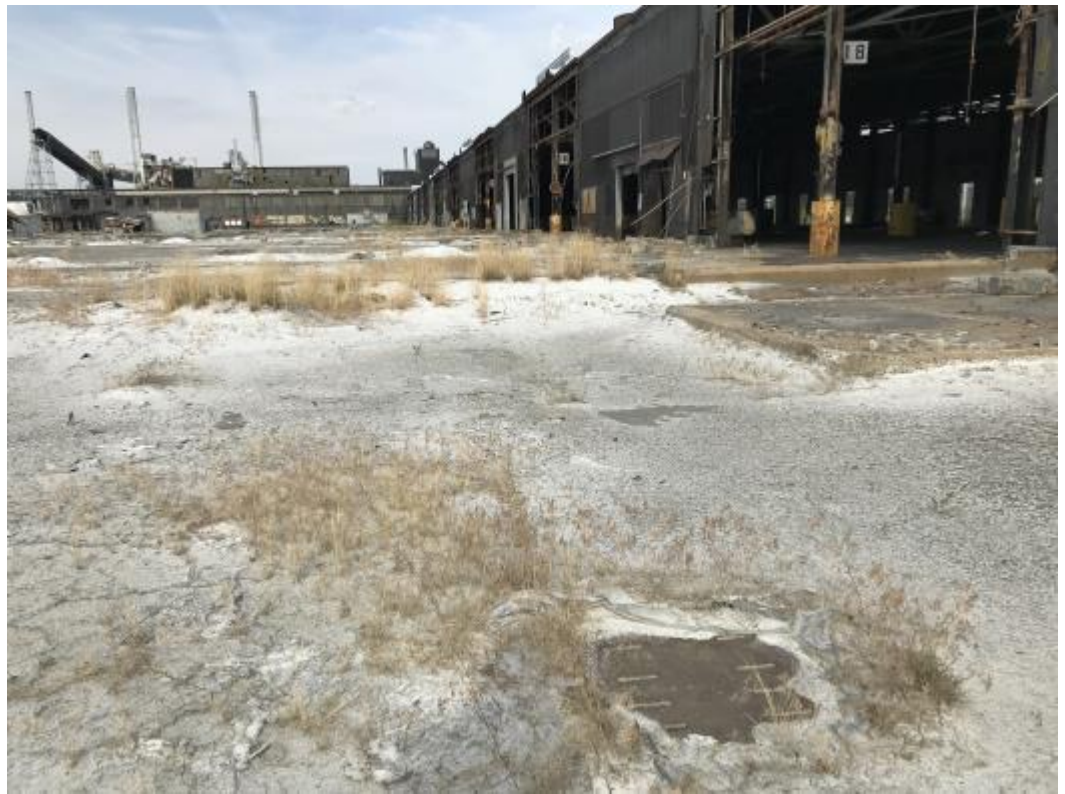
Photo No. 9	Date: 08/01/2020
Photo Coordinates	
Lat	47.755775
Long	-117.373986
Direction Photo Taken: West	
Description: Stormwater drain covered in debris located near Building 34, Bay 18.

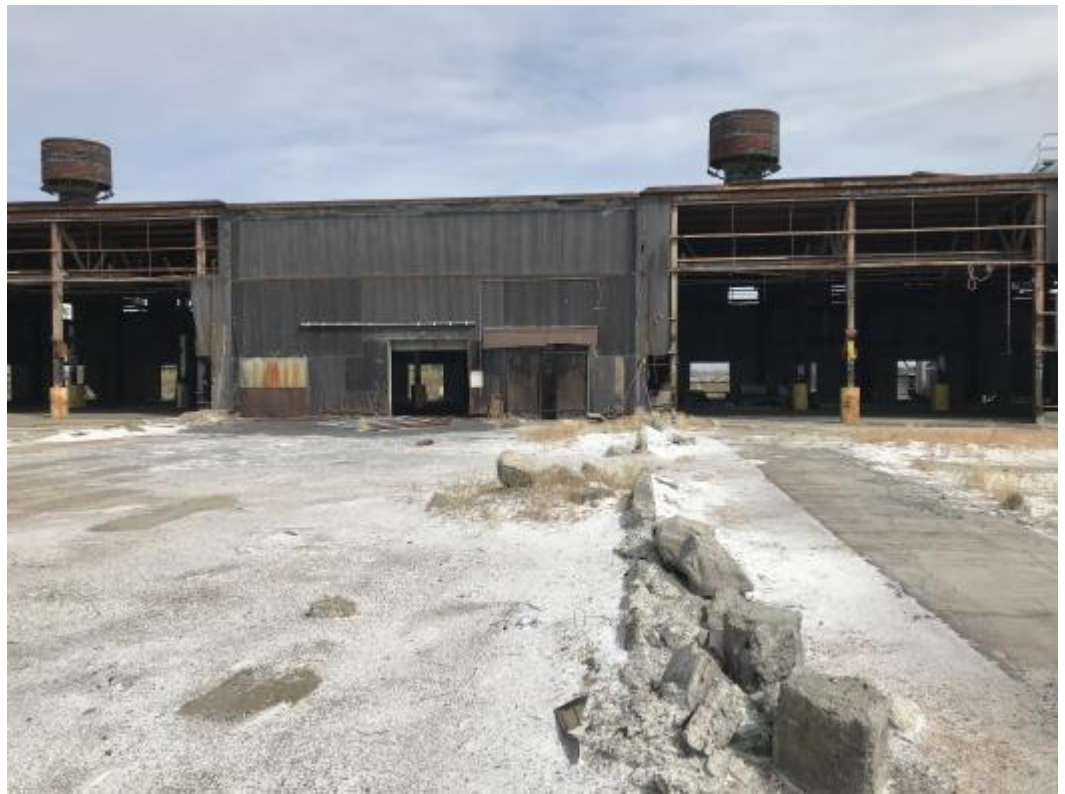
Photo No. 13	Date: 08/01/2020
Photo Coordinates	
Lat	47.755556
Long	-117.374275
Direction Photo Taken: North	
Description: Example of detritus and debris covering the ground by Building 34, Bay 17.

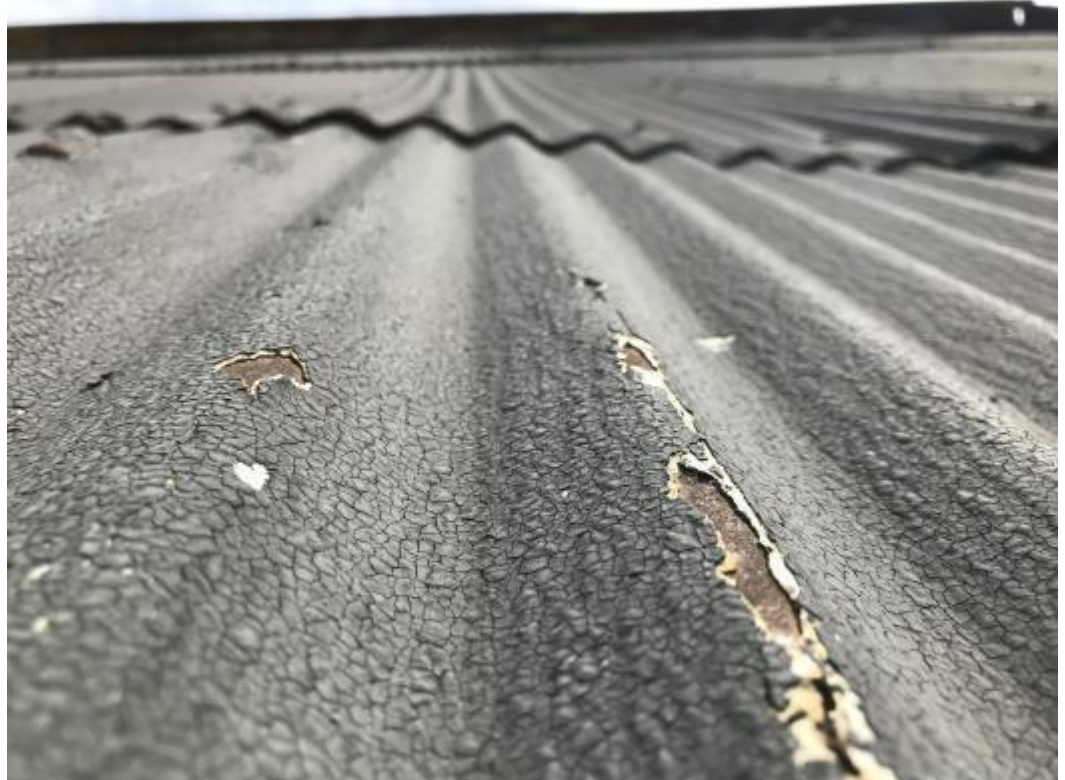
Photo No. 14	Date: 08/01/2020
Photo Coordinates	
Lat	47.755783
Long	-117.375167
Direction Photo Taken: Object	
Description: Close up view of Robertson Siding panels.

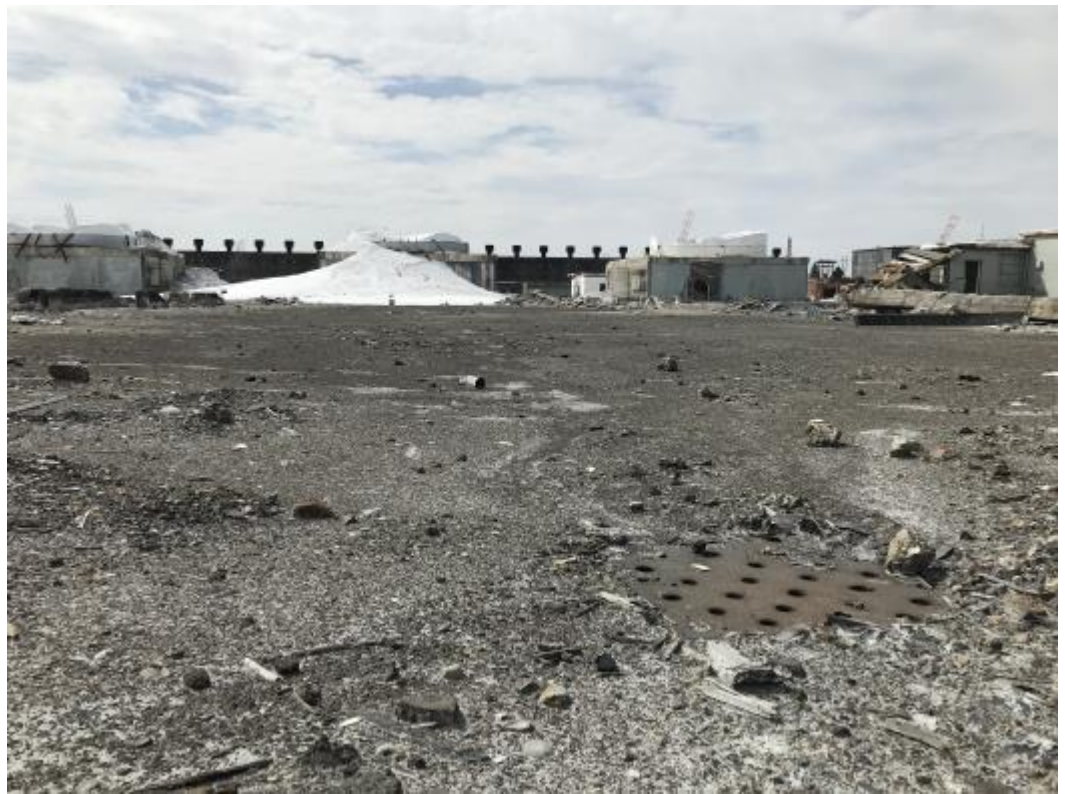
Photo No. 16	Date: 08/01/2020
Photo Coordinates	
Lat	47.755842
Long	-117.375969
Direction Photo Taken: East	
Description: Loosely secured storm drain located near Building 34, Bay 8. Example of common several slip, trip, and fall hazards at the Site.

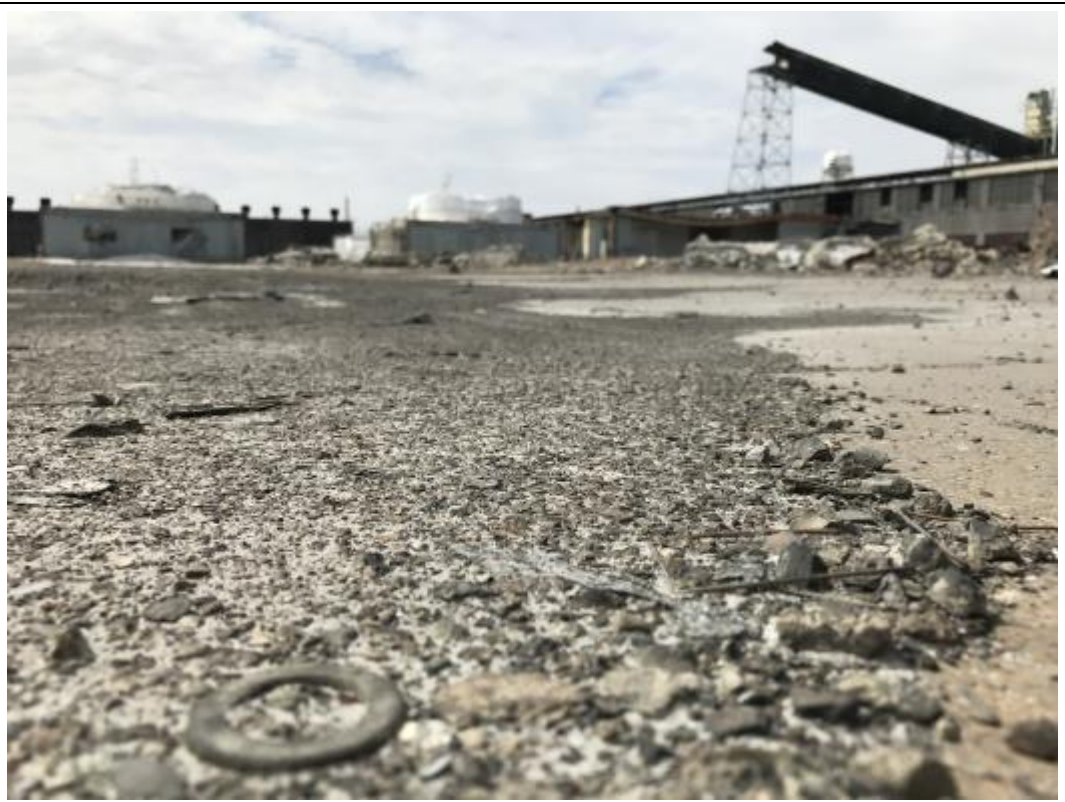
Photo No. 18	Date: 08/01/2020
Photo Coordinates	
Lat	47.755772
Long	-117.376792
Direction Photo Taken: West	
Description: Storm drain covered with debris located near Building 34, Bay 4.

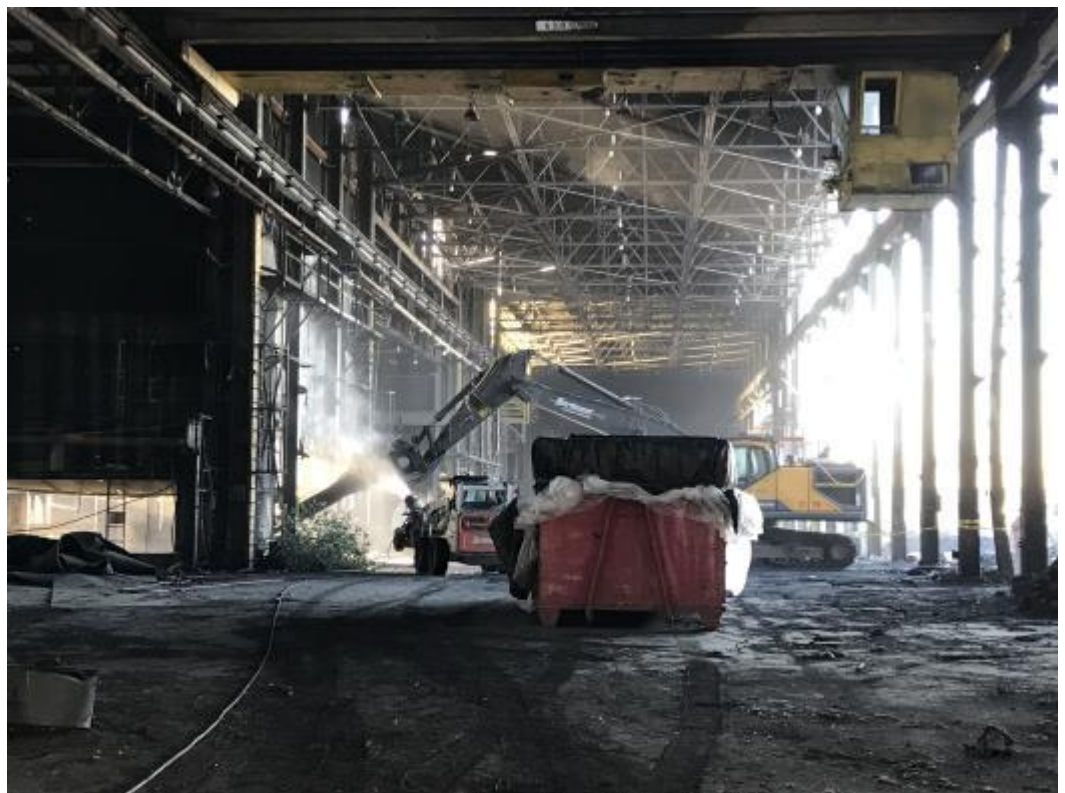
Photo No. 26	Date: 08/18/2020
Photo Coordinates	
Lat	47.755733
Long	-117.380836
Direction Photo Taken: South	
Description: Robertson Siding removal and dust suppression activities within courtyard of Buildings 58/60.

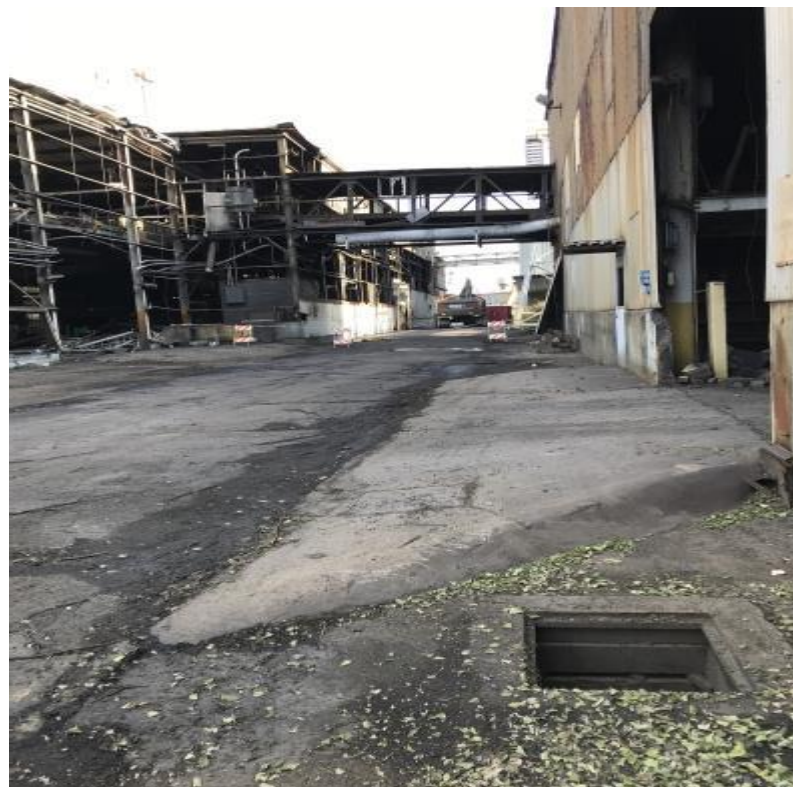
View of open stormwater catch basin prior to installation of new filter sock and grate.

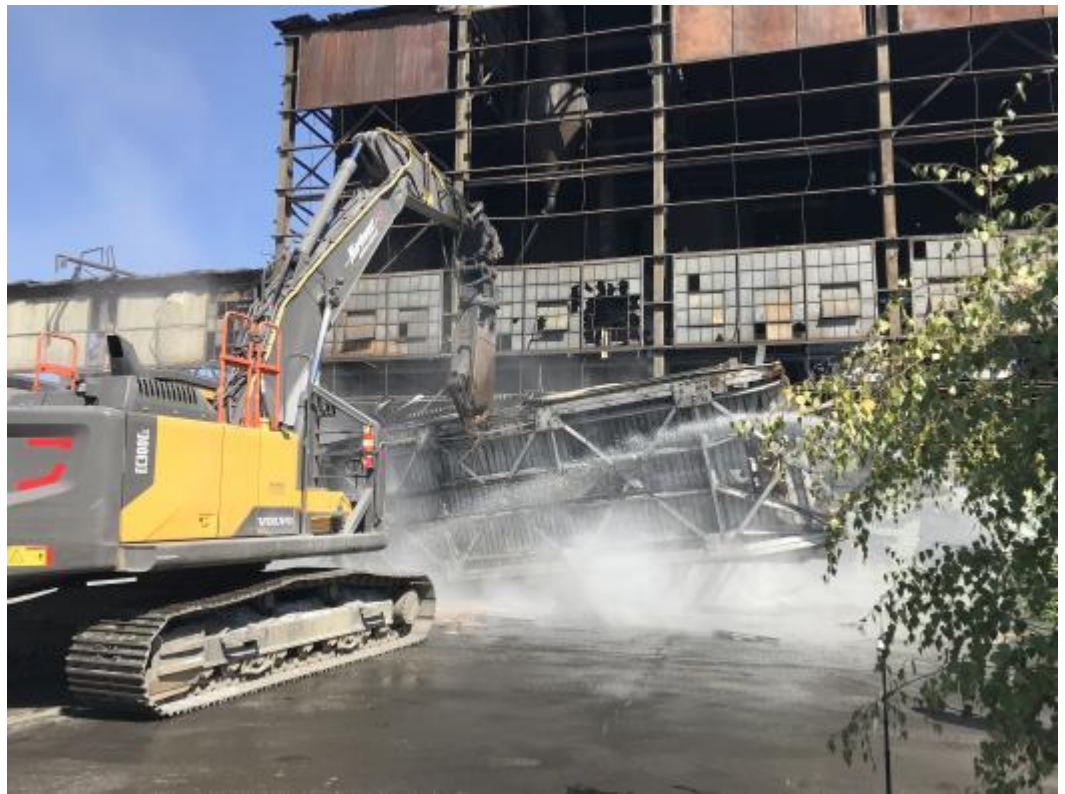
Water suppression as ERRS removes portion of ore bridge.

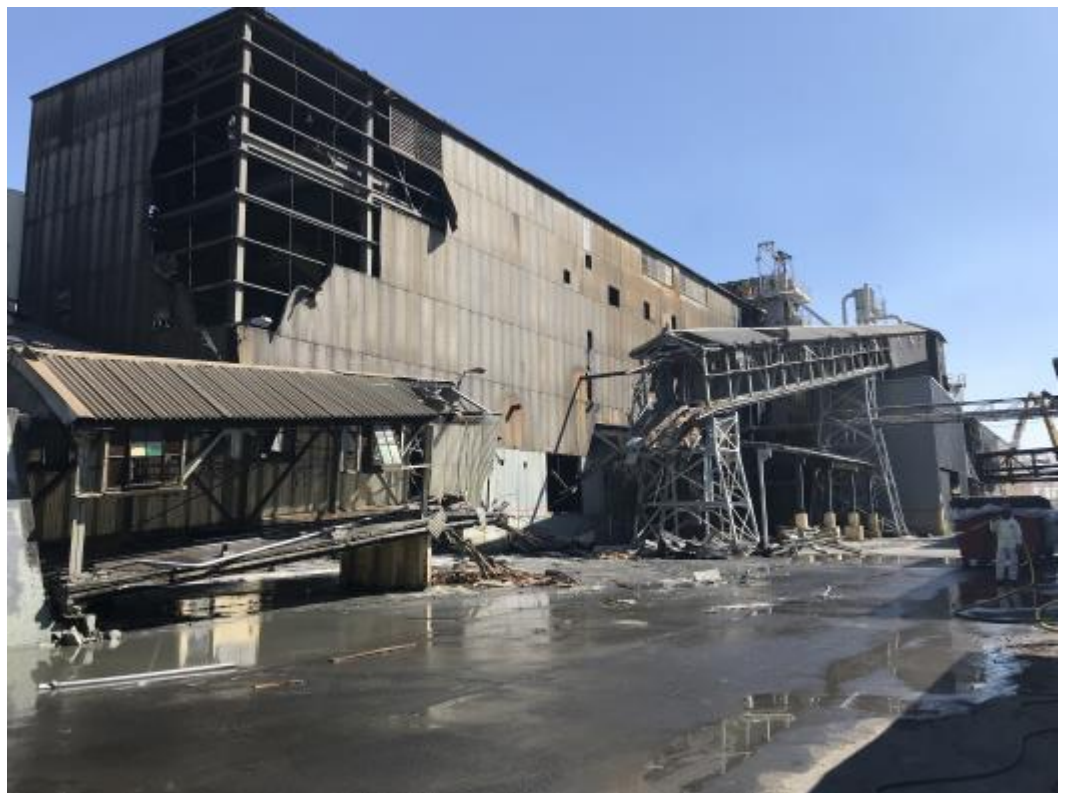
Portion of Building 57 Robertson Siding panels removed. Lower half of ore bridge removed to access Building 57 panels.

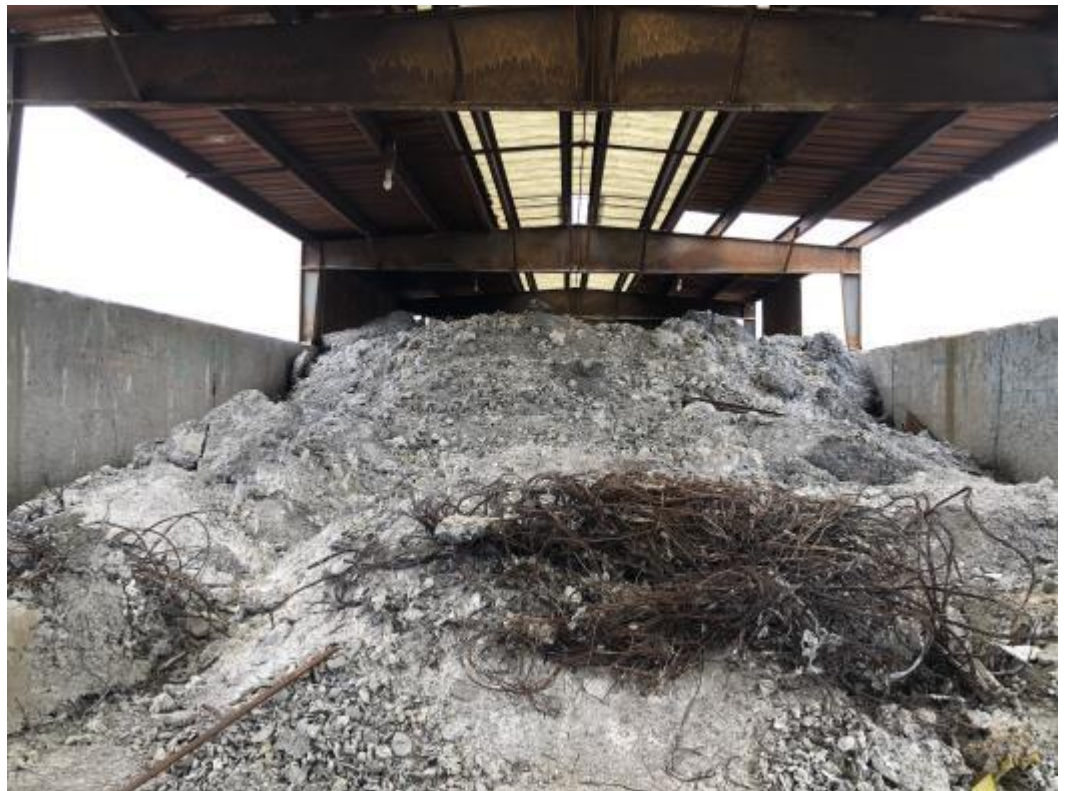
Photo No. 42	Date: 08/08/2020
Photo Coordinates	
Lat	47.757253
Long	-117.380256
Direction Photo Taken: South	
Description: View of reacted ore stockpile located within building 25BS prior to removal.

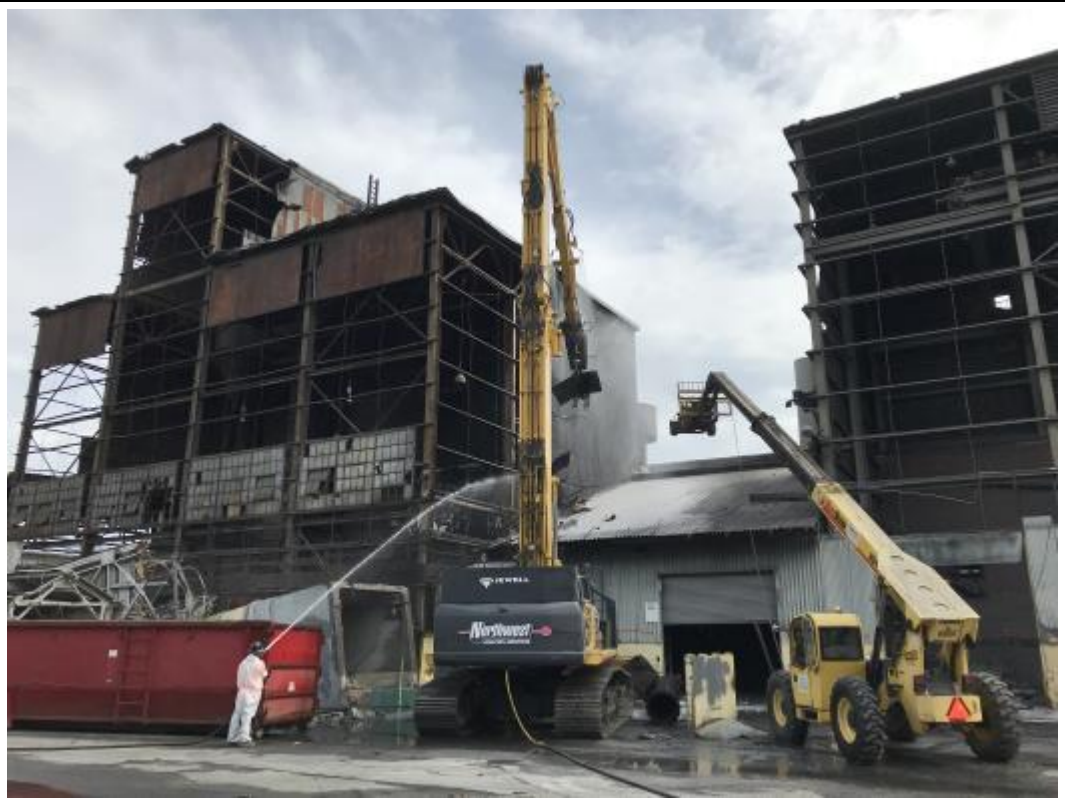
Photo No. 43	Date: 08/20/2020
Photo Coordinates	
Lat	47.755694
Long	-117.378236
Direction Photo Taken: Northeast	
Description: Robertson Siding removal and dust suppression activities along exterior of Building 32A.

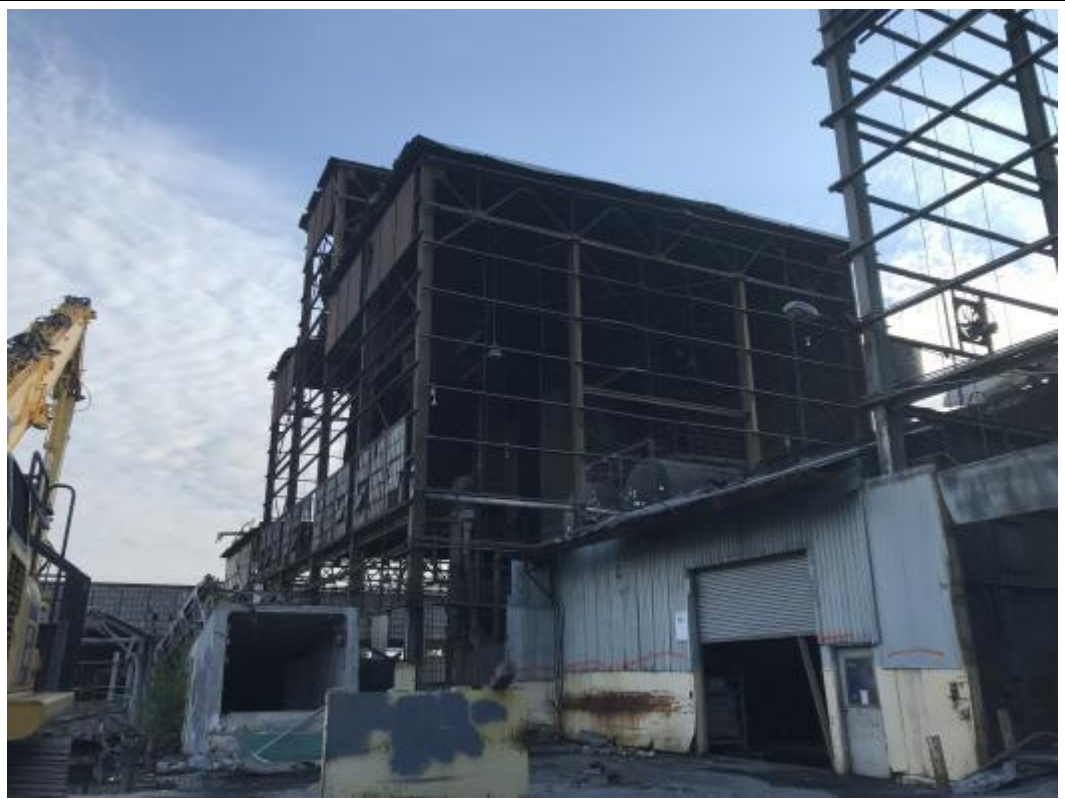
Metal corrugated panels along the interior wall of Building 57.

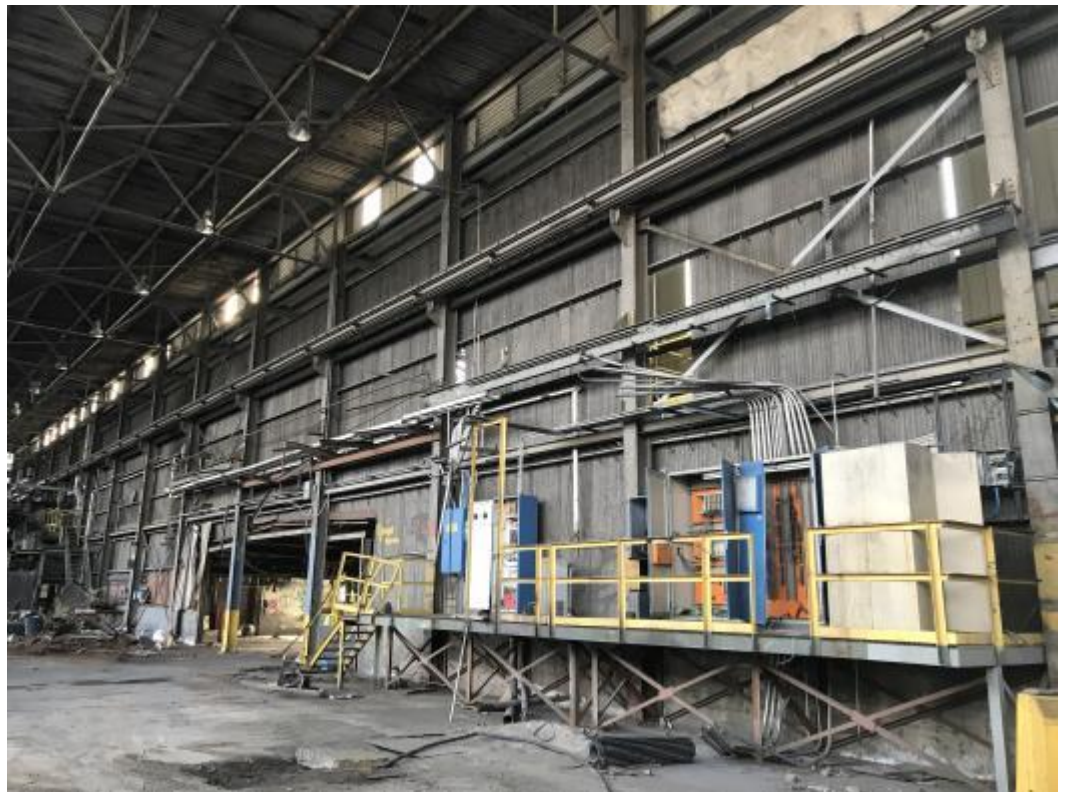
Photo No.
46

Removal of Robertson Siding along northern side of Building 55.

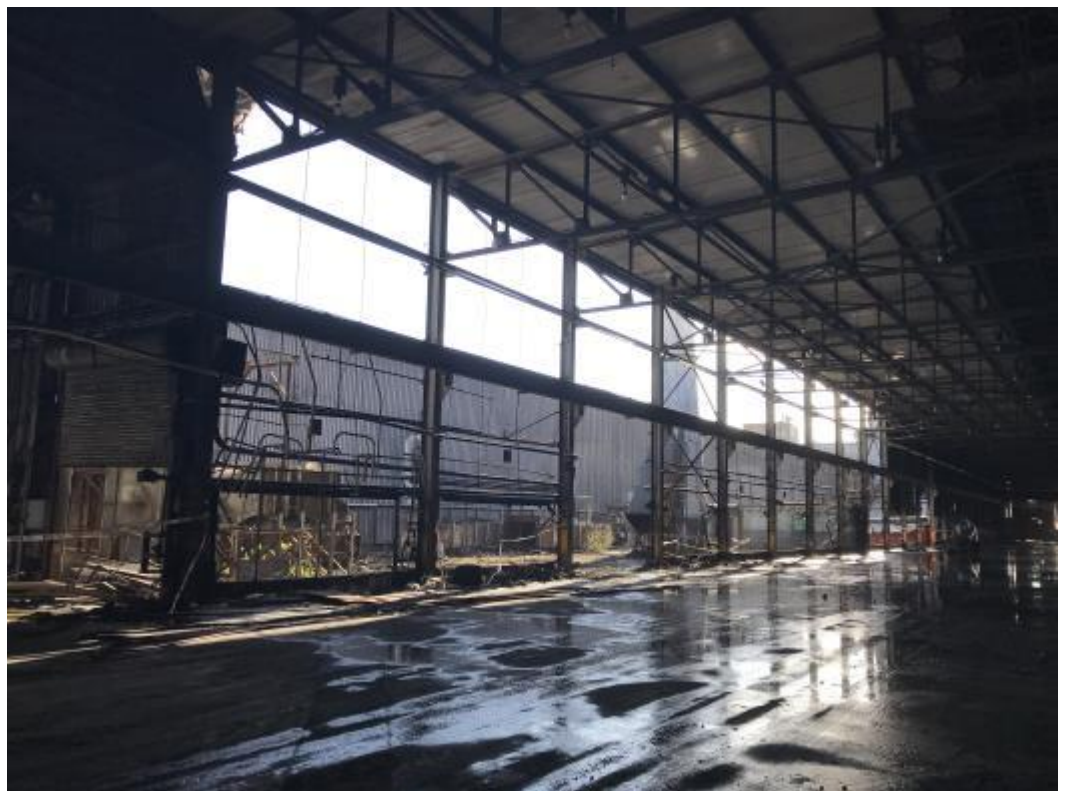
Building 32SC after removal of Robertson Siding.

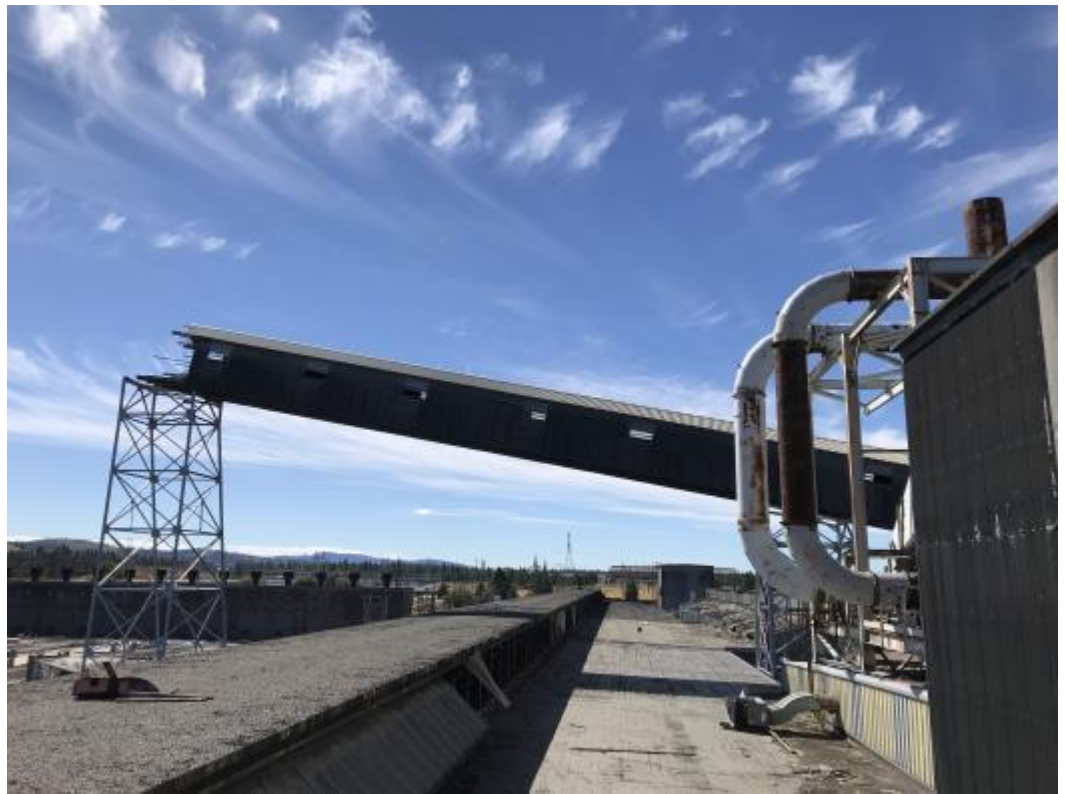
Photo No. 52	Date: 08/22/2020
Photo Coordinates	
Lat	47.755231
Long	-117.377647
Direction Photo Taken: South	
Description: Overview of Building 32 with vents intact and alumina piles.

The alumina and mixed alumina piles stored in the northern and southern portions of Building 32 contain trace concentrations of hazardous substances. START collected samples of alumina and mixed alumina and submitted them for fish bioassay testing. Results of the fish bioassay testing indicated that the alumina and mixed alumina could be disposed of as solid waste which led to the decision that the materials could be stored on-site in a secured location.

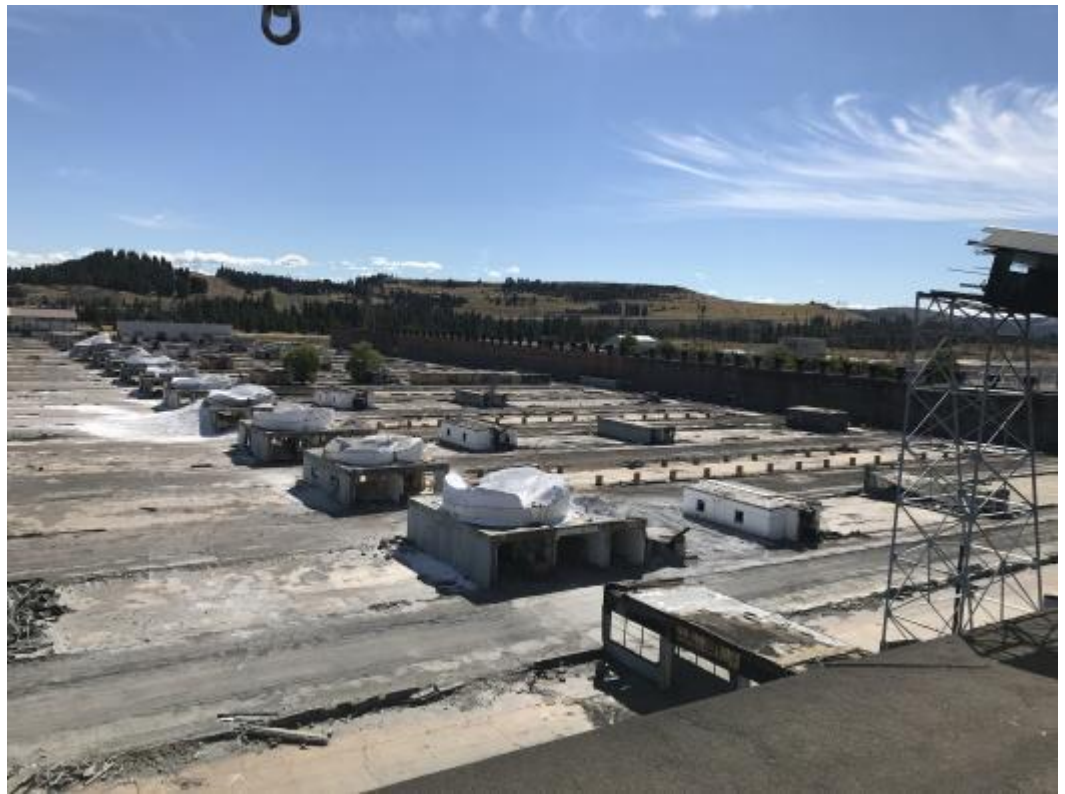
Photo No.
54

View of Building 32 with vents.

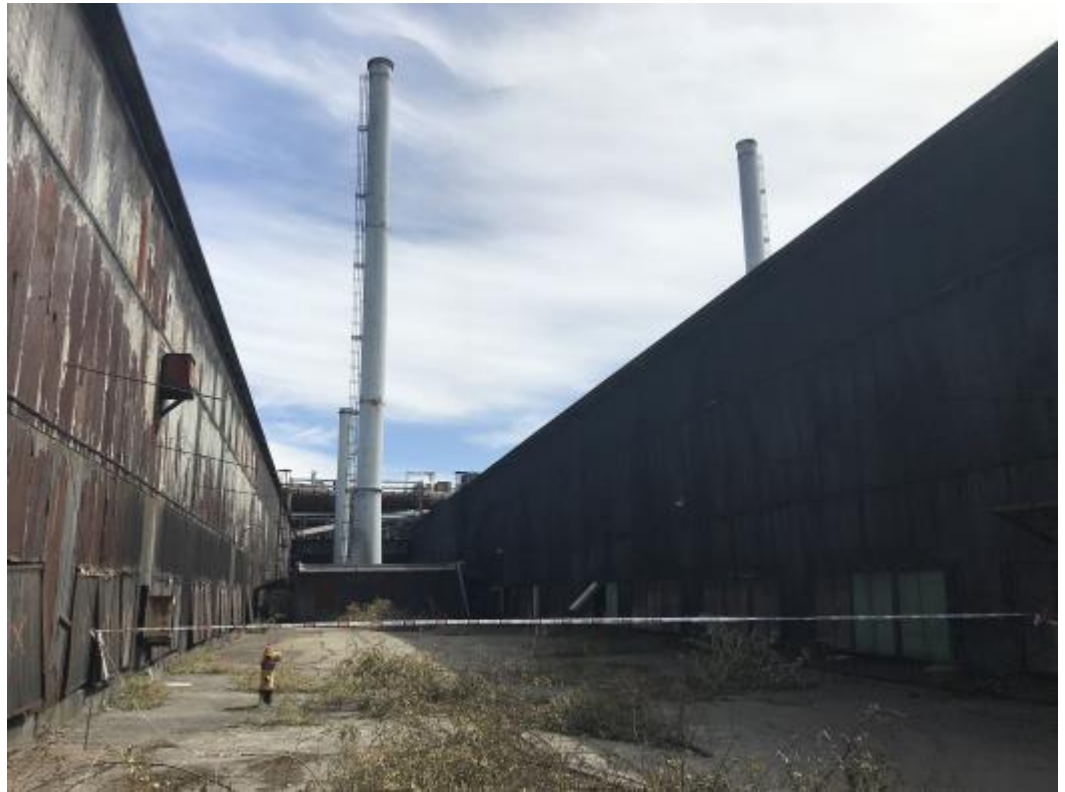
Photo No. 60	Date: 08/25/2020
Photo Coordinates	
Lat	47.755078
Long	-117.380592
Direction Photo Taken: Northwest	
Description: Green coke, ACM material, refuse, and open pits discovered throughout footprint of former Building 54.

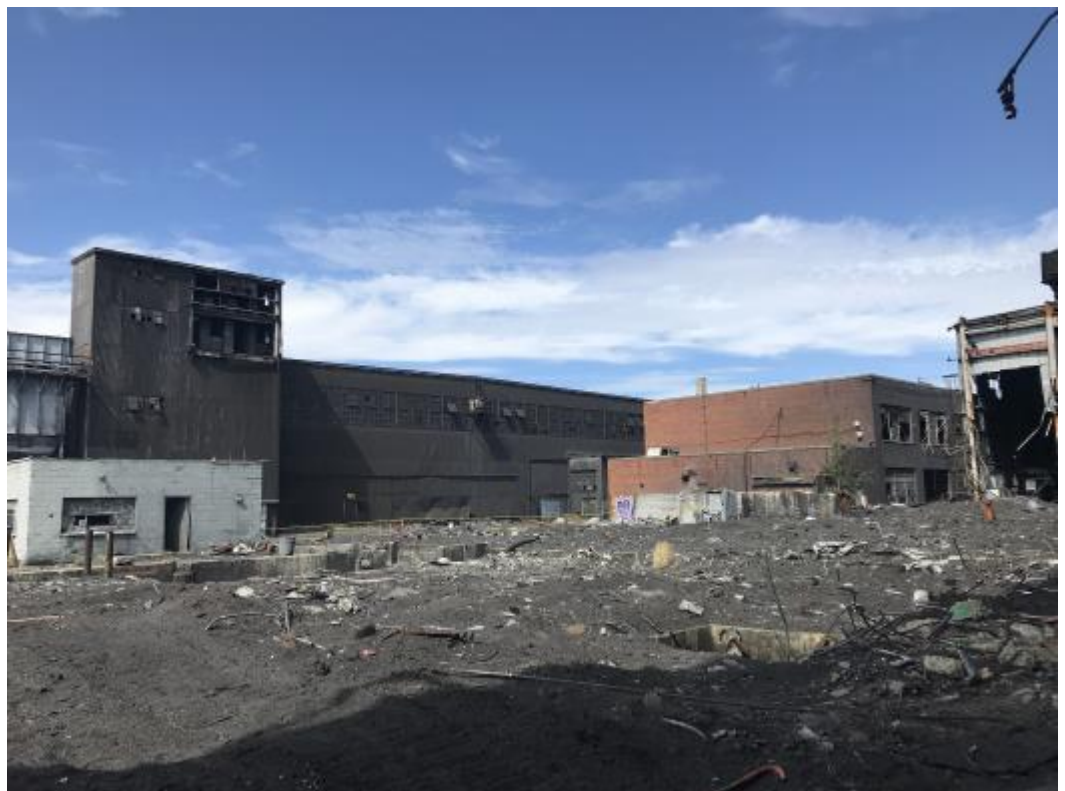
Photo No. 61	Date: 08/25/2020
Photo Coordinates	
Lat	47.754856
Long	-117.380478
Direction Photo Taken: West by Northwest	
Description: Green coke, ACM material, refuse, and open pits discovered throughout footprint of former Building 54.

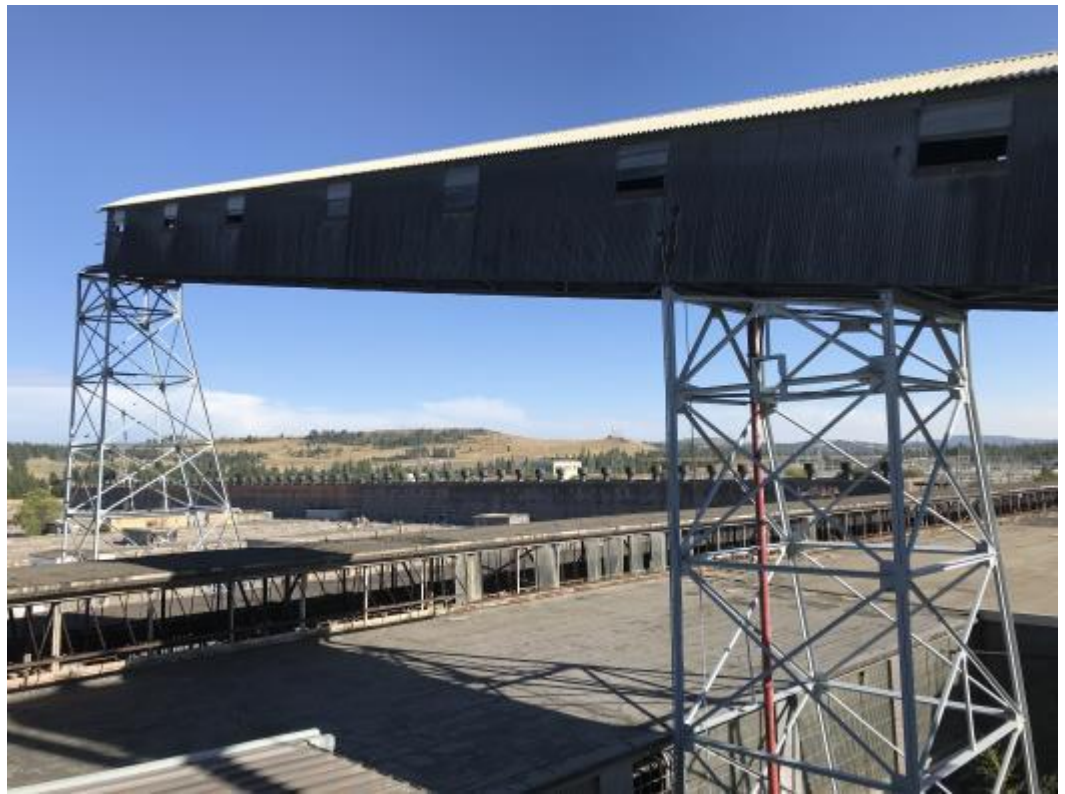
Photo No. 66	Date: 08/27/2020
Photo Coordinates	
Lat	47.7559
Long	-117.380211
Direction Photo Taken: East by Southeast	
Description: One of two outside pipe bridges that contain ACM TSI piping.
