TIME-CRITICAL REMOVAL ACTION REPORT

*Former Kaiser Smelter Site
Mead, Spokane County, Washington*

November 2021
Rev. 2

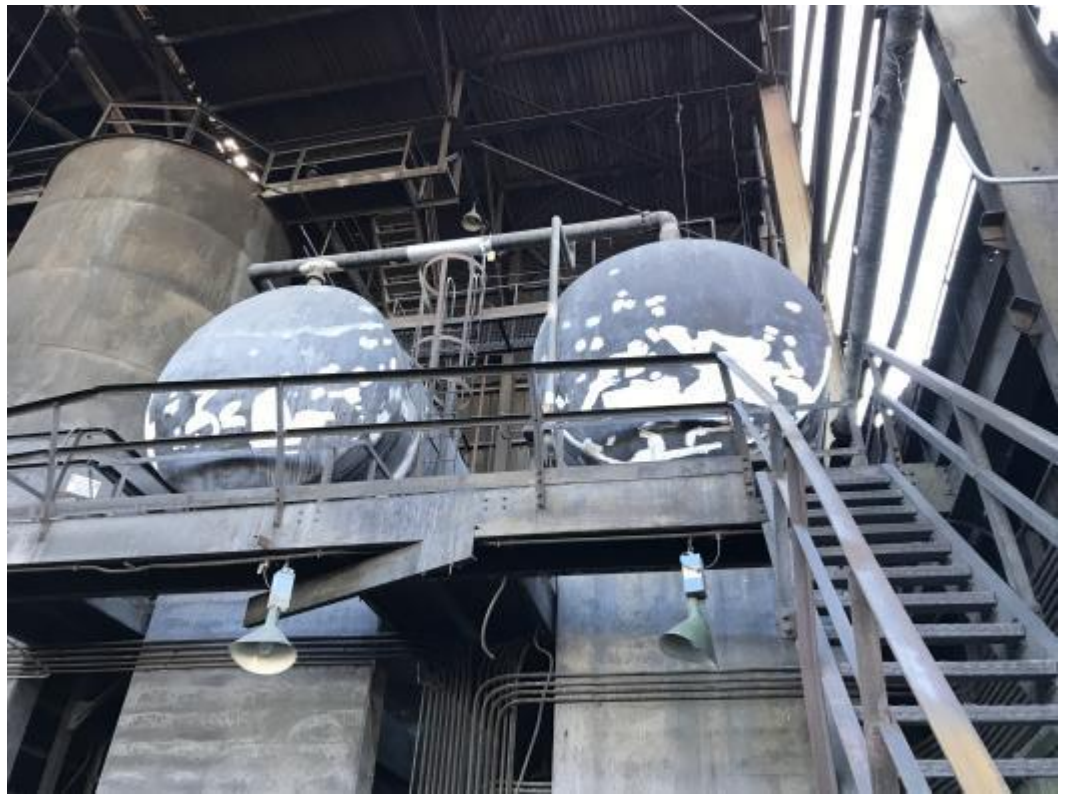
Photo No. 72	Date: 08/29/2020
Photo Coordinates	
Lat	47.755742
Long	-117.378456
Direction Photo Taken: East	
Description: Mag tanks and asbestos piping exposed to elements after Robertson Siding removal.

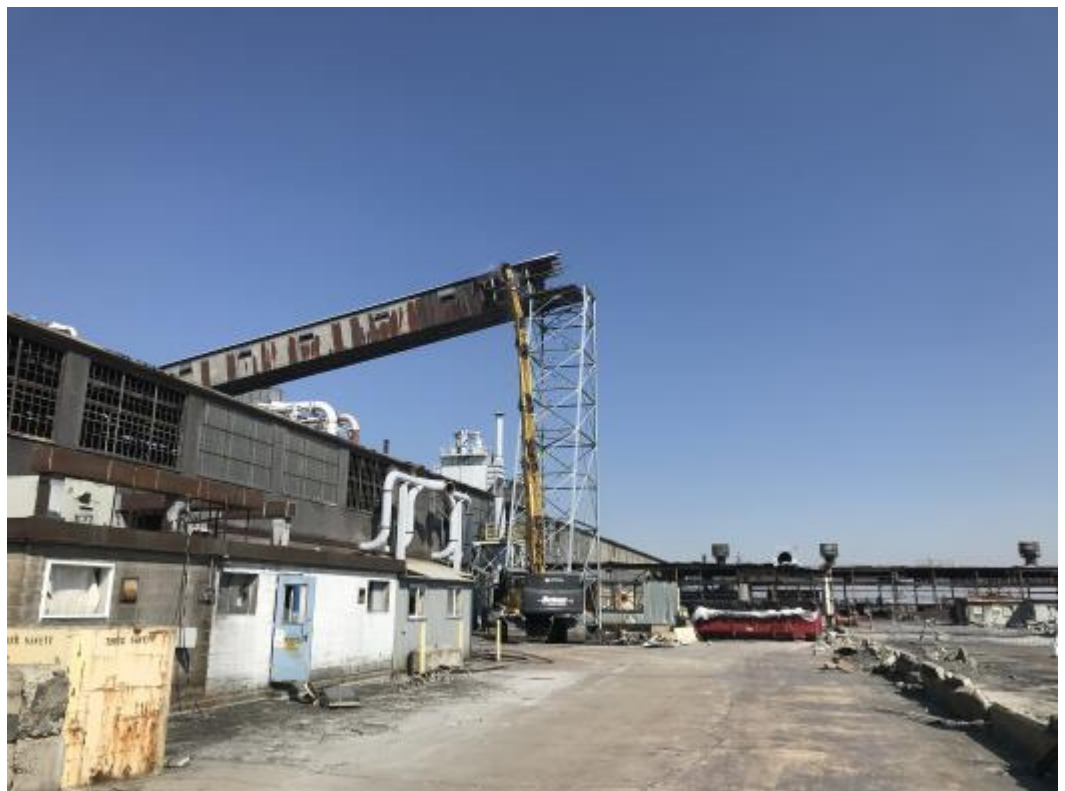
Photo No. 85	Date: 09/01/2020
Photo Coordinates	
Lat	47.754658
Long	-117.377022
Direction Photo Taken: Northwest	
Description: Long-reach excavator removing Robertson Siding panels on upper portion of Ore Bridge within potline area.

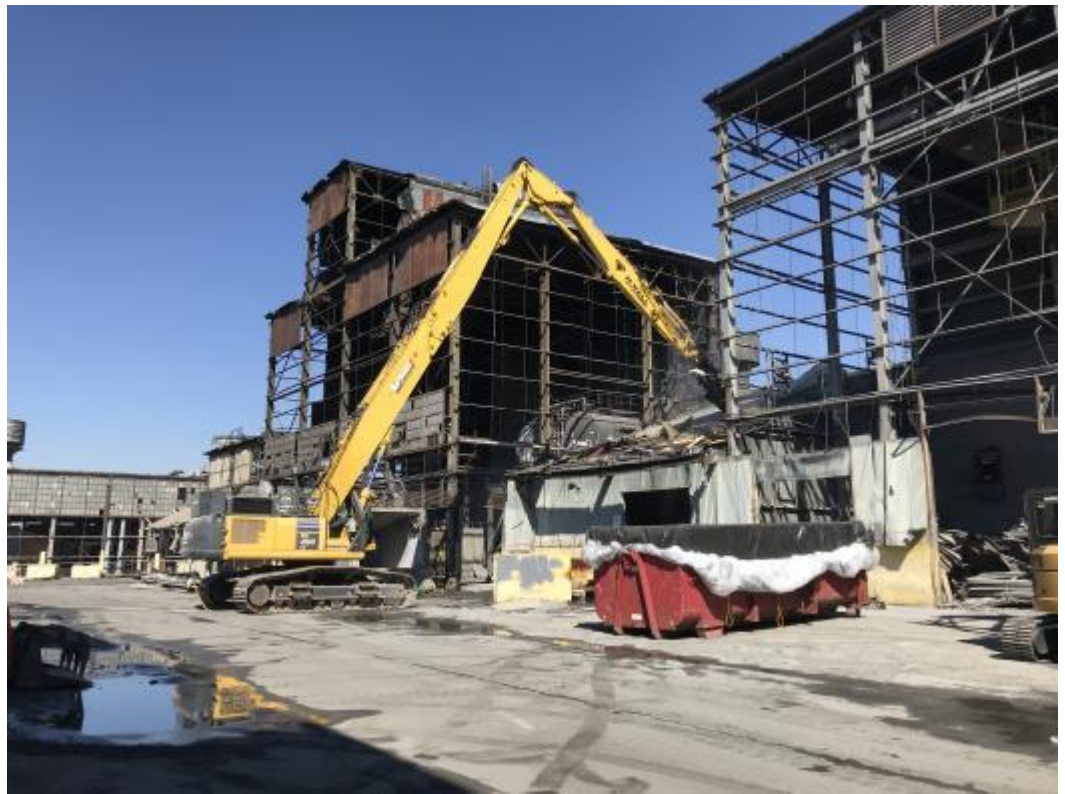
Photo No. 87	Date: 09/01/2020
Photo Coordinates	
Lat	47.755275
Long	-117.377906
Direction Photo Taken: North	
Description: ERRS beginning removal of Robertson Siding along Building 32SC.

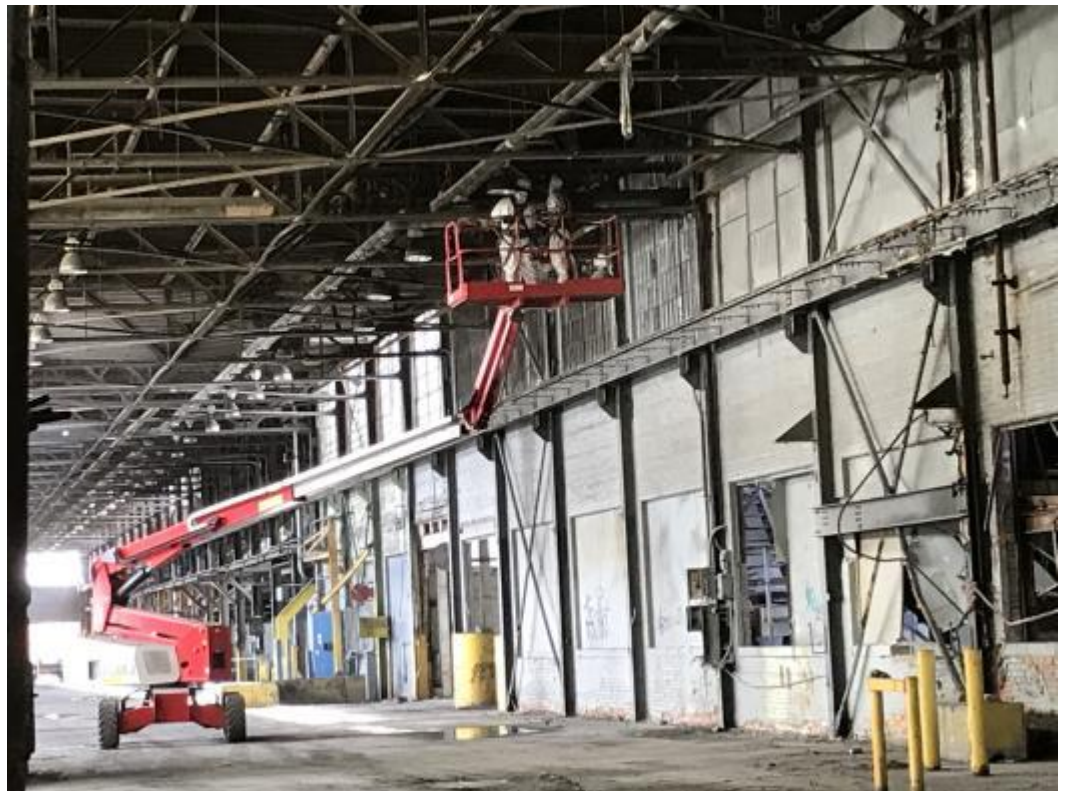
Photo No. 92	Date: 09/02/2020
Photo Coordinates	
Lat	47.755817
Long	-117.377739
Direction Photo Taken: East by Southeast	
Description: ERRS removing mercury vapor lamps and PCB ballasts within Building 32 prior to TSI piping removal.

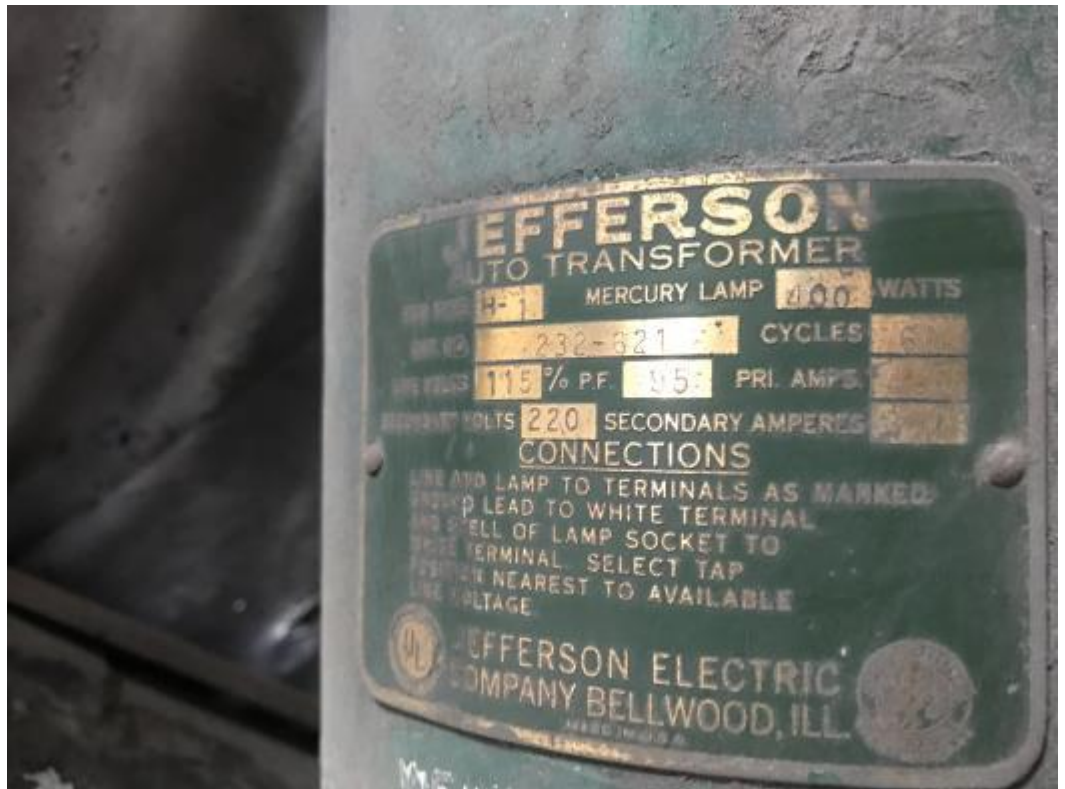
Photo No. 94	Date: 09/02/2020
Photo Coordinates	
Lat	47.755944
Long	-117.377678
Direction Photo Taken: Object	
Description: Manufacturers tag located on PCB ballasts used with mercury vapor lamps.

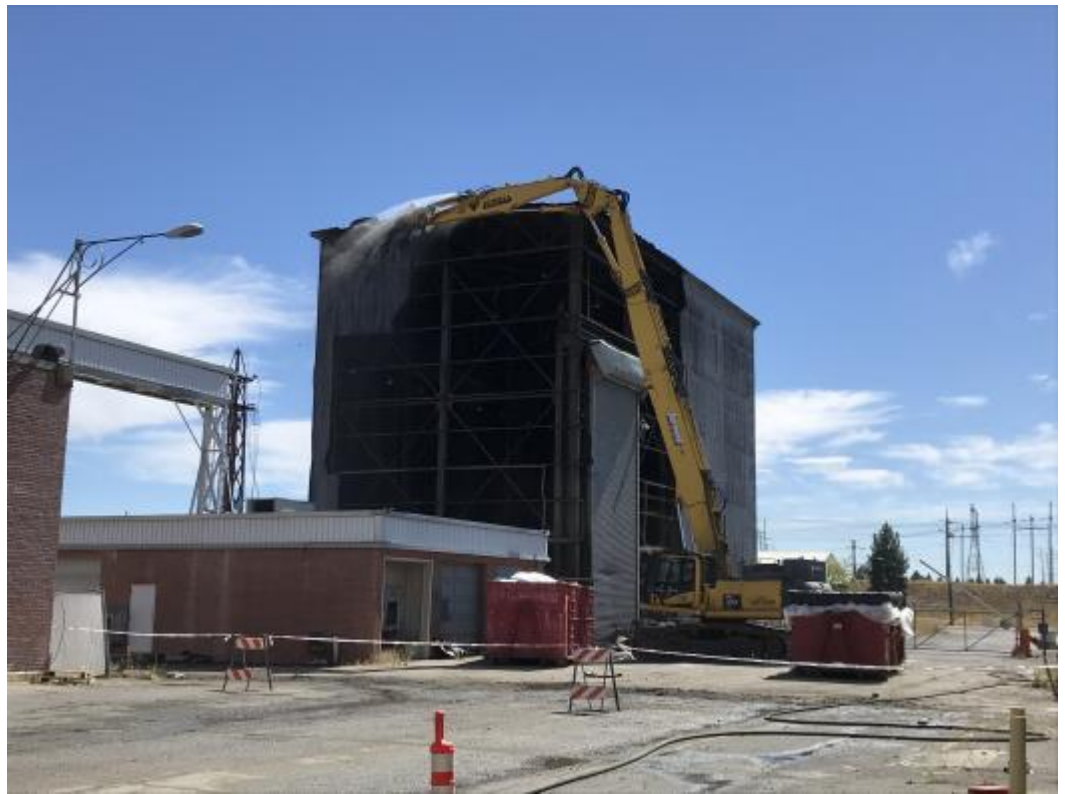
Photo No. 97	Date: 09/03/2020
Photo Coordinates	
Lat	47.765925
Long	-117.393036
Direction Photo Taken: Southeast	
Description: ERRS performing dust suppression and removing Robertson Siding from Building 1A.

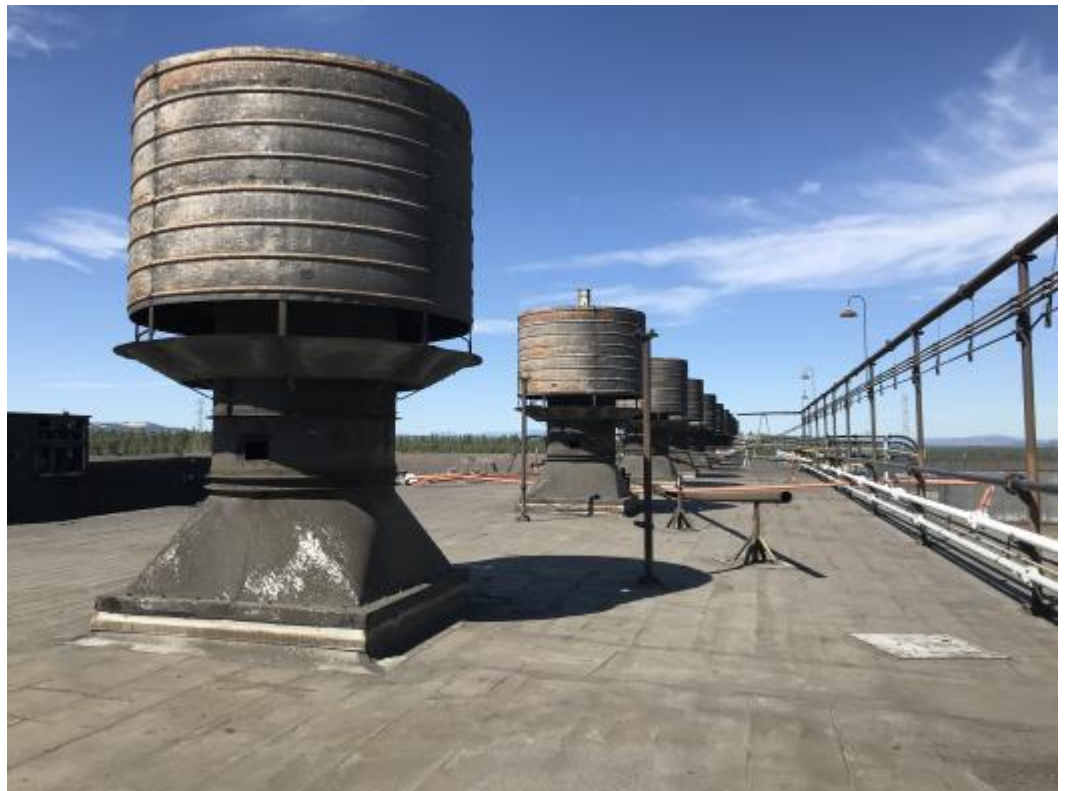
Photo No. 100	Date: 09/03/2020
Photo Coordinates	
Lat	47.754597
Long	-117.380225
Direction Photo Taken: Northwest	
Description: Robertson Ventilators located on roof of Building 54 prior to removal.

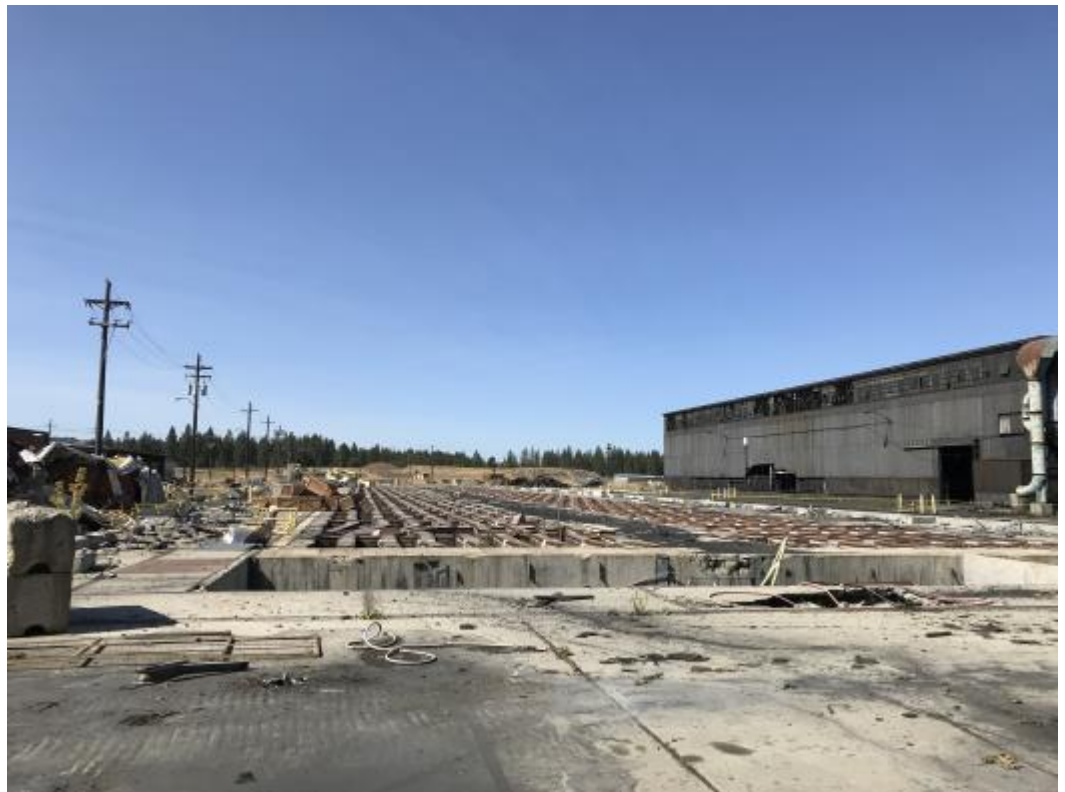
Open oven pits within footprint of former Building 300.

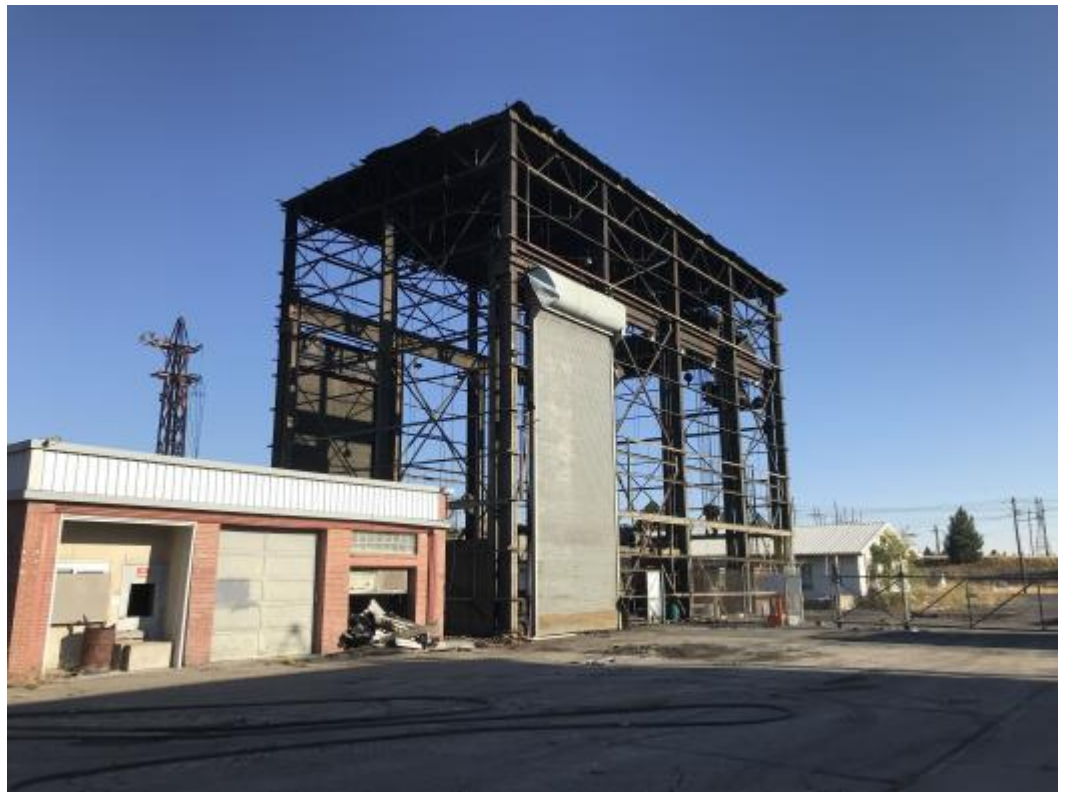
Photo No. 105	Date: 09/08/2020
Photo Coordinates	
Lat	47.753503
Long	-117.378297
Direction Photo Taken: Southeast	
Description: View of Building 1A after removal of Robertson Siding. ERRS placed chain link fence along southern side of Building 1a and connected it to existing fencing to secure Site.

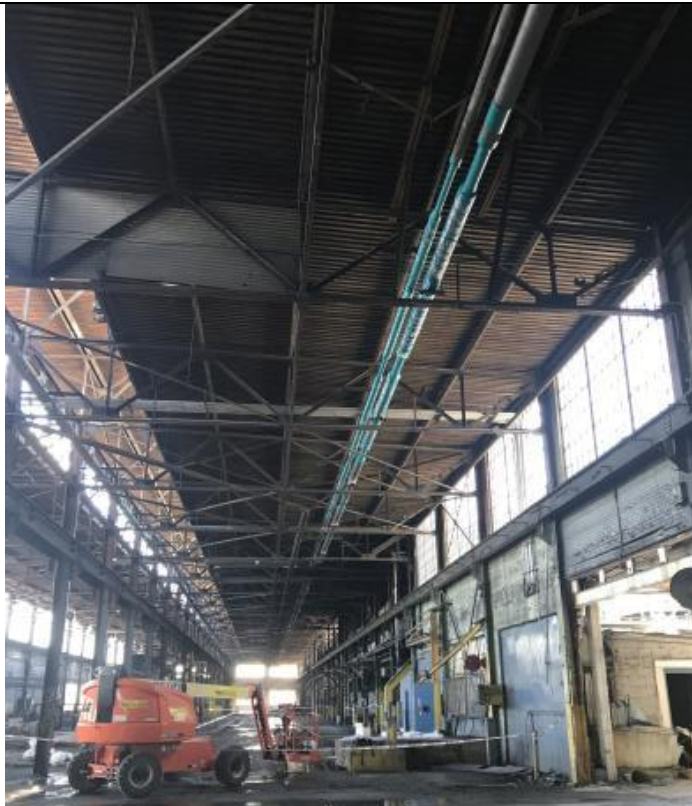
Photo No. 107	Date: 09/09/2020
Photo Coordinates	
Lat	47.764533
Long	-117.392547
Direction Photo Taken: South	
Description: ACM TSI piping along ceiling prepared for removal.

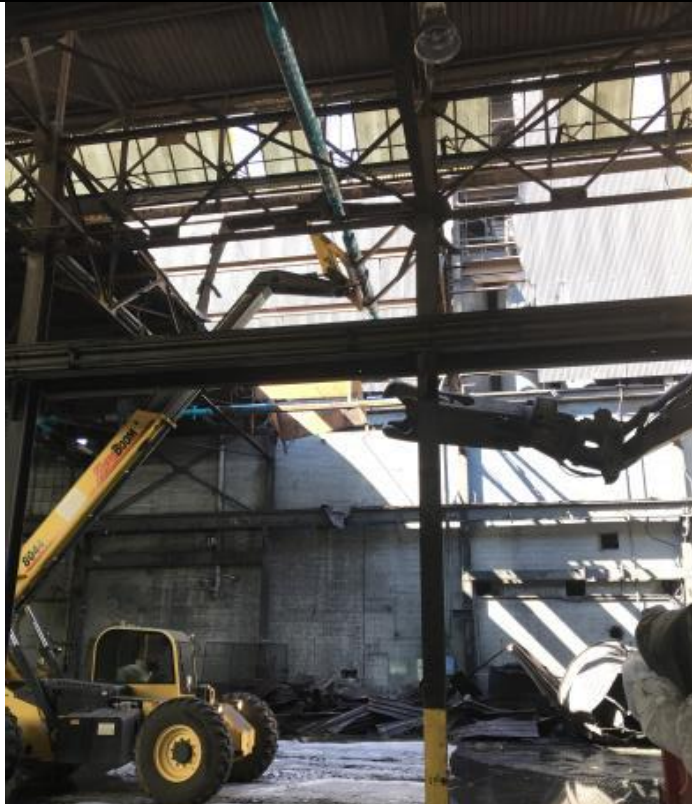
Photo No. 109	Date: 09/10/2020
Photo Coordinates	
Lat	47.755928
Long	-117.377633
Direction Photo Taken: West	
Description: ERRS testing a removal technique for ACM TSI piping.

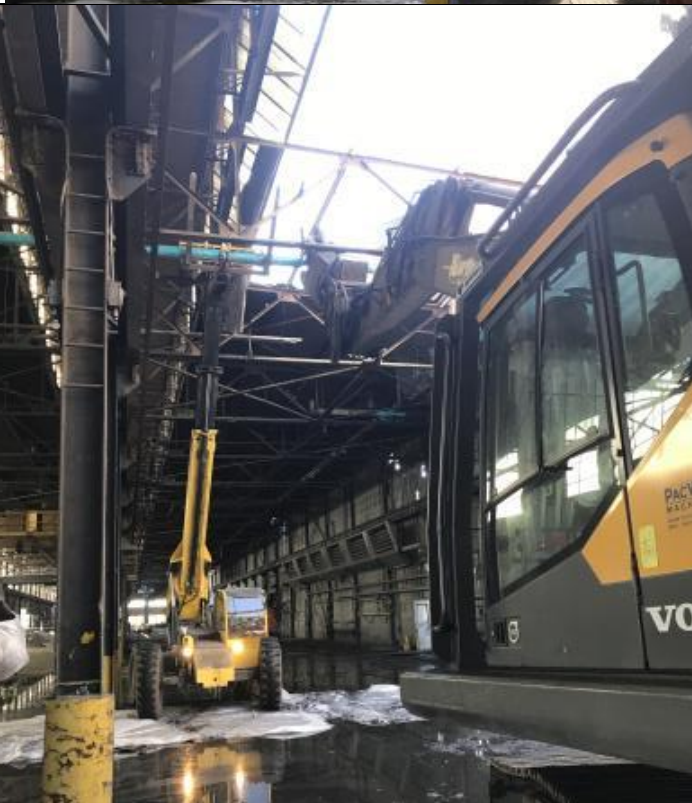
Photo No. 110	Date: 09/10/2020
Photo Coordinates	
Lat	47.756011
Long	-117.377603
Direction Photo Taken: East by Southeast	
Description: ERRS testing a removal technique for ACM TSI piping.

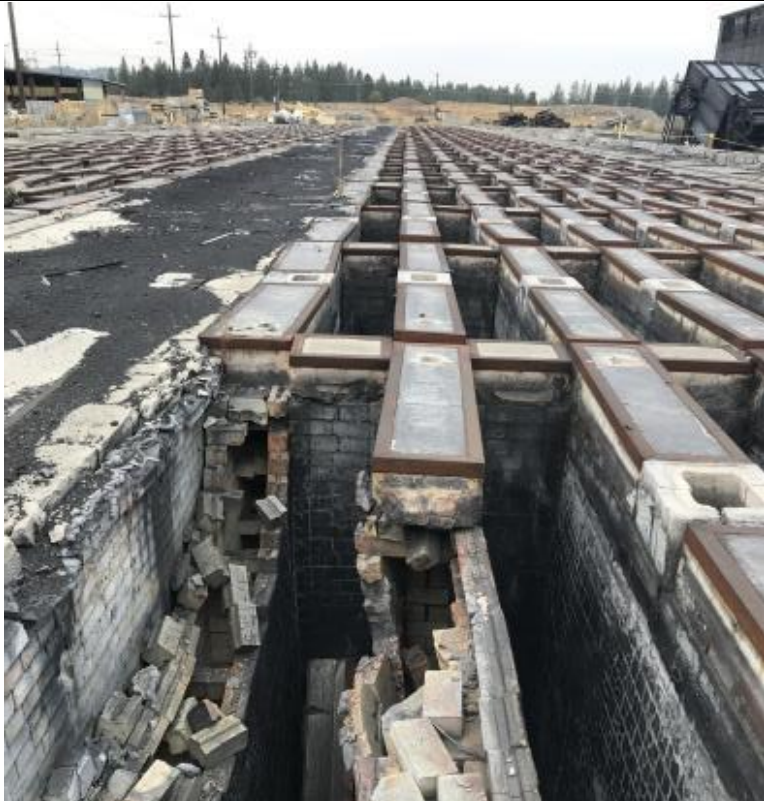
Photo No. 114	Date: 09/23/2020
Photo Coordinates	
Lat	47.754897
Long	-117.3807
Direction Photo Taken: West	
Description: Unstable oven pits footprint of former Building 300.

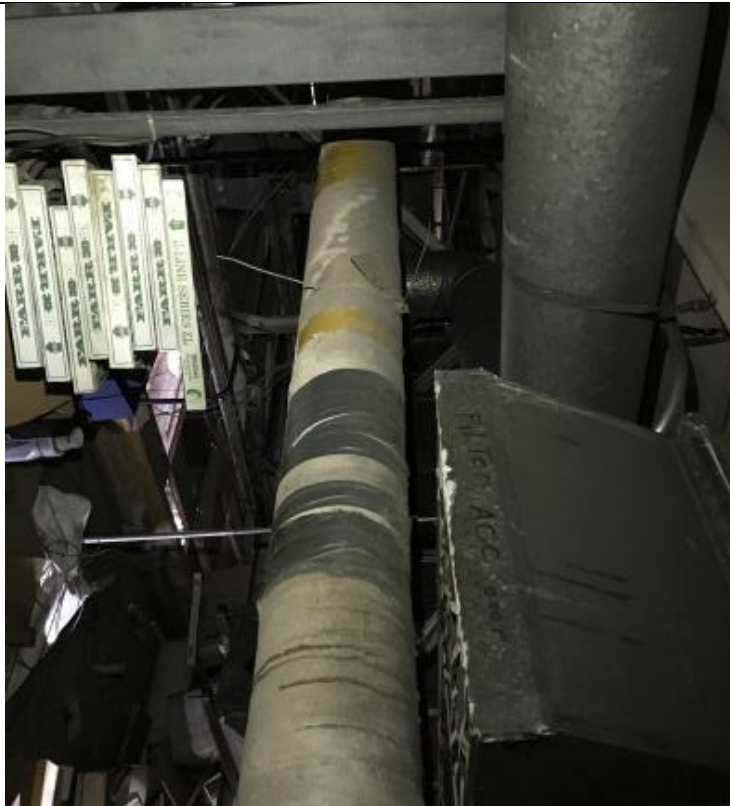
Photo No. 117	Date: 09/25/2020
Photo Coordinates	
Lat	47.753453
Long	-117.3788
Direction Photo Taken: Object	
Description: ACM TSI piping within attic of Building 41.

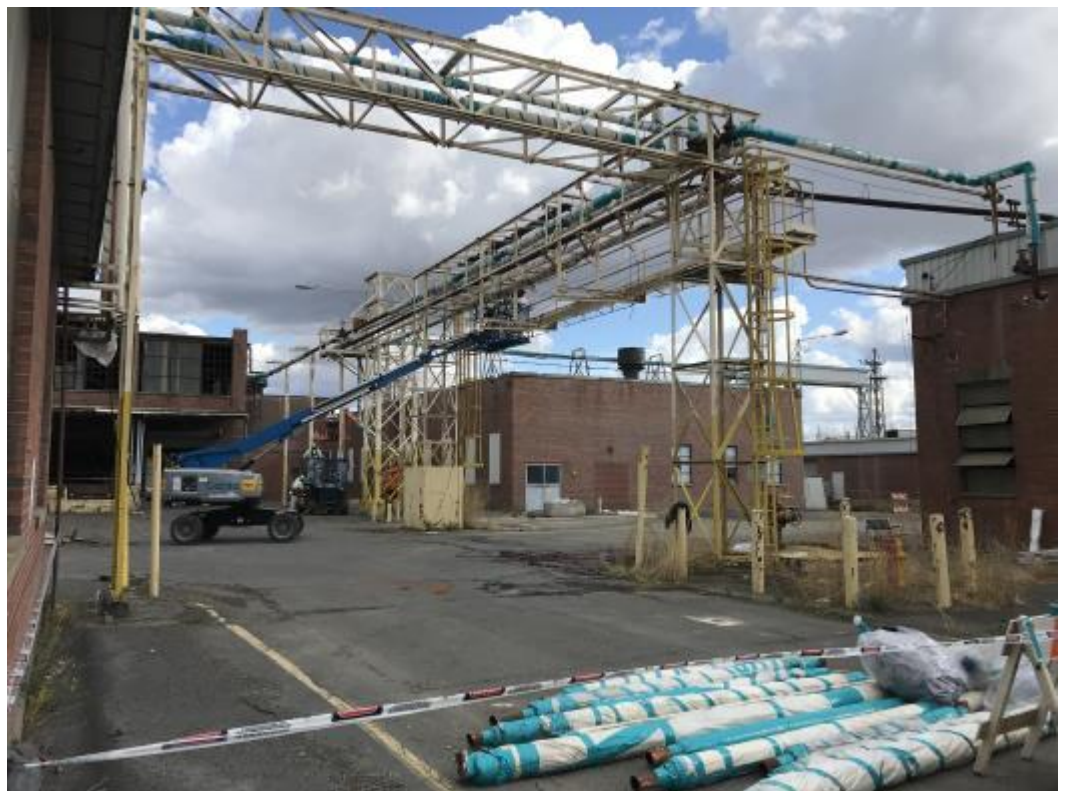
Photo No. 118	Date: 09/26/2020
Photo Coordinates	
Lat	47.753753
Long	-117.378417
Direction Photo Taken: Southeast	
Description: ERRS wrapping, glove-bagging, and removing ACM TSI piping along Pipe Bridge.

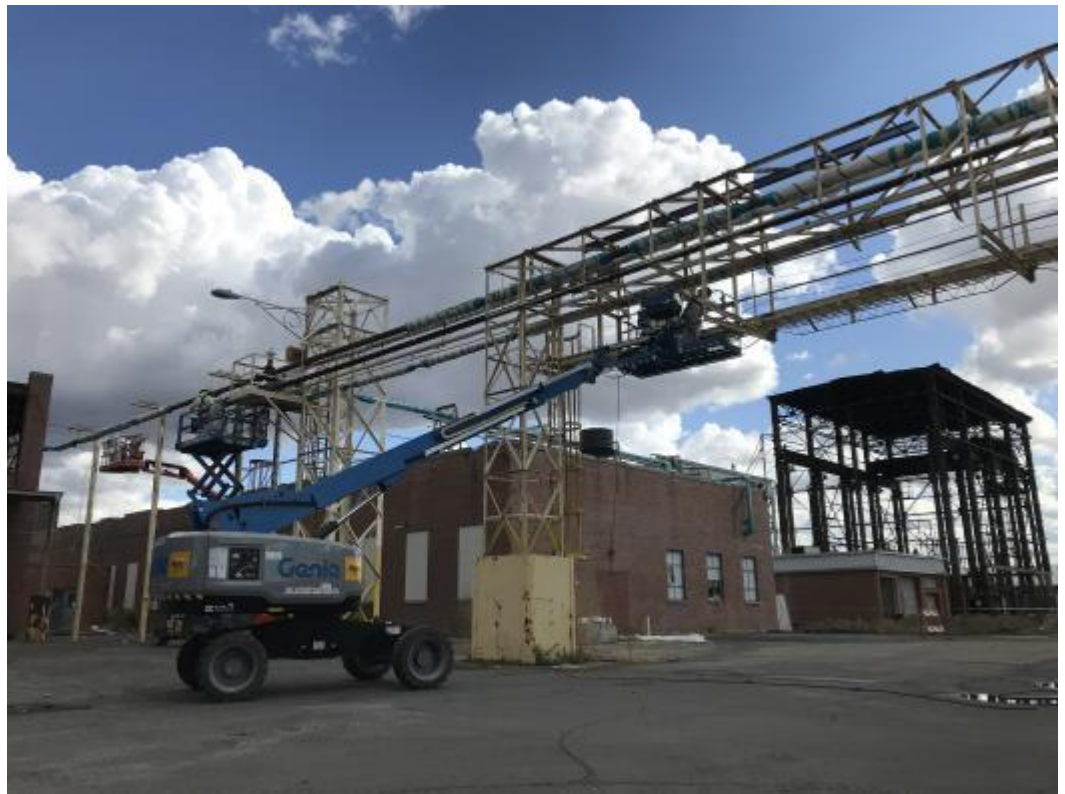
Photo No. 119	Date: 09/26/2020
Photo Coordinates	
Lat	47.753739
Long	-117.378189
Direction Photo Taken: East	
Description: ERRS wrapping, glove-bagging, and removing ACM TSI piping along Pipe Bridge.

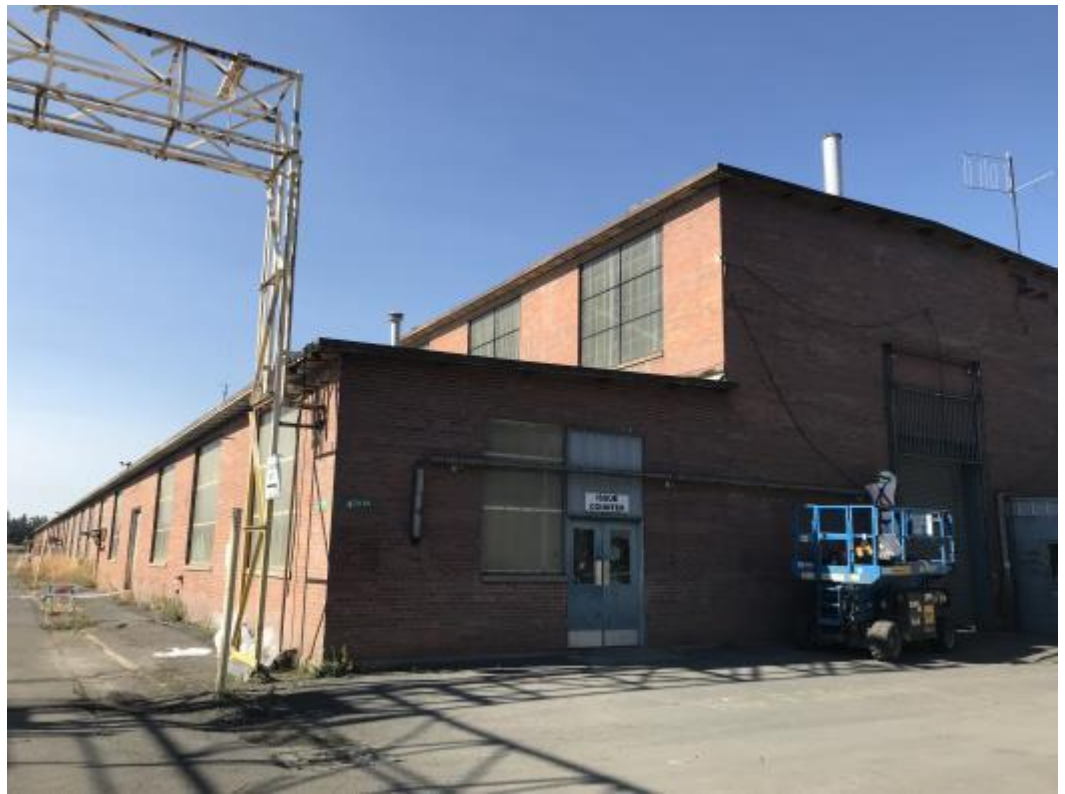
Photo No. 123	Date: 09/30/2020
Photo Coordinates	
Lat	47.753833
Long	-117.378206
Direction Photo Taken: West	
Description: ERRS removing ACM TSI piping along exterior of Building 44.

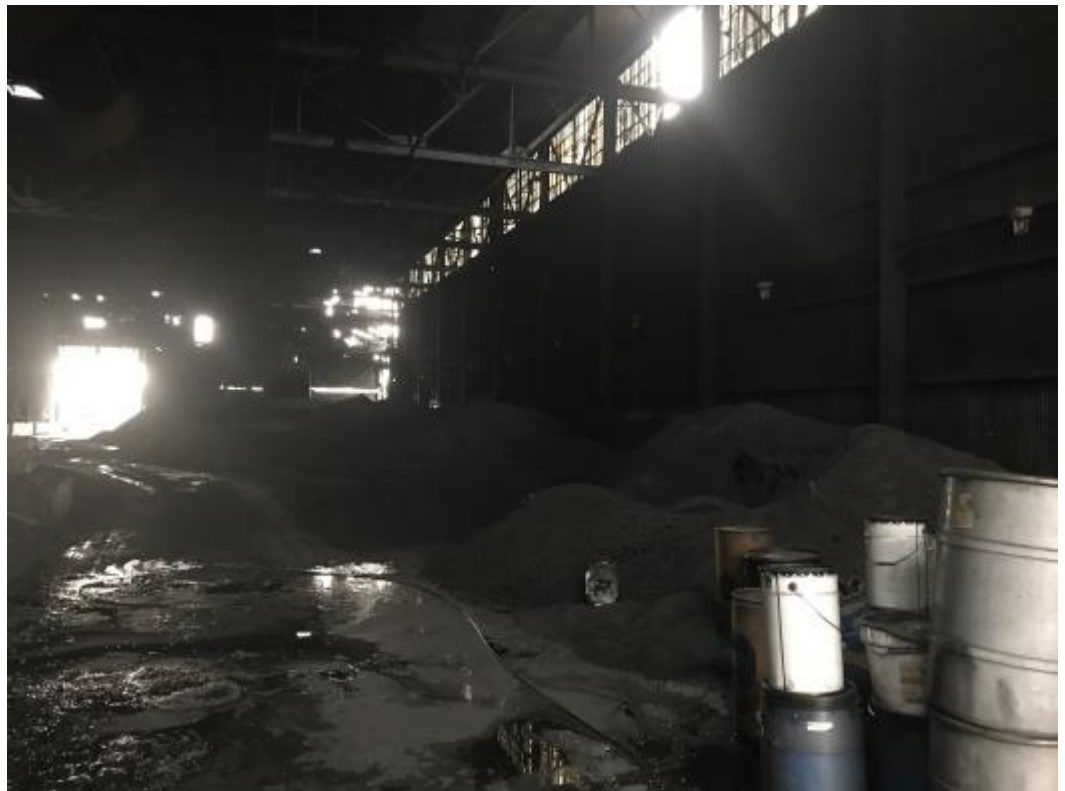
Photo No. 124	Date: 10/01/2020
Photo Coordinates	
Lat	47.765944
Long	-117.39415
Direction Photo Taken: West	
Description: Green coke discovered within northern section of Building 52.

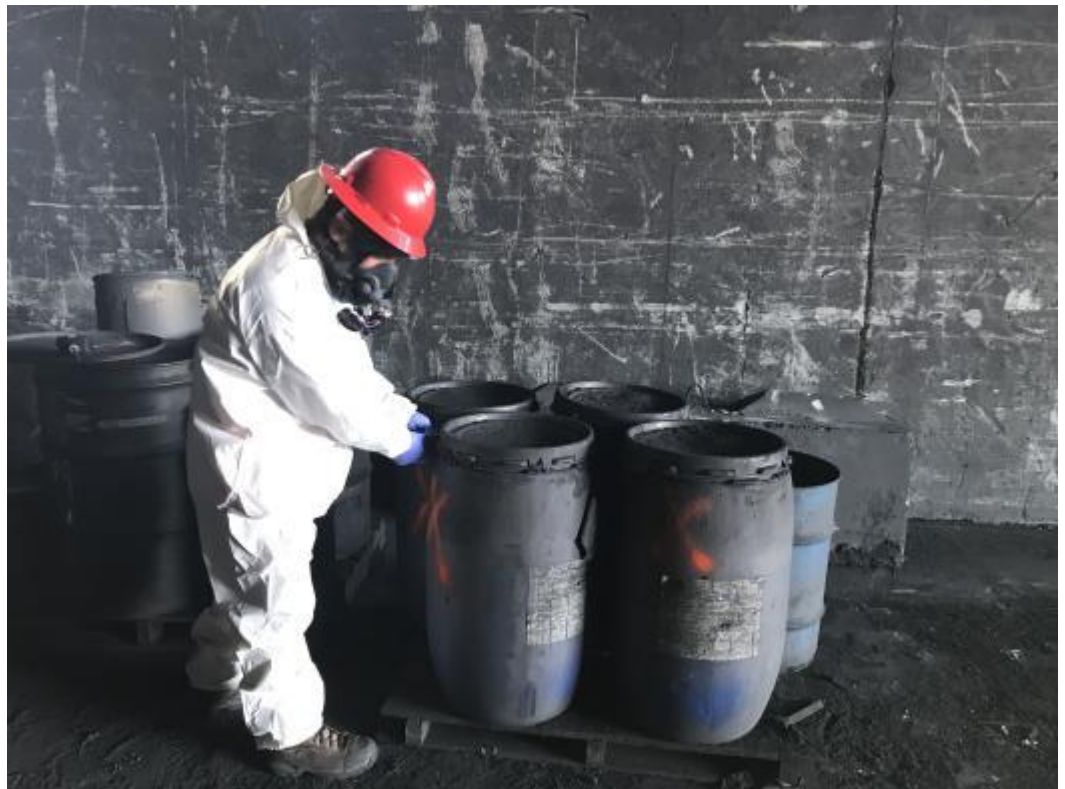
Photo No. 130	Date: 10/03/2020
Photo Coordinates	
Lat	47.755408
Long	-117.38205
Direction Photo Taken: Southwest	
Description: START and ERRS carefully removed lids of 55-gallon drum while using a PID meter. Drums contained green coke and coal tar.

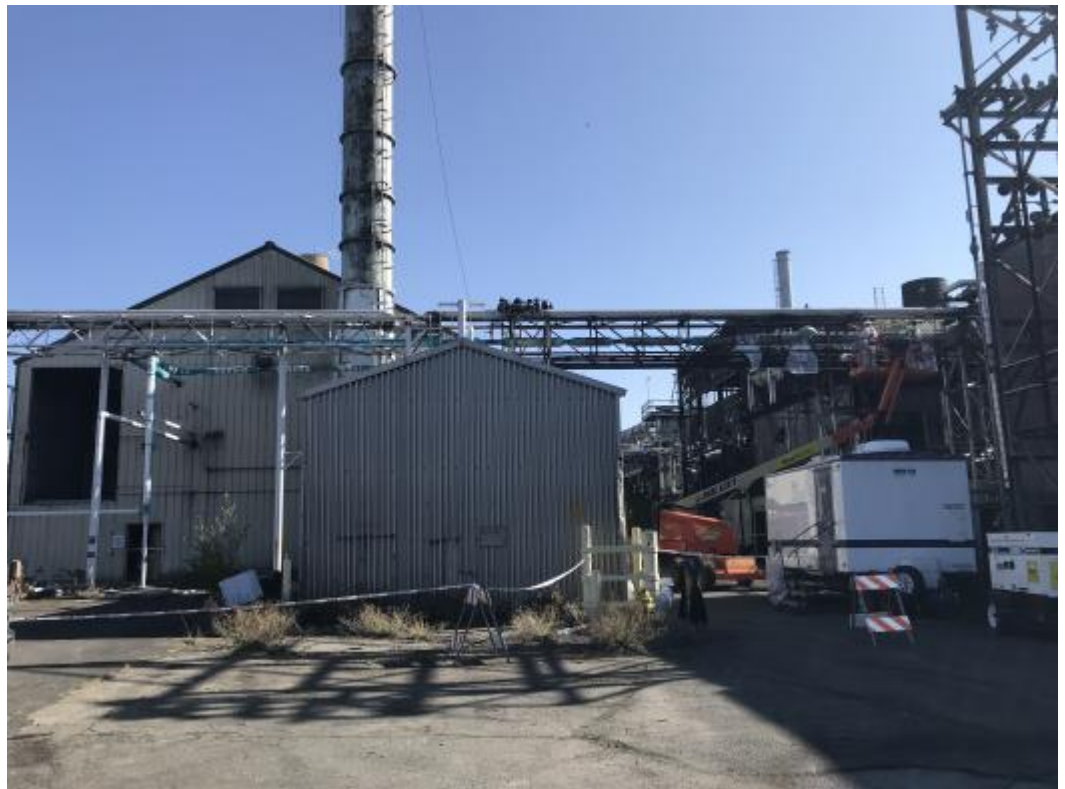
Photo No. 132	Date: 10/05/2020
Photo Coordinates	
Lat	47.7559
Long	-117.381019
Direction Photo Taken: East	
Description: ERRS preparing segments of ACM TSI piping with glove-bags for cutting.

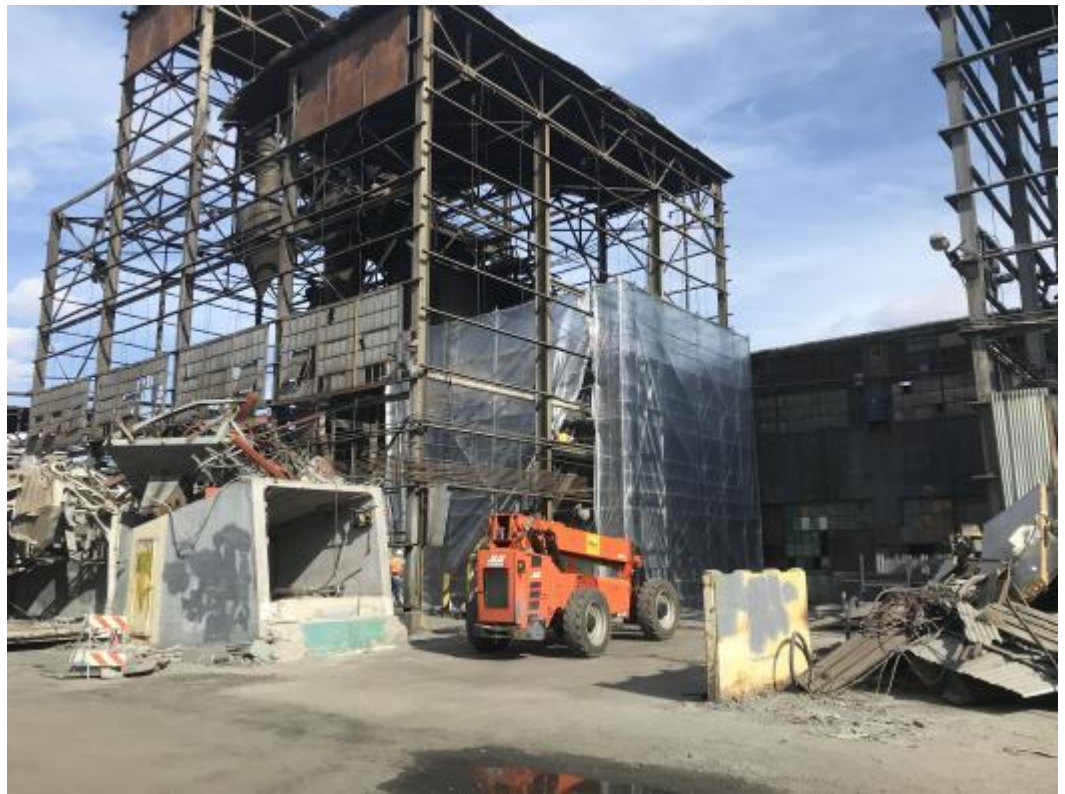
Photo No. 133	Date: 10/08/2020
Photo Coordinates	
Lat	47.755592
Long	-117.377936
Direction Photo Taken: Northeast	
Description: Preparation for removal of Mag asbestos on ASTs.

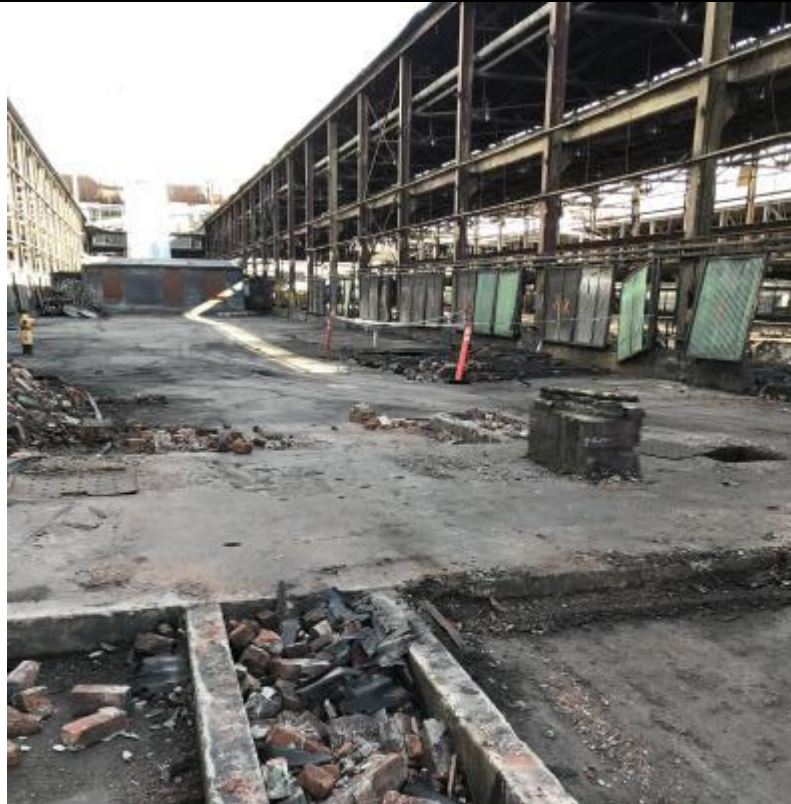
Location of USTs left in place within the subsurface of Courtyard between Building 60/58.

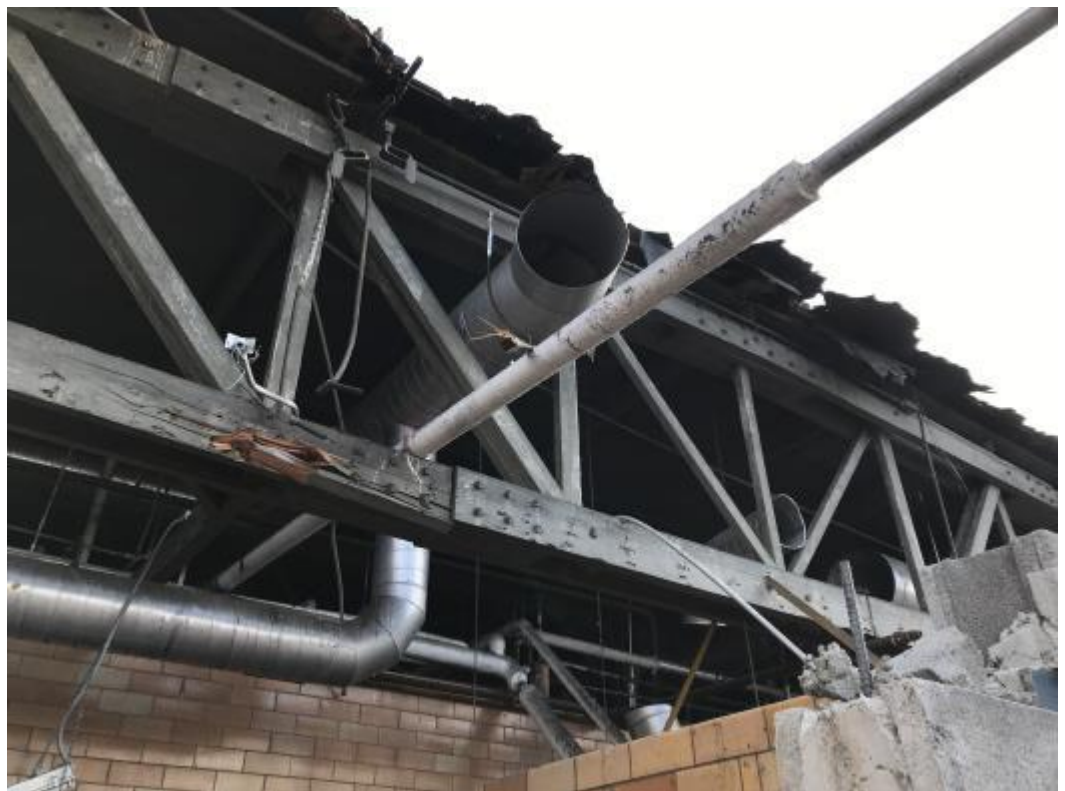
View of Building 49 after removal of roof due to safety concerns regarding structural instability. Roof was demolished to allow safe access to ACM TSI piping.

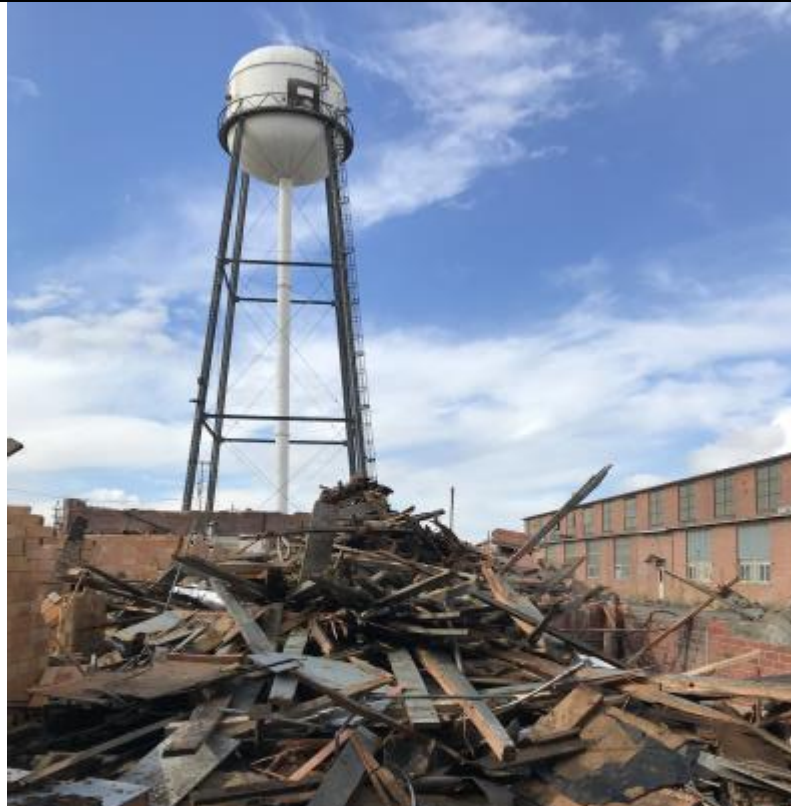
View of Building 49 after removal of roof due to safety concerns regarding structural instability. Roof was demolished to allow safe access to ACM TSI piping.

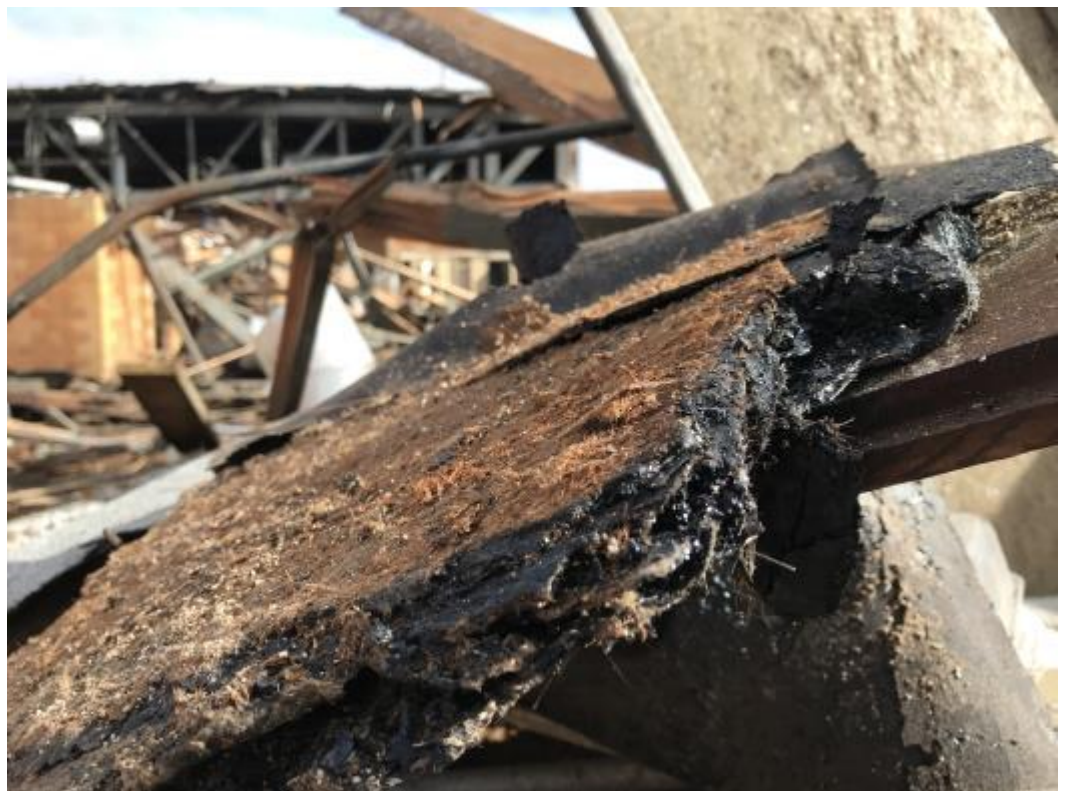
Building 49 roofing sampled for bulk asbestos.

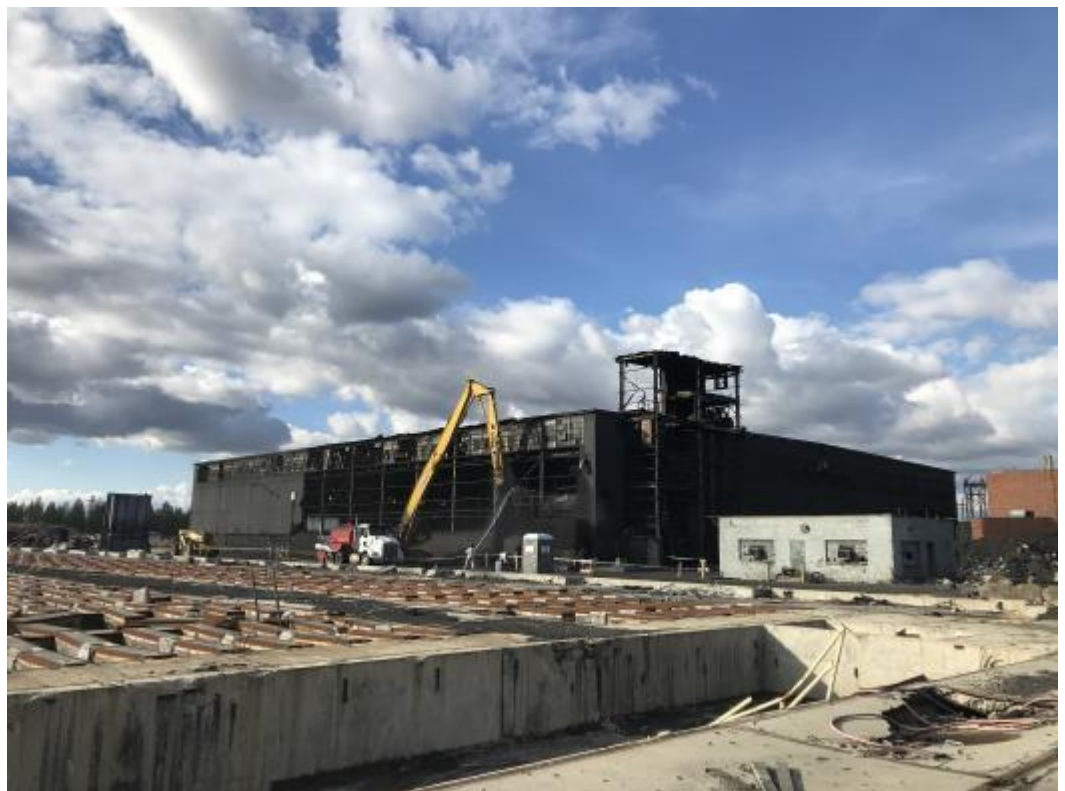
ERRS removing Robertson Siding panels from Building 52.

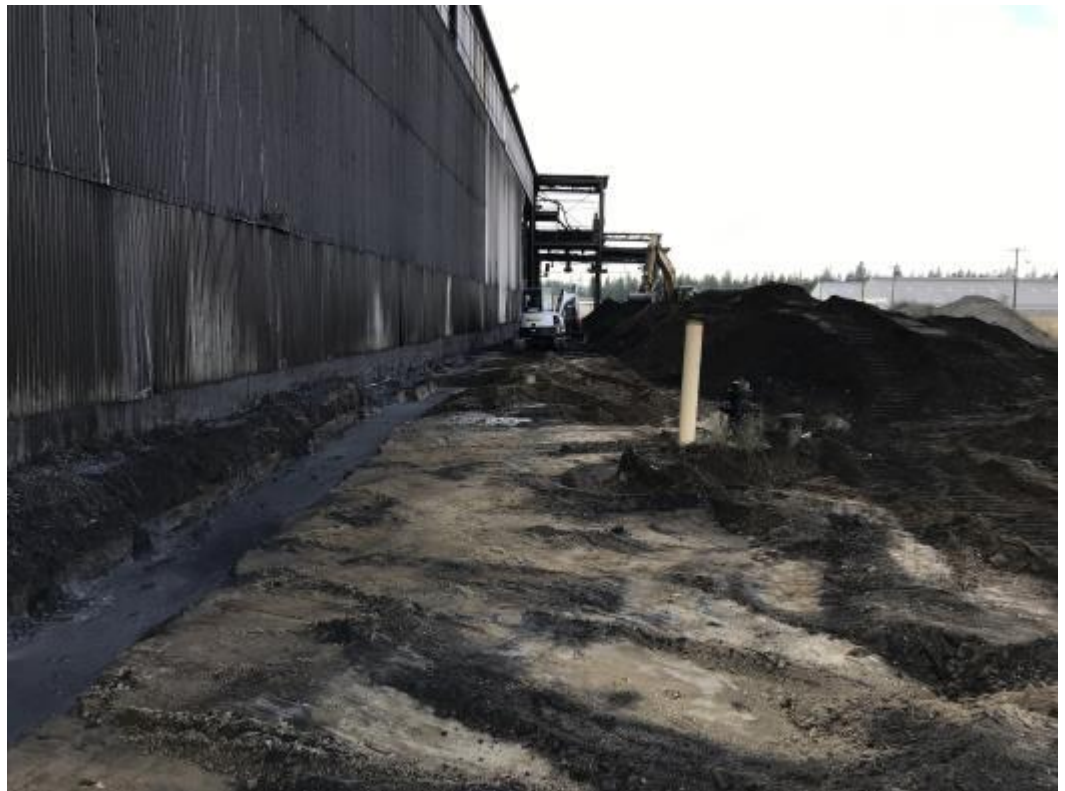
Photo No. 150	Date: 10/22/2020
Photo Coordinates	
Lat	47.755844
Long	-117.38115
Direction Photo Taken: Southwest	
Description: Best management practices were used while removing green coke from Building 52. Dust suppression activities also produced access water. A ditch was installed along northern side of Building 52 to collect excess water. After ditch was no longer needed, it was excavated and disposed as WT02 waste.

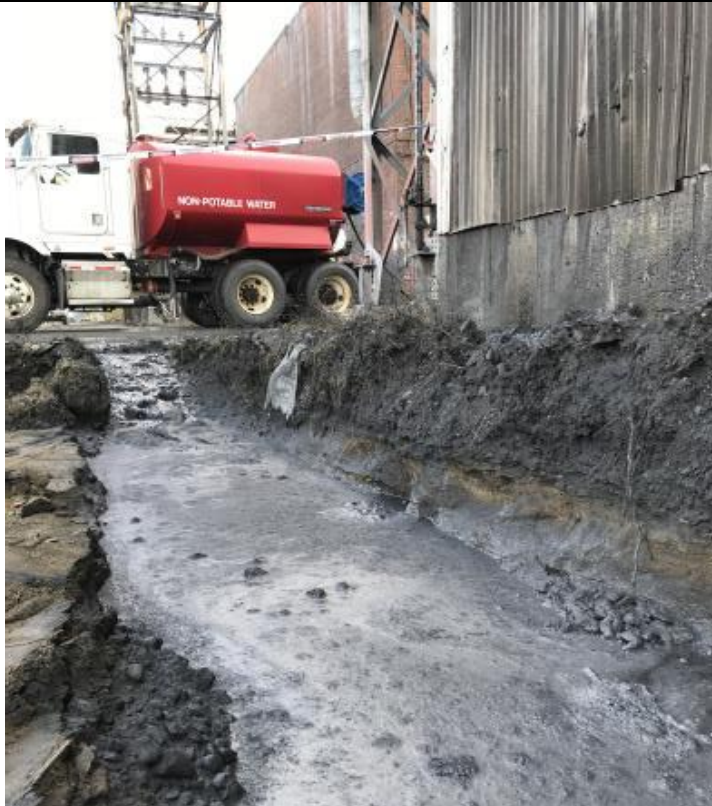
Photo No. 151	Date: 10/22/2020
Photo Coordinates	
Lat	47.755864
Long	-117.381203
Direction Photo Taken: Southeast	
Description: Best management practices were used while removing green coke from Building 52. Dust suppression activities also produced access water. A ditch was installed along northern side of Building 52 to collect excess water. After ditch was no longer needed, it was excavated and disposed as WT02 waste.
