TIME-CRITICAL REMOVAL ACTION REPORT

*Former Kaiser Smelter Site
Mead, Spokane County, Washington*

November 2021
Rev. 2

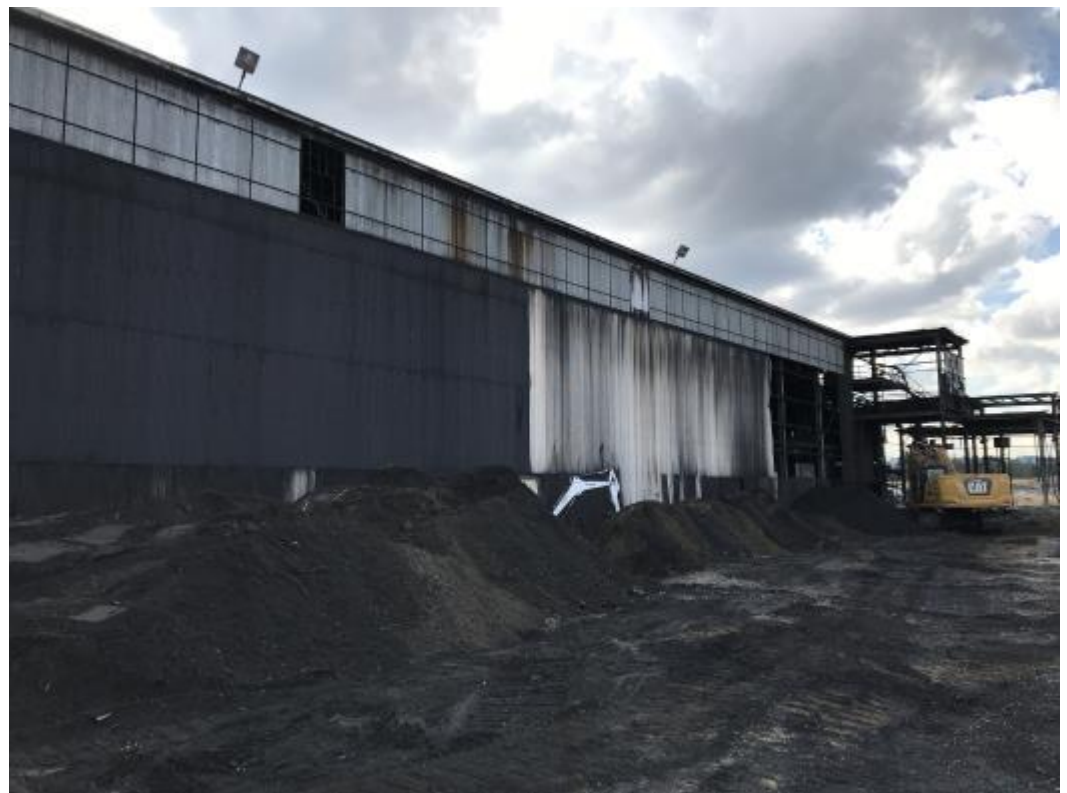
Photo No. 152	Date: 10/22/2020
Photo Coordinates	
Lat	47.755967
Long	-117.381256
Direction Photo Taken: Southwest	
Description: Best management practices were used while removing green coke from Building 52. Dust suppression activities also produced access water. A ditch was installed along northern side of Building 52 to collect excess water. After ditch was no longer needed, it was excavated and disposed as WT02 waste.

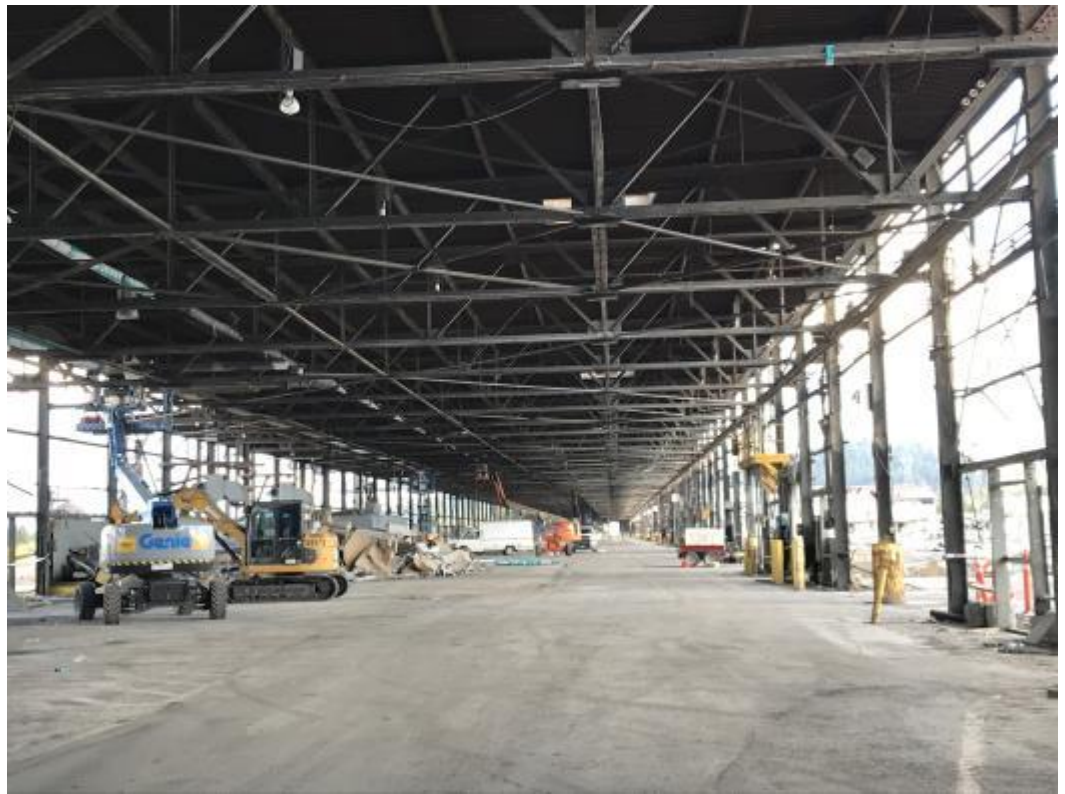
Photo No. 153	Date: 10/22/2020
Photo Coordinates	
Lat	47.755744
Long	-117.377586
Direction Photo Taken: Northeast	
Description: ERRS preparing ACM TSI piping for removal within Building 32.

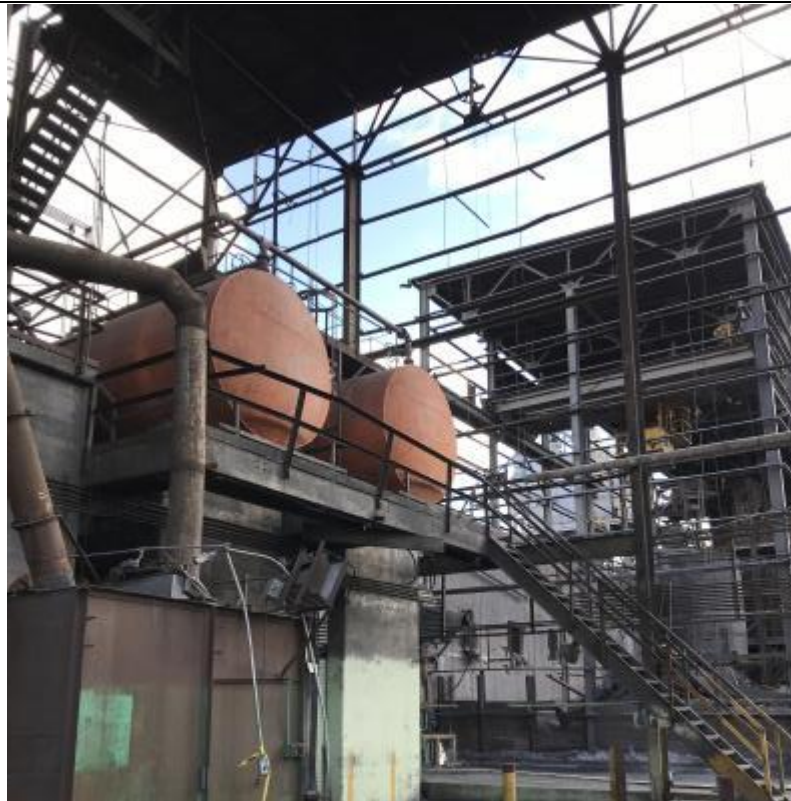
Photo No. 154	Date: 10/22/2020
Photo Coordinates	
Lat	47.755981
Long	-117.378014
Direction Photo Taken: East	
Description: ASTs in 32A after completion of Mag insulation removal.

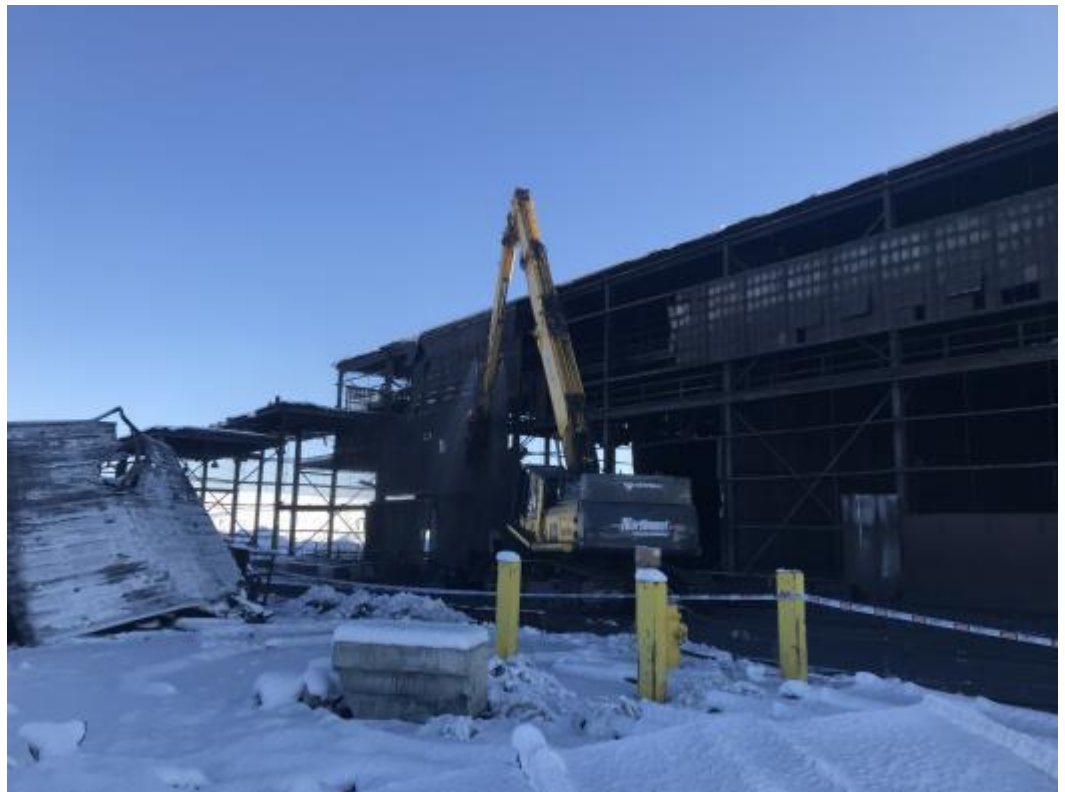
Removal of Robertson Siding panels on Building 52.

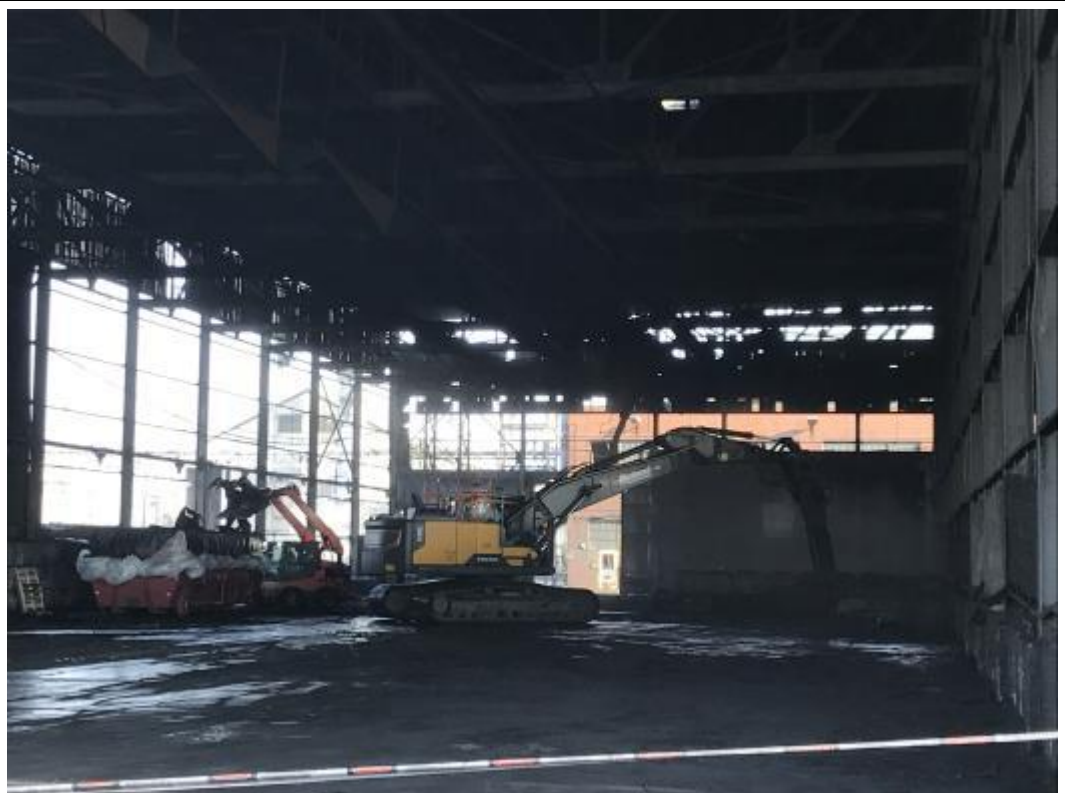
ERRS removing interior Robertson Siding panels within Building 52.

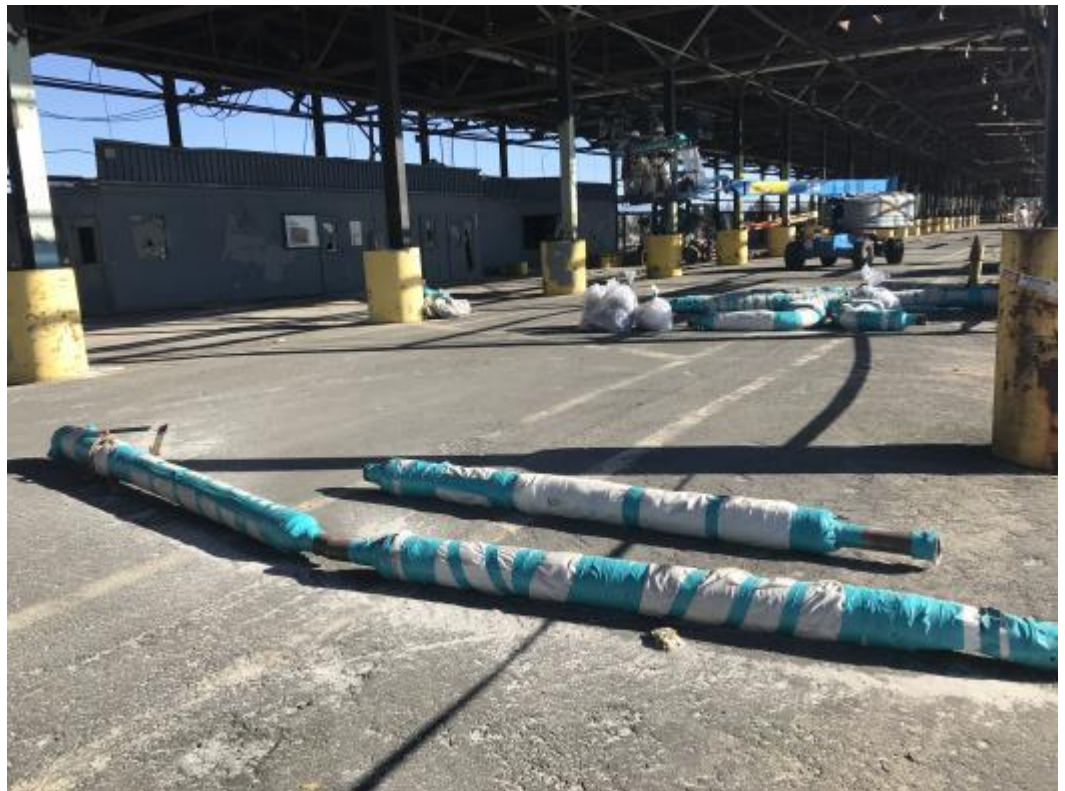
Photo No. 162	Date: 10/31/2020
Photo Coordinates	
Lat	47.755622
Long	-117.373947
Direction Photo Taken: Northeast	
Description: ACM TSI piping in Building 32 staged for disposal.

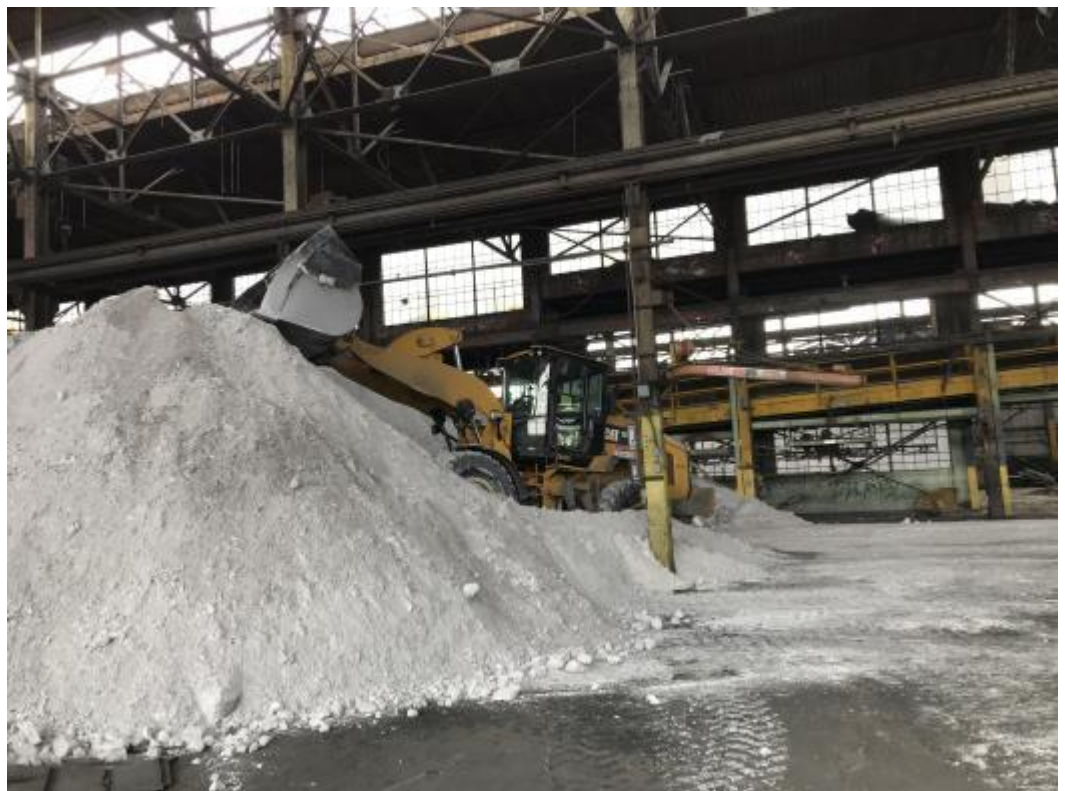
Photo No. 175	Date: 11/03/2020
Photo Coordinates	
Lat	47.754406
Long	-117.377564
Direction Photo Taken: West	
Description: ERRS off-loading alumina in Building 32.

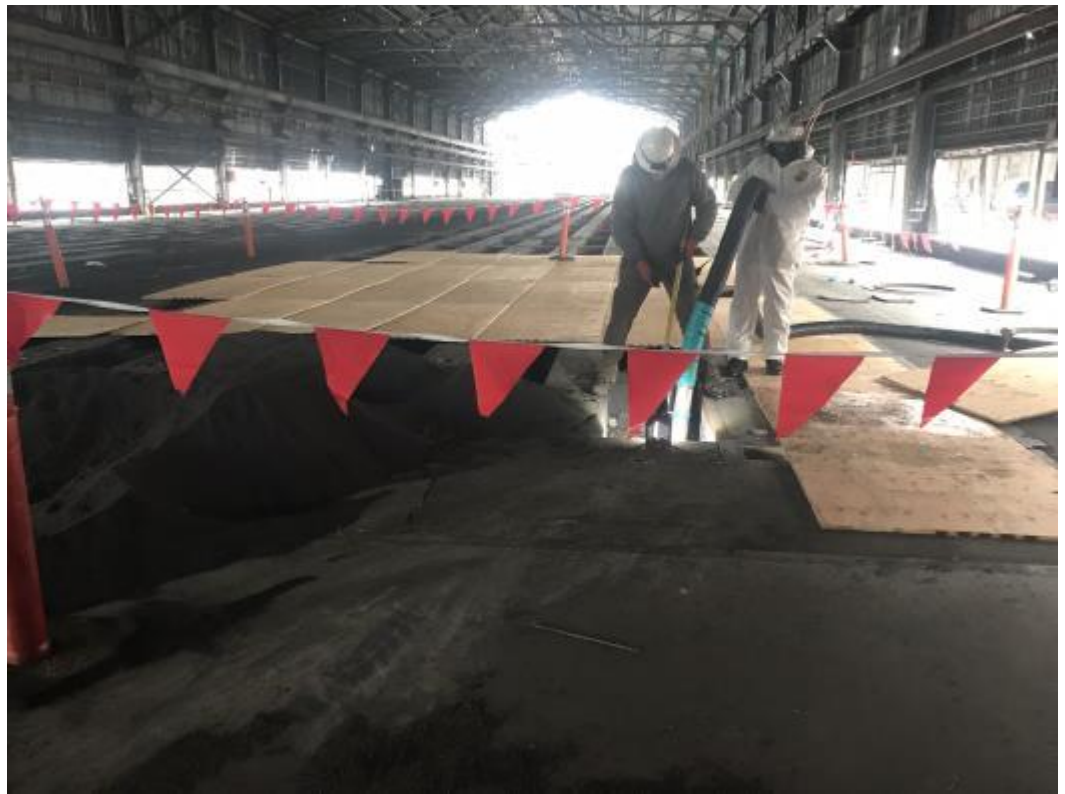
Photo No. 178	Date: 11/18/2020
Photo Coordinates	
Lat	47.755939
Long	-117.382072
Direction Photo Taken: Southeast	
Description: ERRS cleaning out specified storm drains and jet-rodding connection pipes throughout the site.

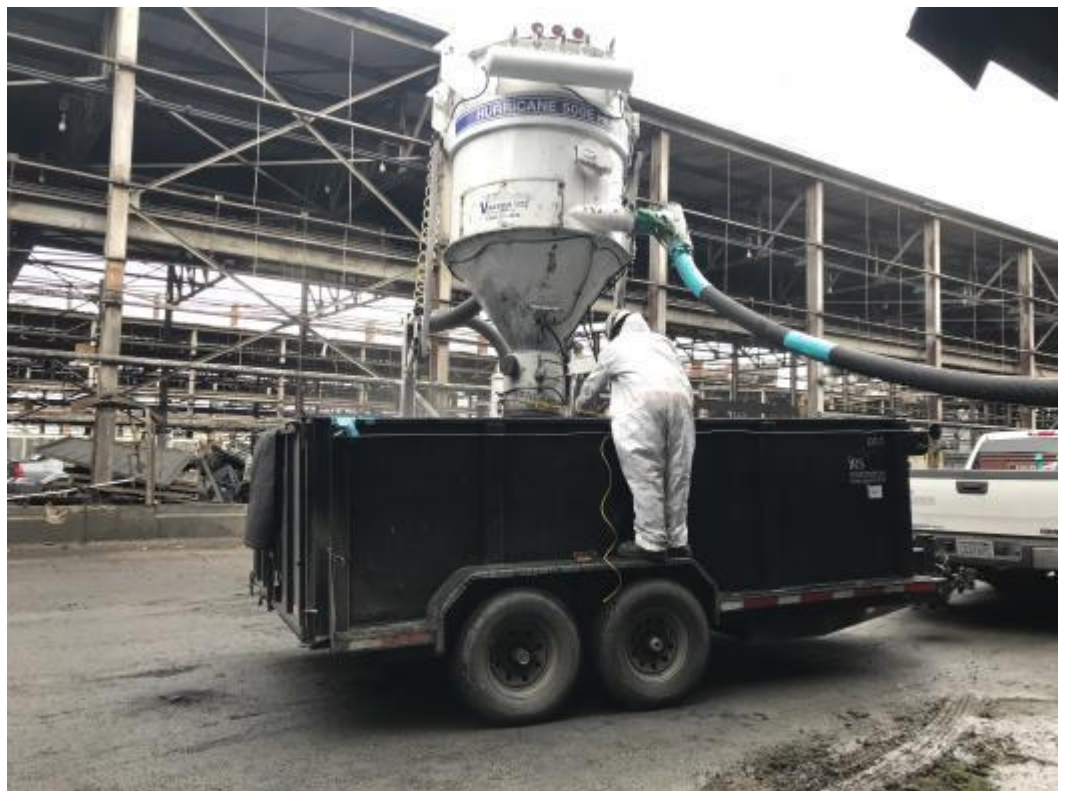
Photo No. 181	Date: 11/19/2020
Photo Coordinates	
Lat	47.755292
Long	-117.372903
Direction Photo Taken: Southeast	
Description: ERRS completing final stages of alumina removal in Potline Area.

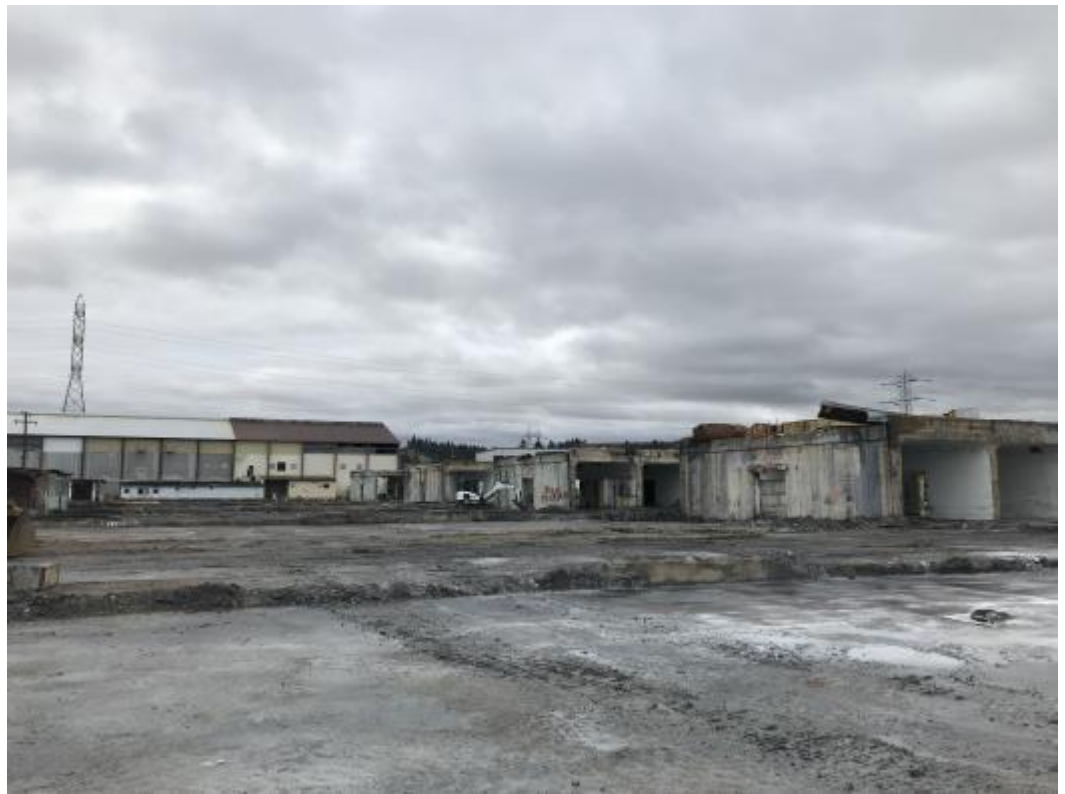
Photo No. 182	Date: 11/19/2020
Photo Coordinates	
Lat	47.755222
Long	-117.372728
Direction Photo Taken: West	
Description: ERRS completing final stages of alumina removal in Potline Area.

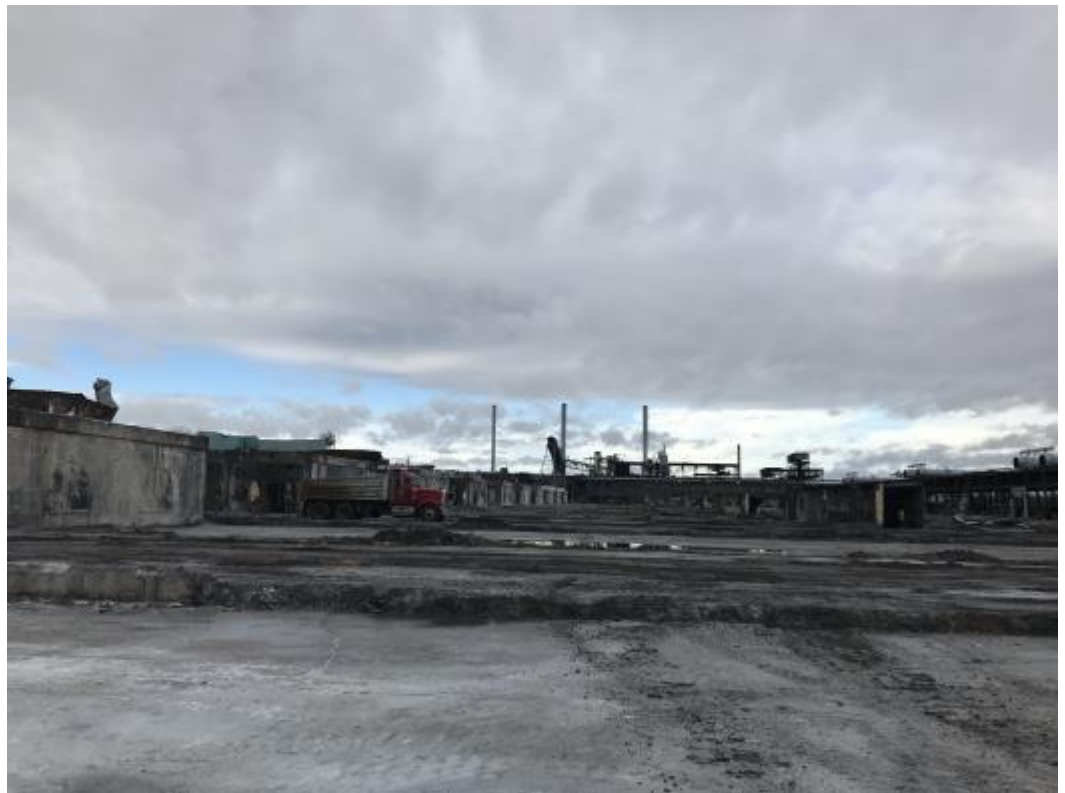
Photo No. 183	Date: 11/19/2020
Photo Coordinates	
Lat	47.755314
Long	-117.373742
Direction Photo Taken: West	
Description: View of Potline Area post alumina removal.

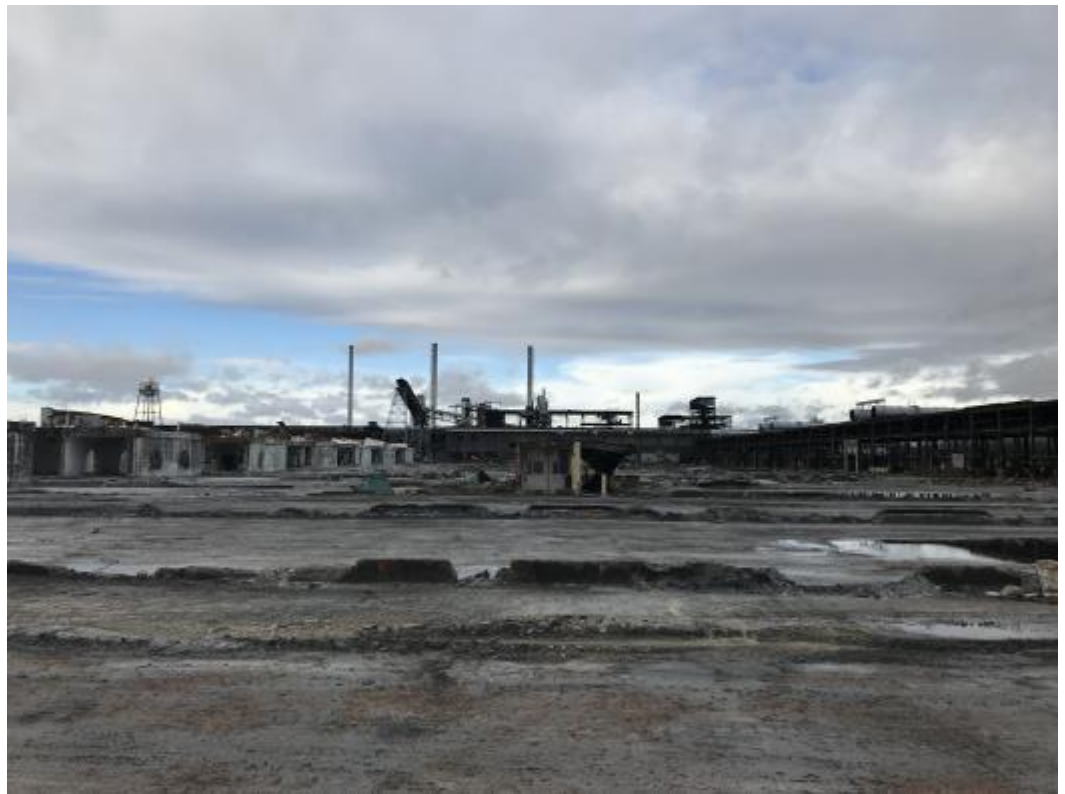
Photo No. 184	Date: 11/19/2020
Photo Coordinates	
Lat	47.755419
Long	-117.373511
Direction Photo Taken: Northwest	
Description: View of Building 32 after completion of removal activities.

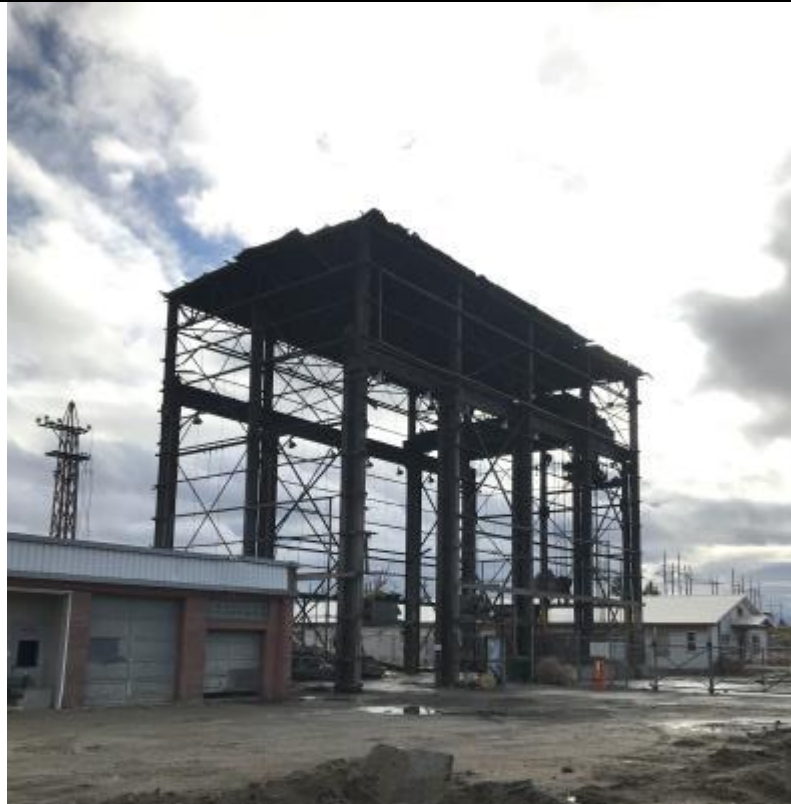
Photo No. 186	Date: 11/19/2020
Photo Coordinates	
Lat	47.75325
Long	-117.3778
Direction Photo Taken: Southeast	
Description: Deactivated pipes in Building 1B discovered to contain remnant transformer oil.

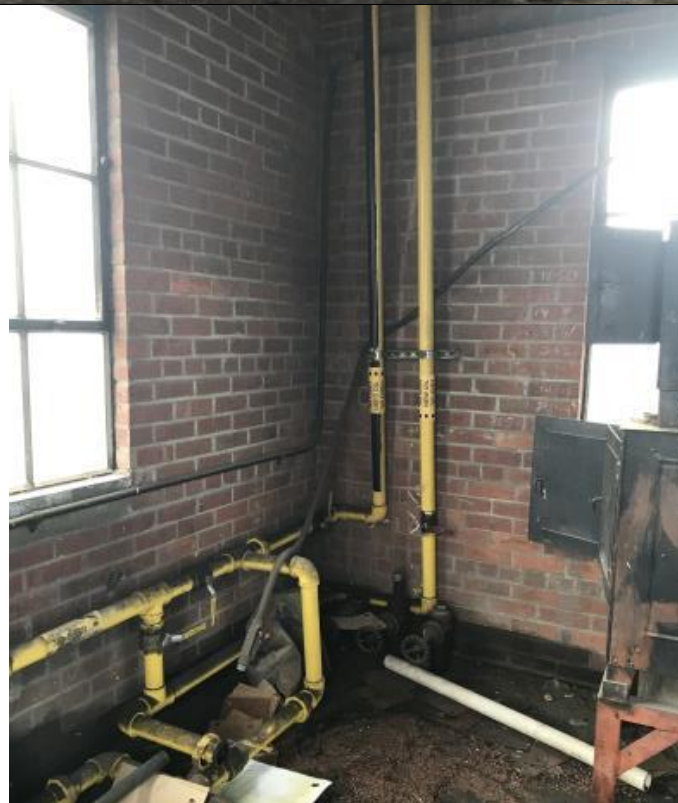
Photo No. 187	Date: 11/19/2020
Photo Coordinates	
Lat	47.753231
Long	-117.377647
Direction Photo Taken: Southwest	
Description: Deactivated pipes near Building 1A and AST discovered to contain remnant transformer oil.

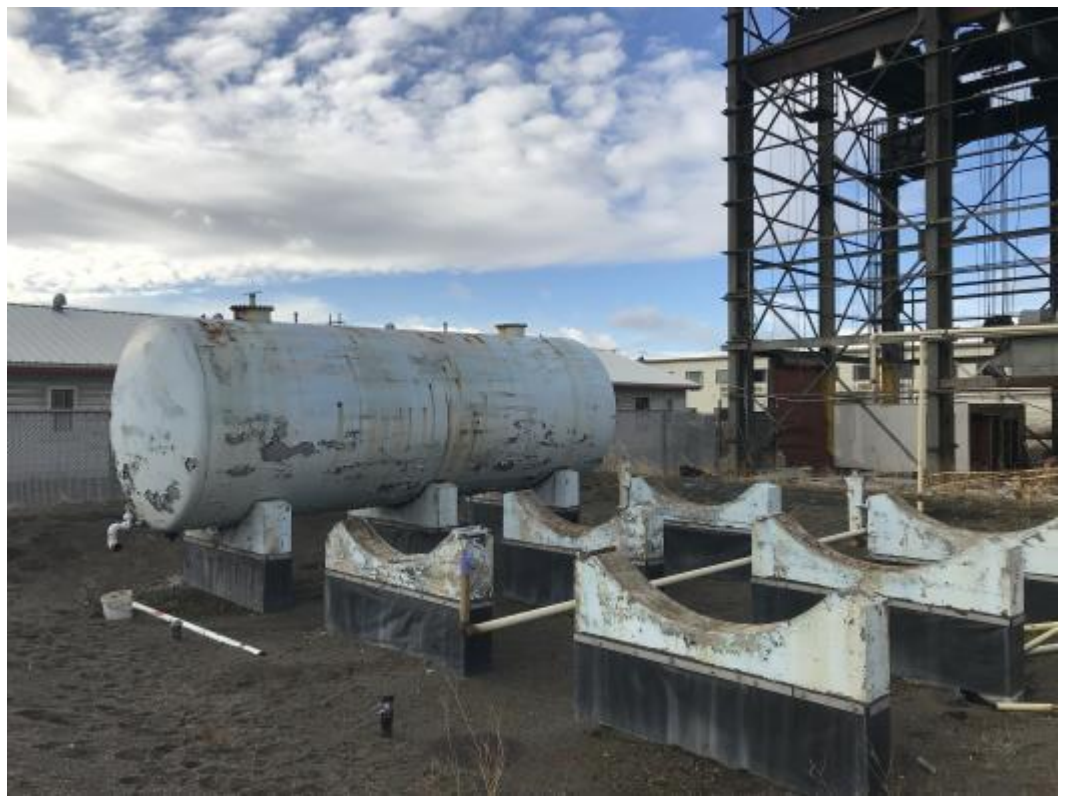
Photo No. 188	Date: 11/20/2020
Photo Coordinates	
Lat	47.753131
Long	-117.377739
Direction Photo Taken: Southwest	
Description: Removal of oil in AST.

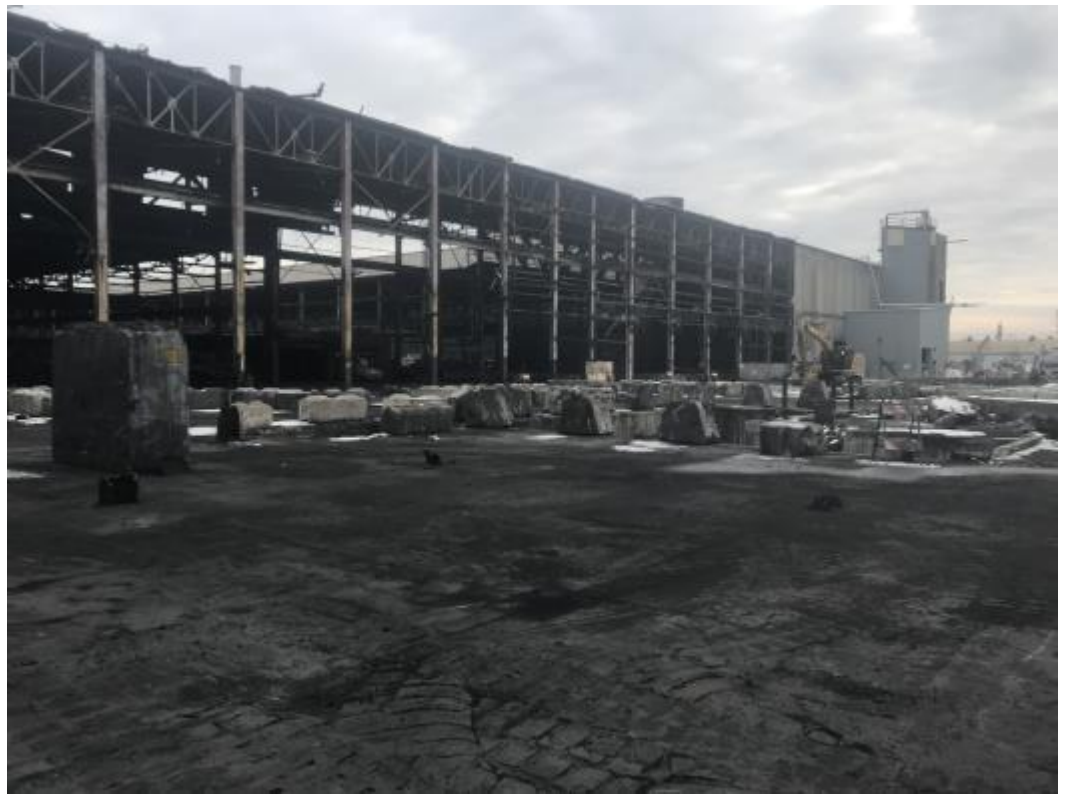
Photo No. 199	Date: 12/07/2020
Photo Coordinates	
Lat	47.755614
Long	-117.375053
Direction Photo Taken: Southeast	
Description: Footprint of former Building 54 with ecology blocks placed around open pits.

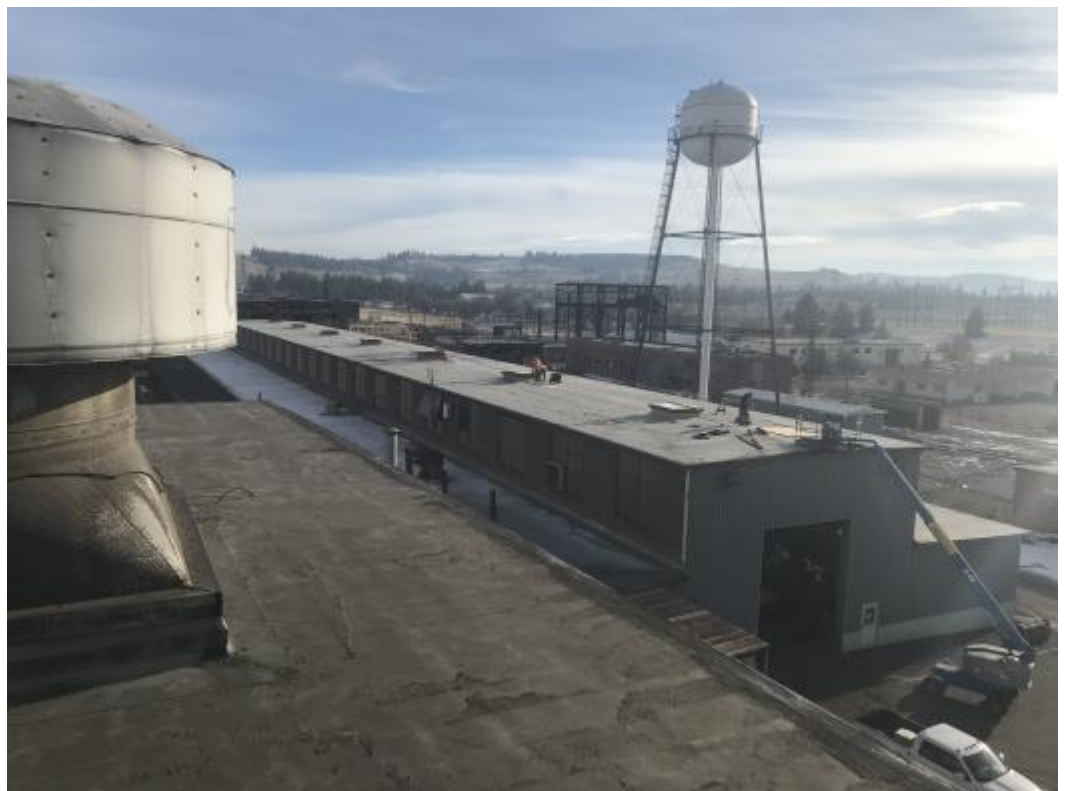
ERRS installing new coverings over roof openings created during Robertson Ventilator removal.

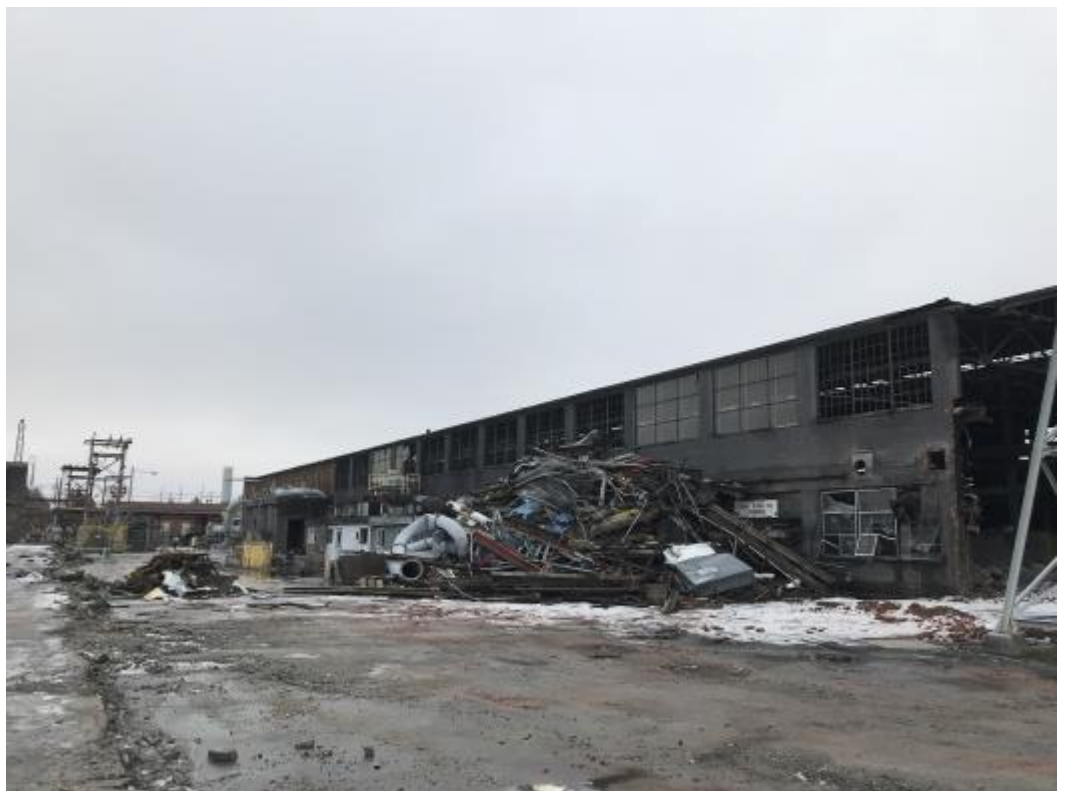
Photo No. 219	Date: 12/09/2020
Photo Coordinates	
Lat	47.75505
Long	-117.380219
Direction Photo Taken: Southeast	
Description: Overview of roof workings after removal activities completed on centrally located structures.

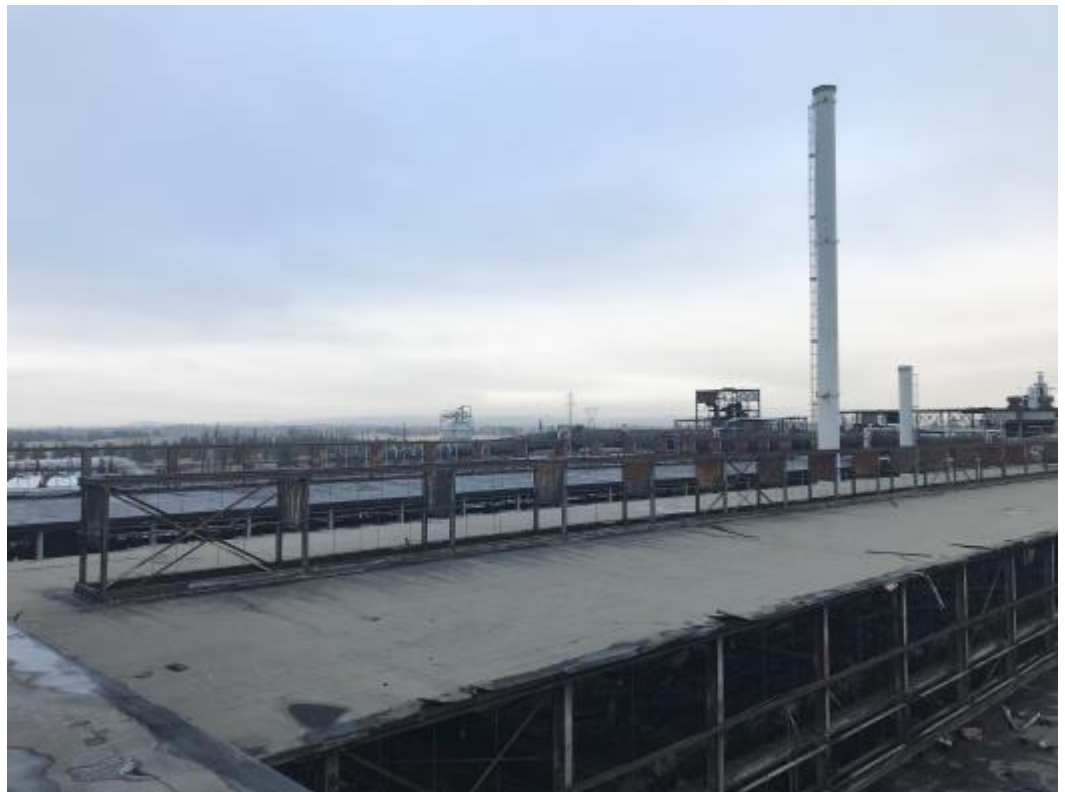
Photo No. 220	Date: 12/09/2020
Photo Coordinates	
Lat	47.754619
Long	-117.380072
Direction Photo Taken: West	
Description: Overview of roof workings after removal activities completed on centrally located structures.

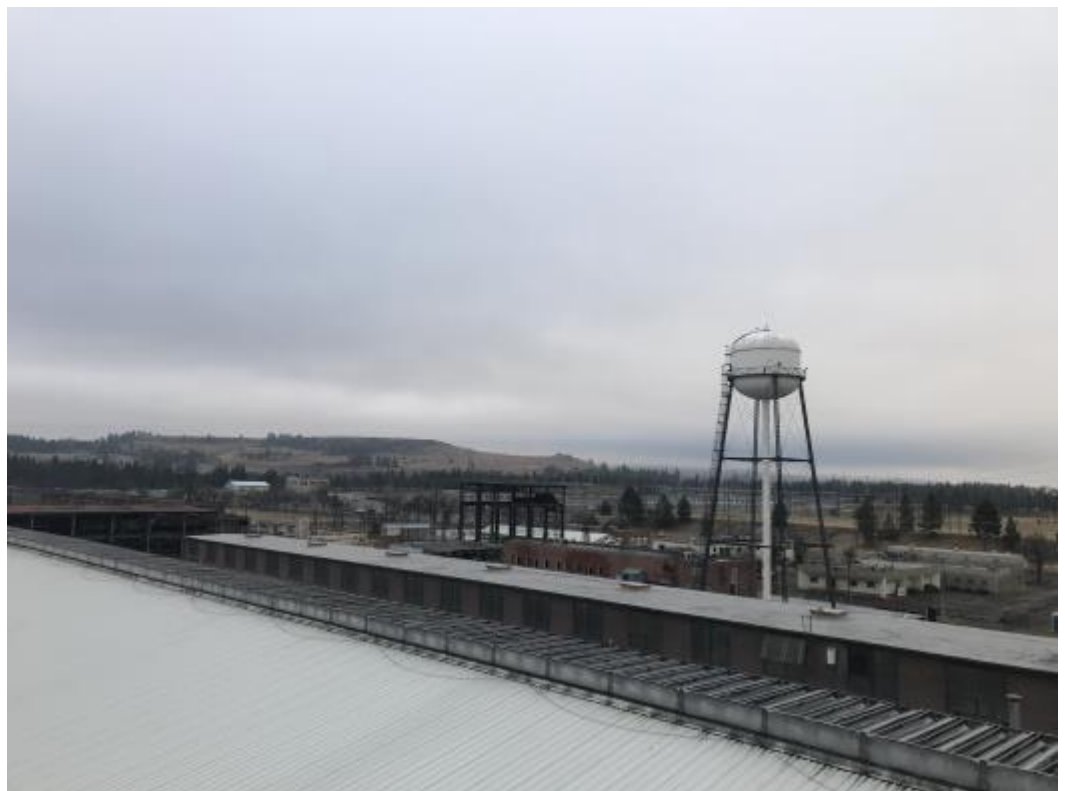
Roof of Building 56 after Robertson Ventilation removal completed.

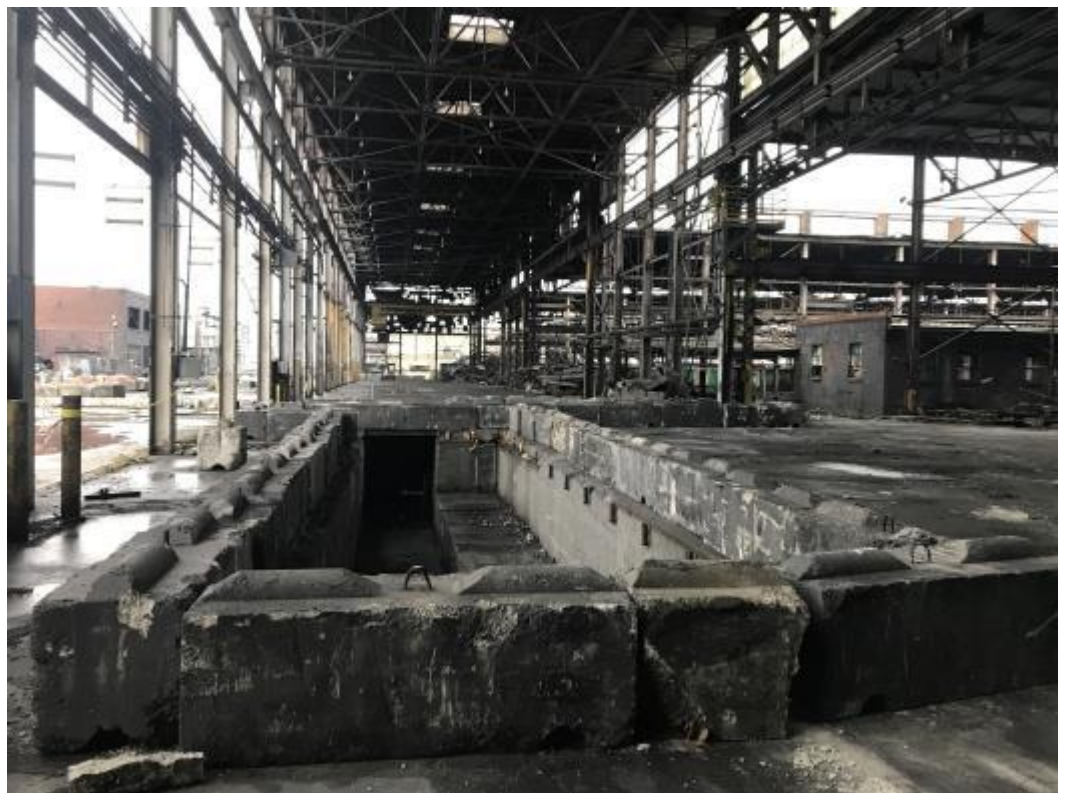
Ecology blocks installed around open pits in footprint of former Building 54.

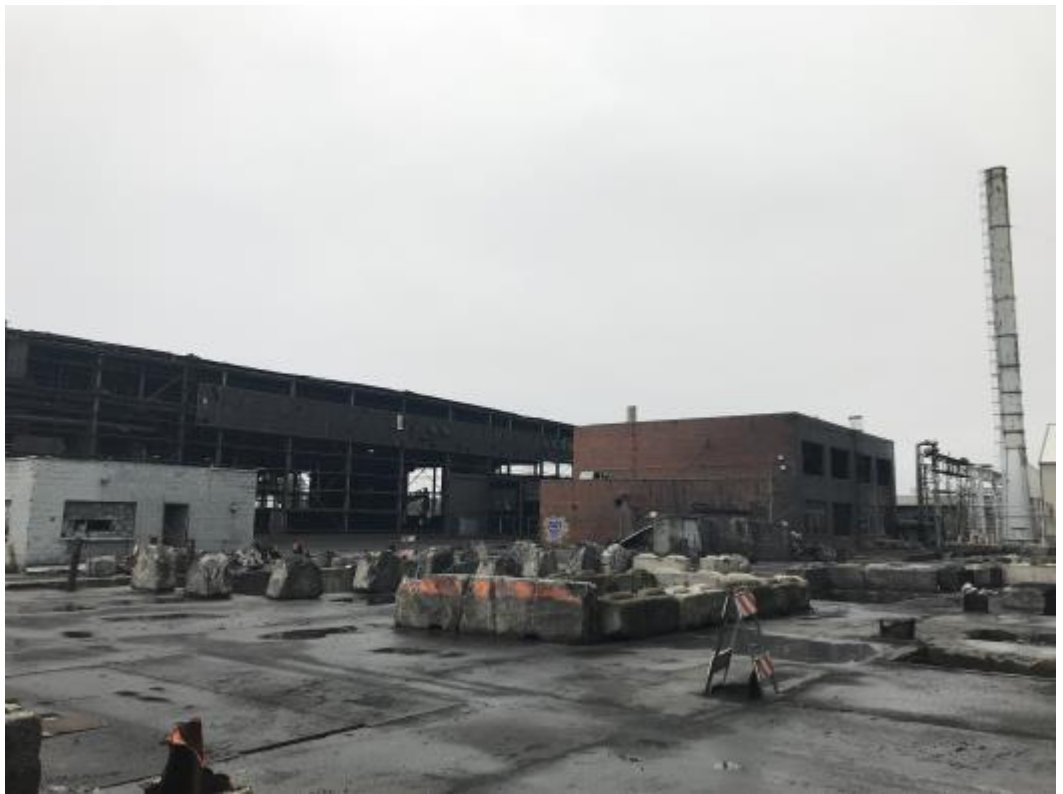
Photo No.
224

Courtyard of Building 60/58 after removal activities completed.

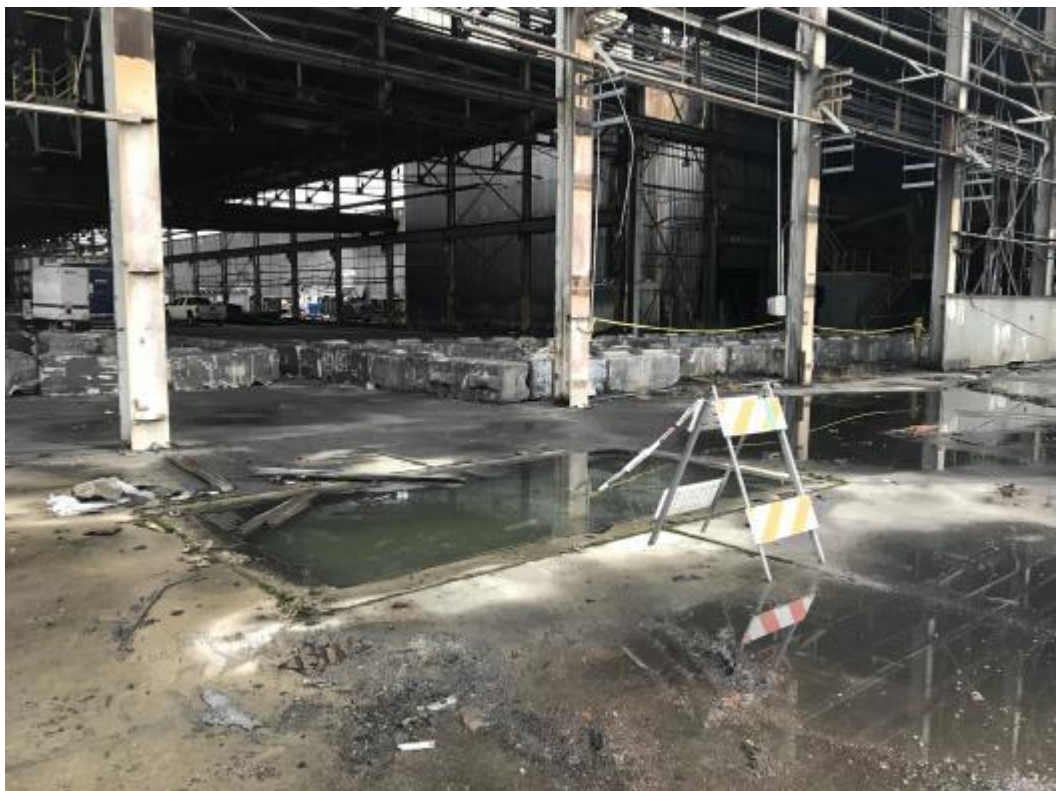
Photo No. 227	Date: 12/09/2020
Photo Coordinates	
Lat	47.755131
Long	-117.381119
Direction Photo Taken: Southeast	
Description: Representative view of paved area near Building 52 and former Building 56 after removal activities completed.

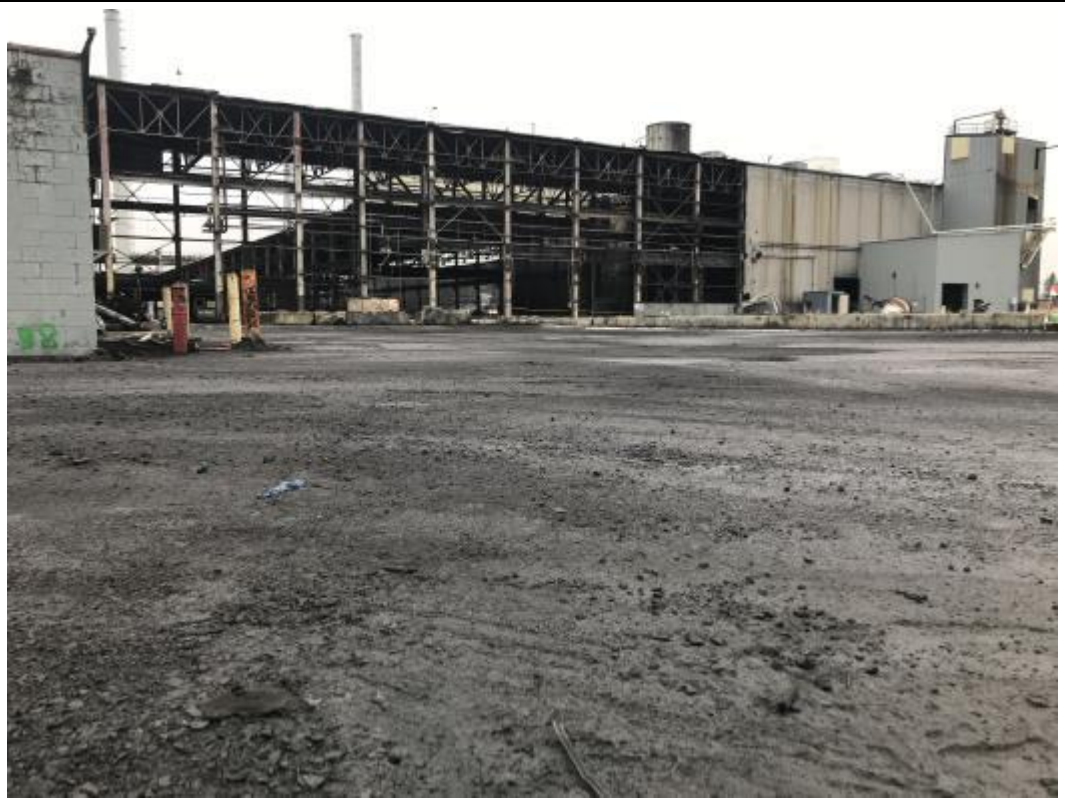
Photo No. 228	Date: 12/09/2020
Photo Coordinates	
Lat	47.75565
Long	-117.381036
Direction Photo Taken: Northwest	
Description: Floor of Building 52 after removal activities completed.

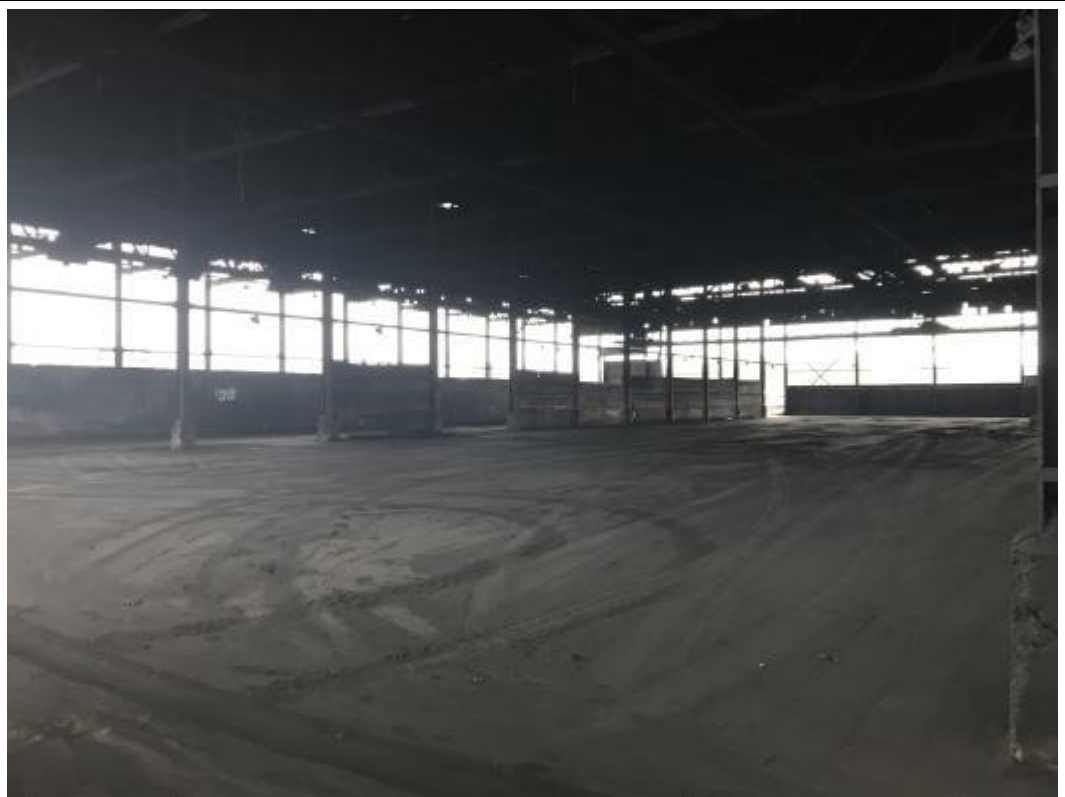
Photo No. 229	Date: 12/09/2020
Photo Coordinates	
Lat	47.755833
Long	-117.380981
Direction Photo Taken: West	
Description: Area north of Building 52 where contaminated soil piles were formerly staged and subsequently removed.

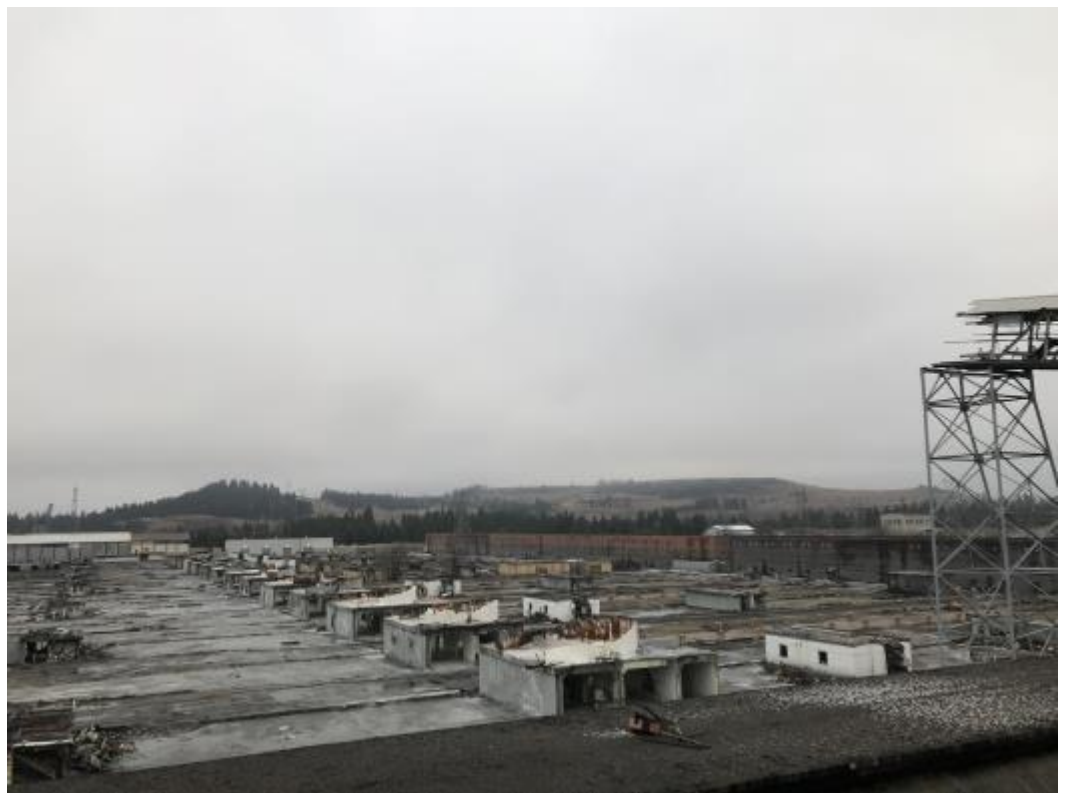
Photo No. 231	Date: 12/09/2020
Photo Coordinates	
Lat	47.755578
Long	-117.374519
Direction Photo Taken: Northwest	
Description: Southern side of Building 34 after removal activities completed.
