TIME-CRITICAL REMOVAL ACTION REPORT

*Former Kaiser Smelter Site
Mead, Spokane County, Washington*

November 2021
Rev. 2

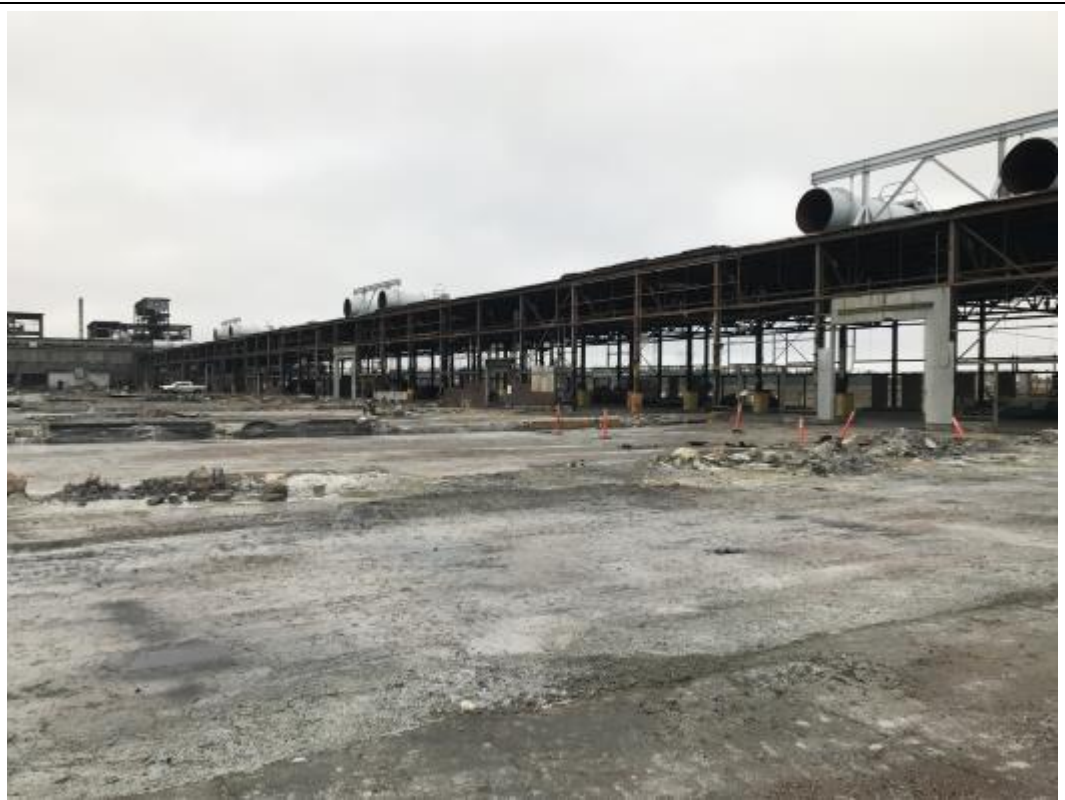
Photo No. 232	Date: 12/09/2020
Photo Coordinates	
Lat	47.755275
Long	-117.374764
Direction Photo Taken: North	
Description: View of southern side of Building 34 and stormwater drains in Potline Area after removal activities completed.

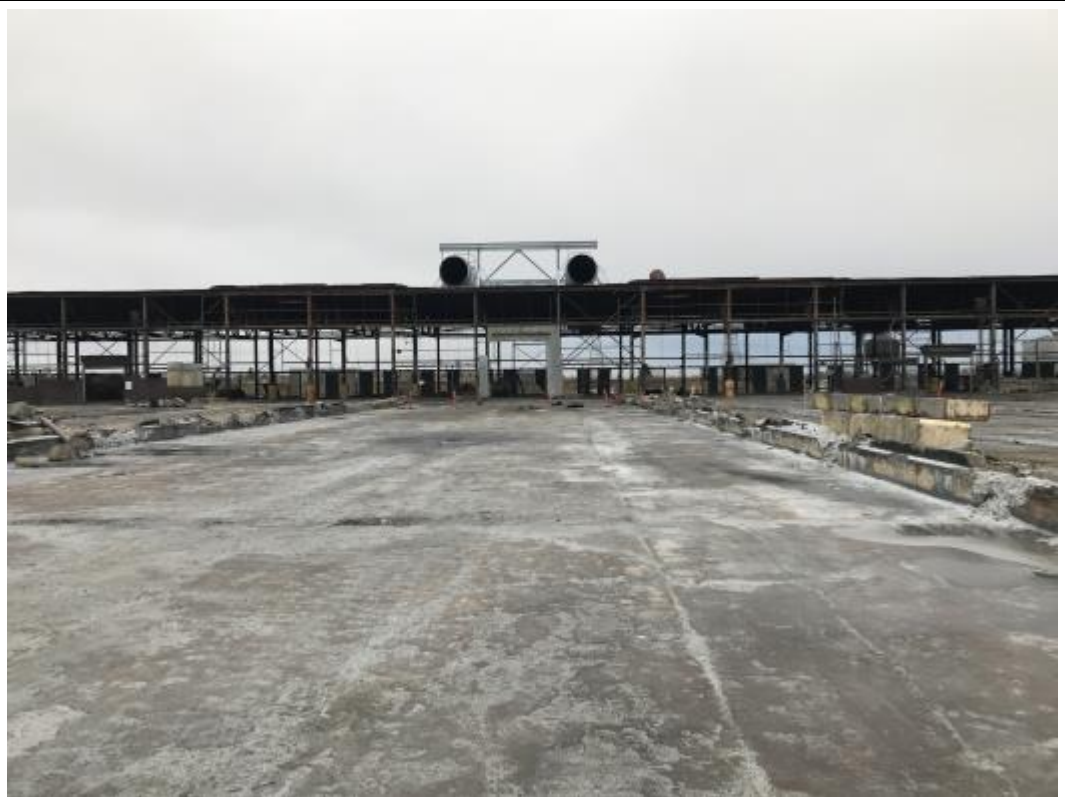
Photo No. 233	Date: 12/09/2020
Photo Coordinates	
Lat	47.755792
Long	-117.372825
Direction Photo Taken: South	
Description: Building 34C after removal of Reacted Ore completed.

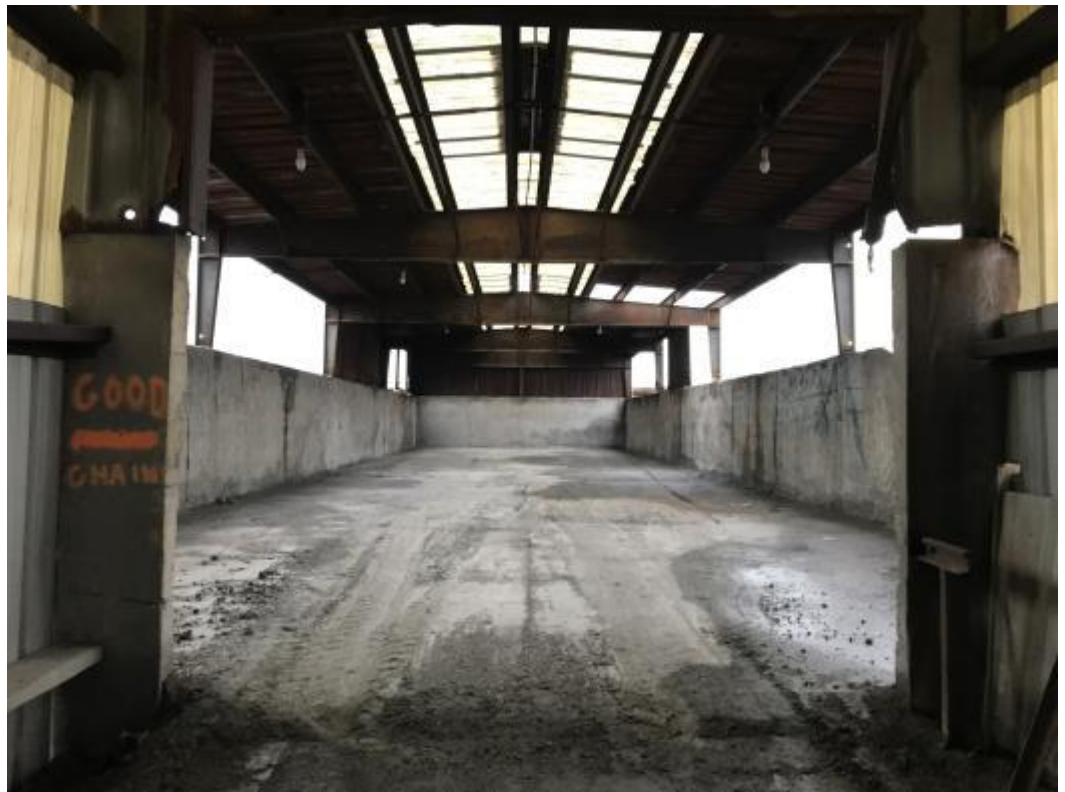
Photo No. 234	Date: 12/09/2020
Photo Coordinates	
Lat	47.755867
Long	-117.370811
Direction Photo Taken: West	
Description: Reacted Ore storage area in eastern end of Building 34 after removal activities completed.

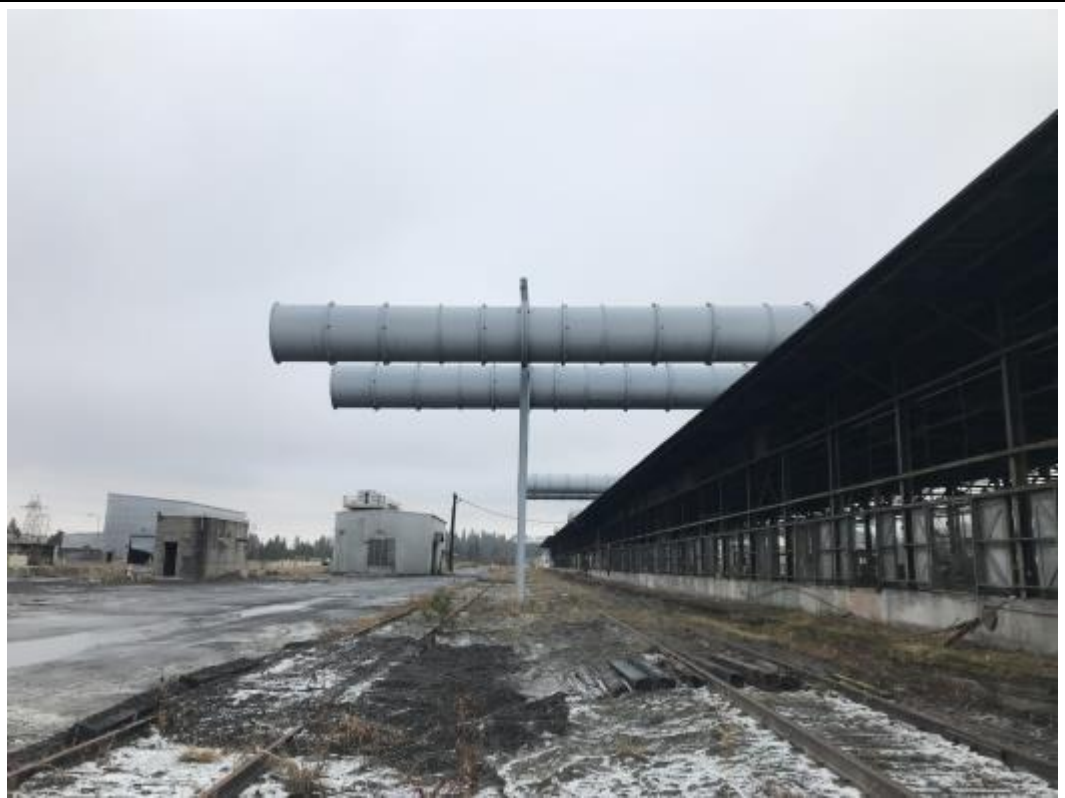
Photo No. 236	Date: 12/09/2020
Photo Coordinates	
Lat	47.756222
Long	-117.377778
Direction Photo Taken: East by Southeast	
Description: Condition of railroad tracks and northern side of Building 34 after completion of removal activities.

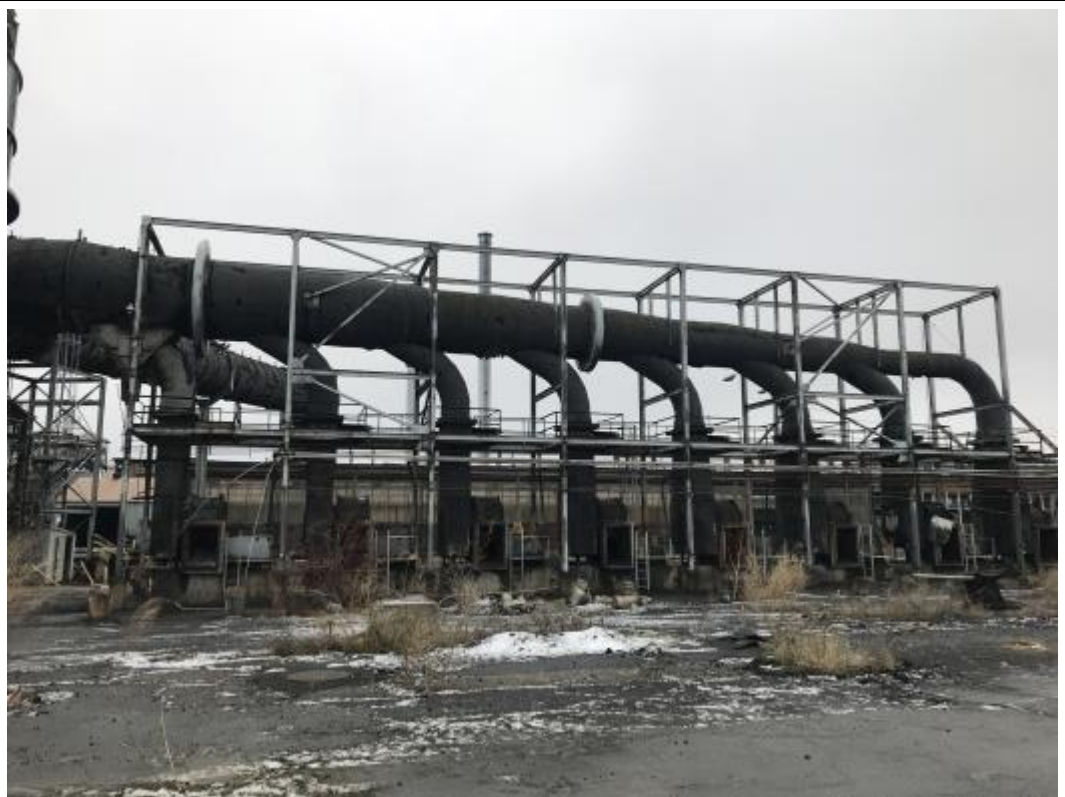
Photo No. 239	Date: 12/09/2020
Photo Coordinates	
Lat	47.756419
Long	-117.380958
Direction Photo Taken: Southeast	
Description: Coal tar pitch ASTs after repairs made to open door in bottom of central AST.

The CTP ASTs contain solidified CTP. The lower hatch to the central tank, which had been removed from the tank prior to the TCRA, was replaced and bolted shut by ERRS. EPA estimates that the volume of solidified CTP contained in the ASTs is 37 CY.

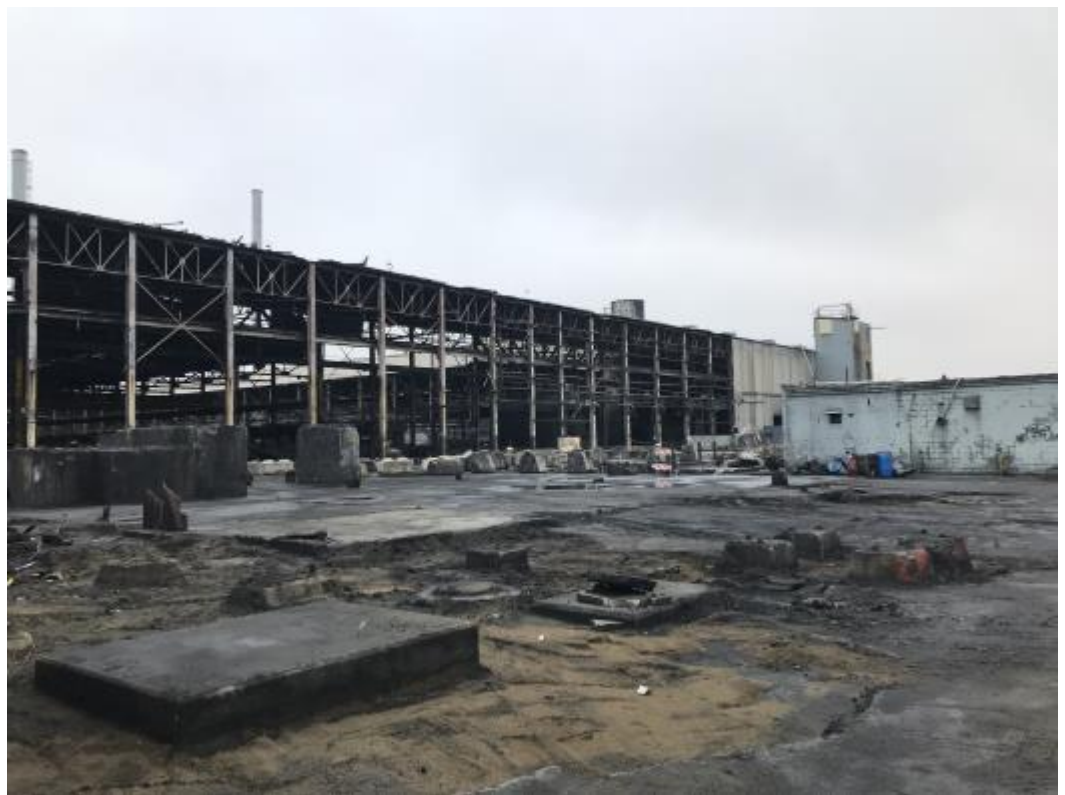
Photo No. 241	Date: 12/09/2020
Photo Coordinates	
Lat	47.755131
Long	-117.380508
Direction Photo Taken: Northwest	
Description: Panoramic view of Building 54 footprint after Site activities and safety improvements completed.

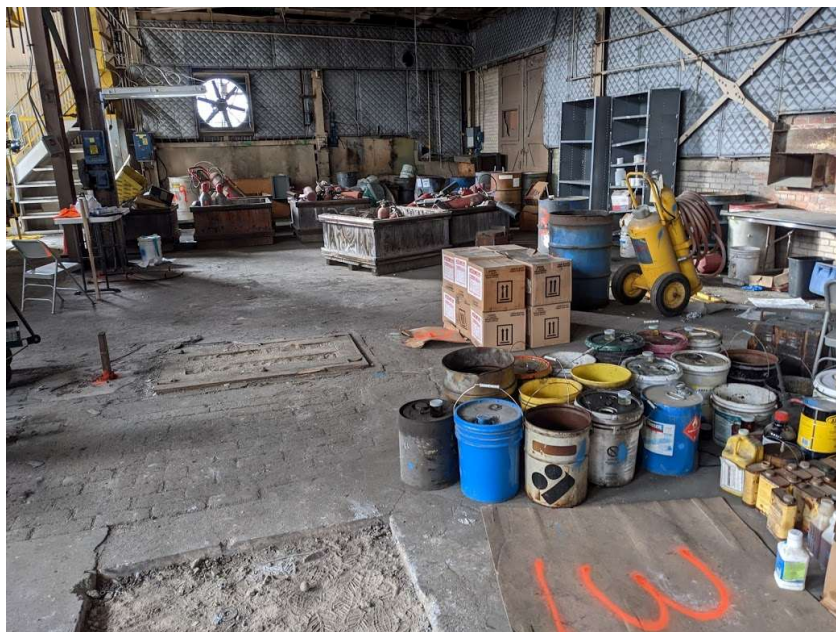
Photo 1 - View of the northwest corner of Building 44

This area contained 12 drums, 7 crates and a number of smaller containers staged. Each staging group was labeled with an ID corresponding to either an inventory code or a DOT hazard class.

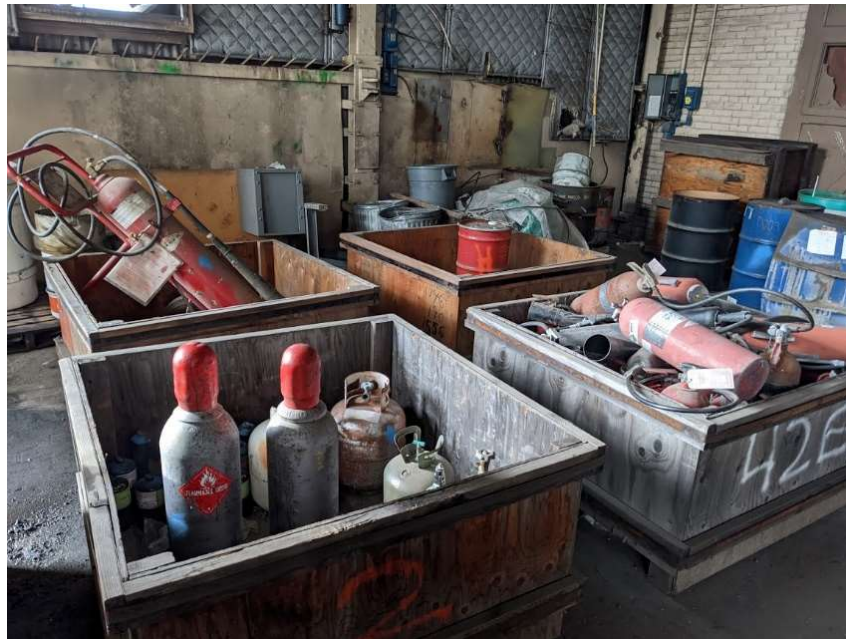
Photo 2 - Crates with compressed gasses

Crates containing multiple items were labeled with the DOT class of the items they contained. The crate containing compressed gas cylinders was labeled as DOT 2. Two gray cylinders with red cylinder caps within this crate were suspected by START to be props; however, that could not be confirmed, and the cylinders were documented as DOT 2. The crate labeled 42 E contained 42 fire extinguishers. A single large fire extinguisher was staged in its own crate. All the fire extinguishers identified on site were grouped and inventoried; however, many were pressurized, and will require depressurization prior to disposal. A single 30-gallon drum labeled D010 was staged in the last crate and contains a DOT class 3, flammable solvent.

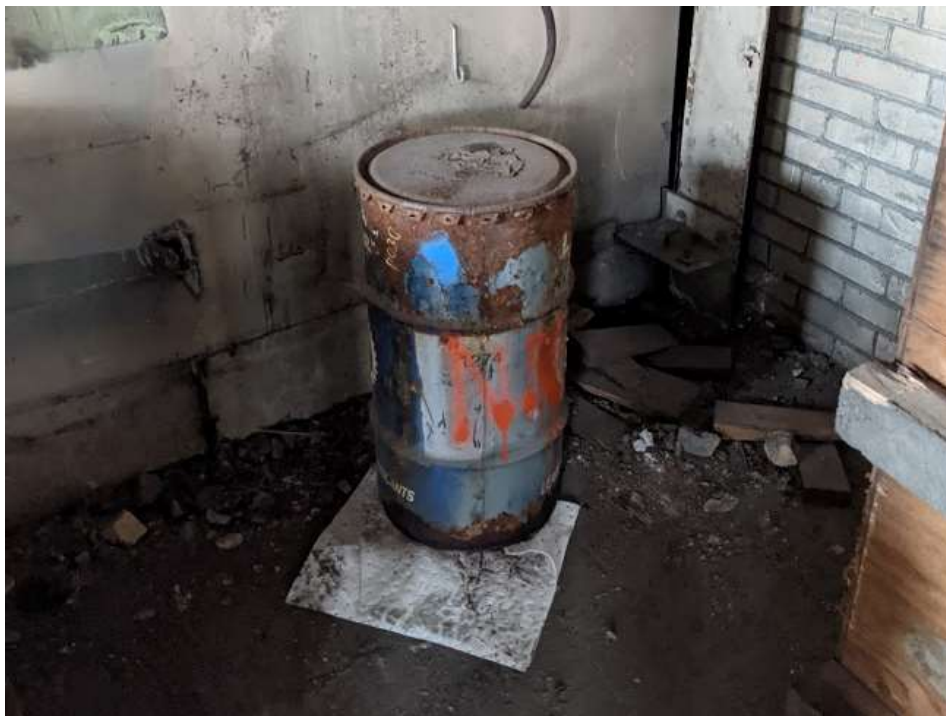
Photo 3 – Drum D030 containing lubricant

D030 was in the northwest corner of the building and was determined through visual observation and SDS research to be a non-DOT-regulated lubricant. During initial inspection, the drum appeared to be leaking, but it was later determined to be residue left by another container. A sorbent pad was placed underneath the container to contain the liquid.

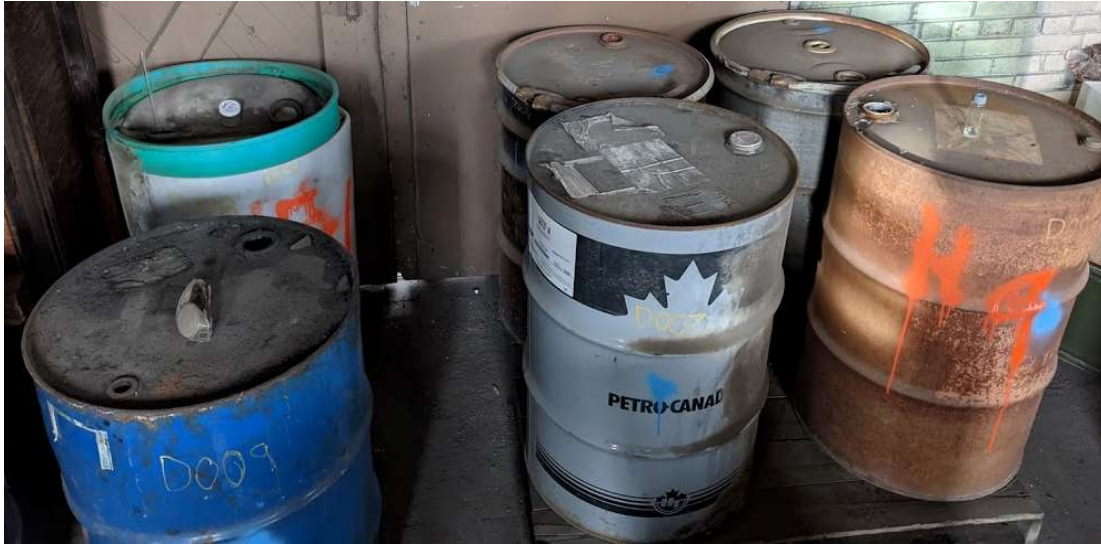
Photo 4 - Drums containing nonregulated material, a 5.1 oxidizer and green coke material.

Six 55-gallon drums were located along the north wall on the west side of building 44, behind the fire extinguisher totes. Drums D006, D007, and D009 had good labels and were categorized as non-DOT regulated by SDS research and visual observations. Drum D008 was determined by First Step Hazard Categorization to be a DOT Class 5.1. D004 and D005

were opened by START and determined by visual observation to be green coke material and can be disposed on site with other site waste.

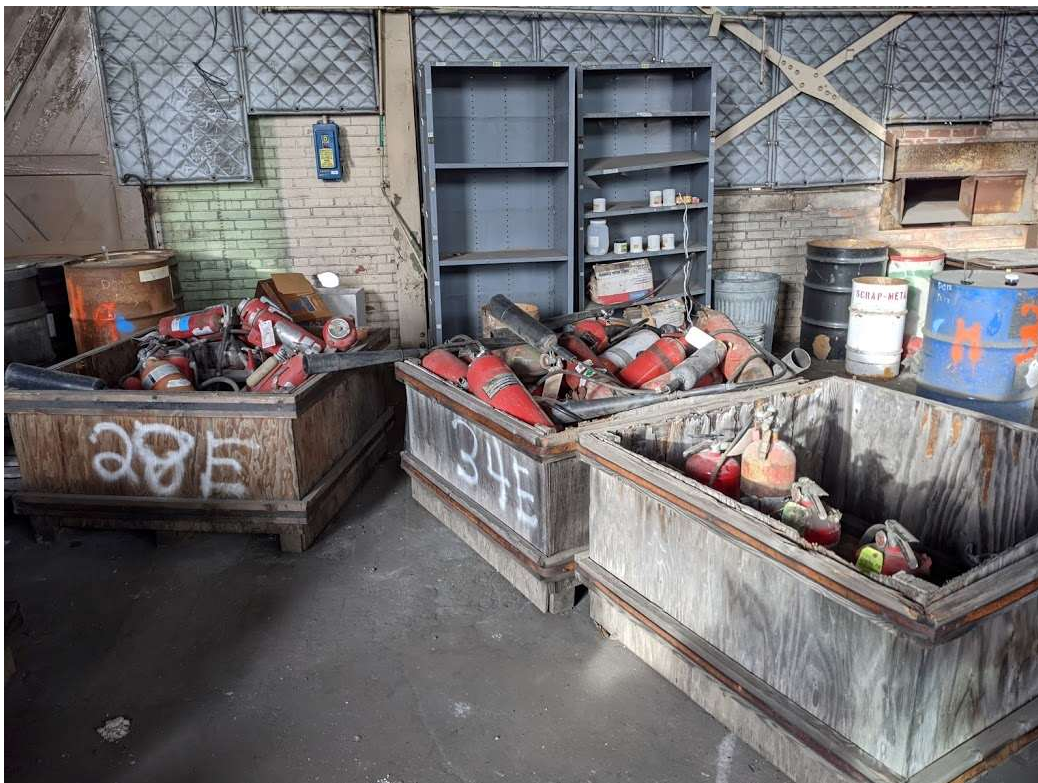
Photo 5 - Crates containing fire extinguishers

Three additional crates pictured below contained fire extinguishers. Crates with large number of fire extinguishers were counted and the quantity labeled on the outside of the crate. All the fire extinguishers identified on site were grouped and inventoried; however, many remained pressurized and will require depressurization before disposal.

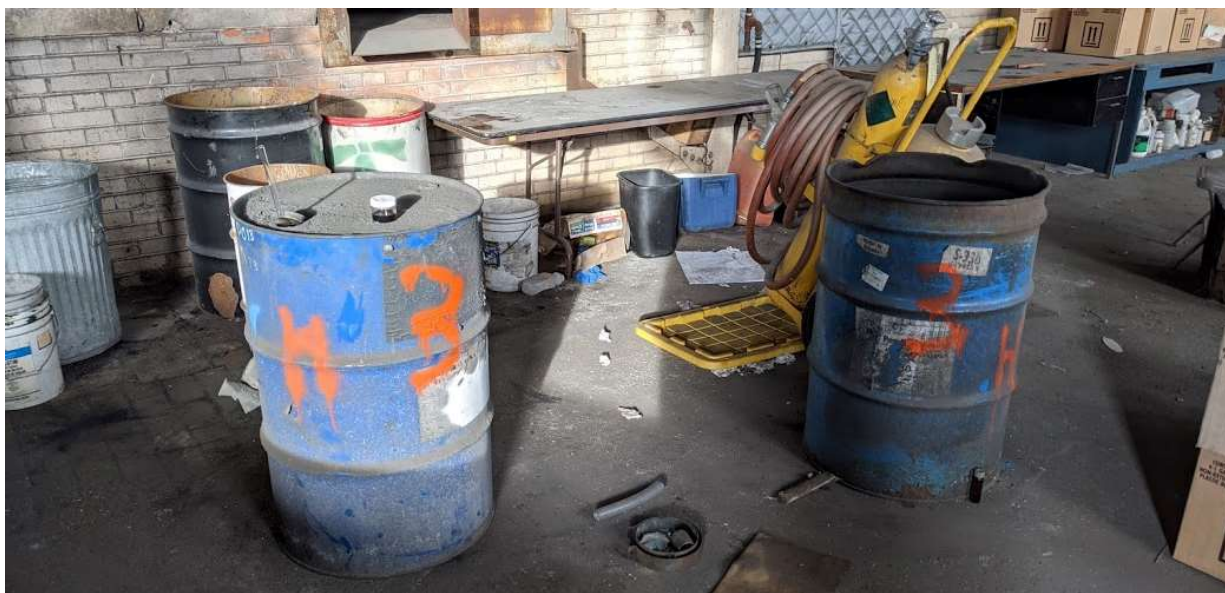
Photo 6 - Drums containing DOT 3 Flammable liquids

Drums D013 and D014 were sampled by START and determined to be DOT class 3 by First Step Hazard Categorization. Drum D014 was open and had no lid. The open drums behind Drums D013 and D014 along the wall were visually inspected by START and contained trash and other debris .

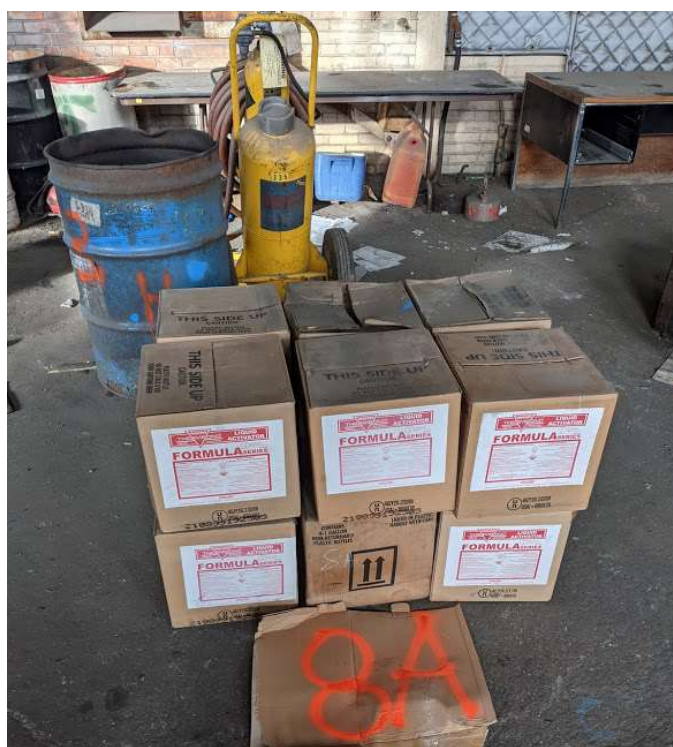
Photo 7 - Boxes of corrosive liquid activator (acidic)

Twelve cases of liquid activator with “Corrosive” labels were categorized through SDS research as DOT 8A acidic liquids. The yellow cylinder behind the liquid activator pile is a fire extinguisher.

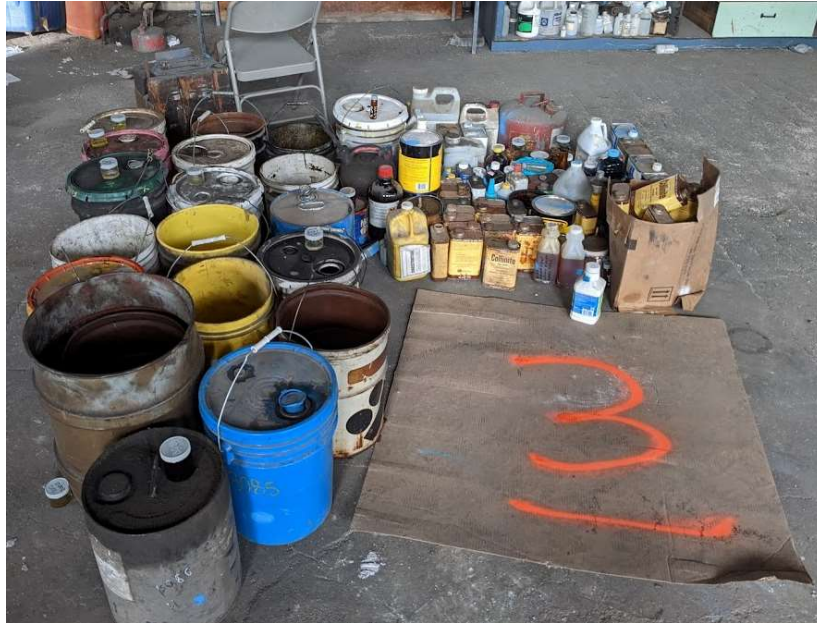
Photo 8 - DOT class 3 containers

All identified DOT class 3 flammable liquid containers with the exception of the 55-gallon drums were staged together by START. This pile consisted of a variety of container types and sizes. Several five gallon buckets were partially full without lids and would require cautious handling to avoid potential spills of flammable liquids. Unlabeled containers were classified using the First Step Hazard Categorization system. Labeled containers were classified through SDS research and visual observation.

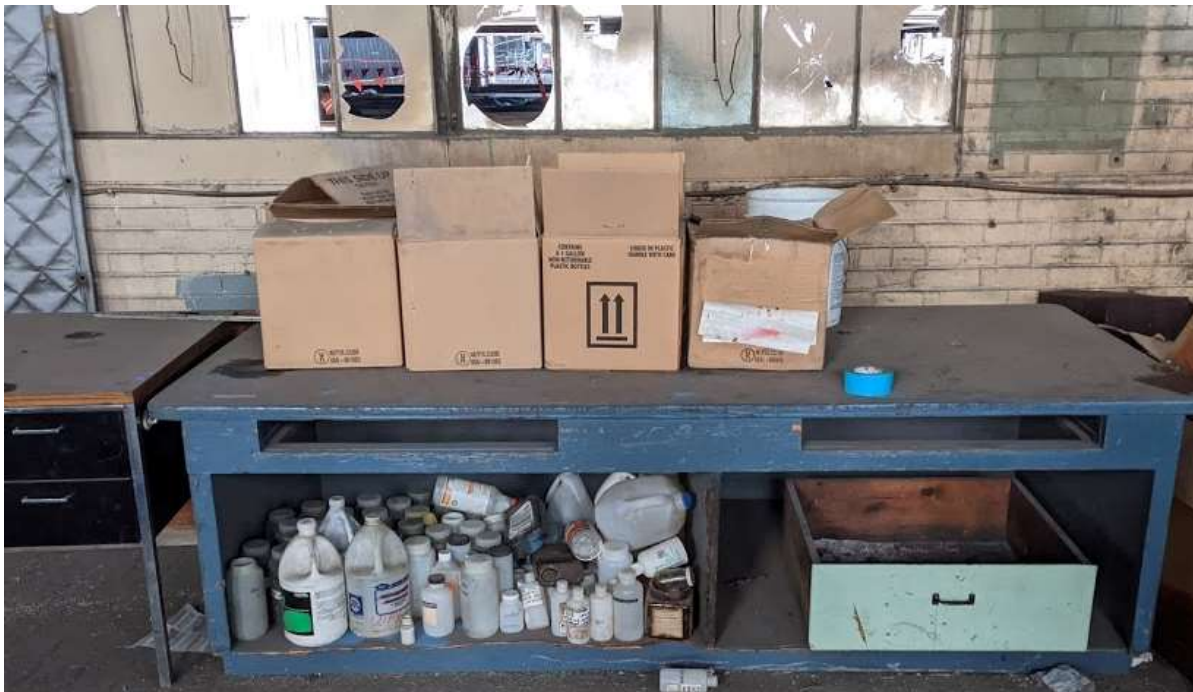
Photo 9 - Empty containers and boxes

The desk along the north wall on the west side of Building 44 contained empty containers and boxes. Other Empty containers were found in a crate near the western garage door of Building 44.

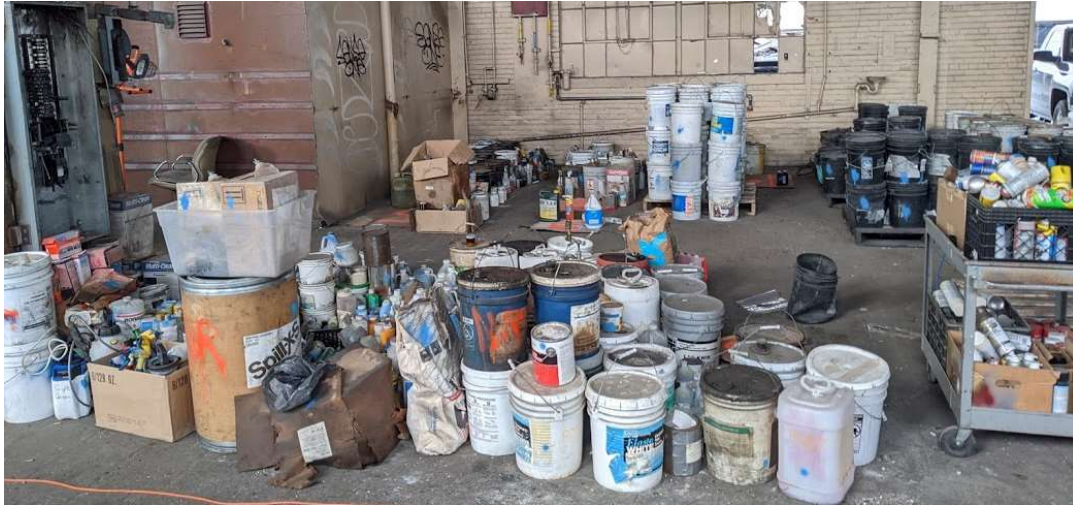
Photo 10 - Small chemical containers staged next to the north entrance of Building 44

This area was the staging area for the following: non-regulated material, DOT Classes 5.1, 5.2, 6, 8A, 8B and 9 and miscellaneous paint containers. These container classes were determined by SDS research or First Step Hazard Categorization.

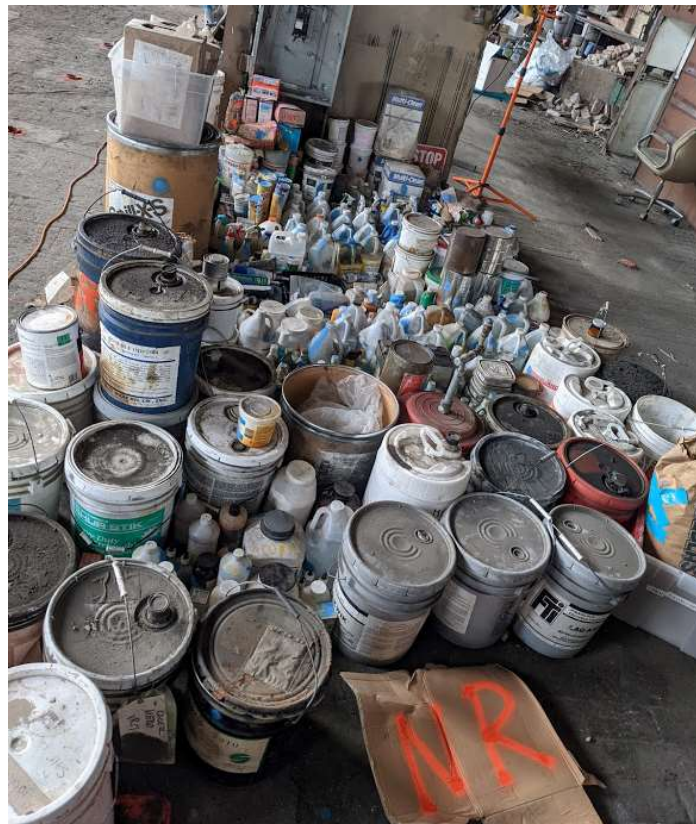
Photo 11 - Miscellaneous non-regulated materials

All the non-DOT-regulated chemicals are staged in an area by the north entrance. The disposal pathway was yet to be determined as of the START-V demobilization from the site. Container types, sizes, and integrity varied. Several containers had open tops and were susceptible to spilling.

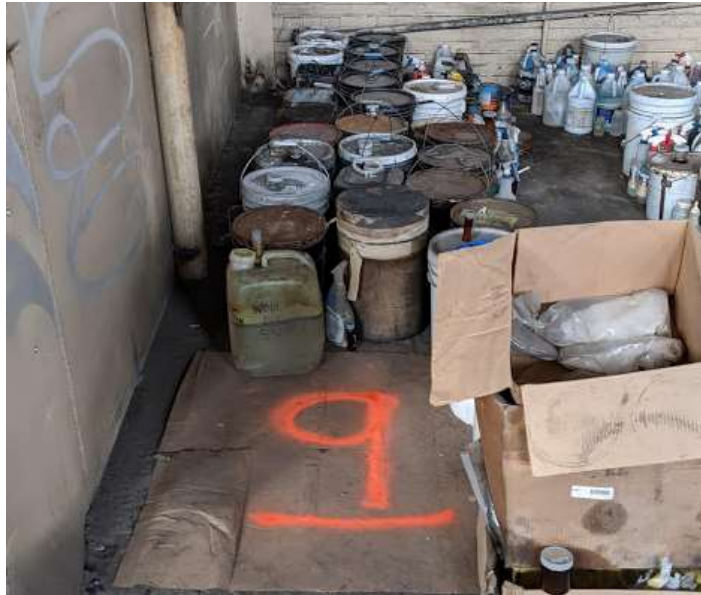
Photo 12 - DOT class 9 containers

All DOT class 9 containers except for 55-gallon drums were staged along the wall by the north entrance. Most of these containers were five-gallon buckets, however there were several smaller containers as well. Visible in front of the area were three boxes containing loose, solid material in the open boxes. The bags were labeled as a respiratory hazard if inhaled. Caution should be used while moving or disposing of the chemicals.

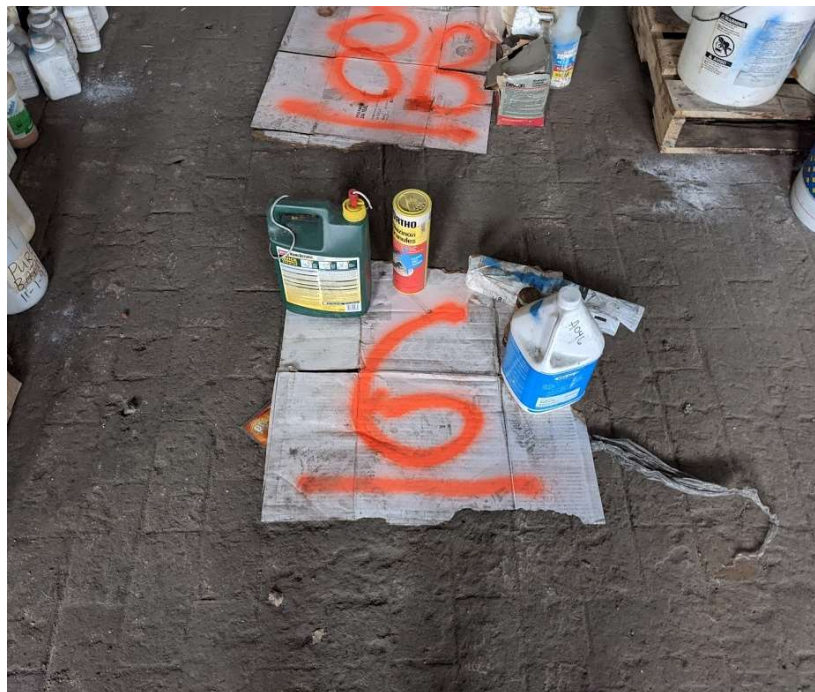
13 - DOT class 6 containers

A small pile of items near the north entrance, beside the DOT class 9, DOT class 8B, and non-regulated materials, were designated as DOT Class 6 containers.

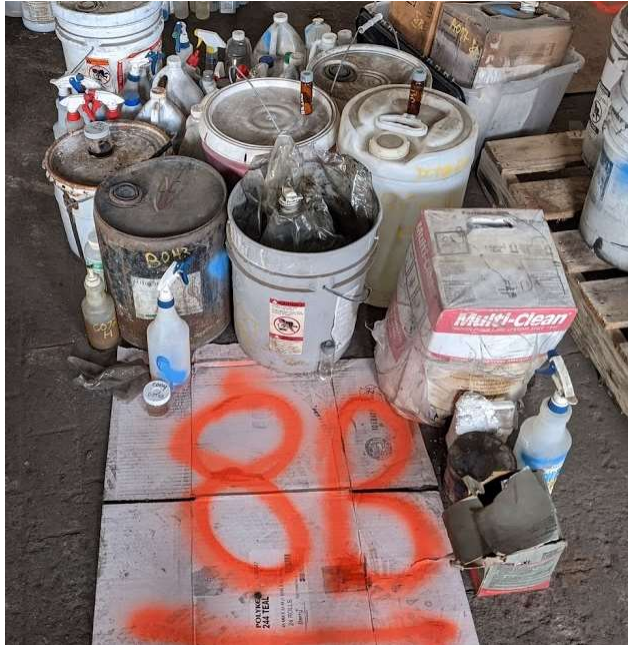
Photo 14 - DOT class 8B containers (basic)

The DOT class 8B containers were grouped beside the DOT class 9 chemicals. There was a variety of container types and sizes (the Multi-Clean box is fragile and needs to be handled with caution to avoid a potential spill of corrosive liquid). This pile was located near the north wall near the north entrance.

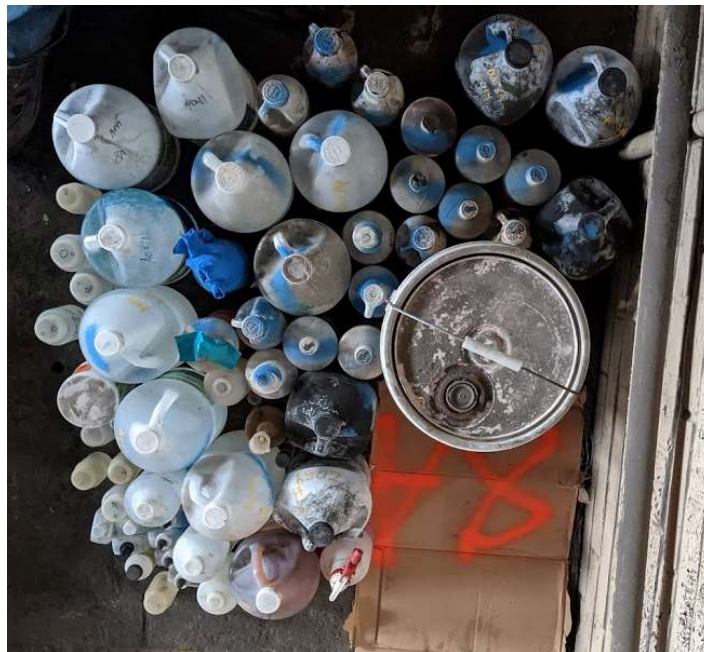
Photo 15 - DOT class 8A containers (acidic)

The DOT class 8A: acidic containers were grouped along the north wall. There were a variety of container types and sizes. Some containers lacked caps and were closed with either a latex glove or duct tape. (These containers require cautious handling avoid spills of corrosive materials. This pile was located along the north wall near the north entrance.

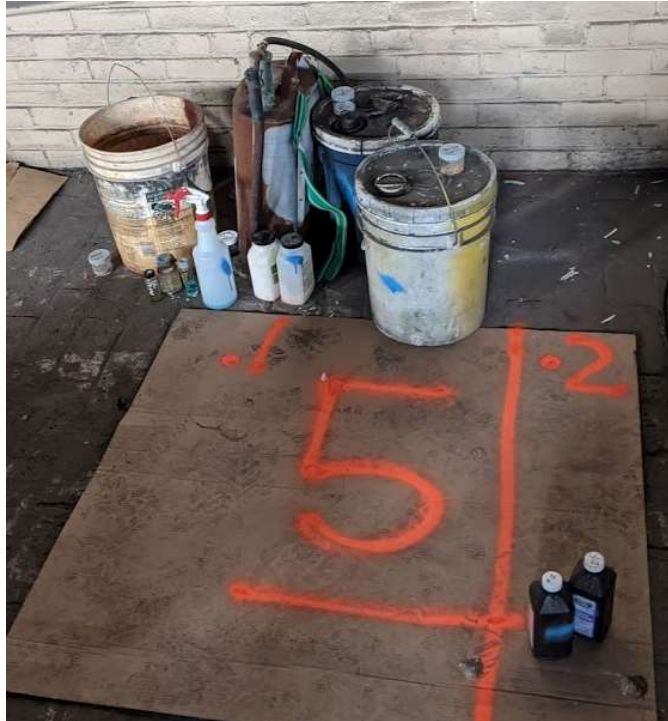
Photo 16 - DOT class 5.1 and 5.2 oxidizers

DOT 5.1 and DOT 5.2 chemicals were grouped together along the north wall next to the north entrance. One of the five-gallon buckets in the 5.1 section did not have a lid and requires cautious handling to avoid a potential spill of oxidizing material. The two 5.2 containers were placed on the bottom right of the cardboard on the side labeled as "5.2".

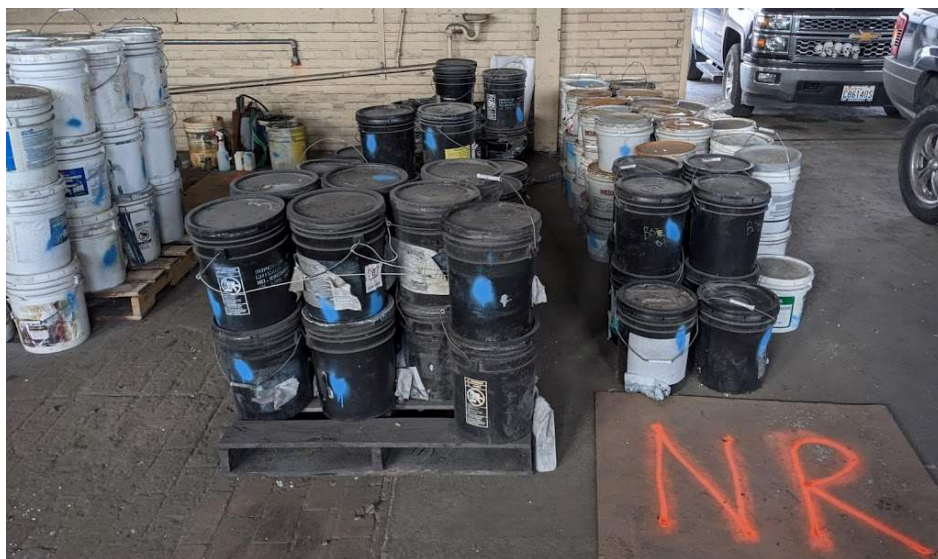
Photo 17 - DOT non-regulated materials

Containers identified as DOT non-regulated material in five-gallon buckets were located inside the north door. These containers hold non-hazardous material and may be left on site if deemed appropriate.

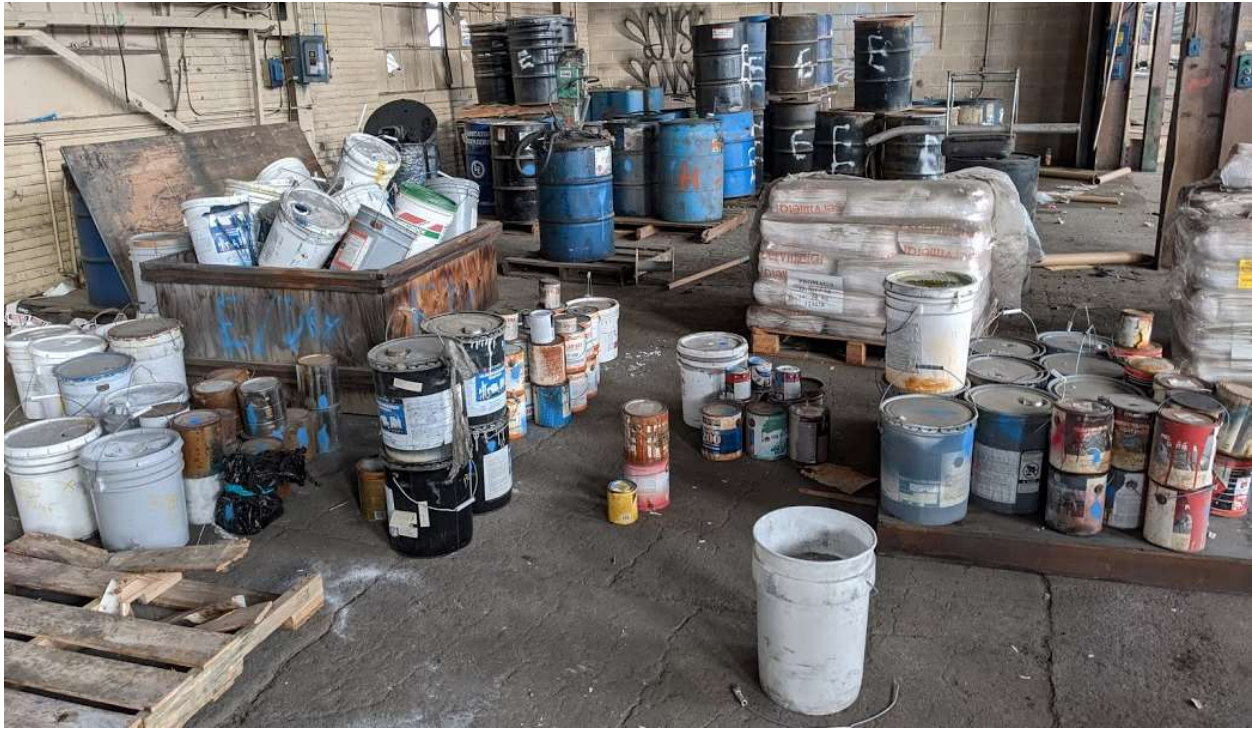
Photo 18 - Miscellaneous paint containers

A number of paint and paint related materials can be found in near the north entrance of building 44 and were staged by the following categorizations: polyurethane-based paint, latex paint, oil-based paint, unknown/unlabeled paint cans or buckets, high-solvent mixtures, and epoxies/adhesives. The crate next to these piles contained dry or empty paint cans and buckets that may be crushed and disposed of as solid waste.

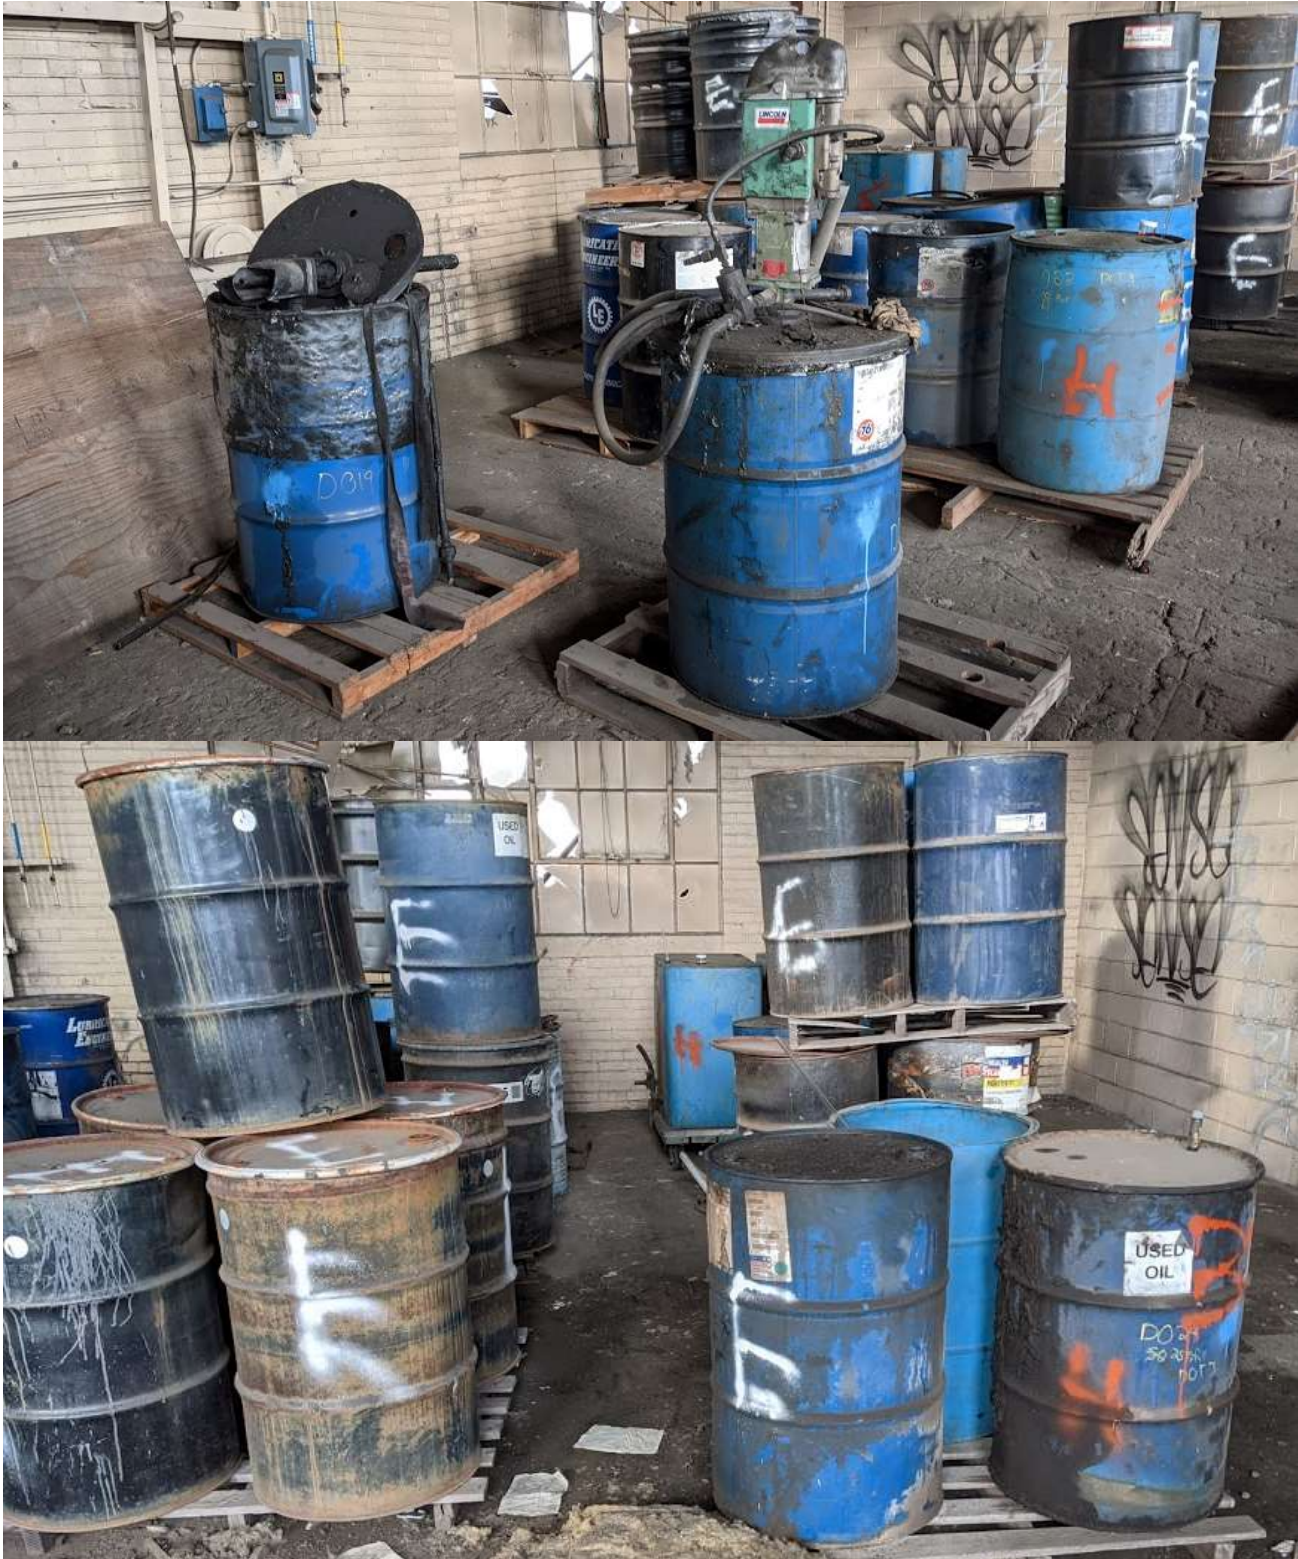
Photo 19 - Miscellaneous drums

Several 55-gallon drums were located east of the north entrance. Most were empty and were indicated as empty with an "E" marked on the drum's side. Drum D020 was determined by START by the label and appearance as DOT Class 3 material. Drums D018, D019, D021 and D022 were determined by START by visual observation and SDS research as DOT non-regulated material. Drums D023, D024, and D025 shown with an orange "H" were also categorized as DOT class 3 as determined by First Step Hazard Categorization.

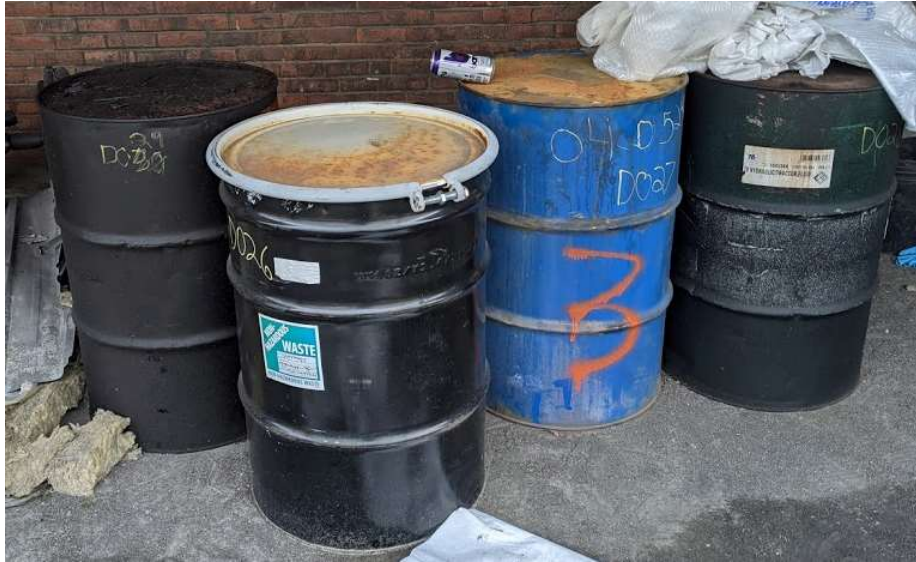
Photo 20 - One DOT 3 drum, two with green coke, and one with soil cuttings.

Outside the north entrance of building 44 were four 55-gallon drums. Drum D027 was determined by First Step Hazard Categorization as DOT Class 3 material, and drums D026 and D028 was categorized by visual observation as DOT non-regulated material (soil cuttings). Drum D029 was categorized by visual observation as green coke.

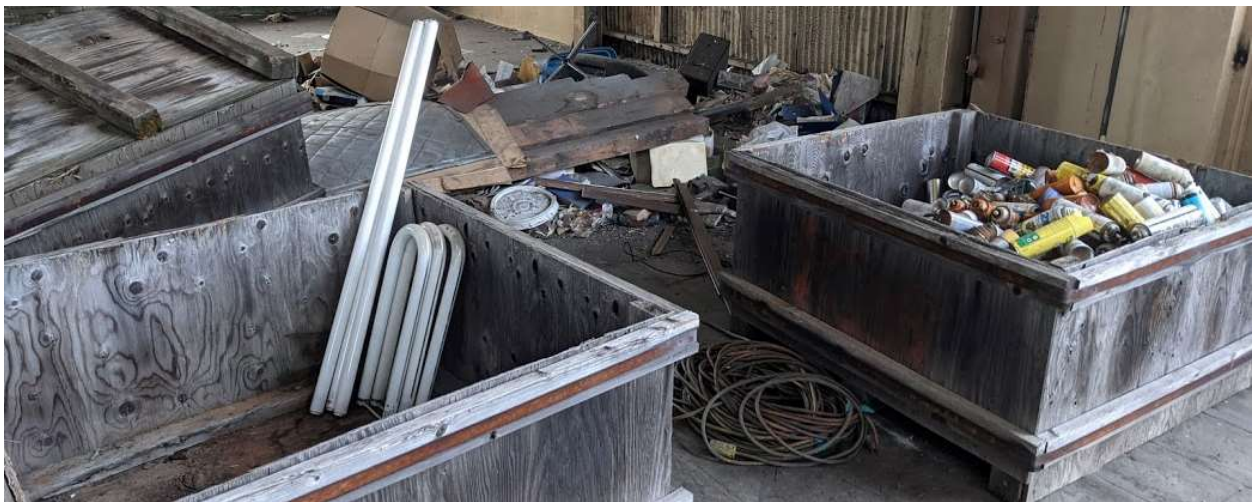
Photo 21 - Crates containing fluorescent light bulbs and miscellaneous aerosol canisters.

The two crates were in the southwest portion of Building 44 near the west entrance. One crate contained fluorescent light bulbs and the other crate contained about 500 aerosol canisters. The aerosol canisters range from empty to full

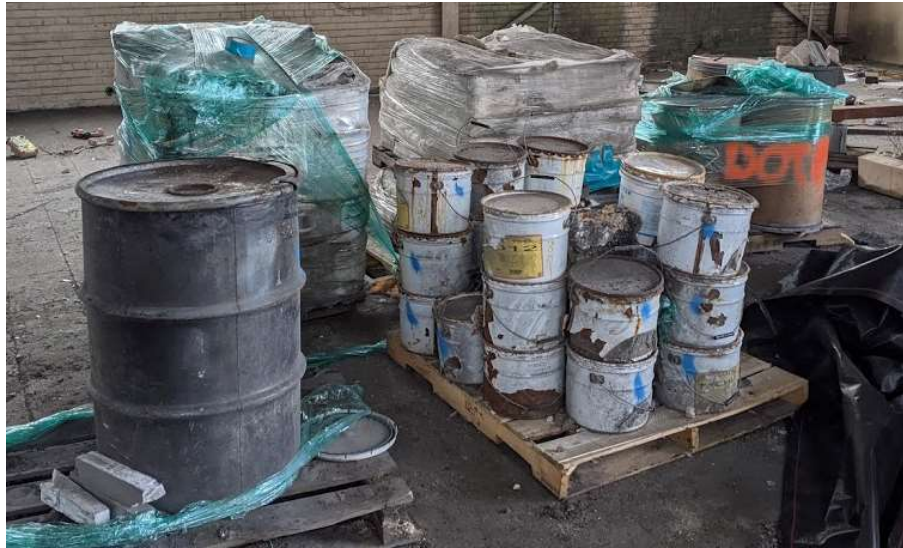
Photo 22 - Miscellaneous mortar materials, green coke, and DOT 9 containers

Drum D015 was determined by visual observation to be green coke material and can be disposed with other site waste streams. The pallets of 2-gallon buckets beside and are non-regulated mortar material determined by visual observation and may be left on site. The pallet with the orange spray paint labeled "DOT 9" is class 9 material determined by First Step Hazard Categorization.

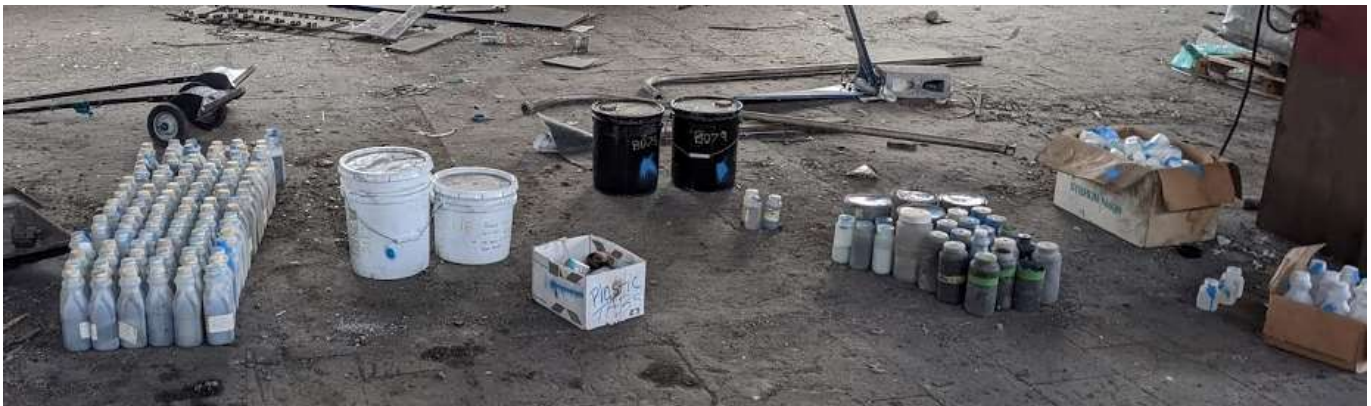
Photo 23 - Lab process samples

The containers located in the southwest portion of building 44 east of the pallets contained small quantities of process samples collected from materials found elsewhere on site. These containers may be disposed in other site waste streams.
