Re: Removal Action Report
Black Butte Mine / Furnace Creek Non-Time Critical Removal Action
Contract Number EP-S7-13-07, Task Order Number 25

REMOVAL ACTION REPORT

**Black Butte Mine Site / Furnace Creek Removal Action
Cottage Grove, Lane County, Oregon
Task Order Number: TO-25**

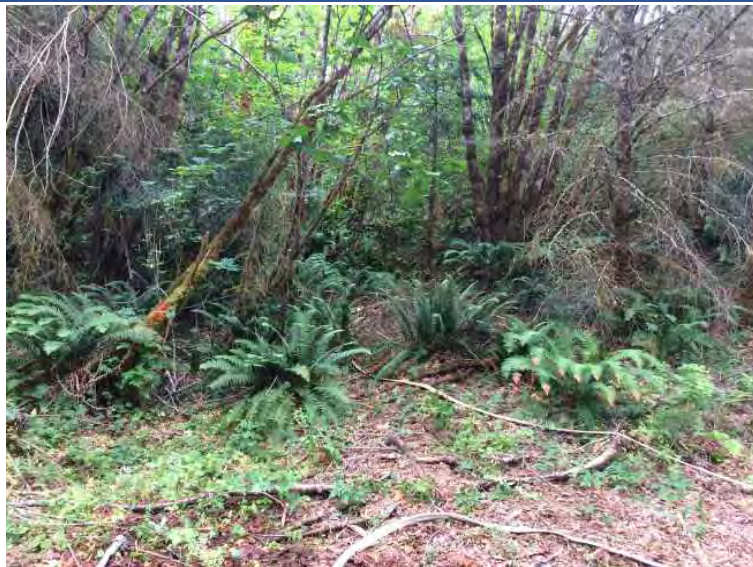
Photo 3 OPWA Upper/South unit, pre-removal condition.

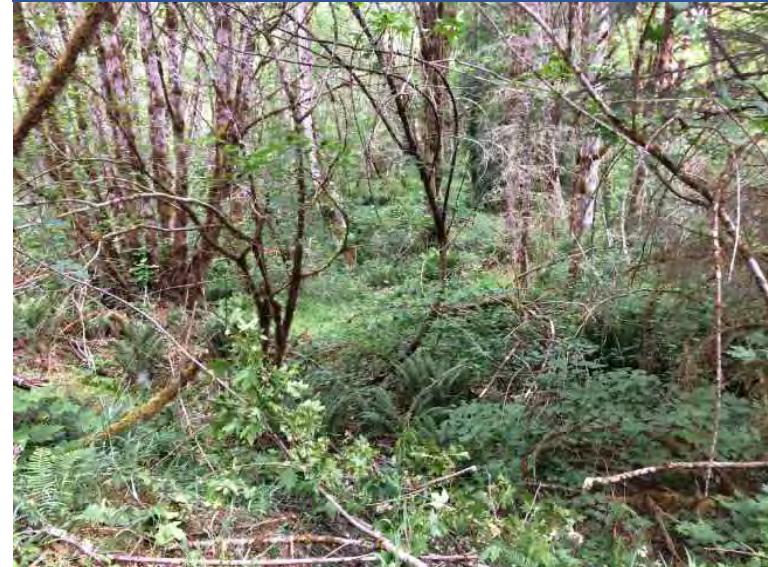
Photo 4 OPWA Lower/North unit, pre-removal condition

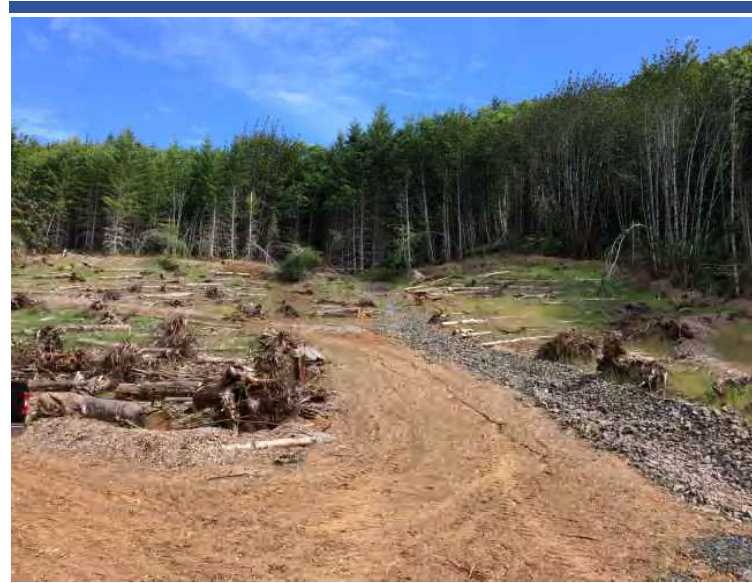
Photo 48 Looking up at BS01 borrow source erosion and Adit Creek seep slope failure at top of slope.

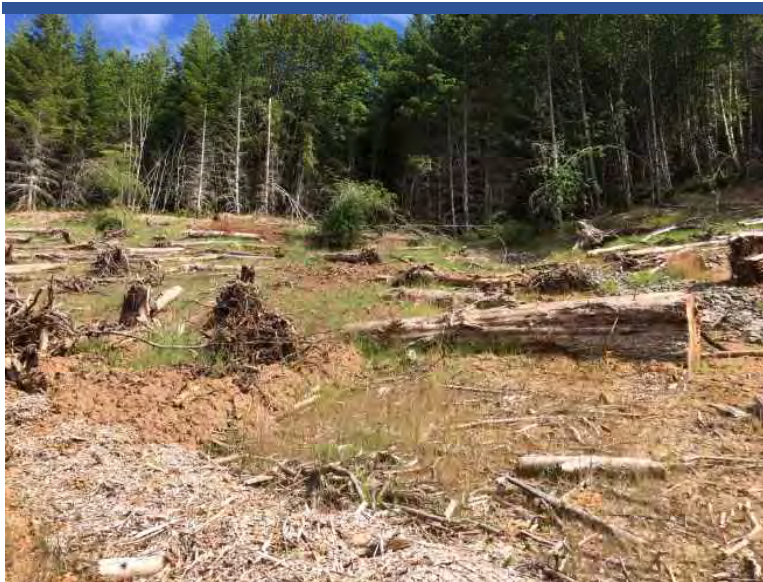
Photo 49 Looking up at Adit Creek seep slope failure at top of slope of BS01.

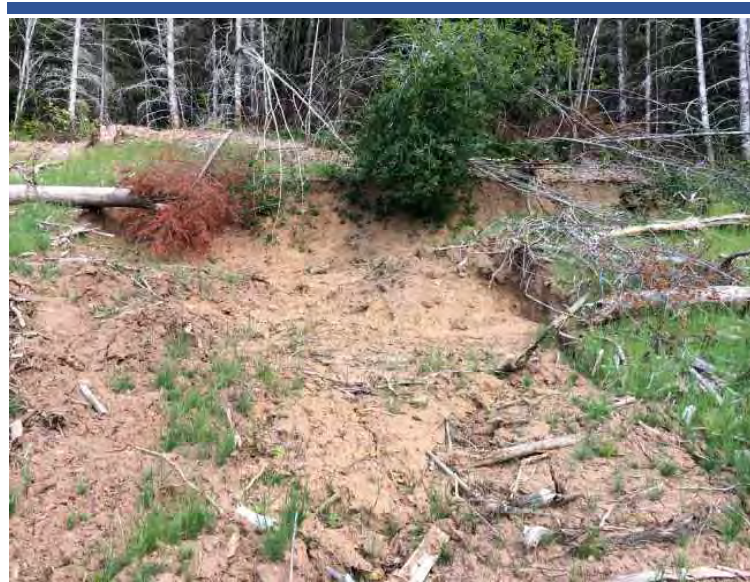
Photo 50 Looking upslope at right bank slope failure of Adit Creek seep at BS01.

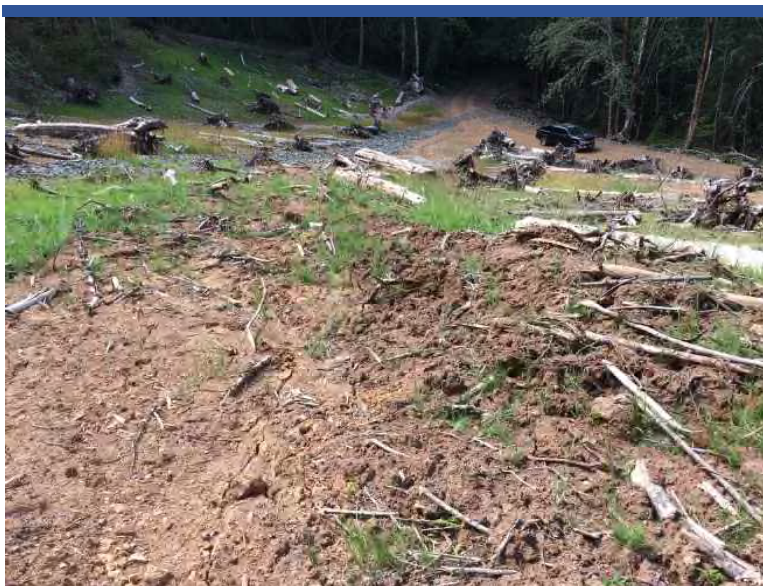
Photo 51 Looking downslope at right bank slope failure of Adit Creek seep at BS01.

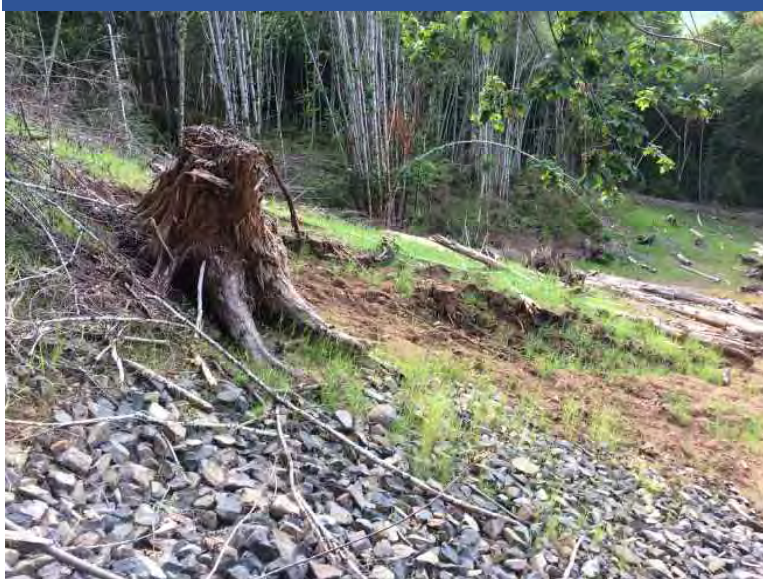
Photo 53 Left bank slope failure of Adit Creek seep at BS01.

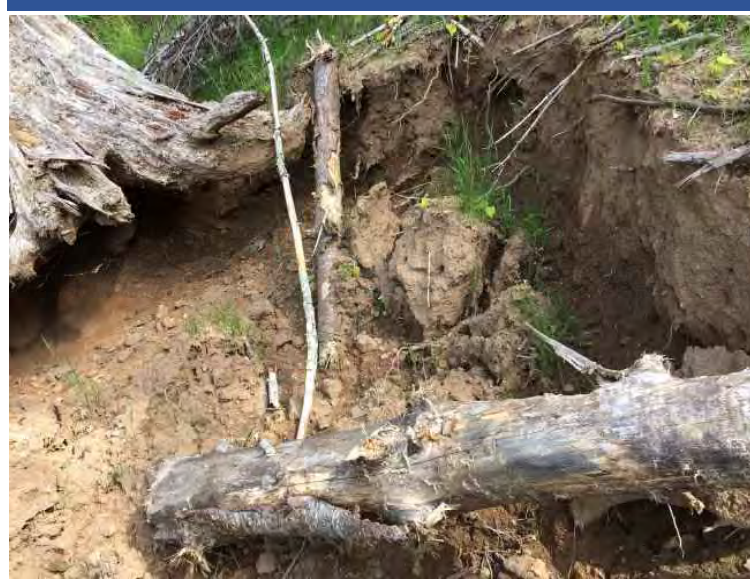
Photo 54 Left bank slope failure of Adit Creek seep at BS01.

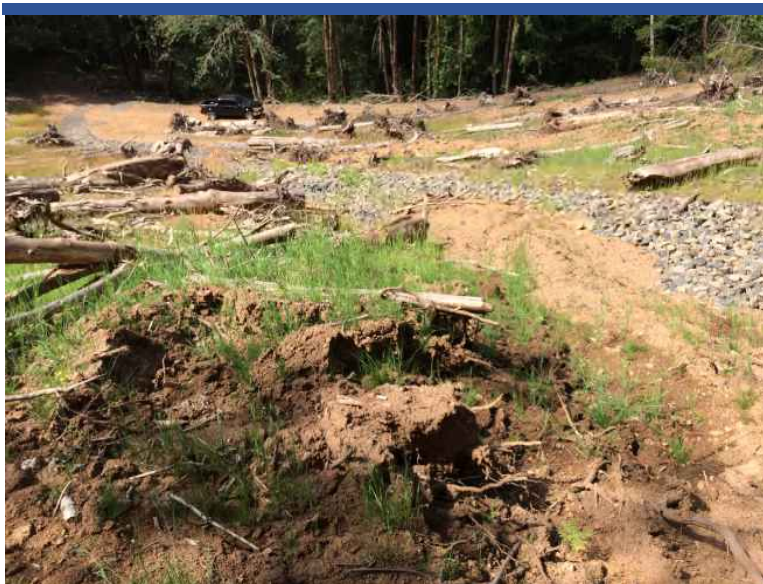
Photo 55 Looking downslope at left bank slope failure of Adit Creek seep at BS01.

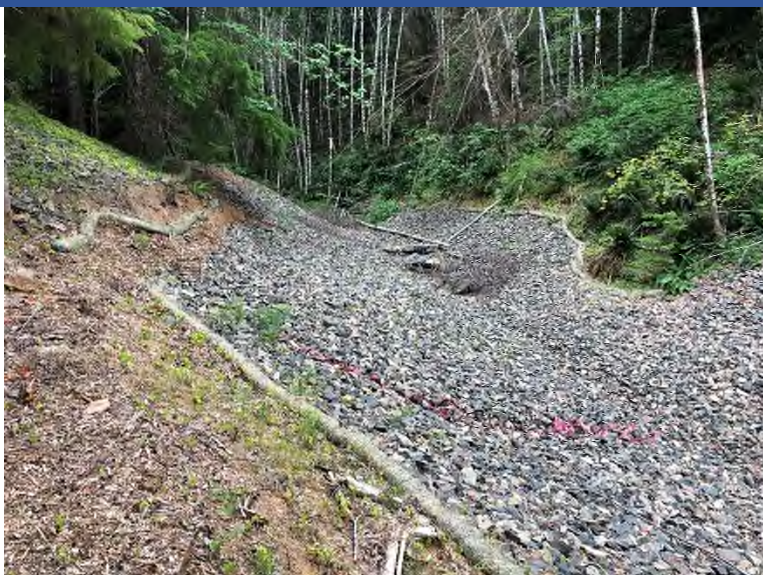
Photo 65 Looking upstream at Furnace Creek Old Furnace right bank slope failure. Downstream extent of slide marked in pink.

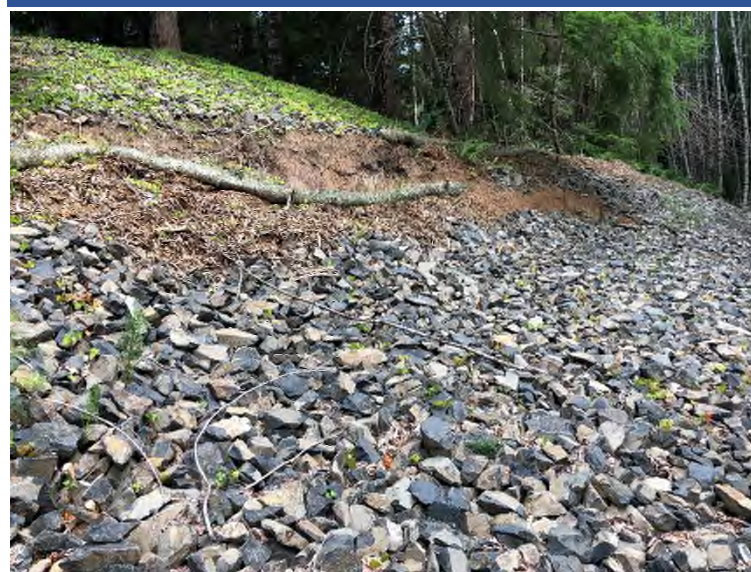
Photo 66 Slope failure and exposed contaminated bank located near right bank of Furnace Creek at STA 1+00.

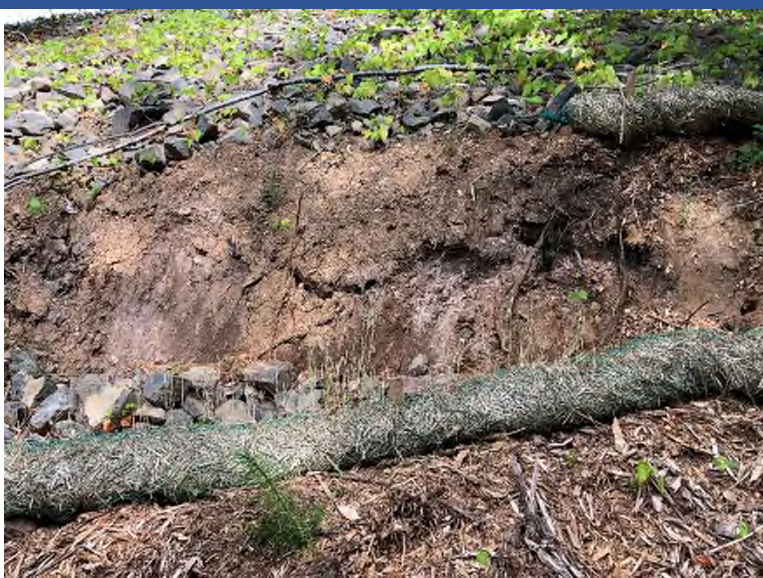
Photo 67 Slope failure and exposed contaminated bank located near right bank of Furnace Creek at STA 1+00.

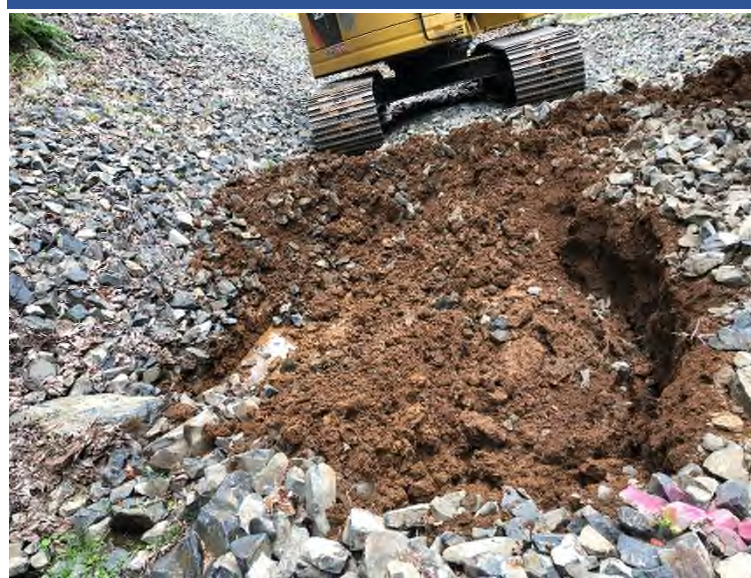
Photo 68 ERRS excavating test pit at upstream extent of toe of Furnace Creek Old Furnace slope failure. Water in pit.

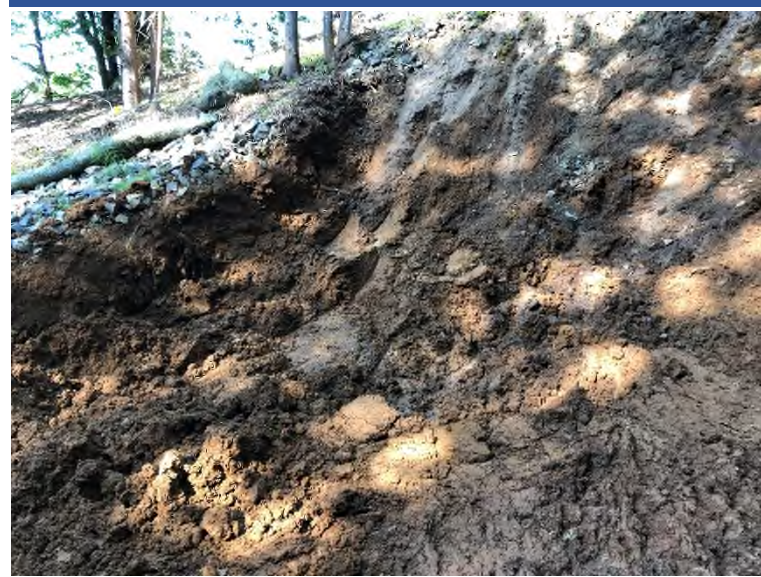
Photo 70 Saturated soils due to subsurface seep at downstream extent of excavated Old Furnace slope failure.

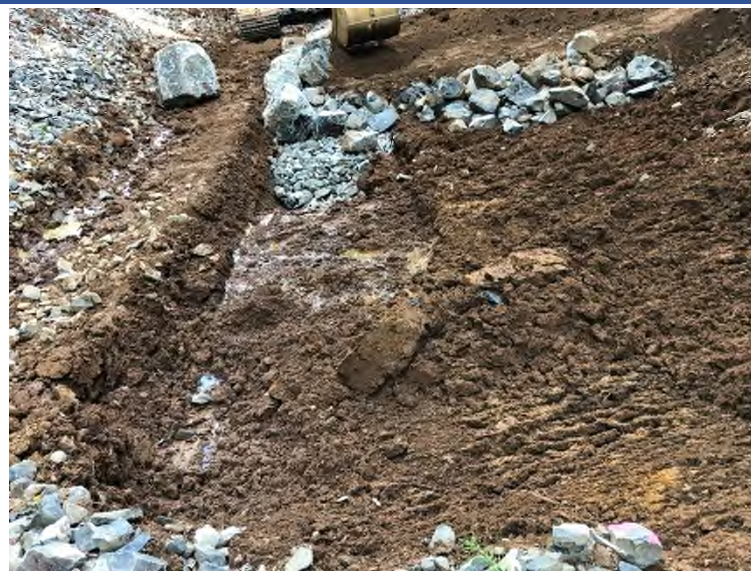
Photo 76 Groundwater infilling upgradient end of key anchor trench at toe of Furnace Creek Old Furnace slide repair area.

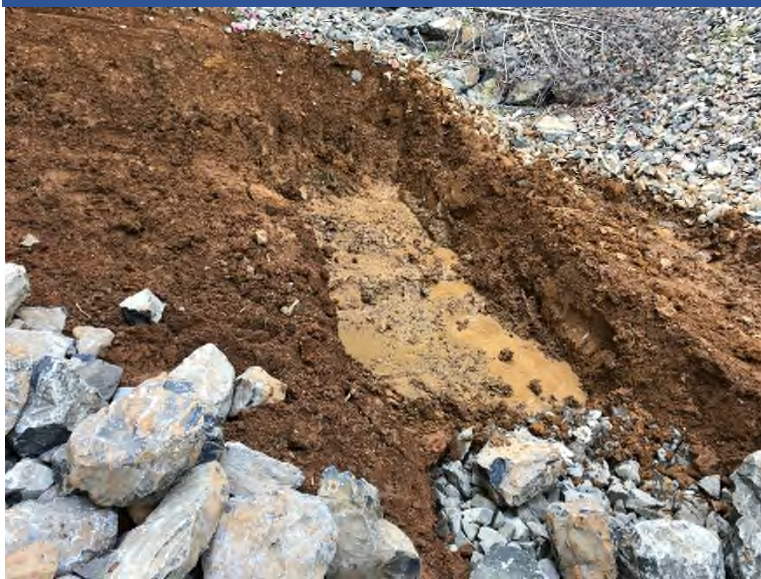
Photo 77 Groundwater infilling upgradient end of key anchor trench at toe of Furnace Creek Old Furnace slide repair area.

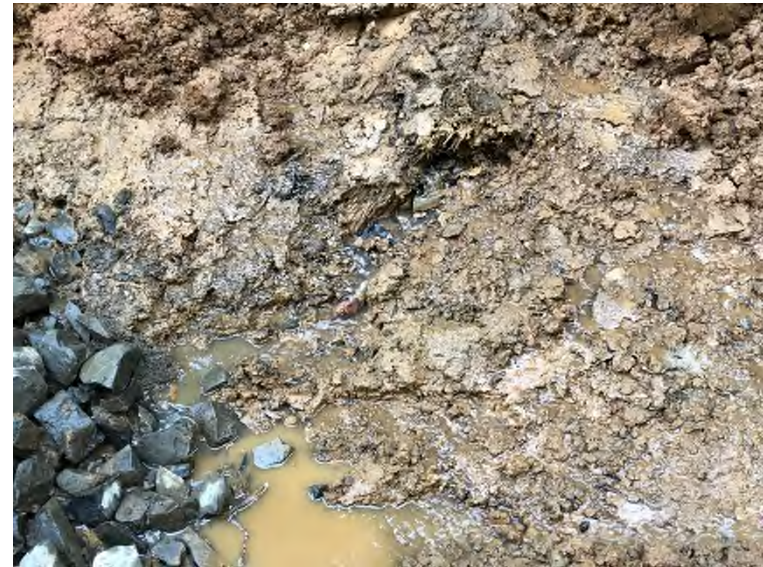
Photo 78 Groundwater and exposed tailings in key anchor trench at toe of Furnace Creek Old Furnace slide repair area.

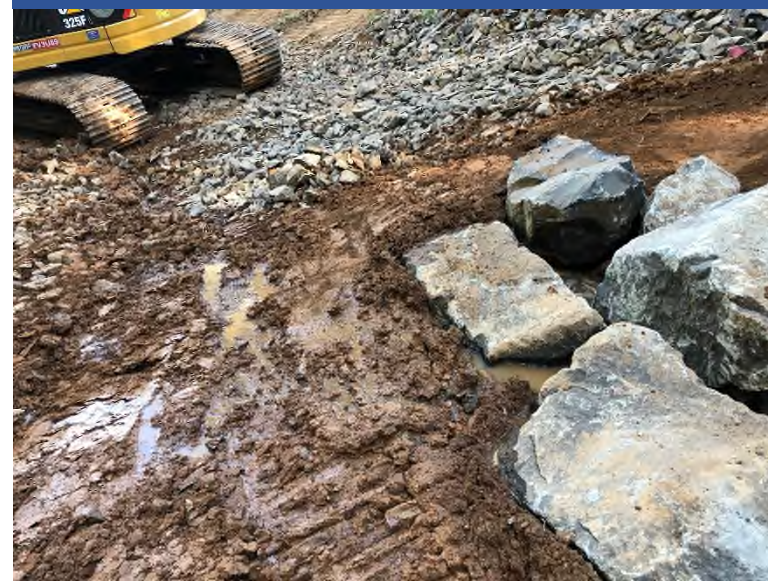
Photo 82 Groundwater flowing out from anchor trench installed for Furnace Creek Old Furnace slide repair action.

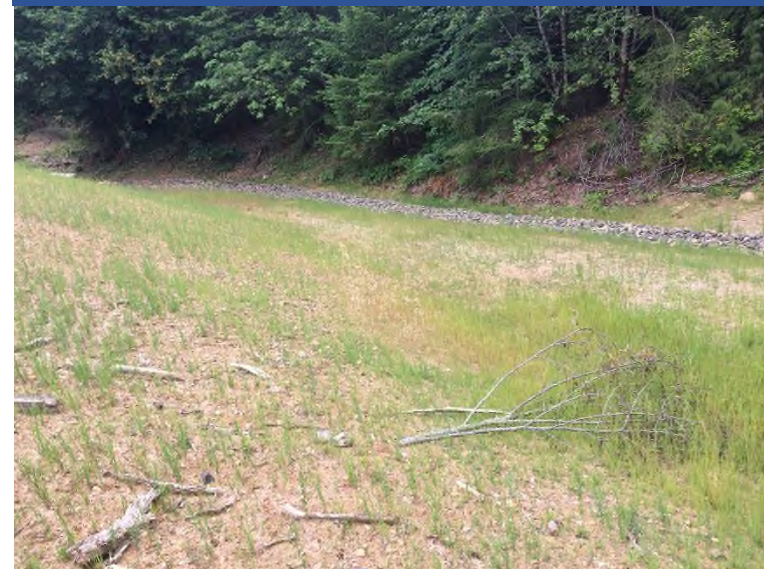
Photo 86 Section of Adit Creek reroute with negative drainage causing overflow, located on east side of repository.
