# **TIME-CRITICAL REMOVAL ACTION REPORT**

*Onalaska Wood Pyrolysis  
Onalaska, Lewis County, Washington*

*SSID: 10TH*

December 2021

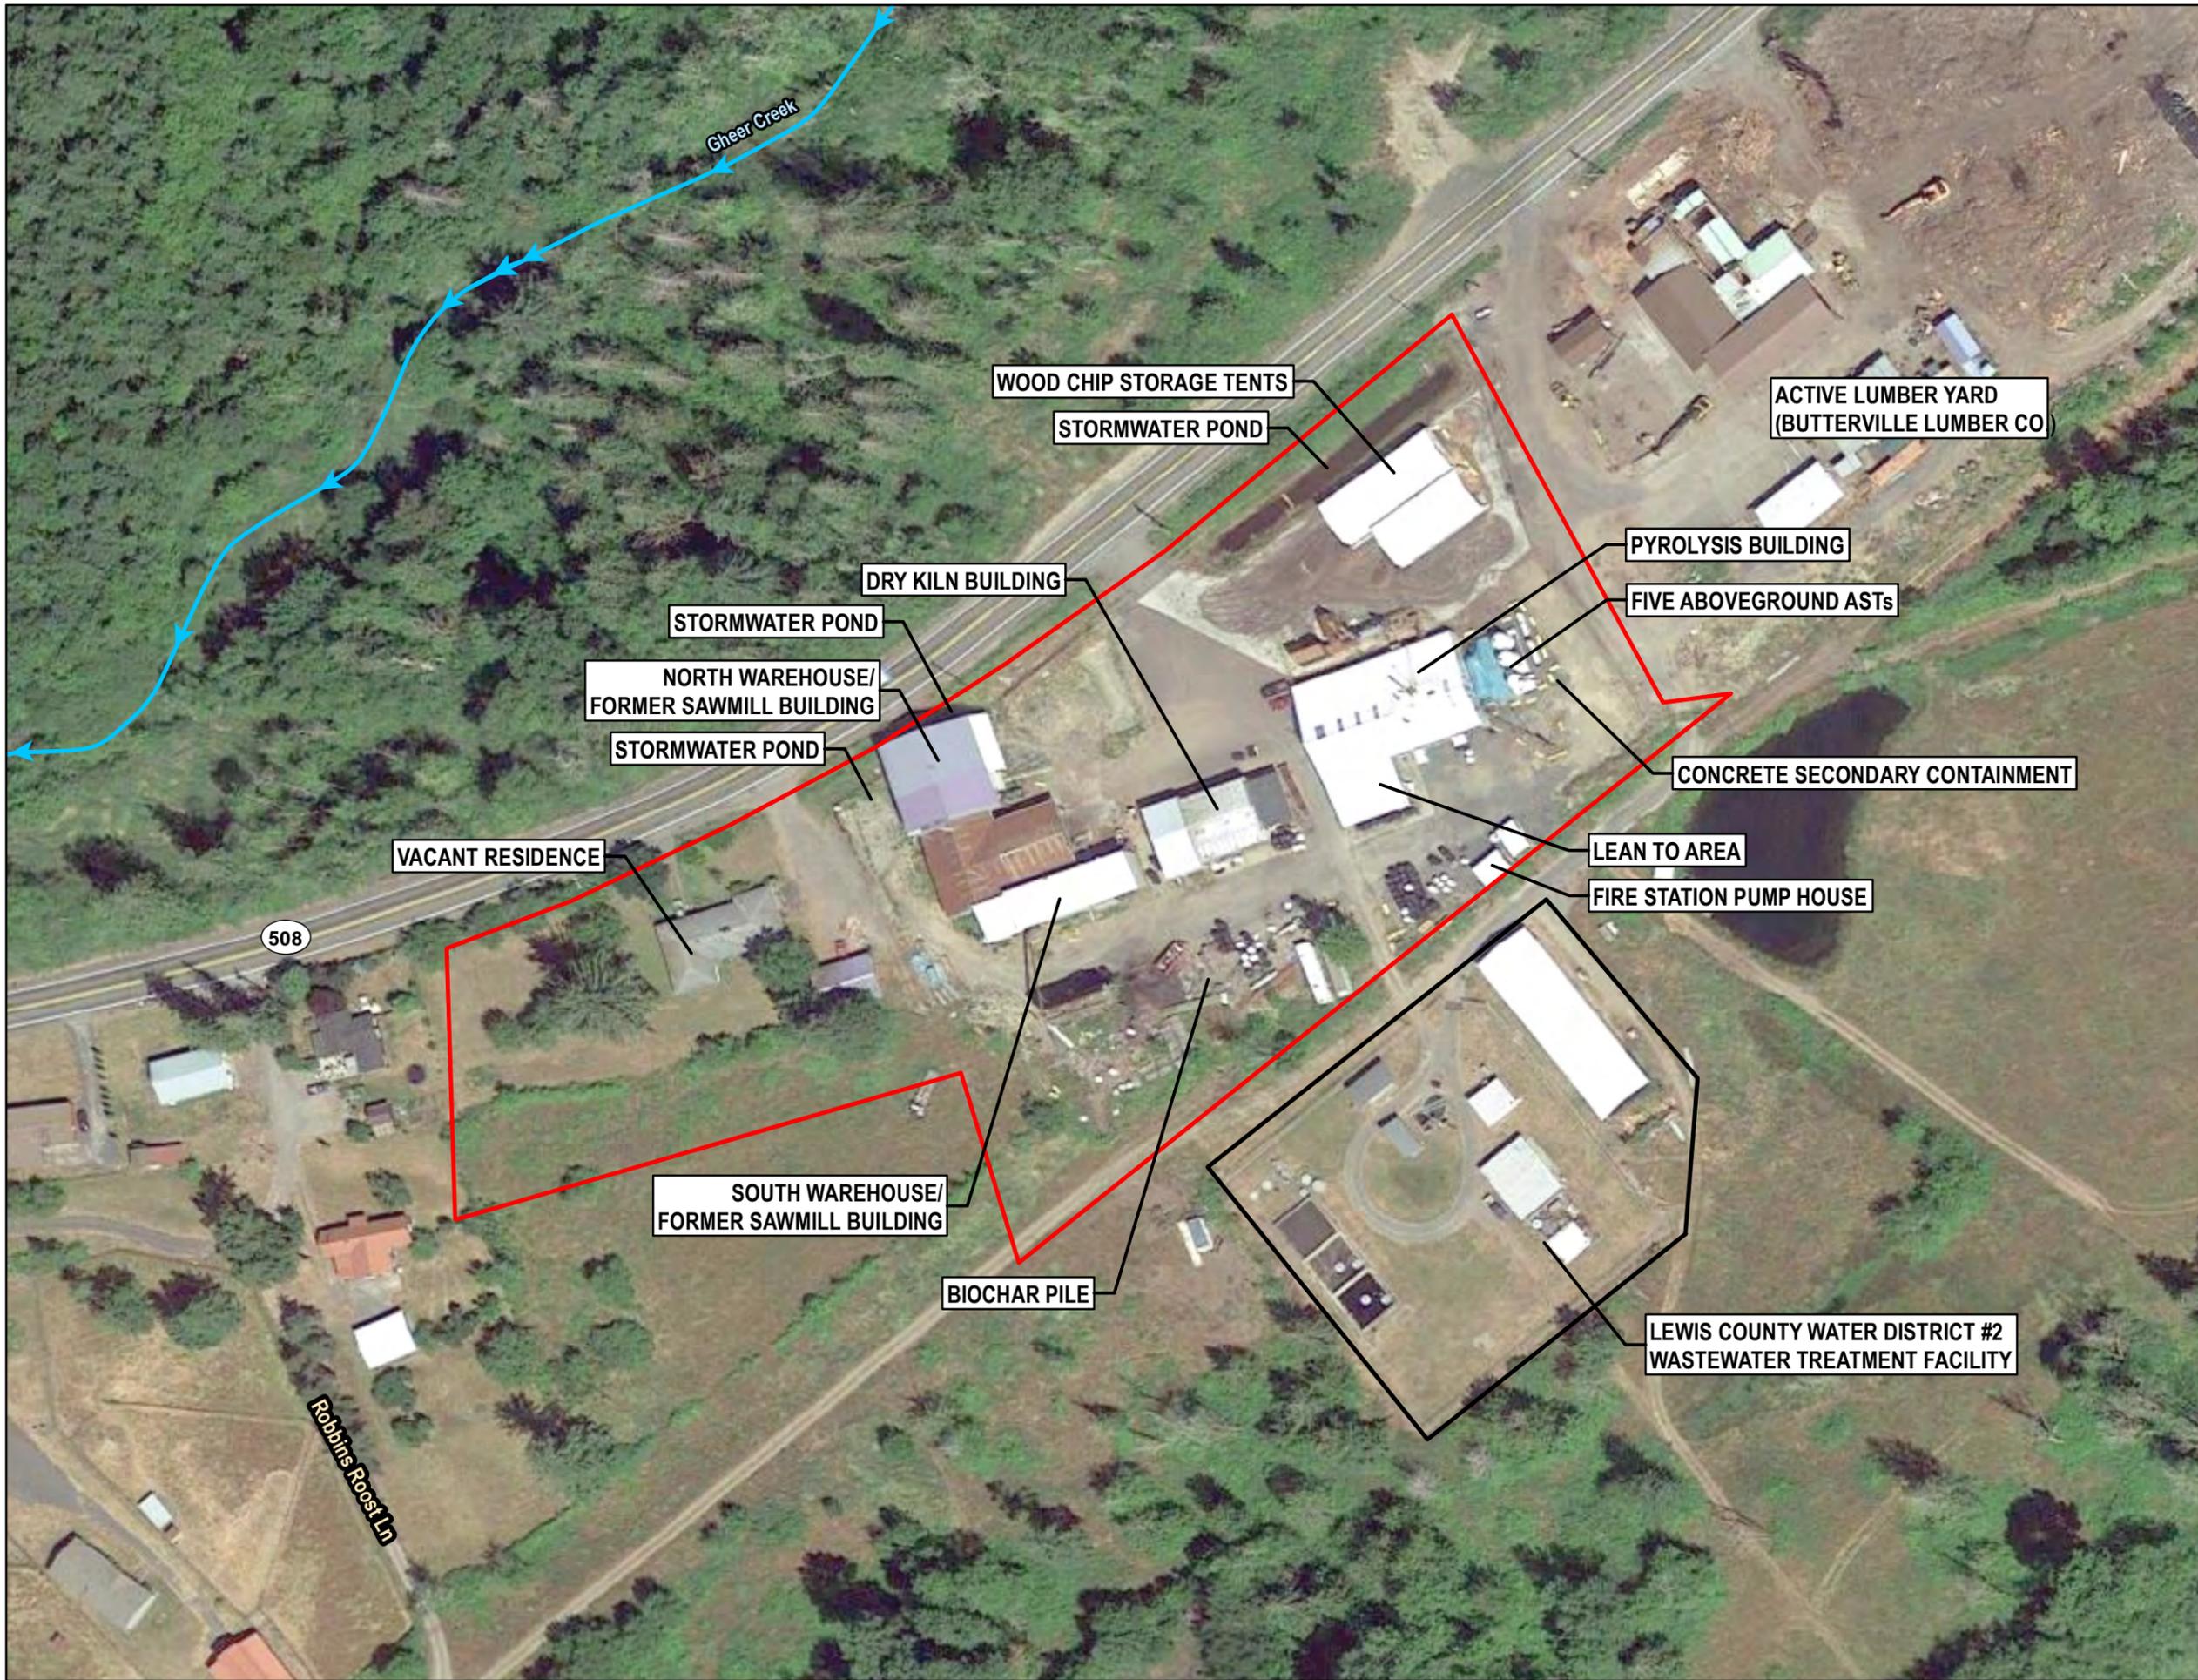
**FIGURE 2-1**  
SITE PLAN  
ONALASKA WOOD PYROLYSIS  
1674 STATE HIGHWAY 508  
ONALASKA, LEWIS COUNTY, WA  
DECEMBER 2021

The Onalaska Wood Pyrolysis Plant is located at 1674 State Highway 508, Onalaska, Lewis County, Washington. The Site includes an 8-acre former sawmill that was converted into an industrial facility for the pyrolysis of wood waste in 2015. Residential and agricultural land surround the Site. The Site is bordered to the north by State Highway 508, to the east by an inactive lumber yard and residence, to the south by a Lewis County Water District #2 (Water District) wastewater treatment plant, and to the west by a residential area. A Site Plan is provided as Figure 2-1

The Site consisted of:

- open-air warehouse/former sawmill building on the northern area of the Site
- open-air warehouse/former sawmill building on the southern area of the Site
- dry kiln building
- lean to/outdoor overhang area
- secondary containment with five Aboveground Storage Tanks (ASTs)
- two standalone 500-gallon poly tanks
- pyrolysis building
- wood chip storage tents
- stormwater ponds

- biochar pile
- fire station pump house
- AST for process water storage
- a vacant residence
