**LIMITED DUE DILIGENCE  
AND  
PHASE II ENVIRONMENTAL SITE ASSESSMENT  
FOR  
YANKTON SIOUX TRIBE ADMINISTRATION BUILDING  
303<sup>rd</sup> STREET AND 388<sup>th</sup> AVENUE  
MARTY, CHARLES MIX COUNTY, SOUTH DAKOTA**

Date Prepared	August 2016
TDD No.	0003/1605-17
Document Control No.	W0361.1A.01055
Contract No.	EP-S8-13-01
U.S. EPA Work Assignment Manager	Christina Wilson

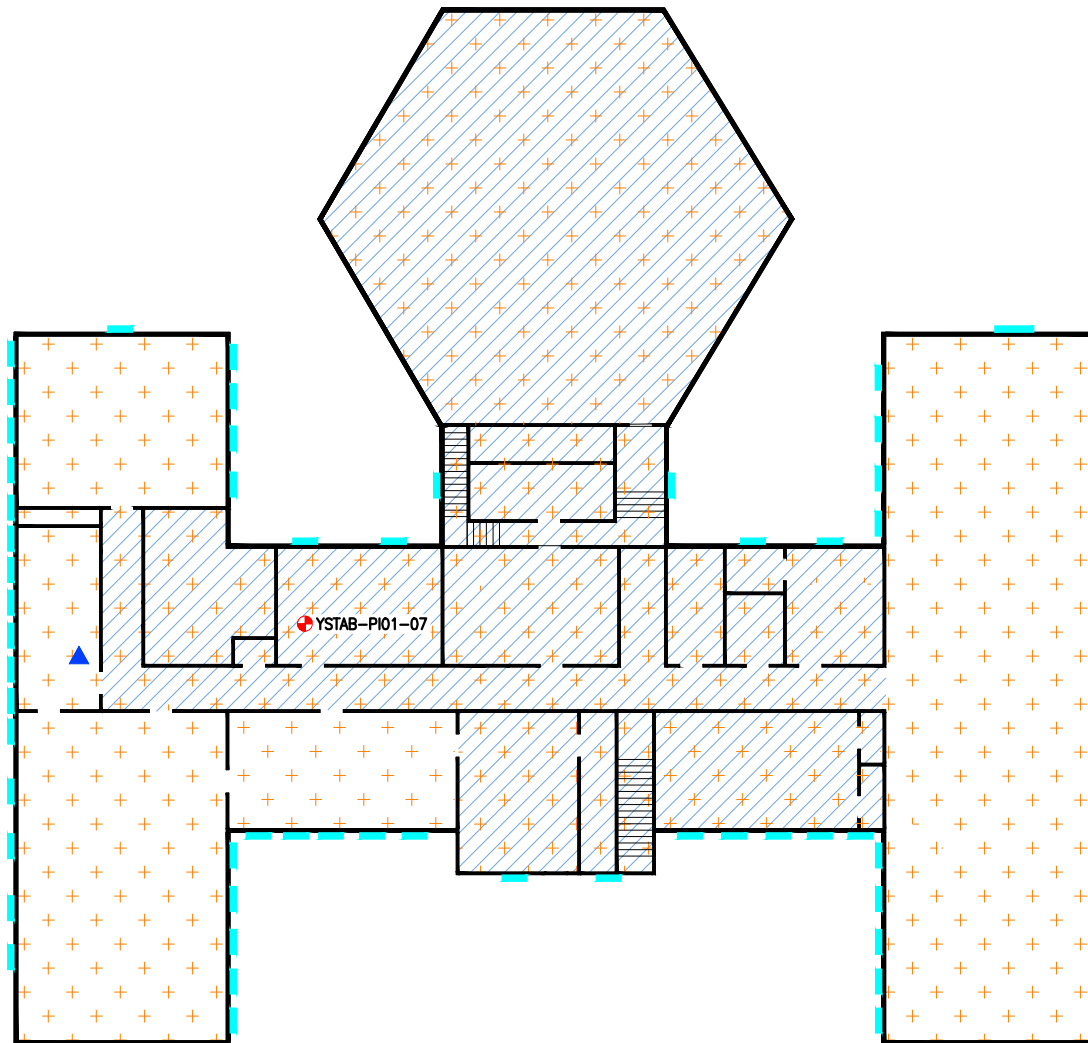
- ACM ASBESTOS CONTAINING MATERIAL
- LBP LEAD BASED PAINT
- ACM SAMPLE LOCATION (APPROXIMATE)
- ACM FLOOR TILE EXTENT
- ACM GLUE PUCKS
- ACM WINDOW CAULK/LBP WINDOW TROUGH
- Hg THERMOSTAT

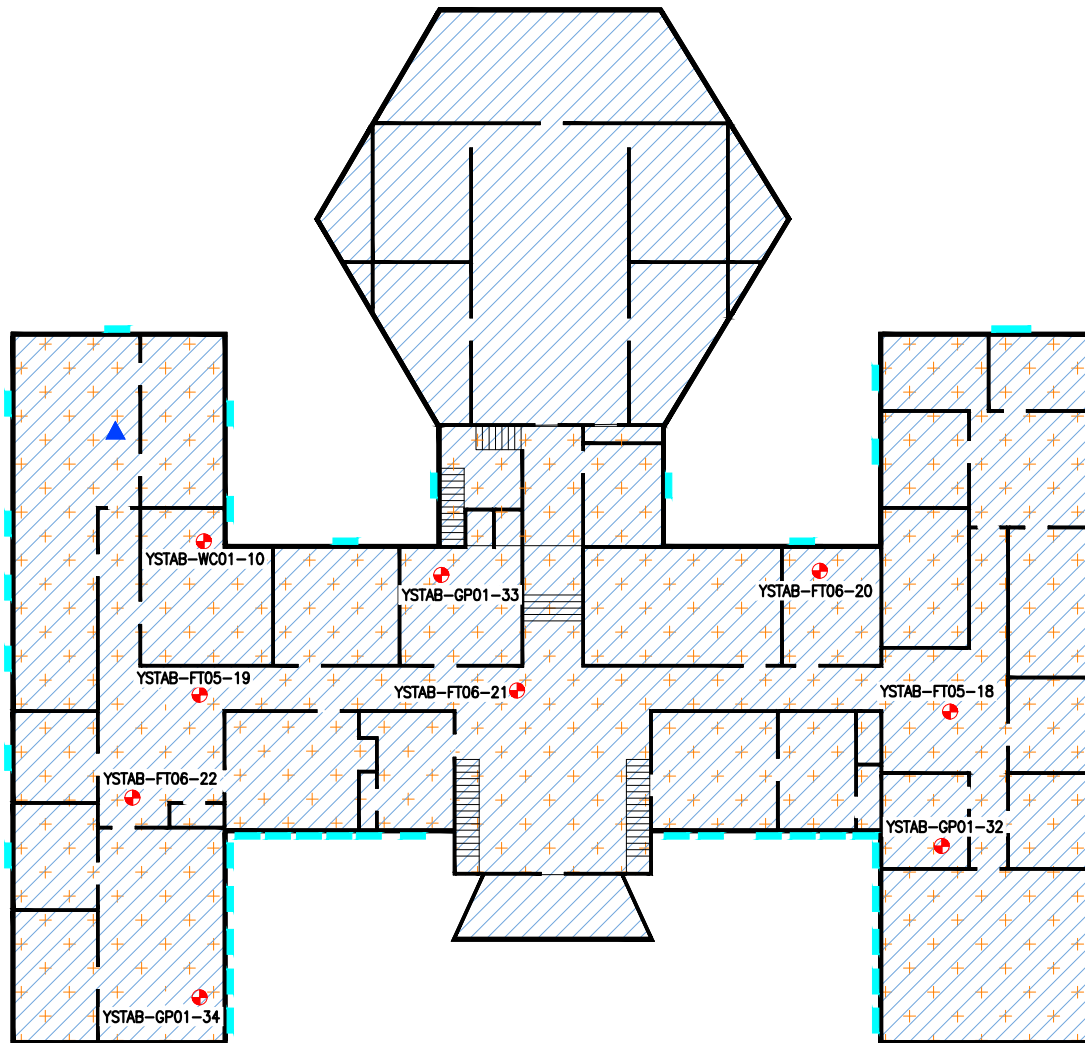
- ACM ASBESTOS CONTAINING MATERIAL
- LBP LEAD BASED PAINT
- ACM SAMPLE LOCATION (APPROXIMATE)
- ACM FLOOR TILE EXTENT
- ACM GLUE PUCKS
- ACM WINDOW CAULK/LBP WINDOW TROUGH
- Hg THERMOSTAT

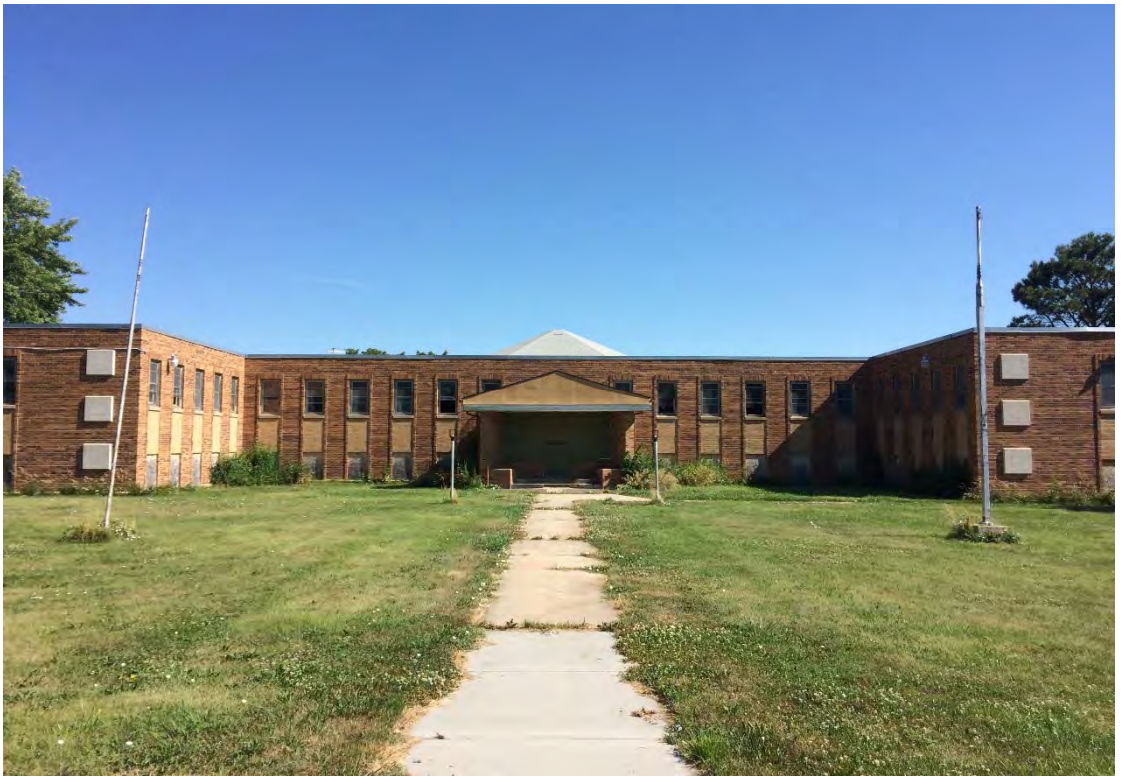
<b>Project Name:</b> YST Administration Building Phase II ESA		<b>Site Location:</b> 303 <sup>rd</sup> Street and 388 <sup>th</sup> Avenue Marty, South Dakota	<b>Project No.</b> 0003/1605-17
<b>Photo No.</b> <b>1</b>	<b>Date:</b> 7/6/2016

<b>Direction Photo Taken:</b> North			
<b>Description:</b> Front of the Administration Building

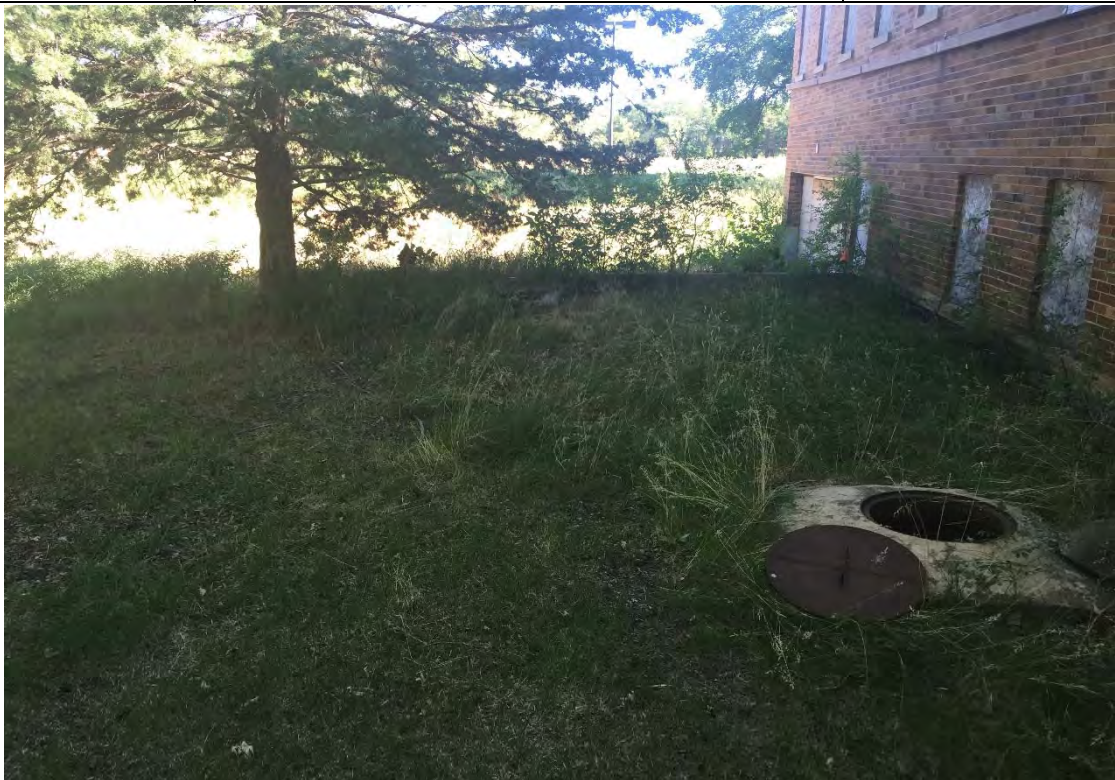
<b>Project Name:</b> YST Administration Building Phase II ESA		<b>Site Location:</b> Yankton, South Dakota	<b>Project No.</b> 20408.012.003.0361. 00
<b>Photo No.</b> <b>3</b>	<b>Date:</b> 7/12/2016

<b>Direction Photo Taken:</b> North			
<b>Description:</b> Area where UST is located.

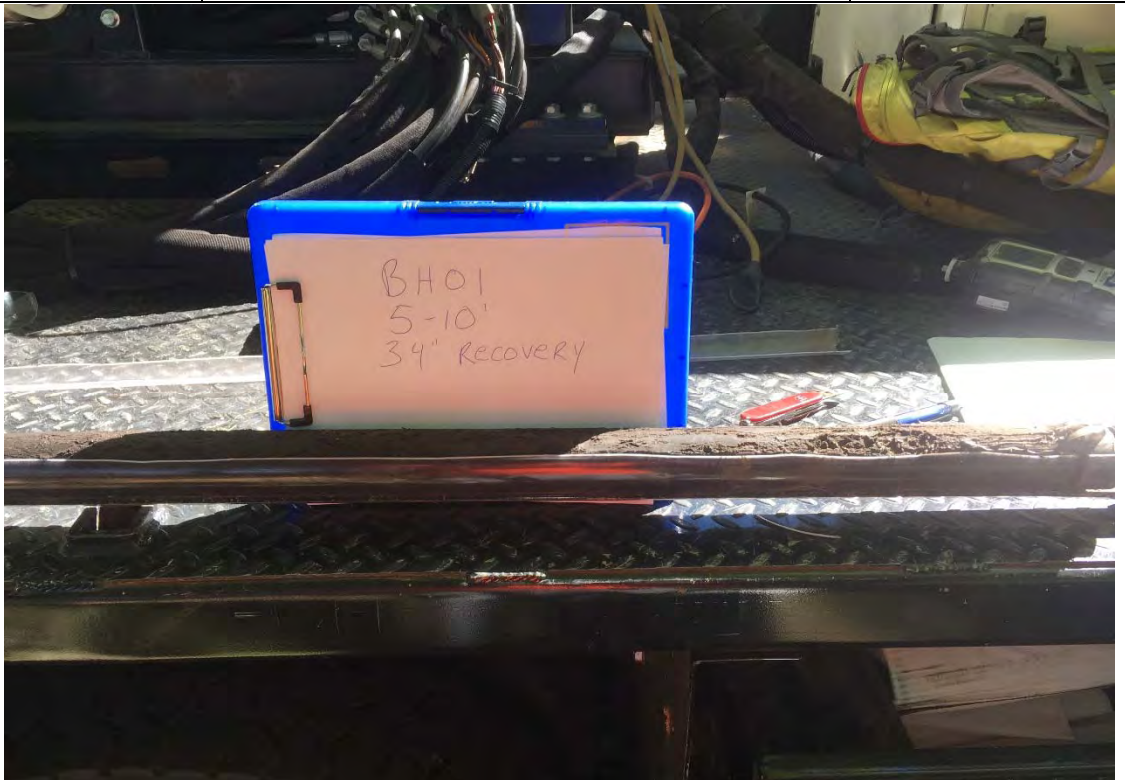
<b>Project Name:</b> YST Administration Building Phase II ESA		<b>Site Location:</b> Yankton, South Dakota	<b>Project No.</b> 20408.012.003.0361. 00
<b>Photo No.</b> <b>5</b>	<b>Date:</b> 7/12/2016

<b>Direction Photo Taken:</b>			
<b>Description:</b> Sample YSTAB-BH01-0910.

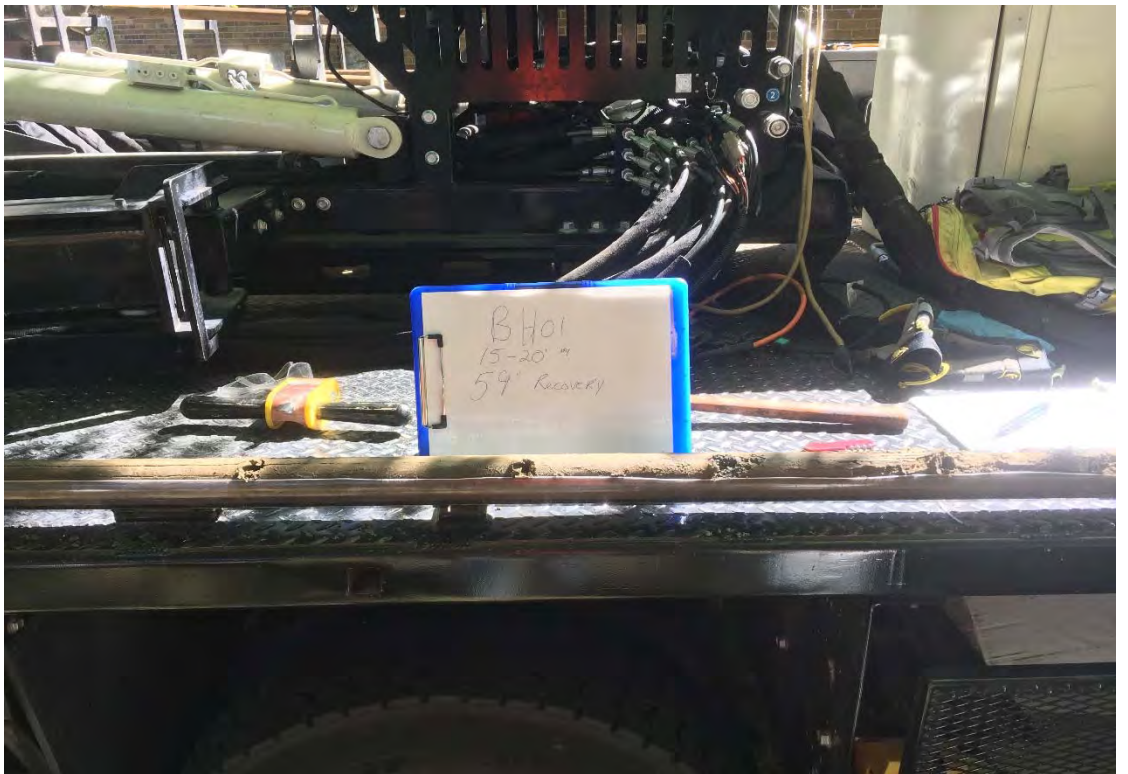
<b>Photo No.</b> <b>6</b>	<b>Date:</b> 7/12/2016

<b>Direction Photo Taken:</b>		
<b>Description:</b> Sample YSTAB-BH01-1920.

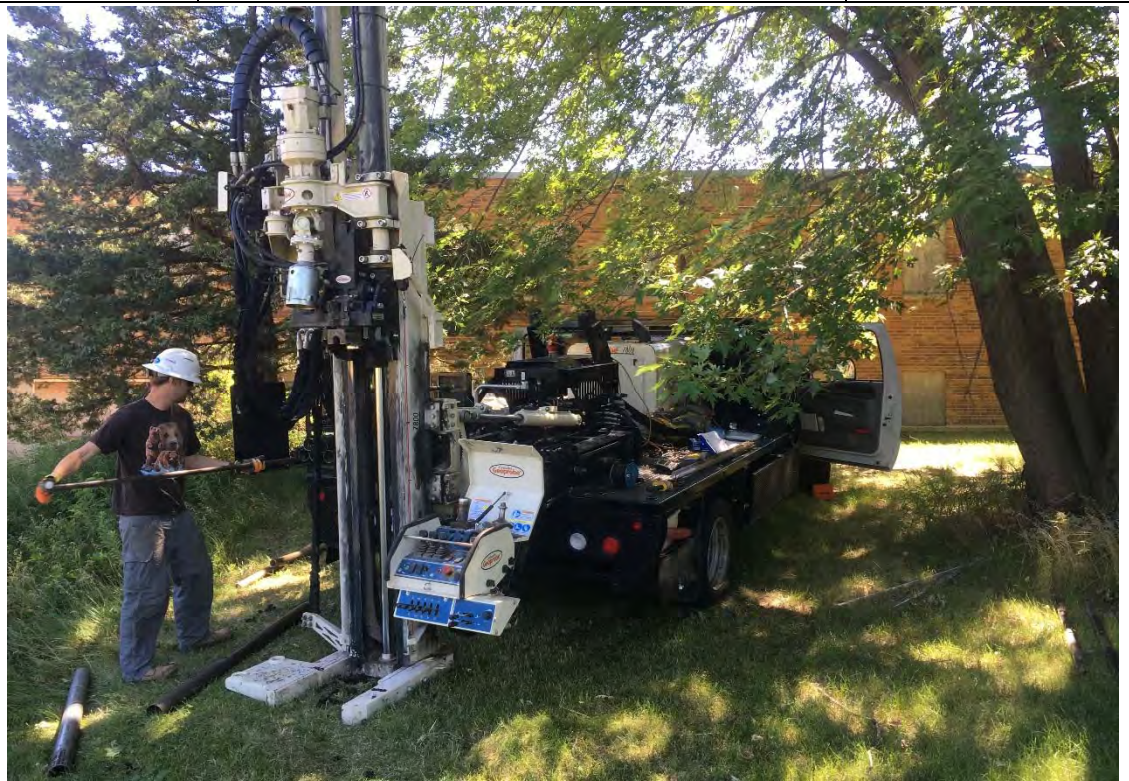
<b>Photo No.</b> <b>8</b>	<b>Date:</b> 7/12/2016
------------------------------	---------------------------

<b>Description:</b> Sample YSTAB-BH02-0910.
--

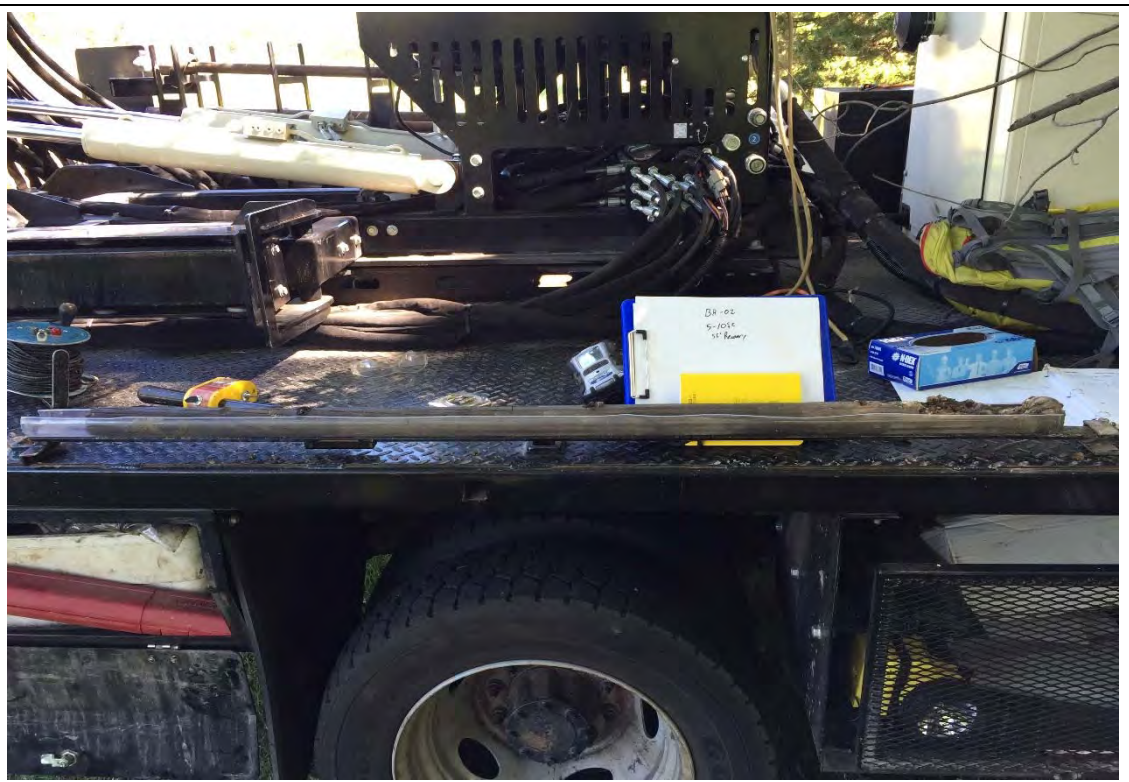
<b>Project Name:</b> YST Administration Building Phase II ESA		<b>Site Location:</b> Yankton, South Dakota	<b>Project No.</b> 20408.012.003.0361. 00
<b>Photo No.</b> <b>9</b>	<b>Date:</b> 7/12/2016

<b>Direction Photo Taken:</b>			
<b>Description:</b> Sample YSTAB-BH02-1213.

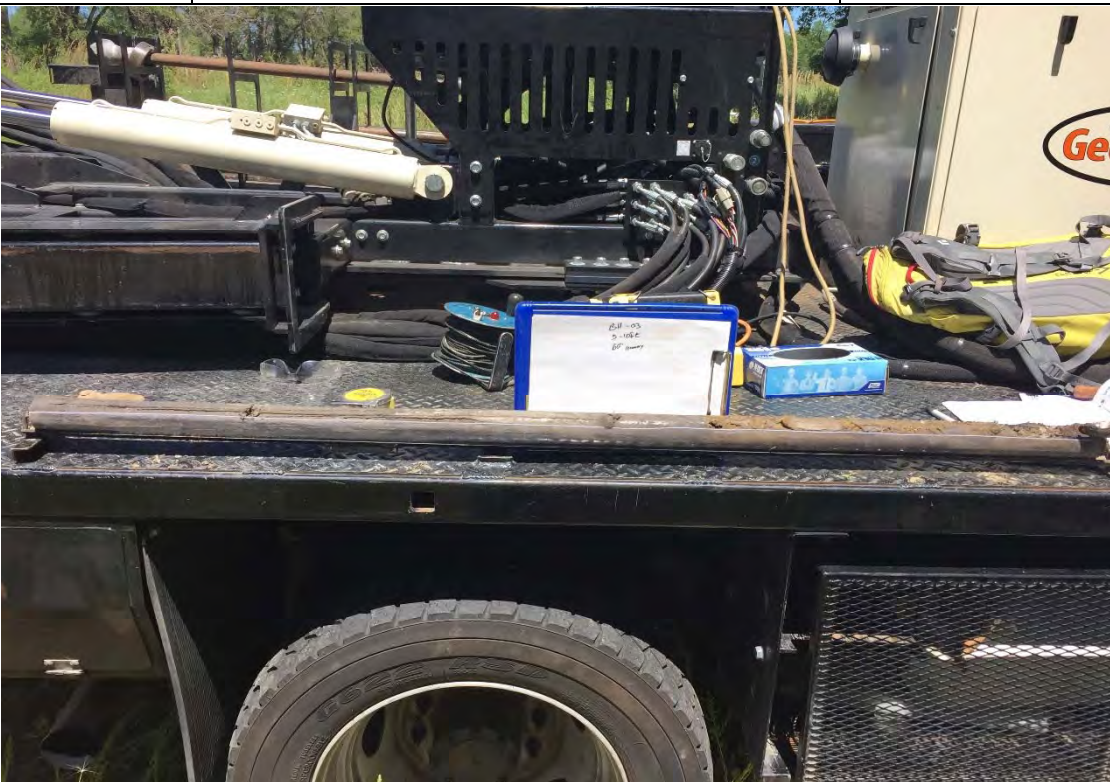
<b>Direction Photo Taken:</b>			
<b>Description:</b> Sample YSTAB-BH03-0910.

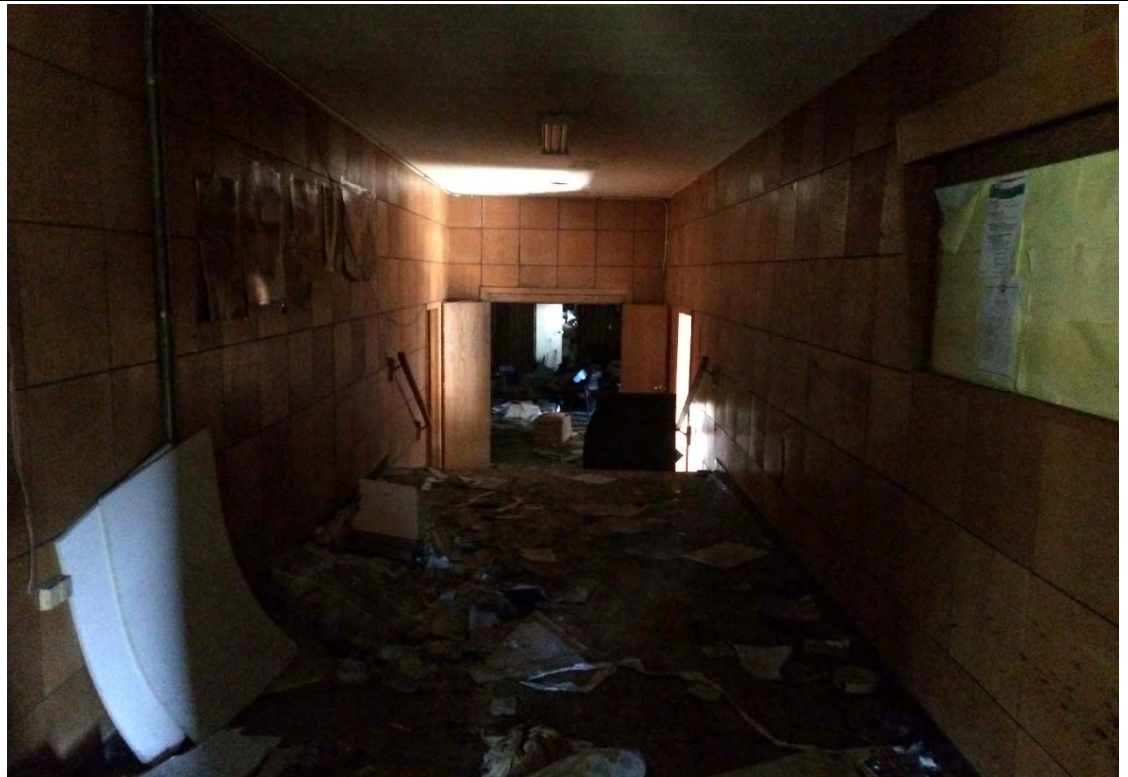
**Description:**  
View of the interior hallway on the second story. ACM floor tile present and walls are wood paneling.

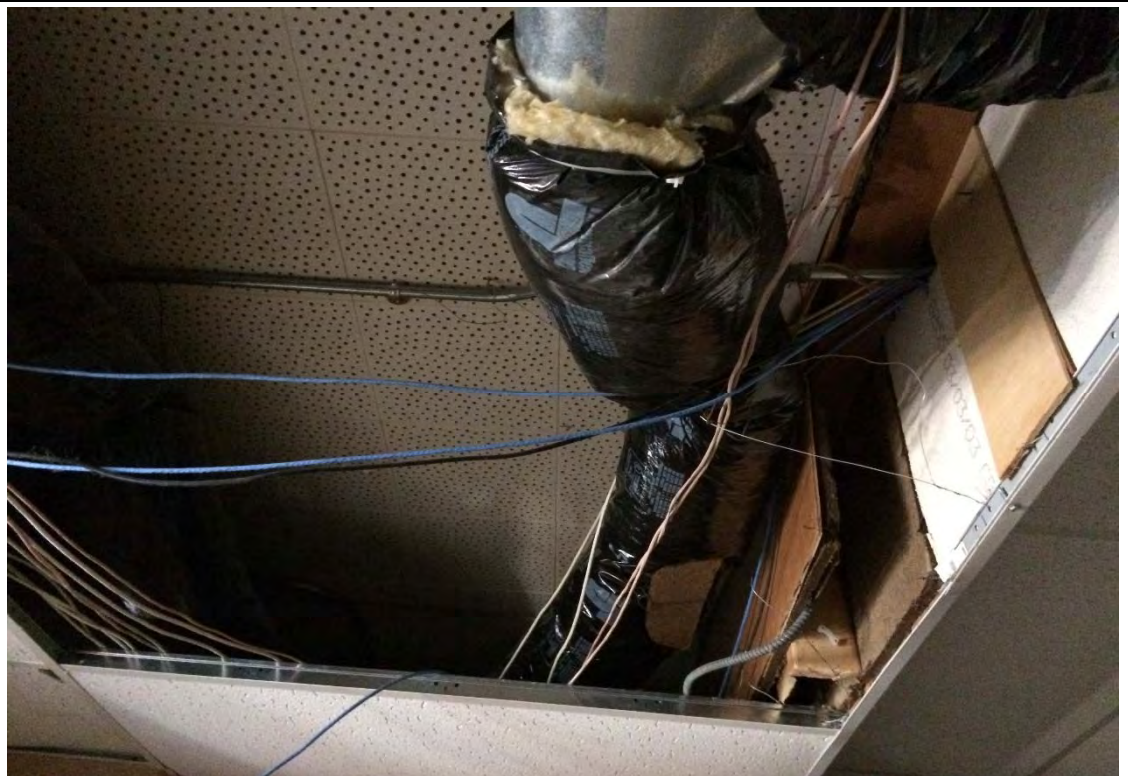
<b>Photo No.</b> <b>14</b>	<b>Date:</b> 7/6/2016
-------------------------------	--------------------------

**Description:**  
View of plenum. Suspended ceiling tiles are below ceiling tiles glued to drywall. Fiberglass insulation on HVAC system.

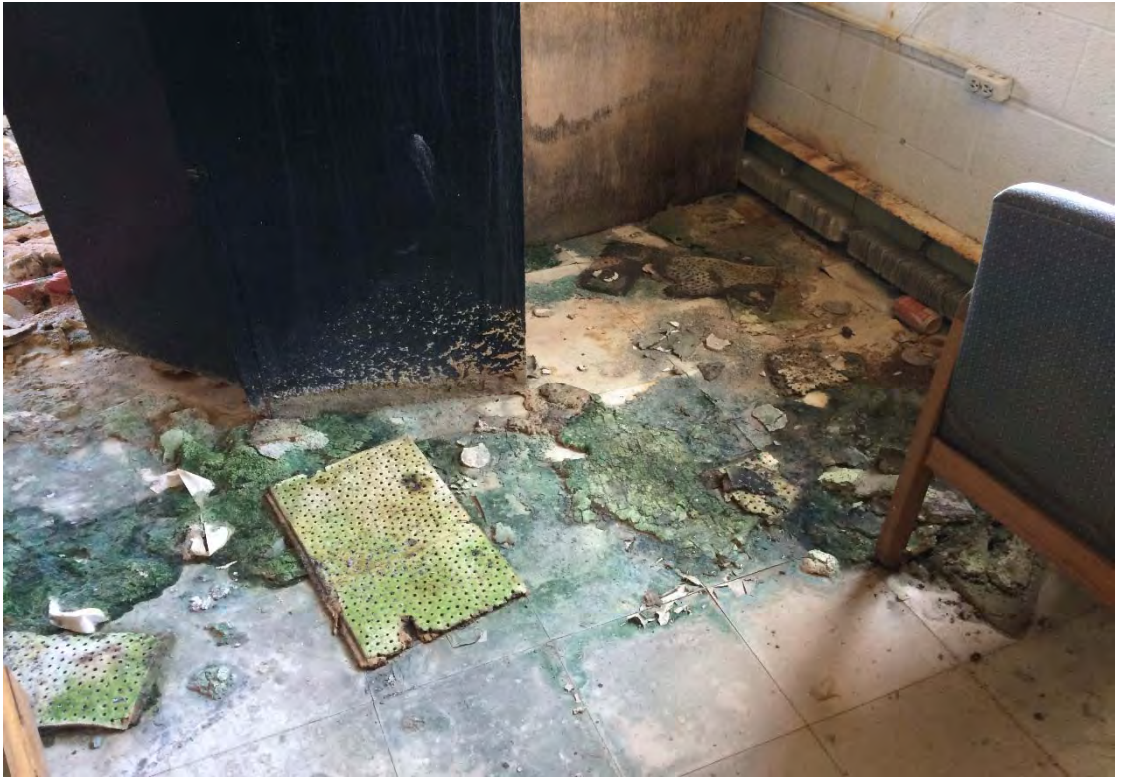
<b>Project Name:</b> YST Administration Building Phase II ESA		<b>Site Location:</b> Yankton, South Dakota	<b>Project No.</b> 20408.012.003.0361. 00
<b>Photo No.</b> <b>15</b>	<b>Date:</b> 7/6/2016

<b>Direction Photo Taken:</b>			
<b>Description:</b> Water damage to the ceiling which shows algae and mold growth present.

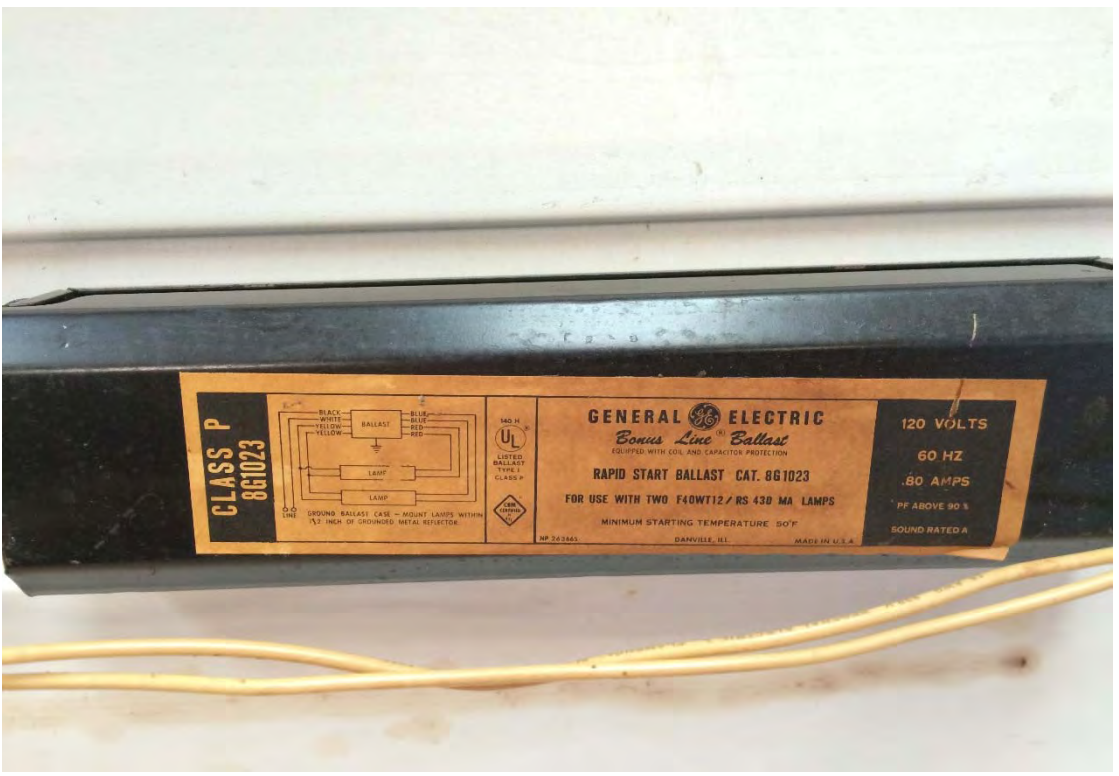
<b>Project Name:</b> YST Administration Building Phase II ESA		<b>Site Location:</b> Yankton, South Dakota	<b>Project No.</b> 20408.012.003.0361. 00
<b>Photo No.</b> <b>17</b>	<b>Date:</b> 7/6/2016

- Of the light ballasts observed, one polychlorinated biphenyl (PCB) ballast was observed. None of the light fixtures observed in the building appeared to be leaking fluids. PCBs are considered COCs in relation to the Site.
- Two mercury-containing thermostat switches were observed in the building, one on each level. Mercury is considered a COC in relation to the Site.
- Mold was encountered at the Site on both levels. Additionally, the lower level of the hexagonal structure was flooded during the inspection. Mold is considered a COC in relation to the Site.

<b>Direction Photo Taken:</b>			
<b>Description:</b> One older ballast was encountered with potential to be containing PCBs.

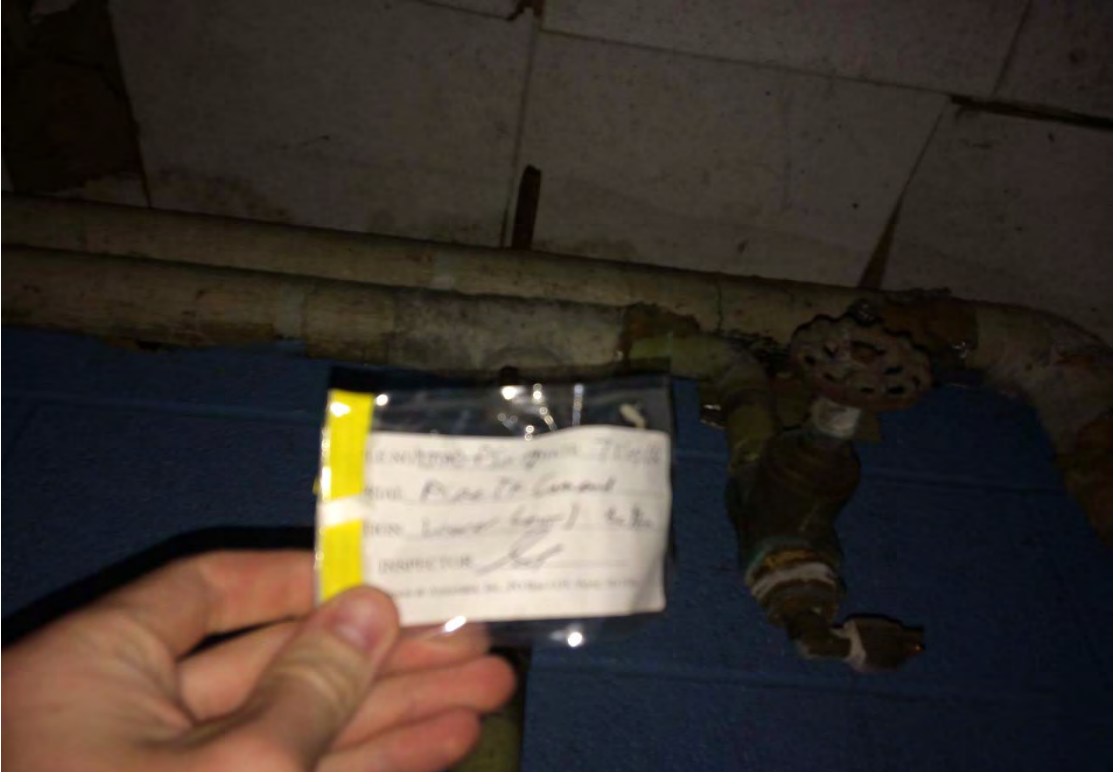
<b>Photo No.</b> <b>18</b>	<b>Date:</b> 7/6/2016

<b>Direction Photo Taken:</b>		
<b>Description:</b> Confirmed ACM sample YSTAB-PI01-07. This was a sample of the cementitious pipe fittings present throughout the lower level.

- Based on the ACM identified at the site, START recommends conducting ACM remediation. Prior to any renovations, work penetrating the ceilings, or demolition a proper plan for mitigation and/or disposal of ACM should be developed, and any work conducted should be performed by a company certified to handle ACM materials.
- Based on the LBP identified at the Site, START recommends encapsulation of LBP since the building is to be renovated for future use.
- If PCB-containing equipment (e.g., light ballasts) is encountered during renovation or repair activities, it should be properly removed and disposed.
- The mercury-containing thermostat switches should be removed and properly disposed.
- Mold should be removed and remediated by a certified restoration company and clearance air samples should be performed after the work is completed.

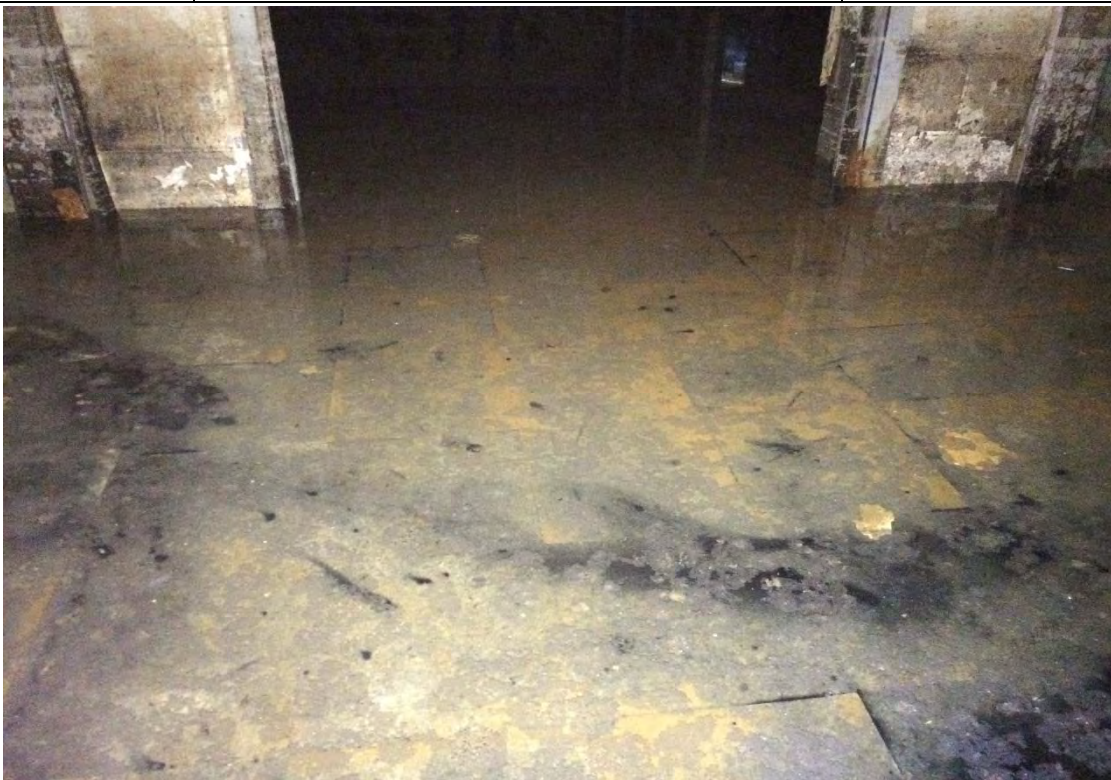
<b>Project Name:</b> YST Administration Building Phase II ESA		<b>Site Location:</b> Yankton, South Dakota	<b>Project No.</b> 20408.012.003.0361. 00
<b>Photo No.</b> <b>19</b>	<b>Date:</b> 7/6/2016

<b>Direction Photo Taken:</b>			
<b>Description:</b> Standing water with mold growth in the lower hexagonal portion of the building. About 6 inches of water was present during the site visit.

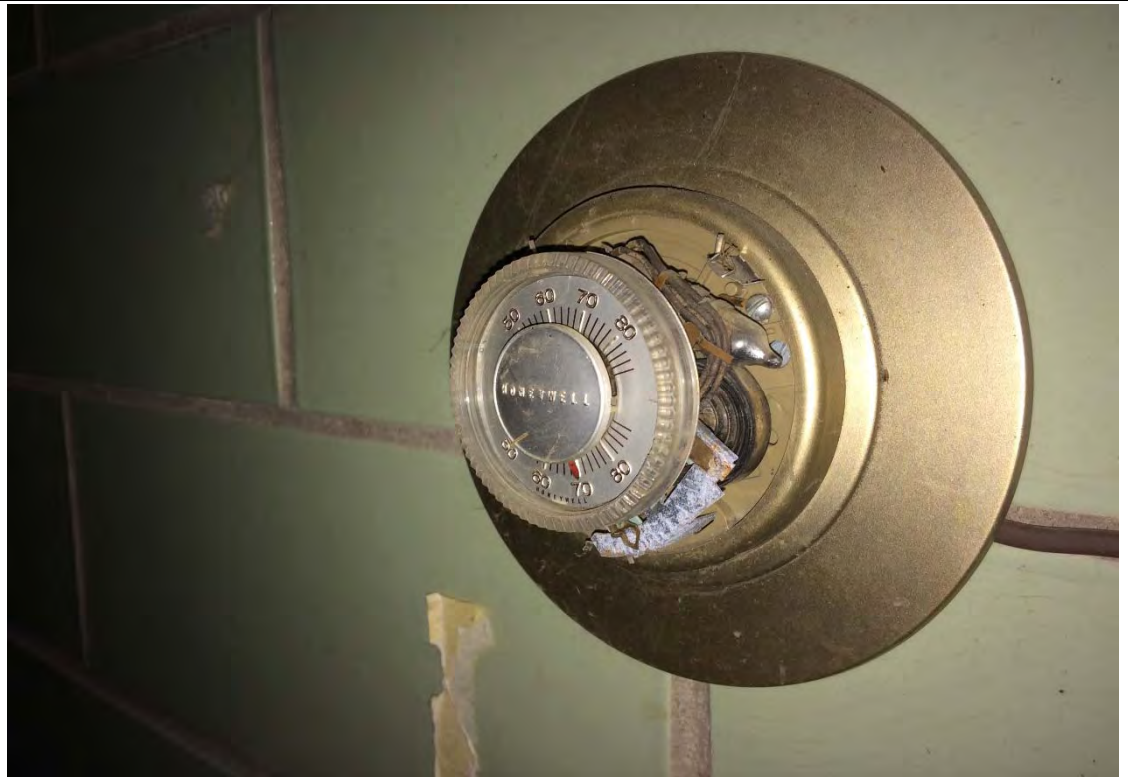
**Description:**  
First of two mercury thermostats encountered at the subject property. This one was located on the lower level.

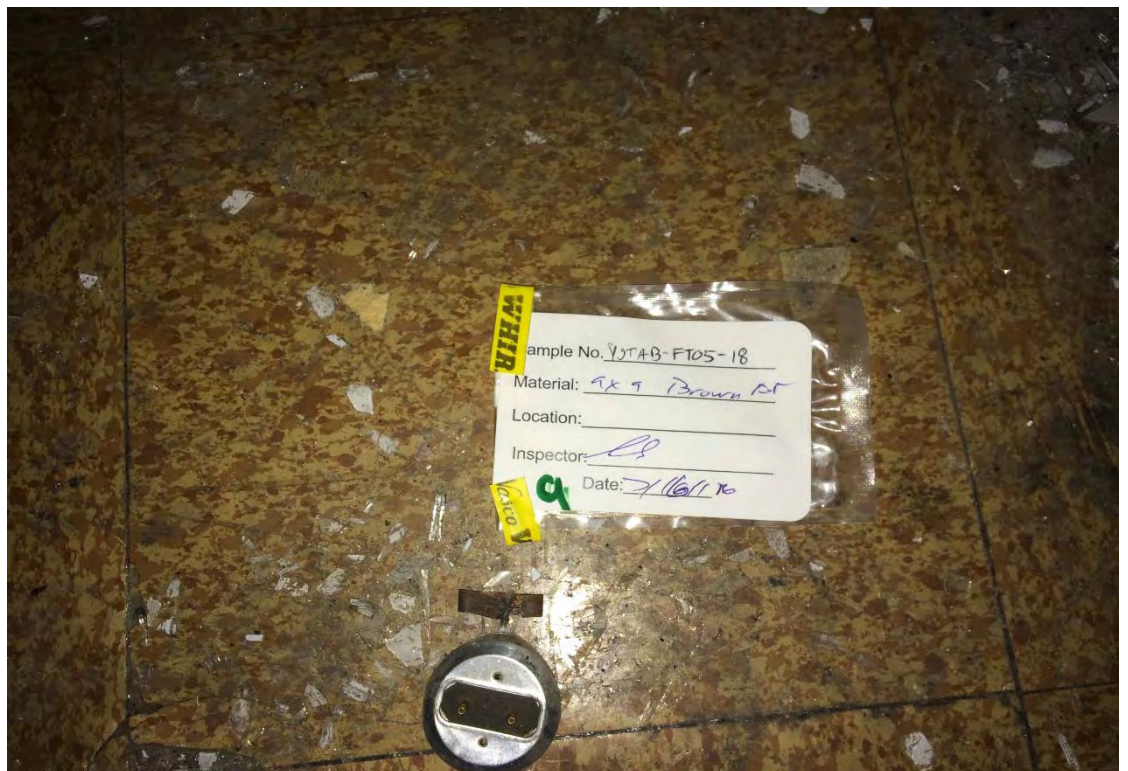
<b>Photo No.</b> <b>22</b>	<b>Date:</b> 7/6/2016
-------------------------------	--------------------------

**Description:**  
Confirmed ACM sample YSTAB-FT05-18. Floor tile present throughout most of the building.

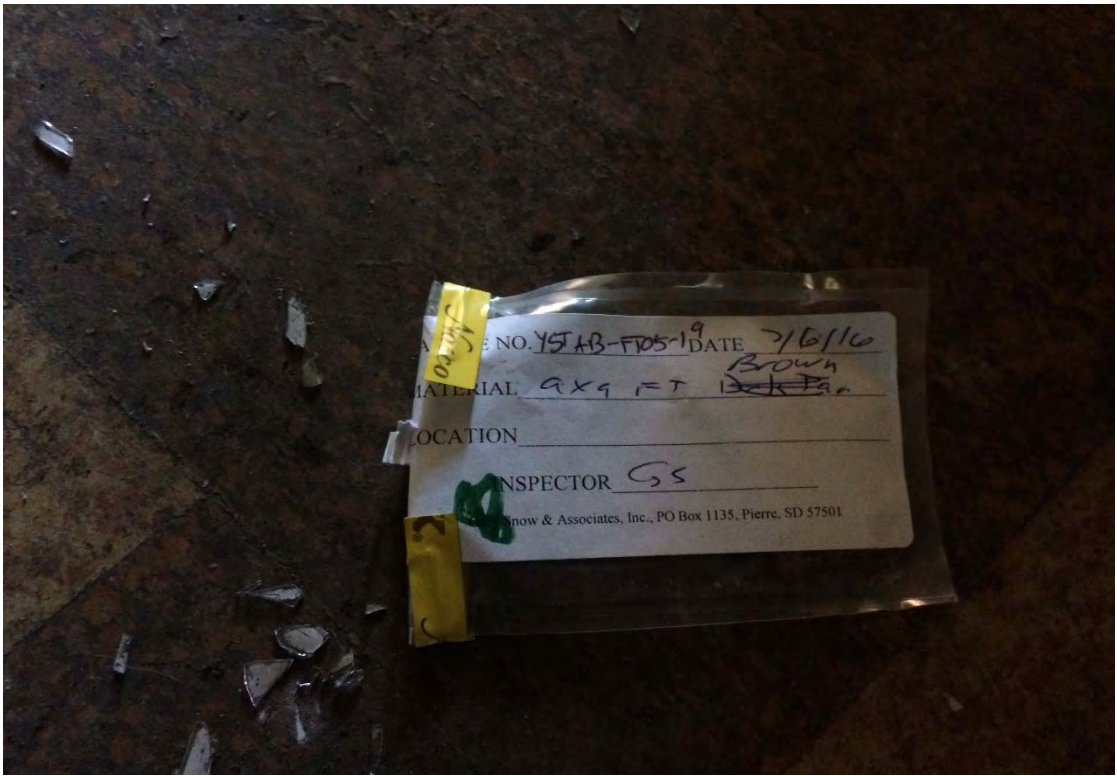
<b>Project Name:</b> YST Administration Building Phase II ESA		<b>Site Location:</b> Yankton, South Dakota	<b>Project No.</b> 20408.012.003.0361. 00
<b>Photo No.</b> <b>23</b>	<b>Date:</b> 7/6/2016

<b>Direction Photo Taken:</b>			
<b>Description:</b> Confirmed ACM sample YSTAB-FT05-19. Floor tile present throughout most of the building.

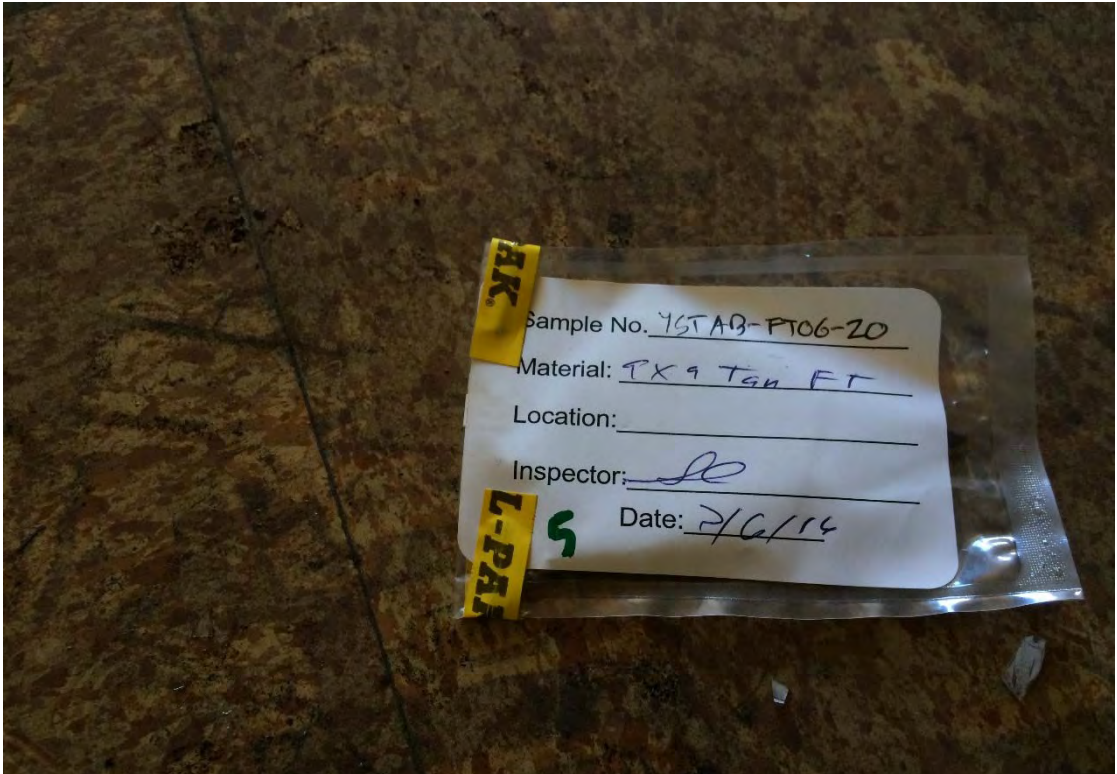
<b>Photo No.</b> <b>24</b>	<b>Date:</b> 7/6/2016

<b>Direction Photo Taken:</b>		
<b>Description:</b> Confirmed ACM sample YSTAB-FT06-20. Floor tile present throughout most of the building.

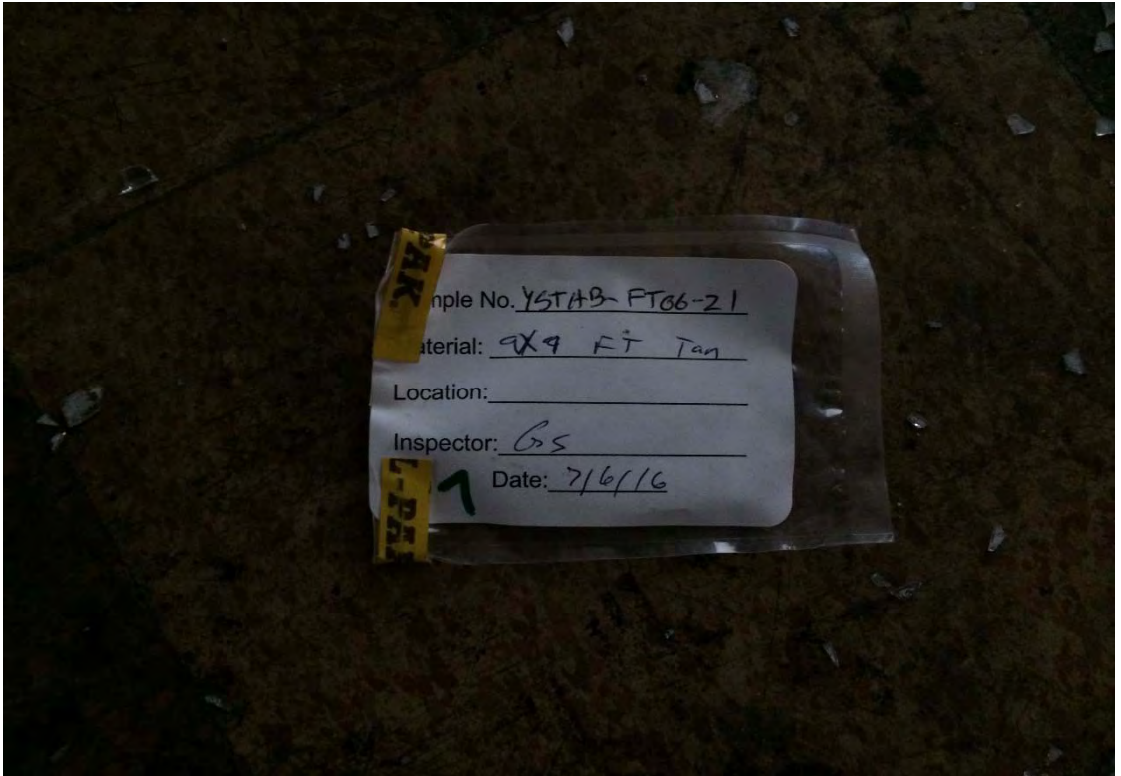
<b>Project Name:</b> YST Administration Building Phase II ESA		<b>Site Location:</b> Yankton, South Dakota	<b>Project No.</b> 20408.012.003.0361. 00
<b>Photo No.</b> <b>25</b>	<b>Date:</b> 7/6/2016

<b>Direction Photo Taken:</b>			
<b>Description:</b> Confirmed ACM sample YSTAB-FT06-21. Floor tile present throughout most of the building.

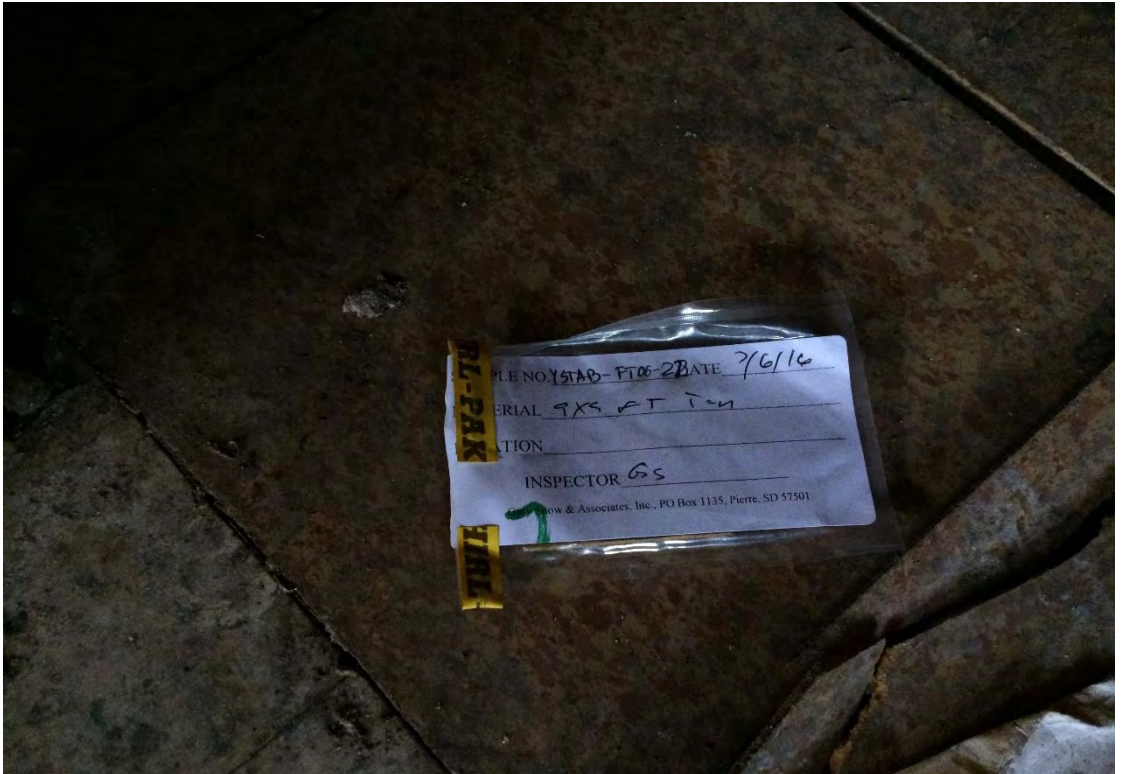
<b>Photo No.</b> <b>26</b>	<b>Date:</b> 7/6/2016

<b>Direction Photo Taken:</b>		
<b>Description:</b> Confirmed ACM sample YSTAB-FT06-22. Floor tile present throughout most of the building.

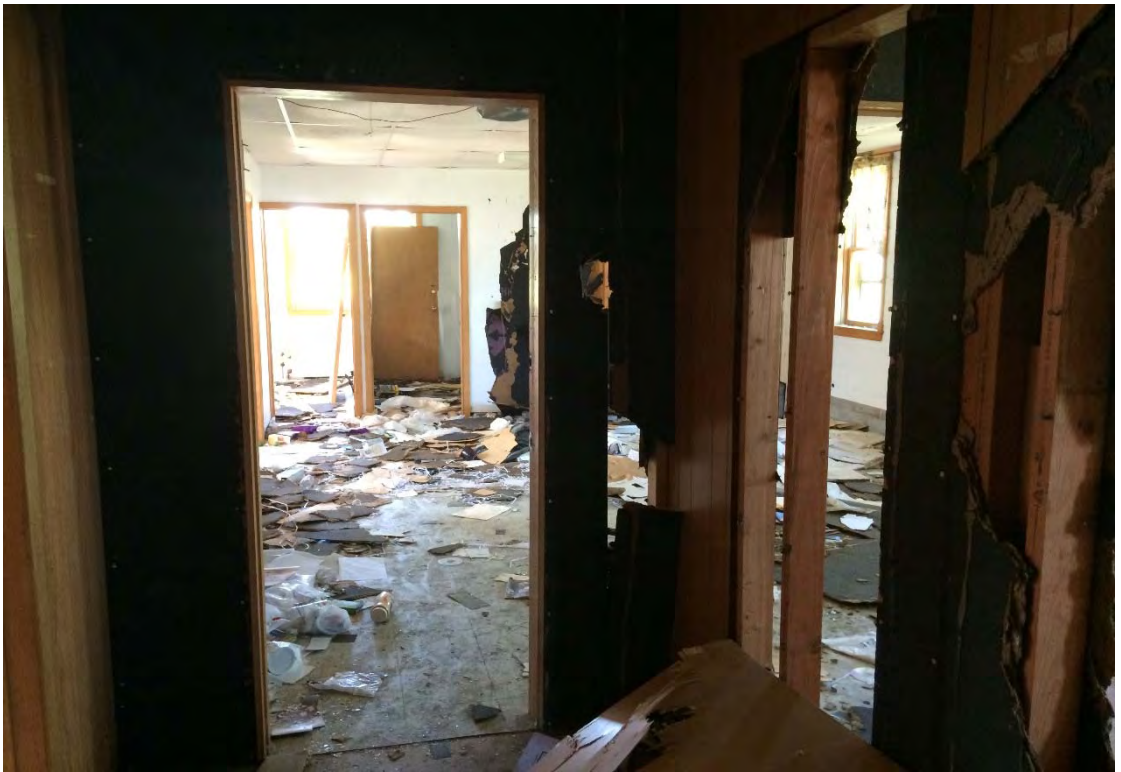
<b>Photo No.</b> <b>30</b>	<b>Date:</b> 7/6/2016

<b>Direction Photo Taken:</b>		
<b>Description:</b> One of the wings on the upper level. Walls are framed and have wall board attached. No insulation was present.

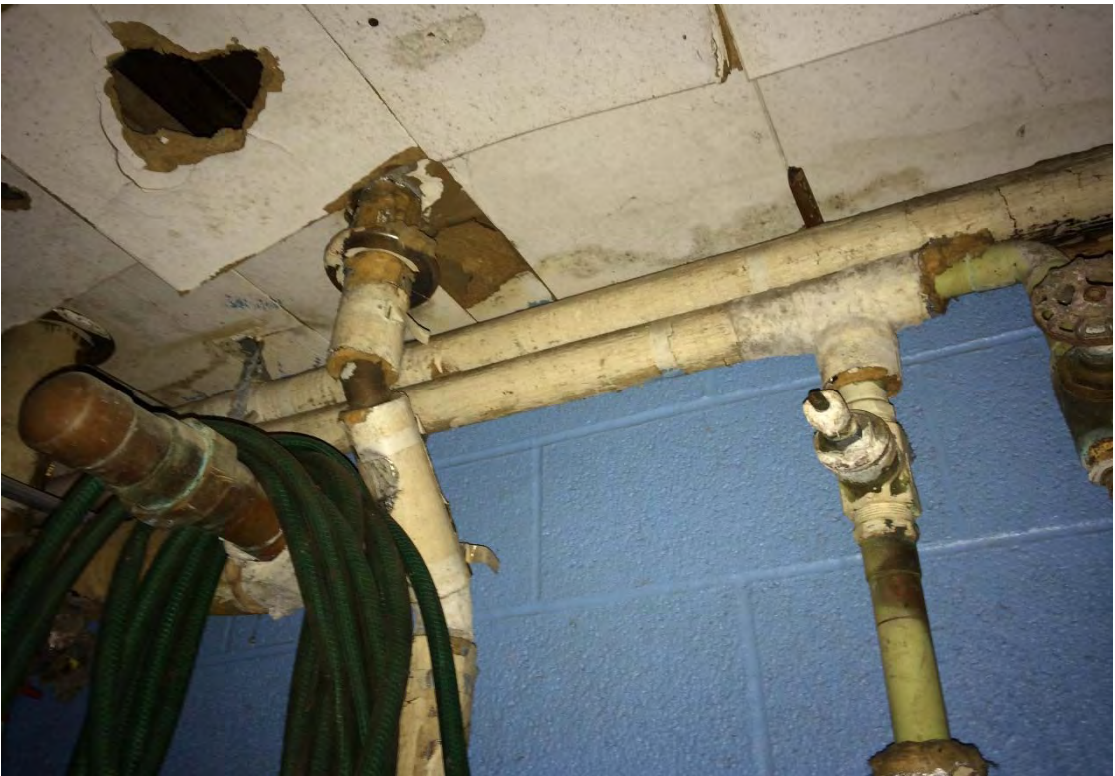
<b>Project Name:</b> YST Administration Building Phase II ESA		<b>Site Location:</b> Yankton, South Dakota	<b>Project No.</b> 20408.012.003.0361. 00
<b>Photo No.</b> <b>31</b>	<b>Date:</b> 7/6/2016

<b>Direction Photo Taken:</b>			
<b>Description:</b> View of some piping in a maintenance room. Fiberglass insulation was observed on the pipe runs with ACM cementitious fittings.
