**LIMITED DUE DILIGENCE  
AND  
PHASE II ENVIRONMENTAL SITE ASSESSMENT  
FOR  
YANKTON SIOUX TRIBE ADMINISTRATION BUILDING  
303<sup>rd</sup> STREET AND 388<sup>th</sup> AVENUE  
MARTY, CHARLES MIX COUNTY, SOUTH DAKOTA**

Date Prepared	August 2016
TDD No.	0003/1605-17
Document Control No.	W0361.1A.01055
Contract No.	EP-S8-13-01
U.S. EPA Work Assignment Manager	Christina Wilson

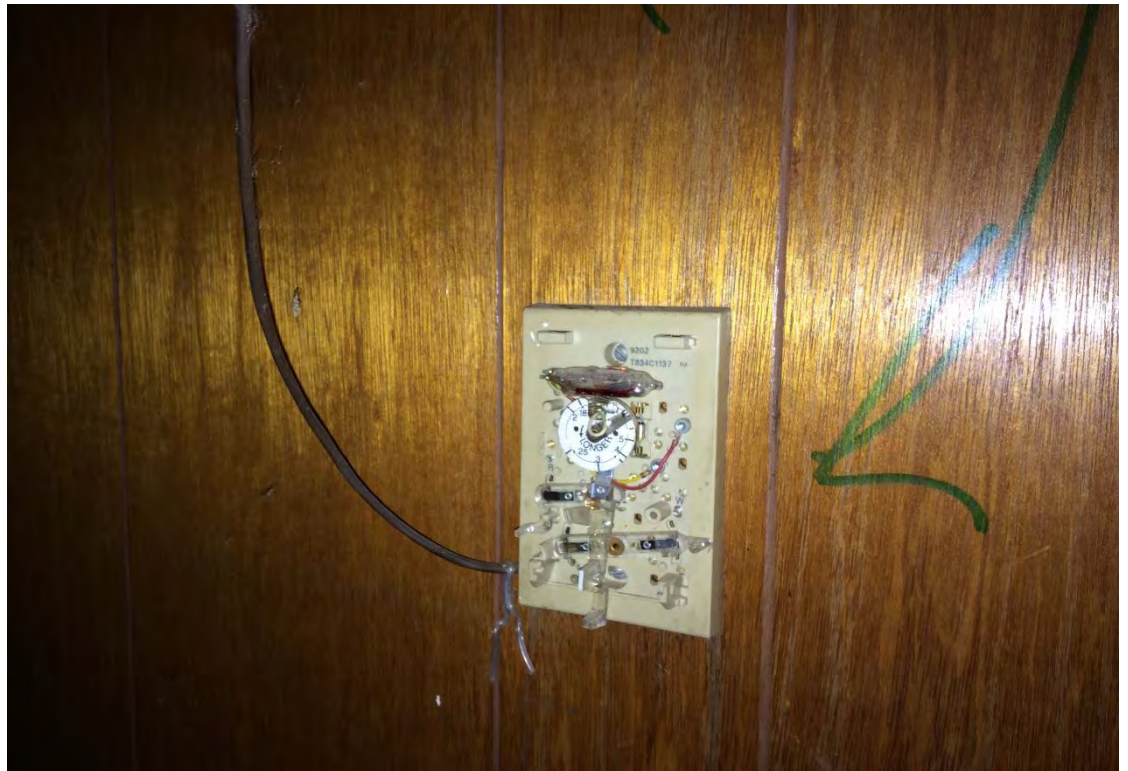
**Description:**  
Second of two mercury thermostats encountered at the subject property. This one was located on the upper level.

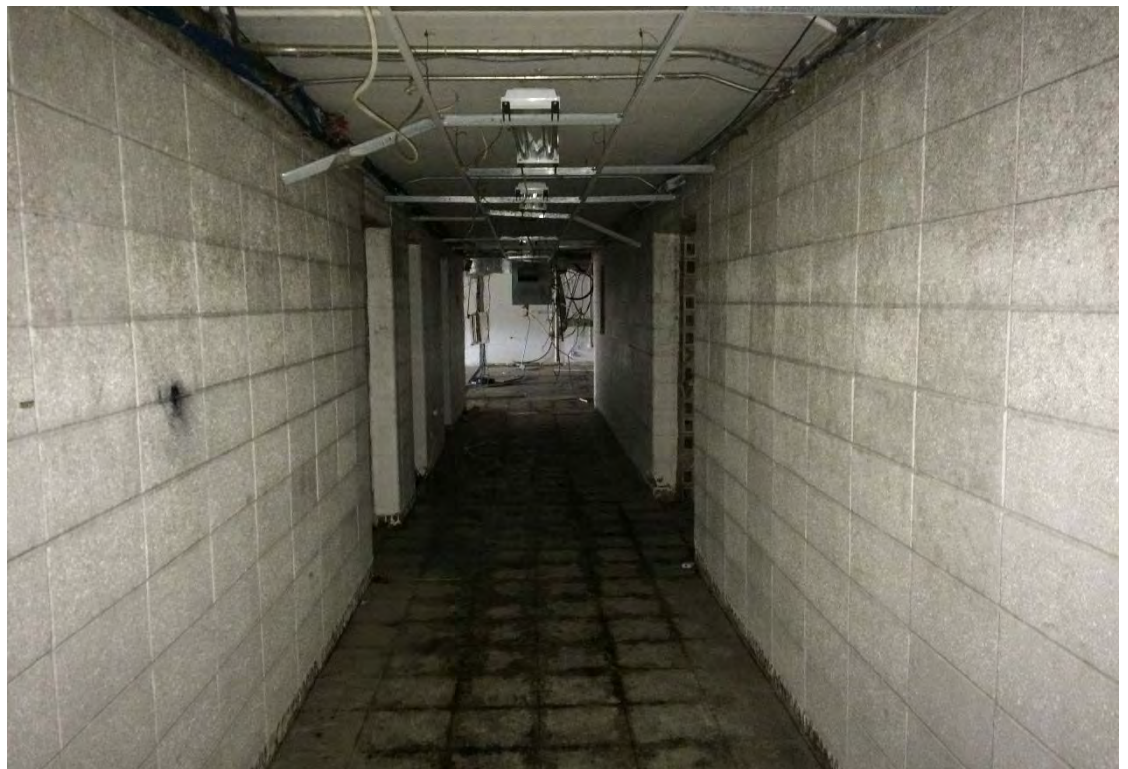
<b>Photo No.</b> <b>34</b>	<b>Date:</b> 7/6/2016
-------------------------------	--------------------------

**Description:**  
View of a hallway on the lower level. Severe water damage to the ACM floor tiles and mold is present as well.
