**ACTION MEMORANDUM**

**SUBJECT:** Approval and Funding for a Removal Action at the Star Valley Drinking Water Site in Grover, Lincoln County, Wyoming pursuant to the On-Scene Coordinator's delegated authority under CERCLA Section 104

# Star Valley Drinking Water Incident

## Photo Log

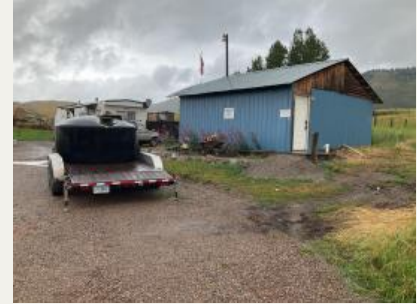
Description: Artesian well house that serves as the community water source. Note temporary water tank placed in front of the building by property owner to supply residents with non-potable water.

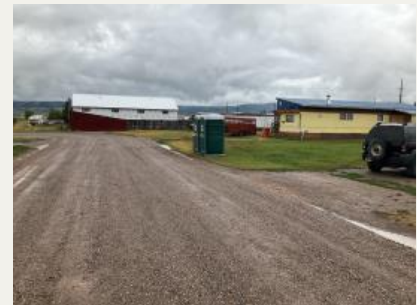
Description: Looking west towards front of trailer park. EPA's Response Team brought three sets of temporary toilets / hand washing stations and shared them with residents.

Legal access was obtained from the owner of the trailer court for all outdoor areas, a majority of the unimpacted owners, and five of the six impacted homeowners. The owner of the sixth home is the individual who reportedly put the material in the system and did not respond. This sixth impacted home was completely disconnected from the water distribution system on August 6, 2022, so that flushing of the system could proceed. Portable toilets and hand wash stations were set up in the trailer court.

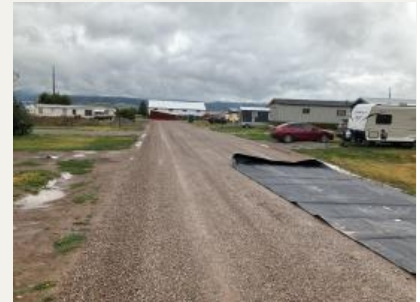
Description: Looking west towards front of trailer park. In the foreground, containment being rolled out for installation beneath the Response Teams frac tanks.

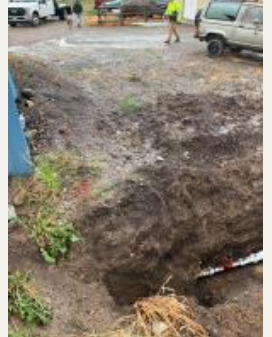
Description: Control valve in water distribution system piping installed by the operator at lot 1 to isolate the contaminated homes.

The drinking water owner/operator shut down the system, notified all residents and quickly installed two valves to isolate the contaminated homes.

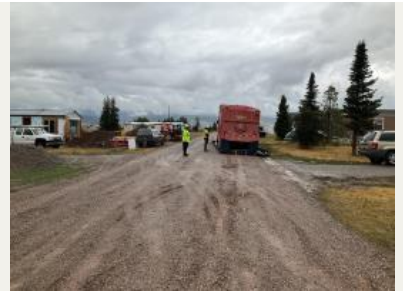
Description: Looking west as frac tank staging is in progress.

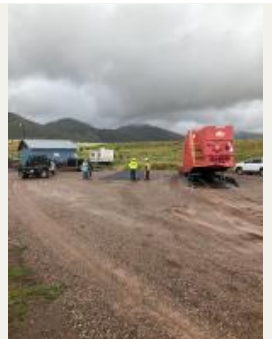
Description: Frac tank staging area near well house. The community's artesian well does not appear to be impacted.

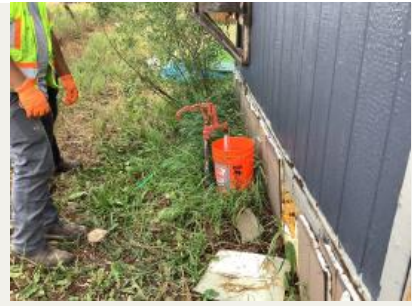
Description: Observing water conditions EPA's Team work to flush the water line in a trailer.

Flushing involved systematically opening all the hot and cold water taps at each property moving away from the well house. The homes in the unimpacted zone were flushed on August 6, 2022. No visible sheen, oily substances nor odors were encountered during this process.

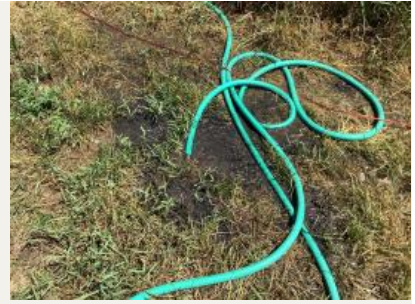
Description: Stained area surrounding water hose caused by the oily substance of concern.

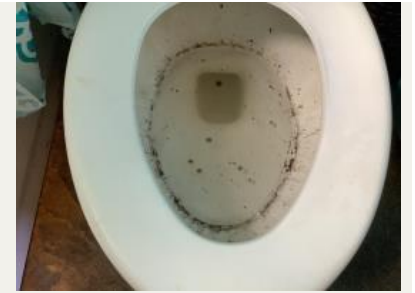
Description: Oily substance of concern observed in a toilet.

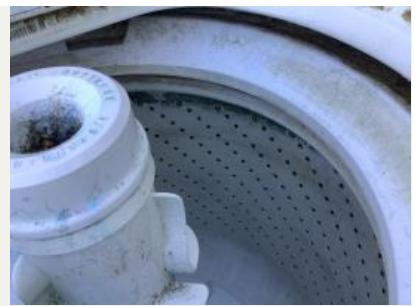
Description: Oily substance of concern stained inside of a washing machine.

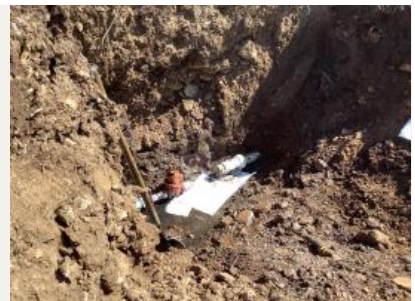
Description: Control valve located at lot 7 is cut to add connection for flushing into a frak tank.

The Response Team flushed the 5 impacted homes on August 7, 2022. This process started by cutting the main line behind the isolation valve that was installed just west of the last impacted home. This segment of the main line was drained to install a water collection bib next to the isolation valve. When the main was cut, approximately 15 gallons of water mixed with a heavy oily substance was released. This material was collected and sampled. The main line was then pressurized and flushed for 15 minutes. Little to no visibly contaminated water was generated.

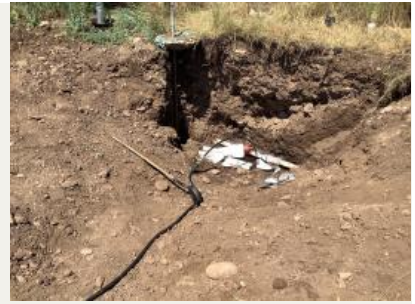
Description: Installed connection at the control valve located at lot 7 for flushing into frak tank.

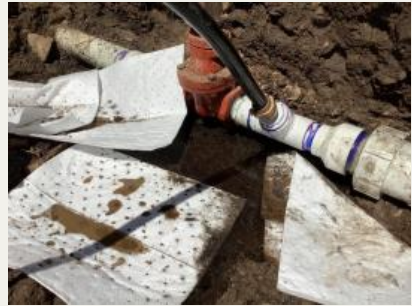
Description: Absorbent pads used to collect the oily substance of concern from water collected under the control valve located at lot 7.

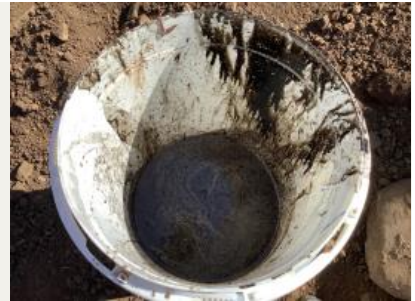
Description: Oily substance of concern that was collected from near the control valve located at lot 7.

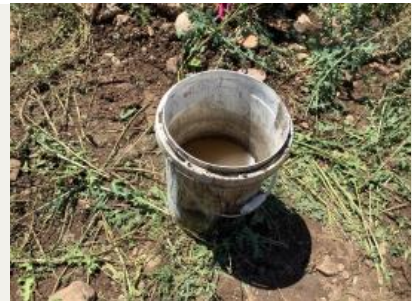
Description: Oily substance of concern that was collected from near the control valve located at lot 7.

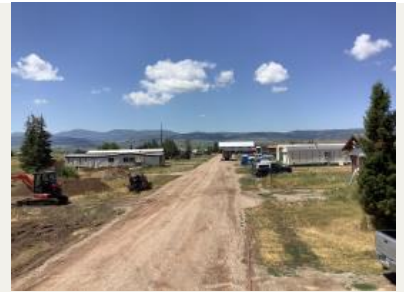
Description: First 4 trailers that were effected by the oily substance of concern. Facing east.

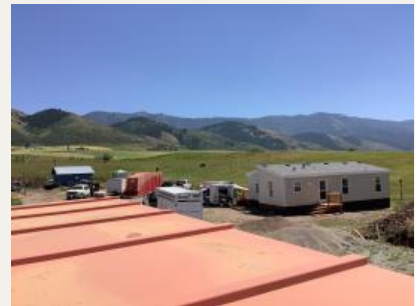
Description: Pump house (small building on the left and lot 28, where START was staged for sample processing. Taken from atop frak tank and facing southeast.

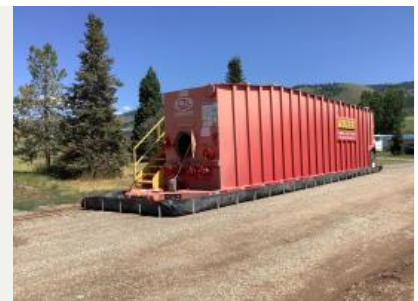
Description: Frak tank being used to collect flushed water from main water line.

The Team flushed the main in this isolated segment again for 15 minutes before opening the isolation valve and reversing the flow in the main so that the water ran from the well, through the unimpacted segment and finally through the impacted segment. The entire main was flushed again under this configuration for approximately 30 minutes with no visual signs of contamination.

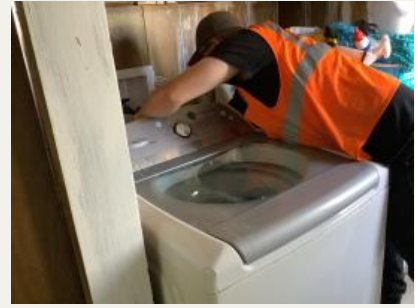
Description: Disconnecting water lines connected to a washing machine inside of trailers during water line flushing process.

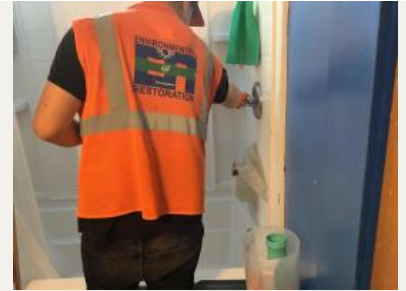
Description: Flushing a shower inside a trailer.

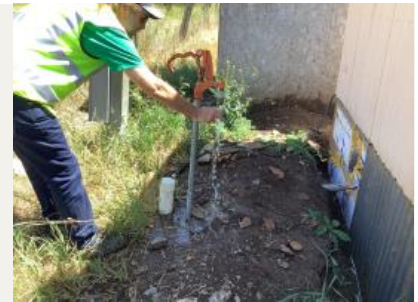
Description: Monitoring water for contamination during the flushing of an external water tap.
