**INTEGRATED SITE ASSESSMENT AND
REMOVAL SITE EVALUATION REPORT**

**SUNSHINE LAUNDRY SITE
FORT DODGE, IOWA**

EPA SEMS ID – IAN000706520

**Superfund Technical Assessment and Response Team (START) 5 Contract
Contract No. 68HE0719D0001, Task Order 19F0086.008**

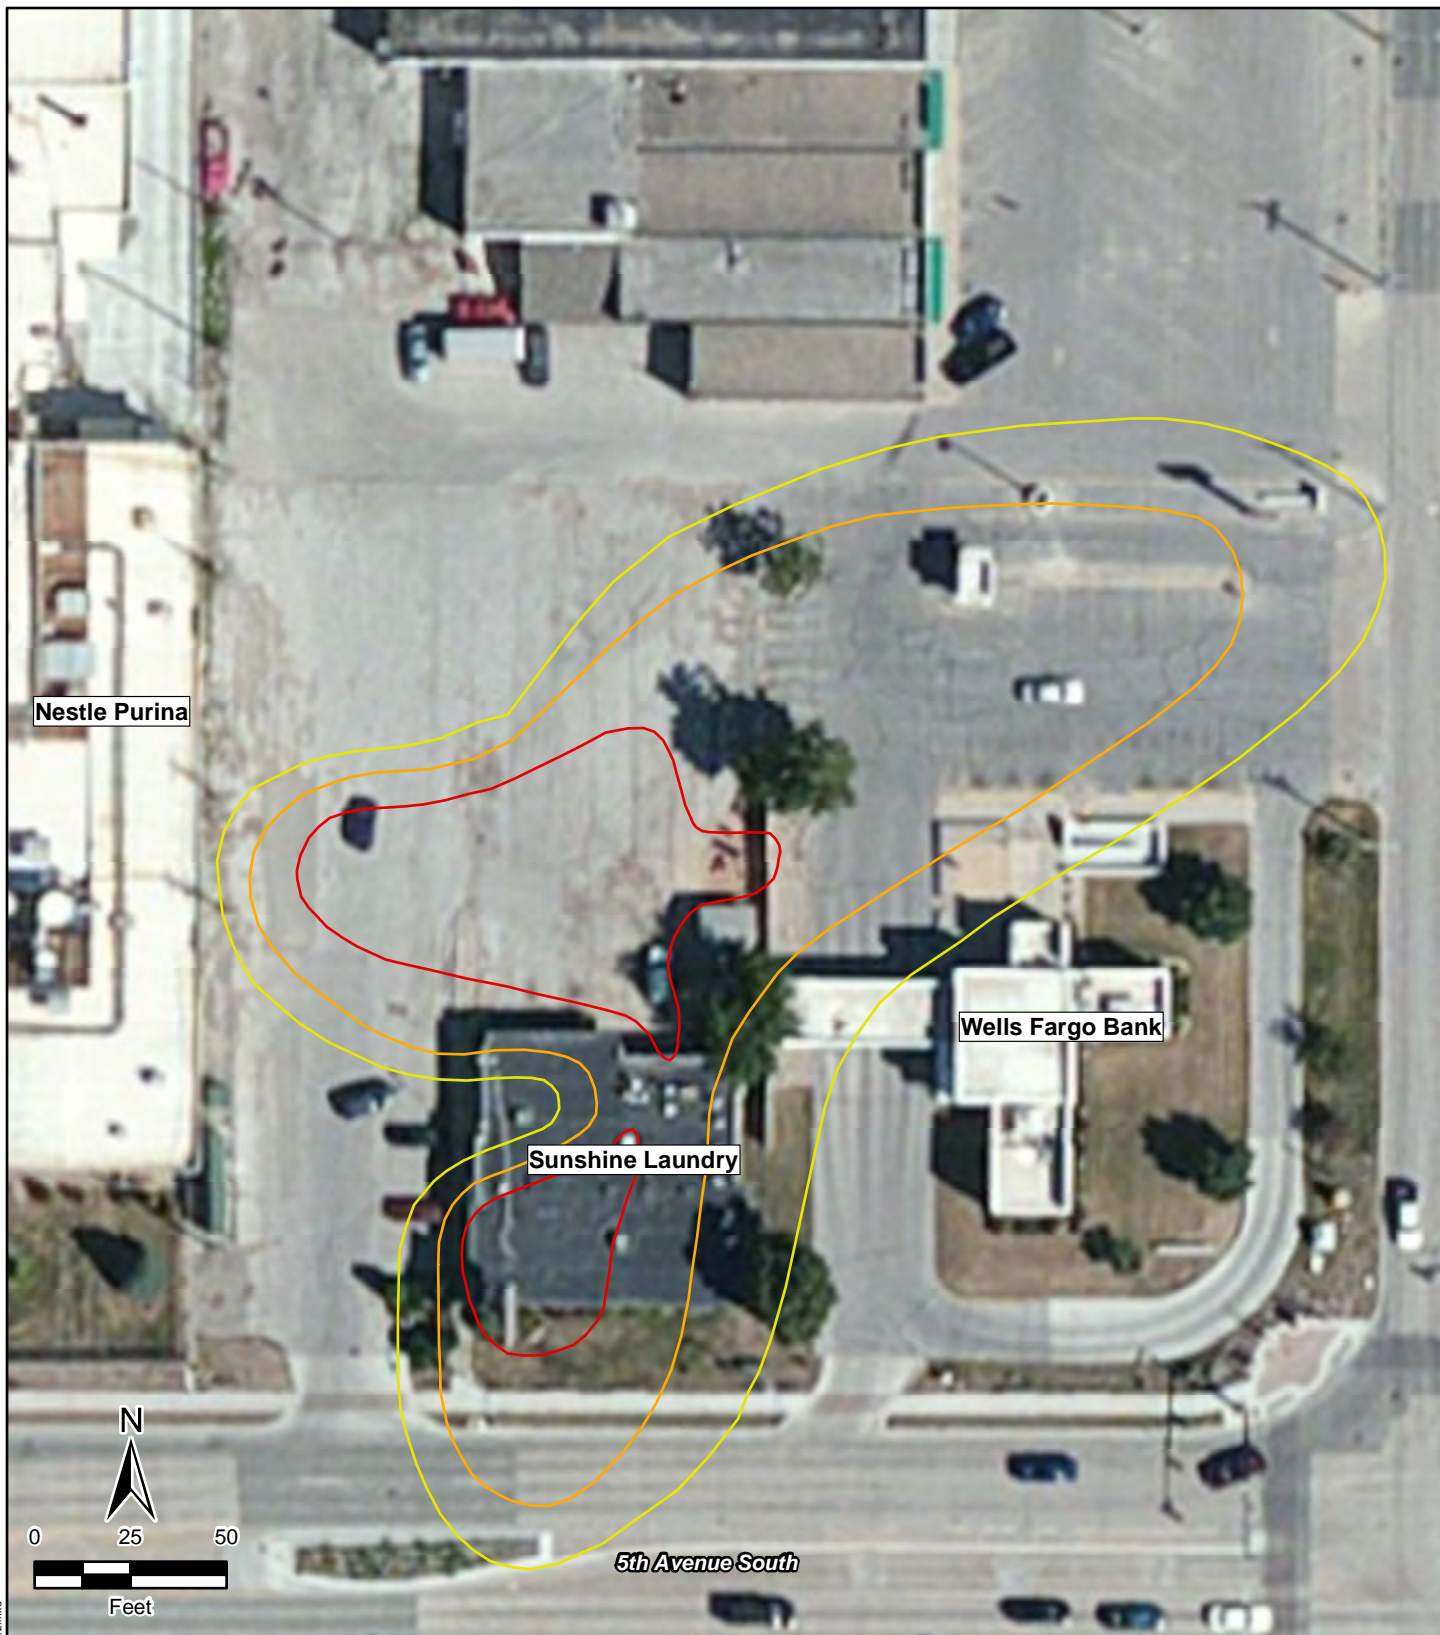
Figure 11
Groundwater Results Map

PCE isoconcentration plume	µg/L	Micrograms per liter
 	5 µg/L	PCE Tetrachloroethene
 	100 µg/L	
 	1,000 µg/L

Table 4 lists VOCs detected in the MW samples, and these results are shown on Figure 11 in Appendix A. PCE was detected at 3,700 µg/L in the groundwater sample from MW-3, and at 23 µg/L in the sample from MW-6—both exceeding the 5 µg/L MCL. The sample collected from MW-3, north of the building, also contained an estimated 250 µg/L of TCE (estimated), 880 µg/L of *cis*-1,2-DCE, and 140 µg/L of *trans*-1,2-DCE, which also exceeded their respective MCLs. PCE, TCE, and *cis*-1,2-DCE concentrations in MW-3 also exceeded the ISS for a nonprotected groundwater source (the federal MCLs are used for the protected groundwater standards).

Table 6 below lists the VOCs detected in the 14 groundwater samples, and Figure 11 indicates these results. Site-related VOCs were detected at seven locations. PCE was detected in six of the groundwater samples at concentrations between 28 and 2,500 µg/L. Because of the high concentrations previously detected at the site, a 5 µg/L detection limit (the MCL) was applied for this analysis; consequently, lower levels of VOCs may be present where indicated as “undetected” in Table 6. The 2 µg/L MCL for vinyl chloride was below the detection limit. Vinyl chloride detections at TW-11 (11 µg/L) and TW-12 (31 µg/L) exceeded the MCL.

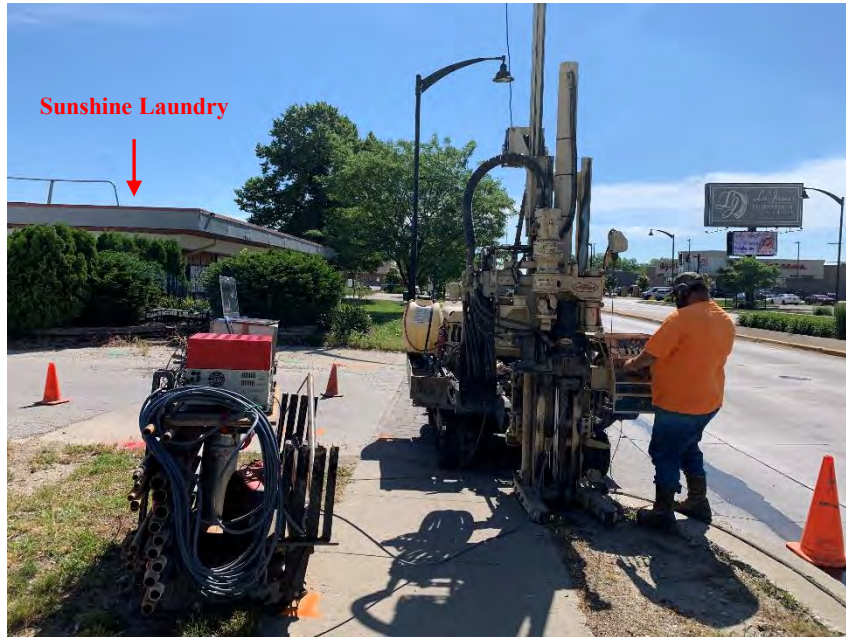
TETRA TECH PROJECT NO. X9030..19F.0086.008 DIRECTION: East	DESCRIPTION	This photograph shows Membrane Interface Probe (MIP)-1 location; collocated with Soil Boring (SB)-5 and Temporary Well (TW)-6.	1
	CLIENT	Environmental Protection Agency - Region 7	DATE 6/7/2021
	PHOTOGRAPHER	Jenna Mead

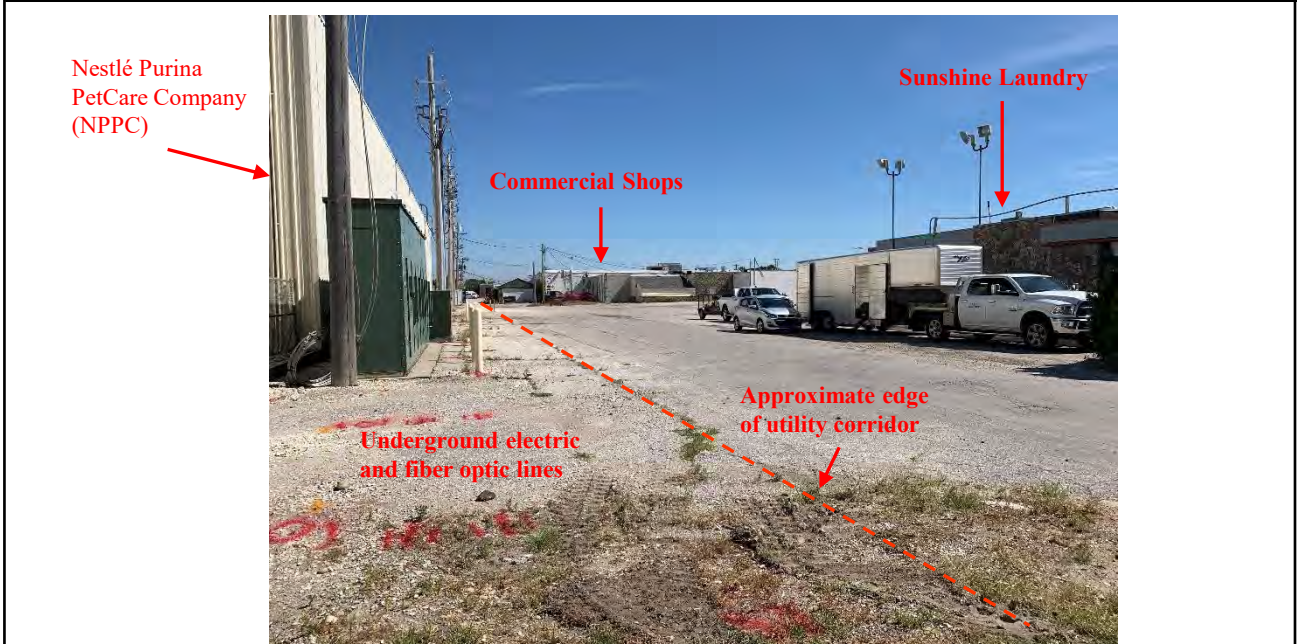
TETRA TECH PROJECT NO. X9030.19F.0086.008 DIRECTION: North	DESCRIPTION	This photograph shows power and communications utility easement at west side of Sunshine Laundry.	2
	CLIENT	Environmental Protection Agency - Region 7	DATE 6/7/2021
	PHOTOGRAPHER	Jenna Mead

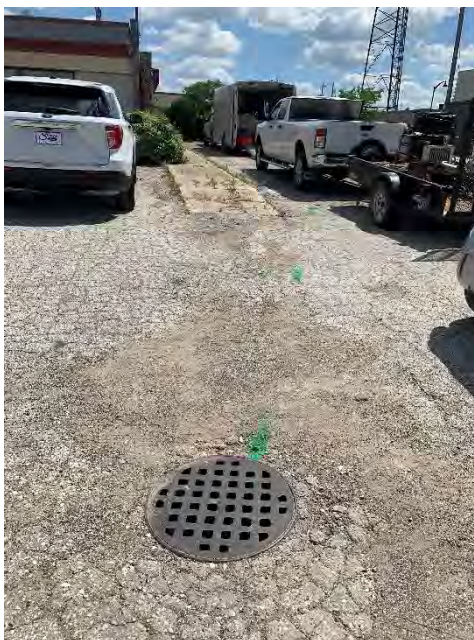
<p>TETRA TECH PROJECT NO. X9030..19F.0086.008 DIRECTION: South</p>	DESCRIPTION	This photograph shows the storm sewer drain in parking lot north of Sunshine Laundry.	3
	CLIENT	Environmental Protection Agency - Region 7	DATE 6/7/2021
	PHOTOGRAPHER	Jenna Mead

PCE was detected in 17 samples at concentrations as high as an estimated 31,000 $\mu\text{g}/\text{kg}$ in a sample collected at 12-13 feet bgs near a stormwater drain about 50 feet north of the former dry cleaner building. TCE and other PCE degradation compounds were detected in 11 soil samples, generally in the north central portion of the site. The fuel-related VOCs benzene and toluene were also detected in one sample collected in this area. Fuel-related VOCs are known to enhance PCE and TCE degradation (EPA 1998).

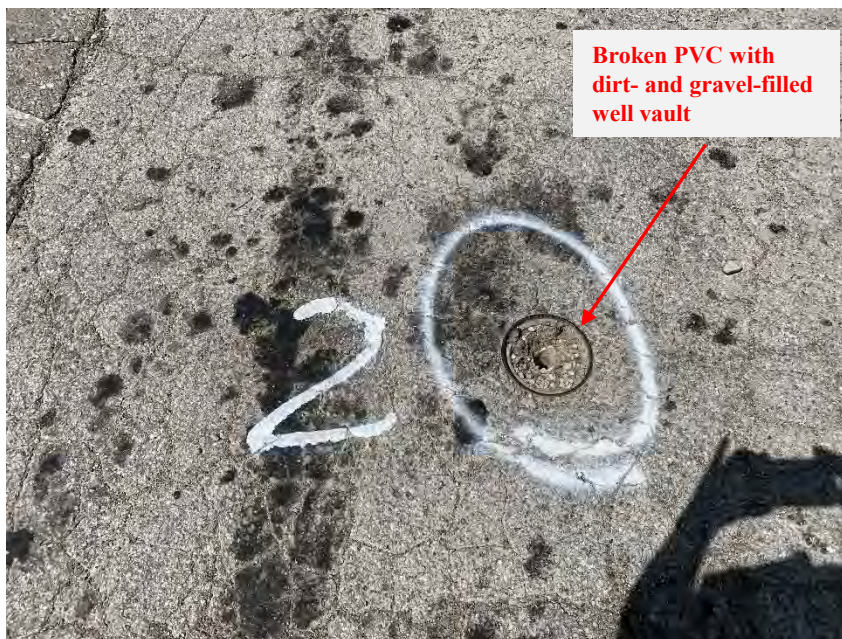
<p>TETRA TECH PROJECT NO. X9030..19F.0086.008 DIRECTION: -</p>	DESCRIPTION	This photograph shows open PVC with no well cap or vault cover at MW-2; not sampled.	5
	CLIENT	Environmental Protection Agency - Region 7	DATE 6/7/2021
	PHOTOGRAPHER	Jenna Mead

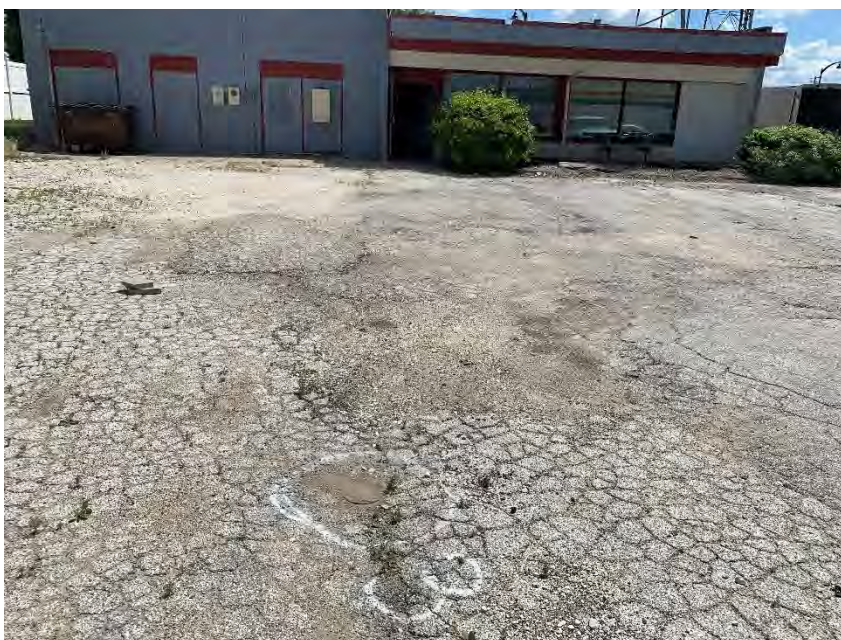
<p>TETRA TECH PROJECT NO. X9030.19F.0086.008 DIRECTION: South</p>	DESCRIPTION	This photograph shows MW-3 with vault cover in place, north of Sunshine Laundry building.	6
	CLIENT	Environmental Protection Agency - Region 7	DATE 6/7/2021
	PHOTOGRAPHER	Jenna Mead

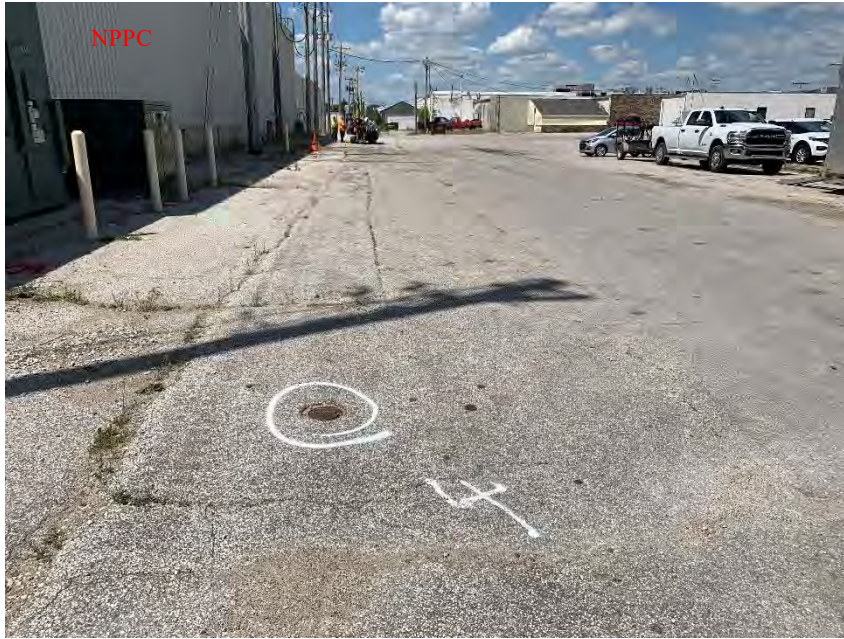
TETRA TECH PROJECT NO. X9030..19F.0086.008 DIRECTION: North	DESCRIPTION	This photograph shows MW-4 with 4-inch vault cover in place.	7
	CLIENT	Environmental Protection Agency - Region 7	DATE 6/7/2021
	PHOTOGRAPHER	Jenna Mead

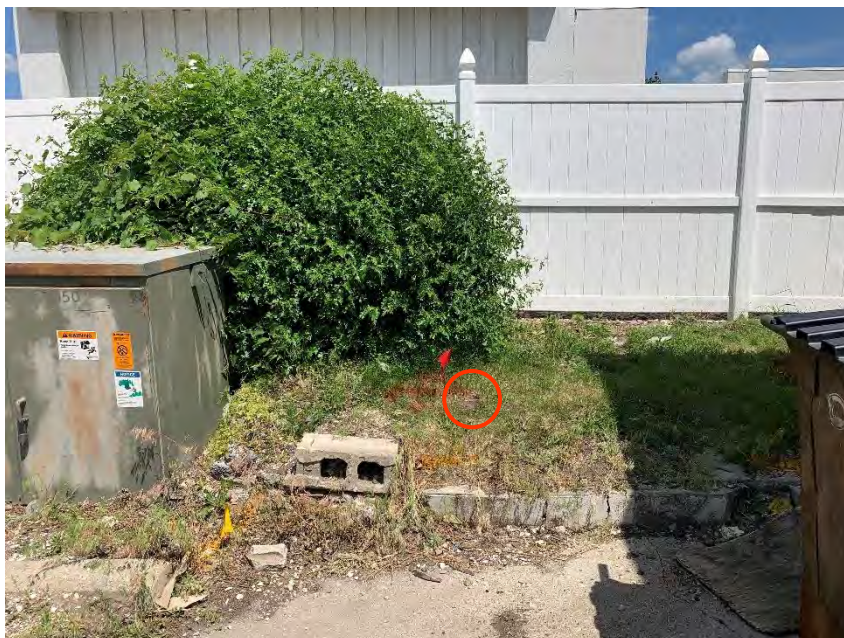
TETRA TECH PROJECT NO. X9030.19F.0086.008 DIRECTION: East	DESCRIPTION	This photograph shows MW-6 location just northeast of Sunshine Laundry building. Note underground electrical flag and markings.	8
	CLIENT	Environmental Protection Agency - Region 7	DATE 6/7/2021
	PHOTOGRAPHER	Jenna Mead

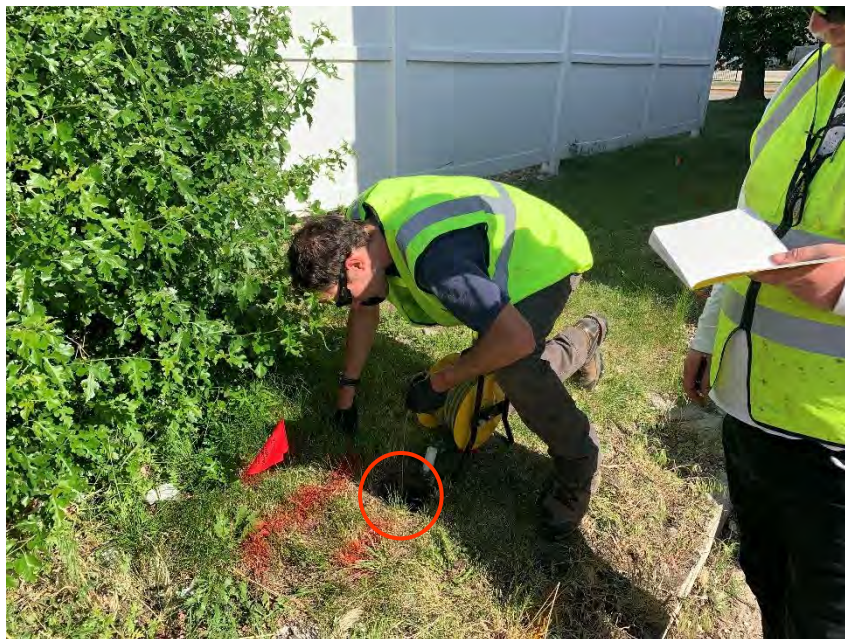
<p>TETRA TECH PROJECT NO. X9030..19F.0086.008 DIRECTION: Southeast</p>	DESCRIPTION	This photograph shows water level measurement at MW-6. Note: the subsurface electrical post-dates installation of MW-6.	9
	CLIENT	Environmental Protection Agency - Region 7	DATE 6/7/2021
	PHOTOGRAPHER	Jenna Mead

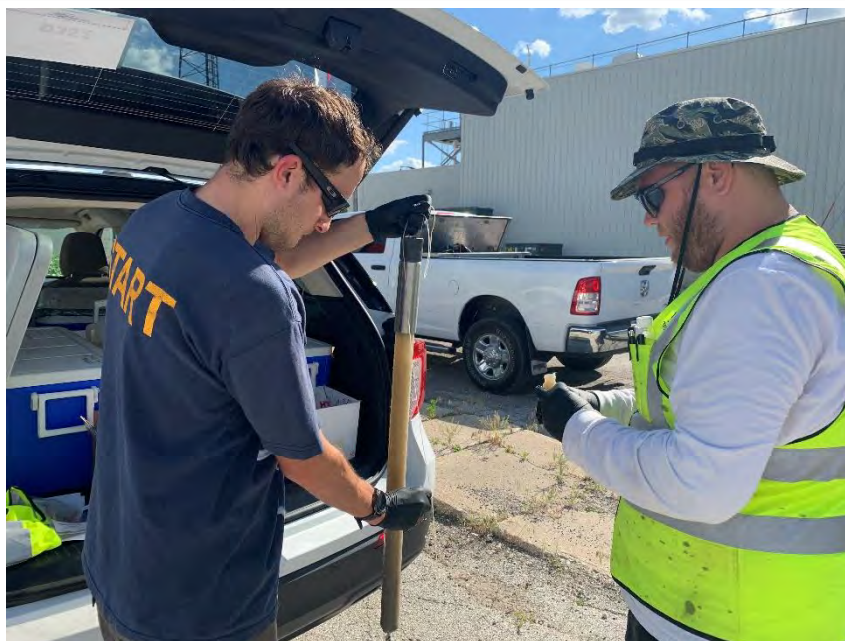
<p>TETRA TECH PROJECT NO. X9030.19F.0086.008 DIRECTION: Southwest</p>	DESCRIPTION	This photograph shows groundwater sample collected at MW-3 by use of a HydraSleeve™ sampling device.	10
	CLIENT	Environmental Protection Agency - Region 7	DATE 6/7/2021
	PHOTOGRAPHER	Jenna Mead

Samples were collected by use of HydraSleeve™ samplers, a method that does not require well purging prior to sampling. Various studies have indicated that analytical results obtained from zero-purge sampling are comparable to those acquired from low-flow sampling or from purging three well volumes. Zero-purge sampling assumes horizontal flow through the well screen or formation, which sustains constant equilibrium between the water in the well and the surrounding aquifer. Under this condition, presence of stagnant well water is less likely, thus eliminating need for purging prior to sampling.

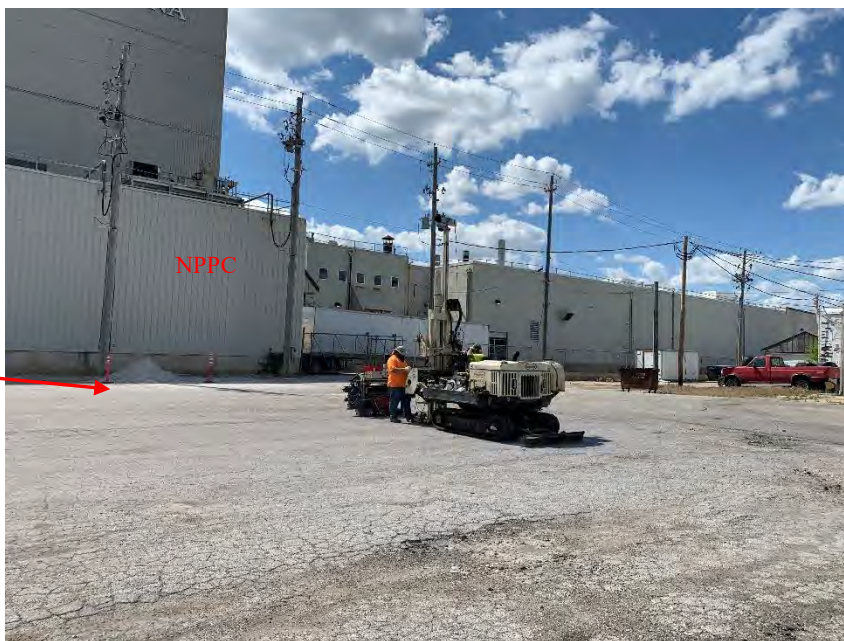
TETRA TECH PROJECT NO. X9030..19F.0086.008 DIRECTION: Northwest	DESCRIPTION	This photograph shows MIP-6 location.	11
	CLIENT	Environmental Protection Agency - Region 7	DATE 6/7/2021
	PHOTOGRAPHER	Jenna Mead

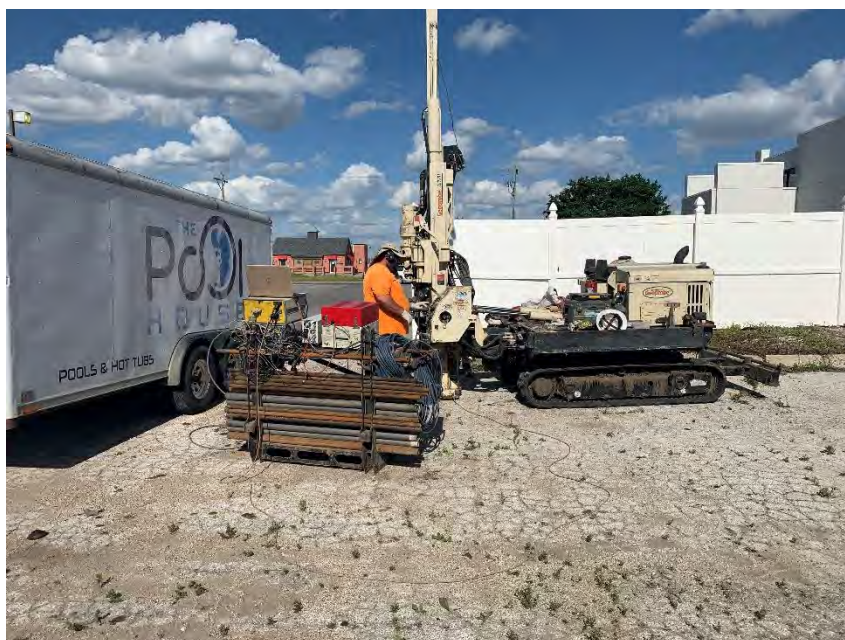
TETRA TECH PROJECT NO. X9030.19F.0086.008 DIRECTION: East	DESCRIPTION	This photograph shows MIP-8 location. Collocated with SB-9 and TW-9.	12
	CLIENT	Environmental Protection Agency - Region 7	DATE 6/7/2021
	PHOTOGRAPHER	Jenna Mead

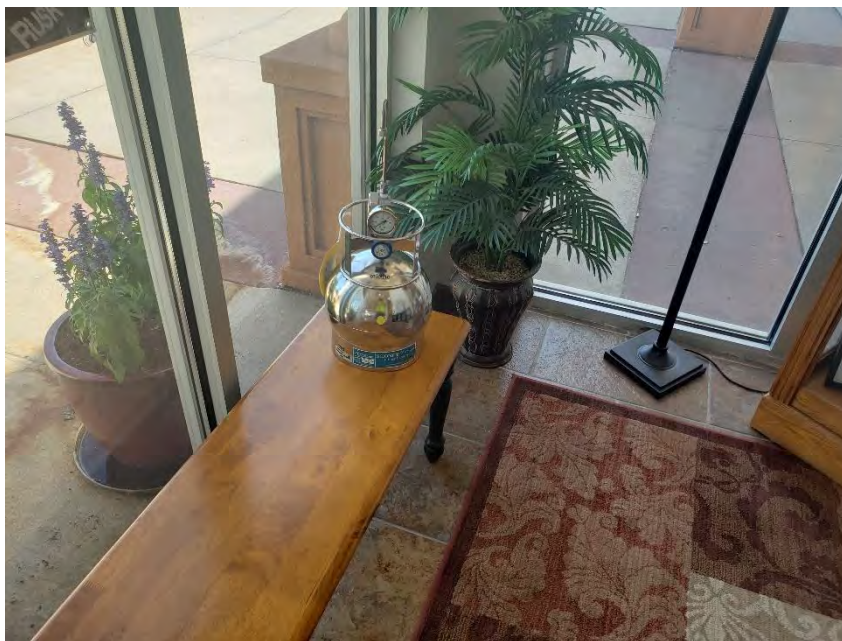
TETRA TECH PROJECT NO. X9030..19F.0086.008 DIRECTION: East	DESCRIPTION	This photograph shows indoor air sample collection at 2419 5 th Avenue South.	15
	CLIENT	Environmental Protection Agency - Region 7	DATE 6/8/2021
	PHOTOGRAPHER	Tim Barbeau

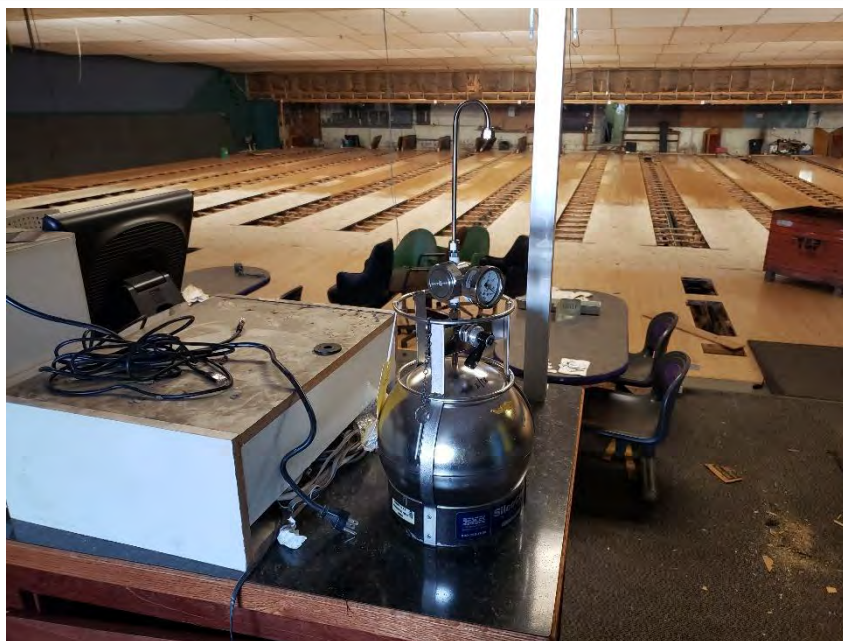
TETRA TECH PROJECT NO. X9030.19F.0086.008 DIRECTION: -	DESCRIPTION	This photograph shows indoor air sample location at vacant bowling alley at 326 S. 25 th Street.	16
	CLIENT	Environmental Protection Agency - Region 7	DATE 6/8/2021
	PHOTOGRAPHER	Tim Barbeau

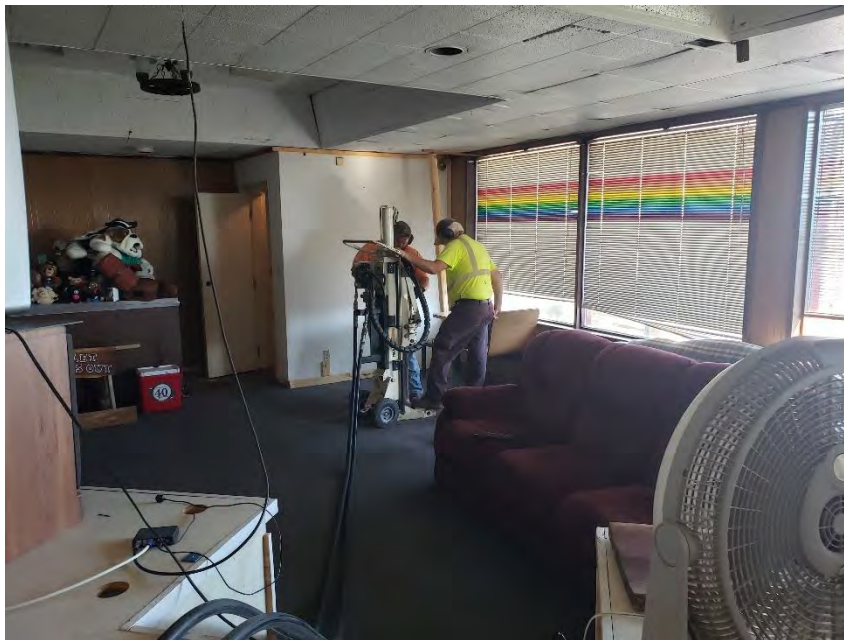
<p>TETRA TECH PROJECT NO. X9030..19F.0086.008 DIRECTION: Northwest</p>	DESCRIPTION	This photograph shows SB-1/TW-1 at northwest quadrant inside Sunshine Laundry near former dry cleaning machine's location.	17
	CLIENT	Environmental Protection Agency - Region 7	DATE 6/9/2021
	PHOTOGRAPHER	Tim Barbeau

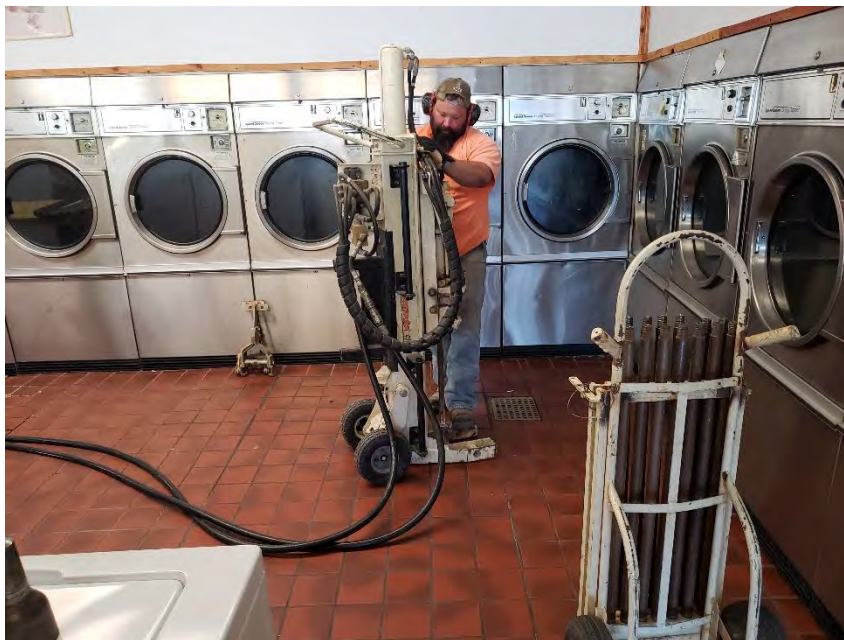
<p>TETRA TECH PROJECT NO. X9030.19F.0086.008 DIRECTION: North</p>	DESCRIPTION	This photograph shows SB-2 location in northeast quadrant of the Sunshine Laundry building.	18
	CLIENT	Environmental Protection Agency - Region 7	DATE 6/9/2021
	PHOTOGRAPHER	Tim Barbeau

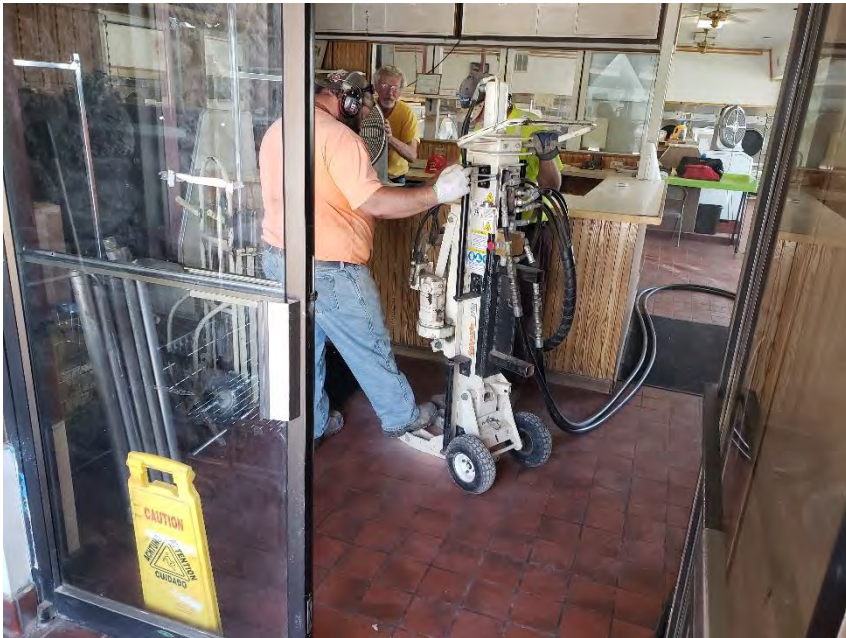
TETRA TECH PROJECT NO. X9030.19F.0086.008 DIRECTION: East	DESCRIPTION	This photograph shows SB-4/TW-2 location inside west entrance at southwest quadrant of the Sunshine Laundry building.	20
	CLIENT	Environmental Protection Agency - Region 7	DATE 6/9/2021
	PHOTOGRAPHER	Tim Barbeau

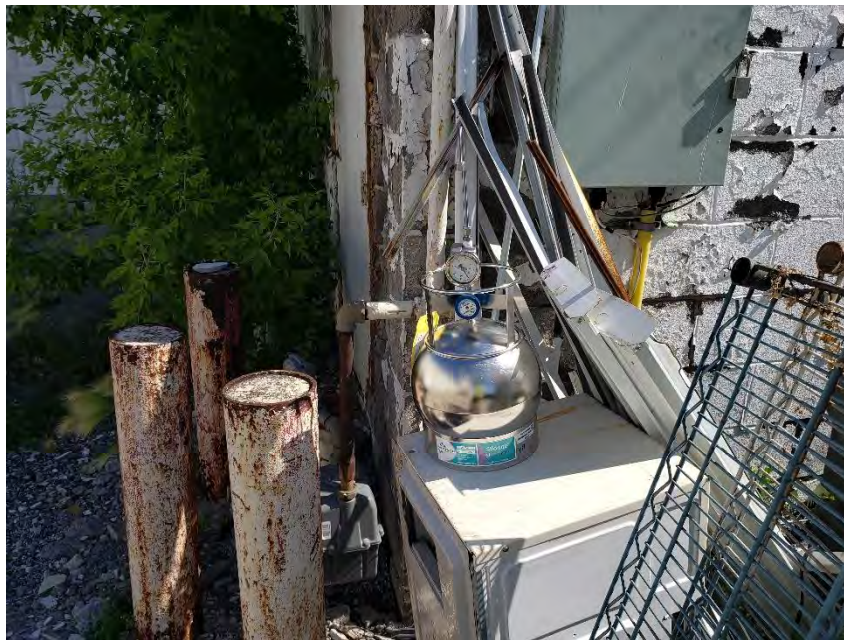
<p>TETRA TECH PROJECT NO. X9030..19F.0086.008 DIRECTION: NA</p>	DESCRIPTION	This photograph shows ambient air sample collection behind building at 330 S. 25 th Street, north of Sunshine Laundry.	21
	CLIENT	Environmental Protection Agency - Region 7	DATE 6/9/2021
	PHOTOGRAPHER	Tim Barbeau

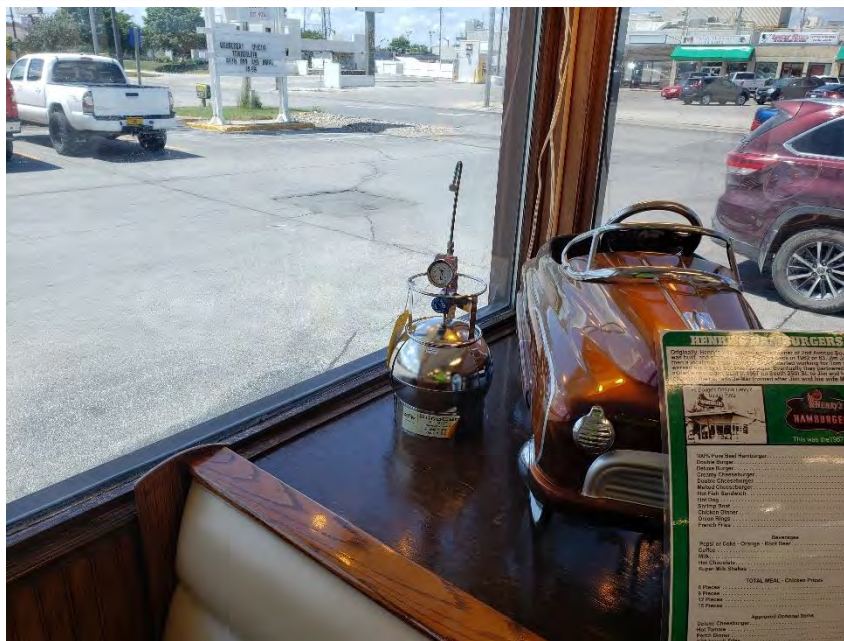
<p>TETRA TECH PROJECT NO. X9030.19F.0086.008 DIRECTION: NA</p>	DESCRIPTION	This photograph shows indoor air sample collection at 325 S. 25 th Street.	22
	CLIENT	Environmental Protection Agency - Region 7	DATE 6/9/2021
	PHOTOGRAPHER	Tim Barbeau

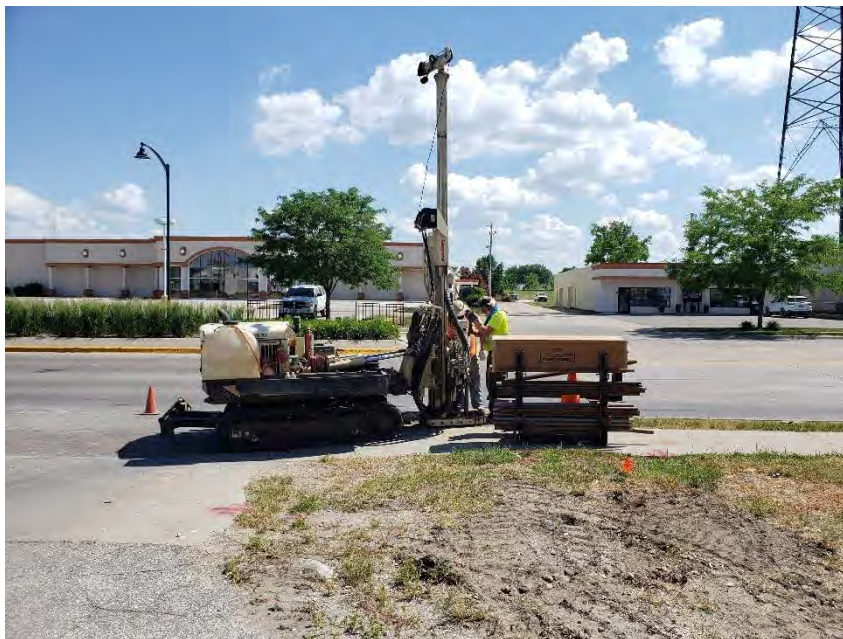
TETRA TECH PROJECT NO. X9030..19F.0086.008 DIRECTION: South	DESCRIPTION	This photograph shows SB-5 near southwest corner of Sunshine Laundry property; collocated with MIP-1 and TW-6.	23
	CLIENT	Environmental Protection Agency - Region 7	DATE 6/9/2021
	PHOTOGRAPHER	Tim Barbeau

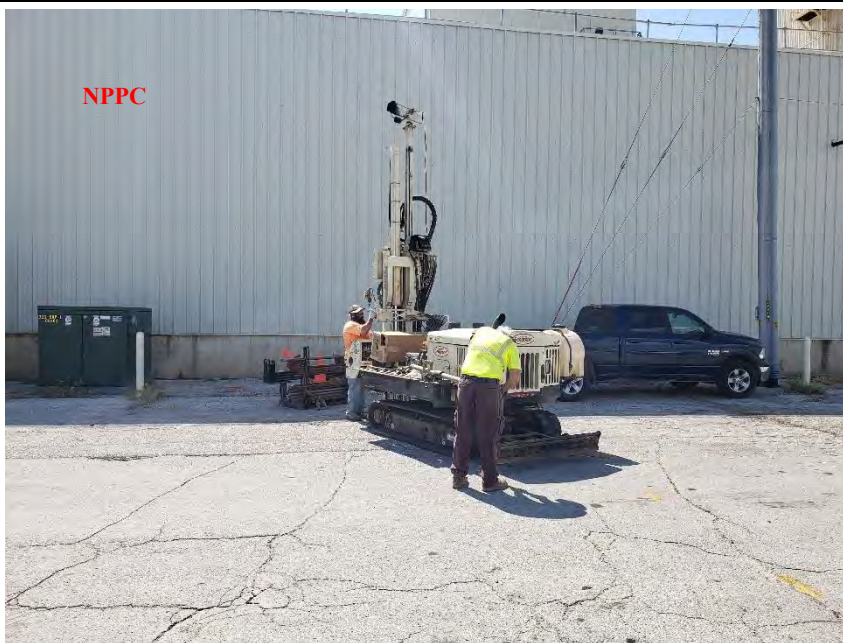
TETRA TECH PROJECT NO. X9030.19F.0086.008 DIRECTION: West	DESCRIPTION	This photograph shows SB-6 location; collocated with MIP-3, TW-7, and Soil Gas (SG)-2.	24
	CLIENT	Environmental Protection Agency - Region 7	DATE 6/9/2021
	PHOTOGRAPHER	Tim Barbeau

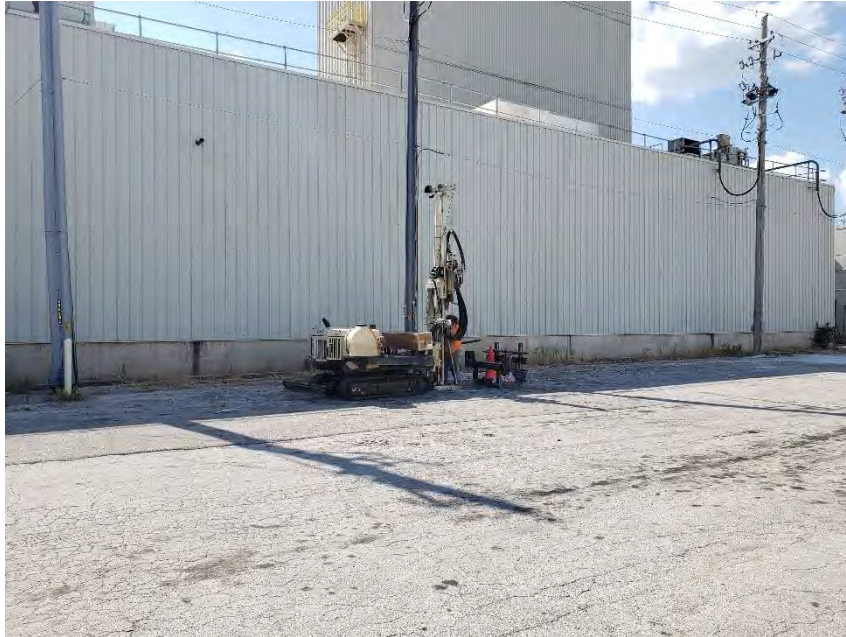
TETRA TECH PROJECT NO. X9030..19F.0086.008 DIRECTION: Northwest	DESCRIPTION	This photograph shows SB-7 location; collocated with MIP-4 and SG-1.	25
	CLIENT	Environmental Protection Agency - Region 7	DATE 6/9/2021
	PHOTOGRAPHER	Tim Barbeau

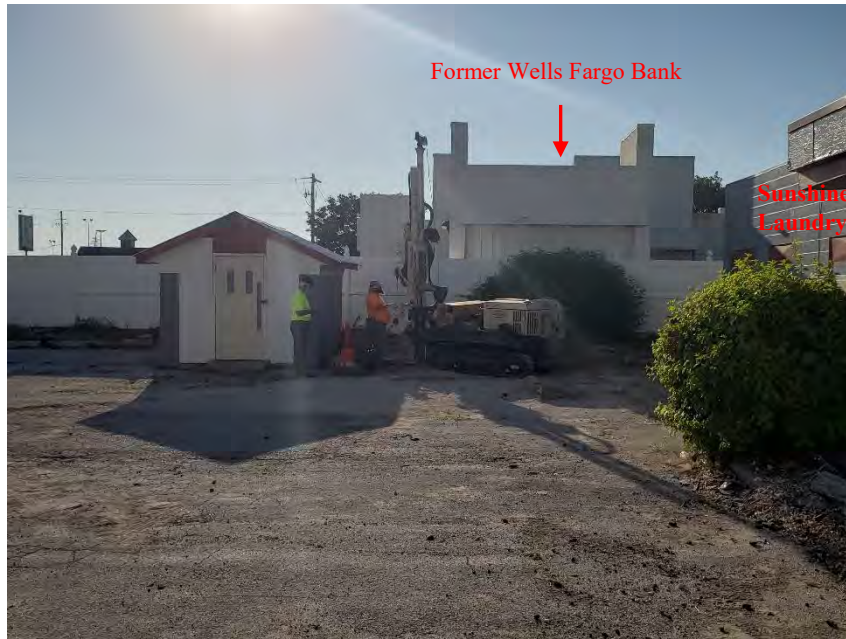
<p>TETRA TECH PROJECT NO. X9030..19F.0086.008 DIRECTION: East</p>	DESCRIPTION	This photograph shows SB-10 location between Sunshine Laundry building and shed; collocated with MIP-10.	27
	CLIENT	Environmental Protection Agency - Region 7	DATE 6/10/2021
	PHOTOGRAPHER	Tim Barbeau

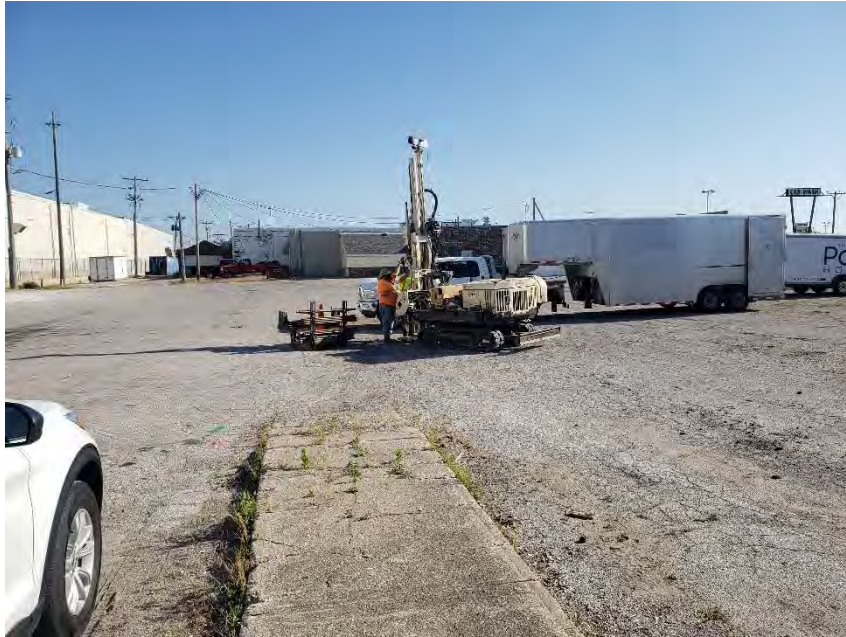
<p>TETRA TECH PROJECT NO. X9030..19F.0086.008 DIRECTION: North</p>	DESCRIPTION	This photograph shows SB-12 location just northeast of stormwater drain; collocated with MIP-12 and TW-8.	29
	CLIENT	Environmental Protection Agency - Region 7	DATE 6/10/2021
	PHOTOGRAPHER	Tim Barbeau

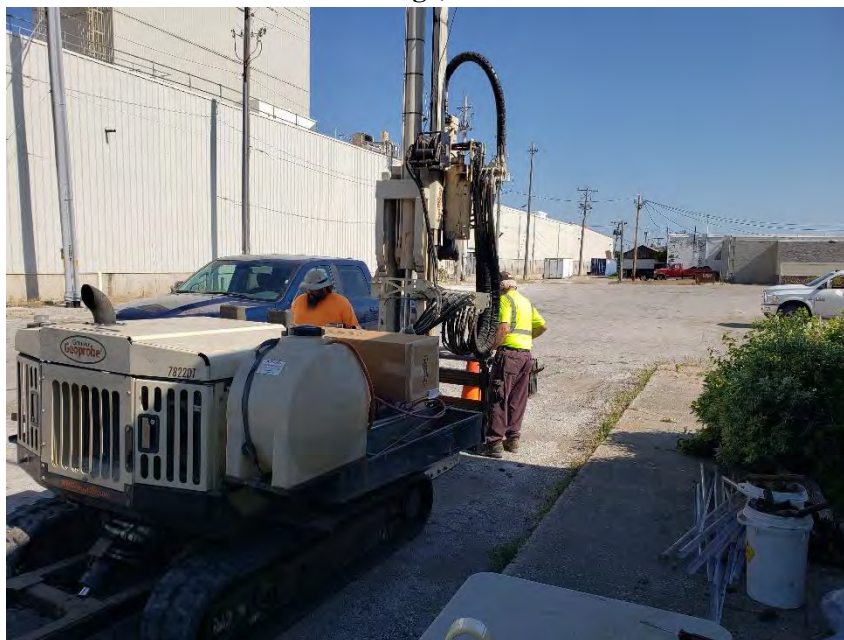
<p>TETRA TECH PROJECT NO. X9030..19F.0086.008 DIRECTION: North</p>	DESCRIPTION	This photograph shows SB-15 just northwest of Sunshine Laundry building; collocated with MIP-13.	31
	CLIENT	Environmental Protection Agency - Region 7	DATE 6/10/2021
	PHOTOGRAPHER	Tim Barbeau

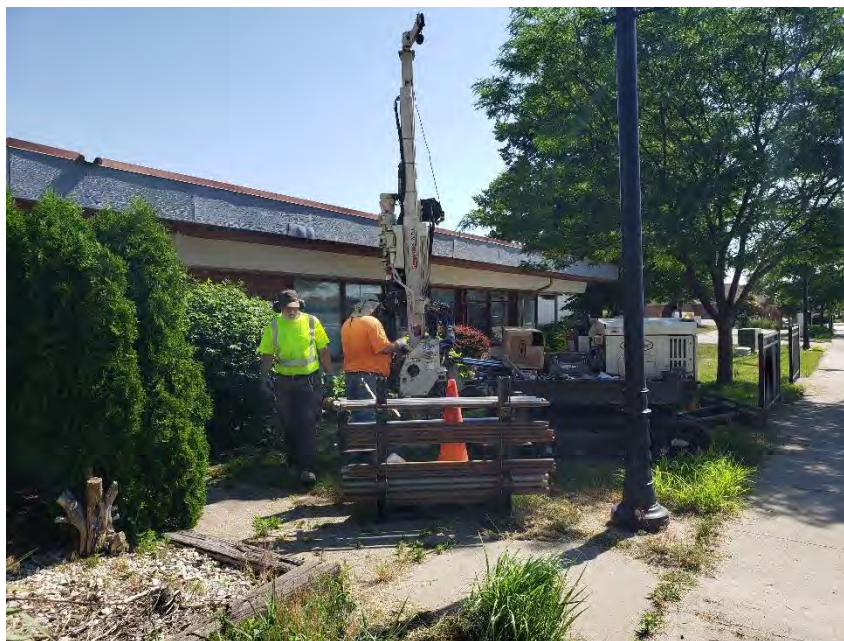
<p>TETRA TECH PROJECT NO. X9030.19F.0086.008 DIRECTION: East</p>	DESCRIPTION	This photograph shows SB-16 south of Sunshine Laundry; collocated with MIP-15 and TW-3.	32
	CLIENT	Environmental Protection Agency - Region 7	DATE 6/10/2021
	PHOTOGRAPHER	Tim Barbeau

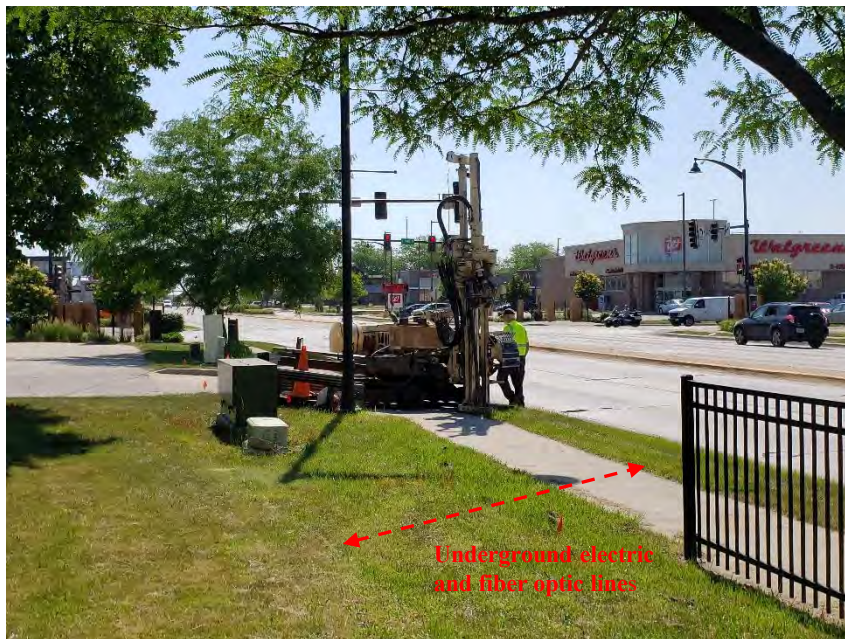
TETRA TECH PROJECT NO. X9030..19F.0086.008 DIRECTION: Southeast	DESCRIPTION	This photograph shows SB-17 at City easement near southeast corner of Sunshine Laundry property; collocated with TW-4.	33
	CLIENT	Environmental Protection Agency - Region 7	DATE 6/10/2021
	PHOTOGRAPHER	Tim Barbeau

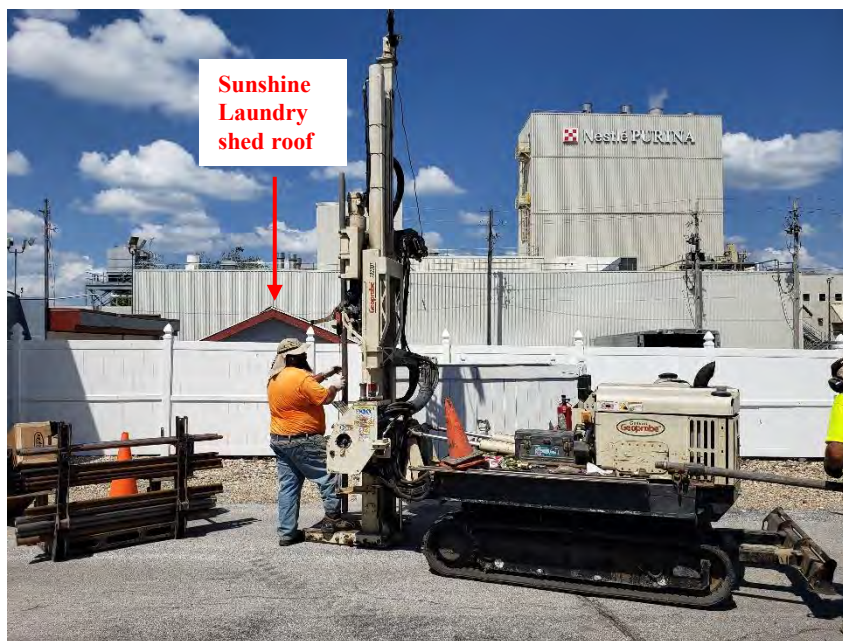
<p>TETRA TECH PROJECT NO. X9030..19F.0086.008 DIRECTION: West</p>	DESCRIPTION	This photograph shows SB-19 location north of drive-through teller lanes for former Wells Fargo Bank.	35
	CLIENT	Environmental Protection Agency - Region 7	DATE 6/10/2021
	PHOTOGRAPHER	Tim Barbeau

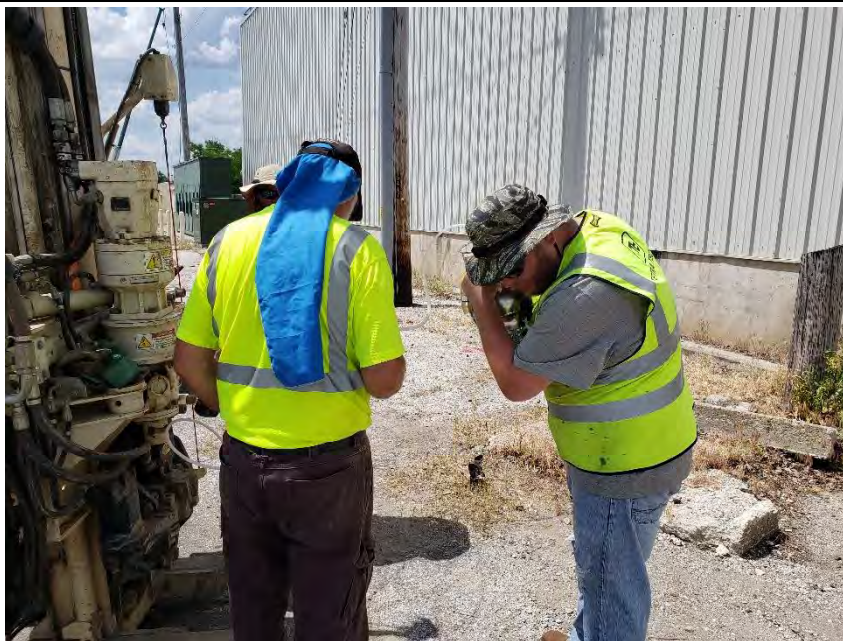
<p>TETRA TECH PROJECT NO. X9030.19F.0086.008 DIRECTION: Southwest</p>	DESCRIPTION	This photograph shows sample collection at SG-1 (MIP-4 location); re-sampled due to water drawn into canister.	36
	CLIENT	Environmental Protection Agency - Region 7	DATE 6/10/2021
	PHOTOGRAPHER	Tim Barbeau

Because a utility corridor is immediately east of the NPPC facility building, SG samples were collected about 12 to 15 feet from the building rather than within 10 feet, as specified in EPA Region 7's Vapor Intrusion Guide for comparison to these VISLs (EPA 2019). In addition, samples were collected at about 4-4.5 feet bgs—rather than the recommended depth of greater than 5 feet bgs—because an initial sampling attempt at 6 feet bgs encountered groundwater.

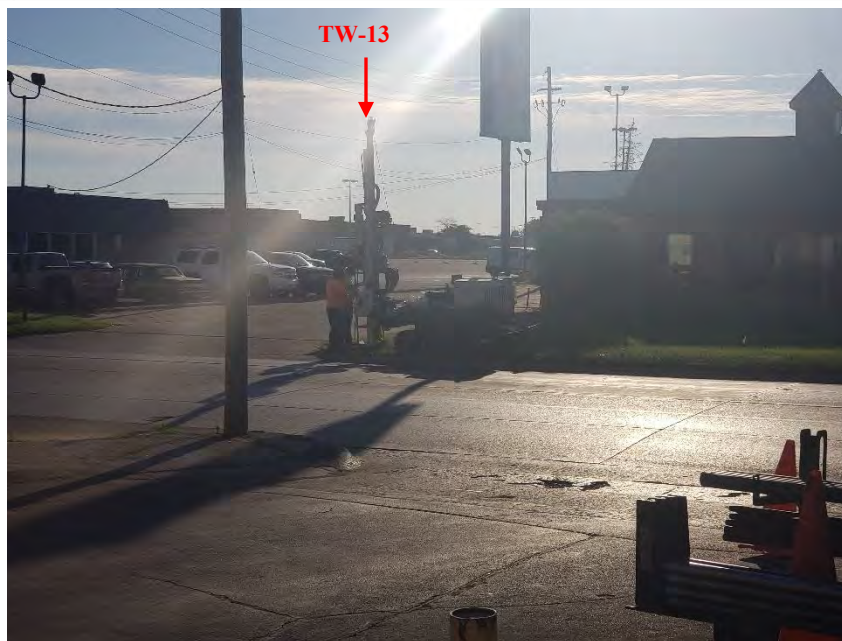
TETRA TECH PROJECT NO. X9030.19F.0086.008 DIRECTION: East	DESCRIPTION	This photograph shows TW-13 location across S. 25 th Street, northeast of site.	38
	CLIENT	Environmental Protection Agency - Region 7	DATE 6/11/2021
	PHOTOGRAPHER	Tim Barbeau

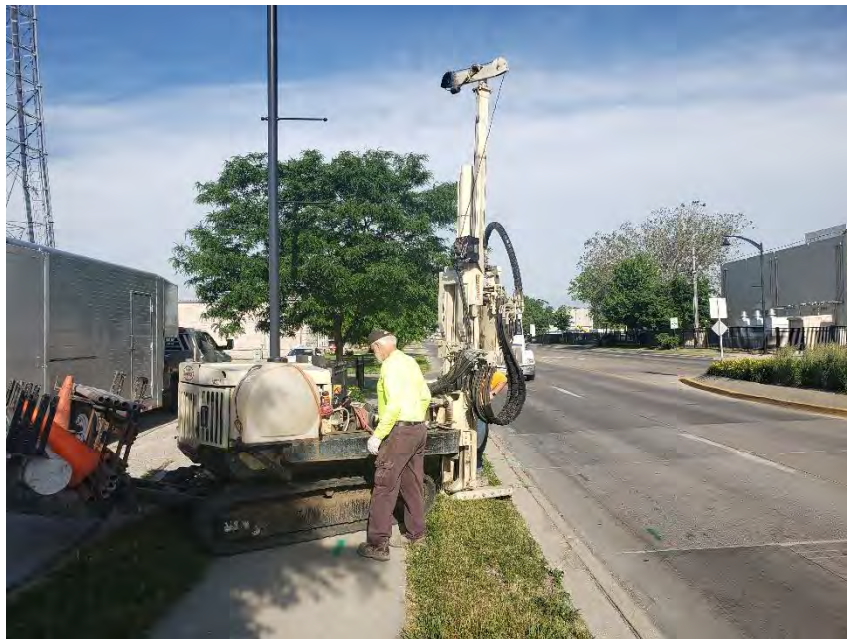
<p>TETRA TECH PROJECT NO. X9030.19F.0086.008 DIRECTION: West</p>	DESCRIPTION	This photograph shows TW-14 location across 5 th Avenue South from Sunshine Laundry property.	40
	CLIENT	Environmental Protection Agency - Region 7	DATE 6/11/2021
	PHOTOGRAPHER	Tim Barbeau

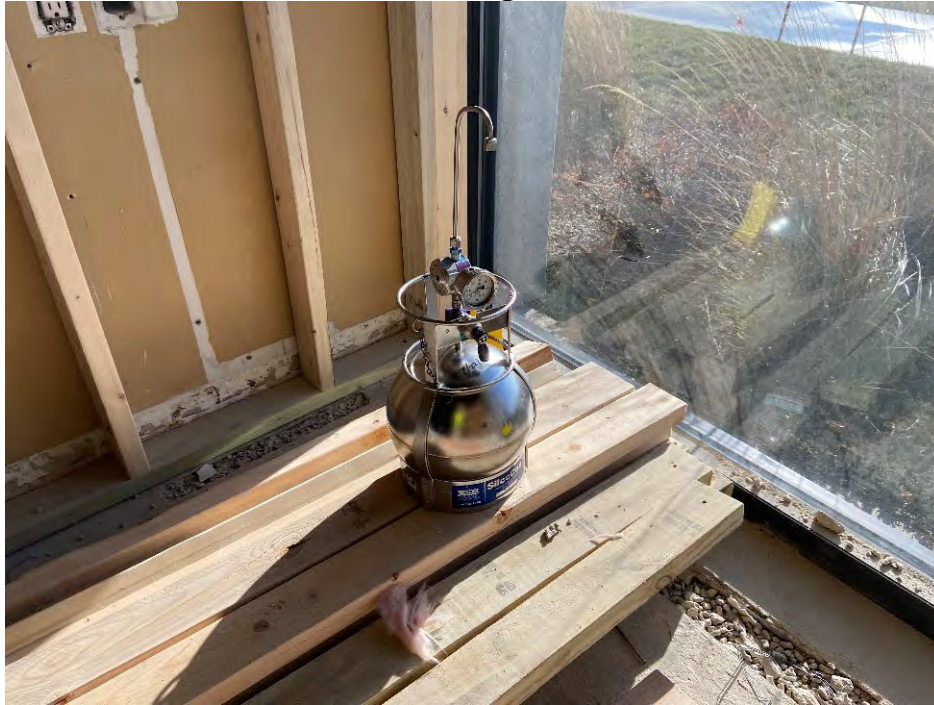
TETRA TECH PROJECT NO. X9030.19F.0086.008 DIRECTION: Southeast	DESCRIPTION	This photograph shows the indoor air sample collected at the former Wells Fargo Bank building at 406 South 25 th Street.	41
	CLIENT	Environmental Protection Agency - Region 7	DATE 12/15/2021
	PHOTOGRAPHER	Tim Barbeau
