**INTEGRATED SITE ASSESSMENT AND
REMOVAL SITE EVALUATION REPORT**

**SUNSHINE LAUNDRY SITE
FORT DODGE, IOWA**

EPA SEMS ID – IAN000706520

**Superfund Technical Assessment and Response Team (START) 5 Contract
Contract No. 68HE0719D0001, Task Order 19F0086.008**

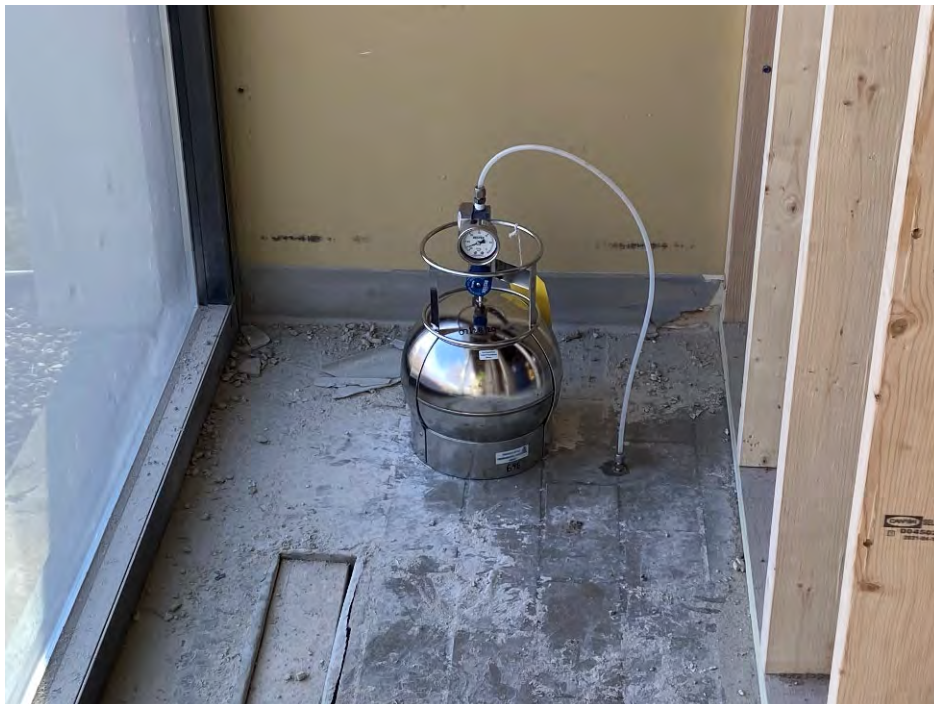
TETRA TECH PROJECT NO. X9030.19F.0086.008 DIRECTION: South	DESCRIPTION	This photograph shows the sub-slab sample collected at 406 South 25 th Street.	42
	CLIENT	Environmental Protection Agency - Region 7	DATE 12/15/2021
	PHOTOGRAPHER	Tim Barbeau

During the June 2021 sampling event, START received permission to collect sub-slab vapor samples at five of the eight properties where owners had granted indoor air sampling access. A hammer drill equipped with a 5/8-inch-diameter concrete bit was used to penetrate the concrete slab at each location. An approximately 4-inch-long, 5/8-inch-diameter stainless steel tube (vapor pin) with a silicon fitting was inserted through the drill hole into the sub-slab material. Vapor pin sample ports are easily removed after completion of sampling, and only the silicon fitting must be replaced for reuse. A removable plug on top of the vapor pin allows the port to be sealed and left in place for additional sampling, if desired.

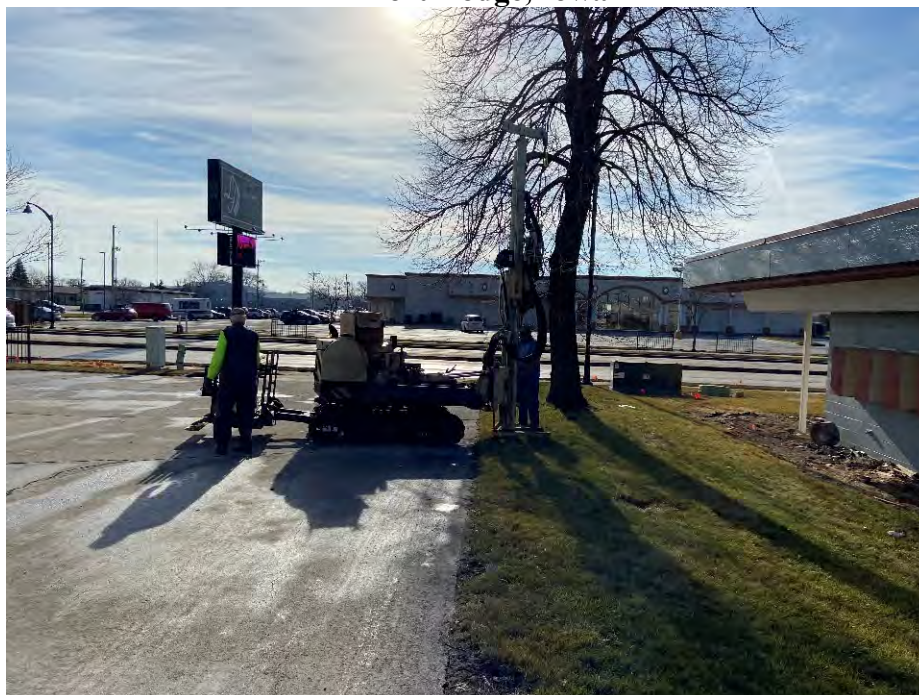
TETRA TECH PROJECT NO. X9030.19F.0086.008 DIRECTION: South	DESCRIPTION	This photograph shows soil boring (SB)-20 near the southwest corner of the former Wells Fargo Bank property.	43
	CLIENT	Environmental Protection Agency - Region 7	DATE 12/15/2021
	PHOTOGRAPHER	Tim Barbeau

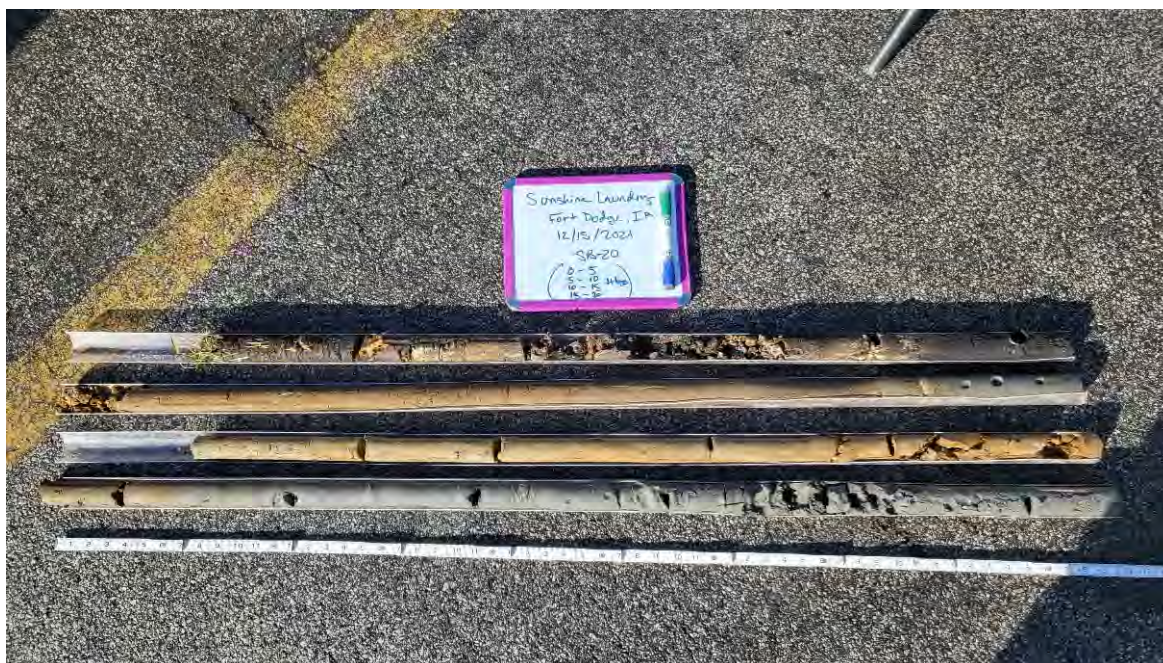
TETRA TECH PROJECT NO. X9030.19F.0086.008 DIRECTION: -	DESCRIPTION	This photograph shows the soil core from SB-20 in 5-foot intervals from 0-20 feet below ground surface (bgs).	44
	CLIENT	Environmental Protection Agency - Region 7	DATE 12/15/2021
	PHOTOGRAPHER	Stephanie Caples

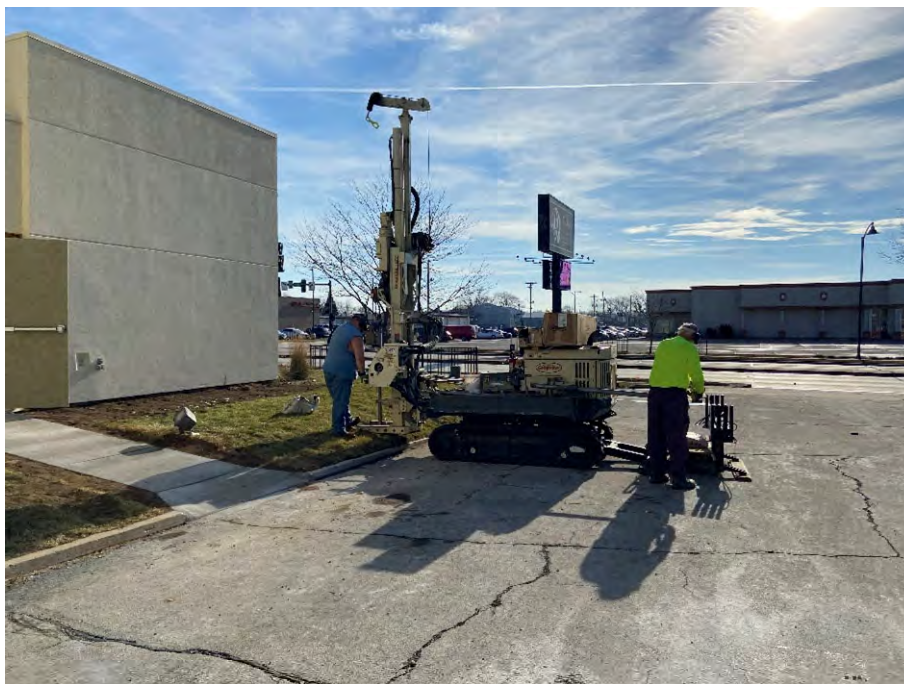
TETRA TECH PROJECT NO. X9030.19F.0086.008 DIRECTION: South	DESCRIPTION	This photograph shows SB-21.	45
	CLIENT	Environmental Protection Agency - Region 7	DATE 12/15/2021
	PHOTOGRAPHER	Tim Barbeau

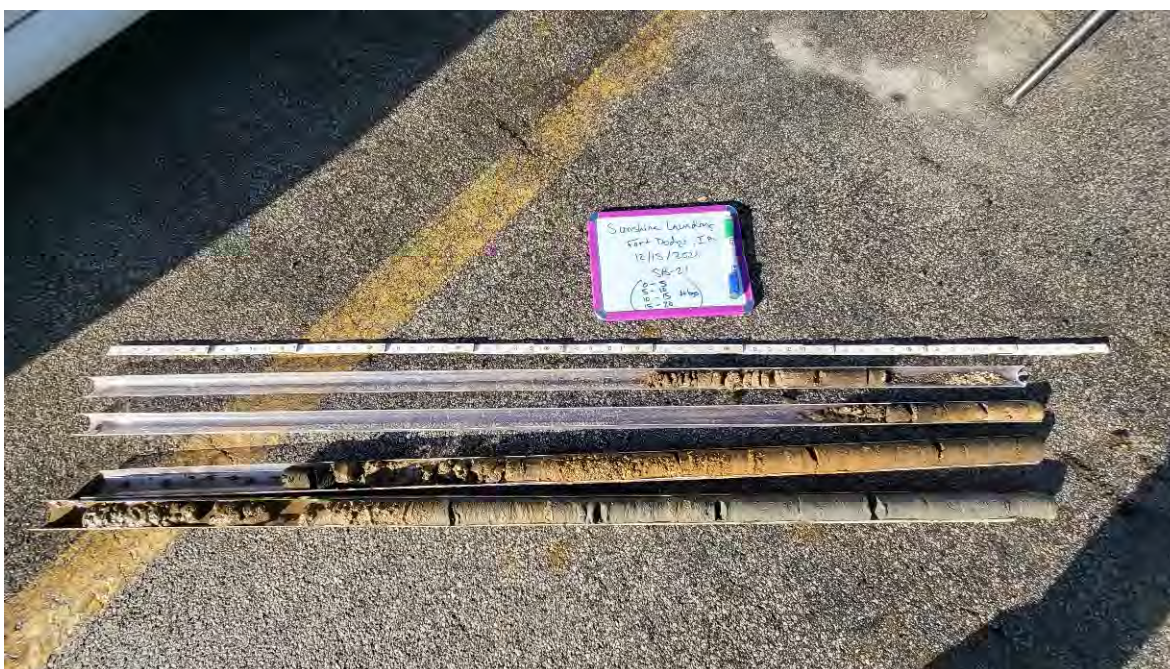
TETRA TECH PROJECT NO. X9030.19F.0086.008 DIRECTION: -	DESCRIPTION	This photograph shows the soil core from SB-21 in 5-foot intervals from 0-20 feet bgs.	46
	CLIENT	Environmental Protection Agency - Region 7	DATE 12/15/2021
	PHOTOGRAPHER	Stephanie Caples

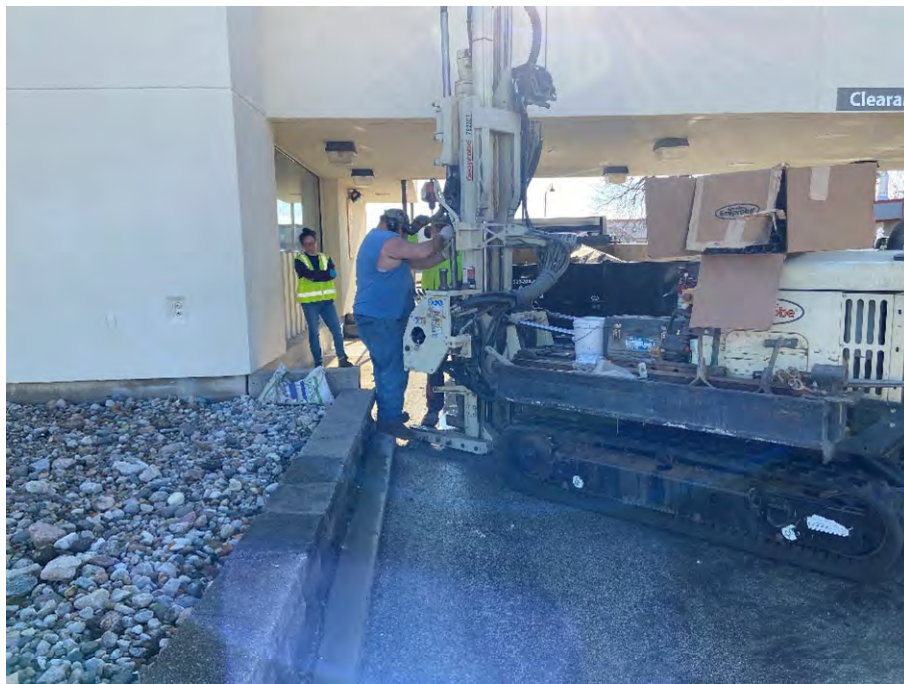
TETRA TECH PROJECT NO. X9030.19F.0086.008 DIRECTION: South	DESCRIPTION	This photograph shows SB-22 near the northwest corner of the former bank building at the canopy over drive-through lanes.	47
	CLIENT	Environmental Protection Agency - Region 7	DATE 12/15/2021
	PHOTOGRAPHER	Tim Barbeau

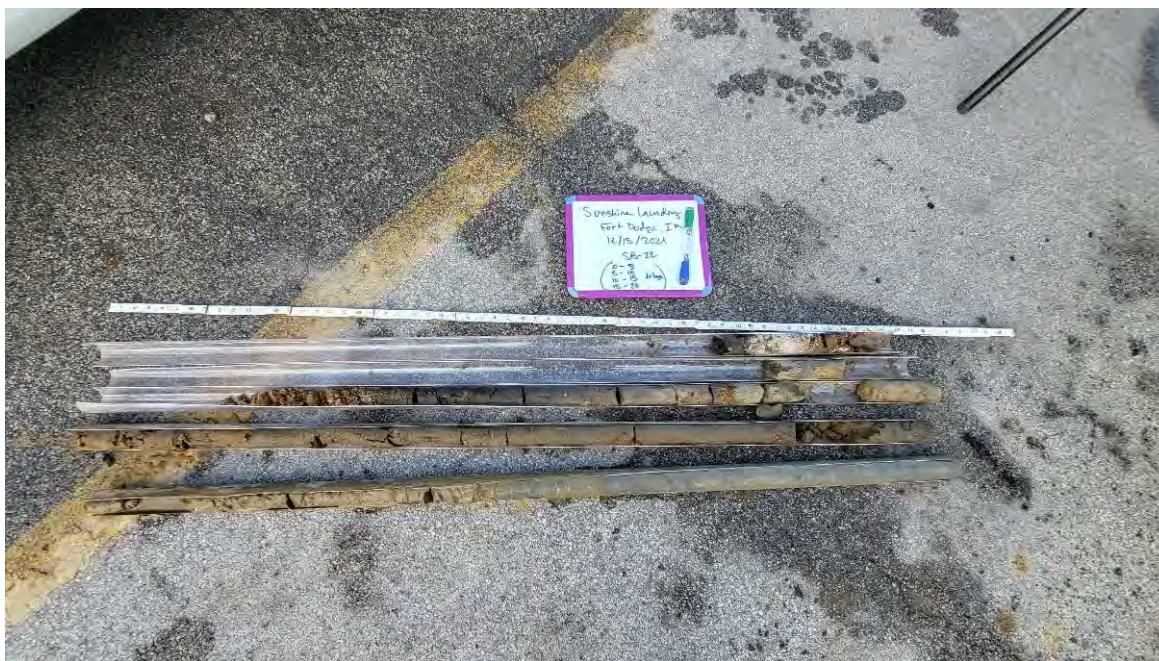
TETRA TECH PROJECT NO. X9030.19F.0086.008 DIRECTION: -	DESCRIPTION	This photograph shows the soil core from SB-22 in 5-foot intervals from 0-20 feet bgs.	48
	CLIENT	Environmental Protection Agency - Region 7	DATE 12/15/2021
	PHOTOGRAPHER	Stephanie Caples

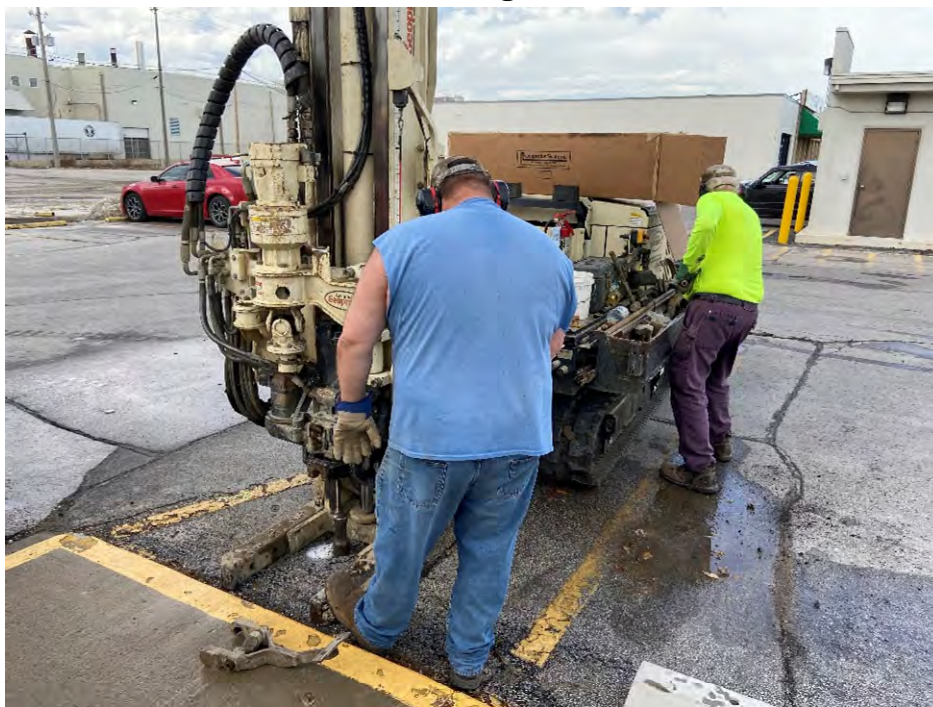
TETRA TECH PROJECT NO. X9030.19F.0086.008 DIRECTION: Northwest	DESCRIPTION	This photograph shows SB-23.	49
	CLIENT	Environmental Protection Agency - Region 7	DATE 12/15/2021
	PHOTOGRAPHER	Tim Barbeau

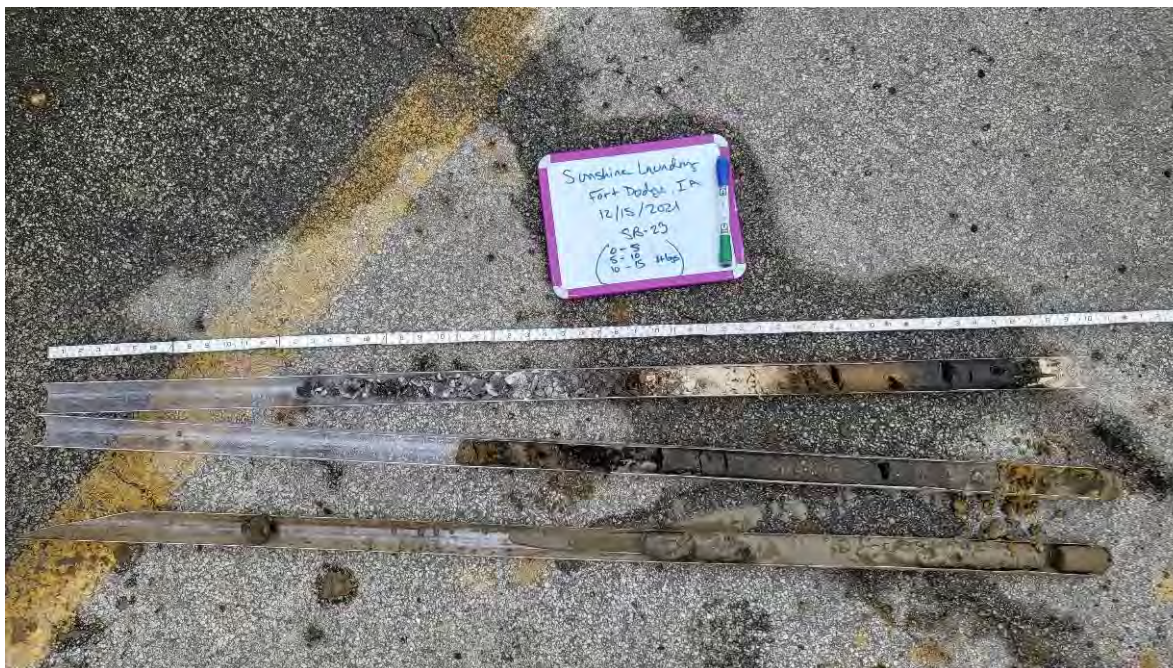
TETRA TECH PROJECT NO. X9030.19F.0086.008 DIRECTION: -	DESCRIPTION	This photograph shows the soil core from SB-23 in 5-foot intervals from 0-15 feet bgs.	50
	CLIENT	Environmental Protection Agency - Region 7	DATE 12/15/2021
	PHOTOGRAPHER	Stephanie Caples

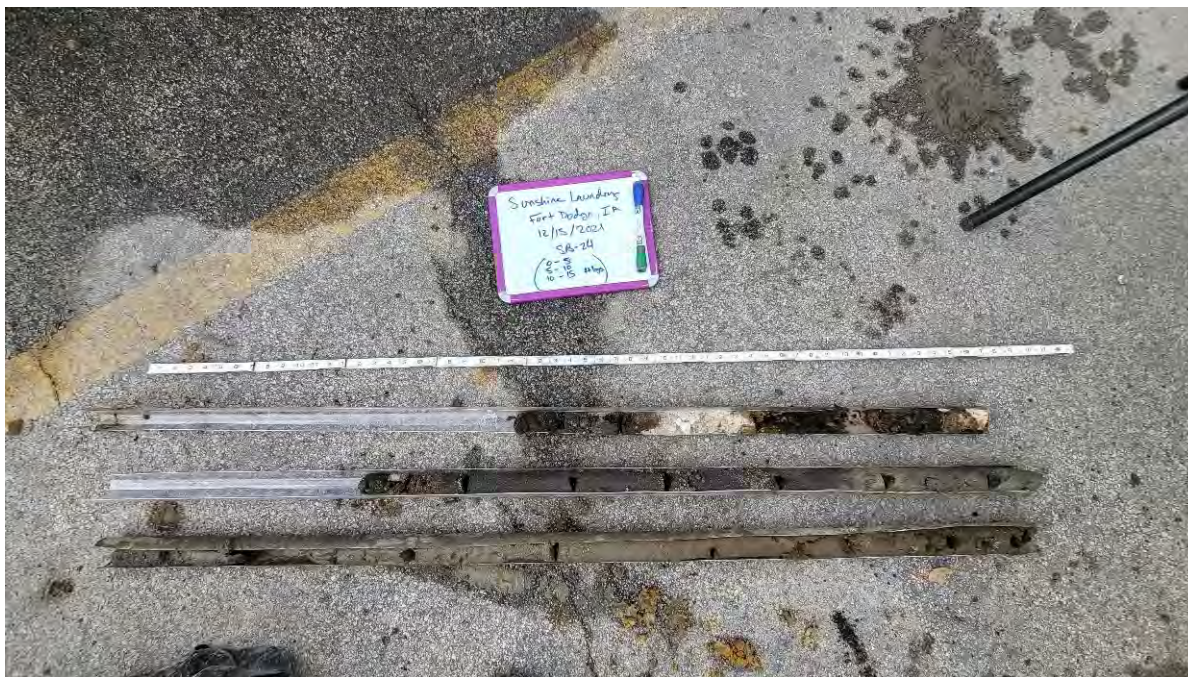
TETRA TECH PROJECT NO. X9030.19F.0086.008 DIRECTION: -	DESCRIPTION	This photograph shows the soil core from SB-24 in 5-foot intervals from 0-15 feet bgs.	52
	CLIENT	Environmental Protection Agency - Region 7	DATE 12/15/2021
	PHOTOGRAPHER	Stephanie Caples

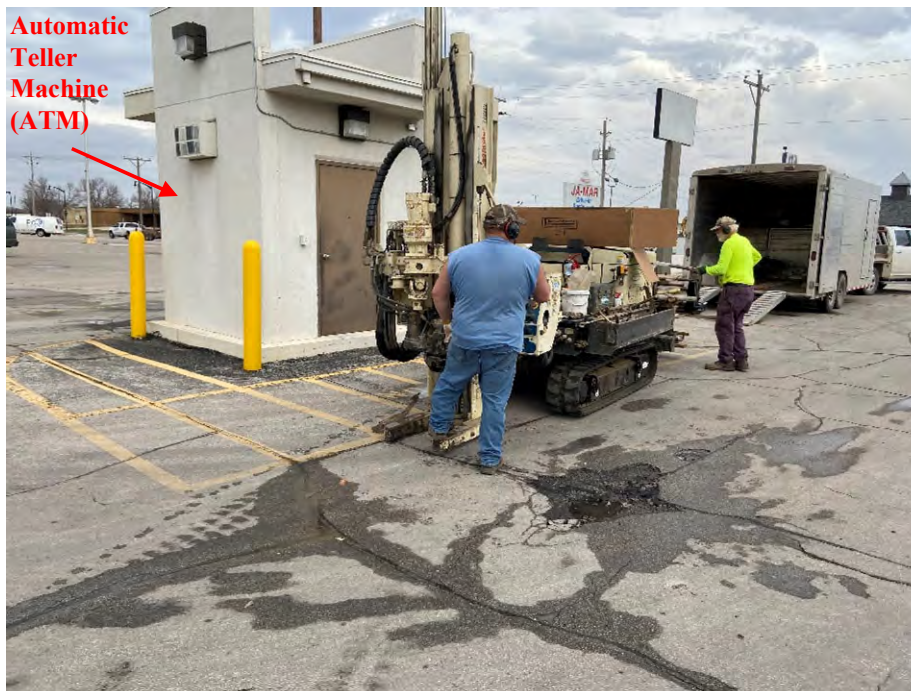
TETRA TECH PROJECT NO. X9030.19F.0086.008 DIRECTION: Northeast	DESCRIPTION	This photograph shows SB-25.	53
	CLIENT	Environmental Protection Agency - Region 7	DATE 12/15/2021
	PHOTOGRAPHER	Tim Barbeau

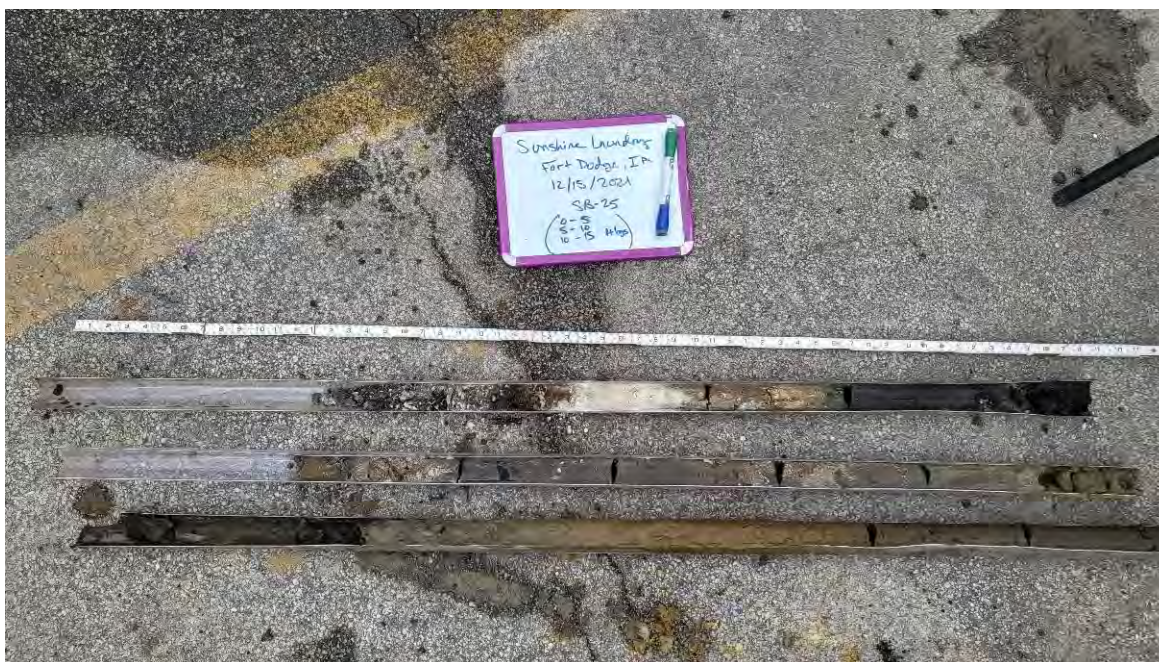
TETRA TECH PROJECT NO. X9030.19F.0086.008 DIRECTION: -	DESCRIPTION	This photograph shows the soil core from SB-25 in 5-foot intervals from 0-15 feet bgs.	54
	CLIENT	Environmental Protection Agency - Region 7	DATE 12/15/2021
	PHOTOGRAPHER	Stephanie Caples

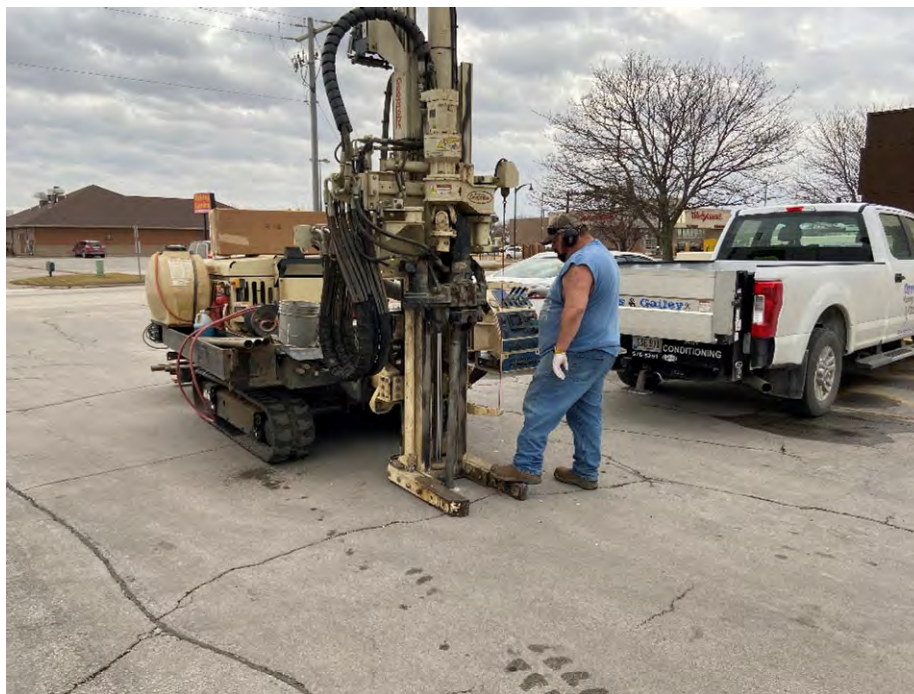
TETRA TECH PROJECT NO. X9030.19F.0086.008 DIRECTION: Southeast	DESCRIPTION	This photograph shows SB-26.	55
	CLIENT	Environmental Protection Agency - Region 7	DATE 12/15/2021
	PHOTOGRAPHER	Tim Barbeau

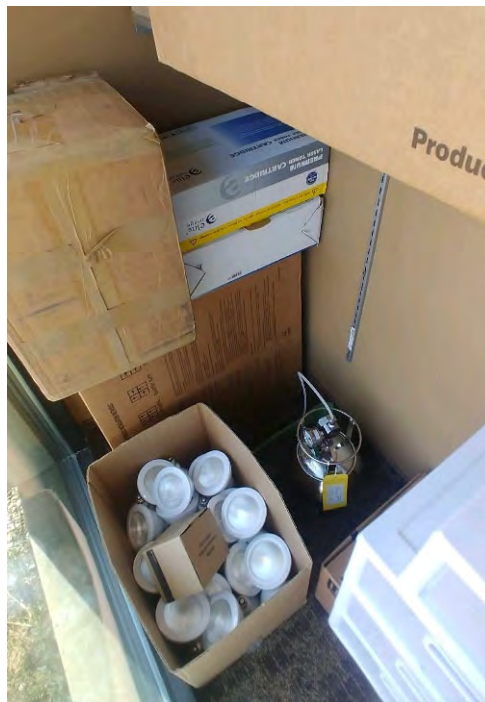
<p>TETRA TECH PROJECT NO. X9030.19F.0086.008 DIRECTION: South</p>	DESCRIPTION	This photograph shows the sub-slab vapor sample collected at Riddle's Jewelry building at 406 South 25 th Street.	57
	CLIENT	Environmental Protection Agency - Region 7	DATE 3/28/2022
	PHOTOGRAPHER	Thomas Kaley

sub-slab vapor sample collected at the former bank about 20 feet southeast of the original sampling location contained PCE at 33 $\mu\text{g}/\text{m}^3$. In March 2022, PCE was detected at 71 $\mu\text{g}/\text{m}^3$ at that sub-slab port location. In June 2022, PCE at 130 $\mu\text{g}/\text{m}^3$ was detected in the sub-slab sample. The PCE-degradation products TCE, *cis*-1,2-DCE, and *trans*-1,2-DCE have also been detected in the sub-slab vapor samples. These compounds were reported in various indoor air and sub-slab samples, but at concentrations well below EPA Region 7 commercial RMLs.

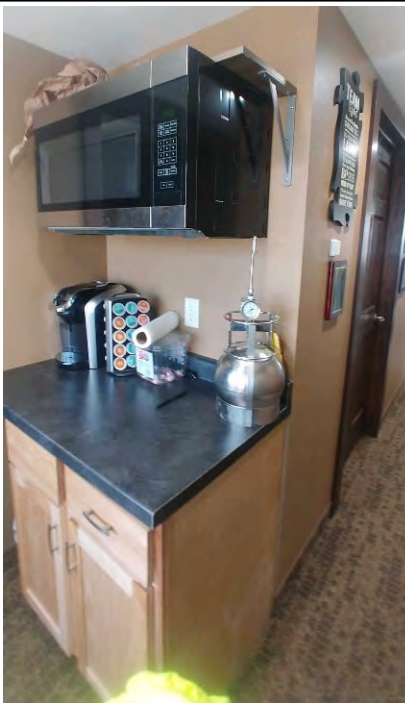
<p>TETRA TECH PROJECT NO. X9030.19F.0086.008 DIRECTION: North</p>	DESCRIPTION	This photograph shows the sub-slab sample collected at 406 South 25 th Street.	58
	CLIENT	Environmental Protection Agency - Region 7	DATE 12/28/2021
	PHOTOGRAPHER	Thomas Kaley
