Lisbon Valley Mining District

Removal Site Update

Operations Period: 06 November 14-20, 2022

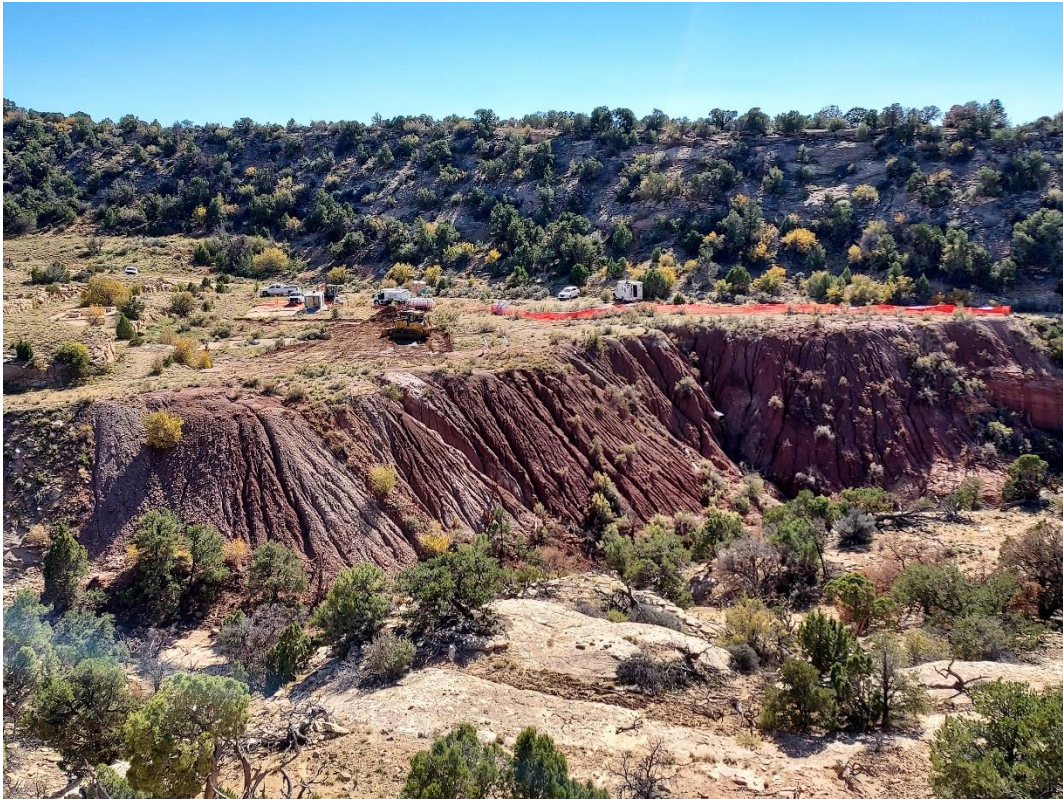
Radon Mine at the beginning of EPA's Removal Action:

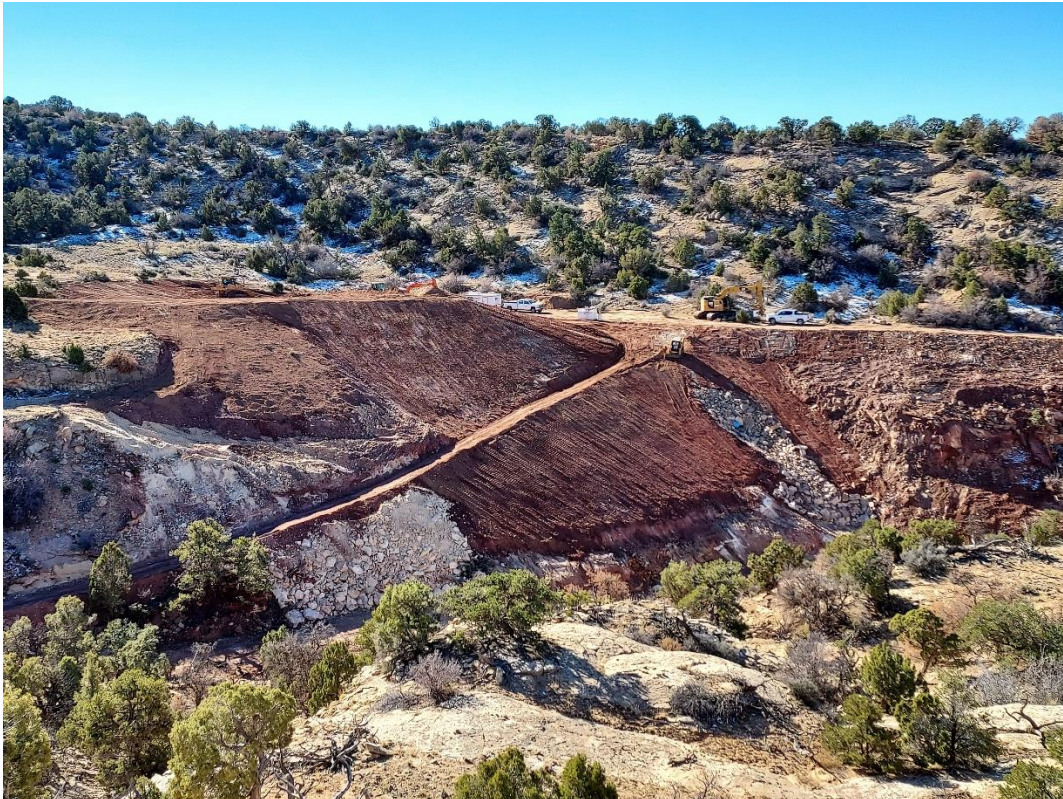
Radon Mine at the End of this Operations Period:

EPA's Response Team pulled the toe of the Radon Mine waste pile completely out of the ephemeral drainage and above a conservative 10' deep floodway. The toe was pulled back to native bedrock in many locations and rock was used to protect native soil from erosion. Mine waste removed from the drainage was moved to the top of the pile.

The Team left the drainage and regraded their access ramp into a runoff control ditch. The entire waste pile was graded to better control erosion and keep mine waste from entering the drainage and migrating off-Site.

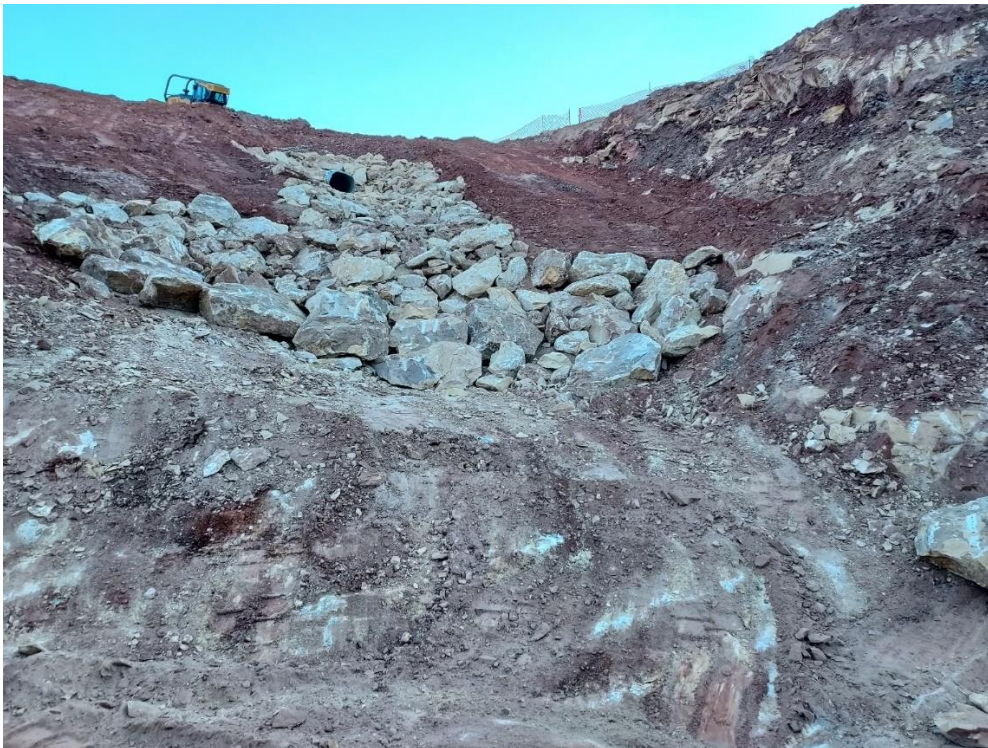
New Toe of Waste Pile and Outfall of Culvert at the Radon Mine
