## Lisbon Valley Mining District Removal Site Update

**Operations Period:** 08 November 28 – December 4, 2022

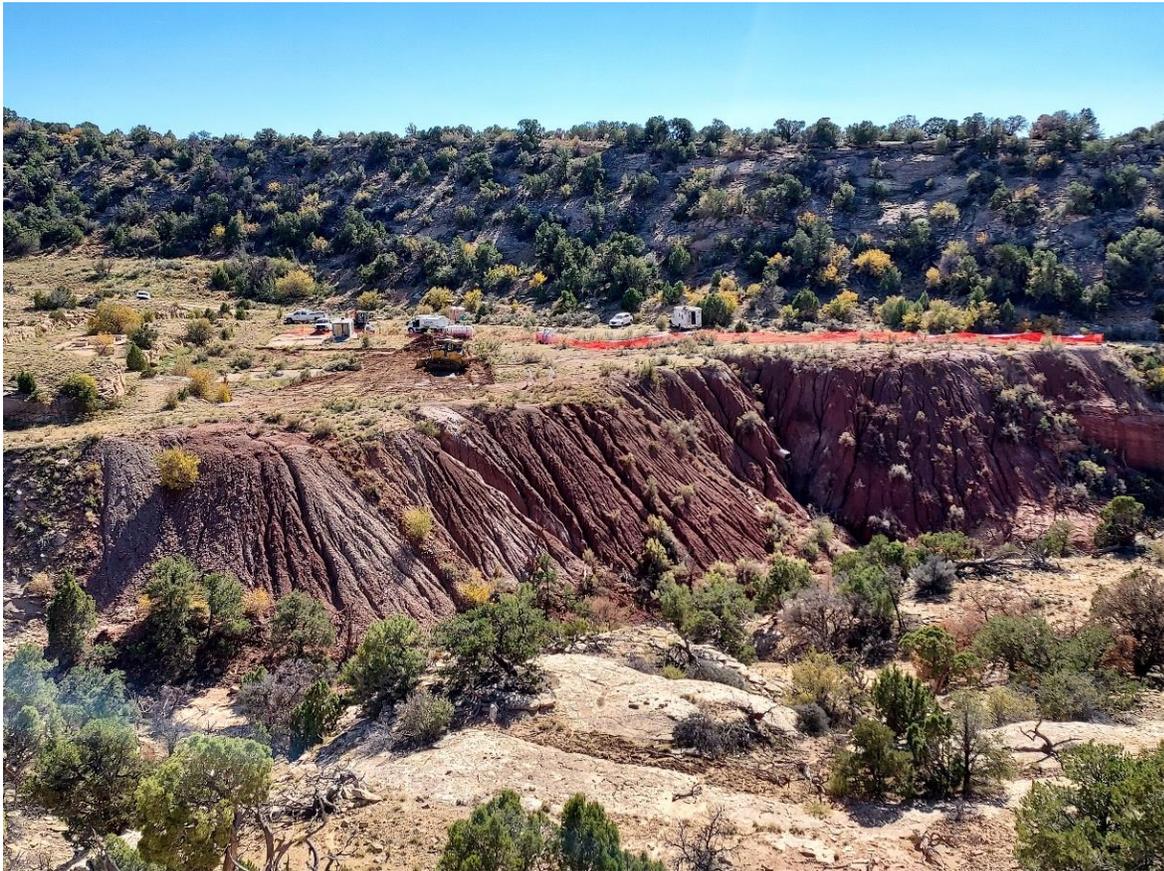
**Radon Mine at the beginning of EPA's Removal Action:**

1. Remove radioactive metal debris found on surface of waste pile.
2. Regrade the waste pile and install erosion control features.
3. Pull toe of the waste pile out of the ephemeral drainage.
4. Restrict visitor access until new vegetation is established.

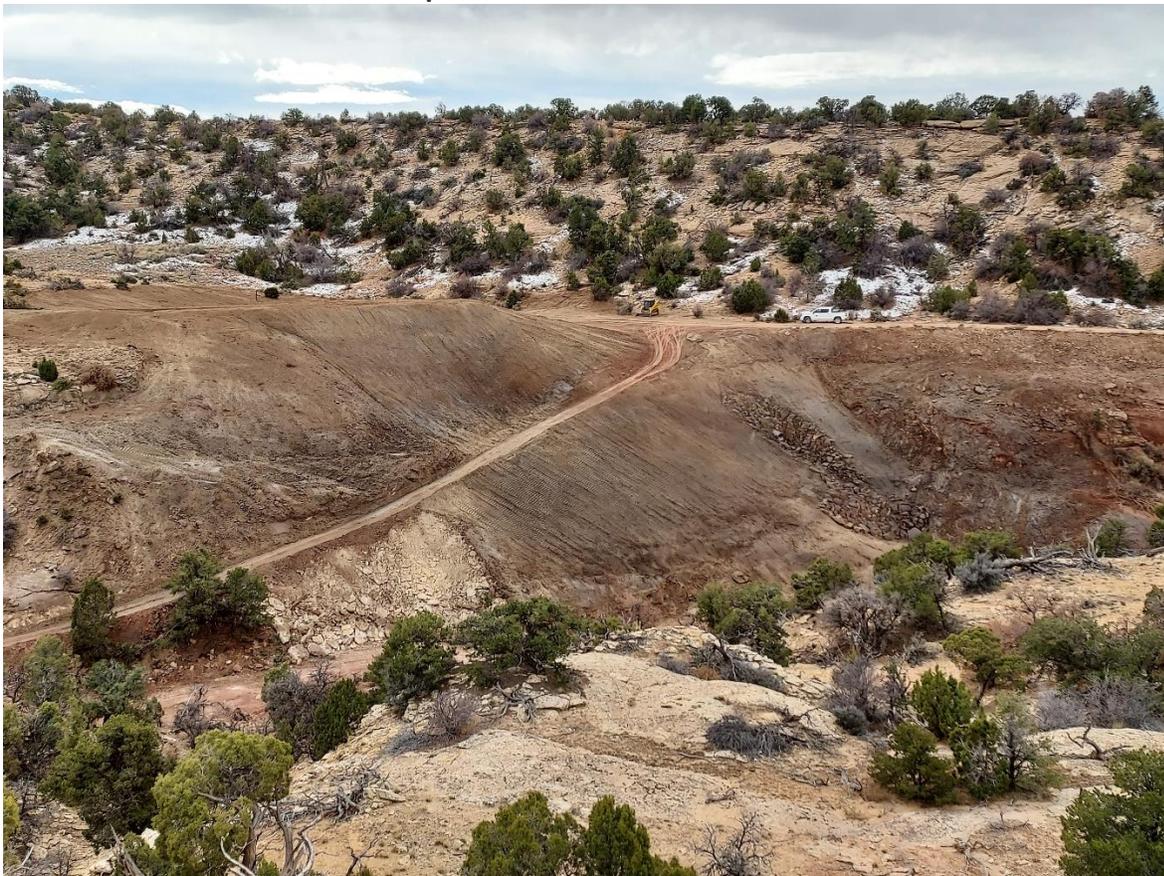
**Radon Mine at the End of this Operations Period:**

EPA's Response Team insured that the gate to the mine access road (which is located where the access road leaves the county road) remained locked and secure. The lock is not permanent but will remain in place for 1-3 years until vegetation is established on the regraded waste pile.

The Response Team will finish installing warning signs as well as erosion control waddles and rock water bars. The crew also plans to add an additional layer of hydro mulch on top of the seed and mulch that was previously applied.

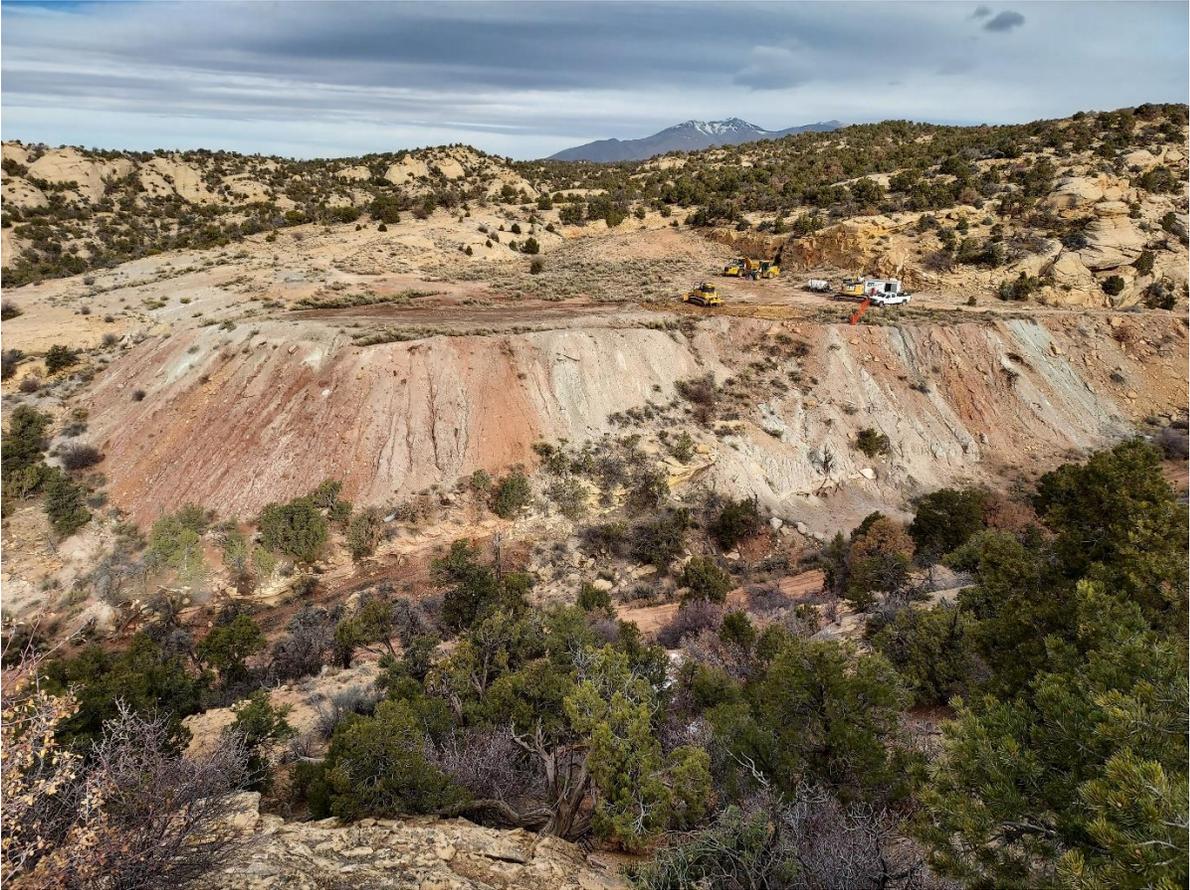
**Columbia Shaft at the beginning of EPA's Removal Action:**

1. Regrade the waste pile and install erosion control features.
2. Restrict camping and access to the waste pile.

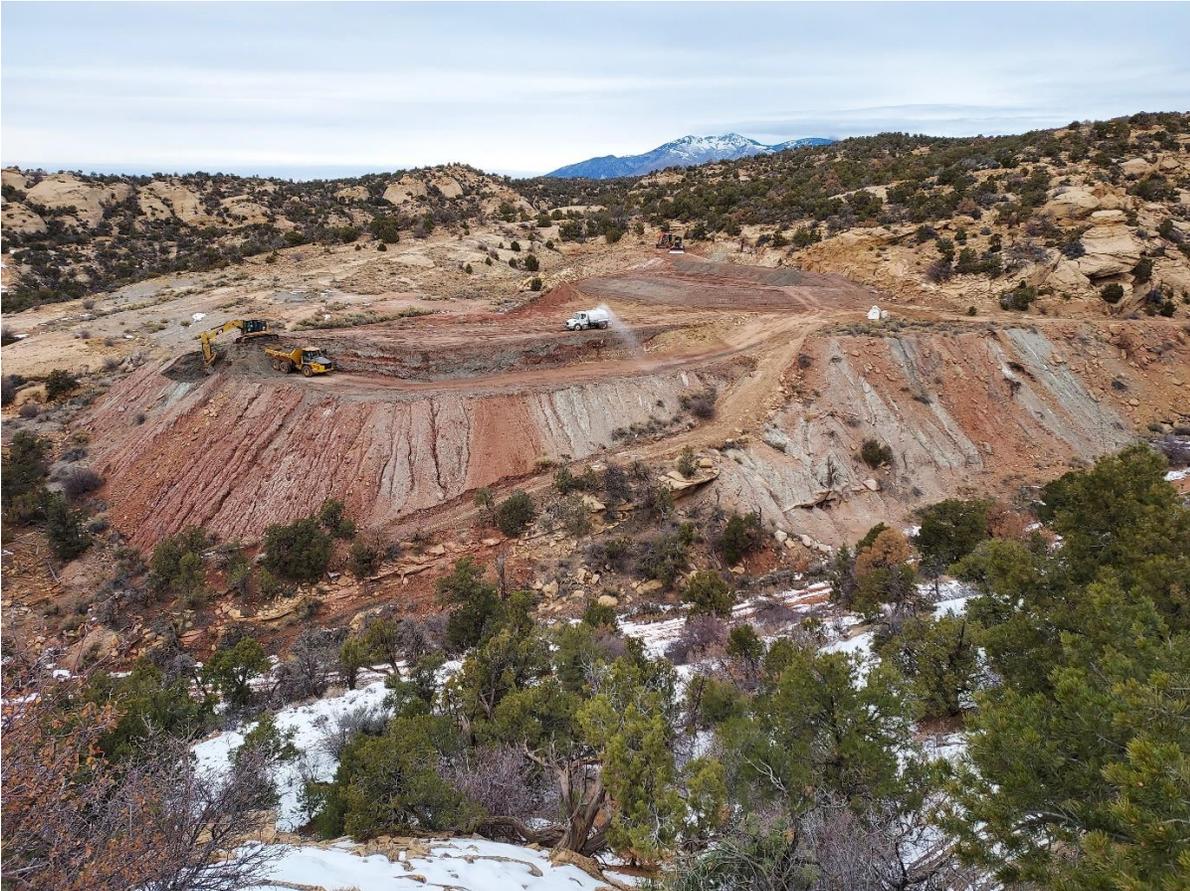
**Columbia Shaft at the End of this Operations Period:**

The crew removed the top 10 feet of waste material along the entire crown of the waste pile's face. This material was hauled a short distance to the top of the waste pile and deposited along a rock face that was quarried when the shaft was developed.

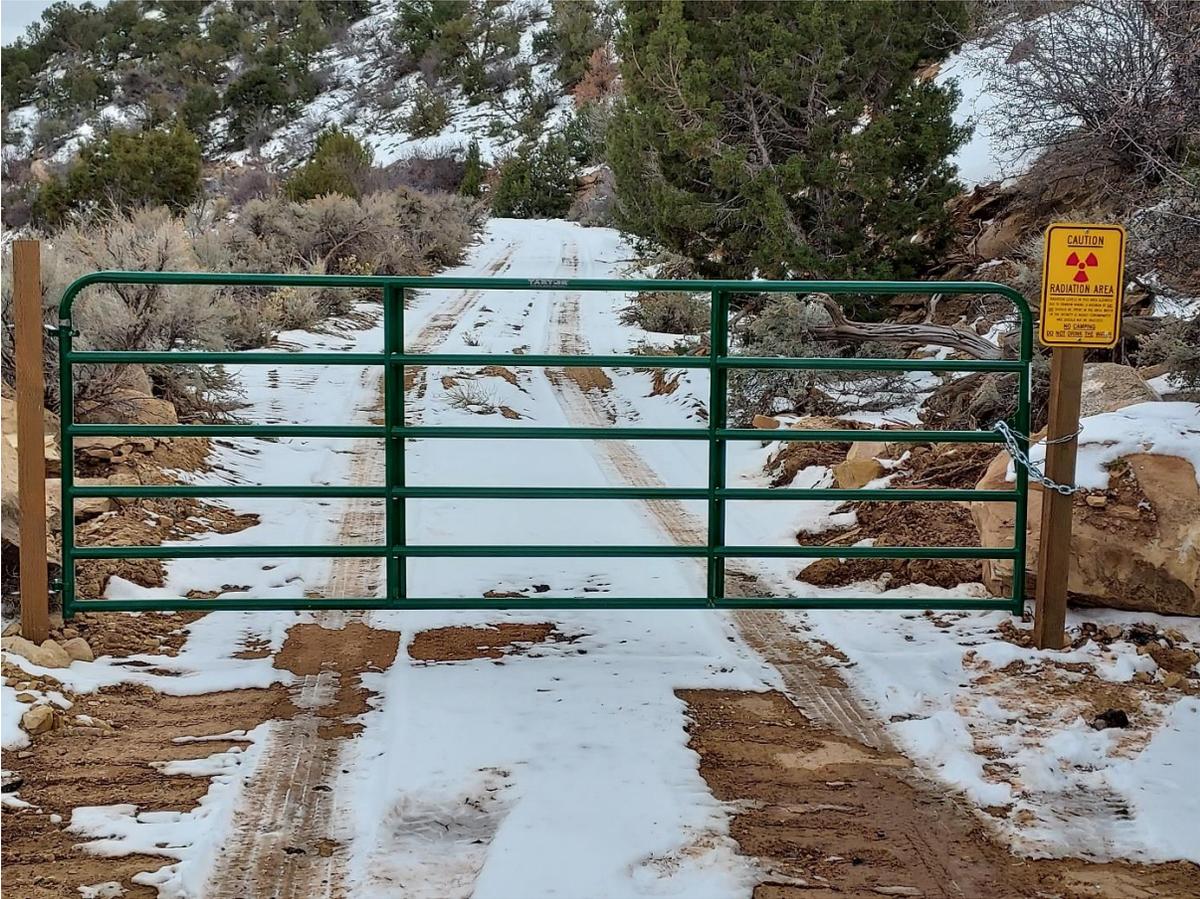
Gate and BLM Warning Sign Installed at Entrance to Mine Access Road

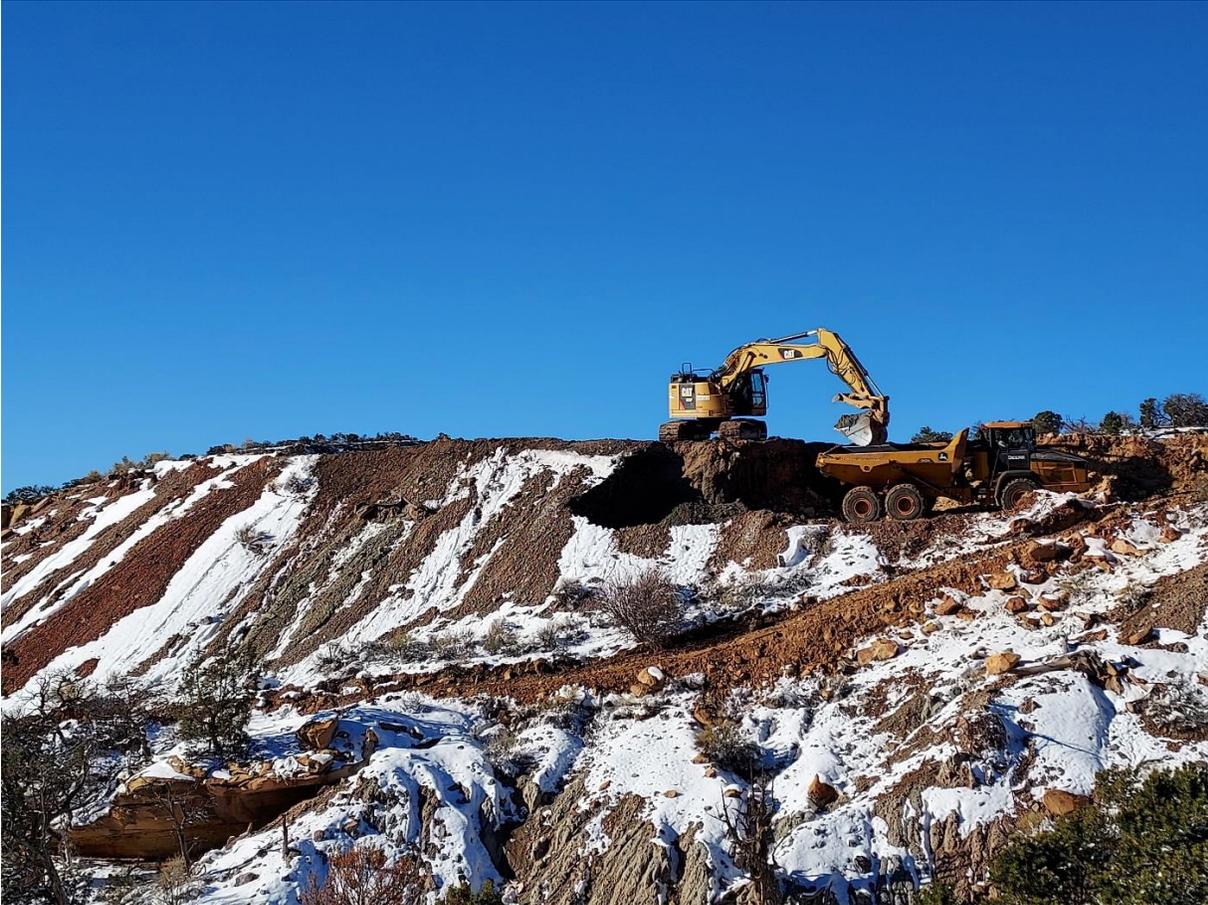
Removing the First Lift of Waste Material at the Columbia Shaft
