Former GE Hudson Falls Facility

Powerhouse Deconstruction - Overview

Powerhouse Deconstruction Progress

Allen Mill Deconstruction Status

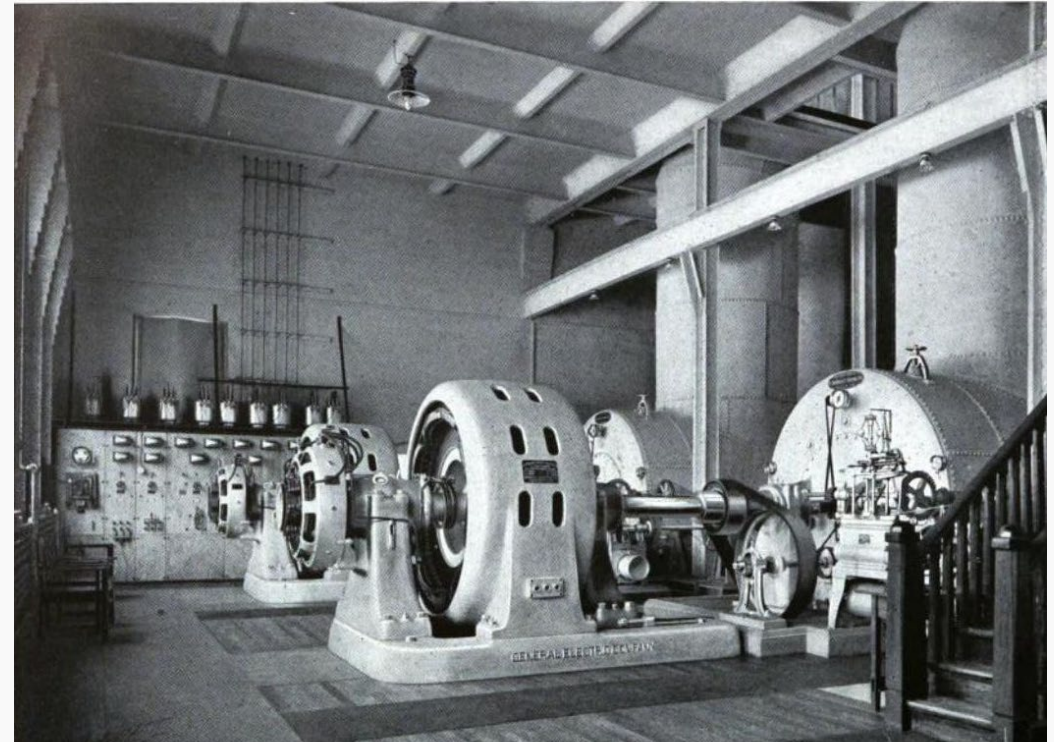
Historic photograph showing the interior of the Powerhouse Building (formerly the Union Bag & Paper Company's plant), which contained three pairs of turbines developing 1200 horsepower

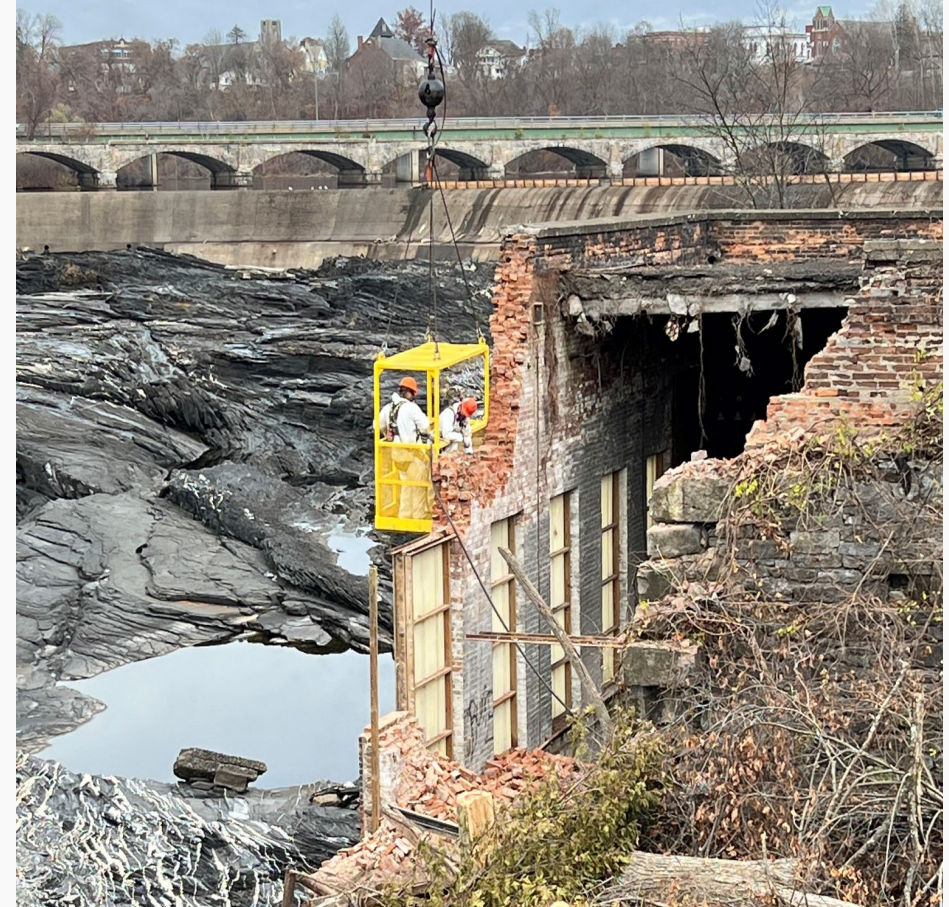
This photo shows the Powerhouse building being carefully dismantled using hand tools to limit disturbances to bedrock and minimize fallen debris into the river

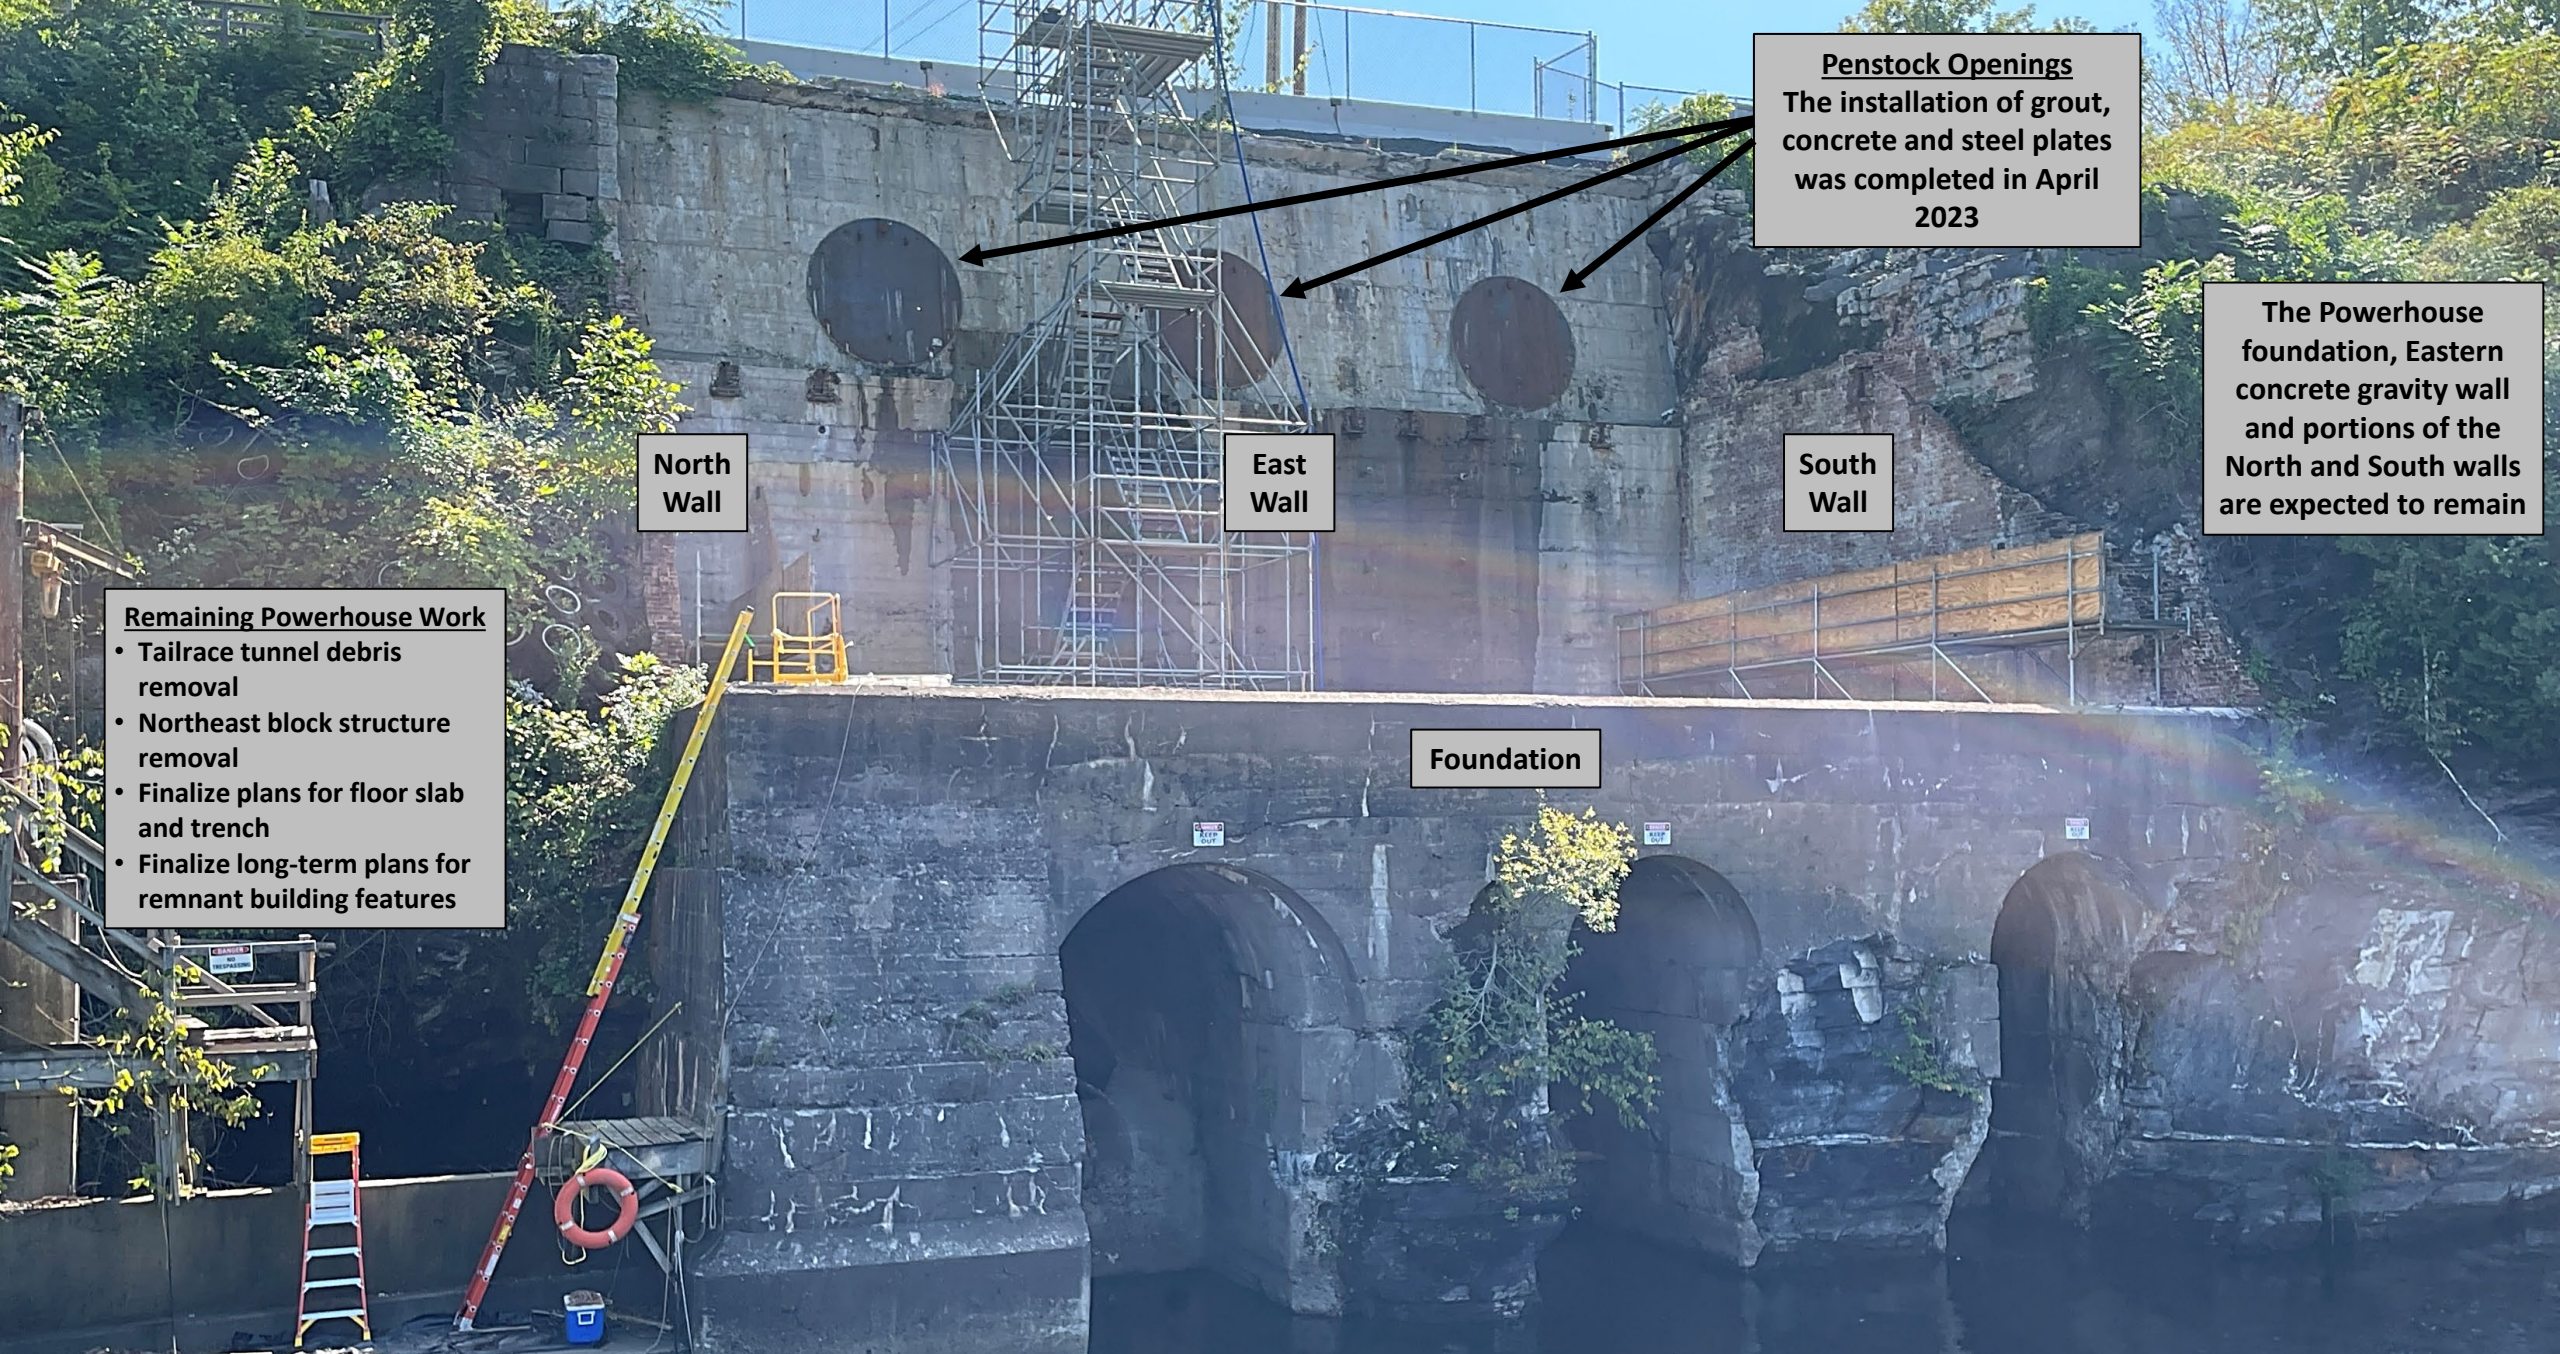
Photograph of Remaining Structures Following Deconstruction (September 2023)

Penstock Openings
The installation of grout, concrete and steel plates was completed in April 2023

The Powerhouse foundation, Eastern concrete gravity wall and portions of the North and South walls are expected to remain

- Remaining Powerhouse Work**
- Tailrace tunnel debris removal
 - Northeast block structure removal
 - Finalize plans for floor slab and trench
 - Finalize long-term plans for remnant building features

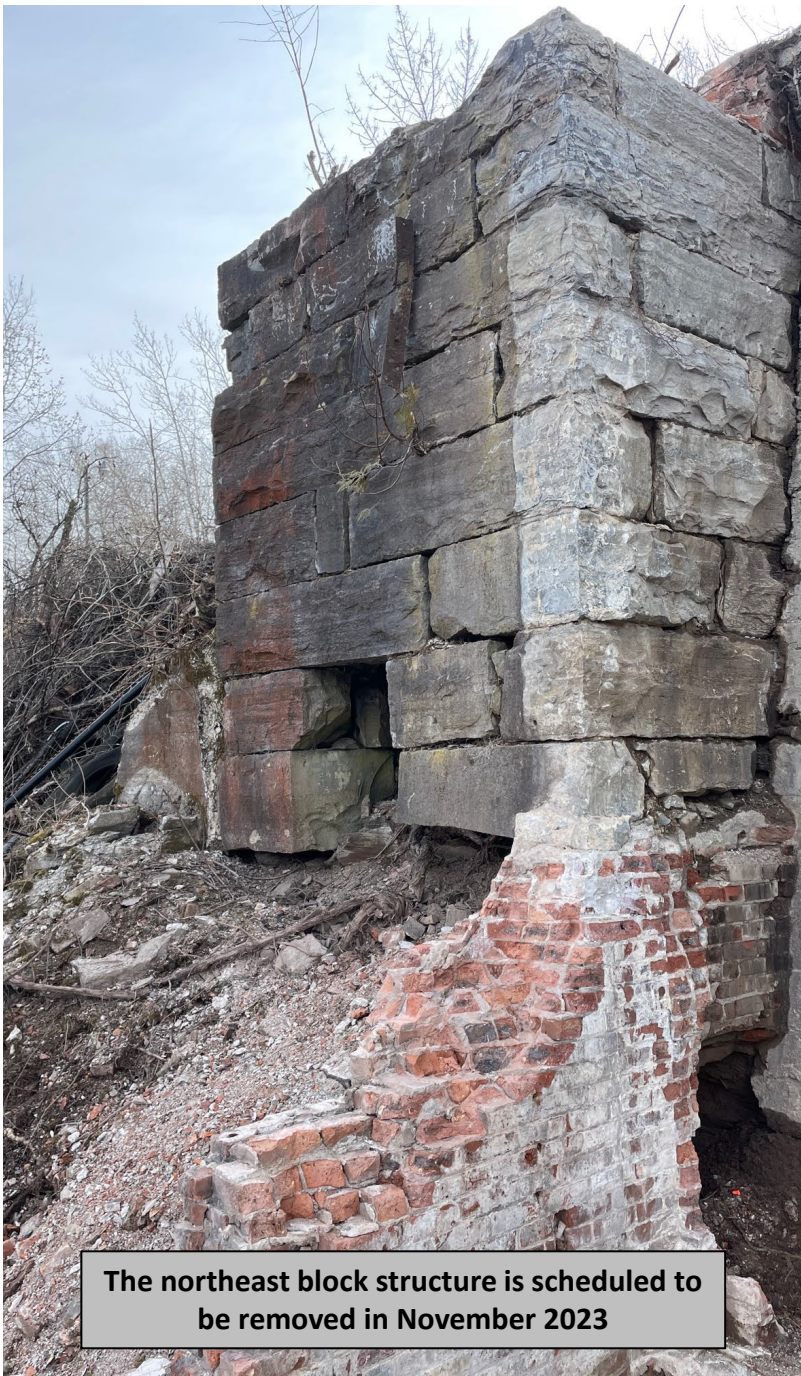
The northeast block structure is scheduled to be removed in November 2023

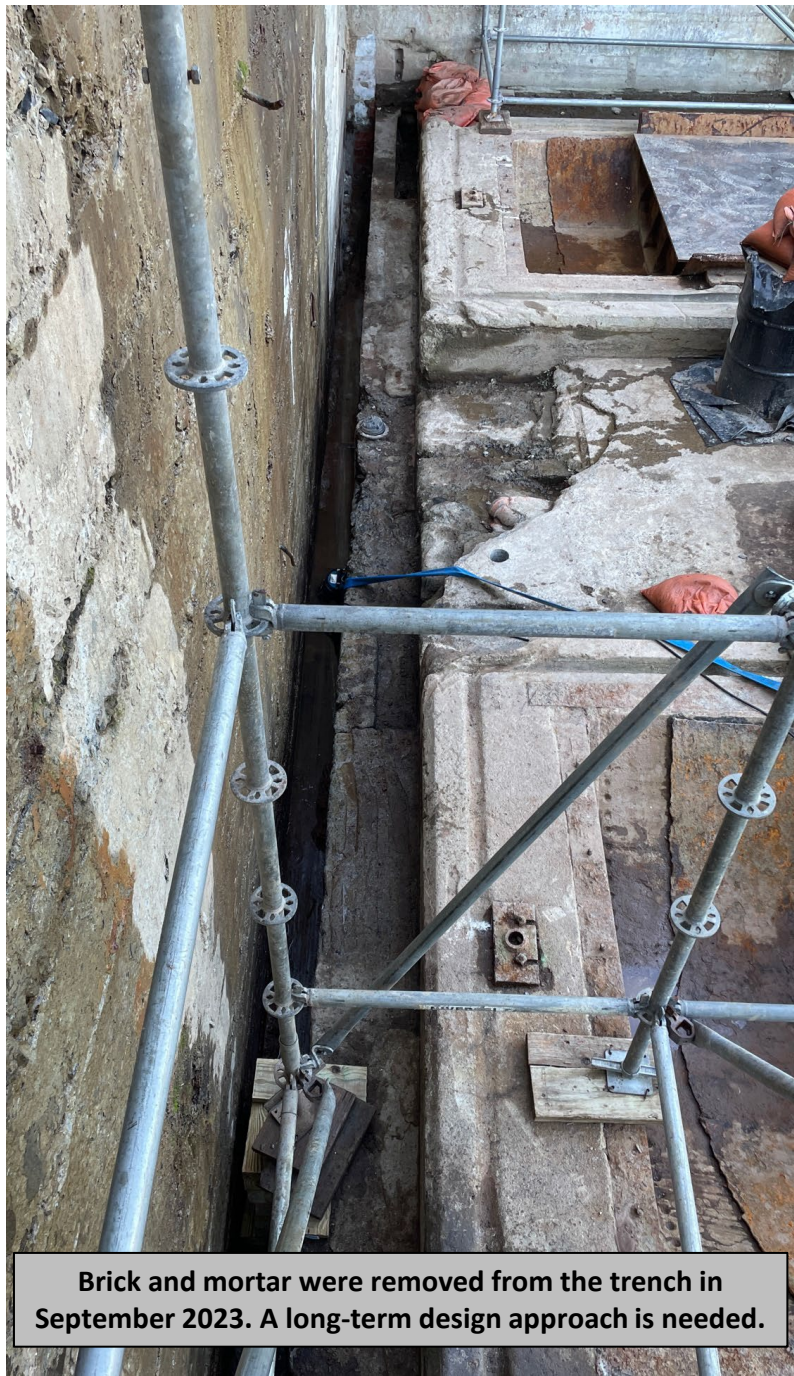
Brick and mortar were removed from the trench in September 2023. A long-term design approach is needed.

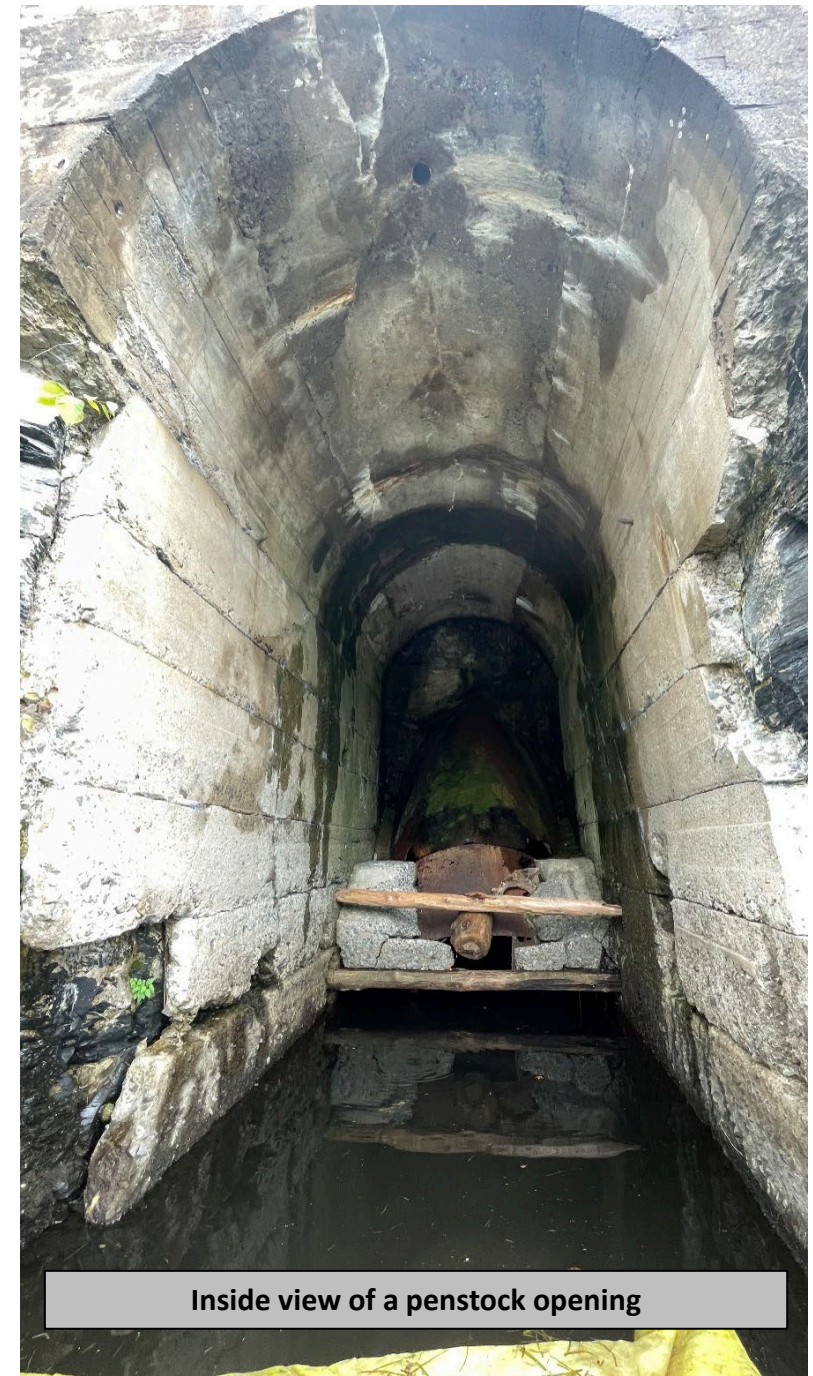
Inside view of a penstock opening

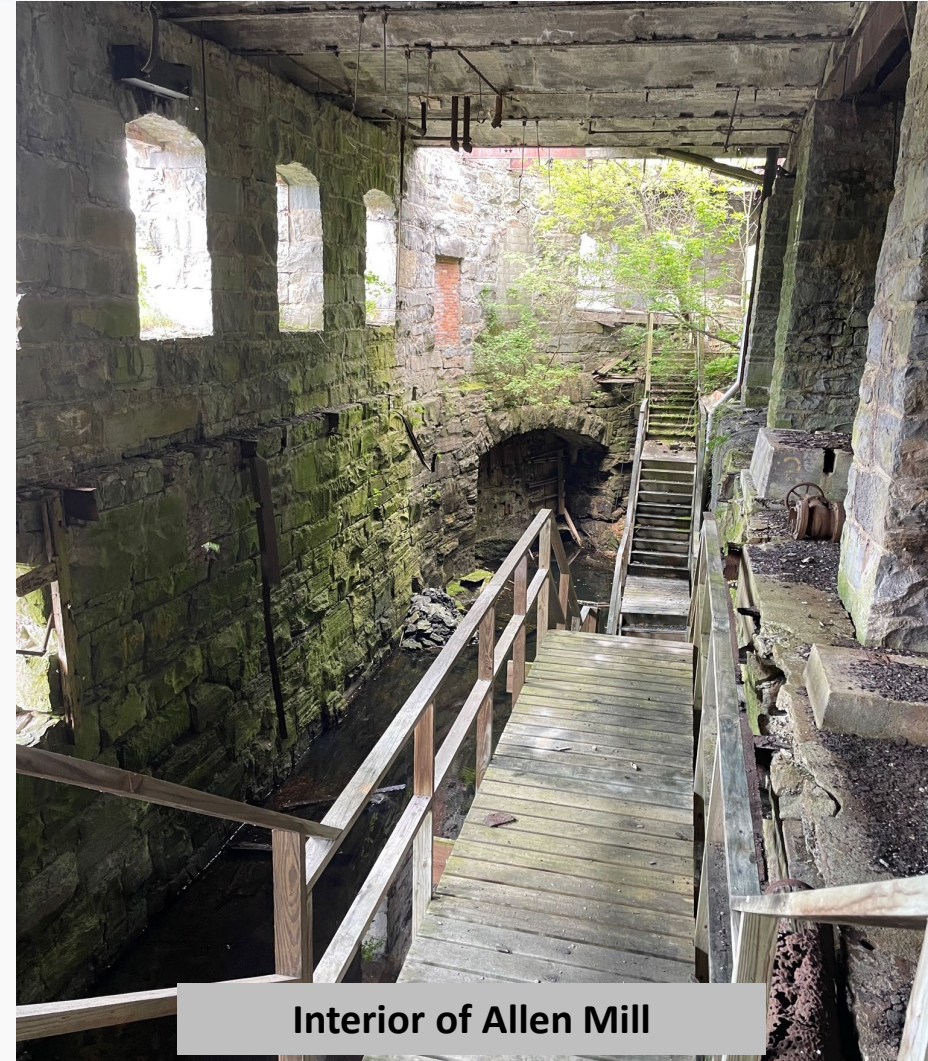
Interior of Allen Mill
