**REMOVAL PROGRAM  
AFTER ACTION REPORT  
FOR THE  
FORMER SQUANNACOOK SPORTSMANS CLUB SITE  
GROTON, MIDDLESEX COUNTY, MASSACHUSETTS  
12 SEPTEMBER 2022 THROUGH 4 DECEMBER 2023**

REVISION 1.0

December 2023  
Revised February 2024

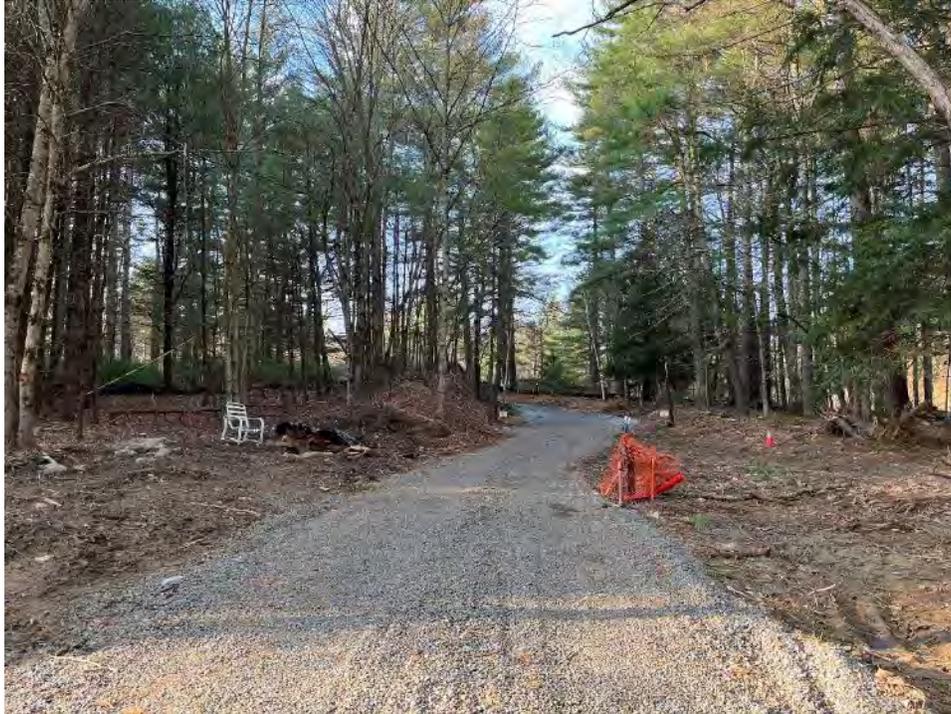
**SCENE:** View of the site roadway on the Town of Groton property. Photograph taken facing south.

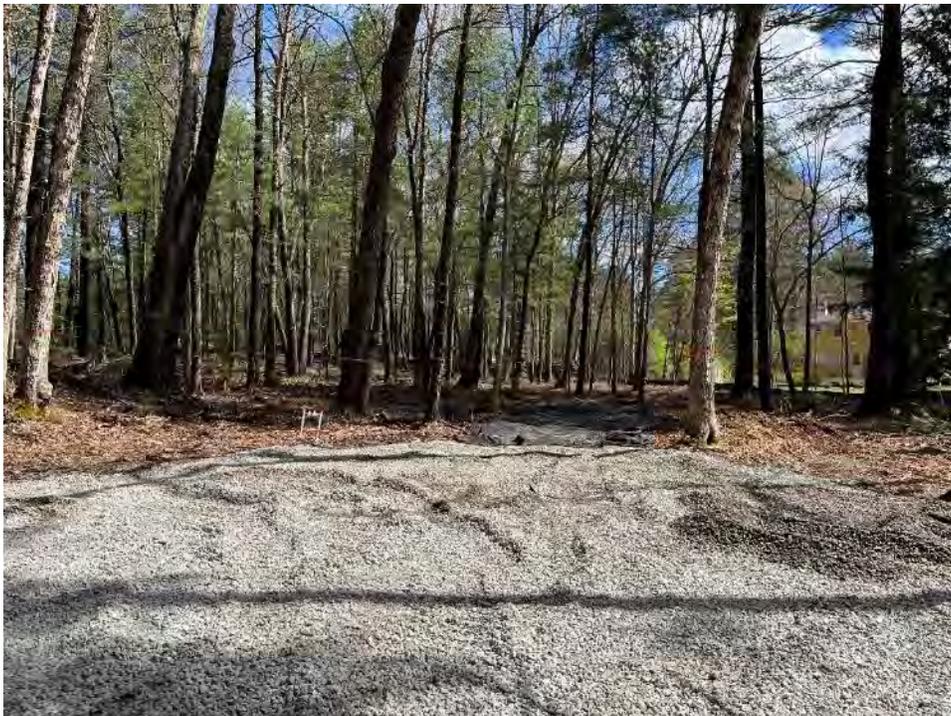
**SCENE:** View of the residential property before excavation at the end of the site road. Photograph taken facing north.

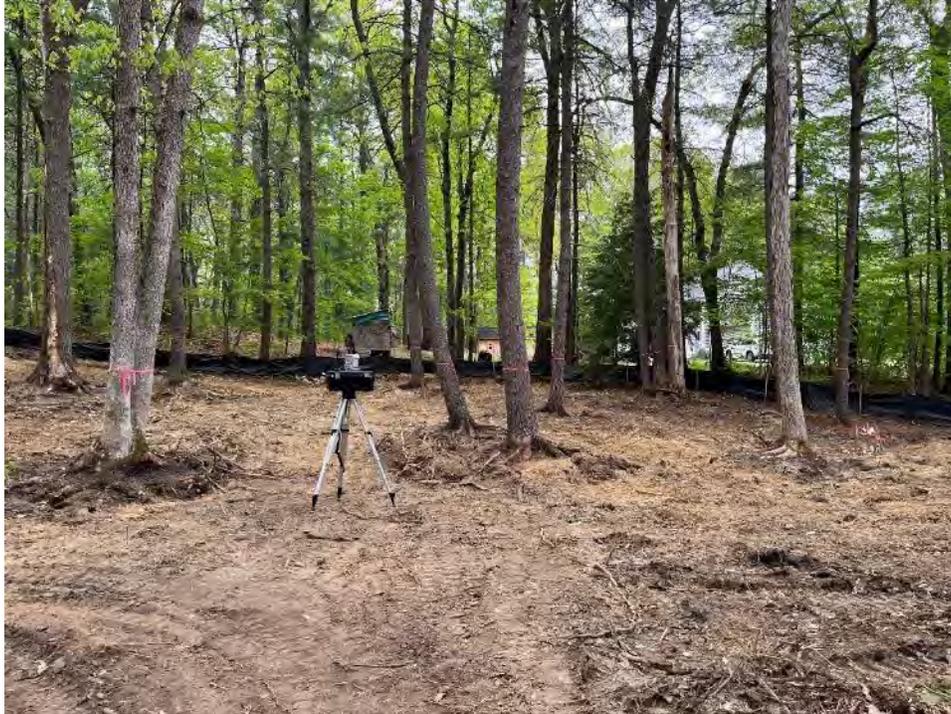
**SCENE:** View of perimeter air monitoring on the northern end of the residential property after soil excavation. Photograph taken facing north.

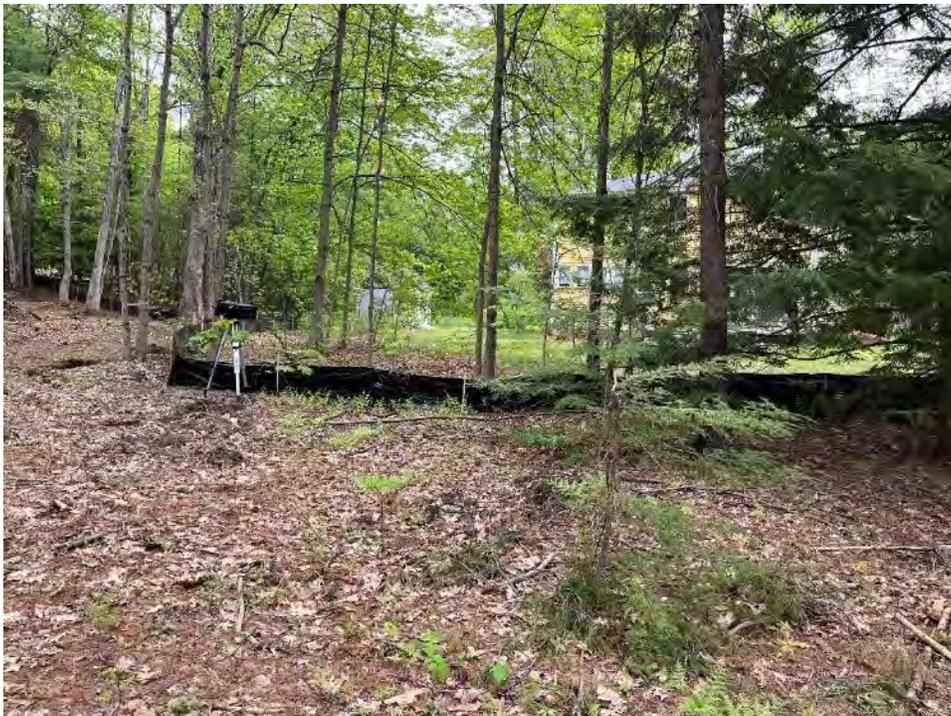
**SCENE:** View of perimeter air monitoring inside the silt fence on the residential property near the home before excavation of the area. Photograph taken facing northeast.

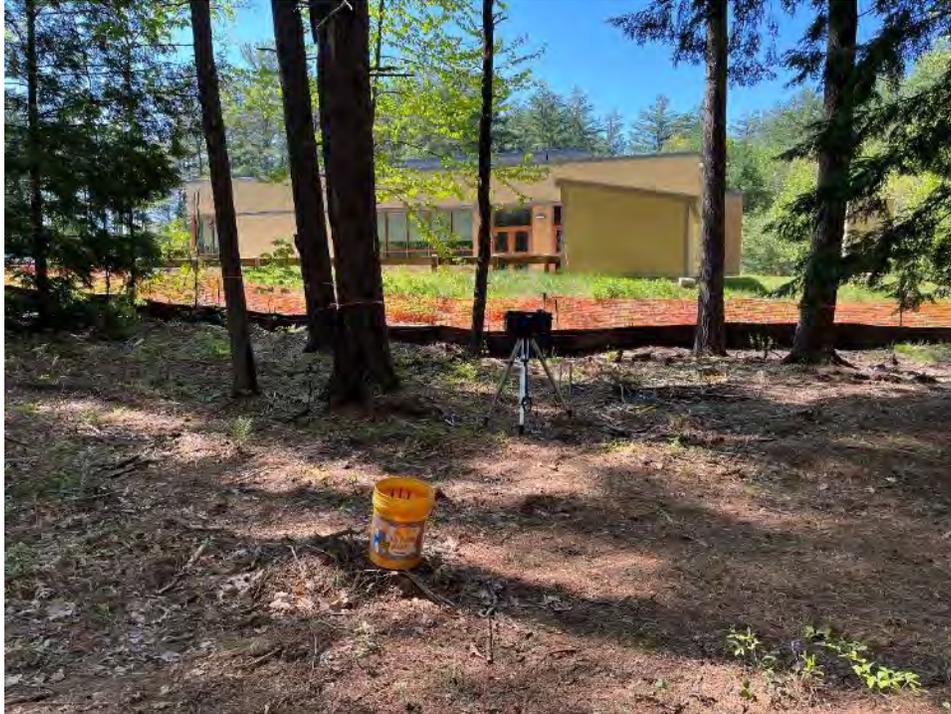
**SCENE:** View of perimeter air monitoring on the residential property in front of the Groton Senior Center. Photograph taken facing southeast.

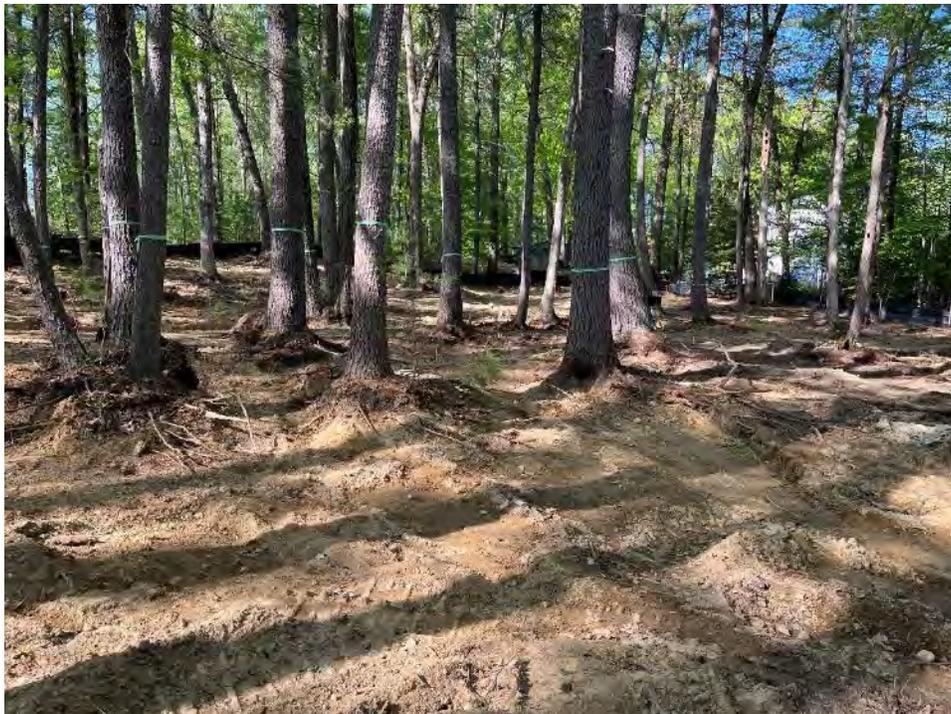
**SCENE:** View of the residential property post-excavation. Photograph taken facing north.

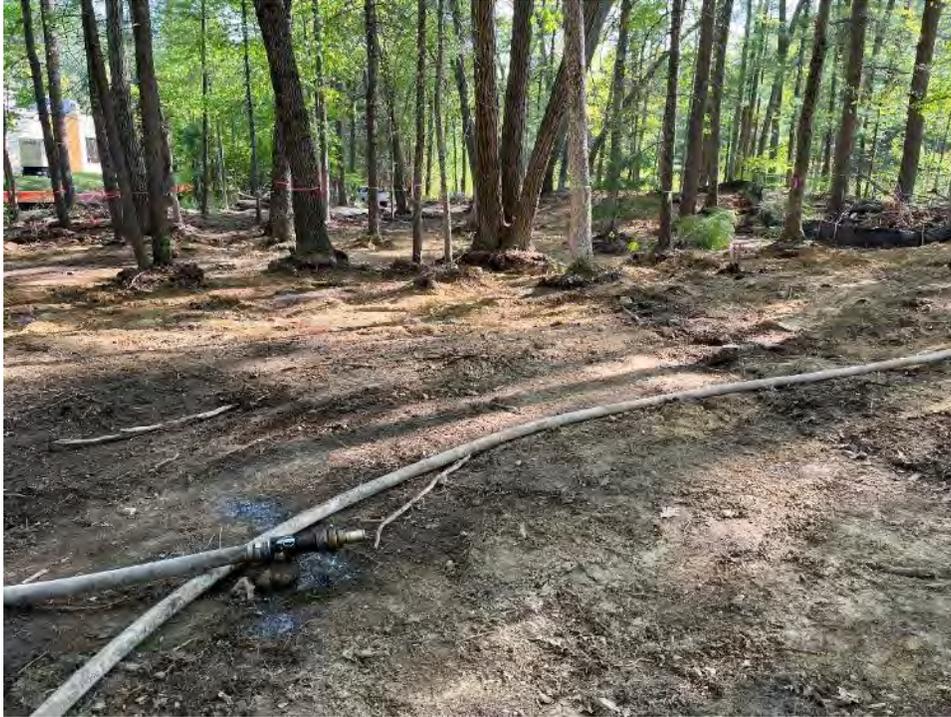
**SCENE:** View of the residential property post-excitation with dust suppression equipment. Photograph taken facing south.

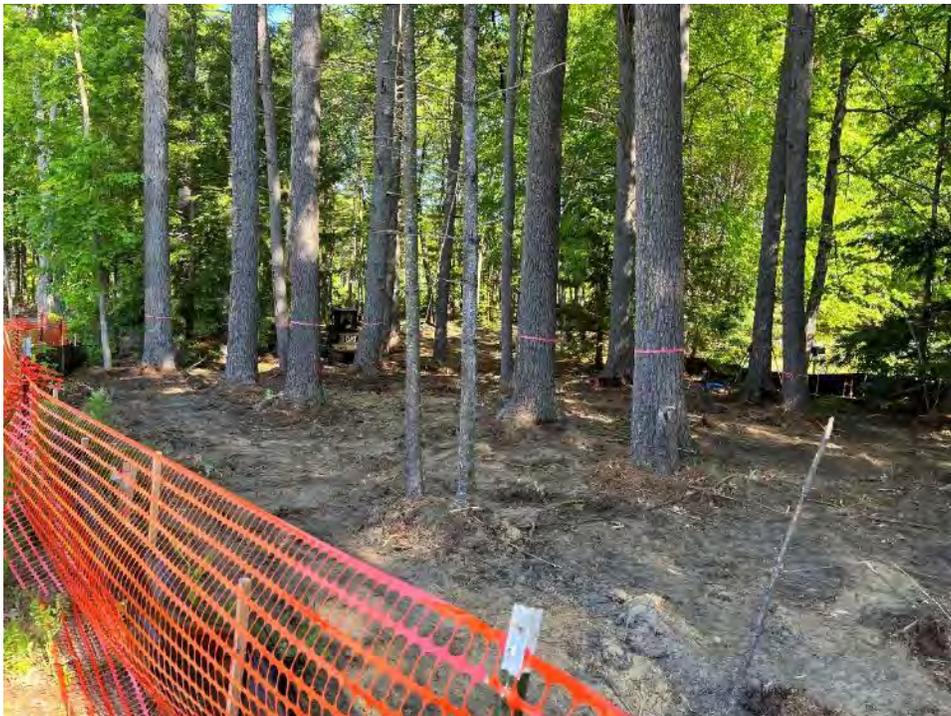
**SCENE:** View of the residential property post-excitation in between the Senior Center building and residential home. Photograph taken facing northwest.

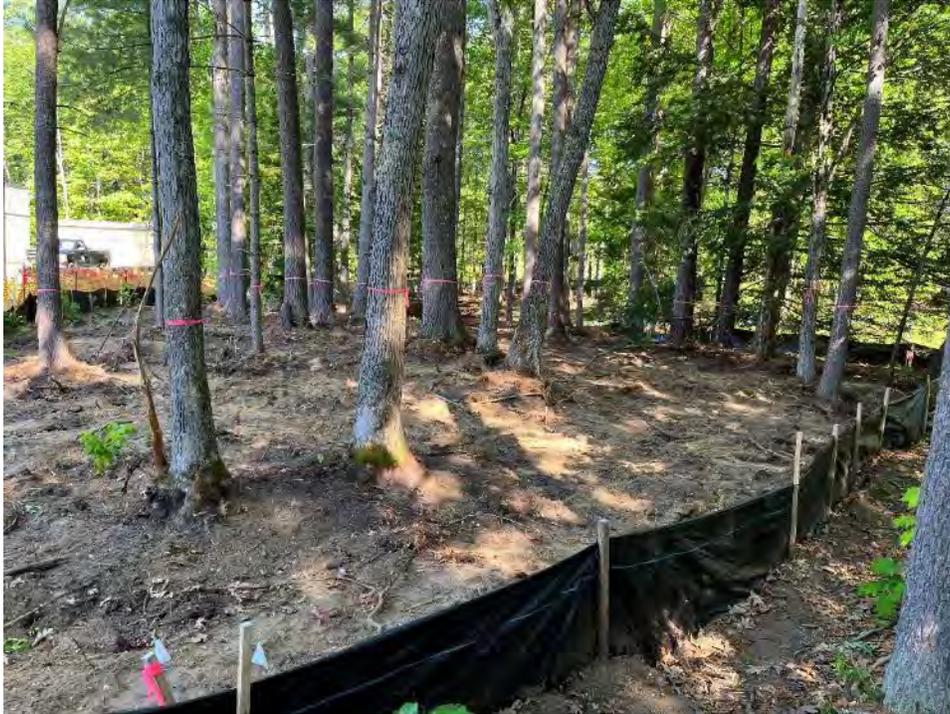
**SCENE:** View of the residential property post-excavation in between the Senior Center building and residential home. Photograph taken facing southwest.

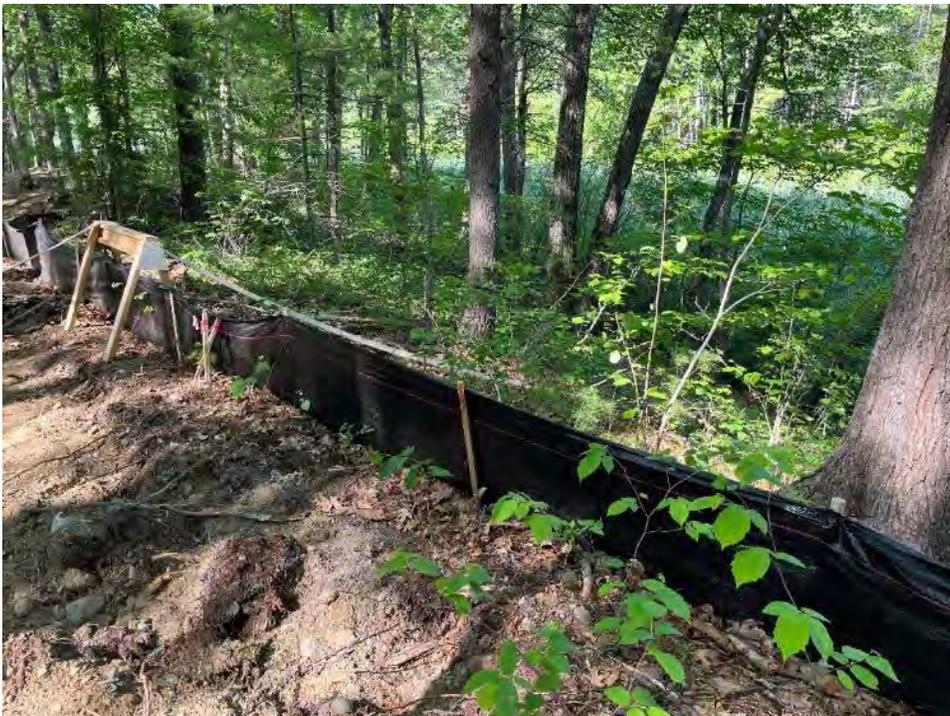
**SCENE:** View of the silt fence separating the work zone and the wetlands including the dust suppression equipment. Photograph taken facing southwest.

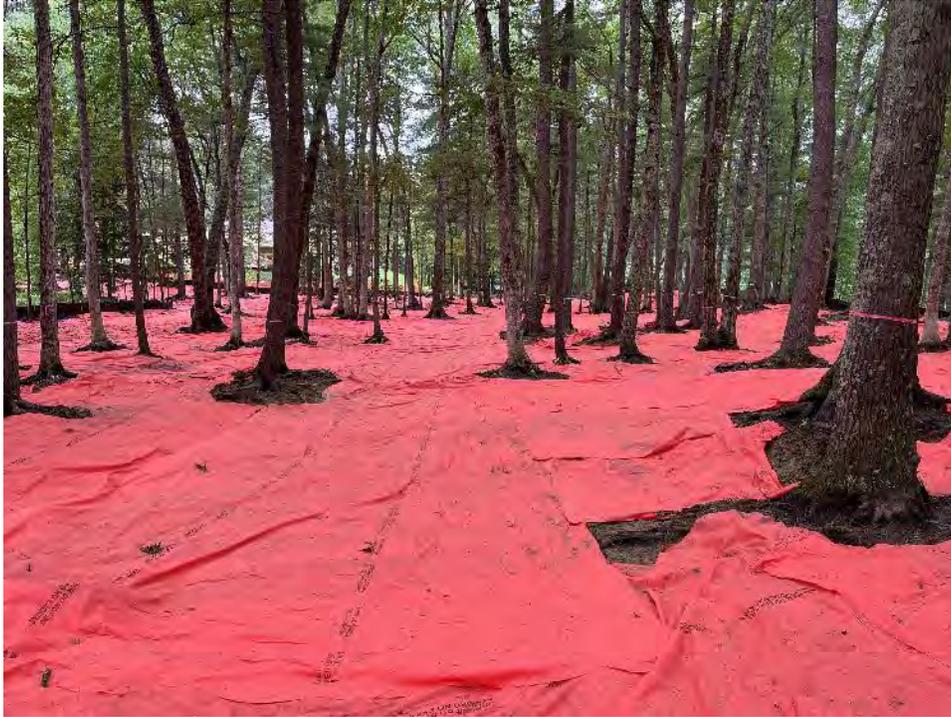
**SCENE:** View of the residential property post-excavation with geotextile fabric. Photograph taken facing south.

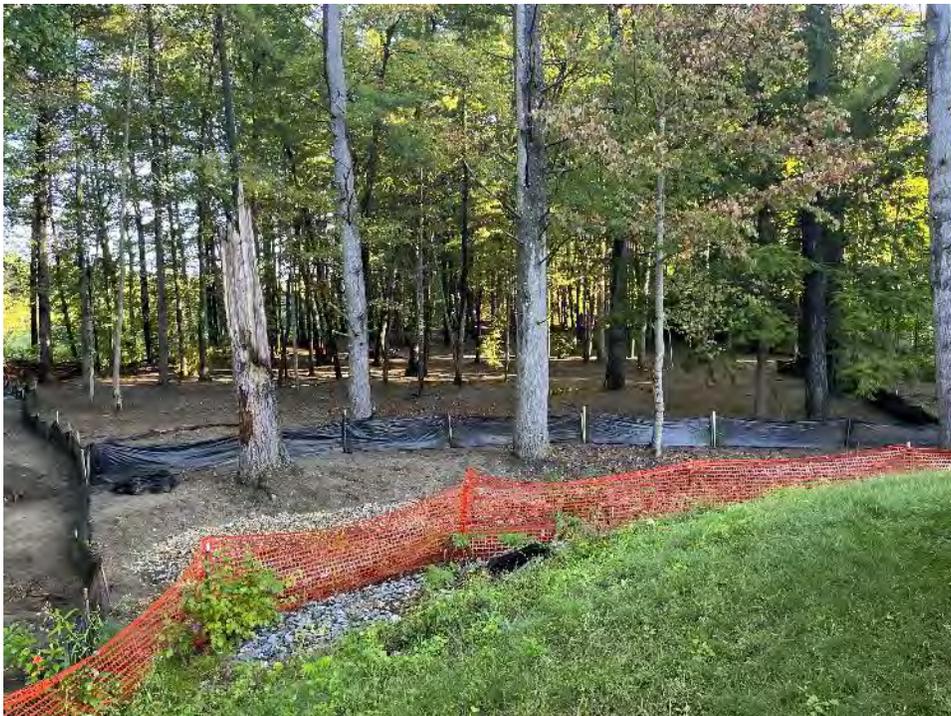
**SCENE:** View of the residential property and the Senior Center property after backfilling activities. Photograph taken facing north.

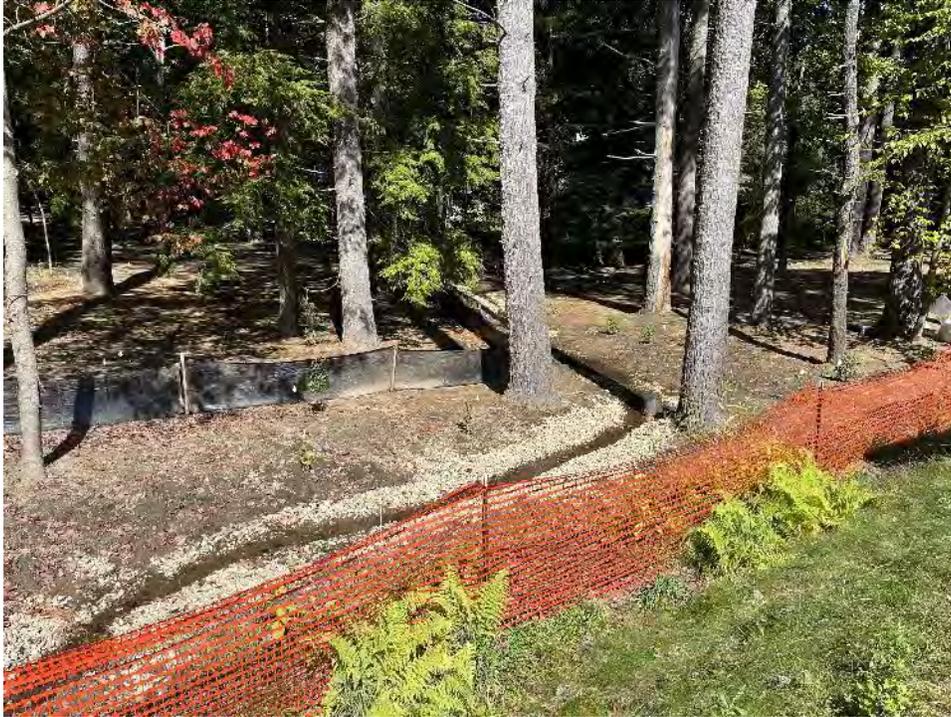
**SCENE:** View of the water drainage swale on the residential property and in between the residential property and the Senior Center. Photograph taken facing north.

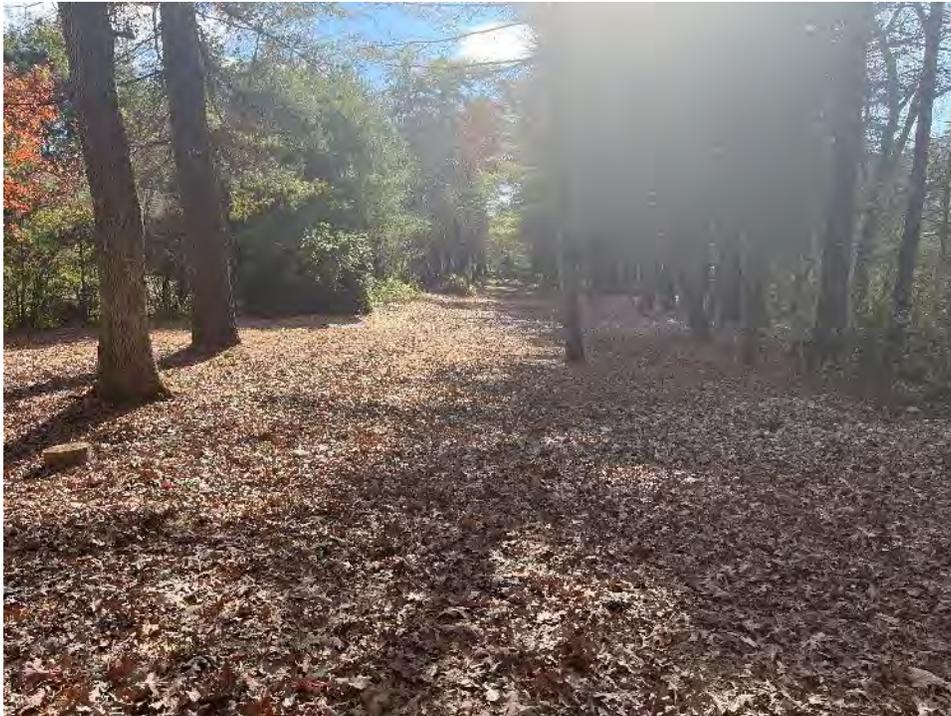
**SCENE:** View of the site roadway on the Town of Groton property after removal and site restoration was complete. Photograph taken facing south.

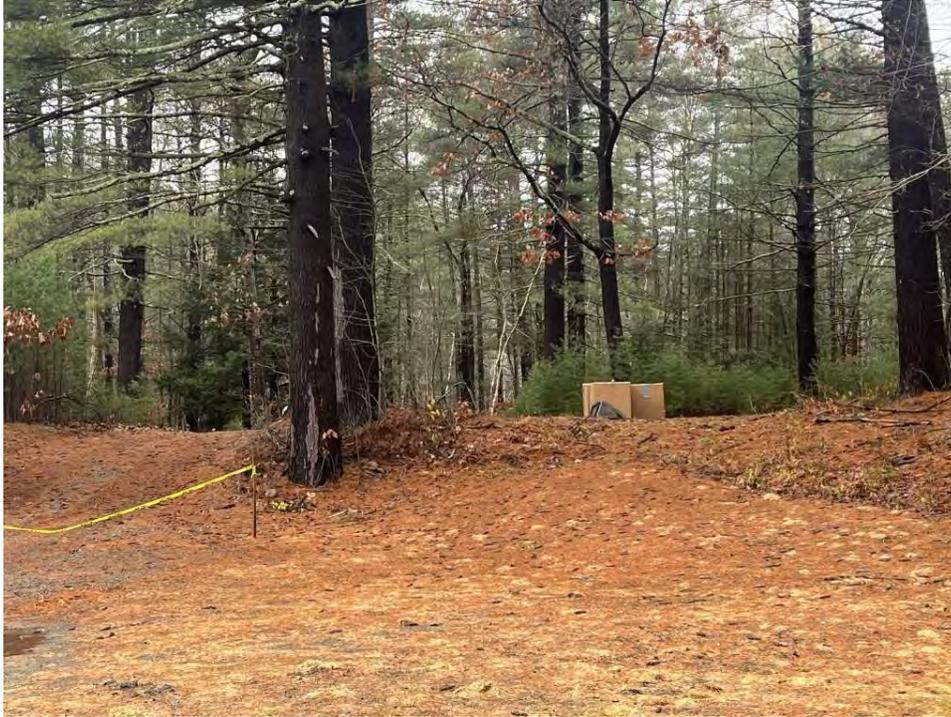
**SCENE:** View of the cubic yard boxes of silt fence and contaminated personal protective equipment (PPE) before transportation and disposal. Photograph taken facing north.

- On 4 December 2023, Tradebe was on site to ship the final cubic yard box of hazardous material from the site (see Appendix D, Waste Disposal Summary Table).

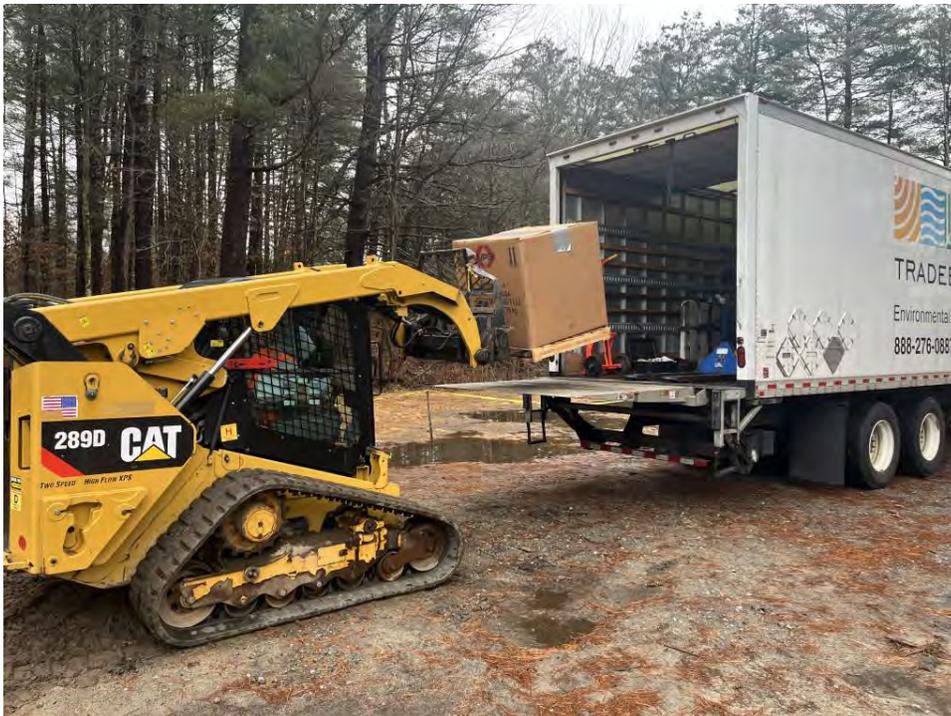
**SCENE:** View of the cubic yard boxes being loaded out for disposal. Photograph taken facing east.
