**PHASE II ENVIRONMENTAL SITE ASSESSMENT
FOR
CROW TRIBAL BUILDING
#1 BAATCHEEITCHE AVENUE
CROW AGENCY, BIG HORN COUNTY, MONTANA**

Date Prepared	April 2020
TDD No.	0003/2001-02
Document Control No.	W0764.1A.02235
Contract No.	EP-S8-13-01
U.S. EPA Work Assignment Manager	Greg Davis

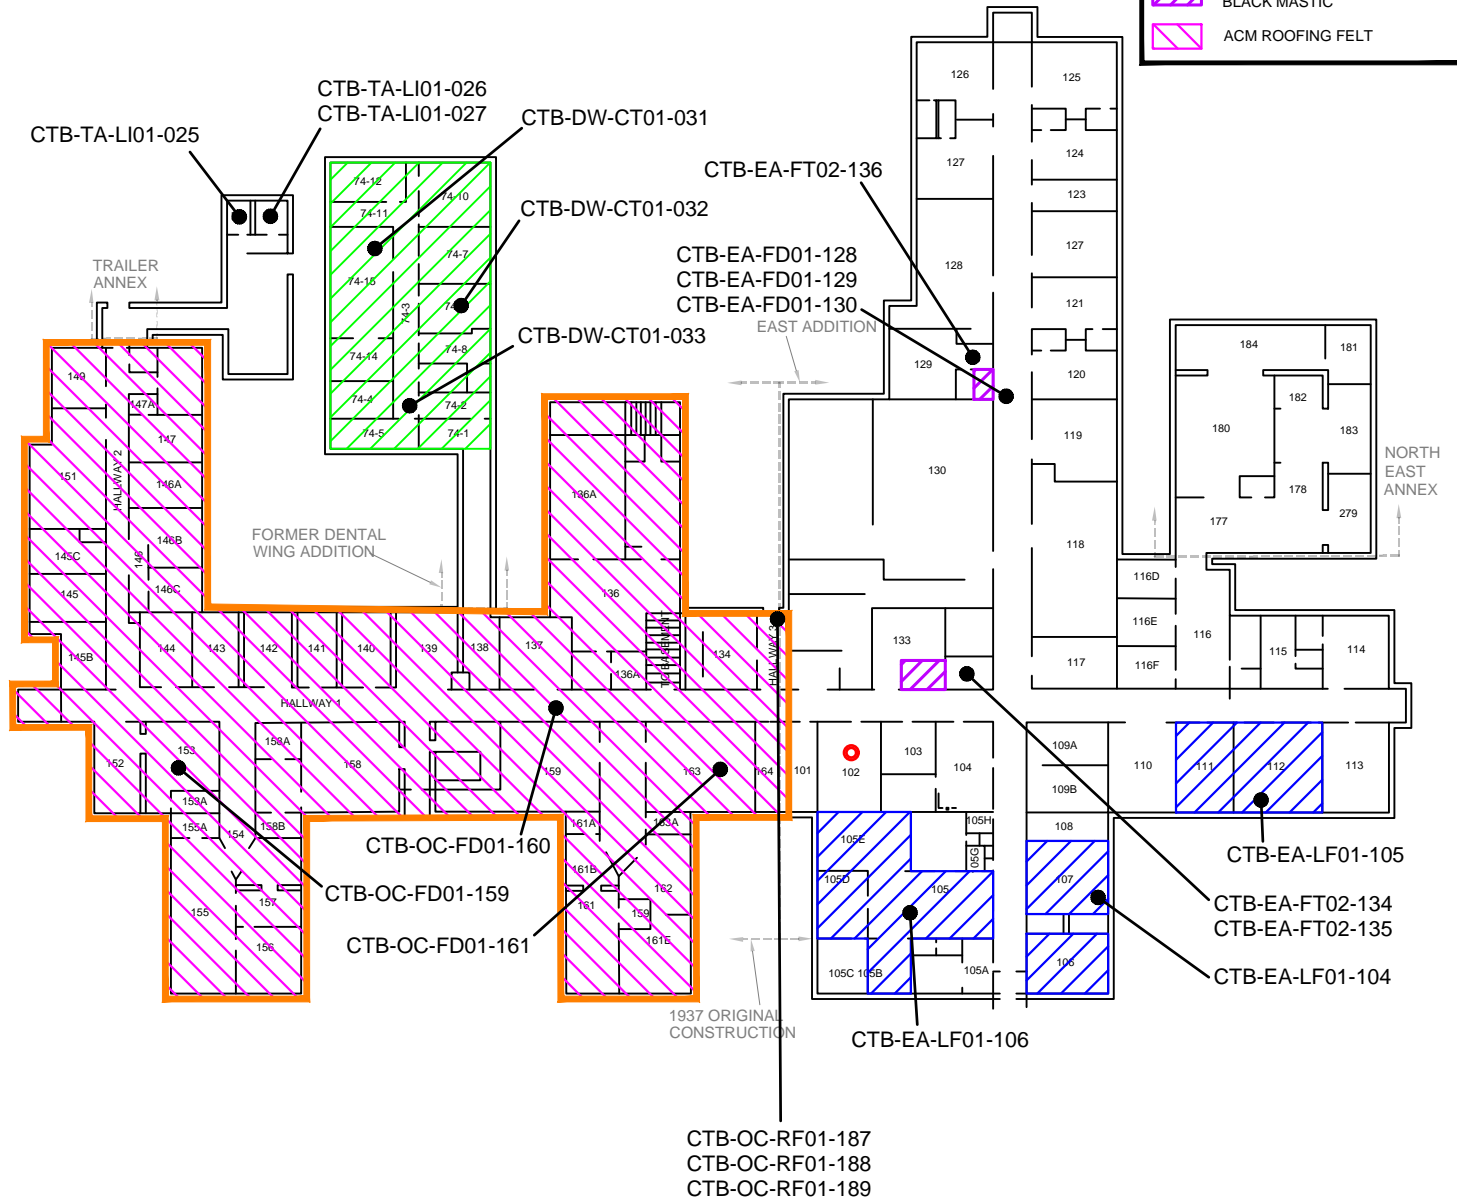
Figure
3

- ACM ASBESTOS CONTAINING MATERIAL
- ACM SAMPLE LOCATION (APPROXIMATE)
- ACM PIPE INSULATION AND MUDDIED FITTINGS
- ACM CEILING TILES
- ACM BLACK MASTIC UNDER LAMINATE
- ACM 9"x9" FLOOR TILE AND BLACK MASTIC
- ACM ROOFING FELT

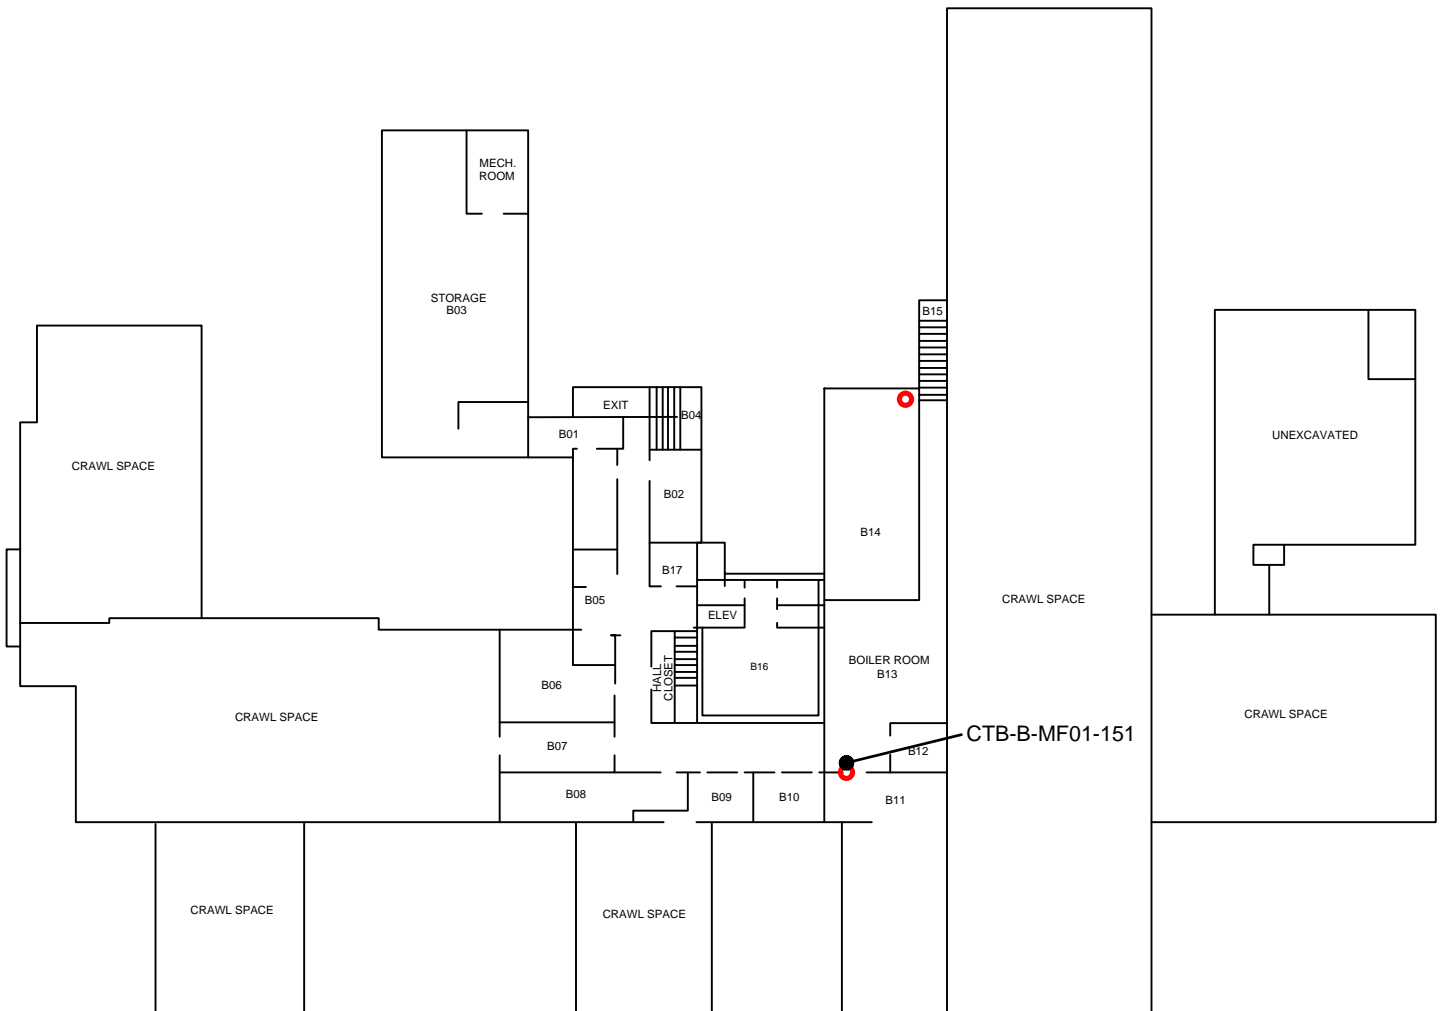
Figure
4

- ACM ASBESTOS CONTAINING MATERIAL
- ACM MUDDED FITTINGS
- ACM SAMPLE LOCATION (APPROXIMATE)

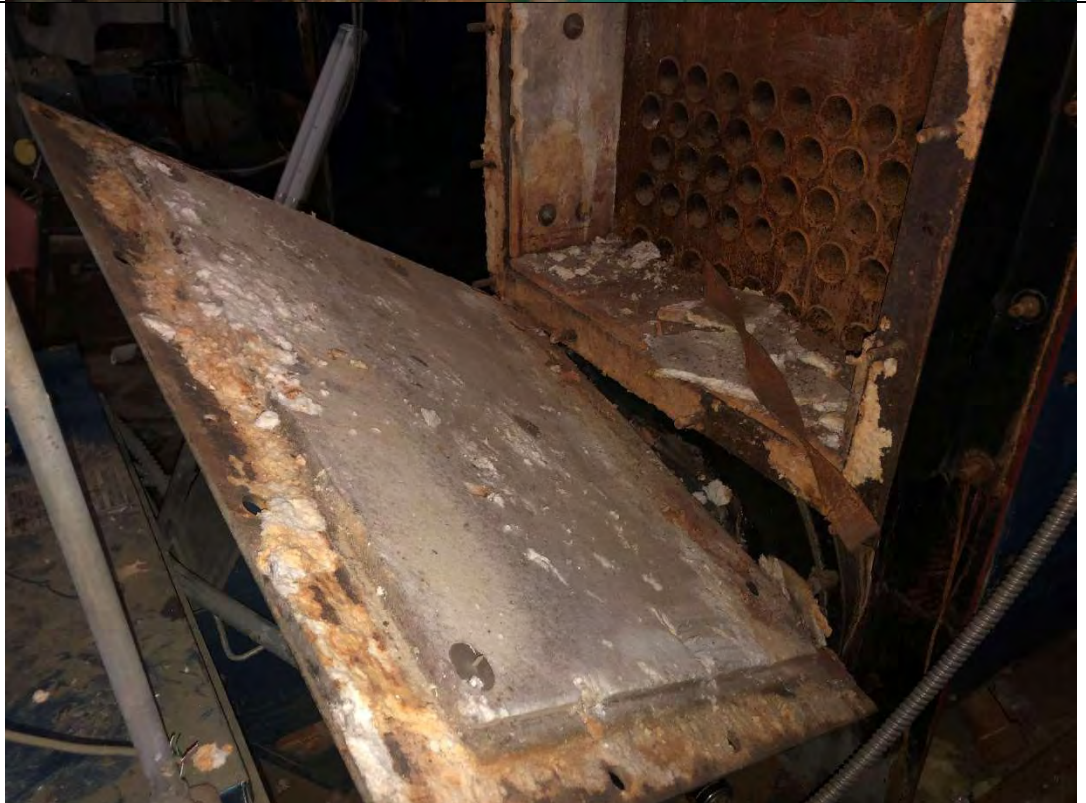
Photo No. 26	Date: 02/16/2020
Photo Coordinates	
Lat	45.564347
Long	-107.455819
Direction Photo Taken: 297.690353143841	
Description: One of the boilers with no asbestos in door gasket or insulation.

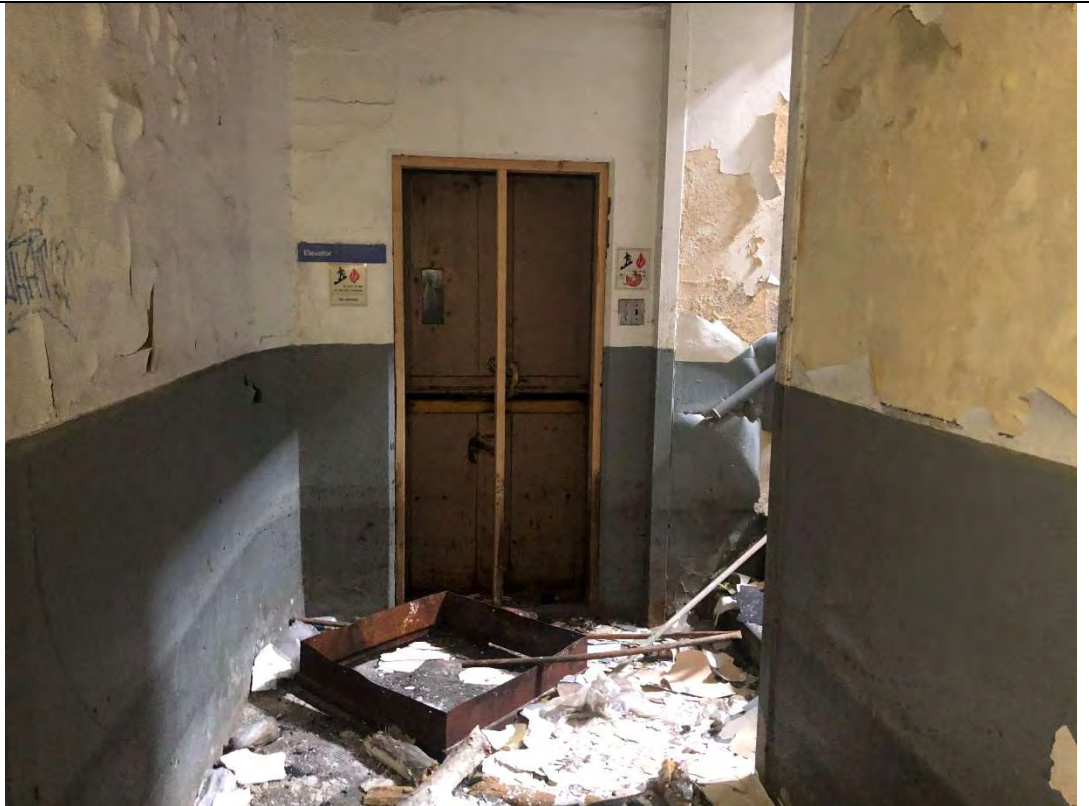
Photo No. 27	Date: 02/16/2020
Photo Coordinates	
Lat	45.603797
Long	-107.460639
Direction Photo Taken: 72.4404602622424	
Description: Elevator door previously identified as asbestos has been removed.

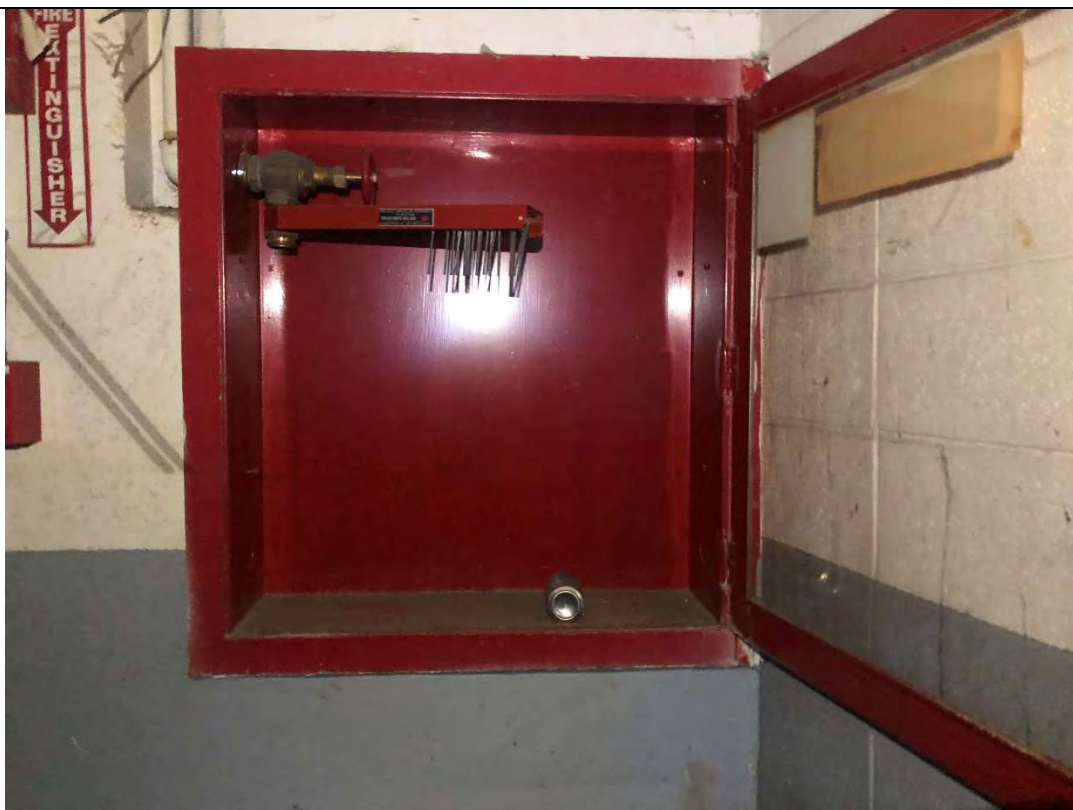
Photo No. 29	Date: 02/16/2020
Photo Coordinates	
Lat	45.603797
Long	-107.460639
Direction Photo Taken: 159.625625625626	
Description: Fire hoses previously identified as asbestos have been removed.

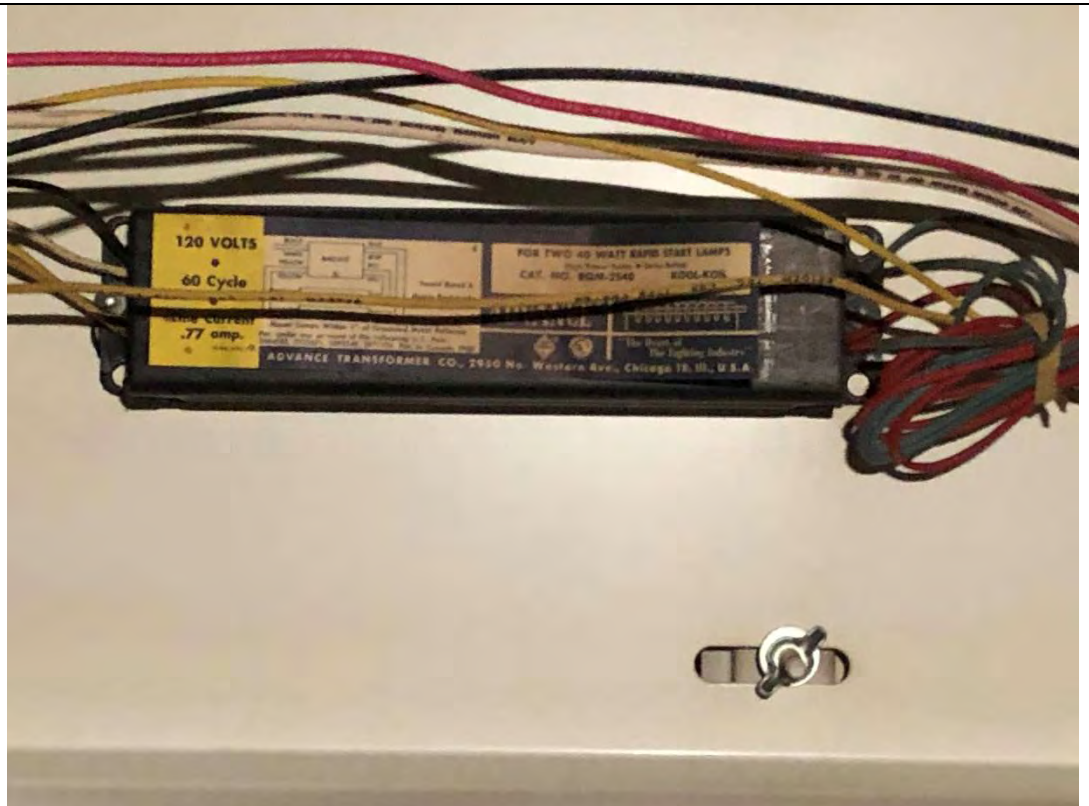
Photo No. 43	Date: 02/14/2020
Photo Coordinates	
Lat	45.603589
Long	-107.460214
Direction Photo Taken: 253.881576535289	
Description: Ballast without a "No-PCBs" label.
