Phase II Environmental Site Assessment (ESA) Building Materials

**GLACIER HOTEL
15 1ST AVENUE SW
CUT BANK, MONTANA**

SWEETGRASS DEVELOPMENT

AUGUST 2016

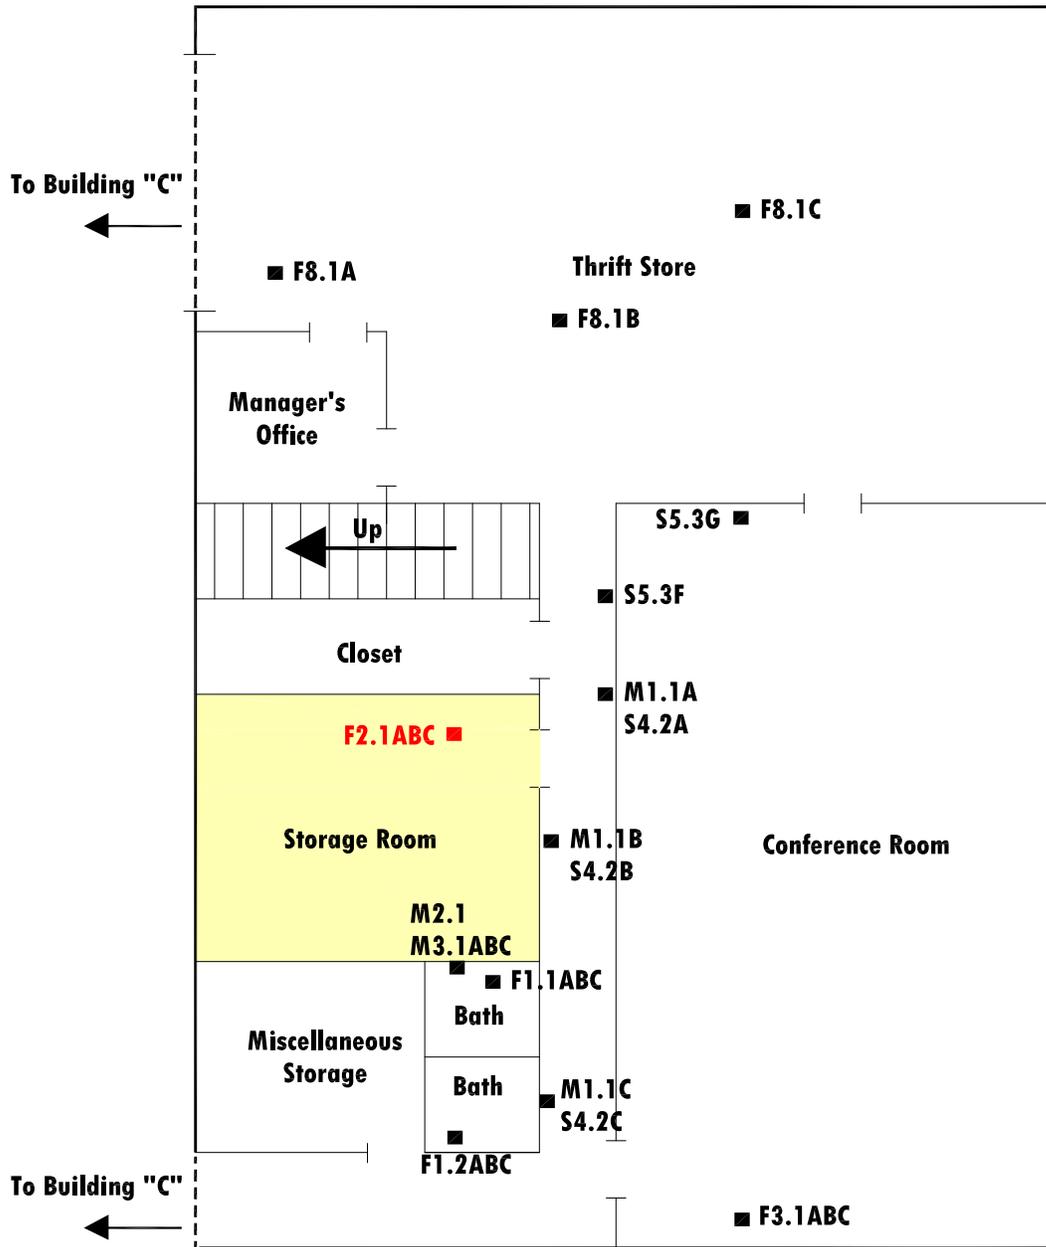
Original Hotel (Building A) - Main Floor
 Asbestos Sample Locations
 Glacier Hotel
 Cut Bank, Montana
 Figure 3b

- Non-Asbestos Containing Material
- Asbestos Containing Material (Positive)
- M - Miscellaneous
- F - Flooring
- S - Surfacing Material
- Yellow Mastic

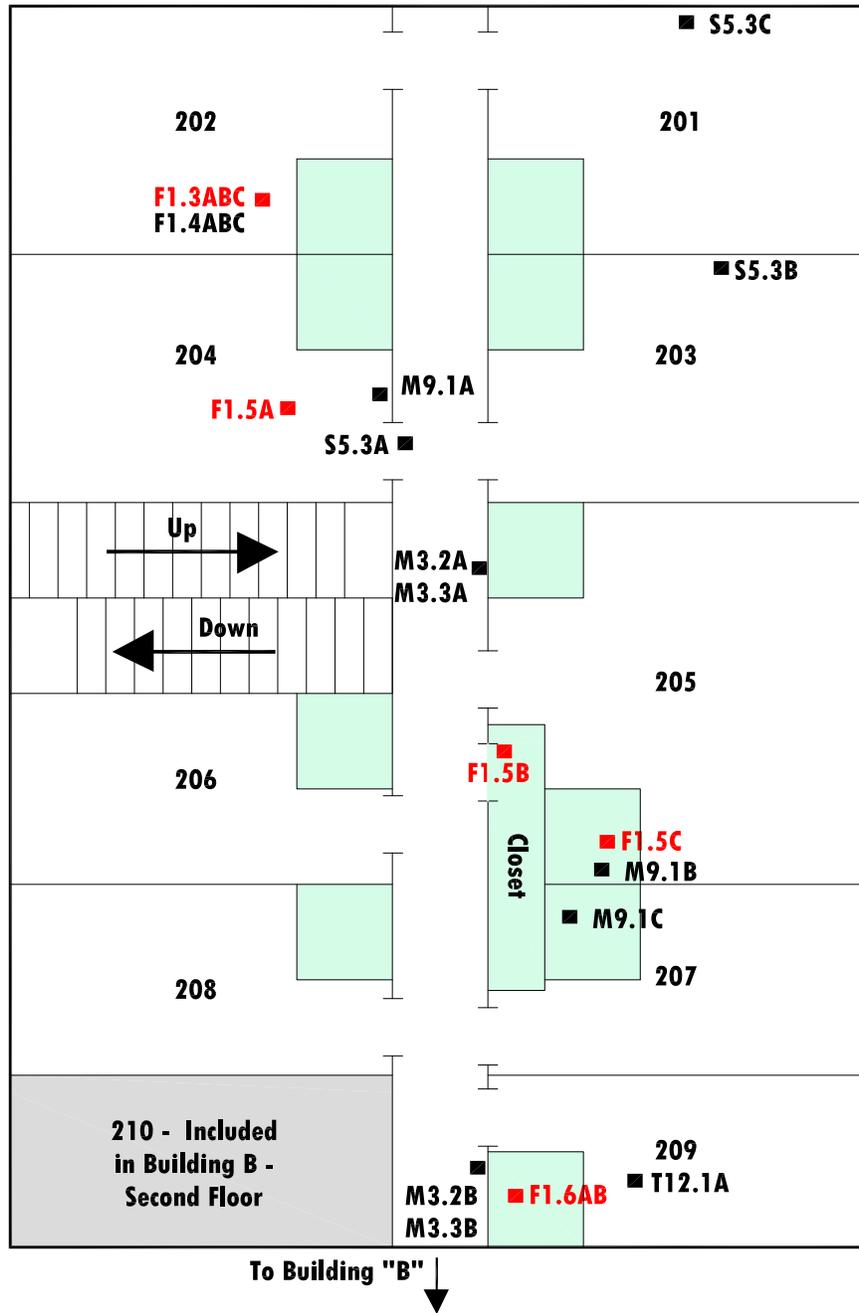
Original Hotel (Building A) - Second Floor
 Asbestos Sample Locations
 Glacier Hotel
 Cut Bank, Montana
 Figure 3c

- Non-Asbestos Containing Material
- Asbestos Containing Material (Positive)
- M - Miscellaneous
- F - Flooring
- S - Surfacing Material
- T - Thermal System Insulation
- Bathroom VSF

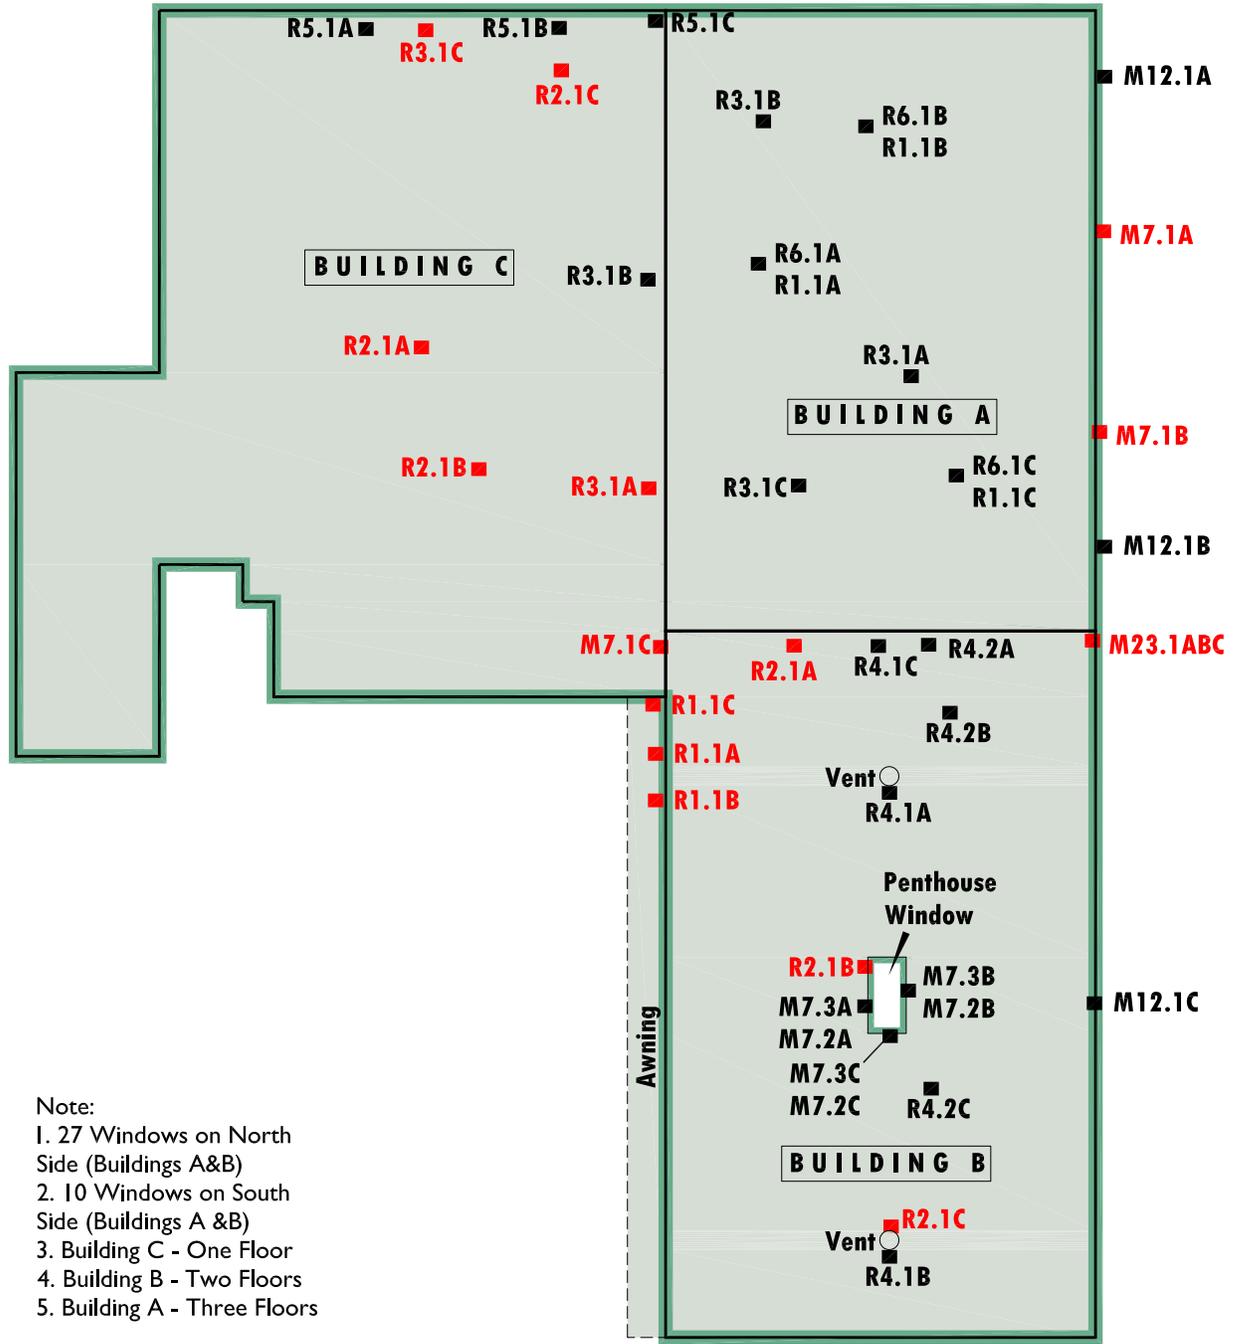
**Buildings A/B/C Roof
 Asbestos Sample Locations
 Glacier Hotel
 Cut Bank, Montana
 Figure 4**

Table 3-2. Materials Containing Asbestos Lounge				
Sample ID	Material Description	Asbestos Type	Asbestos Content	Regulatory Category
R3.1	Silver Paint	Chrysotile	3%	Category I
	Black Roof Coat	Chrysotile	10%	Category I
R2.1	Black Flashing	Chrysotile	5%	Category I
S4.1	Spray-On Texture	Chrysotile	3%	RACM

- Non-Asbestos Containing Material
- Asbestos Containing Material (Positive)
- M - Miscellaneous
- R - Roofing
- Silver Paint/Black Roofing
- Black Flashing

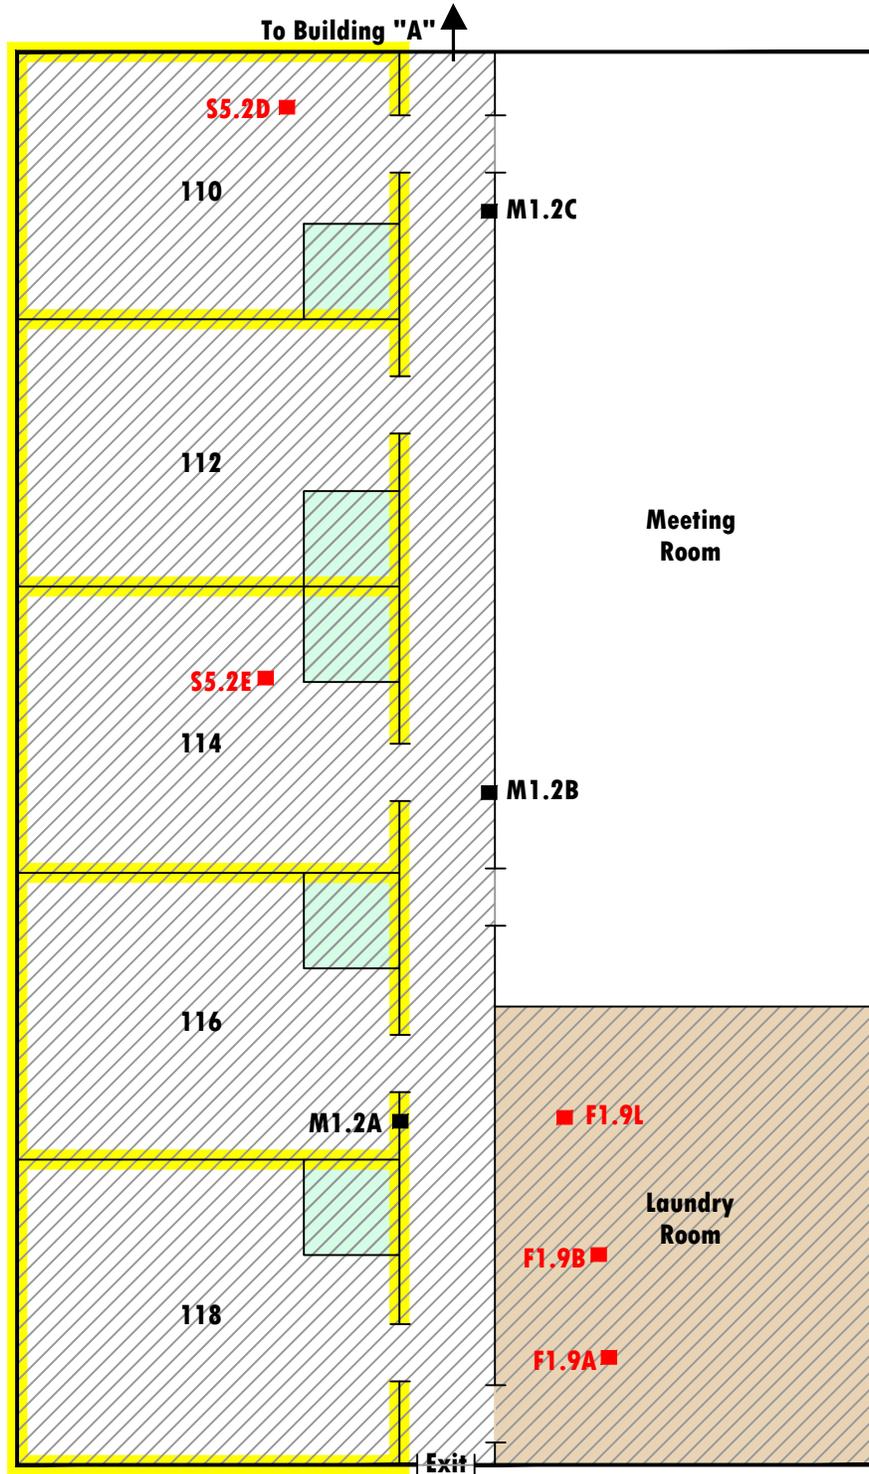
Original Hotel Addition (Building B)
Main Floor
Asbestos Sample Locations
Glacier Hotel
Cut Bank, Montana
Figure 5a

- Non-Asbestos Containing Material
- Asbestos Containing Material (Positive)
- M - Miscellaneous
- F - Flooring
- S - Surfacing Material
- Bathroom VSF
- Laundry Room VSF
- Plaster Ceiling
- Plaster Walls

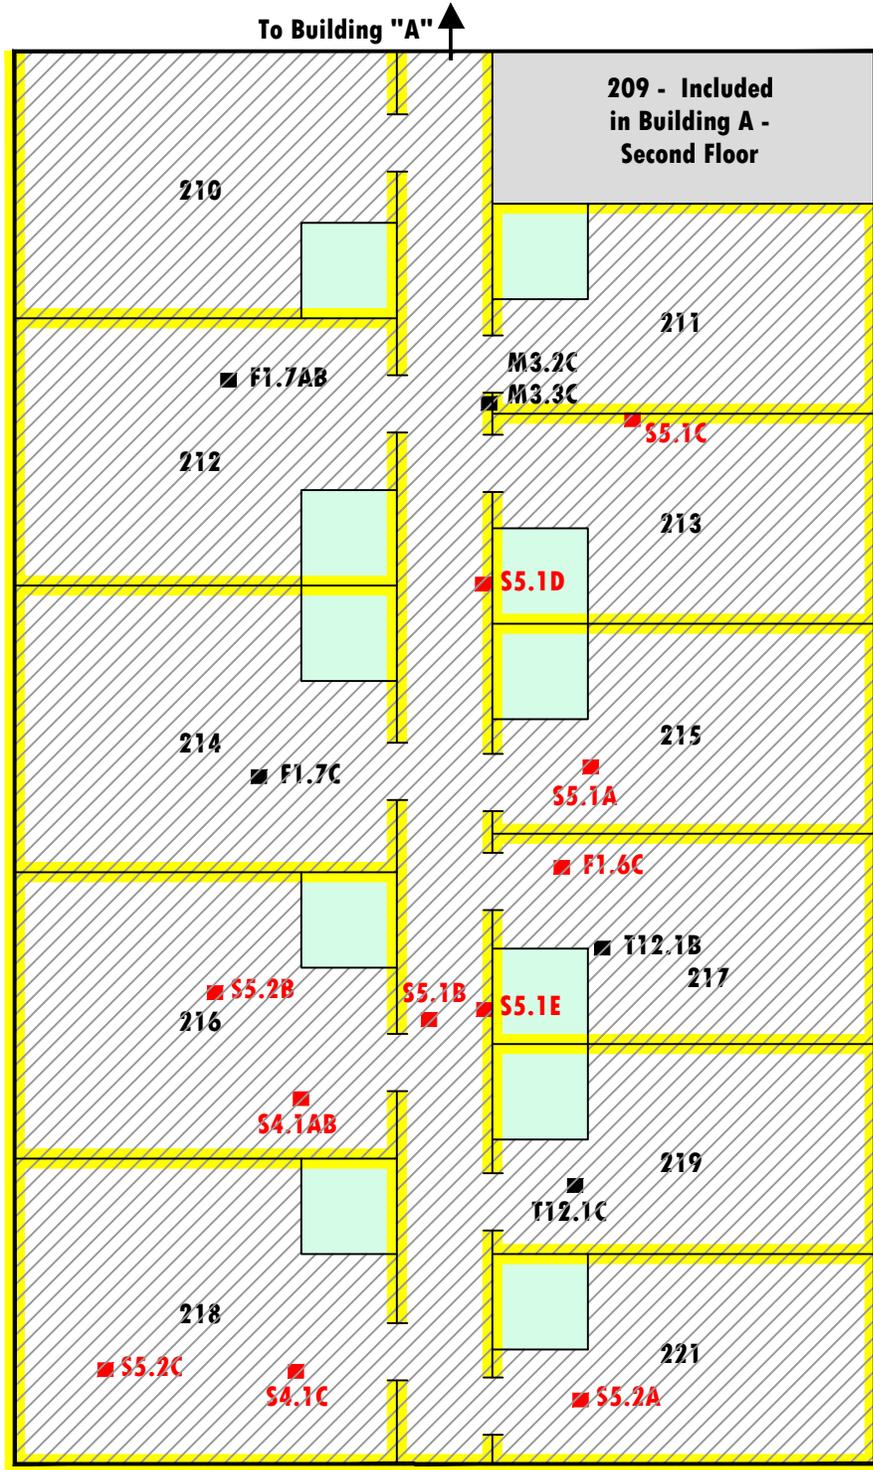
Original Hotel Addition (Building B)
 Second Floor
 Asbestos Sample Locations
 Glacier Hotel
 Cut Bank, Montana
 Figure 5b

- Non-Asbestos Containing Material
- Asbestos Containing Material (Positive)
- M - Miscellaneous
- F - Flooring
- S - Surfacing Material
- T - Thermal System Insulation
- Bathroom VSF
- ▨ Plaster Ceiling
- ▭ Plaster Walls
