**Subject: Contract No. 68HERH19D0018; Task Order (TO) No. 68E0719F0190
Former Rath Buildings, 1442, 1508, 1620, and 1656 Sycamore Street,
Waterloo, Black Hawk County, Iowa
Targeted Brownfields Assessment, Hazardous Materials Survey**

**TARGETED BROWNFIELDS ASSESSMENT
HAZARDOUS MATERIALS SURVEY**

**FORMER RATH BUILDINGS
1442, 1508, 1620, AND 1656 SYCAMORE STREET
WATERLOO, BLACK HAWK COUNTY, IOWA**

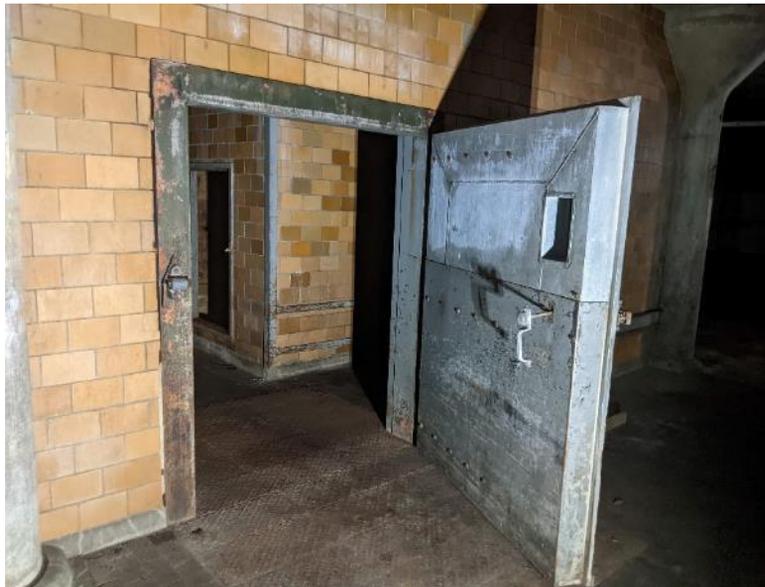
SUBTASK NO. 010.05 Direction: NA	DESCRIPTION	This photograph shows green LBP on a metal door frame in room C64.	58
	CLIENT	EPA	Date
	PHOTOGRAPHER	Cory Nichols	6/16/2022

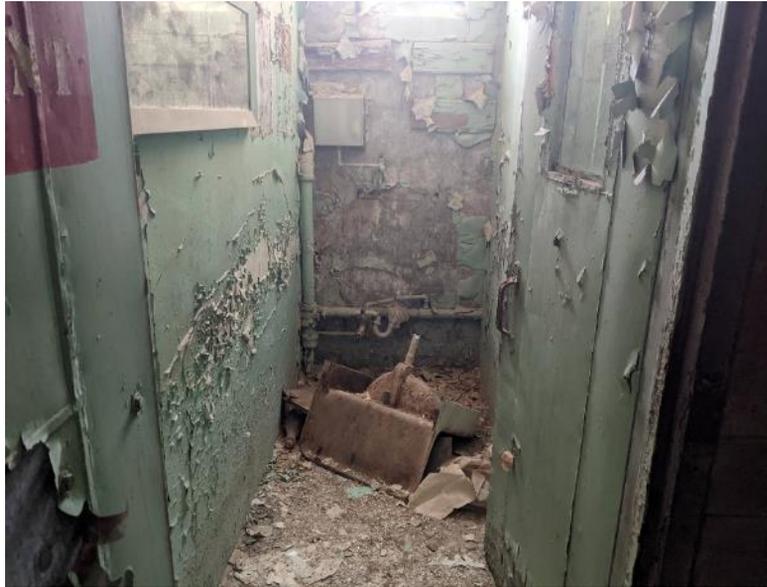
SUBTASK NO. 010.05 Direction: NA	DESCRIPTION	This photograph shows a representative view of green LBP on walls in women's restroom C64.	59
	CLIENT	EPA	Date
	PHOTOGRAPHER	Cory Nichols	6/16/2022

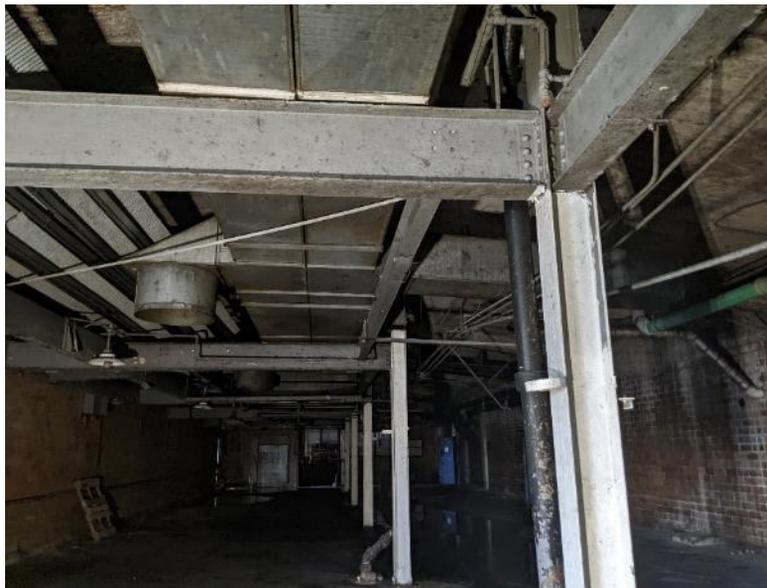
SUBTASK NO. 010.05 Direction: NA	DESCRIPTION	This photograph shows a representative view of white LBP on posts and grey paint on I-beams in room C63.	60
	CLIENT	EPA	Date
	PHOTOGRAPHER	Cory Nichols	6/16/2022

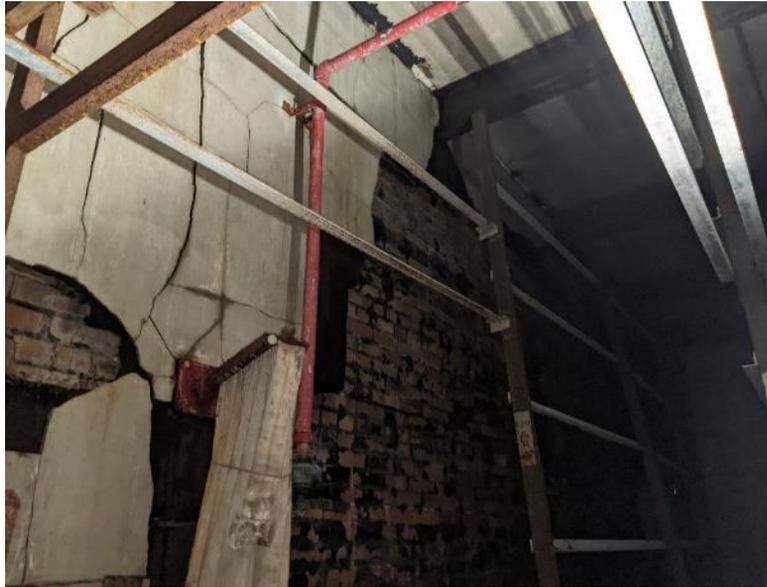
SUBTASK NO. 010.05 Direction: NA	DESCRIPTION	This photograph shows a representative view of red LBP on fire suppression piping.	61
	CLIENT	EPA	Date
	PHOTOGRAPHER	Cory Nichols	6/16/2022

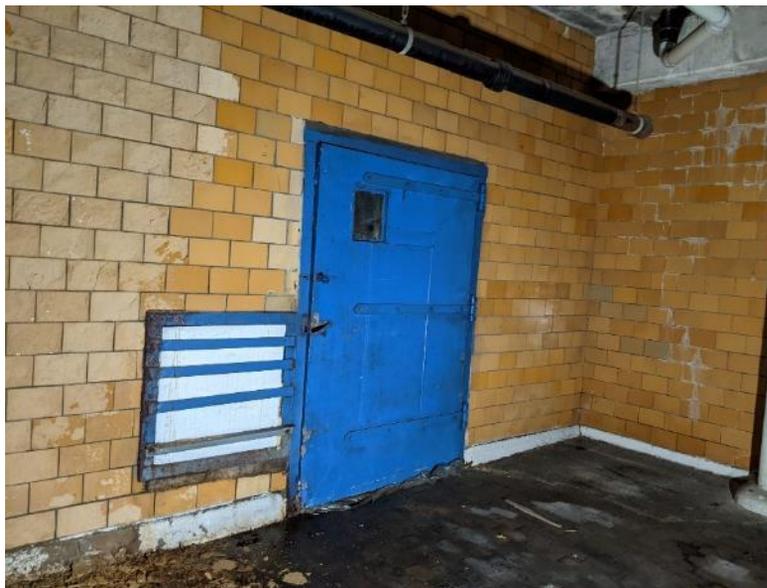
SUBTASK NO. 010.05 Direction: NA	DESCRIPTION	This photograph shows a representative view of blue LBP on metal doors.	62
	CLIENT	EPA	Date
	PHOTOGRAPHER	Cory Nichols	6/16/2022

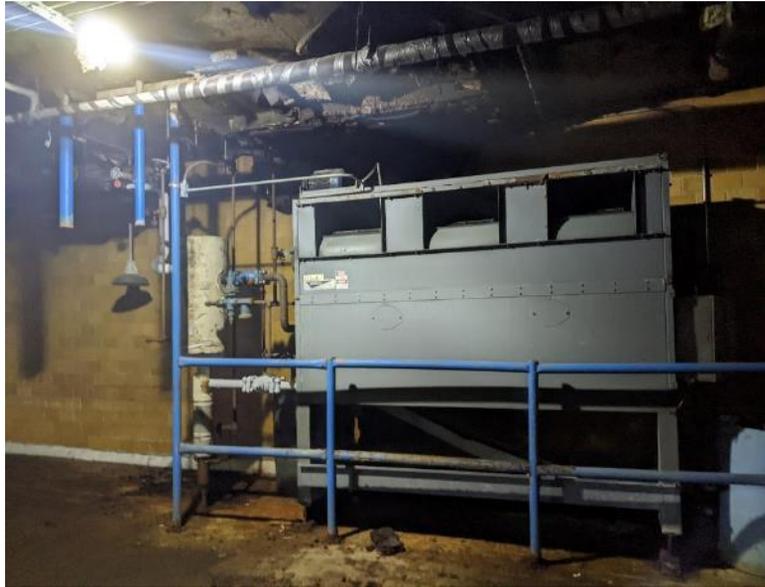
SUBTASK NO. 010.05 Direction: NA	DESCRIPTION	This photograph shows a representative view of blue LBP on a metal guard in room B55.	63
	CLIENT	EPA	Date
	PHOTOGRAPHER	Cory Nichols	6/16/2022

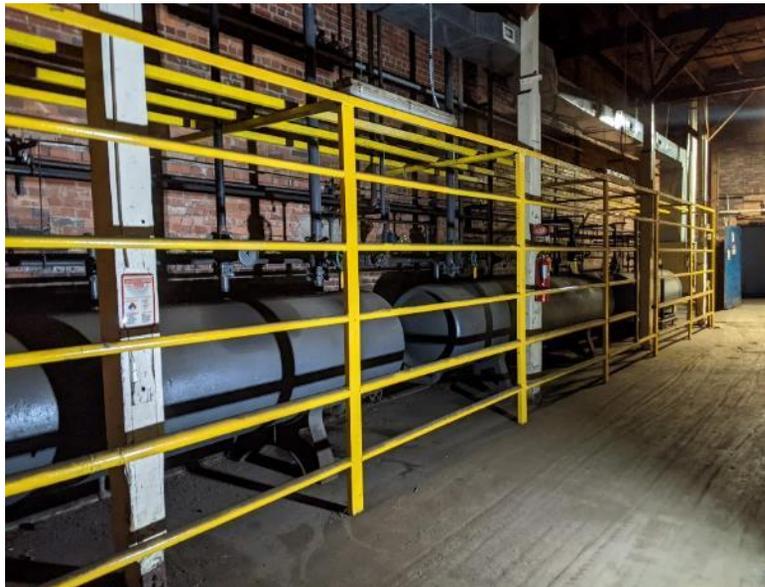
SUBTASK NO. 010.05 Direction: NA	DESCRIPTION	This photograph shows a representative view of yellow LBP on guarding around the ammonia tank in room A42.	64
	CLIENT	EPA	Date
	PHOTOGRAPHER	Cory Nichols	6/16/2022

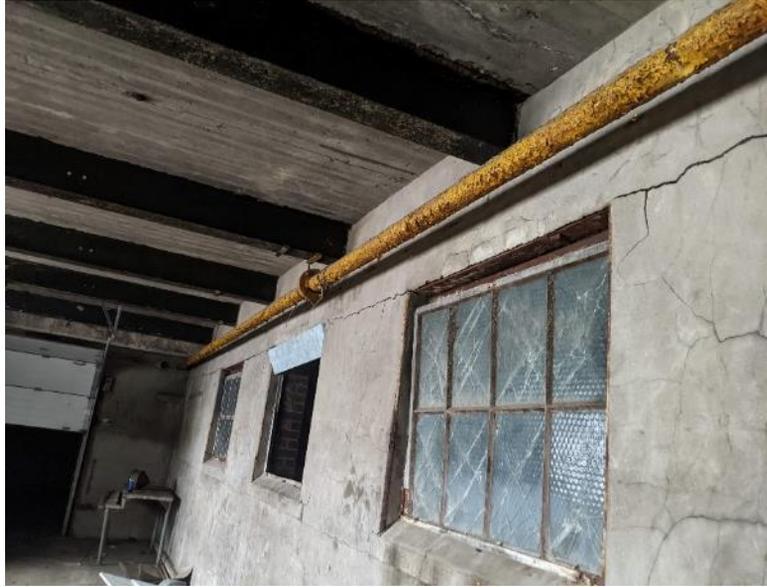
SUBTASK NO. 010.05 Direction: NA	DESCRIPTION	This photograph shows a representative view of yellow LBP on piping in room C33.	65
	CLIENT	EPA	Date
	PHOTOGRAPHER	Cory Nichols	6/16/2022
