Subject: Trip Report
Dempster Industries Site – Beatrice, Nebraska
EPA ID No. NED007282486
U.S. EPA Region 7 START 5, Contract No. 68HE0719D0001
Task Order No. 21F0136
Task Monitor: Michael Davis, On-Scene Coordinator

TRIP REPORT

**REMOVAL ACTION SUPPORT
DEMPSTER INDUSTRIES SITE – BEATRICE, NEBRASKA
EPA ID No. NED007282486**

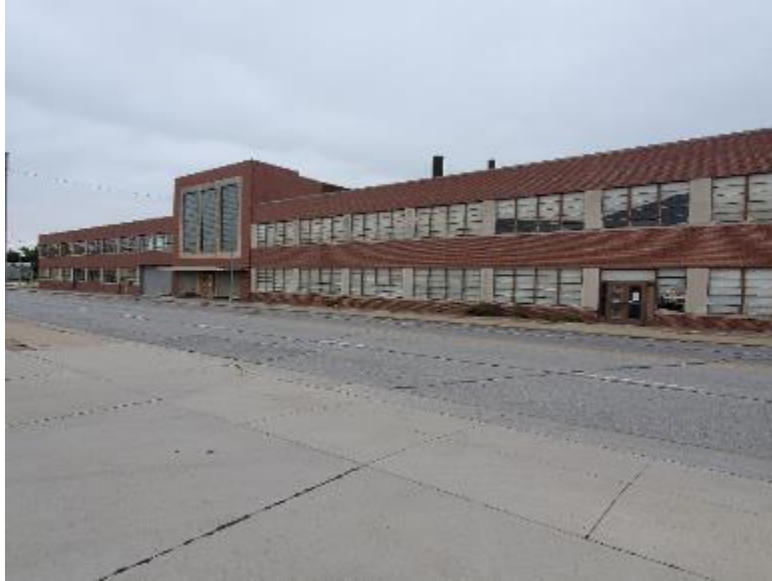
TETRA TECH PROJECT NO. X903021F0136.000 Direction: Southwest	PHOTO DESCRIPTION	This photograph shows the east side of the Dempster Industries Site, bordering S. 6 th Street.	1
	CLIENT	U.S. Environmental Protection Agency (EPA) Region 7	Date
	PHOTOGRAPHER	B. Martin (START)	9/30/21

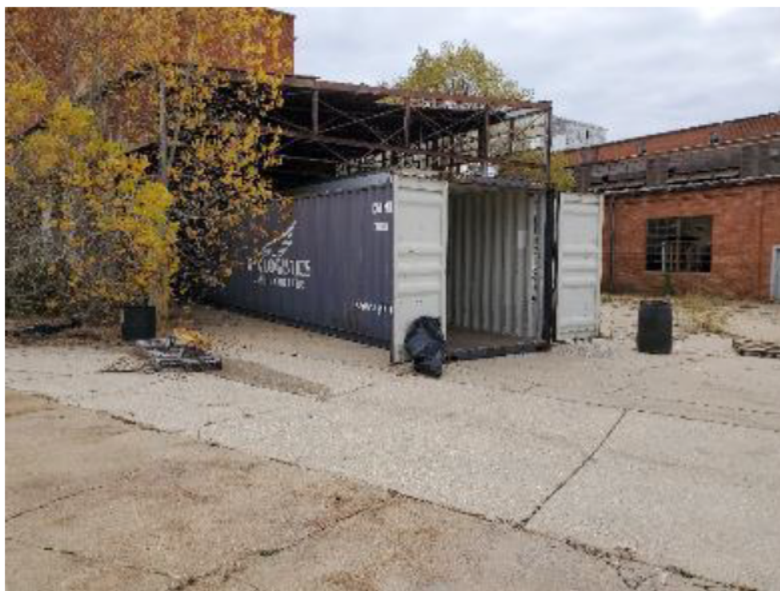
<p>TETRA TECH PROJECT NO. X903021F0136.000</p> <p>Direction: Southeast</p>	PHOTO DESCRIPTION	This photograph shows the Emergency and Rapid Removal Services (ERRS) CONEX box delivered to the site for equipment and waste storage.	17
	CLIENT	EPA Region 7	Date
	PHOTOGRAPHER	B. Martin	11/2/21

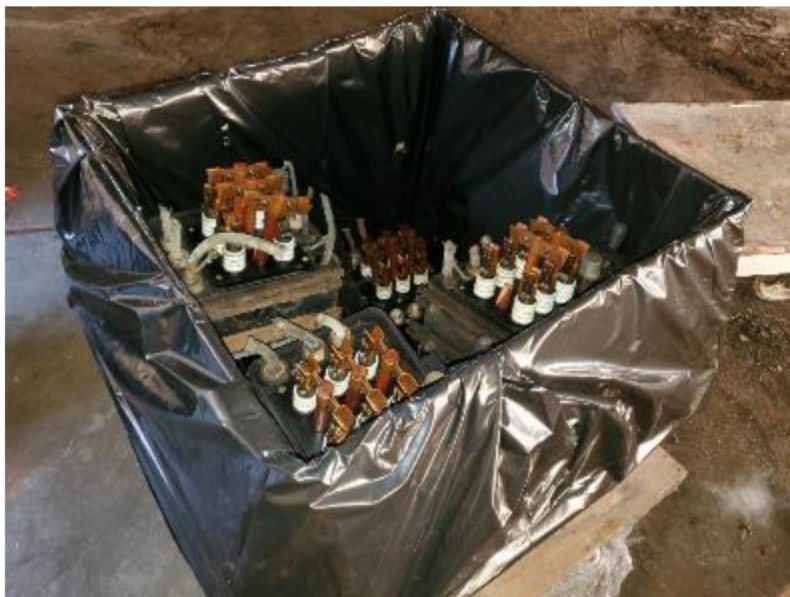
<p>TETRA TECH PROJECT NO. X903021F0136.000</p> <p>Direction: NA</p>	PHOTO DESCRIPTION	This photograph shows PCB-containing capacitor casings from Removal Area 1 bulked in a lined cubic-yard box for disposal.	21
	CLIENT	EPA Region 7	Date
	PHOTOGRAPHER	B. Martin (START)	11/4/21

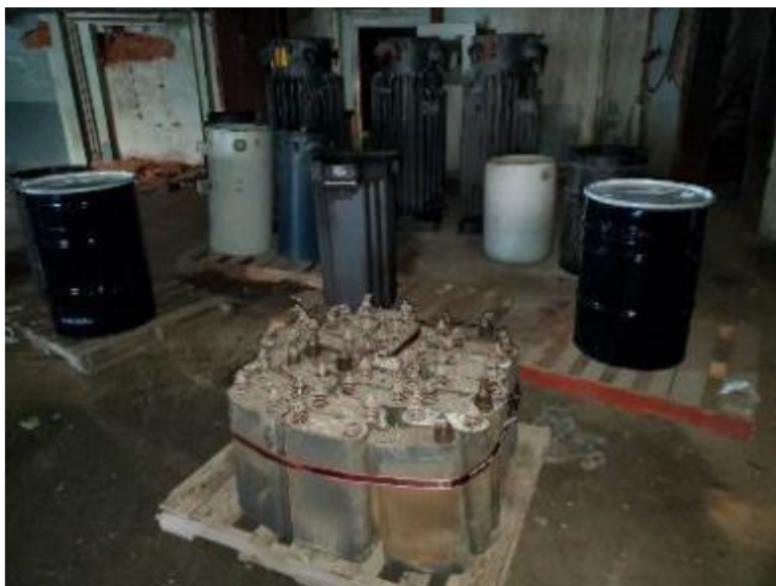
<p>TETRA TECH PROJECT NO. X903021F0136.000</p> <p>Direction: NA</p>	PHOTO DESCRIPTION	This photograph shows the temporary waste staging area for materials removed from Removal Area 1. Capacitors in foreground were subsequently drummed for removal.	22
	CLIENT	EPA Region 7	Date
	PHOTOGRAPHER	B. Martin (START)	11/4/21

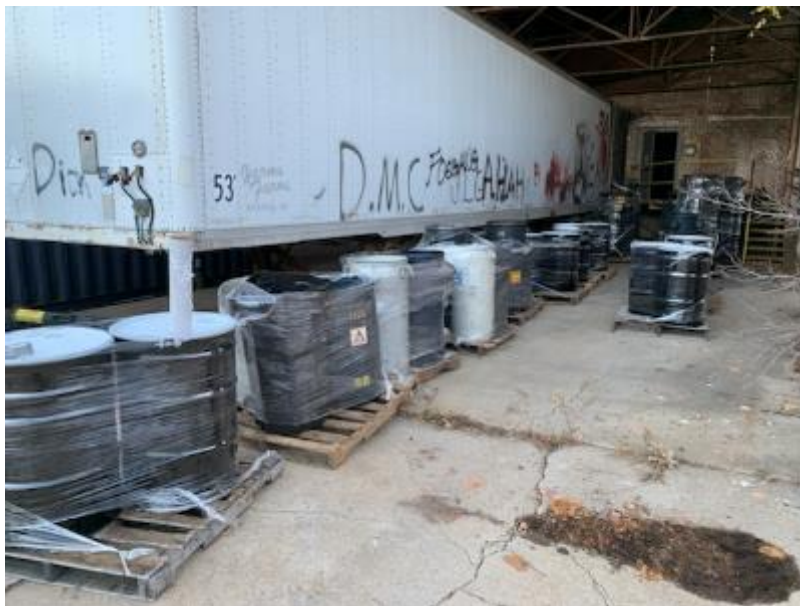
TETRA TECH PROJECT NO. X903021F0136.000 Direction: East	PHOTO DESCRIPTION	This photograph shows the drummed PCB oil and empty transformers staged for disposal.	29
	CLIENT	EPA Region 7	Date
	PHOTOGRAPHER	M. Davis (EPA)	11/5/21

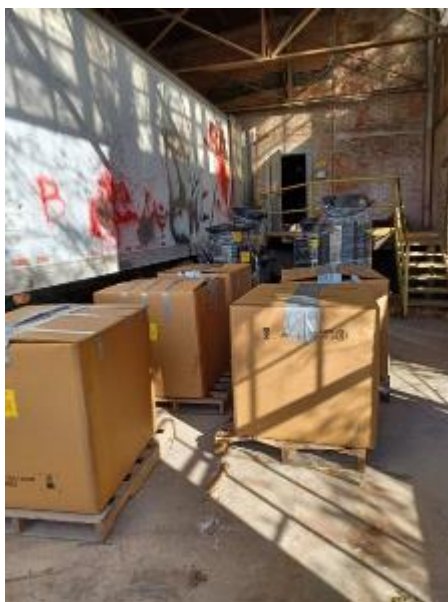
TETRA TECH PROJECT NO. X903021F0136.000 Direction: East	PHOTO DESCRIPTION	This photograph shows the cubic-yard boxes holding PCB-containing solids and empty transformers, staged for disposal.	30
	CLIENT	EPA Region 7	Date
	PHOTOGRAPHER	M. Davis (EPA)	11/5/21
