**MERSEYSIDE
FIRE & RESCUE
SERVICE**

SIGNIFICANT INCIDENT REPORT

Incident: 018965 - 15092020

Address: **Orsted BESS, Carnegie Road, Liverpool, L137HY**

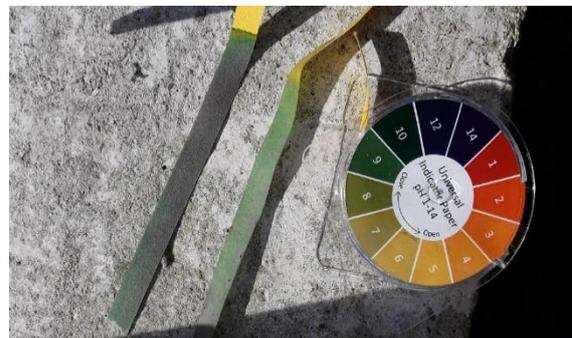
Observation: The run-off was tested and confirmed to be moderately alkaline in nature and although HF was considered to be present, HF has a pH of 3.27 per 1 mol and so should show as red/orange during pH testing. The alkaline return of 8-9 suggests that the vast drain base contained a lime element which has potentially neutralized any acidic run off. Whether this was by design or was a coincidence is unknown.

Observation: Final pH readings confirm neutral readings outside of the unit and a high alkaline content within, (pH of 14) consistent with the base metals used in Li-Ion cells. These metals include cobalt, nickel or manganese ions which are alkaline in nature. It is unconfirmed which metal, if not all, were present within the unit.

Action: Identified installations within station areas are to have Site Specific Risk Information (SSRI) revisited to include health, chemical and environmental hazards underpinned by informed data. This information is to be gathered by operational crews in line with existing procedures for familiarisation of local risks.

Action: The SSRI refresh should consider combined chemical and health hazards within typical units and should be clearly identifiable to MFRS personnel accessing the risk information for any future incidents at BESS sites. This information should be present and easily obtainable on site.

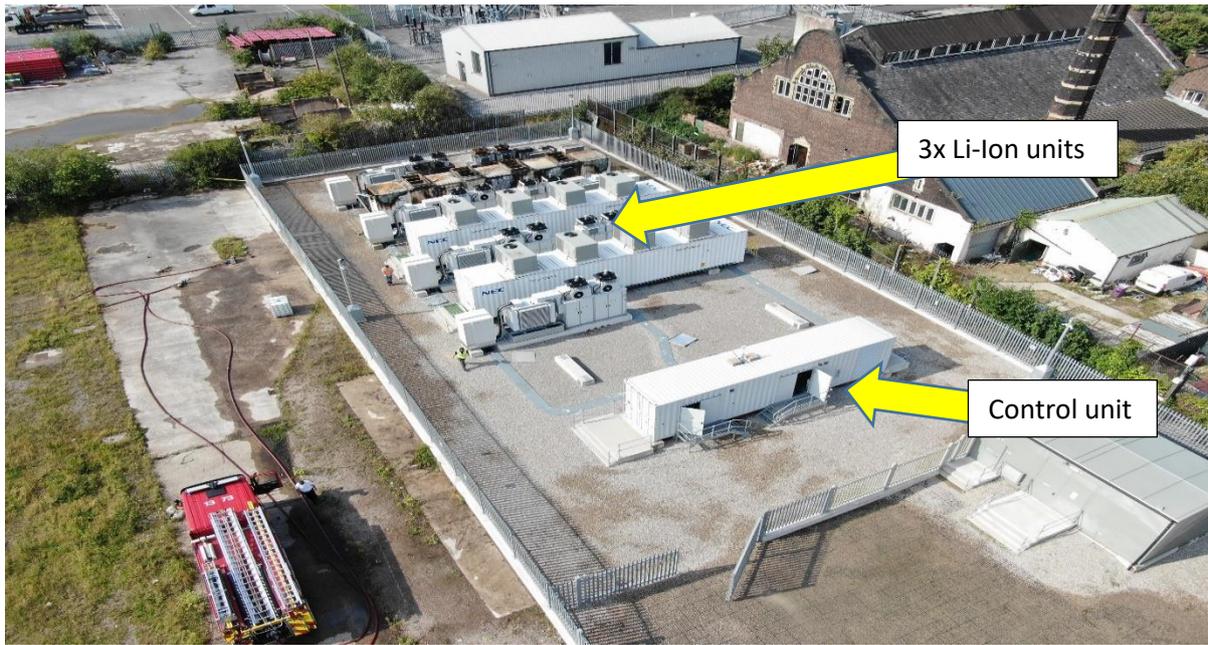
GMFRS AIR unit aerial view of Orsted BESS:

Image above: Taken from GMFRS AIR Unit. Full extent of damage visible. Roof mounted cooling units ejected to side of unit. Pressure damage visible along length of unit. Note scorching of top edge of second unit to mid-right of image. Firefighting tactics mitigated further spread and damaged beyond original unit and blast.

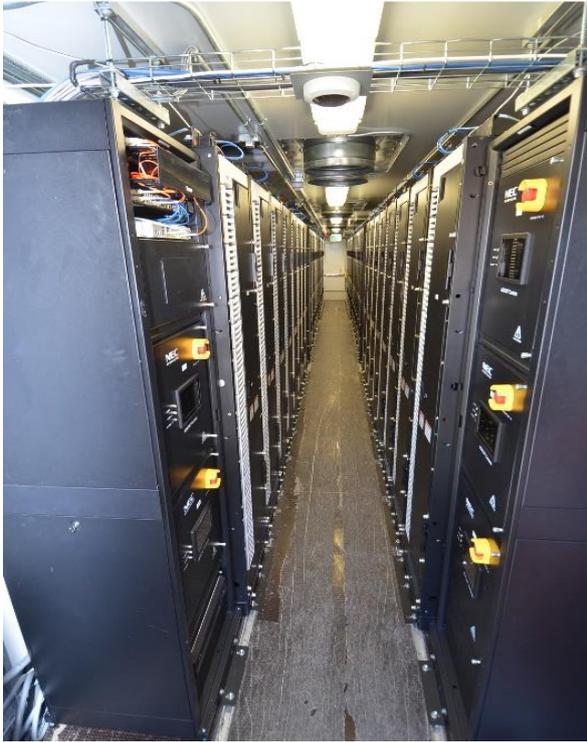
Image left: Central internal view of unaffected unit. Note configuration of lithium ion banks and narrow access corridor.

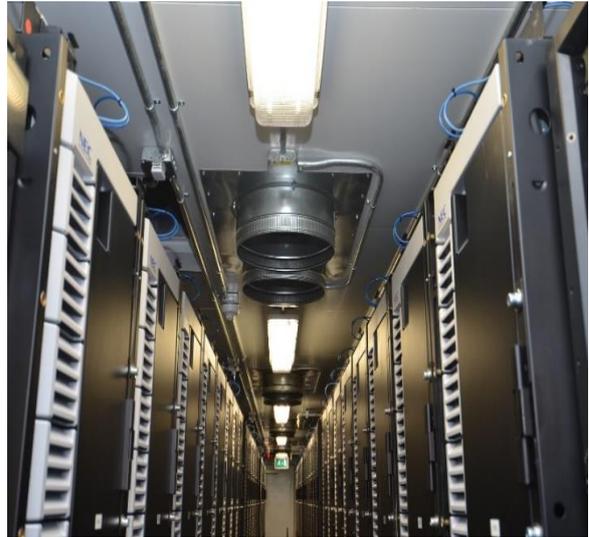
Image above: Cooling vents fitted to ceiling.

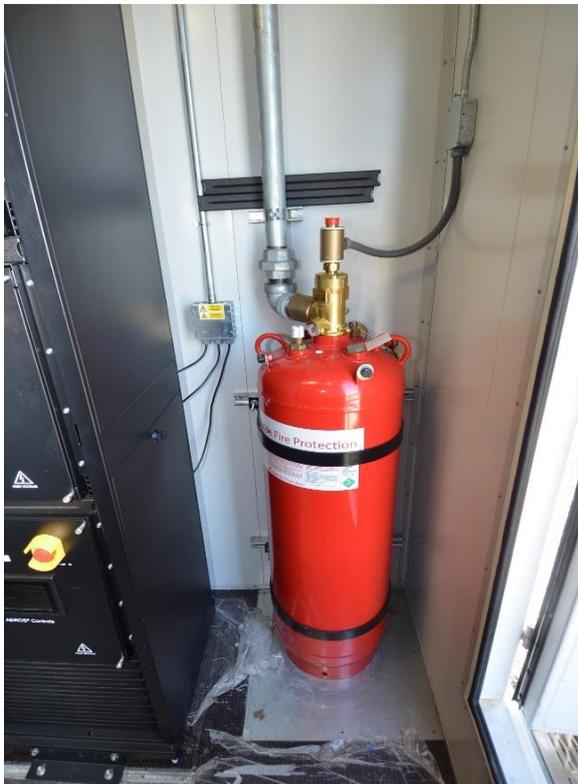
- The NOVEC 1230 system did not actuate, confirmed by internal CCTV.
- A white gas was liberated prior to ignition, indicative of a lithium ion cell failure and liberation of toxic gases detailed above.
- The potential ignition cause is allocated to the failure of a single lithium cell, one of several due for replacement as near end of service life.
- A major blast event was captured by CCTV externally.
- A pressure relief valve may have delayed or prevented a blast event.
- Several elements were ejected from the unit, a component of one of the air cooling units found at 74ft (22.5m) from the unit.

Image left: NOVEC 1230 fixed aerosol system with piping.

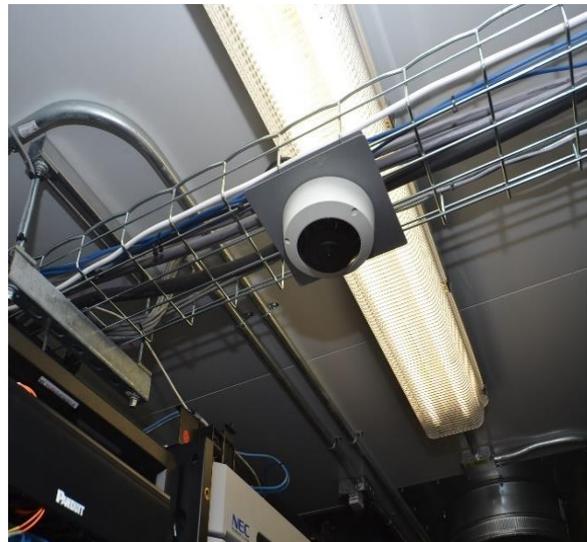
Image above: Combined CCTV and Fire detection unit.
