RE: Results of Borehole Geophysical Logging: ERT-45-I
Site: Crown Cleaners Superfund Site, Village of Herrings, NY

Borehole Geophysical Logging

ERT-45-I

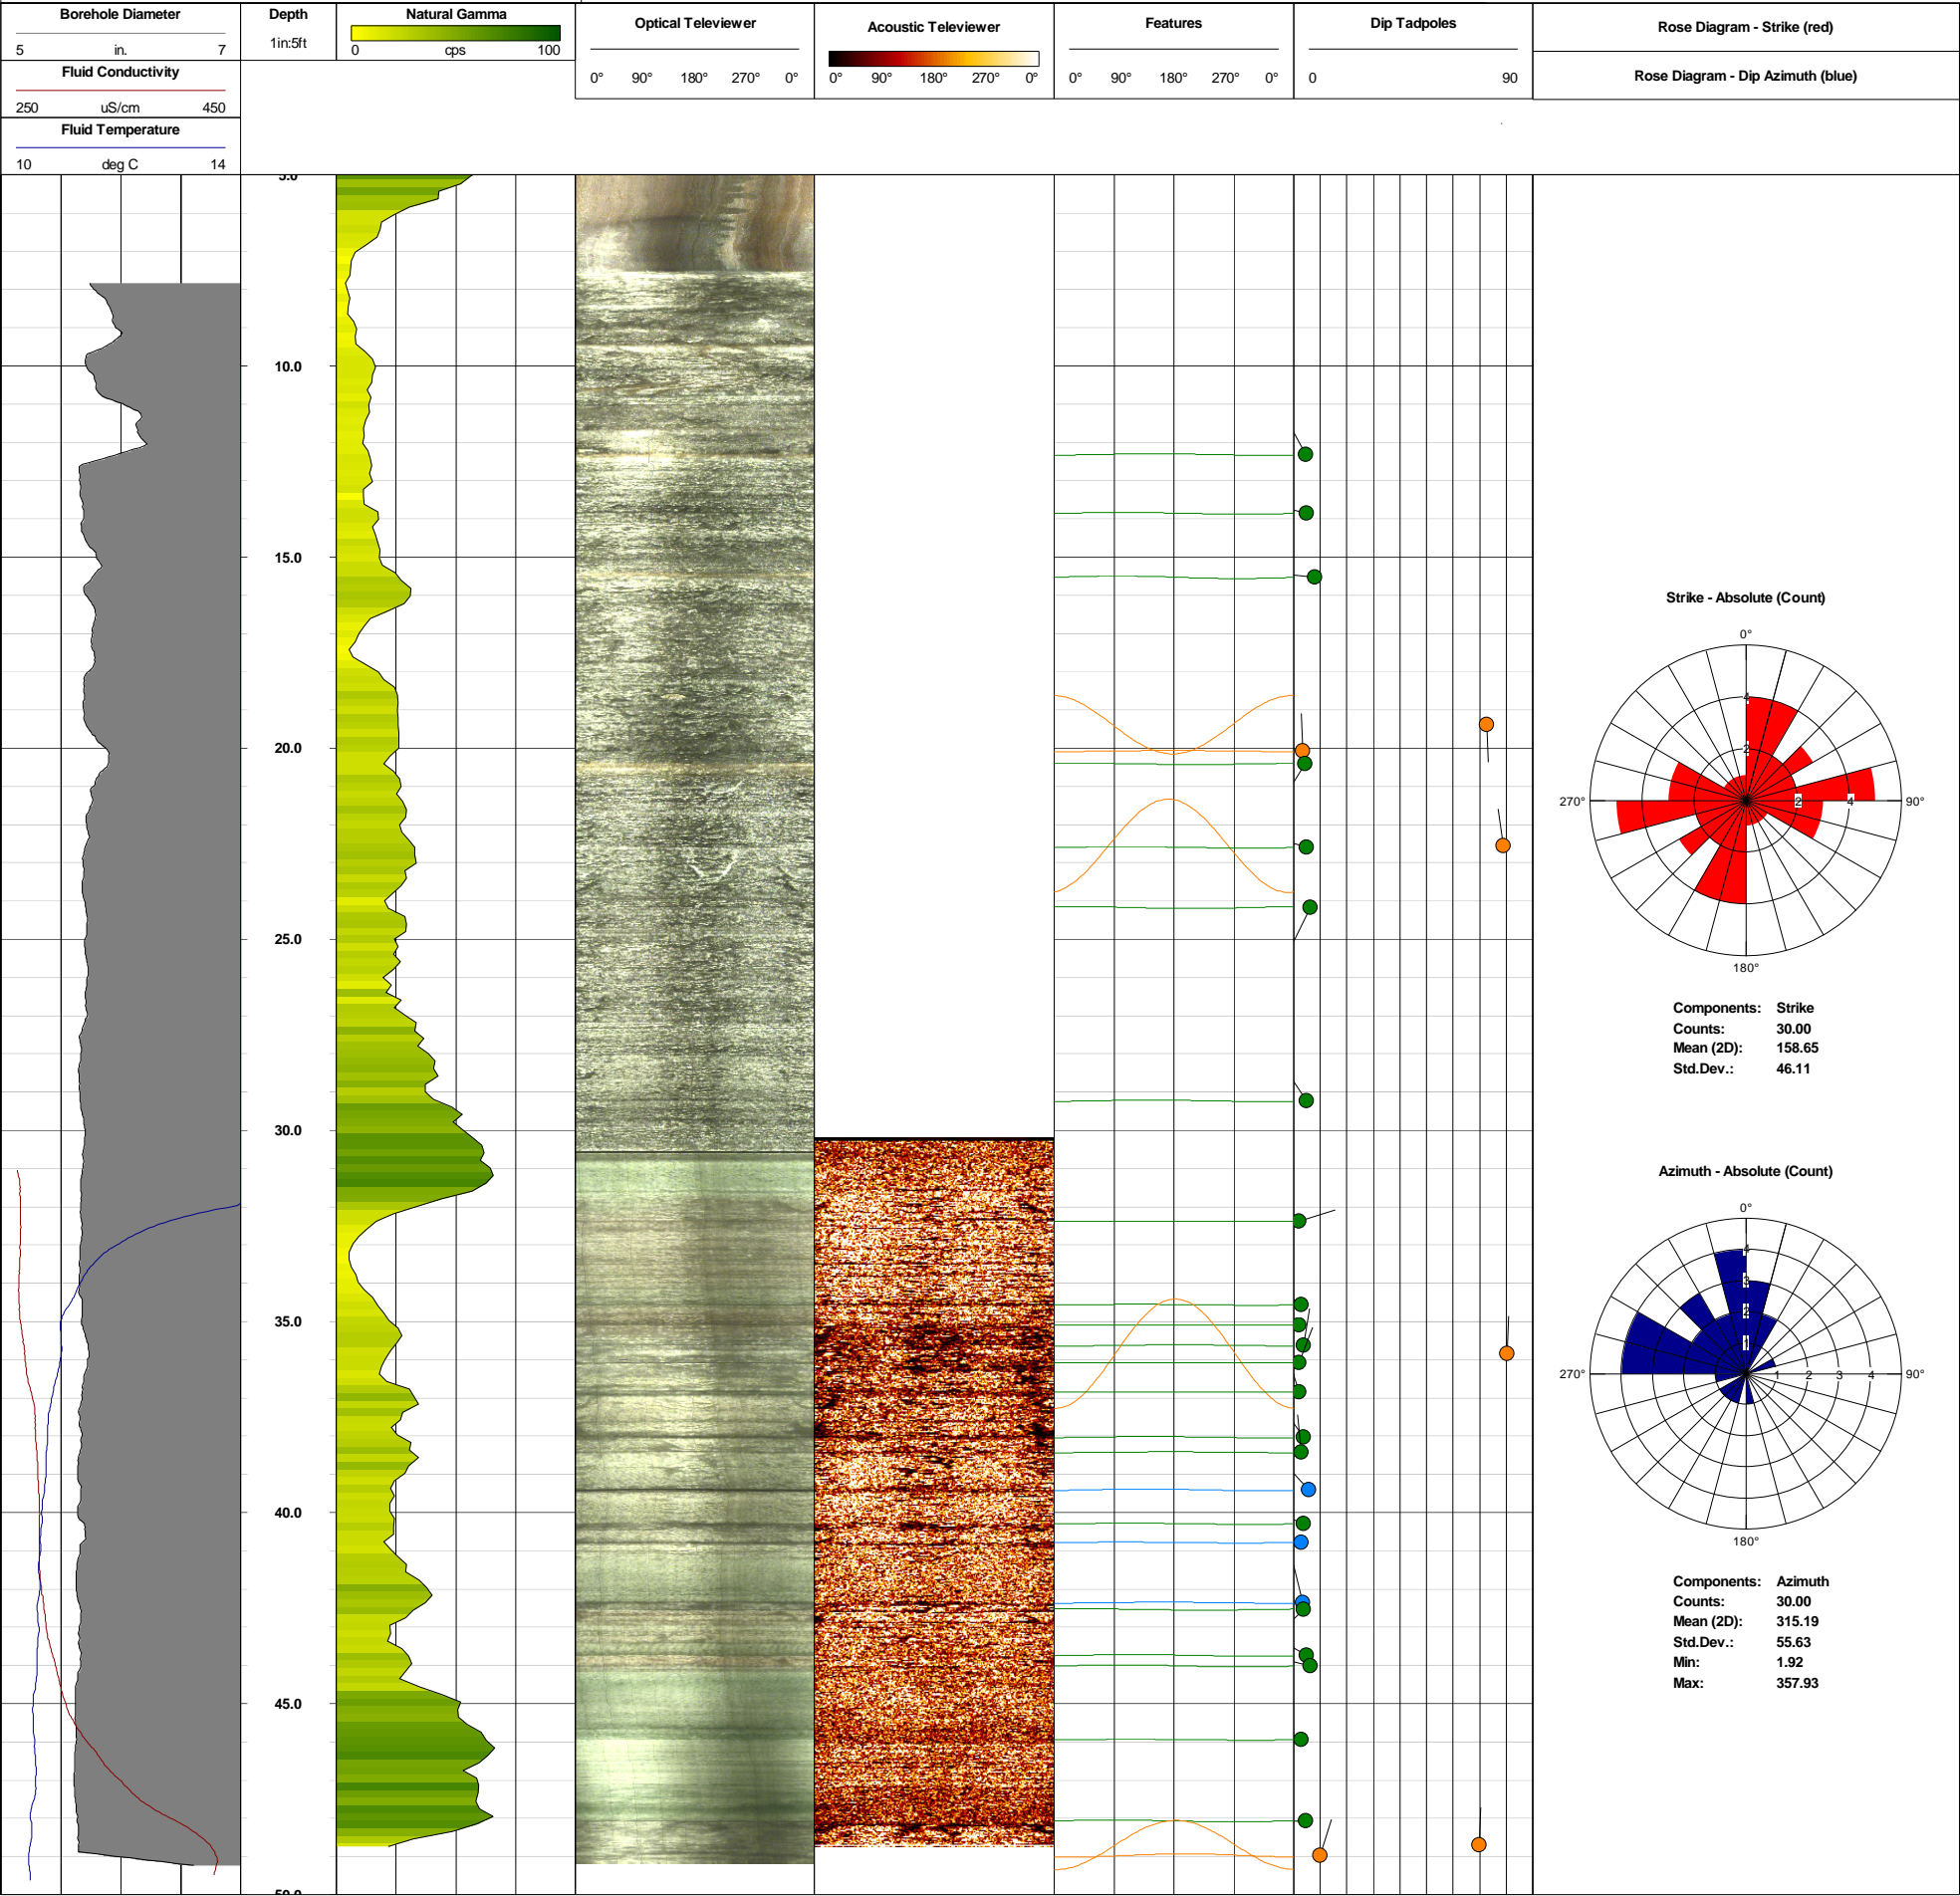
Hairline Fracture/Feature

Discontinuous Hairline Fracture/Feature
-

Bedding/Change in Lithology

Fracture/Feature – obvious, dark sinusoidal line across the entire acoustic image; usually supported by the response of the 3-arm caliper.

Hairline Fracture/Feature – as above, though not as evident; generally minimal aperture noted

Discontinuous Fracture (Hairline or otherwise)/Feature – shape of sinusoidal line is intact; does not span across entire acoustic image.

Bedding/Change in Lithology – shape of sinusoidal line is intact, usually supported by natural gamma log and/or response of acoustic return; generally minimal aperture noted

- Hairline features observed at 39.5', 40.5', 42.5', & 48'
- Relative changes in lithology between 29'-32' & 45'-48' (higher natural gamma)
