**Phase 1 Final Design Deliverable**  
**Camp Bird Removal Action**

**Site Name:** Camp Bird Mine

**Prepared by:** Mike Thompson, Project Coordinator, Caldera Mineral Resources, LLC

CAMP BIRD MINE RECLAMATION  
OURAY COUNTY, COLORADO

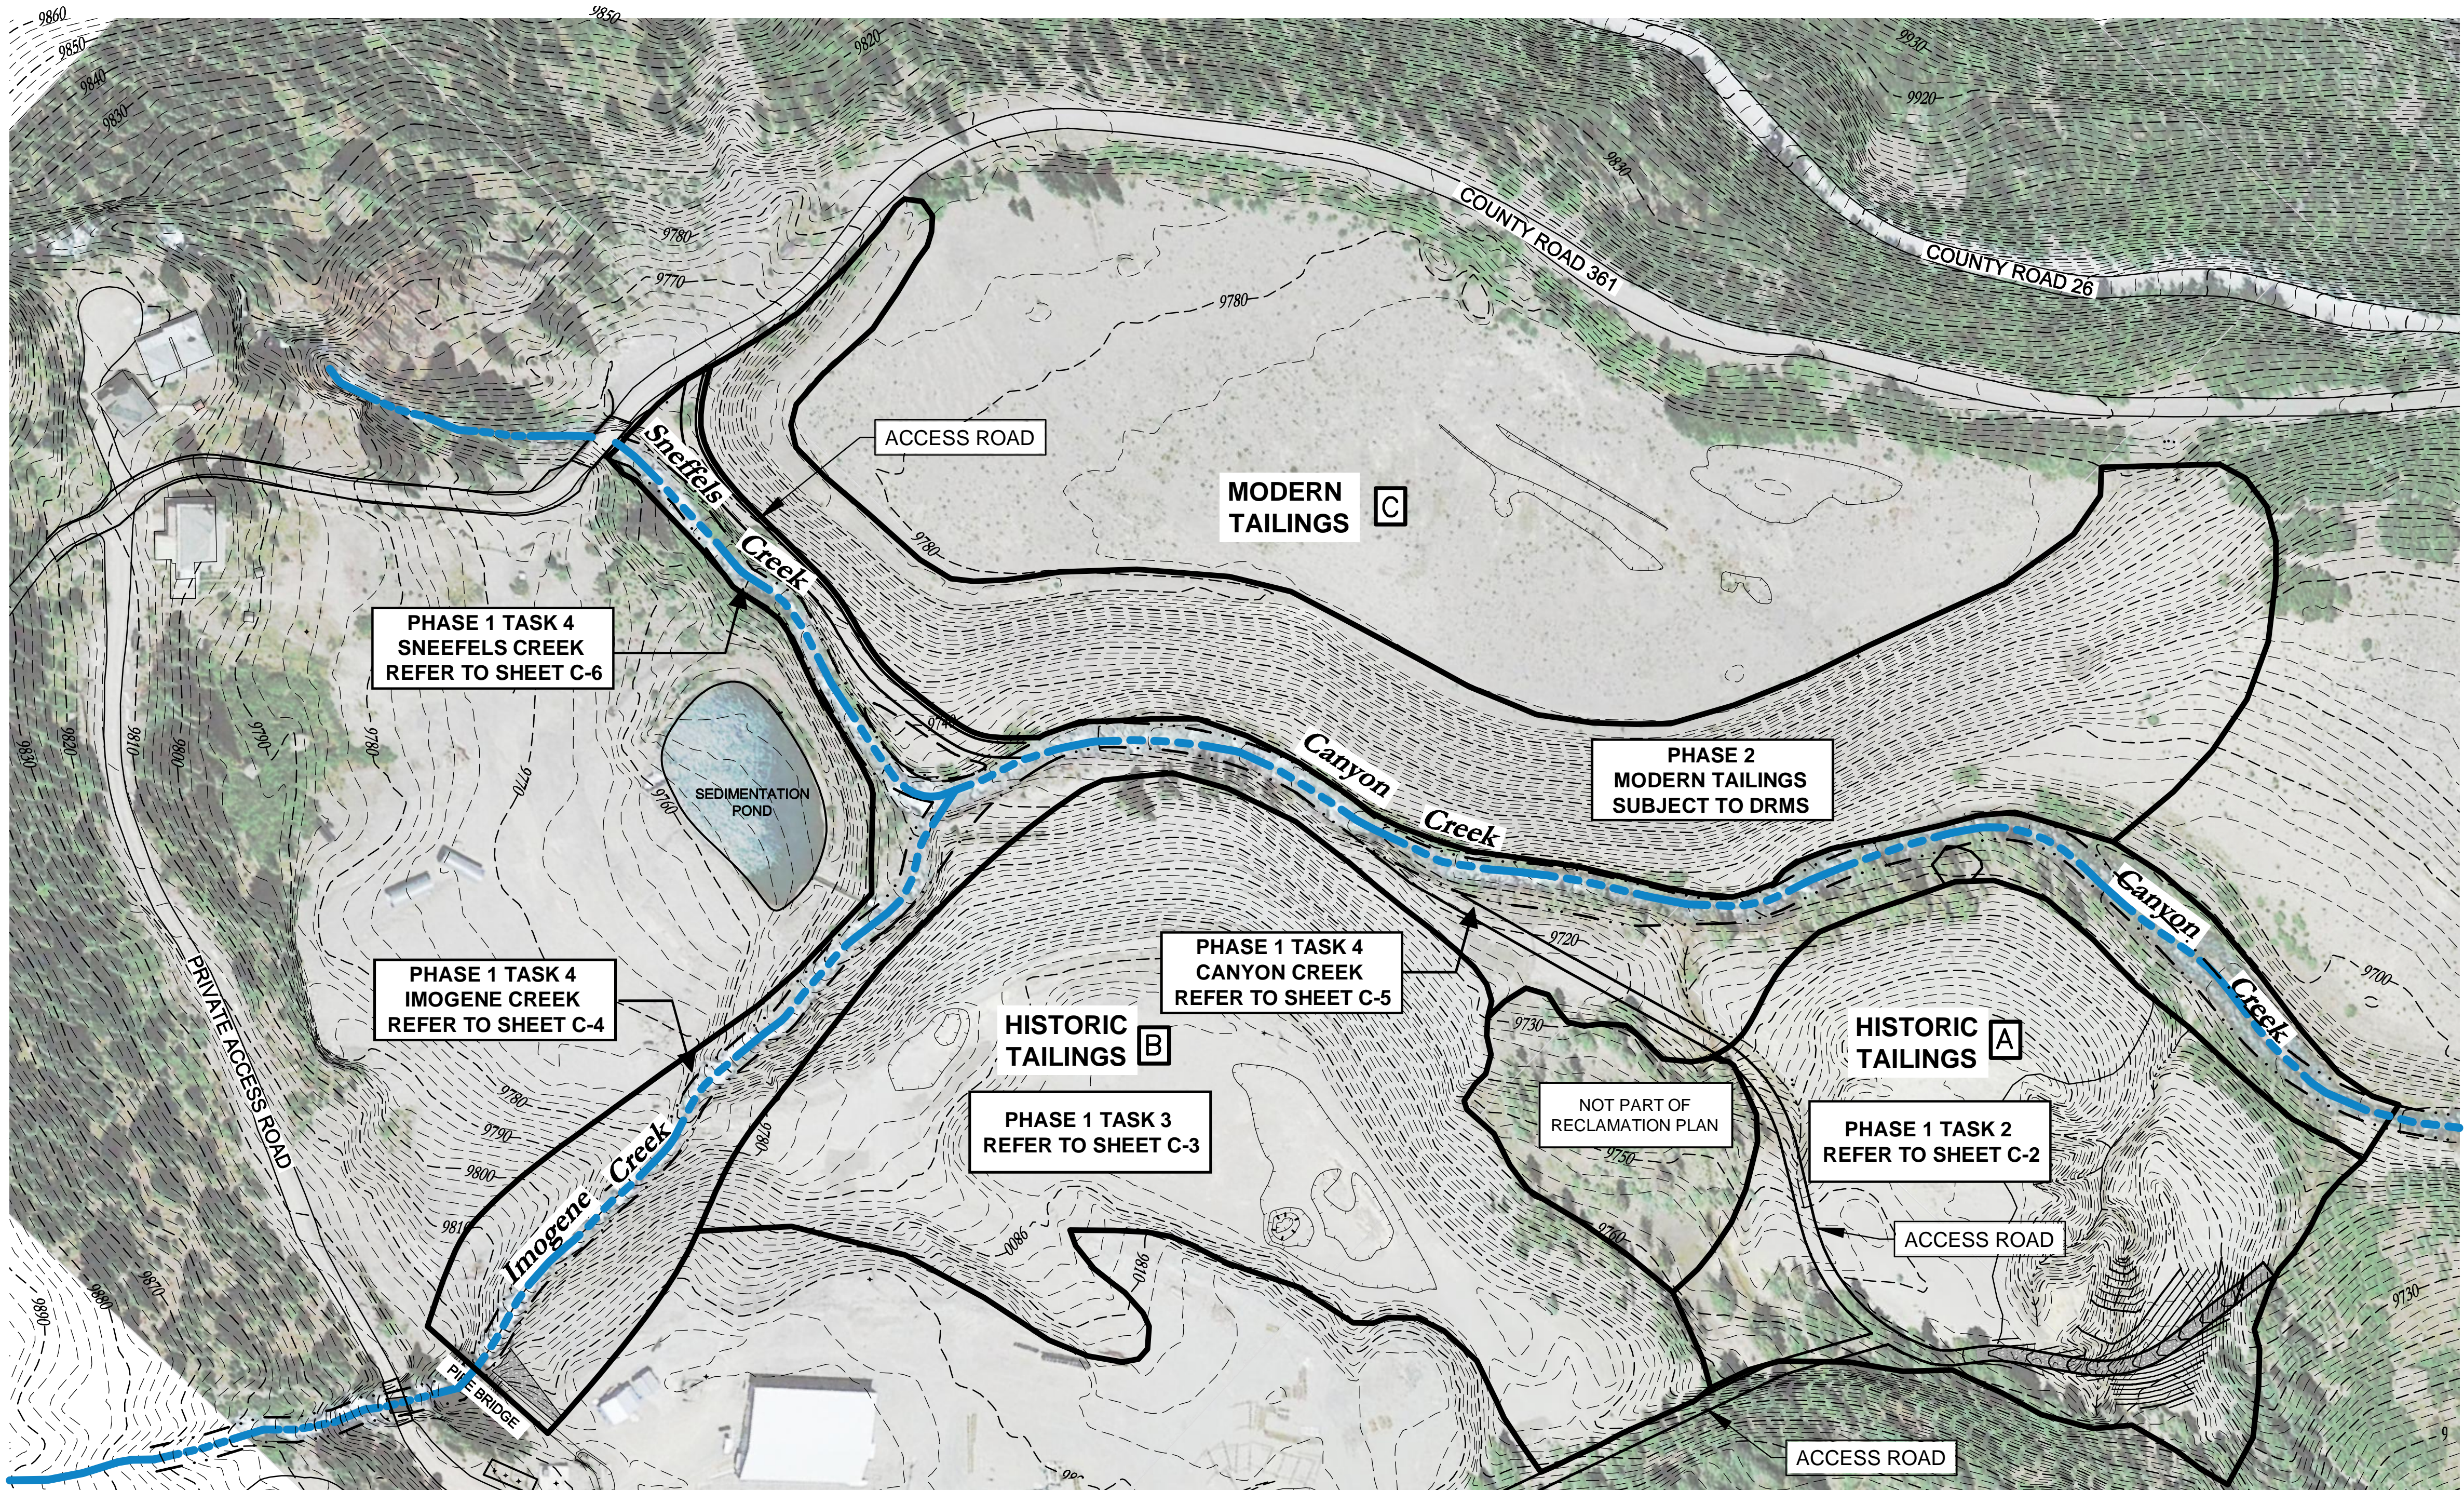
SITE PLAN

- PHASE 1 TASK 2:
- EXCAVATE EAST TAILINGS AND FILL UNNAMED DRAINAGES.
  - REVEGETATE EASTERN HISTORIC TAILINGS **A**
- PHASE 1 TASK 3:
- SHAPE AND REVEGETATE HISTORIC TAILINGS **B**
- PHASE 1 TASK 4:
- IMOGENE CREEK RESTORATION AND REVEGETATION
  - CANYON CREEK RESTORATION AND REVEGETATION
  - SNEFFELS CREEK RESTORATION AND REVEGETATION

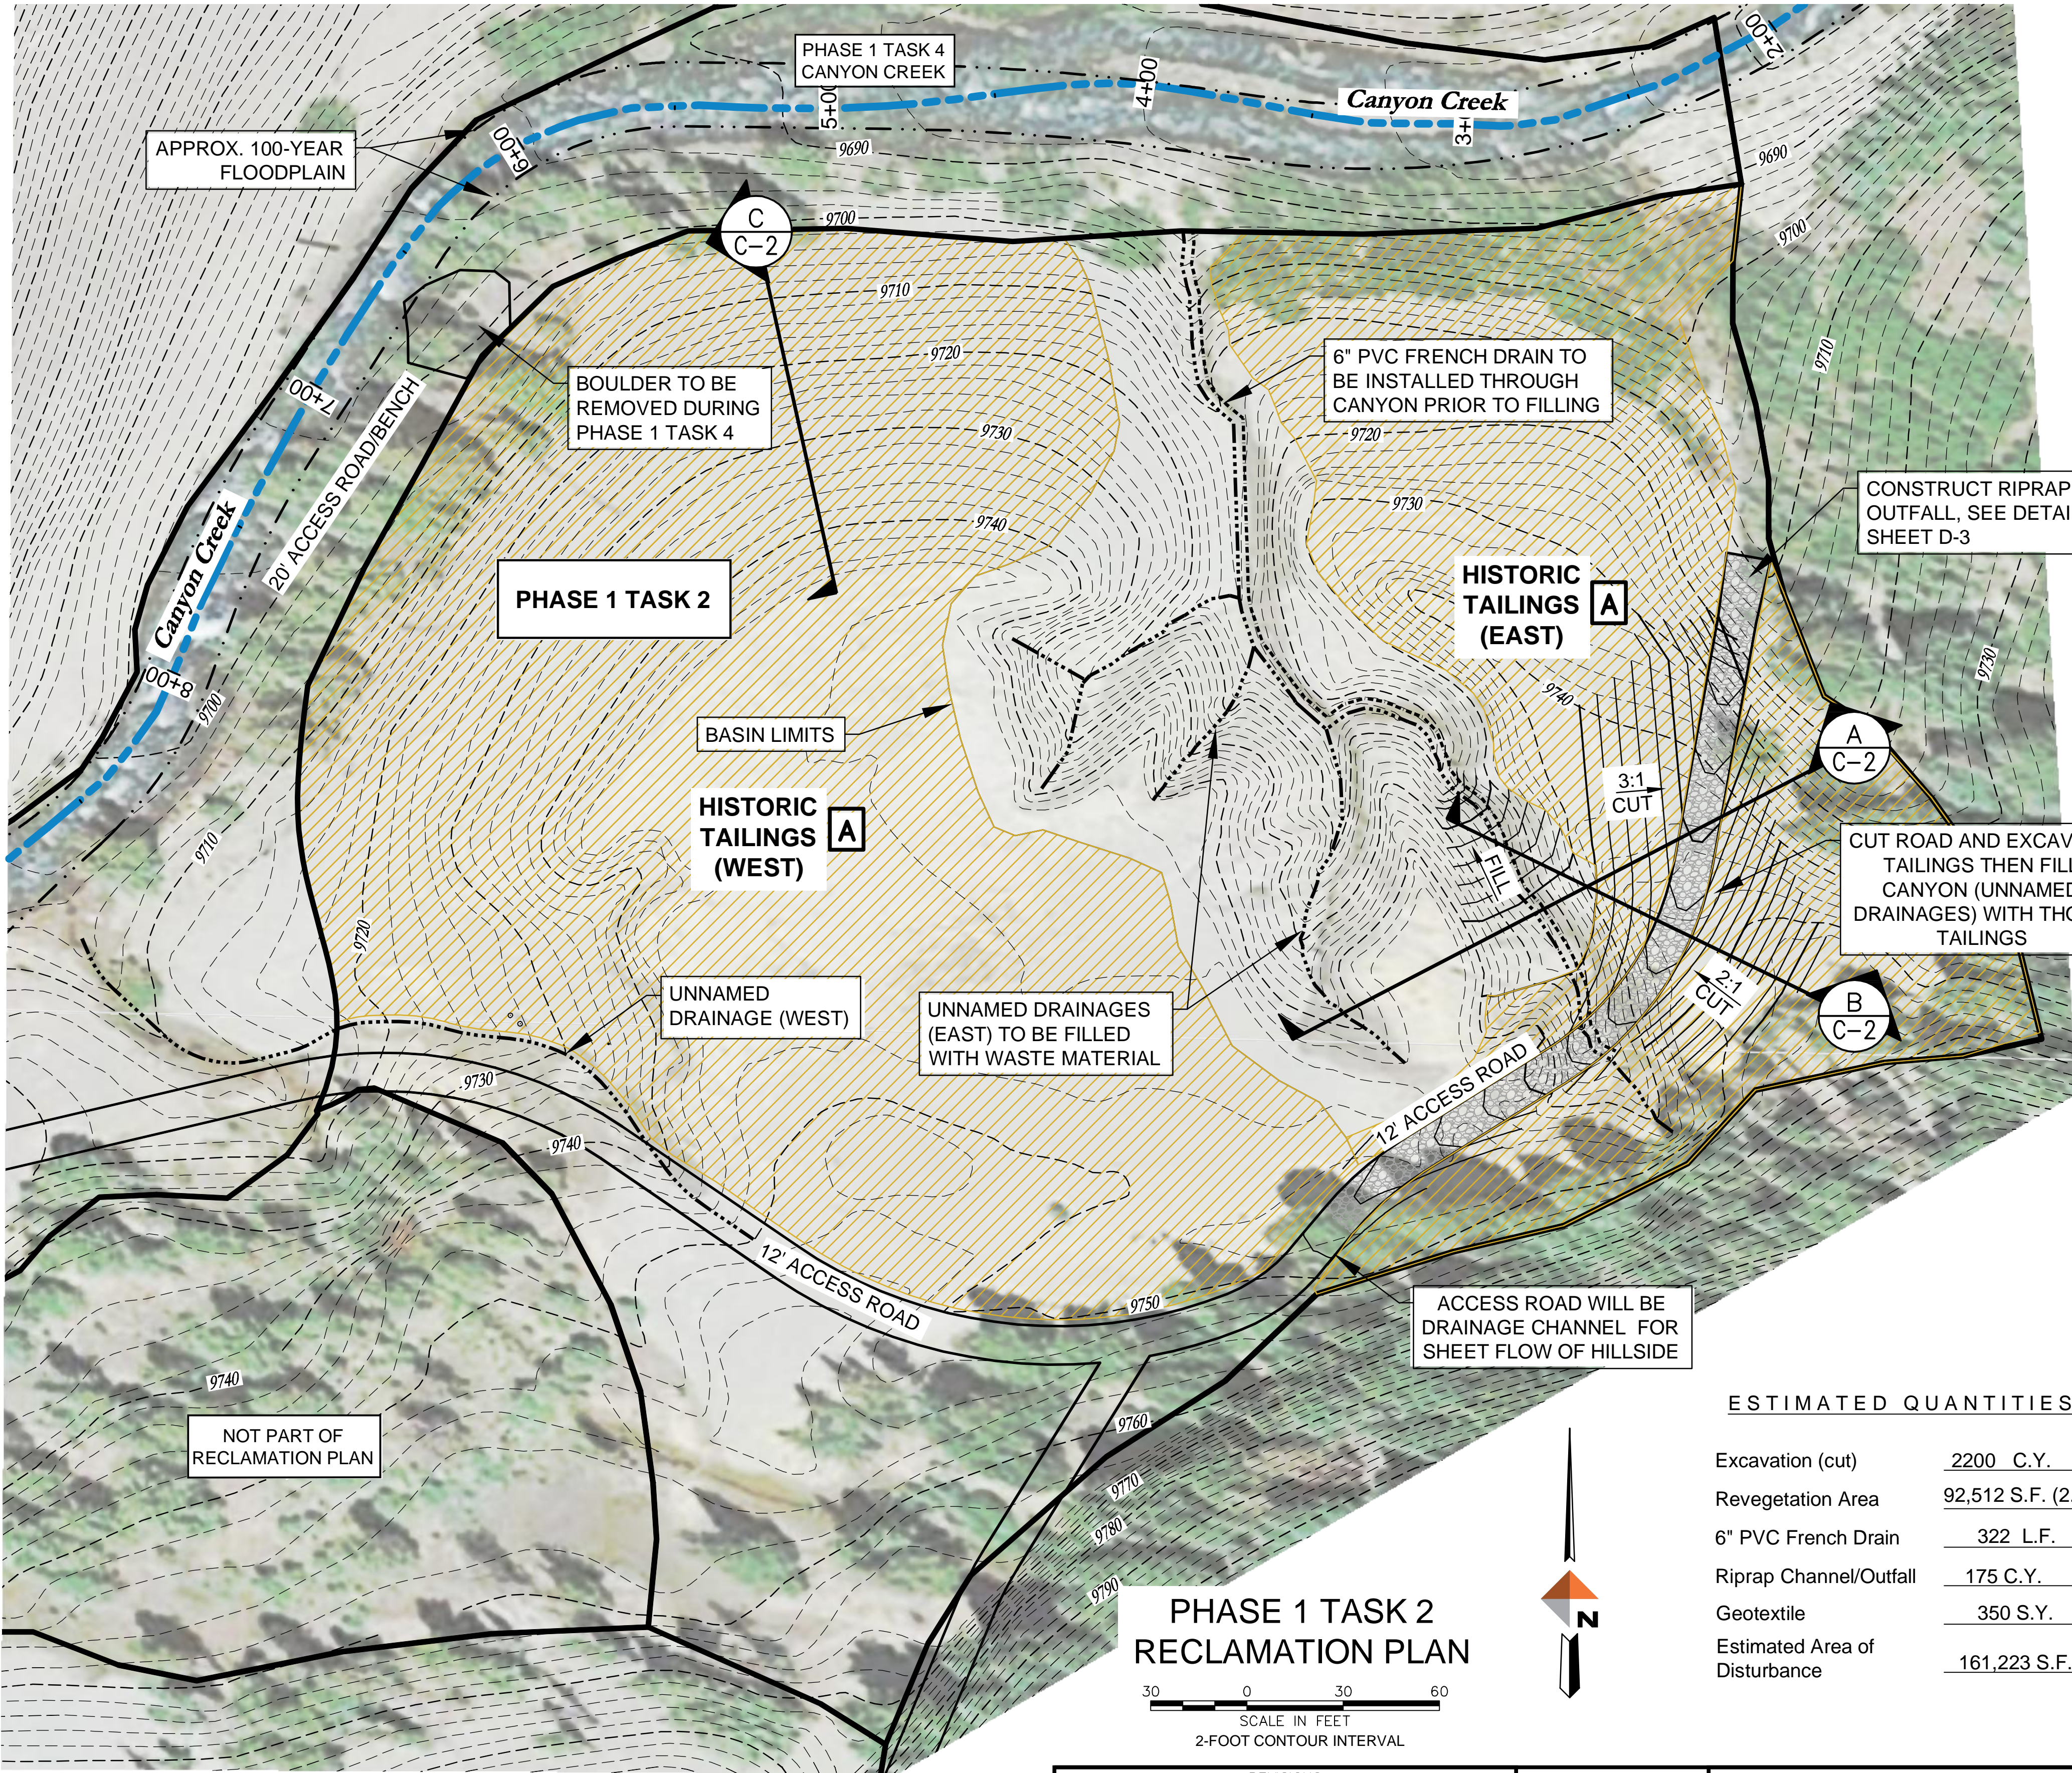
PHASE 1 TASK 2  
RECLAMATION PLAN

PHASE 1 TASK 2 WORK PLAN (2017)

1. Cut access roads for construction equipment. Road will eventually become the drainage outfall after excavation and revegetation.
2. Excavate tailings material at southeast area and fill Unnamed Drainage (East) with those tailings.
3. Revegetation of slopes by contractor using approved seed mix, and Erosion Control Measures (ECM's) (see Sheet D-3).

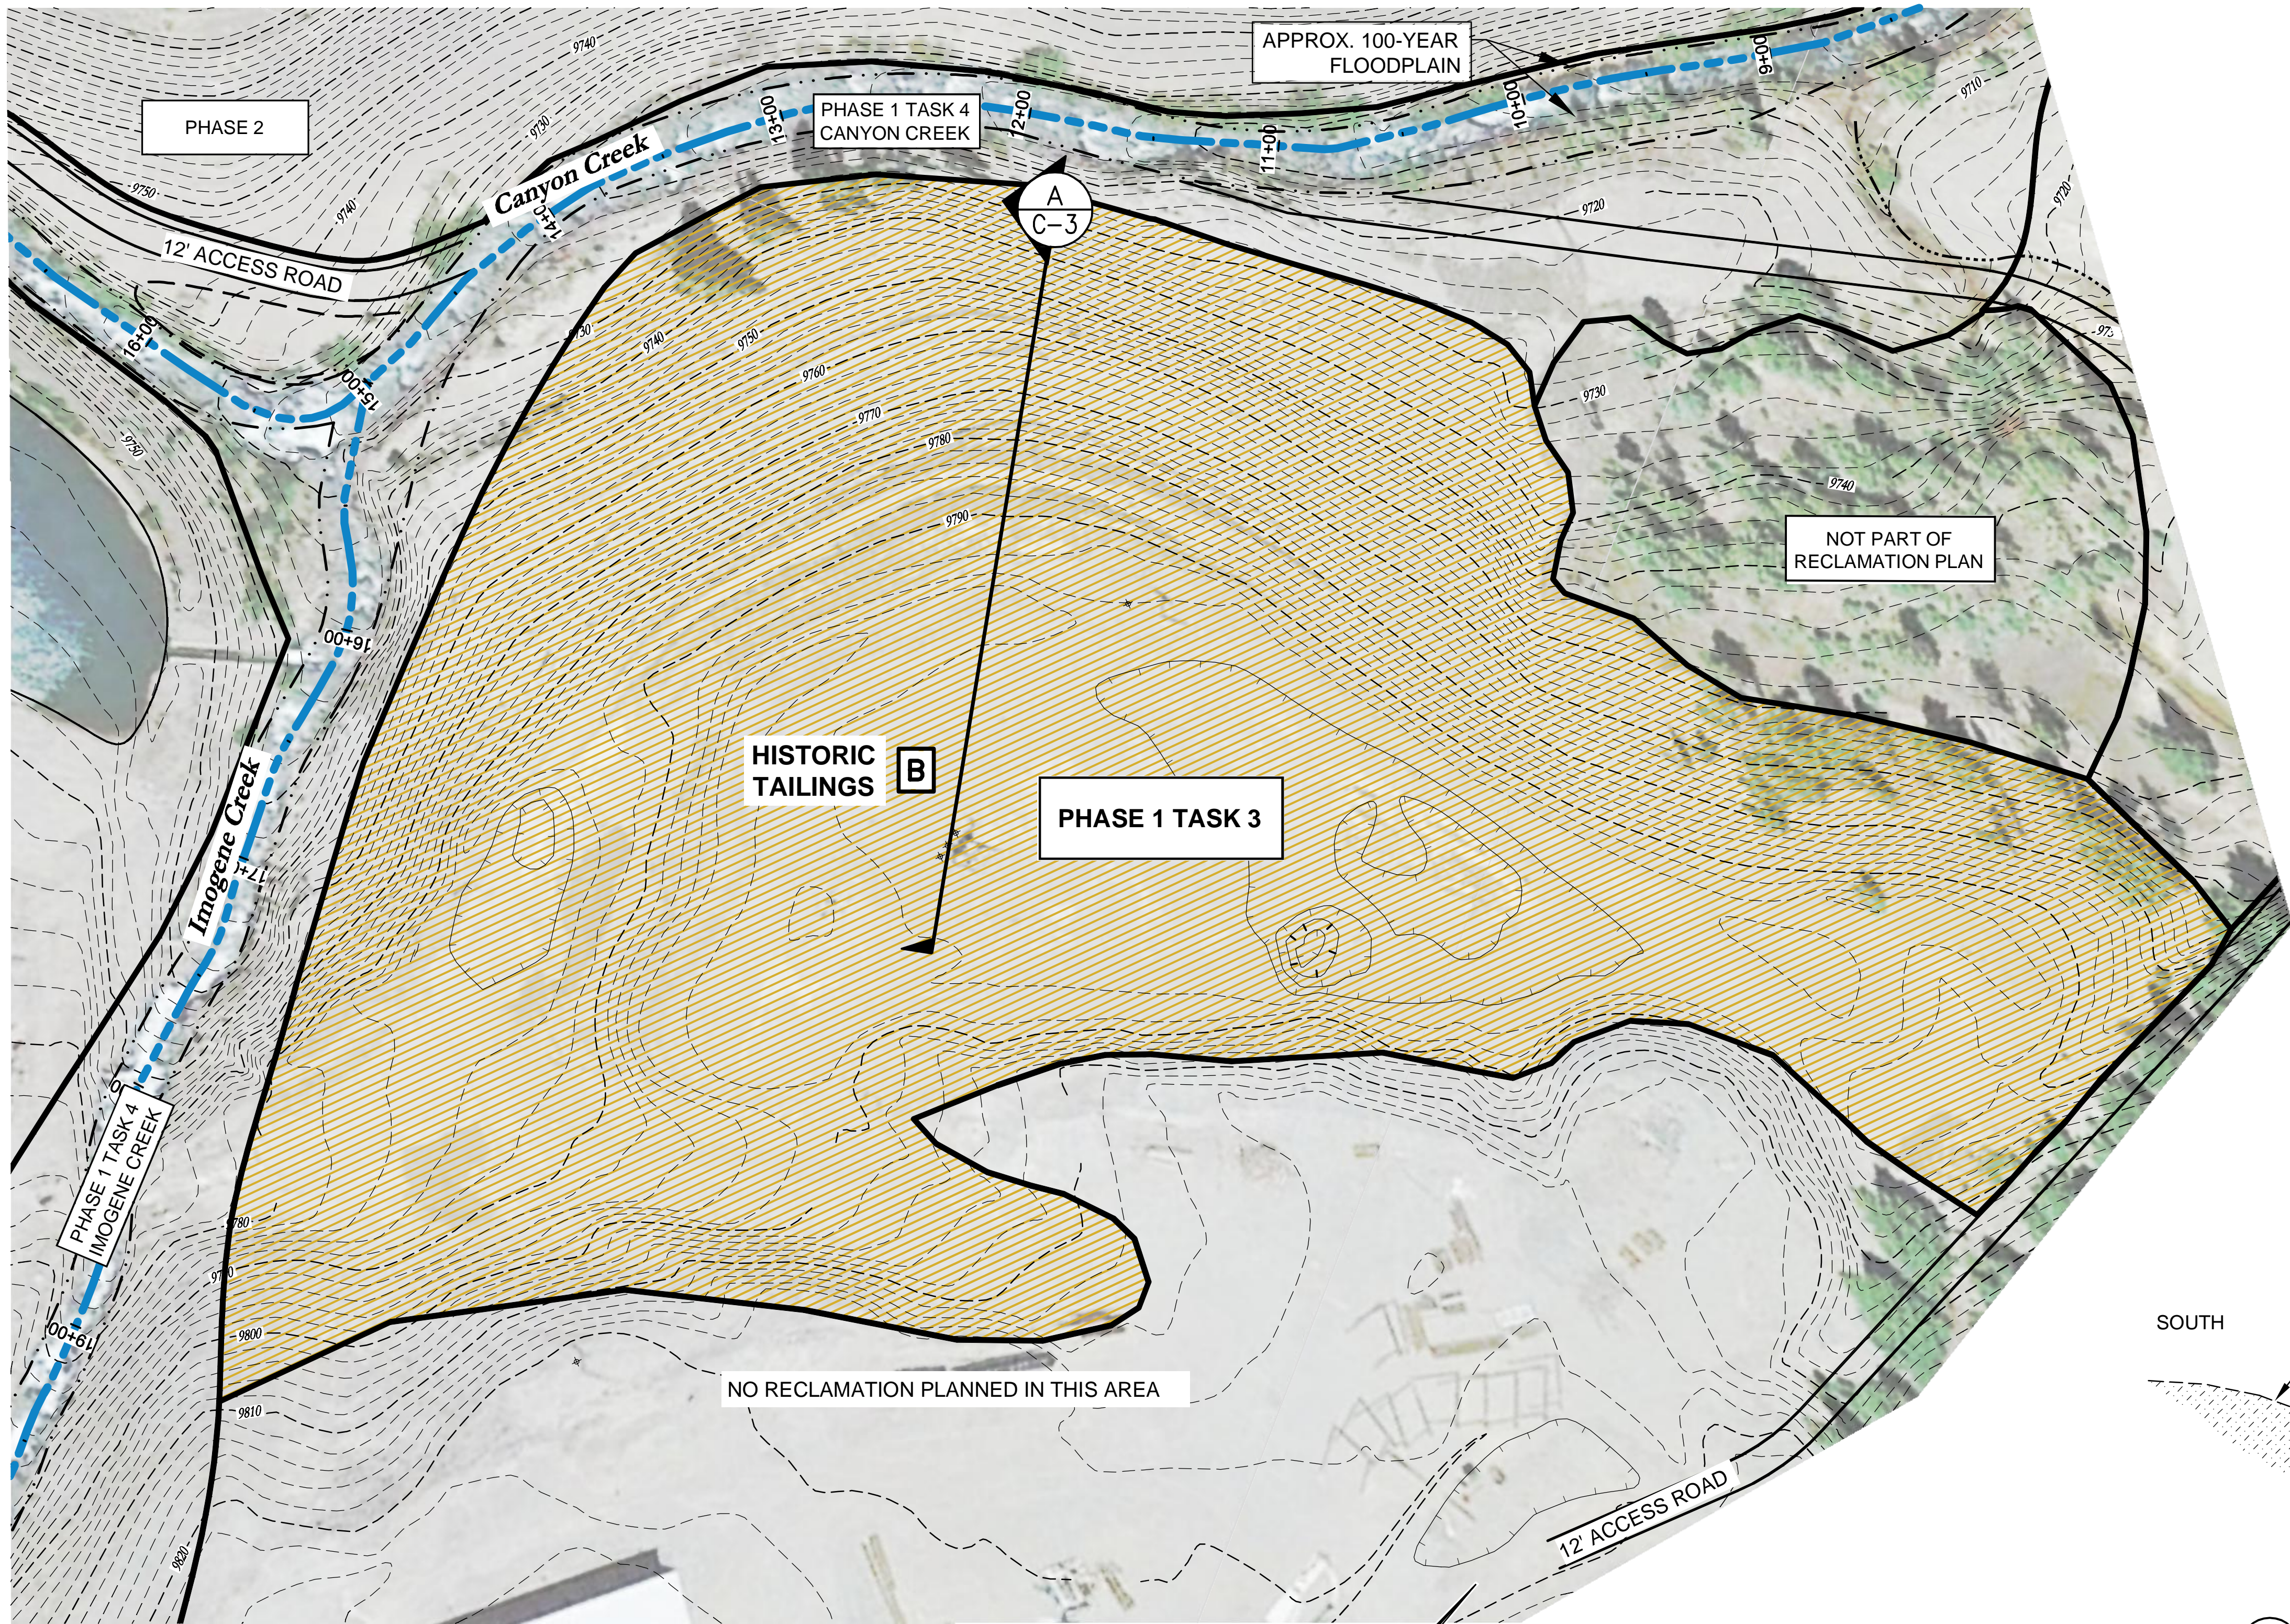
PHASE 1 TASK 3  
RECLAMATION PLAN

PHASE 1 TASK 3 WORK PLAN (2017)

1. Develop access roads as needed for constructing current and future areas.
2. Regrade Historic Tailings **B** for revegetation by contractor. Remove timbers and debris as part of this task.
3. Revegetation by contractor using approved seed mix and Erosion Control Measures (ECM's) (See Sheet D-3).

The drawing for P1T2 is conceptual and does not reflect the exact conditions. As of the date of this submittal, the entire downstream historic tailings cell has been regraded, shaped and prepped for capping. The slopes on all sides have been reduced to the minimum grade possible without compromising the structural integrity of underlying slime layers. Tailings have been removed entirely from the toe, which is now comprised of a natural colluvial deposit that was buried beneath 10s of feet of windblown tailings sand.

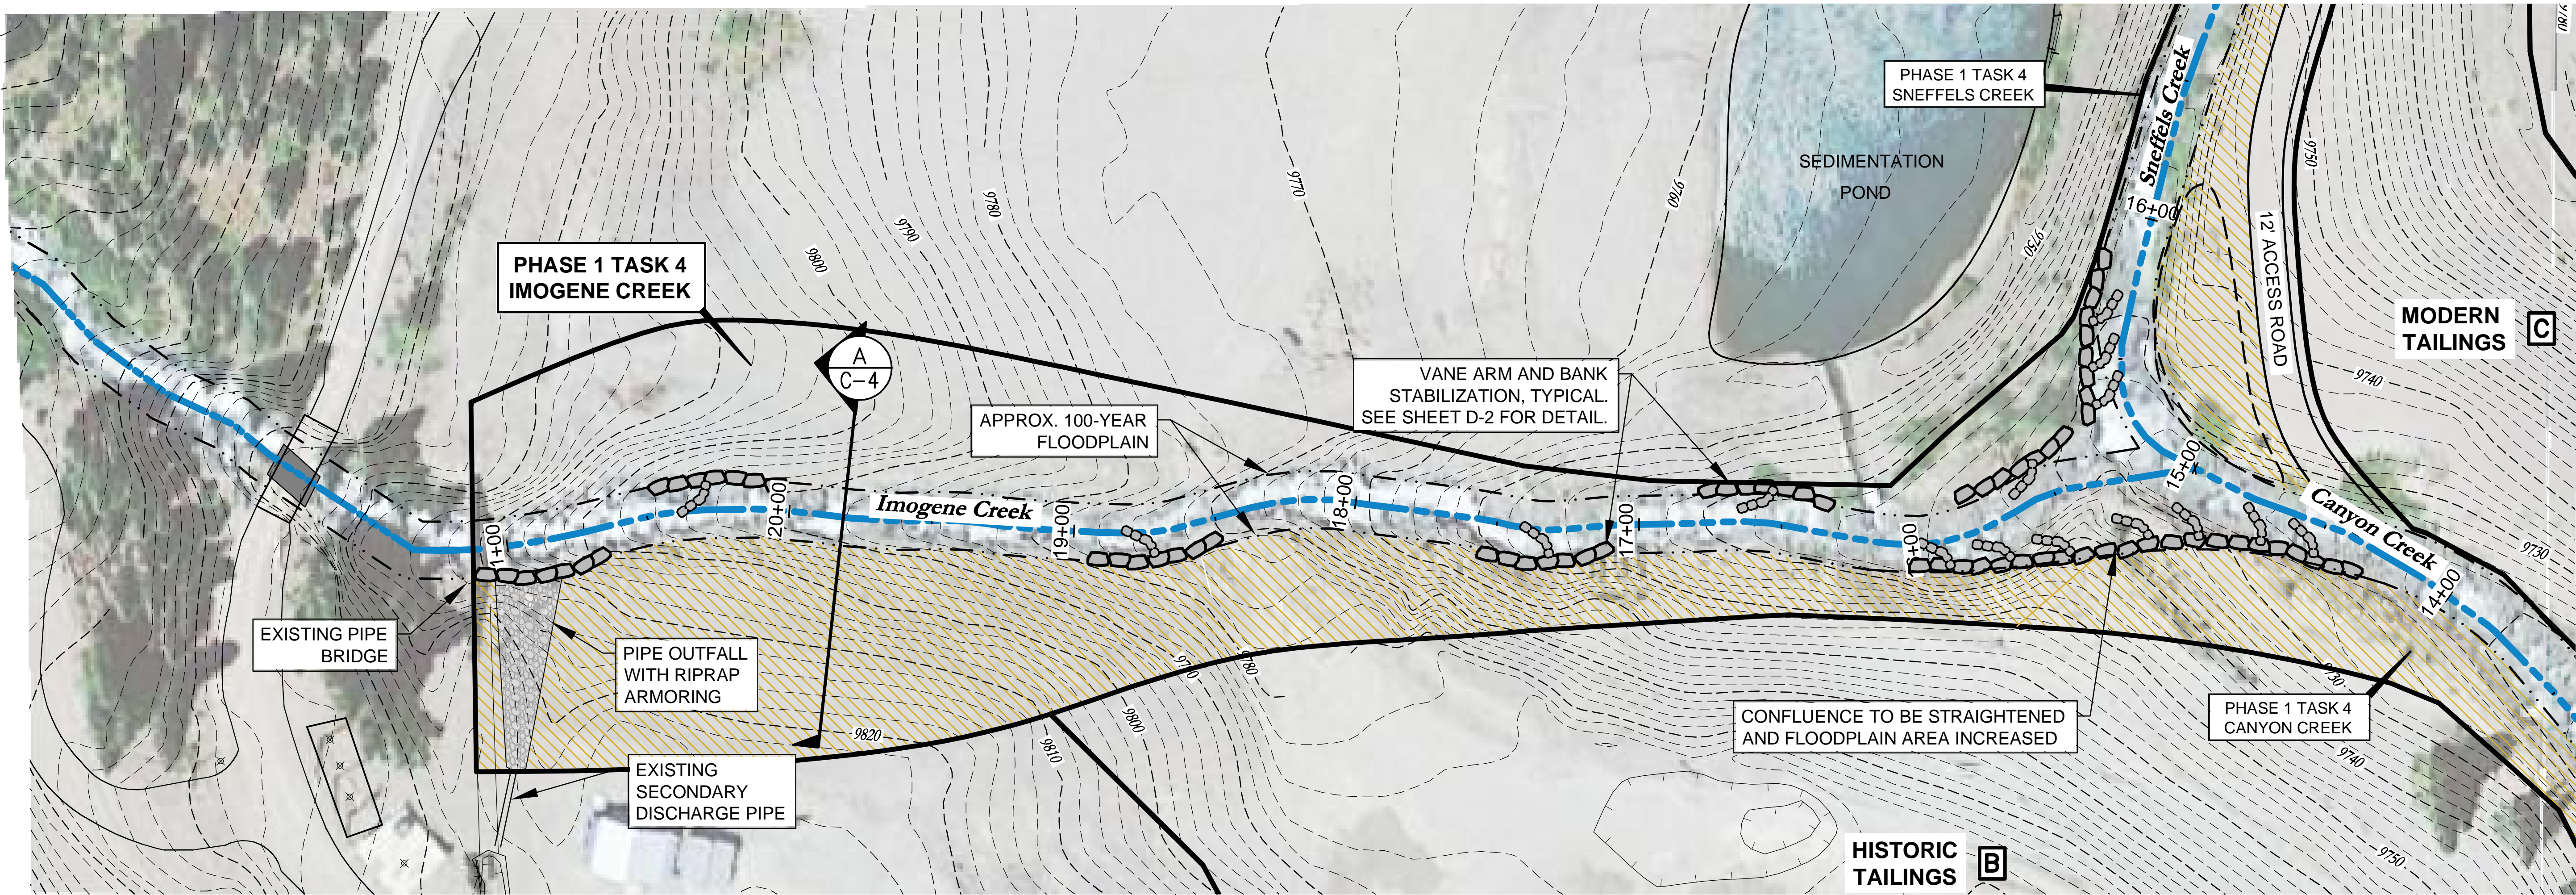
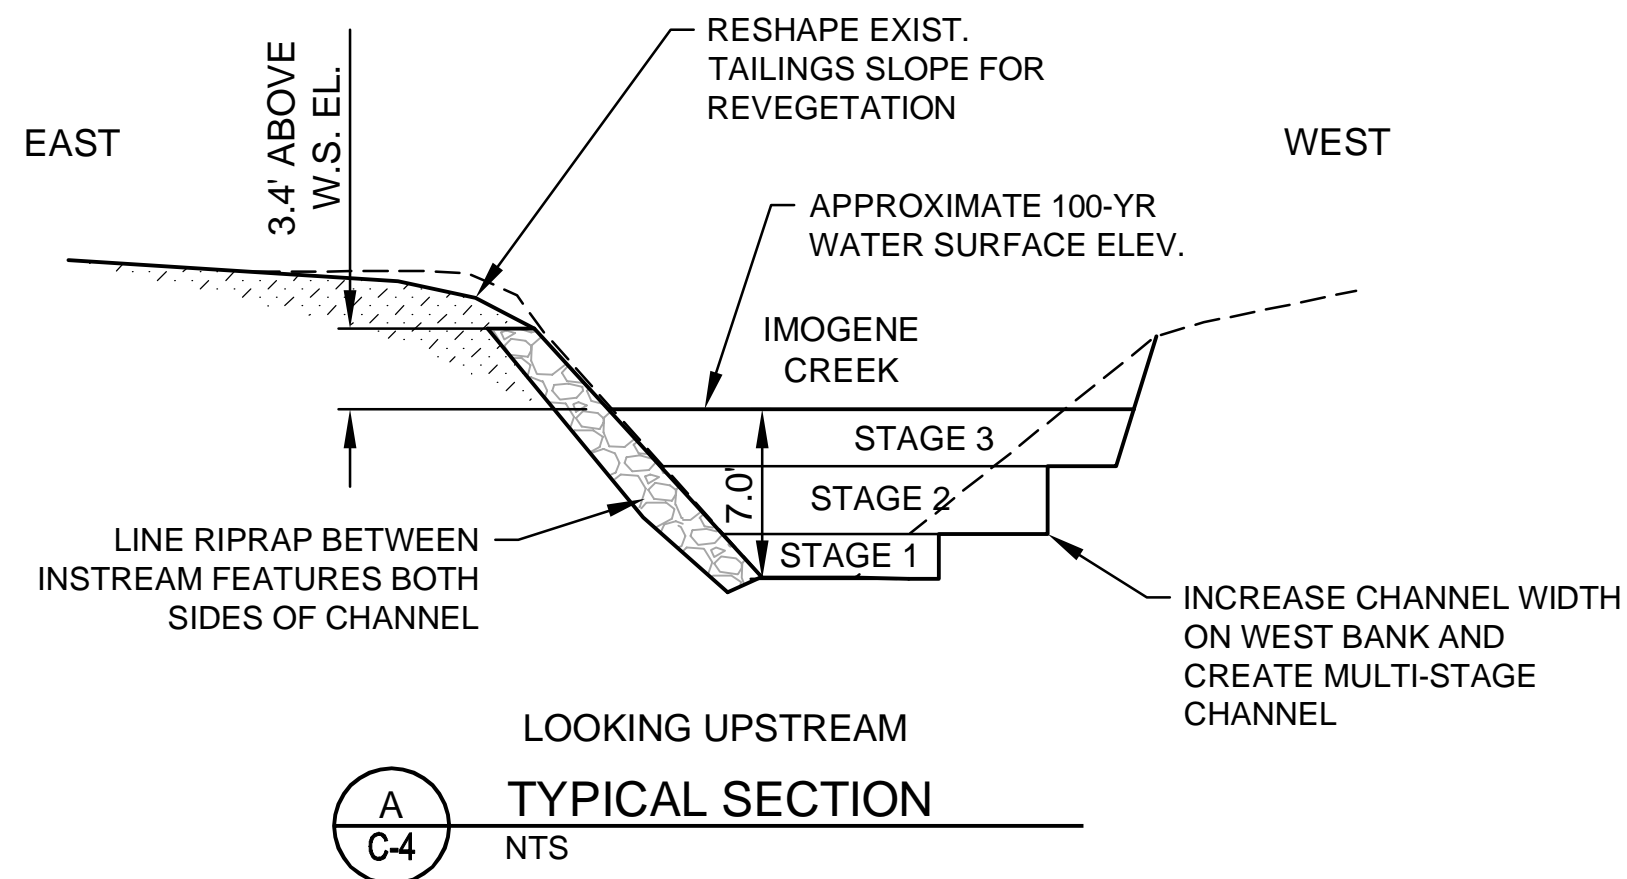
PHASE 1 TASK 4, IMOGENE CREEK  
RECLAMATION PLAN

PHASE 1 TASK 4  
IMOGENE CREEK WORK PLAN (2017)

- Contractor to lay back historic tailings on east bank of Imogene Creek to accommodate stream restoration. Should slurry ("slime") be encountered, cease work and contact DOWL for guidance to stabilize slope. Existing mine debris (timbers, metal debris, etc.) shall be removed.
- Contractor to install stream restoration features, which includes reshaping channel and installing boulder vane arms as generally shown herein and armoring both banks. Actual locations and dimensions of will be determined by contractor during construction.
- Revegetation in areas shown using approved seed mix and Erosion Control Measures (ECM's) (See Sheet D-3).
- Vane arm location, extent and quantities are approximate. Location will be determined in the field.

Imogene Creek from the pipe bridge to the low water crossing is completed. The stream channel was quadrupled in size, a large sinuous bend was constructed, all loose mine debris and loose boulders were removed, and 3 vane arms with accompanying bank stabilization were constructed. Large boulders were used for bank stabilization beneath and adjacent to the pipe bridge. The banks of Imogene were laid back to approximately 3H:1V. Approximately 30 feet of the secondary discharge pipe was dismantled to remove the pipe from the stream channel and bank. All old cribbing along the right and left banks was removed and replaced with bank stabilization boulders. Mine features pinned to bedrock (e.g. historic trestle footers and the foundation for the coarse ore bin) were left in place due to their strength and historical significance.

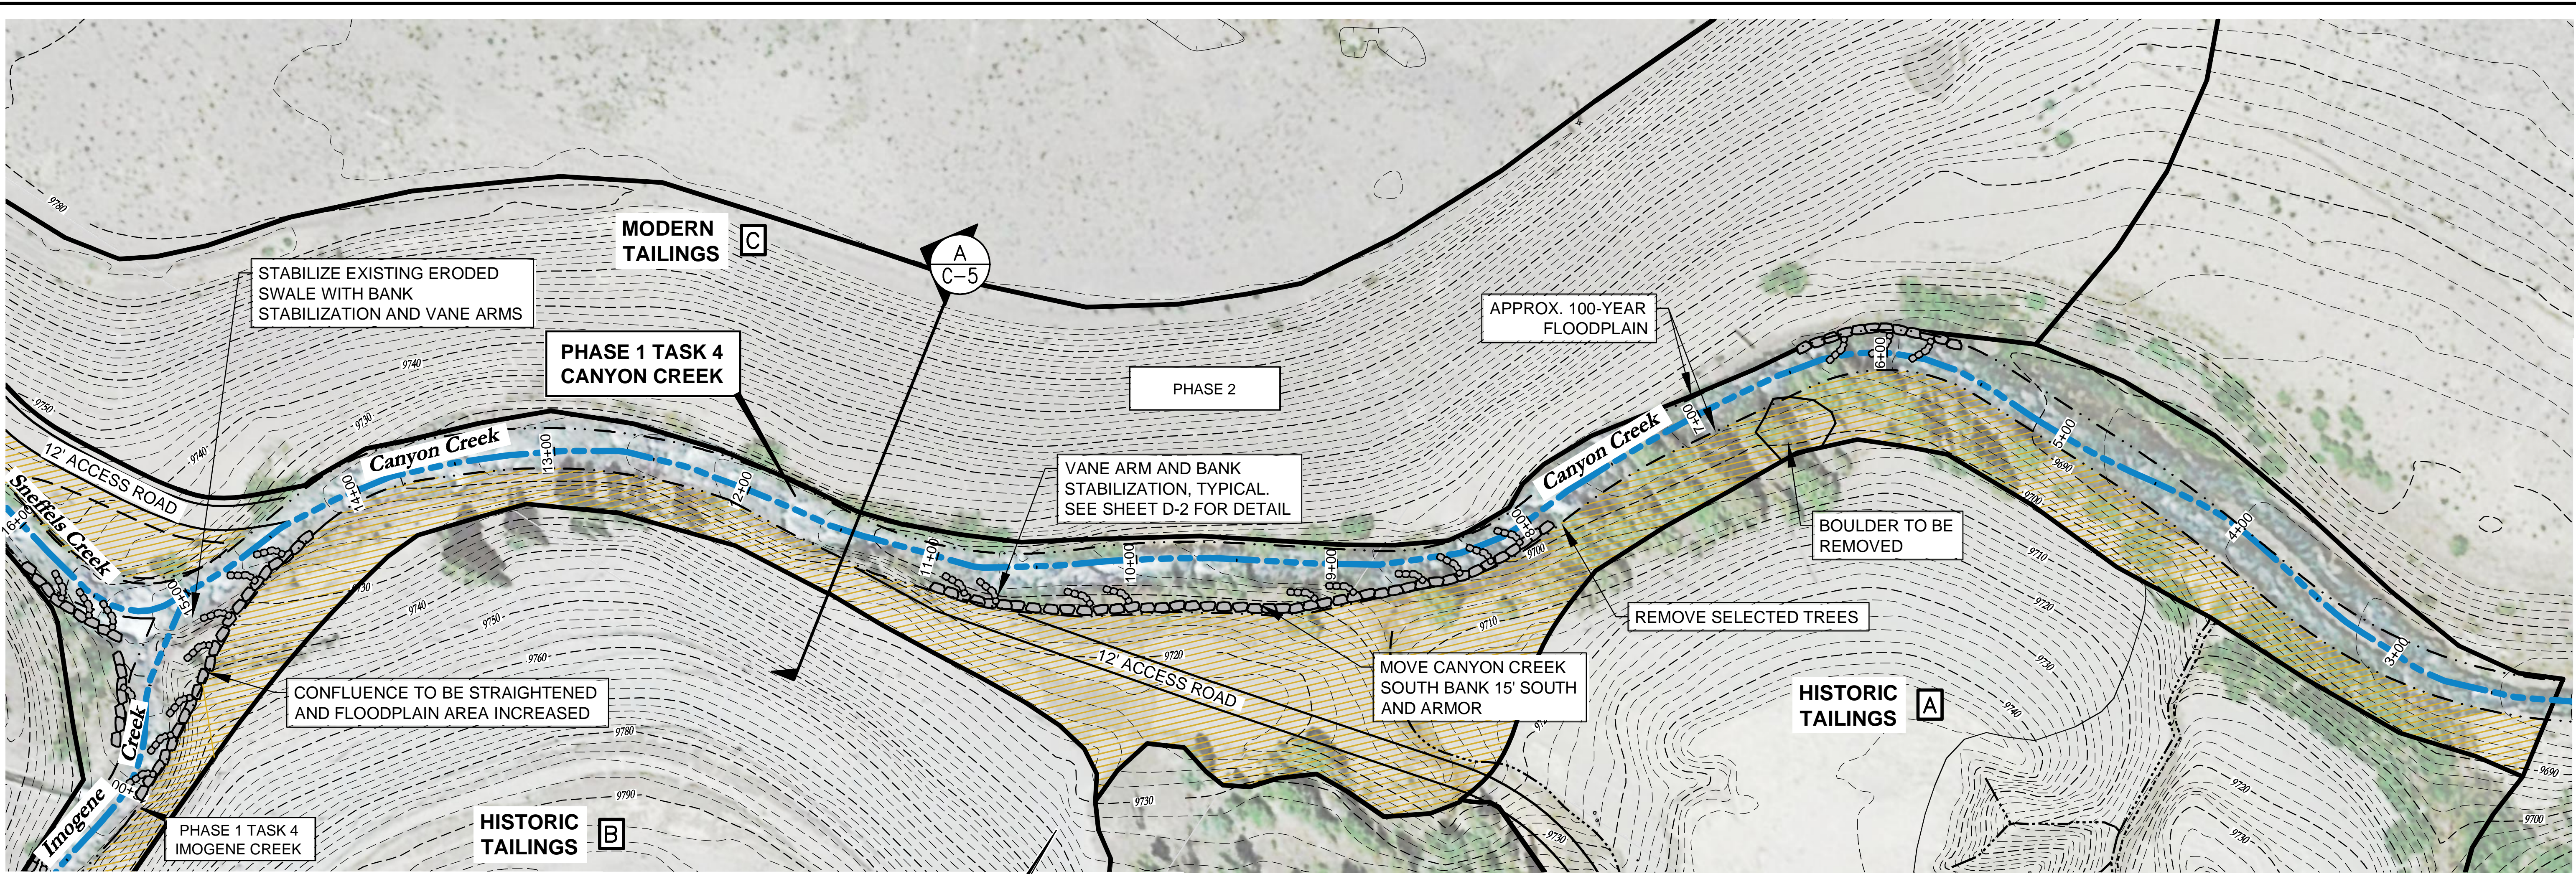
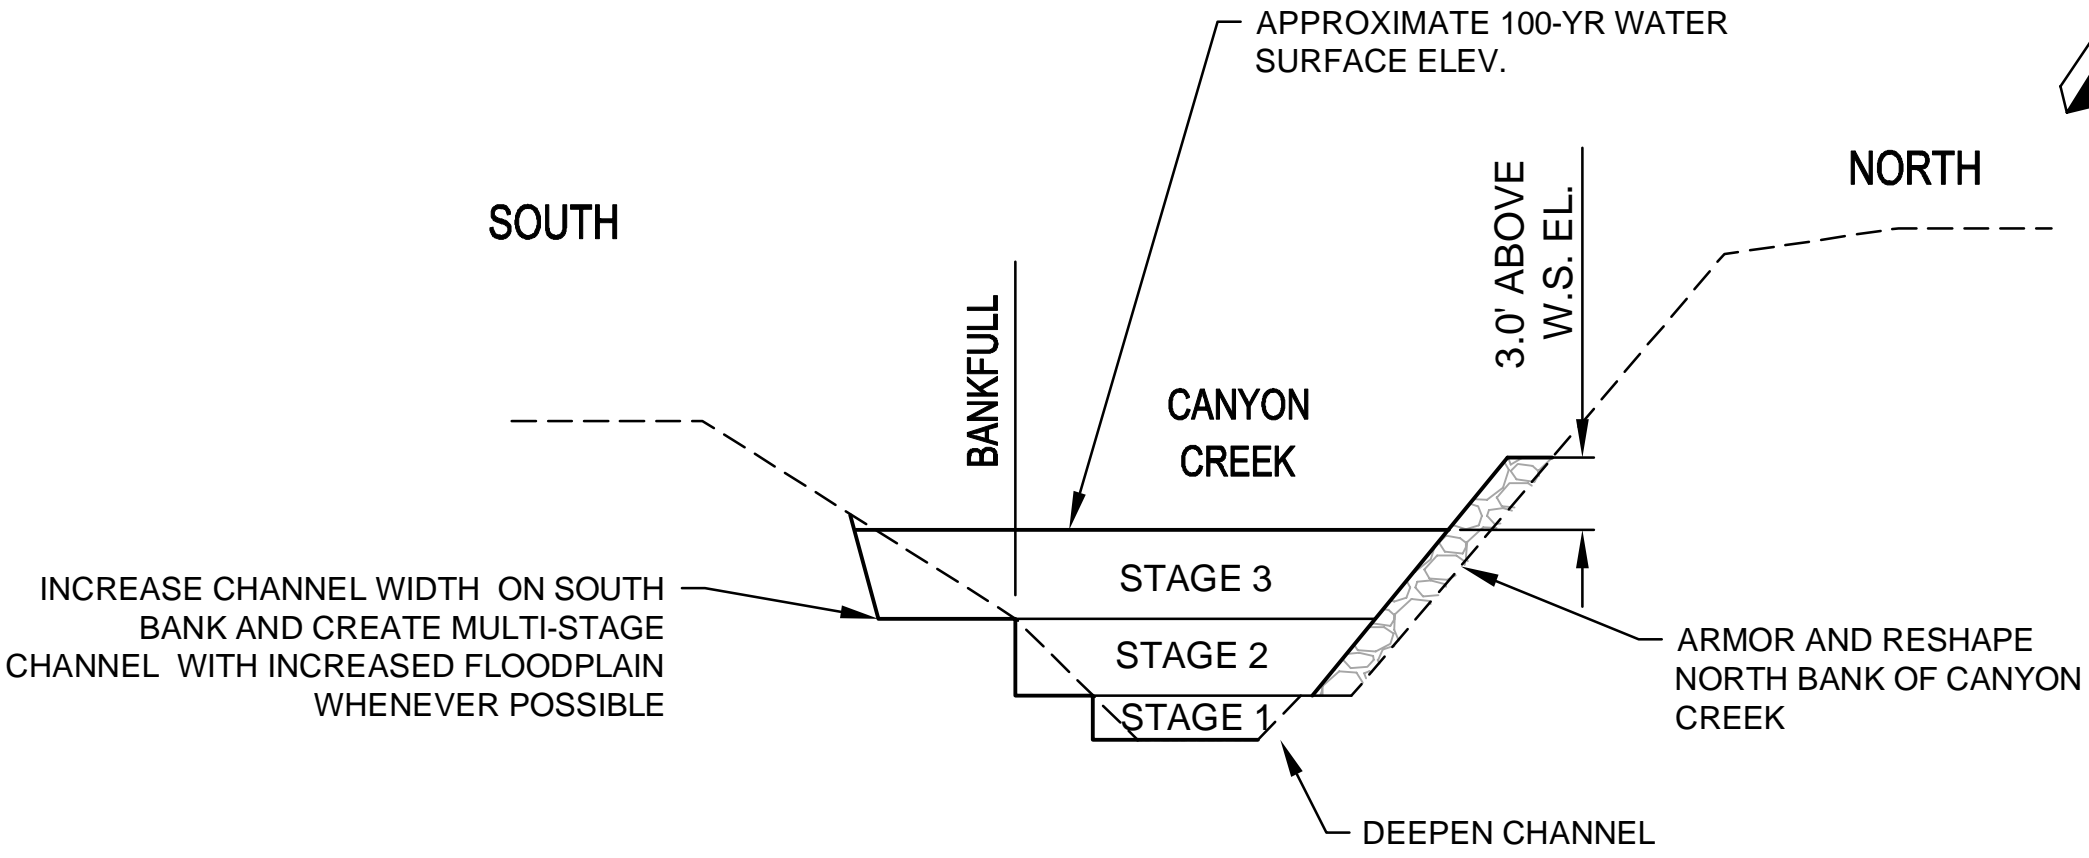
PHASE 1 TASK 4 - CANYON CREEK RECLAMATION PLAN

PHASE 1 TASK 4  
CANYON CREEK WORK PLAN (2018)

- Develop access road on south bank of Canyon Creek for construction/vegetation access.
- Remove large boulder by approved method to create required stream restoration material.
- Contractor to thin density of trees along south bank to open channel within floodplain.
- Reshape Canyon Creek north and south banks.
- Install stream restoration features including multi-stage channel, vane arms, scour pools and riprap armoring of banks in the general locations shown herein. Actual locations and dimensions will be determined in the field.
- No excavation of the north bank will be permitted.
- Revegetate a strip above the instream work using approved seed mix and Erosion Control Measures (ECM's).
- Vane arm location, extent and quantities are approximate. Location will be determined in the field.

The large boulder in the floodplain down gradient from P1T2 tailings pile has been blasted and completely removed and most trees that could constrict high flows were removed.
